MINUTES FROM RESTORATION ADVISORY BOARD MEETING 21 FEBRUARY 2008 NSWC  
INDIAN HEAD MD  
2/21/2008  
NSWC INDIAN HEAD

# INSTALLATION RESTORATION PROGRAM

## RESTORATION ADVISORY BOARD (RAB) MEETING

**Date of Meeting:** February 21, 2008, 5:00 pm

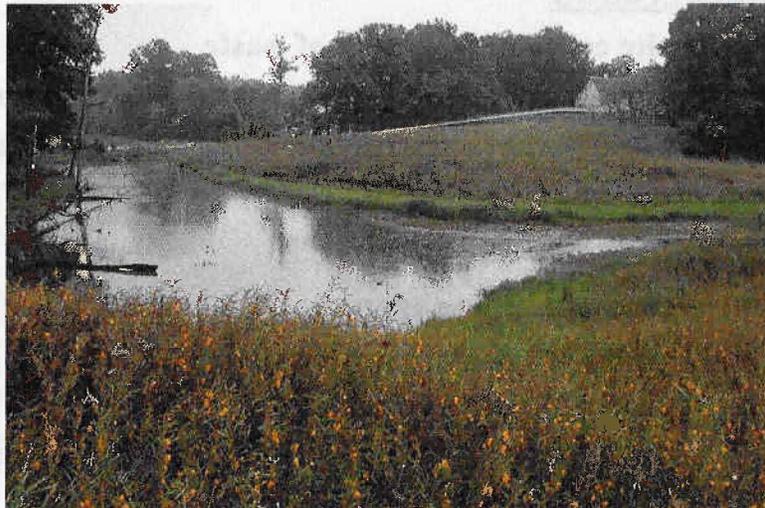
**Site 12-Town Gut Landfill**

- 4.8 Acre site containing 3 areas of waste
- 3 waste areas are divided by 2 ponds and Atkins Road Extension
- Landfill composed of construction rubble and landscaping debris

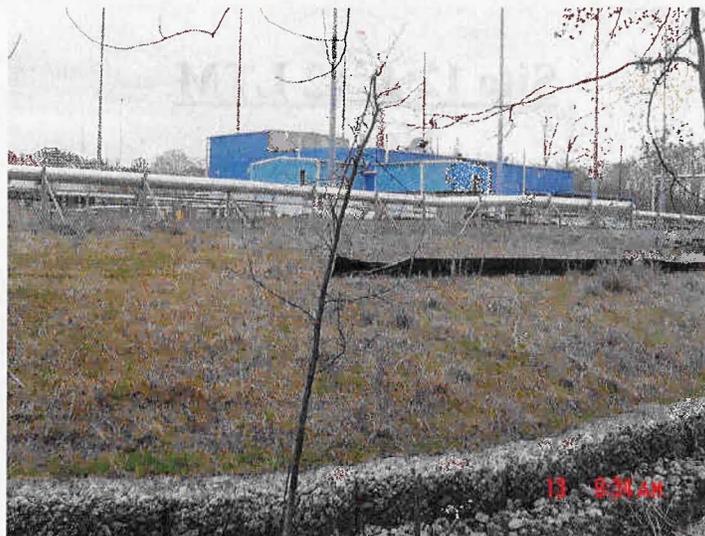
### Site 42-Olsen Road Landfill

- 2 acre site near Building 1866
- Landfill composed of solid wastes, demolition debris, wood, metal, and steel drums
- Remedial action included 1.43 acre engineered cap and extension of asphalt area

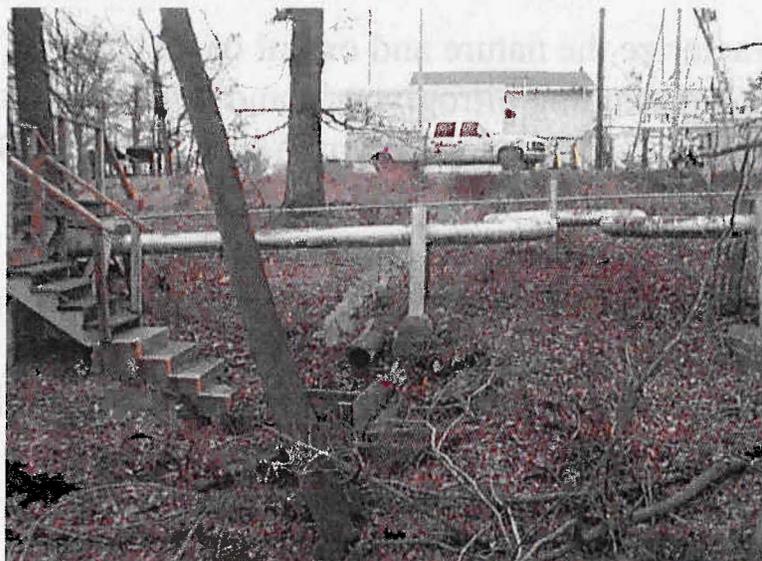
## *Site 19- Catch Basins at Chip Collection Houses*

- Consists of drainage areas leading from two chip collection houses, Buildings 785 and 1051
- Releases from catch pad outfalls may have contaminated stream sediments
- Only Building 785 remains in operation
- Wastewater is now recycled rather than discharged to swales
- Contaminants of concern include inorganics and explosives

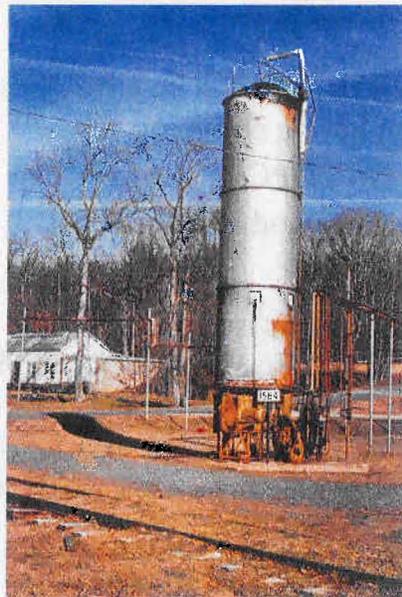
### *Site 27- Thermal Destructor 1*

- Site is located north of Hershey Road and 400' from the Mattawoman Creek
- Former destructor was located on concrete pad (Building 1584)
- The incinerator operated from 1976-1979 and burned hydrazine-containing fuel and UDMH-contaminated wastewater
- Potential spills from operations may have contaminated soils surrounding concrete pad

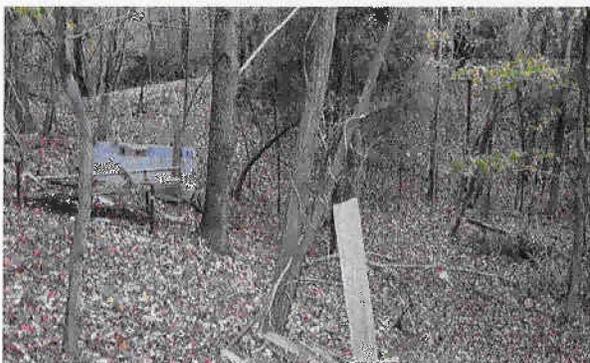
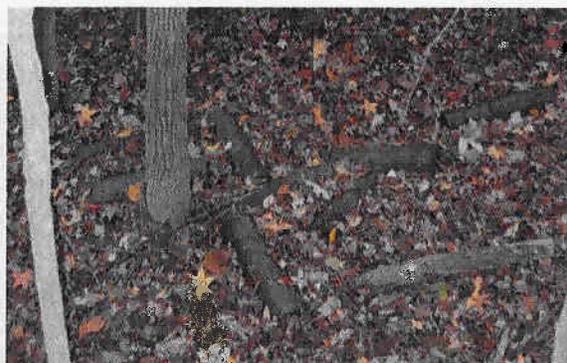
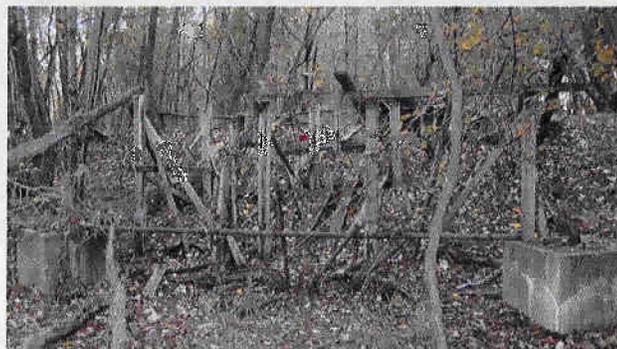
# Air Blast Pond (UXO 1)

- Metallic debris is a problem both inside and outside the Air Blast Pond. A 57mm projectile (expended) was recovered at this site (on the berm).
- Geophysics survey to perform site footprint reduction will require extensive metallic interference removals
- Operations included testing/detonation of bulk explosives (TNT, PETN, HBX-1, HBX-2, H-6, C4, and Composition B).
- Based on materials observed outside/adjacent to Air Blast Pond (drums, pipe sections, solid metallic training items), other training may have been performed at site.
- Limited soil sampling during the VI for soil (surface and subsurface) inside and outside the pond and sediment outside the Air Blast Pond confirmed no detectable explosives.
- Perform surface/subsurface sampling (explosives) to confirm/supplement existing environmental data.

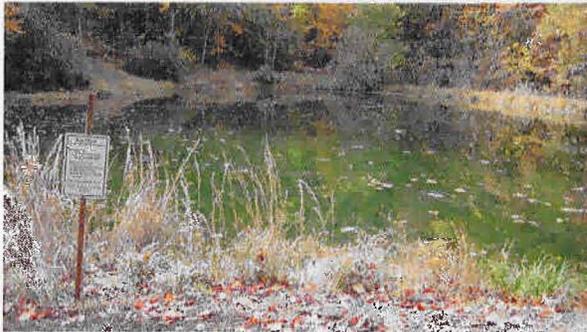
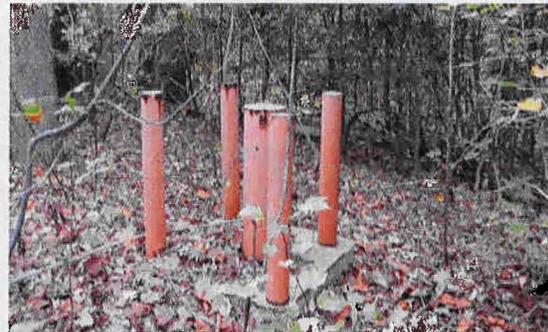
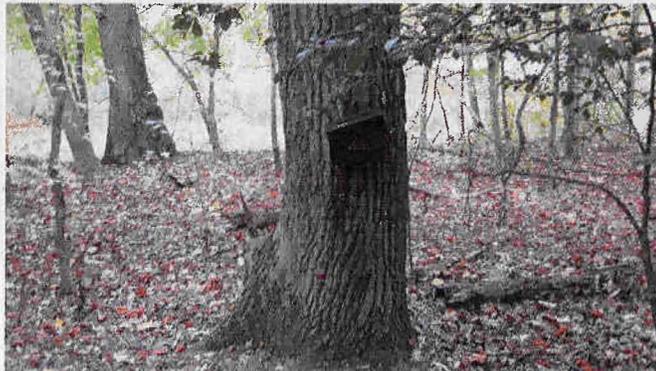
## Area 8 (UXO 2)

- **Need to supplement Visual Inspection (VI) environmental data.**
- **Operations included TNT blocks, detonation cord, fuzes, etc. Inert training items may remain on the pond bottom.**
- **Perform detector-aided general surface sweep within 25 feet of inert training device locations (connected to shot points) to identify any remaining training materials at site.**
- **Selected subsurface sampling for explosives with anomaly avoidance. Regular maintenance for water shot-points may have included periodic re-excavation with materials from hole bottom moved and redeposited on the hole margins.**
- **Site has three groundwater wells. Need for additional groundwater sampling points or adequacy in using existing wells for explosives/perchlorate (confirmatory sampling)**
- **Selected soil sampling to supplement existing environmental data (confirmatory sampling).**

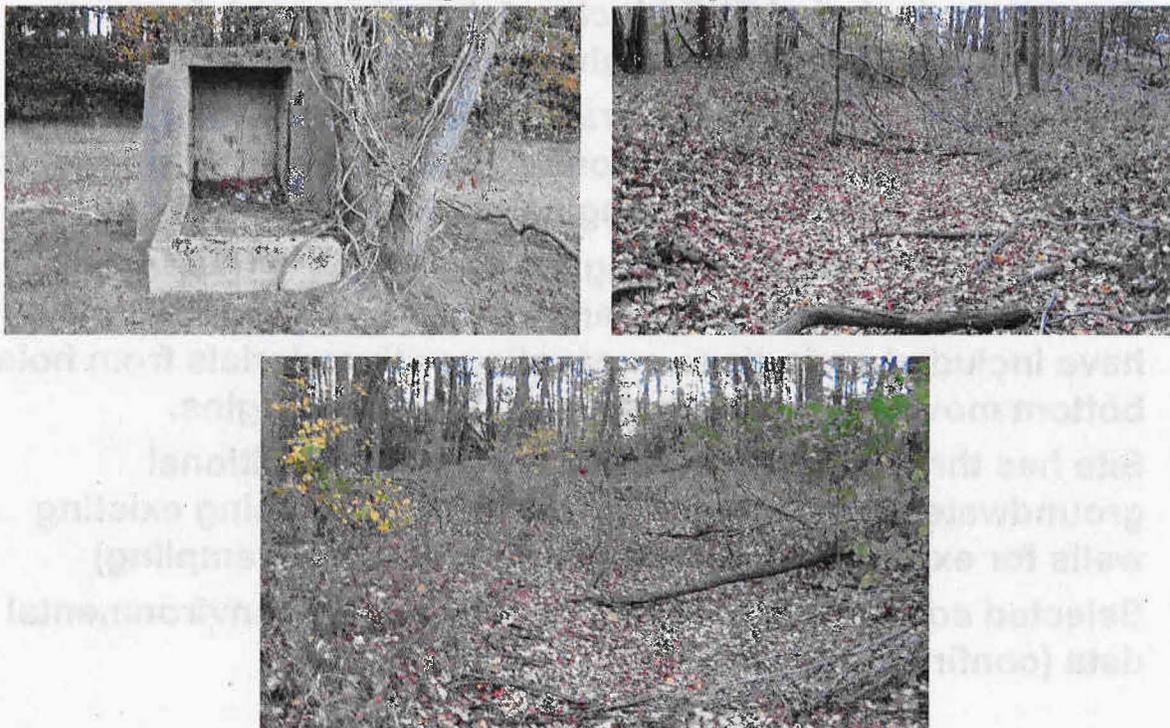
# EOD School Demolition Area (UXO 28)

- No recommended geophysics approach for this site.
- Use UXO detector-aided survey to focus small transect spacing around concrete structure and a coarser transect spacing to reconnoiter the rest of the site (5 acres)
- Need for vegetation removal (grass mowing and limited underbrush removal-forest portions) to support surface sweep activities and soil-sampling performance.
- Perform selected subsurface sampling of munitions constituents (MCs) with anomaly avoidance to supplement existing environmental data.

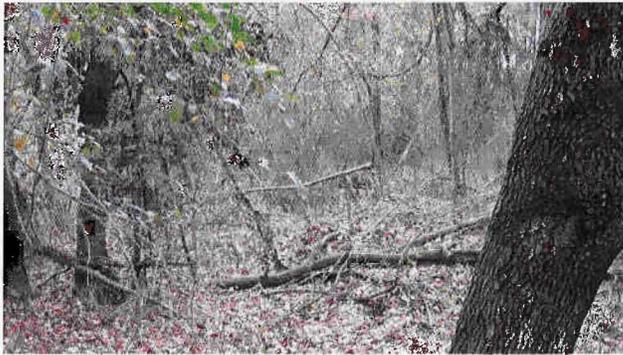
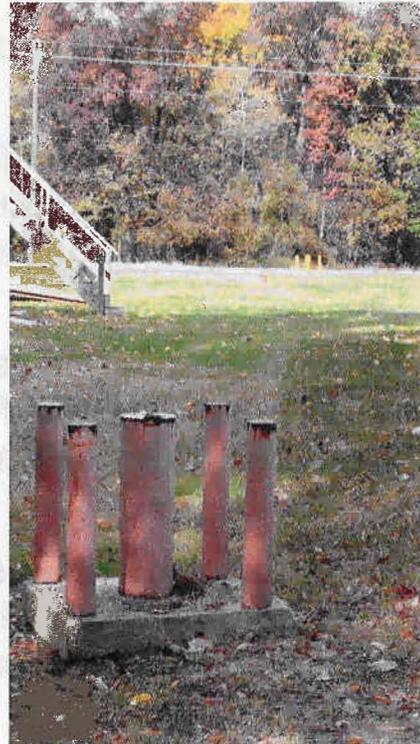
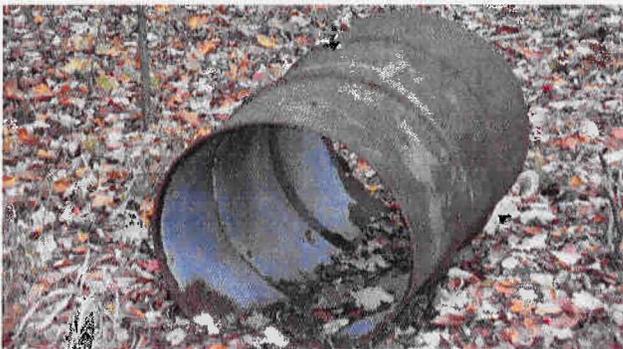
## Basic IED Area (UXO 4)

- No recommended geophysics approach for this site.
- UXO detector-aided survey is recommended to reconnoiter the range.
- Focus survey with smaller transect spacing around the detonation area
- Need for vegetation removal (grass mowing and some limited underbrush removal in forested portions) to support detector-aided survey actions and sample collection.
- Selected subsurface sampling to supplement existing environmental data.
- Uses a similar approach to that proposed for the Advanced IED Area.

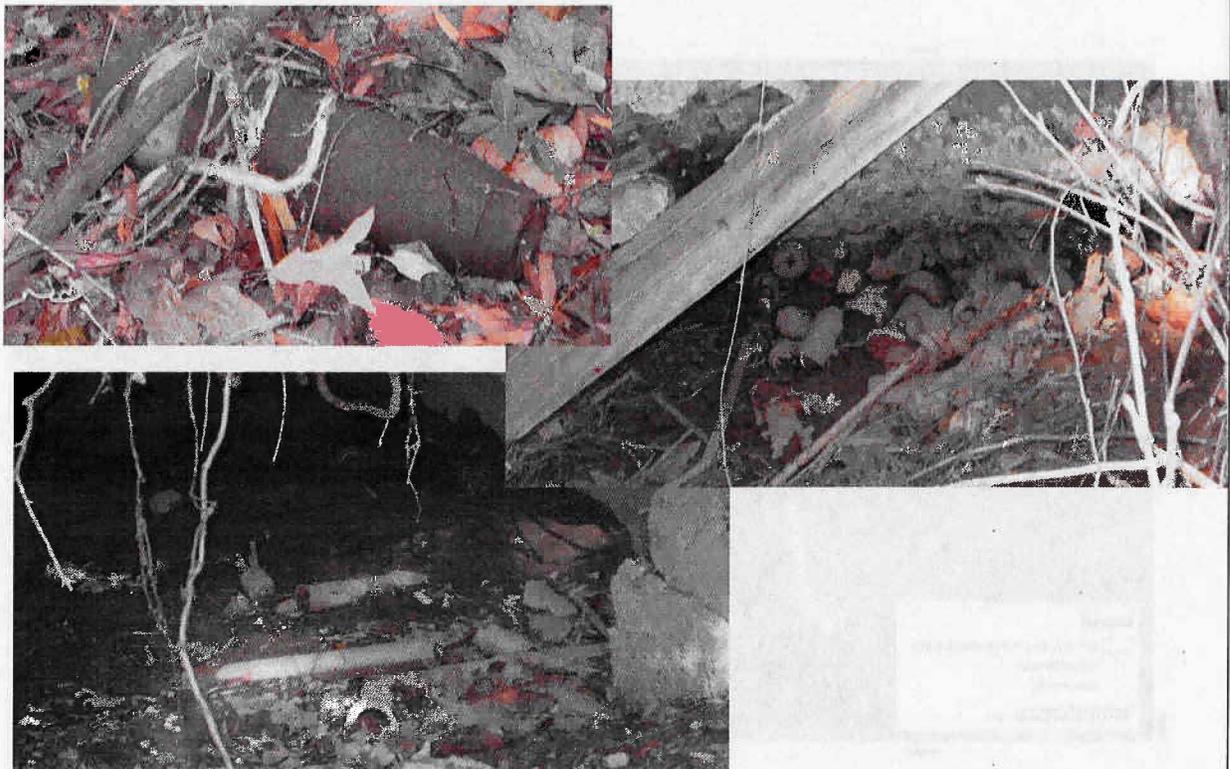
# Advanced IED Area (UXO 5)

- UXO detector-aided survey for the entire site
- Focused UXO detector-aided survey near the concrete structure and site berms with 100% coverage
- Need for vegetation removal (grass mowing and some limited underbrush removal in forested portions) to support geophysical survey/sample collection programs
- Selected subsurface sampling for munitions and explosives of concern (MECs) with anomaly avoidance to supplement existing site data.
- ESS may be required due to potential munitions hazards, scrap munitions, detonation cord, fuzes, igniters, etc. observed at the site.
- Removal of non-MEC scrap materials
- Possible use of facility EOD to perform removals

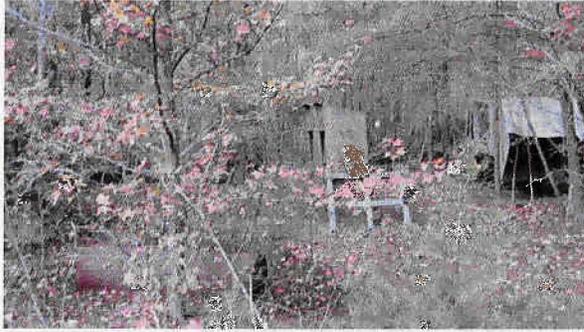
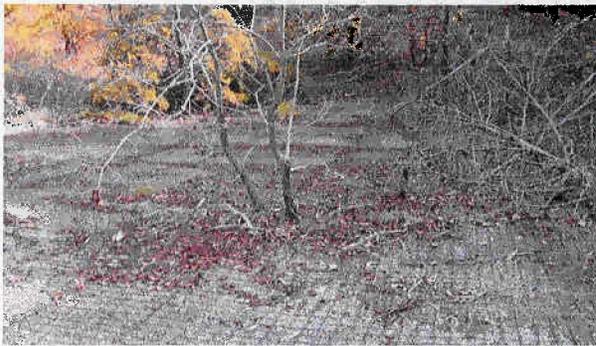
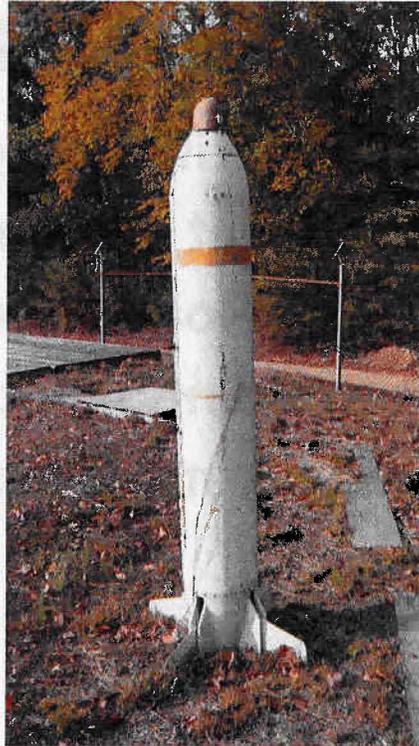
## Test Area 1 (UXO 21)

- **Selected subsurface sampling to supplement existing environmental data and perform site footprint reduction. The southeastern corner of the site appears to have been the site of some explosive training activities.**

- **Geophysics sweep of bowl not possible due to iron mesh reinforcement in asphalt materials. Recommend a 100-percent detector-aided surface sweep for site outside bowl.**

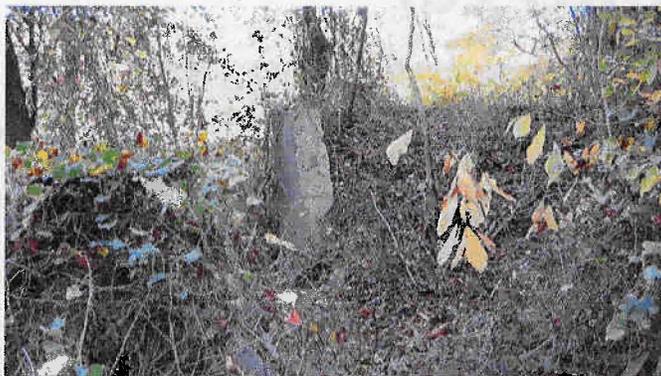
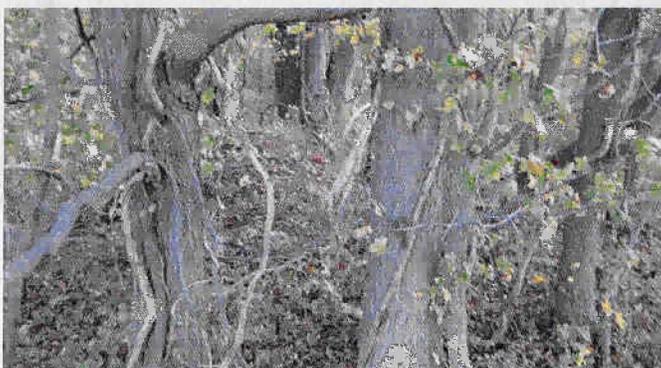
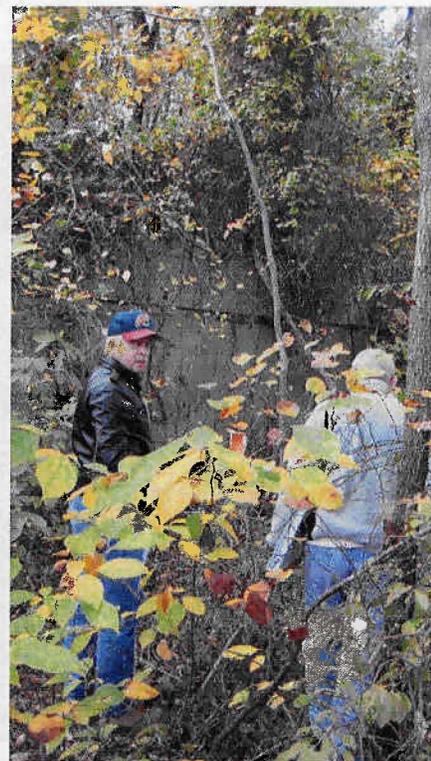
# Marine Rifle Range (UXO 14)

- Two discrete target butts on east end of rifle range.
- Target butt soil (subsurface) to be field-screened using XRF instrumentation to identify subsoil lead concentrations.
- Lead is the marker compound. Need reference concentration—either health-based or risk-based for lead in soil to evaluate samples against.
- Emphasis on field analyses, with limited laboratory analysis to confirm lead/other metal concentrations in target butt subsurface soil.
- Consider limited soil sampling in front of target butts (undershot) and beyond target butts (overshot) to delineate zones of projectile and/or metals accumulation beyond the range target butts.
- Selected subsurface sampling to supplement existing environmental data and perform site footprint reduction.

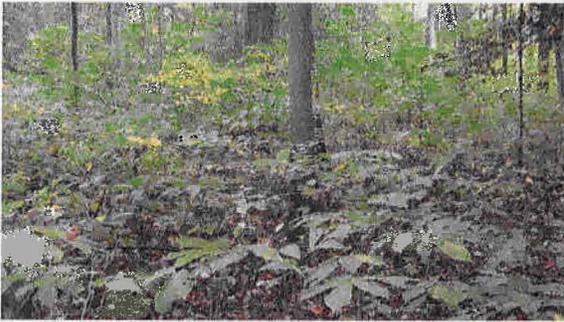
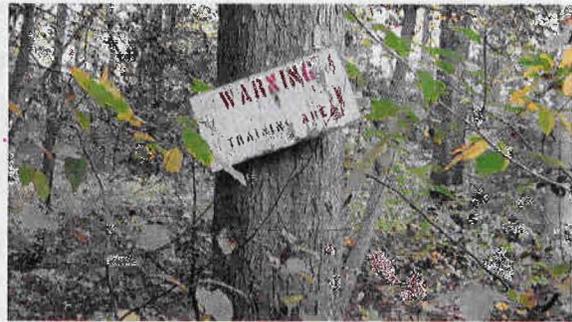
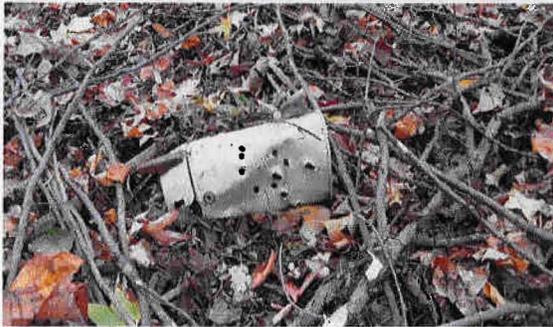
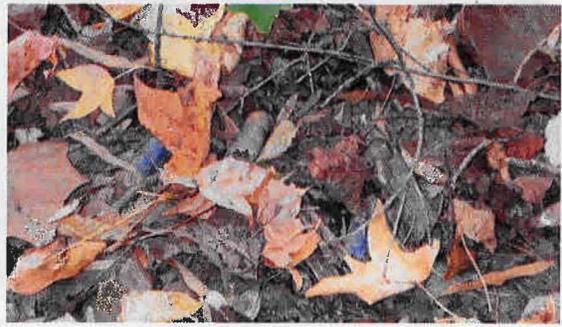
# Roach Road Rifle Range (UXO 25)

- **Historical aerial photographs will be used to verify the location of the rifle range. The PA verified that the location of Roach Road was modified in this area (road shifted in 1982).**
- **The 1963 memorandum indicates a barricade (target butt) was constructed behind the targets using earth and railroad timbers.**
- **Range soil to be field-screened using XRF instrumentation to identify subsoil lead concentrations.**
- **Lead is the marker compound. Need reference concentration—either health-based or risk-based for lead in soil to evaluate samples against.**
- **Emphasis on field analyses, with limited laboratory analysis to confirm lead/other metal concentrations in range soil. discrete target butts on east end of rifle range.**

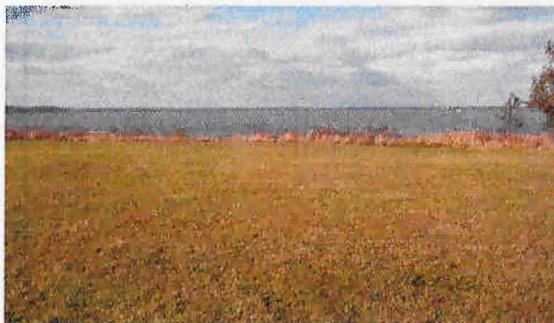
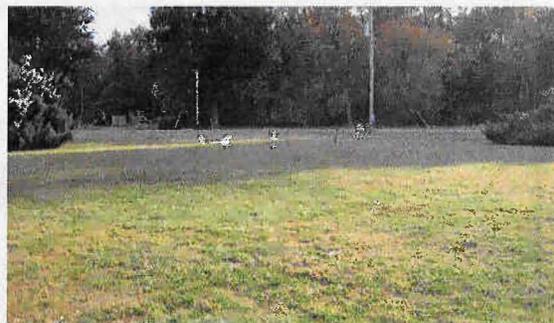
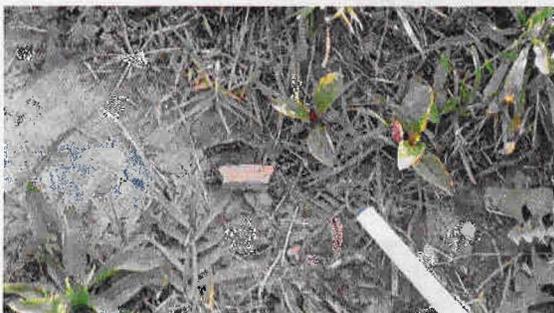
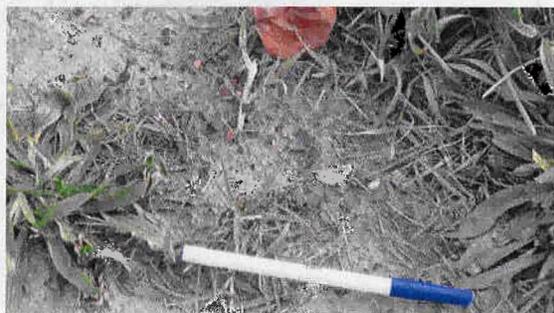
# Old Skeet & Trap Range (UXO 15)

- Superimpose maximum fall zone for shot onto MRP site map. Much of the maximum fall zone may be in the Potomac River (underwater).
- Surface soil samples to be field-screened using XRF instrumentation to identify subsoil lead concentrations.
- Lead is the marker compound. Need reference concentration—either health-based or risk-based for lead in soil sample screening.
- Soil samples to be evaluated for PAHs (clay pigeons are a source for these compounds), and many fragments are present on this range.
- Emphasis on field analyses, with limited laboratory analysis to confirm lead/other metal concentrations (and PAHs) in surface soil.

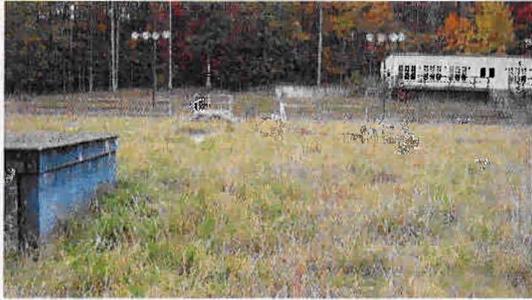
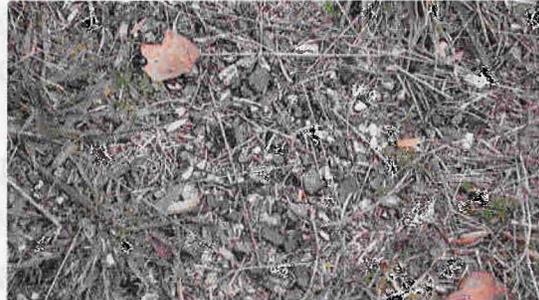
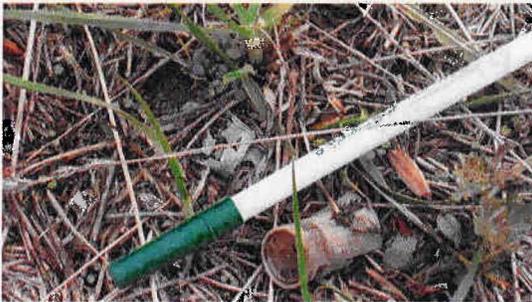
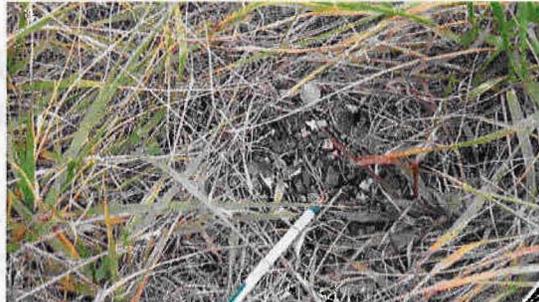
## Rum Point Skeet Range (UXO 16)

- Superimpose maximum fall zone for shot onto MRP site map.
- Surface soil samples to be field-screened using XRF instrumentation to identify subsoil lead concentrations.
- Lead is the marker compound. Need reference concentration either health-based or risk-based for lead in soil to evaluate samples against.
- Soil samples to be evaluated for PAHs since clay pigeons are a source for these compounds. Many clay pigeon fragments and plastic shot gun wads were observed at surface and are present on this range.
- Emphasis on field analyses, with limited laboratory analysis to confirm lead/other metal concentrations in range soil.
- Sediment samples to be collected from drainage west of range to evaluate particulate transport by surface water

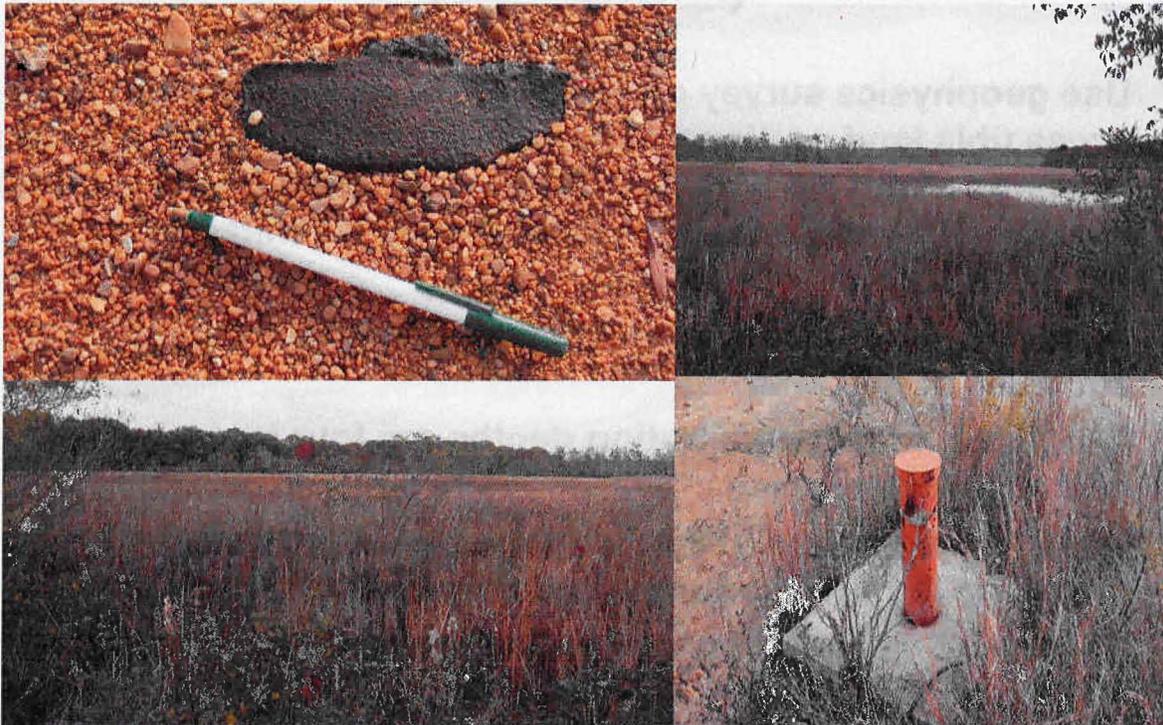
## The Valley Impact Area (UXO 26)

- **Subdivide The Valley Impact Fan Area into general categories**
  - ✓ **Developed Areas (to be excluded)**
  - ✓ **Undeveloped Areas**
  - ✓ **Open Accessible Areas**
  - ✓ **Inaccessible Areas (swamp/wetlands) also to be excluded**
- **Use geophysics surveys with variable transect spacings (small sites – small transect spacing, larger sites – larger transect spacing) to reconnoiter the accessible undeveloped areas of the Valley Impact Area. Question raised as to whether Valley Impacts were ever discovered within the developed areas (Action Item – determine if there is a problem related to these old impacts?)**
- **Historical records and observed munitions fragments and debris at Stump Neck Point (end of peninsula) also indicate EOD training activities (i.e., Range 6) within this area.**

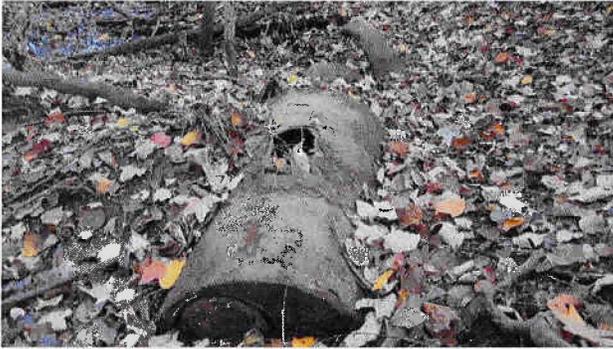
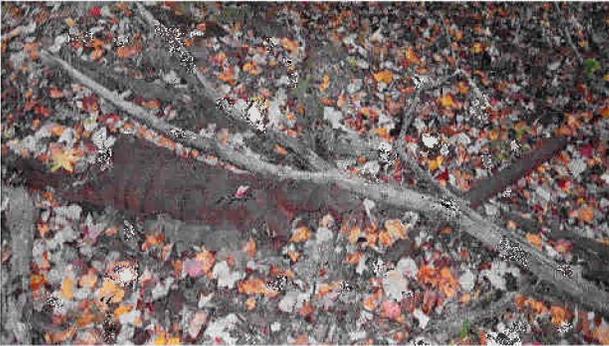
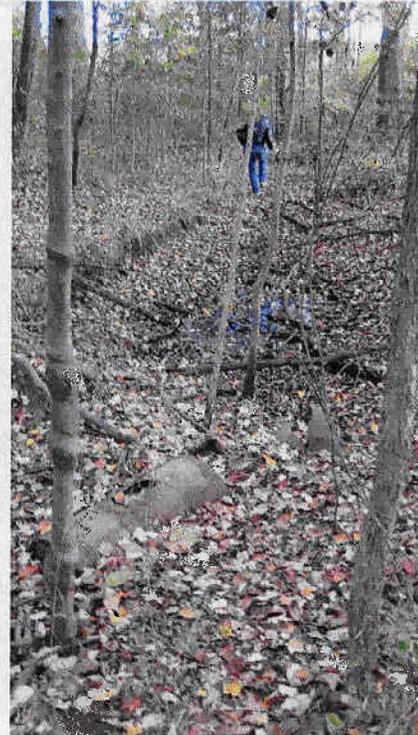
## Torpedo Burial Site (UXO 12)

- Use geophysics survey with 5 ft line spacing to allow coverage for large targets across the site (site grew from inventory to now being about 1.75 acres in area).
- Need for vegetation (underbrush) removal to support geophysical grid performance.
- Looking for shallow burial pits with metallic torpedoes at this site, so the geophysical signal should be very evident.
- Selected subsurface sampling for munitions and explosives of concern (MECs) with anomaly avoidance.

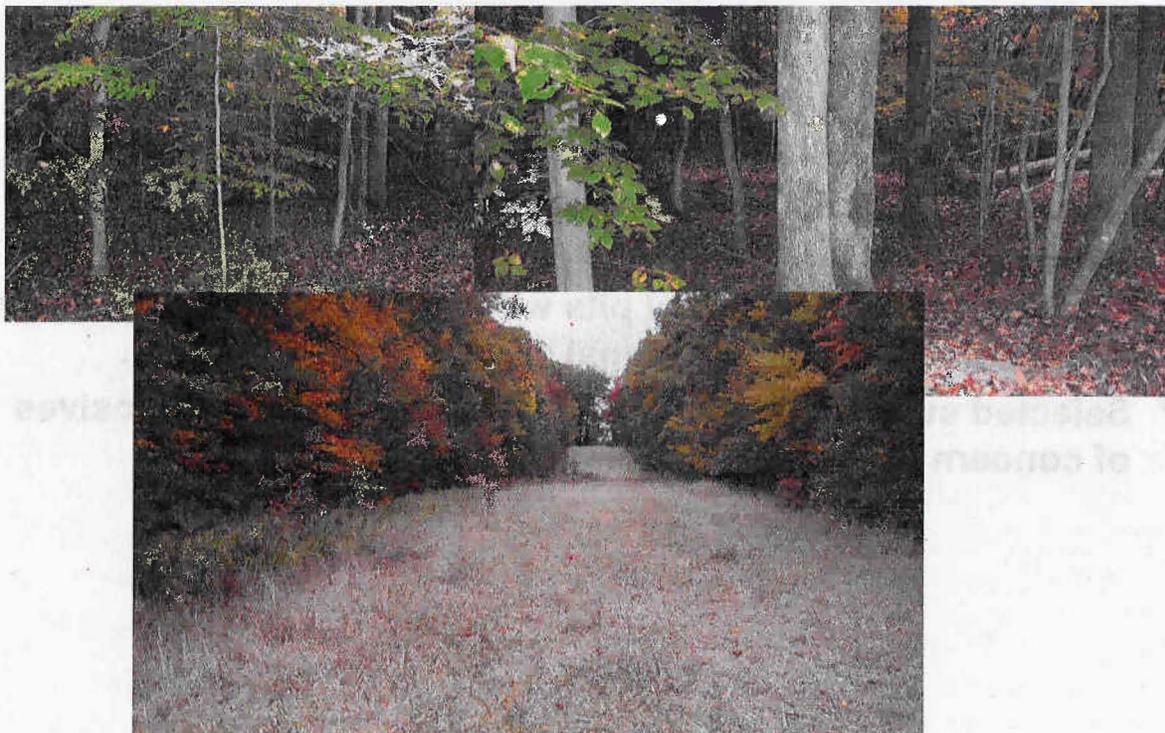
# Torpedo Casing Disposal Site (UXO 23)

- **Use geophysics survey (10-foot line spacing) to search for disposal areas (areas with high metal content [torpedoes]).**
- **Need for vegetation (underbrush) removal to support geophysical grid performance.**
- **Looking for shallow burial pits with metallic torpedo casings at this site, so the geophysical signal should be very evident.**
- **Subsurface anomalies (potential disposal pits) will be included in the selected subsurface soil sampling for munitions and explosives of concern (as residual MEC on casing materials) with anomaly avoidance.**
