MINUTES FROM RESTORATION ADVISORY BOARD MEETING 19 FEBRUARY 2009 NSWC  
INDIAN HEAD MD  
2/19/2009  
NAVFAC WASHINGTON

# INSTALLATION RESTORATION PROGRAM

## RESTORATION ADVISORY BOARD (RAB) MEETING

### Site 28 Removal Action Completion

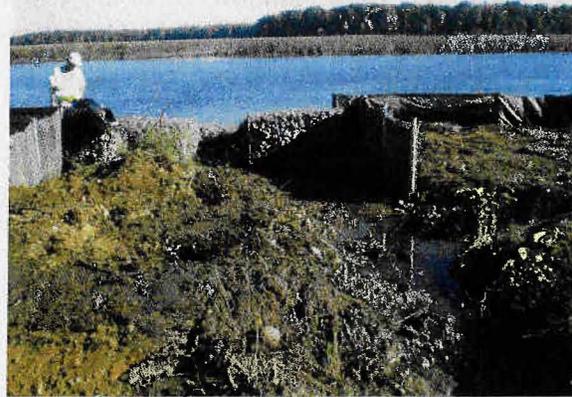
## *Initial Site Activities*

- *Site 28 Activities began in October 2007*
- *Began installation of Erosion & Sediment Controls*
  - *Super Silt Fence*
  - *Gabion Baskets*
  - *Temporary Dike Swale*
  - *Check Dam*

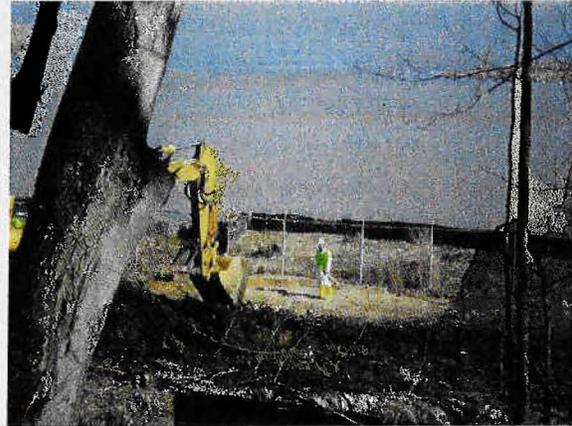
## Initial Excavation

- *Began removal of the top 6 inches of soil for transportation and storage at Caffee Road Landfill*
- *UXO technicians were to observe all excavation operations and remove propellant if identified*

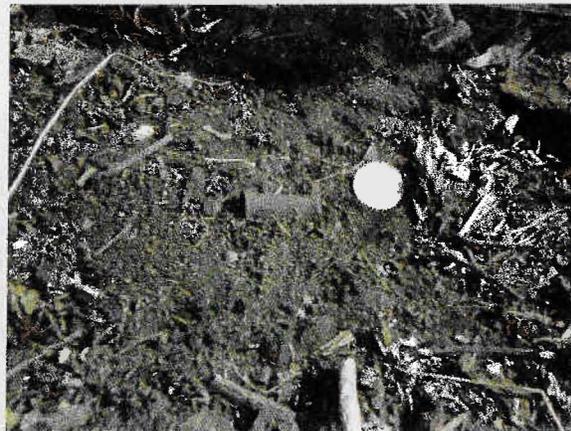
## Identification of Propellant Grains

- *November 2007 site activities were stopped and the crew demobilized due to the identification of 3 single base propellant grains*
- *An Explosive Safety Submission (ESS) and Memorandum of Agreement (MOA) were prepared and approved to address propellant grains identified at the site*
- *Crew remobilized and resumed activities in February 2008*

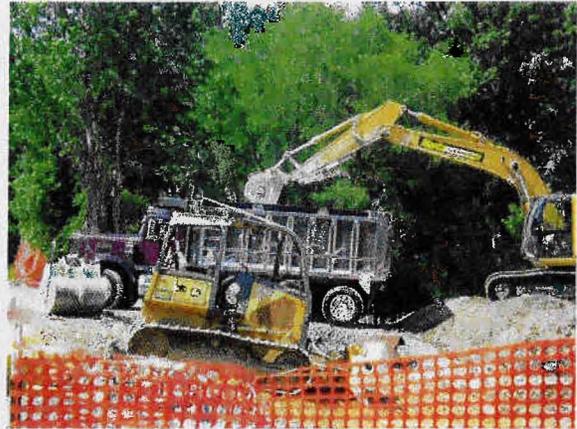
## Transportation and Disposal

- *Screened & certified soils transported off base for disposal*
- *13 Shipments were made*
  - *Total disposal was 5,734 tons*

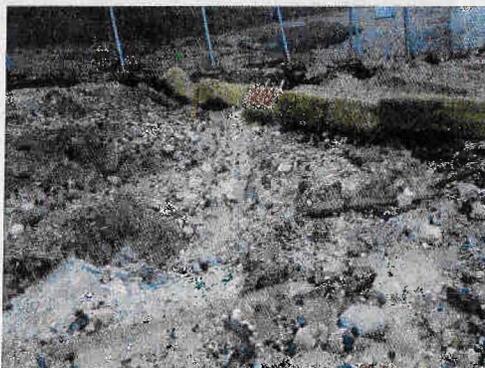
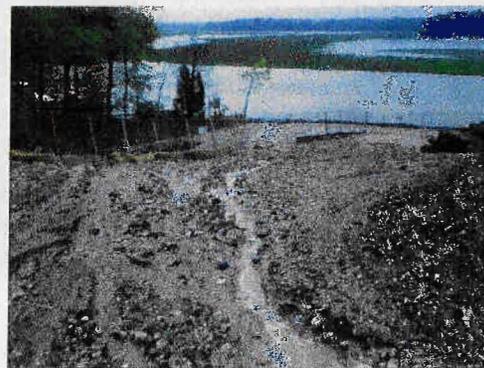
## Weather Damage

- *Severe rainfall caused damage to the site on several occasions*
  - *Required the installation of many new E&S and drainage features to control rainfall on Site 28 and drainage from surrounding sites/areas*
  - *Project activities were delayed while weather related repairs were made*

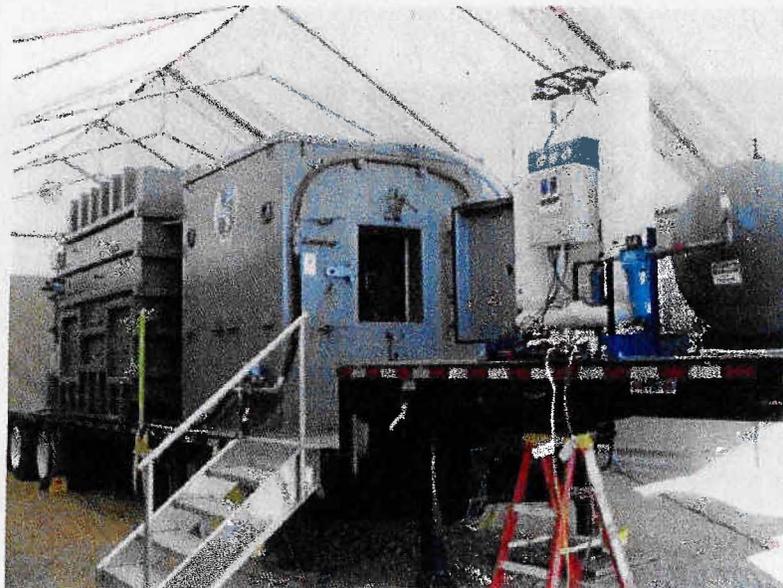
- *CDC will be used to demolish suspect items which qualify for detonation*
  - *Items must be less than 105mm and contain no more than 13 lbs TNT equivalent*
  - *Detonation chamber must have a minimum ¼" armor plating on interior*
- *CDC has an established Explosive Safety Quantity Distance (ESQD) of 0 feet during operations*
- *30 foot exclusion zone (EZ) will be established around the CDC prior to detonation*
- *When EZ is active, only CDC operators and safety personnel are allowed within EZ area*
- *All items waiting for CDC treatment or which cannot be immediately packaged and transported off site will be stored in temporary magazines*

## Contained Detonation Chamber

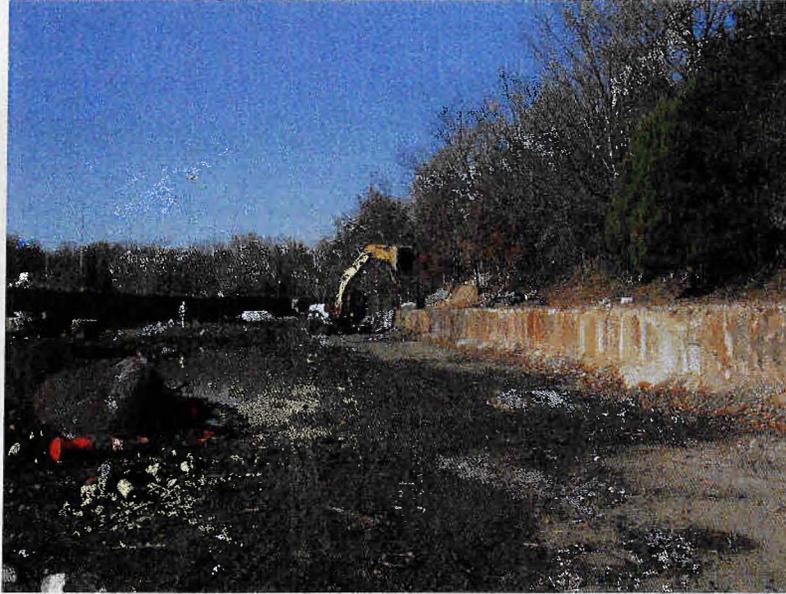
- *Once all soils and items inside the fence are removed, concrete pad will be cleaned and the area will be investigated based on expected COCs (PCBs and lead)*
- *Concrete pad condition will be evaluated and considered in final remedy*
- *COCs outside of fence will have been addressed during excavation, screening, and disposal of soil*
- *Excavation & screening during Phase II expected to last approximately 6 months*

## *Environmental Investigation*

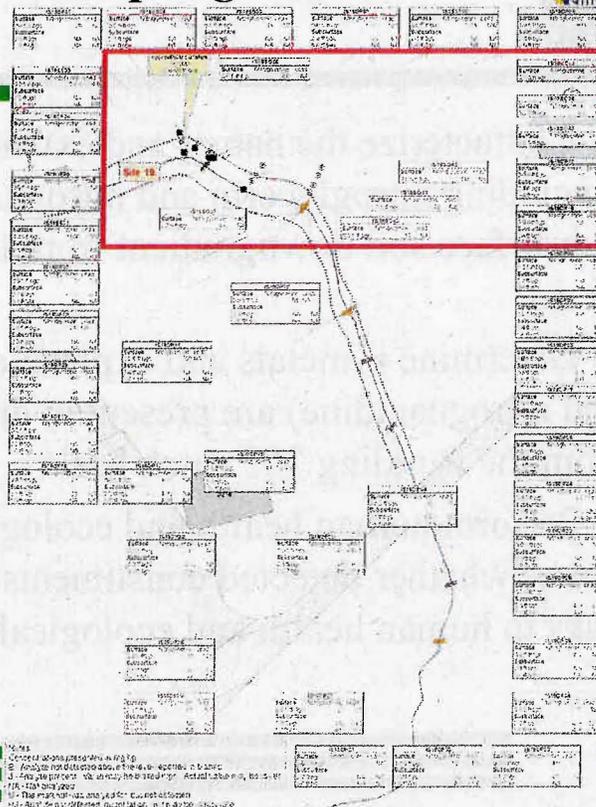
## Site 19 – Sampling Results

- Screening Levels
  - Nitroglycerin = none available
  - Lead = 400 mg/kg
- Most recent samples taken to further delineate lateral extent of lead and nitroglycerin in surface soil

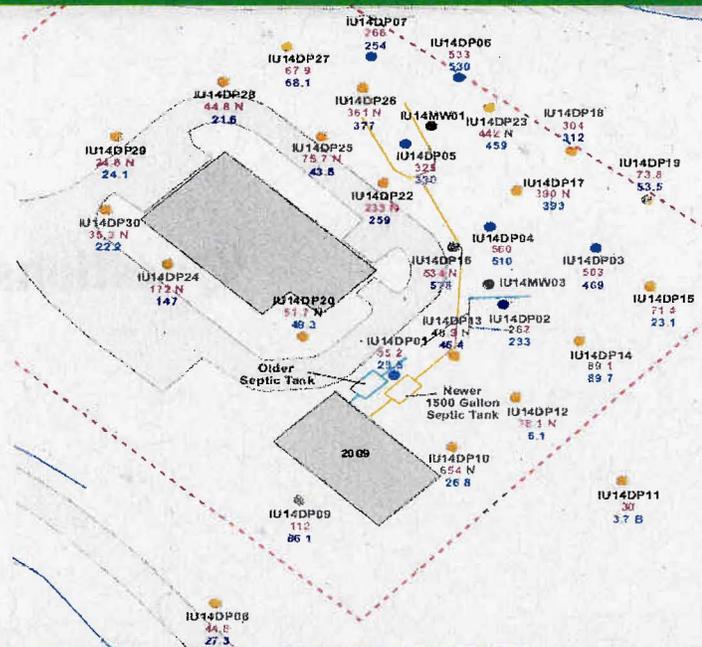
## Stump Neck SWMU 14 – Additional Cobalt Sampling (cont.)

- Red are total cobalt
- Blue are dissolved cobalt

- Objective
  - Characterize the extent of Cobalt in groundwater
  - Take 20 groundwater samples by means of a grid system across the site
    - Grid has 50 foot spacing, with each sample being taken in approximate grid center
  - Two upgradient groundwater samples also collected
- Analysis
  - All groundwater samples were analyzed for total and dissolved Cobalt
  - Background Cobalt at the site is listed as 39.6 ug/L

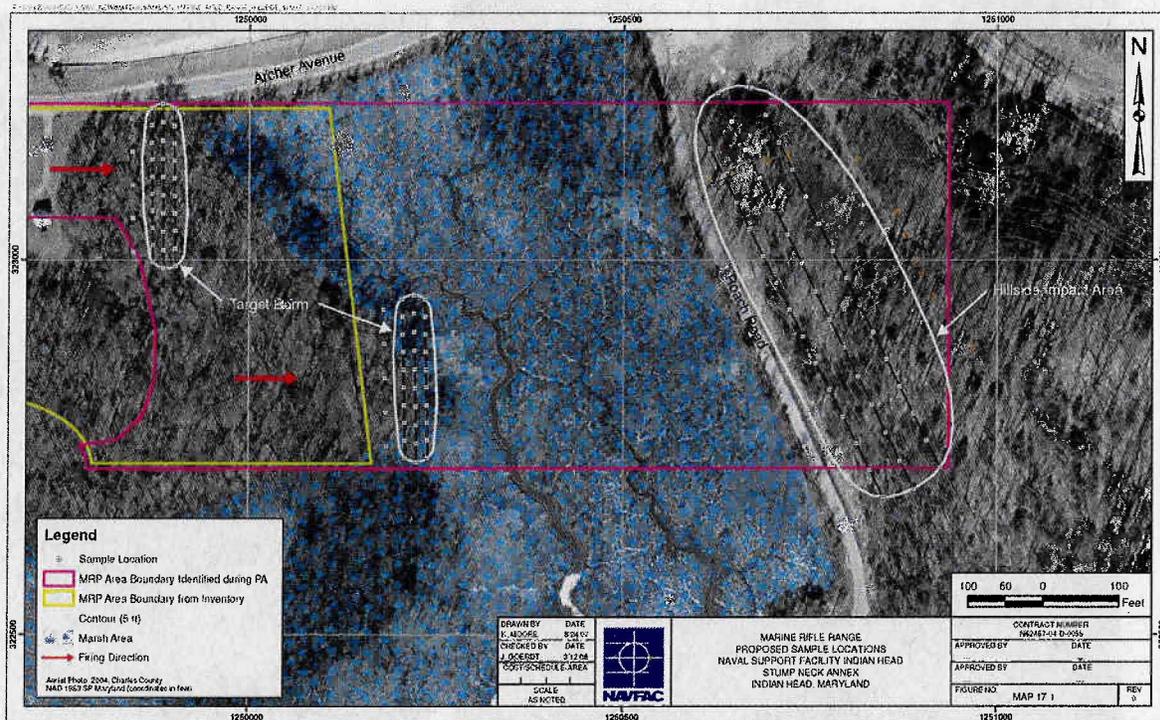
# Marine Rifle Range – Data Collection

- Collect sample at
  - Range floor immediately in front of berms (5 samples each)
  - Berms (30 samples each)
  - Hillside behind berms (45 samples)
- Step-out (vertical or horizontal as necessary)
- Drainage way/sediment samples based on walk-over
- Analytical program for
  - Pb by XRF in field
  - Pb, Sb, As, Zn, Cu, and Sn in lab
  - Analyze 20% but no less than 20 samples by laboratory

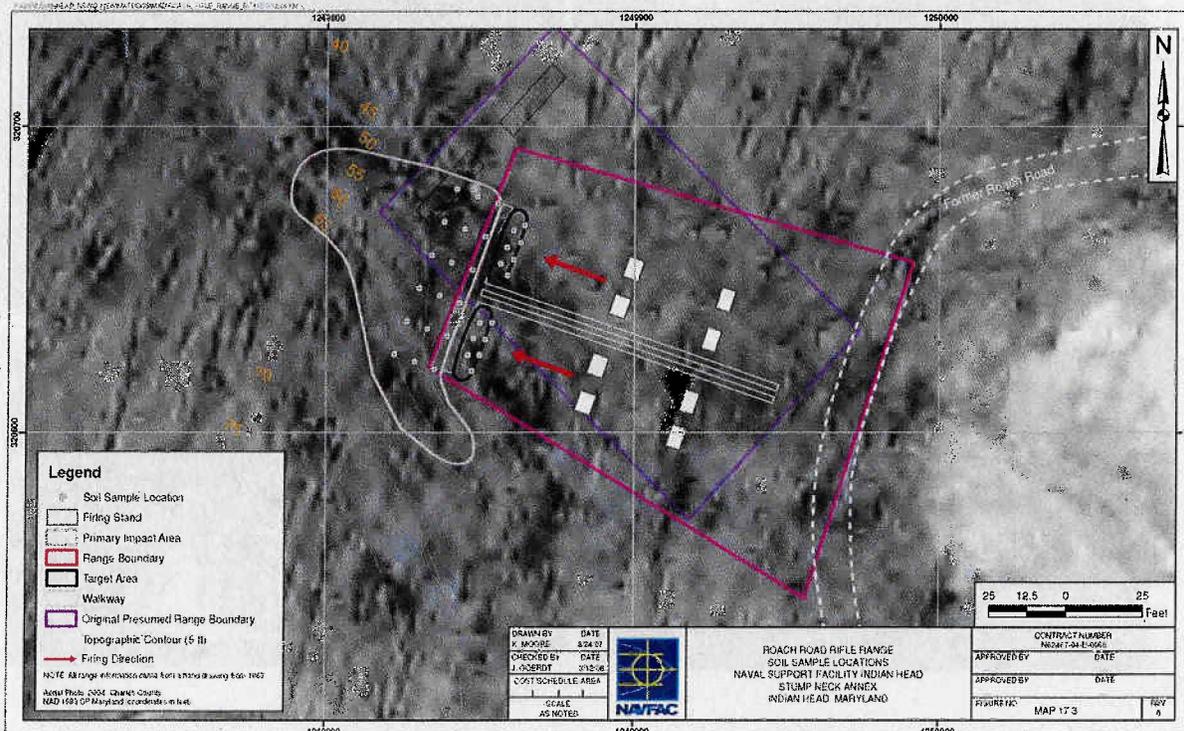
# Roach Road Rifle Range – Data Collection

- Collect sample at
  - Primary impact berms - hillside (32 samples)
- Step-out (vertical or horizontal as necessary)
- Drainage way/sediment samples based on walk-over
- Analytical program for
  - Pb by XRF in field
  - Pb, Sb, As, Zn, Cu and Sn by lab
  - Analyze 20% but no less than 20 samples by laboratory

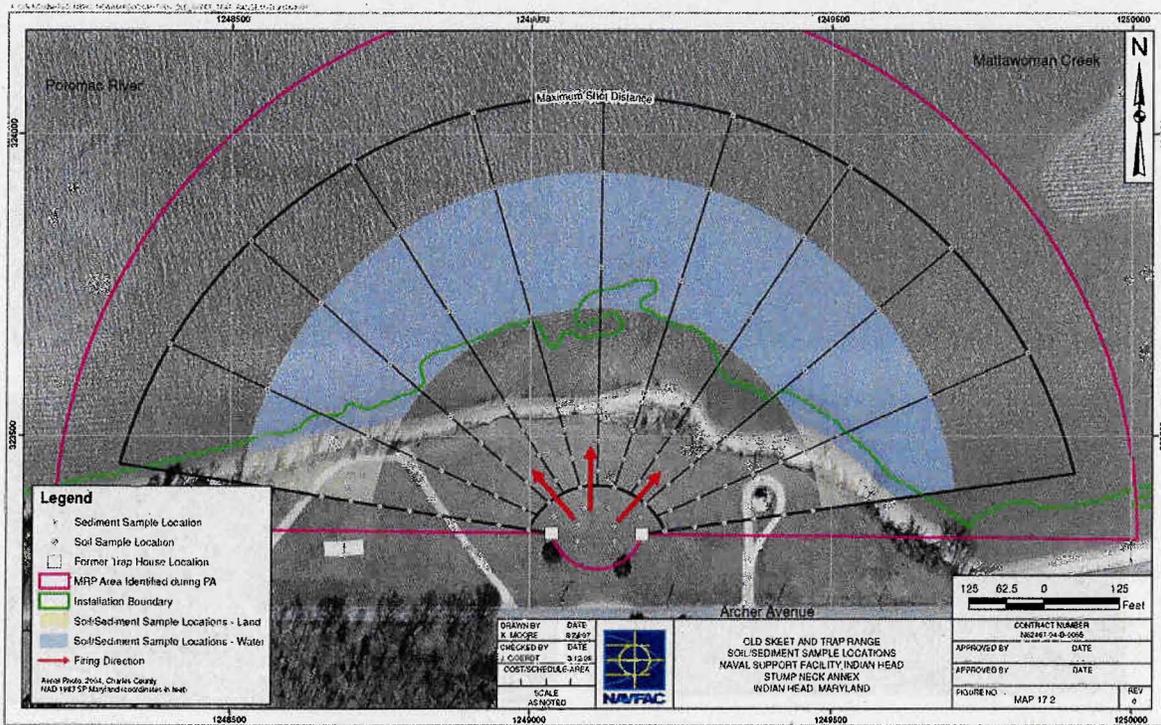
# Old Skeet & Trap Range - Data Collection

- Collect samples at
  - 56 surface soil locations
  - 25 sediment samples within Potomac River
- Step-out (vertical or horizontal as necessary)
- Drainage way/sediment samples based on walk-over
- Analytical program for
  - Pb by XRF in field
  - PAHs, Pb, Sb, As, Zn, Cu, and Sn by lab
  - Analyze 20% but no less than 20 samples by laboratory
  - 3 samples for soil property (pH, TOC, CEC)

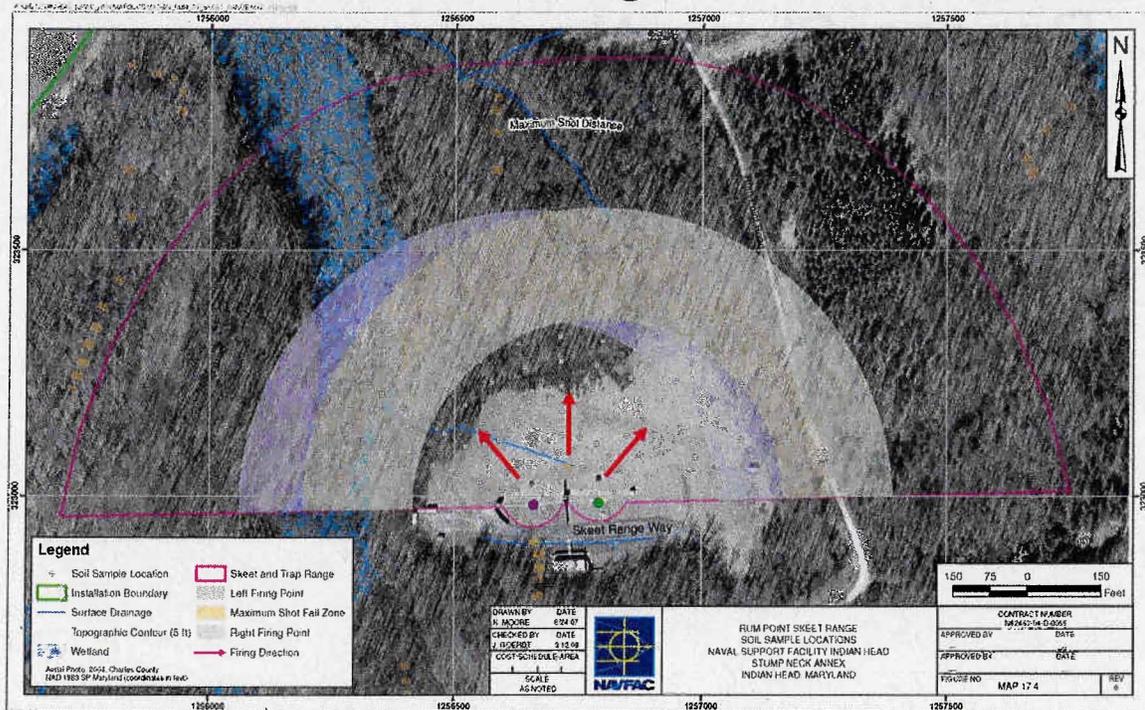
# Rum Point Skeet Range - Data Collection

- Collect samples at
  - 81 surface soil locations
- Step-out (vertical or horizontal as necessary)
- Drainage way/sediment samples based on walk-over
- Analytical program for
  - Pb by XRF in field
  - PAHs, Pb, Sb, As, Zn, Cu, and Sn by lab
  - Analyze 20% but no less than 20 samples by laboratory
  - 3 samples for soil property (pH, TOC, CEC)
