RECORD OF DECISION

Site 6 - Radiographic Facility, Building 1349

Naval Support Facility, Indian Head
Indian Head, Maryland

January 2010

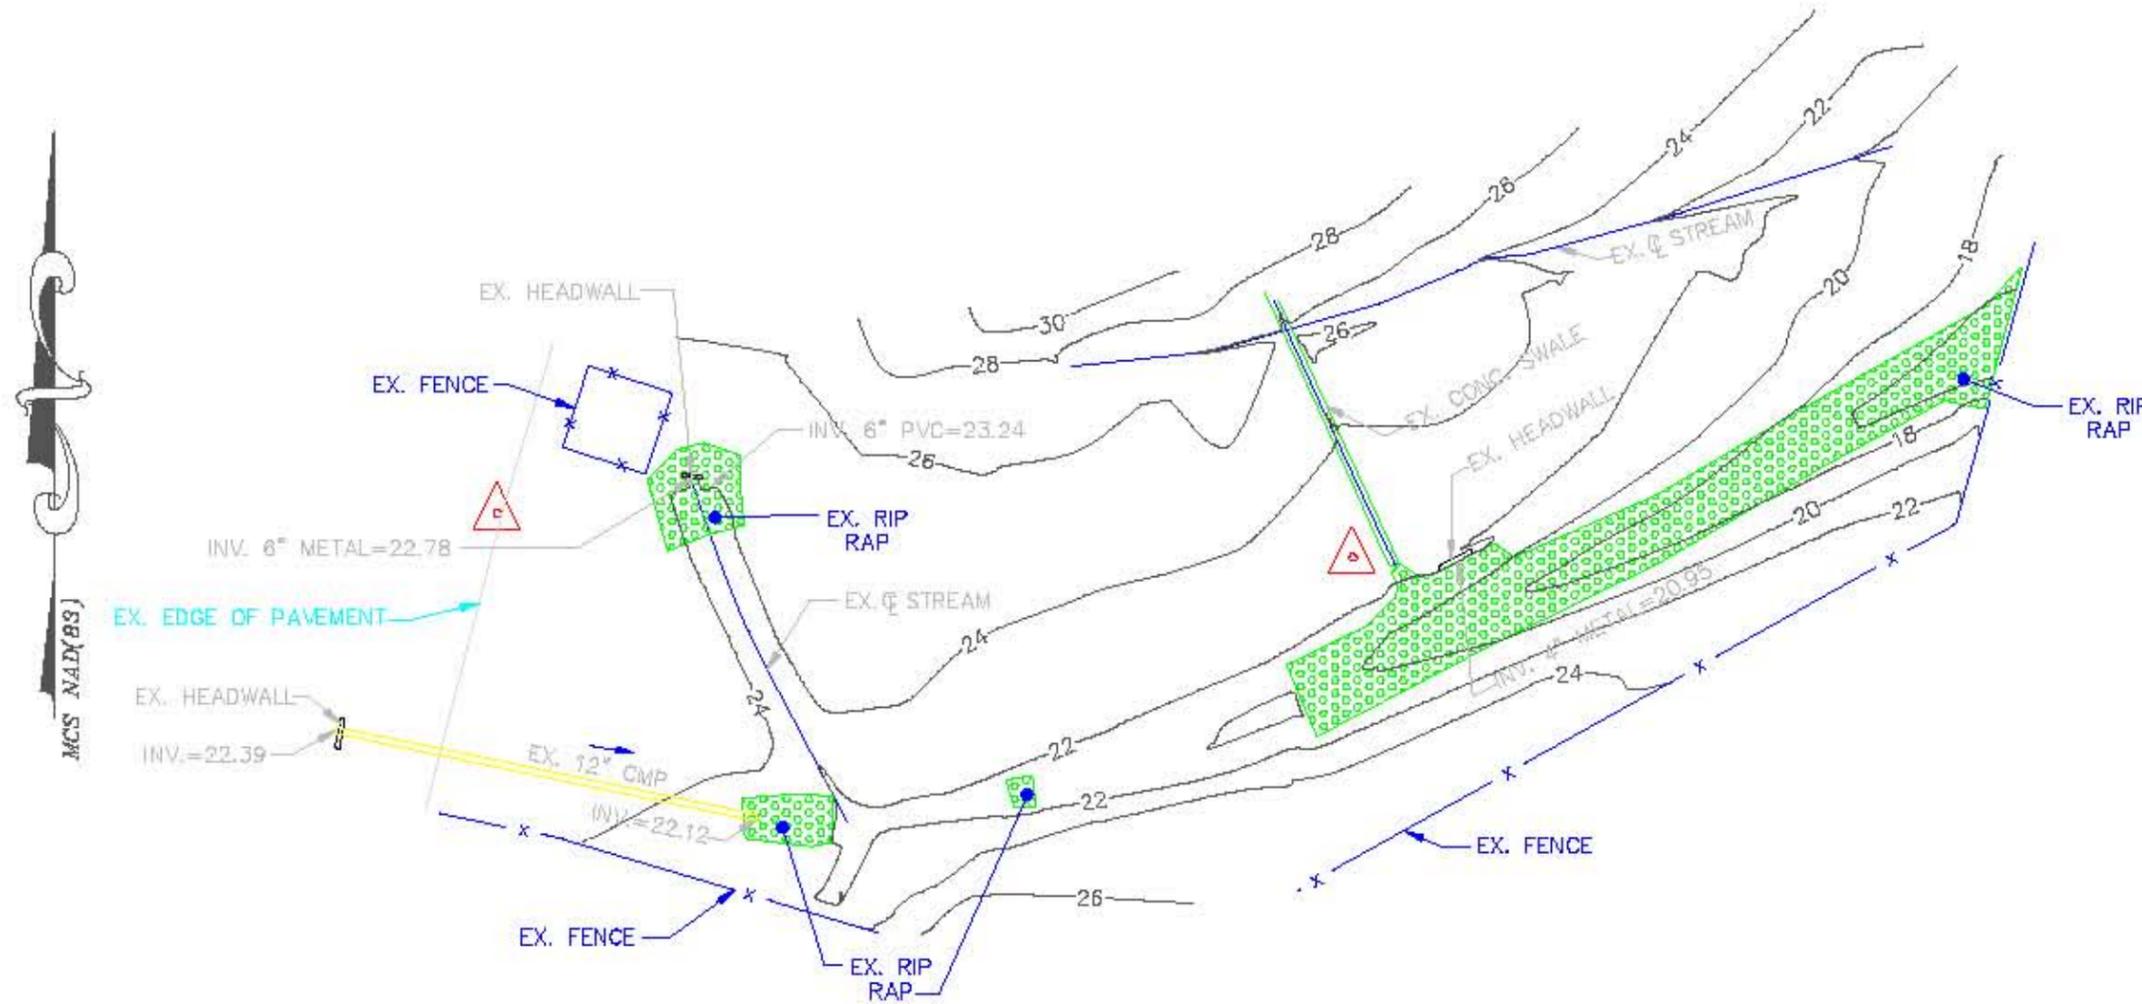
Figure 2-3
As-Built Drawing - Post Removal Action Inside the Fenced Area
Record of Decision - Site 6
NSF-IH, Indian Head, Maryland

Note:
Survey was performed by PHRA in 2008 after the removal action.

The excavated area was backfilled with clean fill material to existing grade, and the ditch was repaired and reshaped to capture stormwater runoff from the site (Photograph 1). Erosion control matting and seeding with native grasses were installed as soil stabilization measures in the upland portion of the site, and riprap was installed along the drainage swale (Photograph 2). In addition, a corrugated metal culvert piping, approximately 40 linear feet, was replaced within the drainage ditch. Figure 2-3 shows the as-built drawing for the site.

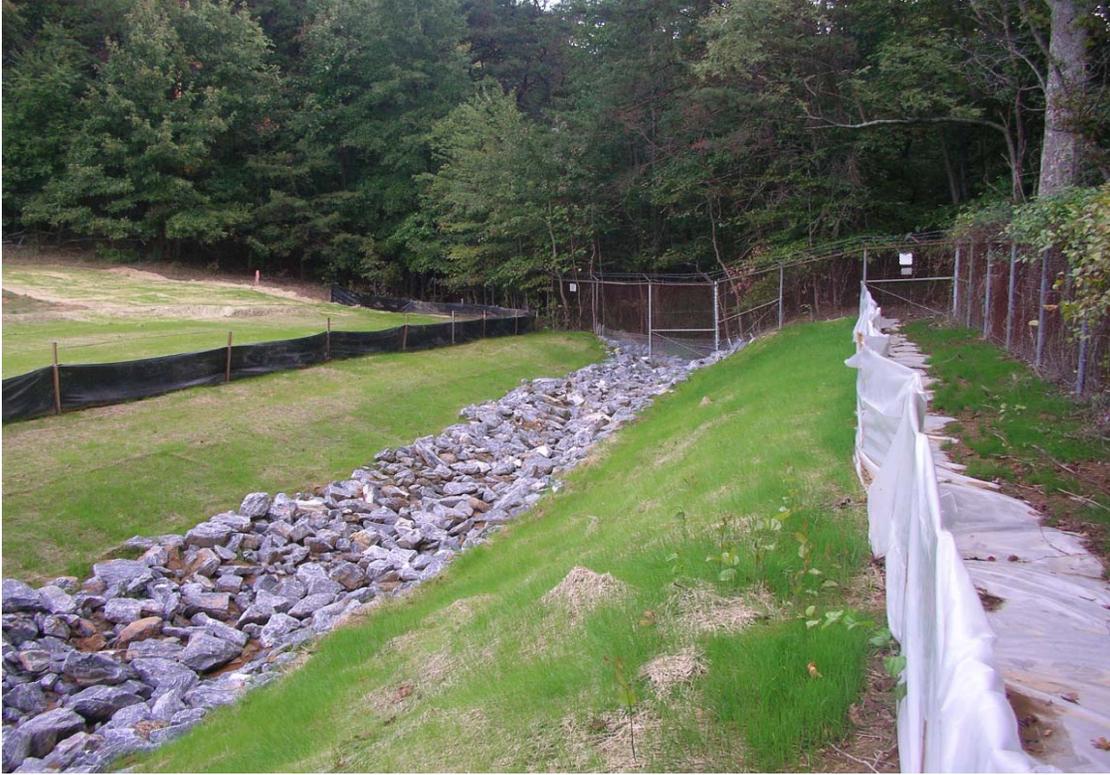
Photograph 1: View to the east-northeast. Repaired drainage ditch toward the fence line.

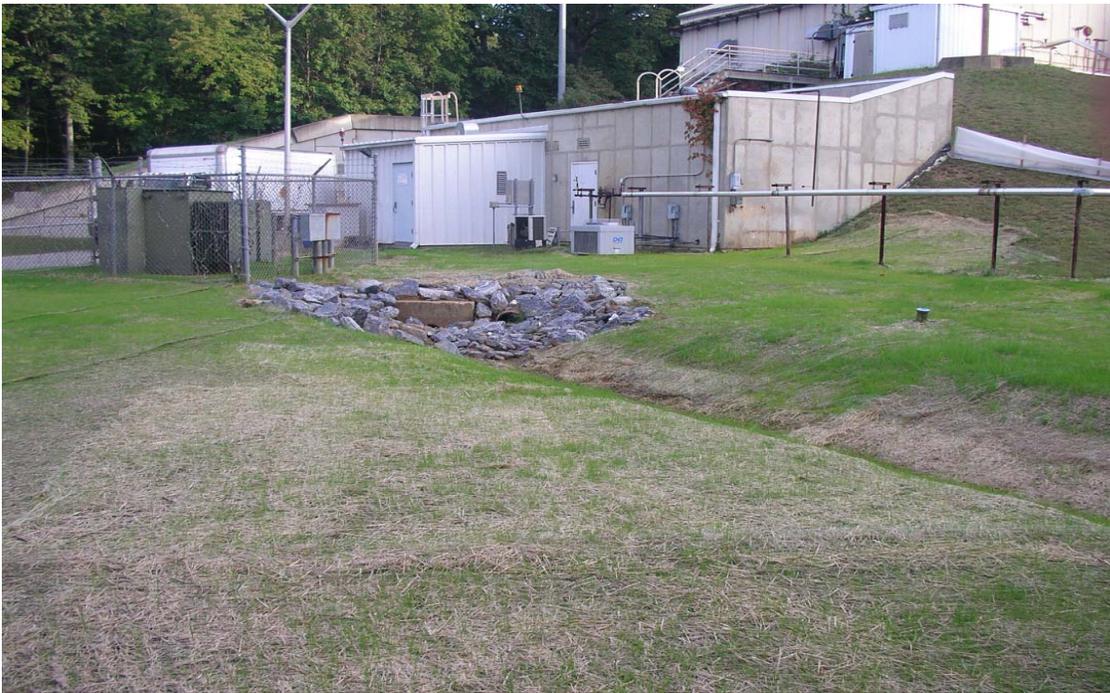
Photograph 2: View to the northeast. Repaired drainage ditch adjacent to Building 1733.
