FINAL FIVE YEAR REVIEW REPORT NSWC INDIAN HEAD MD (PUBLIC DOCUMENT)
07/01/2013
SOVEREIGN CONSULTING

Final Five-Year Review Report

Naval Support Facility Indian Head
Indian Head, Maryland

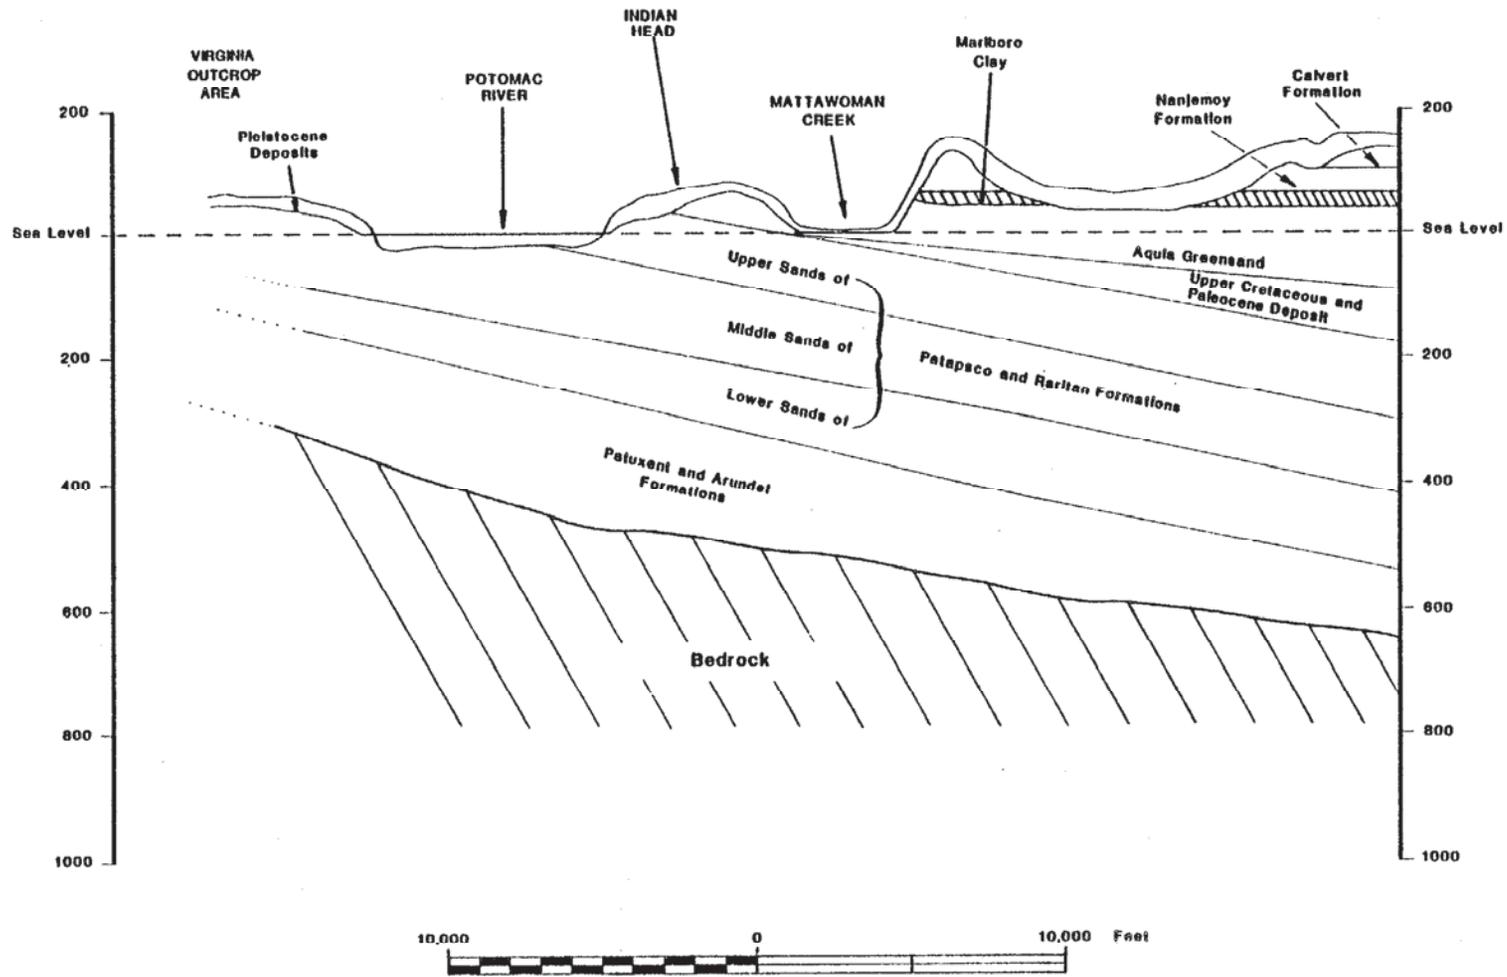
Figure 3-1
Generalized Cross-Section Showing Stratigraphy
Naval Support Facility - Indian Head
Indian Head, Maryland

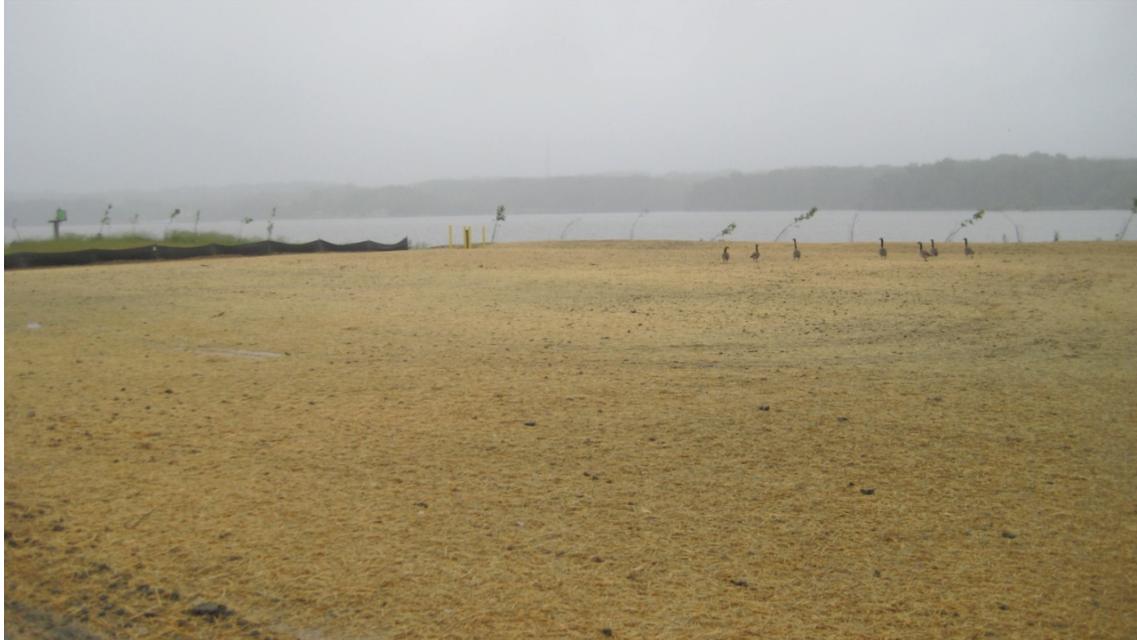
Figure 4-2. Photograph of Site 11 facing southeast.

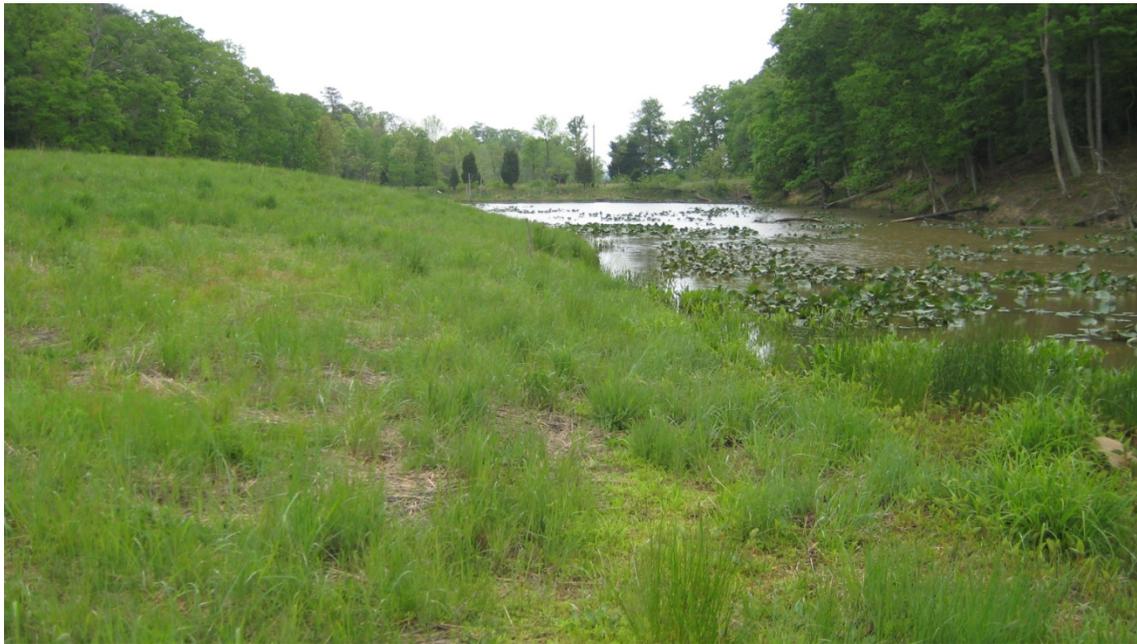
Figure 5-2. Photograph of Site 12 facing south along western portion of sloped landfill.

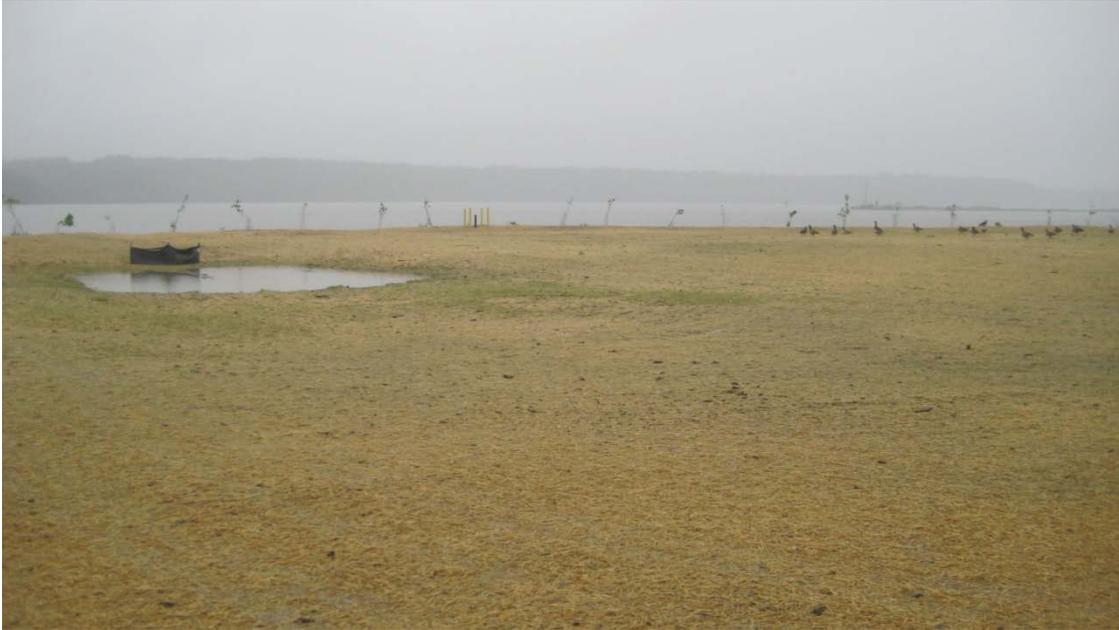
During the site inspection it was noted that the vegetation on the soil cover has not yet been established. In addition, the trees planted along the shoreline appear to be falling down and may not survive. However, the selected remedy appears to be effective and functioning as designed to be protective of human health and the environment, and control exposure pathways that could result in unacceptable risk.

Photo 1: Looking south across unvegetated flat area at wetlands area (wetland plants not established), monitoring well IS11MW10, and Mattawoman Creek.

Based on the results of this Five-Year Review, it is recommended that Site 11 be reseeded as necessary to establish vegetation and the trees along the shoreline be replanted or supported.

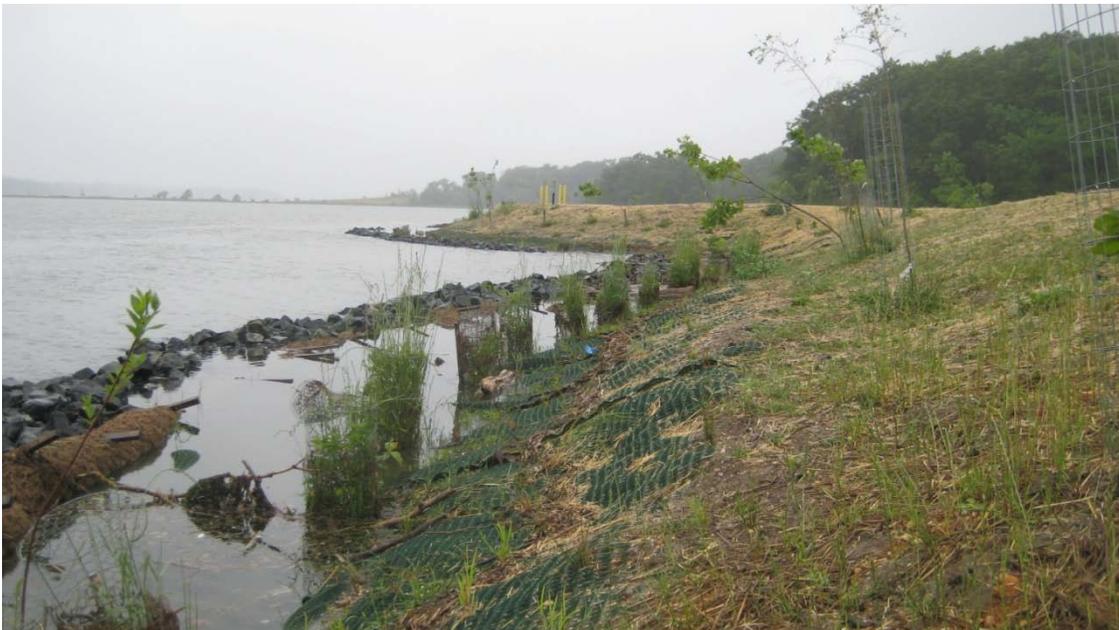
Photo 2: Along Site boundary with Mattawoman Creek looking west. Wetlands vegetation present. Trees slumping and cages not secured to ground. Hillslope not fully vegetated but matting preventing erosion and slumping.

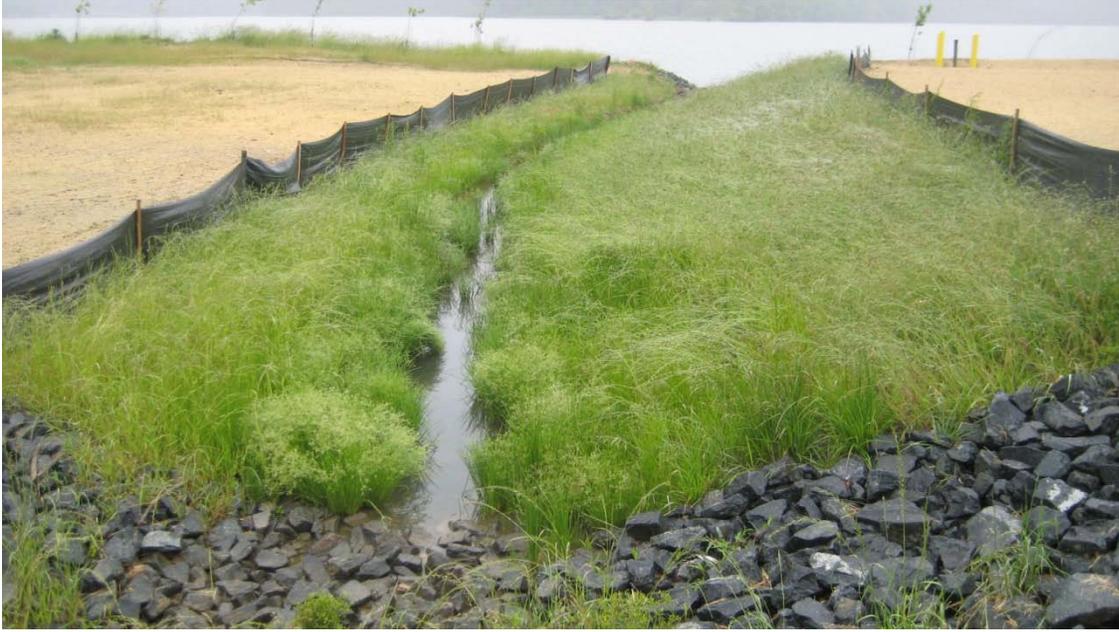
Photo 3: On access road looking south down drainage channel. Vegetation well established and silt fencing in good condition.

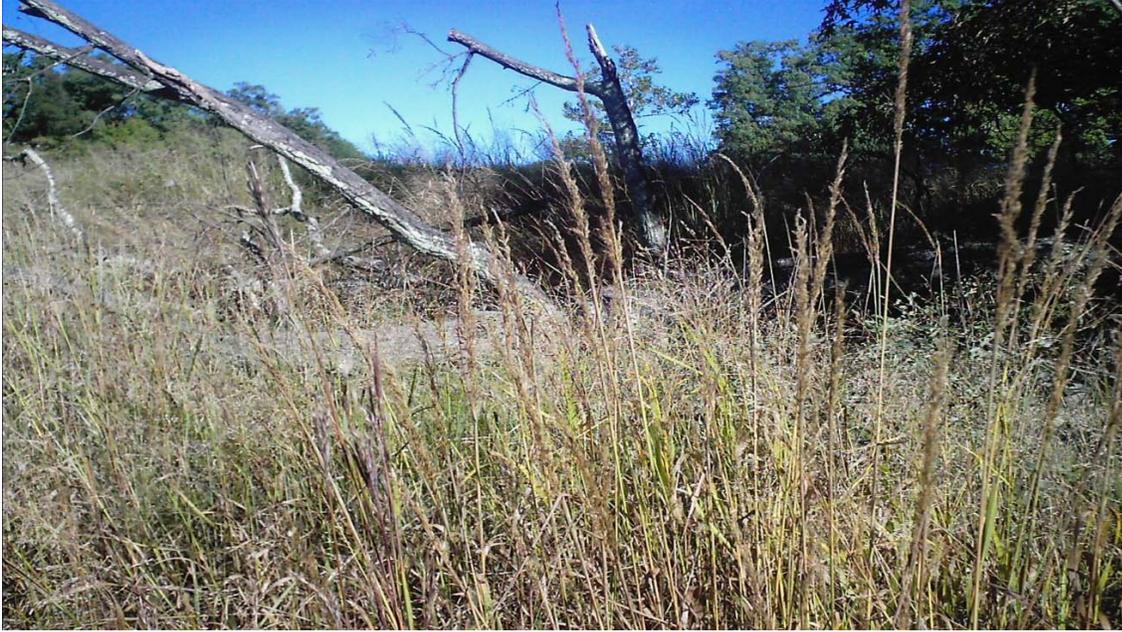
At Site 12, saplings were observed growing in the drainage channels and a fallen tree was observed in one of the drainage channels. At Site 42, site constituents at downgradient well MW-10 demonstrated increasing trends. In addition, tall vegetation and samplings were observed in some of the drainage channels. At Site 11, the vegetation has not been established on the soil cover and the trees planted along the shoreline are falling over and may not survive.

Photo 1: Fallen tree located in rip rap lined ditch on east side of northern portion of the landfill.

Based on the results of this Five-Year Review, it is recommended that the saplings be removed from the drainage channels at Site 12 and 42. In addition, the fallen tree should be removed from the drainage channel at Site 12 and the vegetation be trimmed in the drainage channels at Site 42. It is also recommended that a work plan for Site 42 be developed to investigate downgradient groundwater concentrations to ensure contaminated groundwater is not migrating offsite. Furthermore, it is recommended that the trees be replanted or supported and the soil cover reseeded as necessary to establish the vegetation at Site 11.

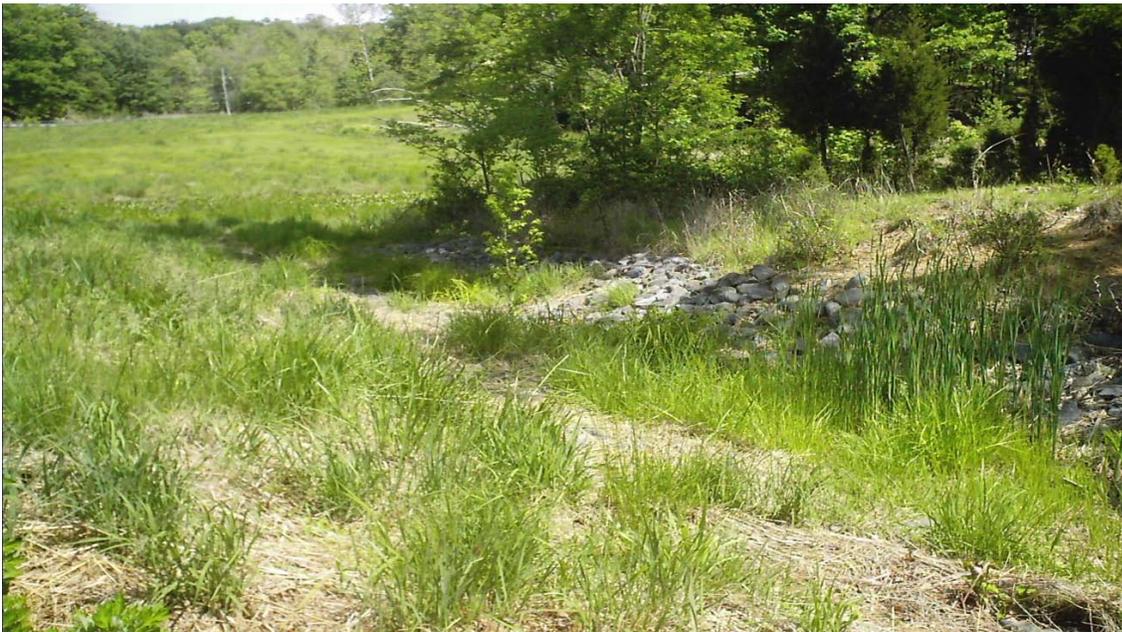
The site inspection, conducted as part of the Five-Year Review, showed that the vegetation on the cover is greater than 6 inches in height in accordance with the site requirements. However, some minor vegetation, including several saplings, were observed in the drainage ditches. Brass locks have been installed on the monitoring wells.

Photo 2: Sapling located in rip rap lined ditch on eastern side of center portion of landfill.

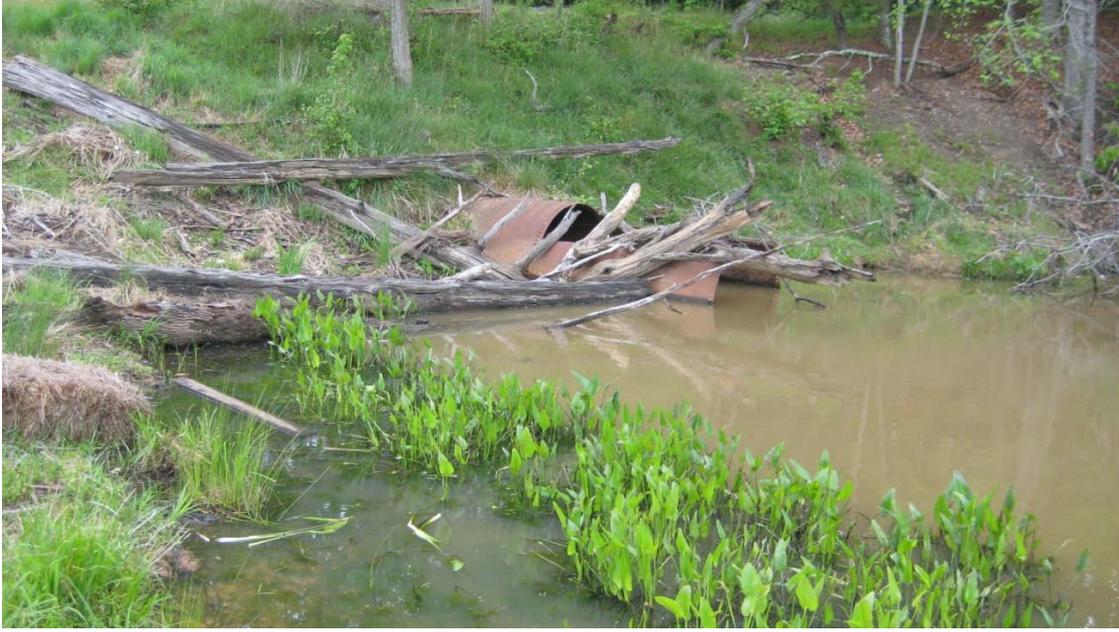
Photo 3: Looking west at the culvert that connects the unnamed pond at Site 12 to South Pond. Culvert is in good condition with no signs of siltation or blockage.

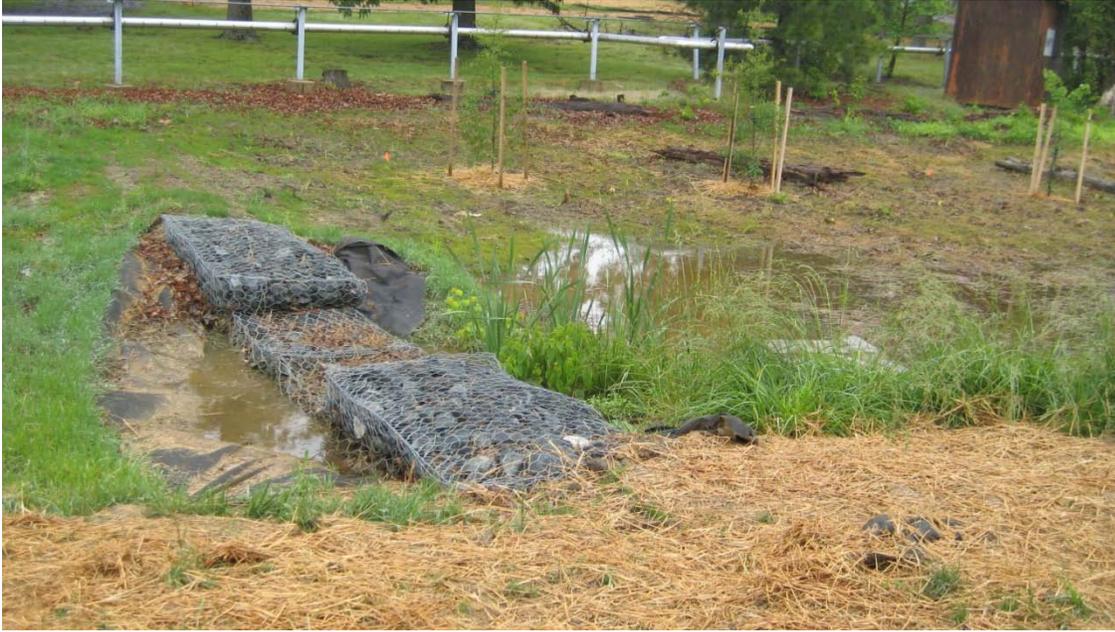
Photo 1: Looking at the small gabion controlling erosion within the drainage channel.

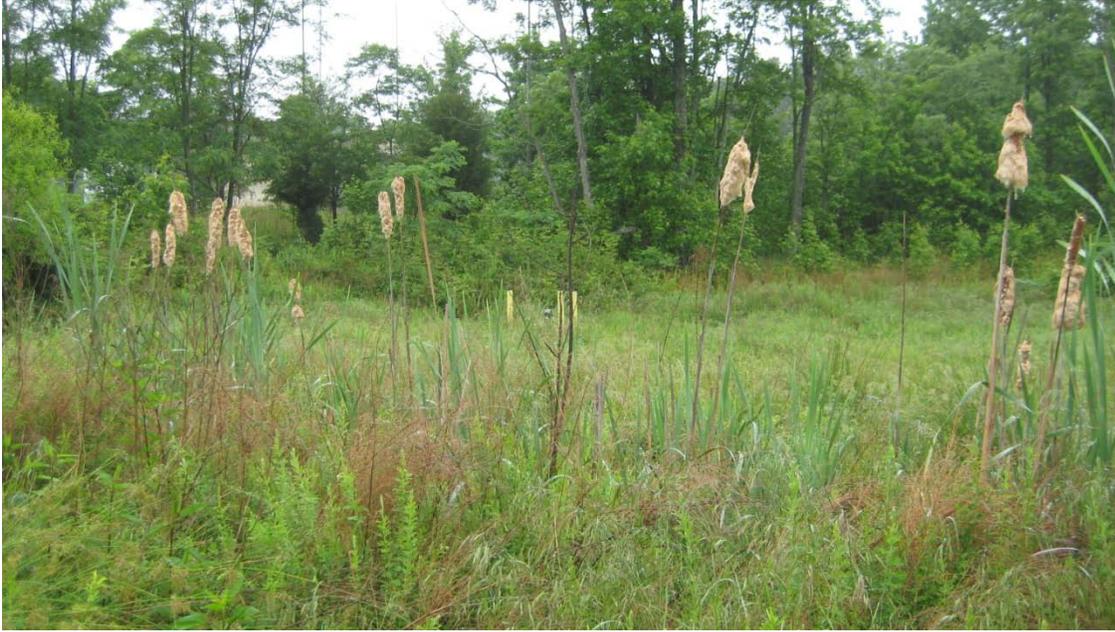
Photo 1: At the southern edge of the area of attainment looking north across a vegetated drainage ditch with IS17MW06 in background. Cattails are present within the ditch.

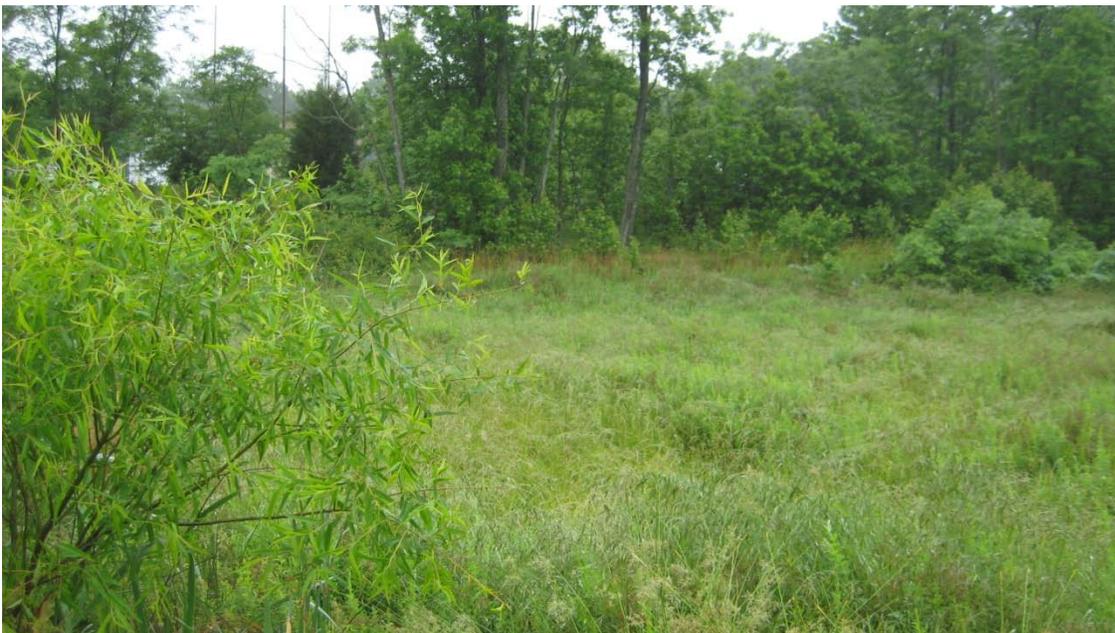
Photo 2: At the drainage ditch looking north towards Building 1569. Vegetation is fully established and no signs of erosion or unauthorized activity.

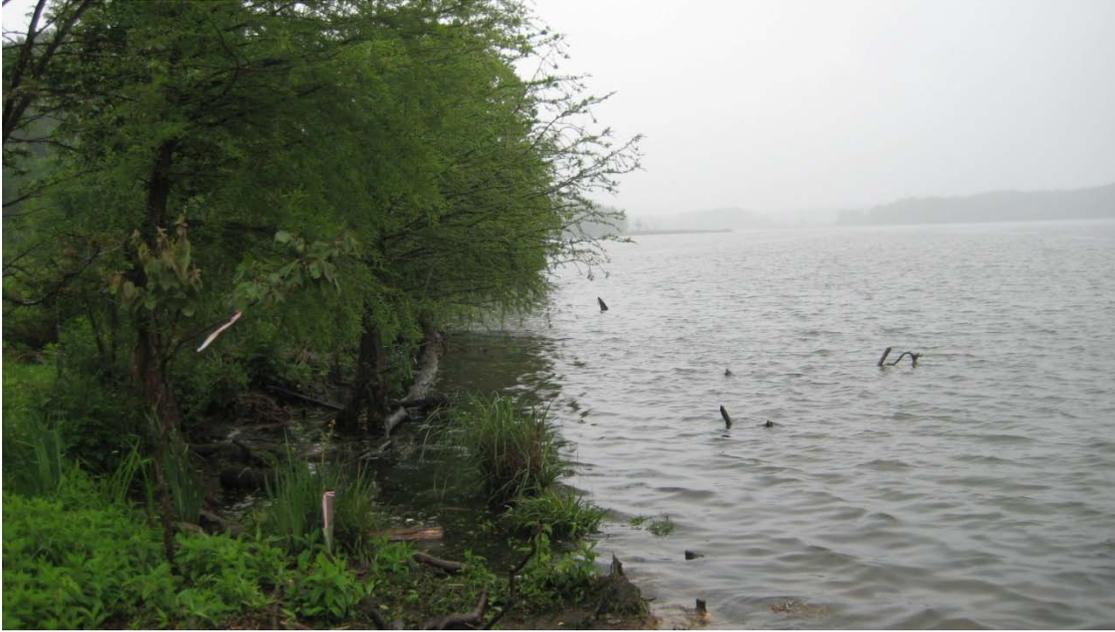
Photo 3: At the southwestern boundary of the Site looking Northeast down the Mattawoman Creek bank. Water is at high tide which has submerged metal debris.

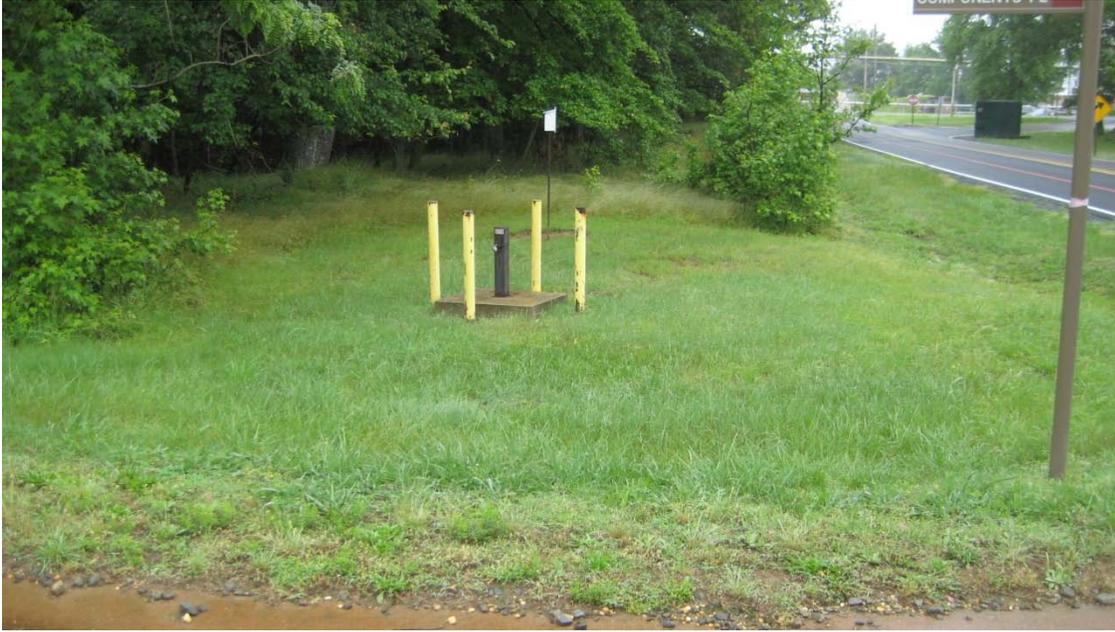
Photo 1: Looking southeast, at the intersection of S. Bronson Road and Components Place, at IS21MW03 which is locked and in good condition.

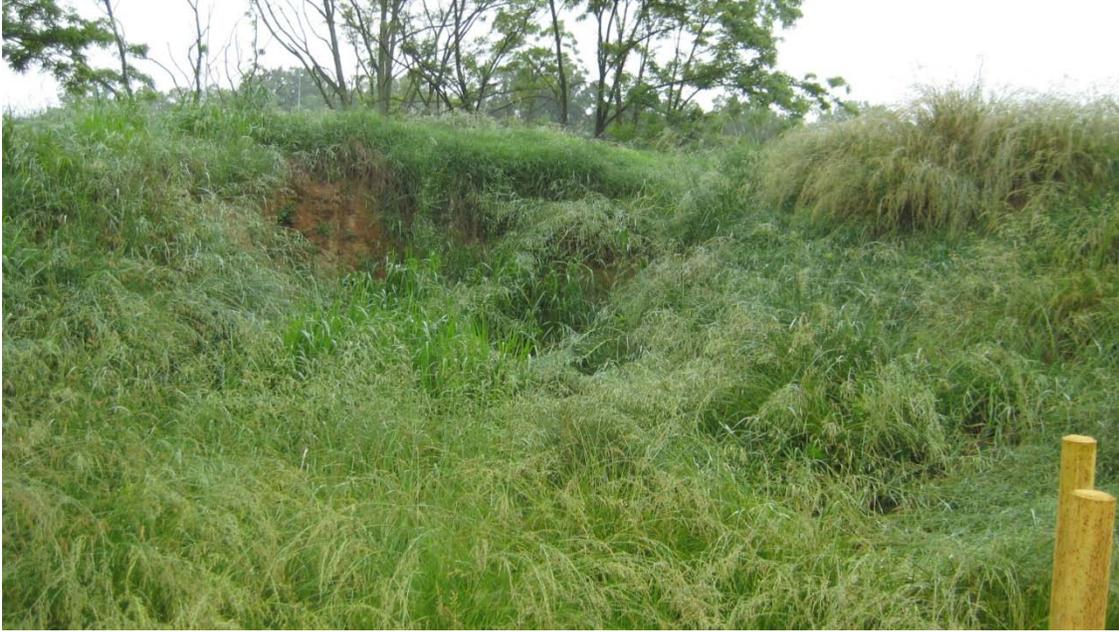
Photo 3: At a monitoring well, near the terminus of the eastern trending small dirt trail, looking north at an exposed earthen face where a slump occurred.

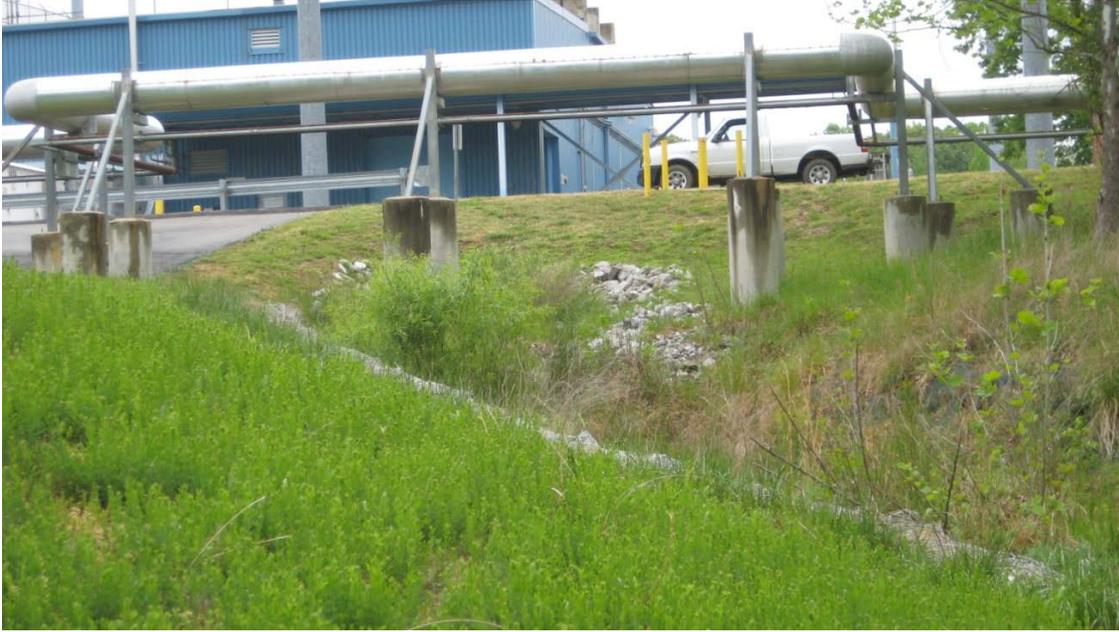
Photo 1: Looking north at upslope along central drainage channel. Saplings observed growing in channel.

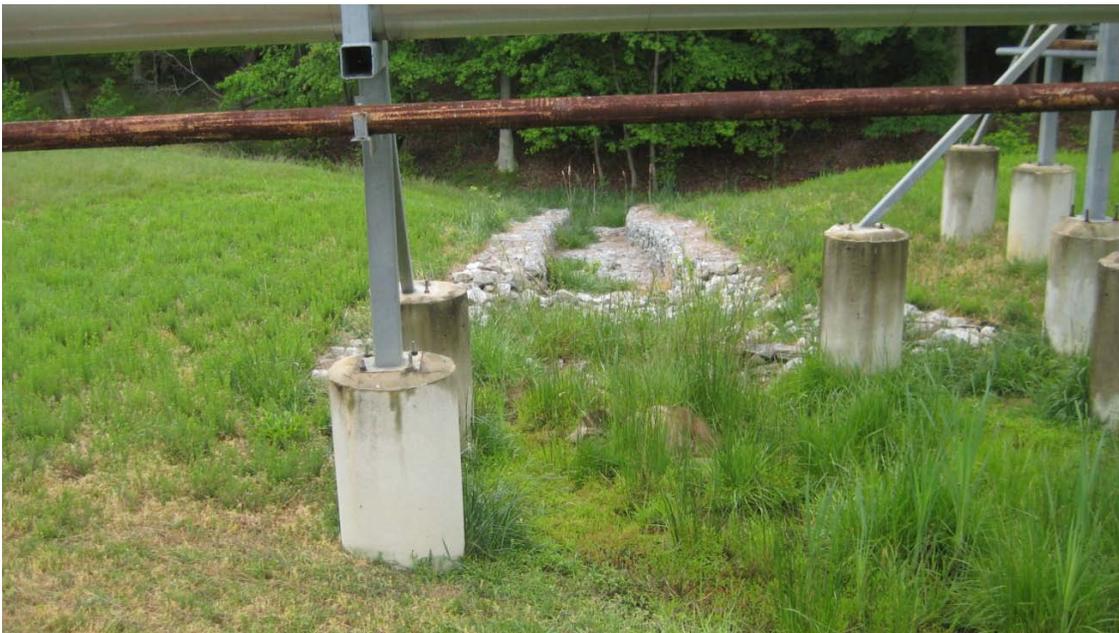
Photo 2: Looking southwest down western drainage channel where it transitions from vegetation to rip rap. Rip rap is in good shape with some grass growth.

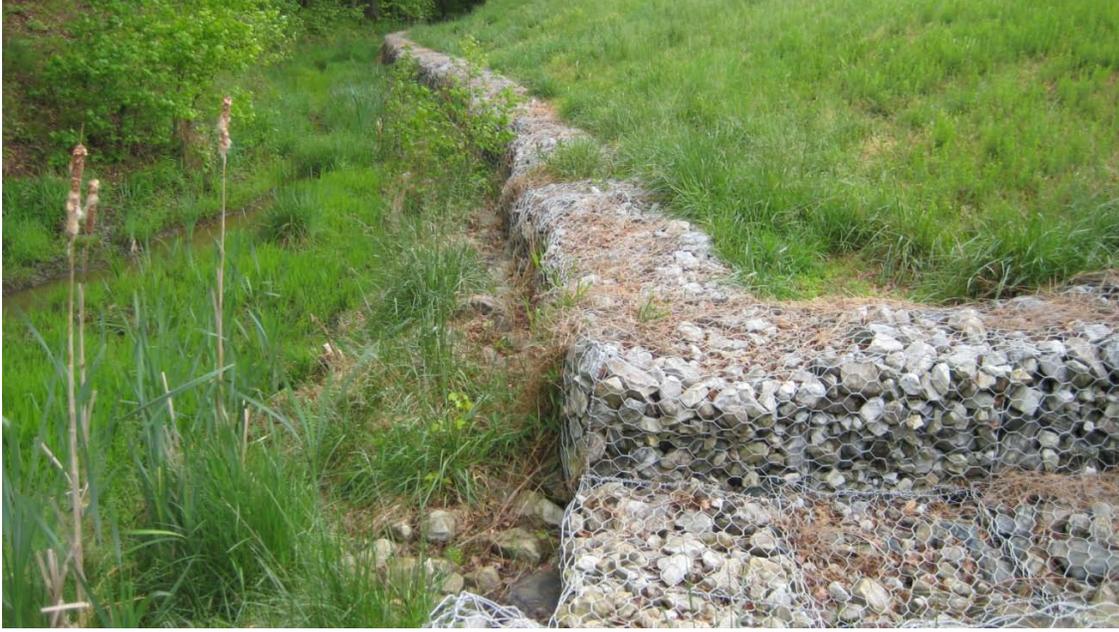
Photo 3: Looking southeast down rip rap retention wall where rip rap drainage channel ends. Retention wall is intact with no signs of damage. Creek on left has a steady flow without major obstructions or damming.

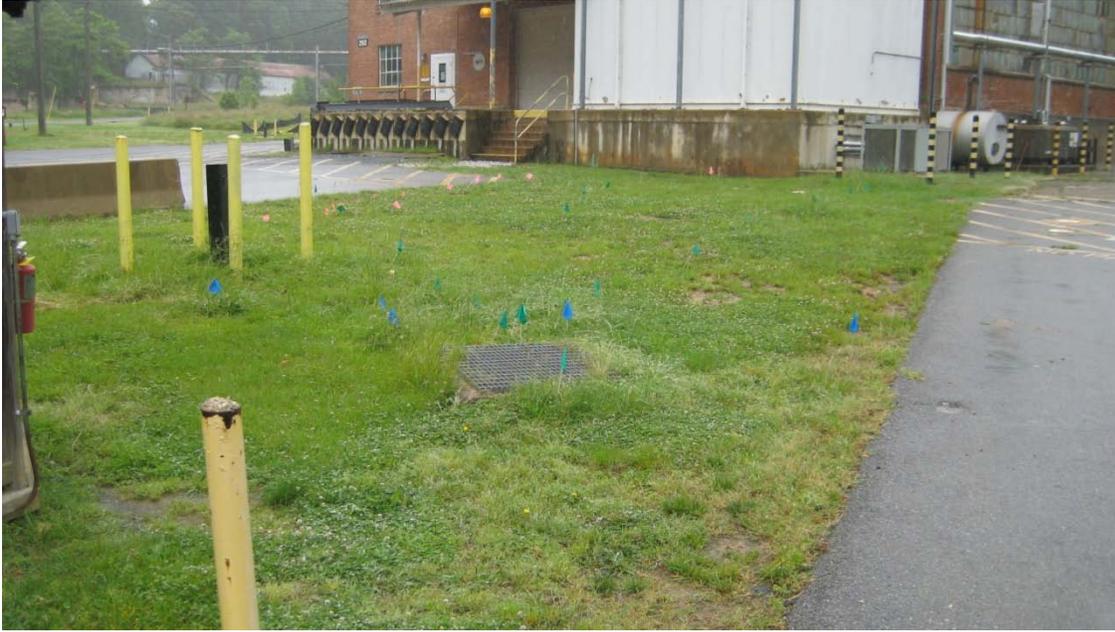
Photo 1: On Bailey Road looking northwest at Building 292. All monitoring wells (stickups and flush mounts) in good condition.
