FINAL TECHNICAL MEMORANDUM FOR RESULTS OF WETLAND DELINEATION
UNEXPLODED ORDNANCE 9 AND 11 (UXO 9) (UXO 11) NSWC INDIAN HEAD MD
3/17/2016
CH2M HILL

Results of Wetland Delineation for UXOs 9 and 11, Naval Support Facility Indian Head, Indian Head, Maryland

PREPARED BY: Brian Colabella/CH2M HILL

DATE: March 17, 2016

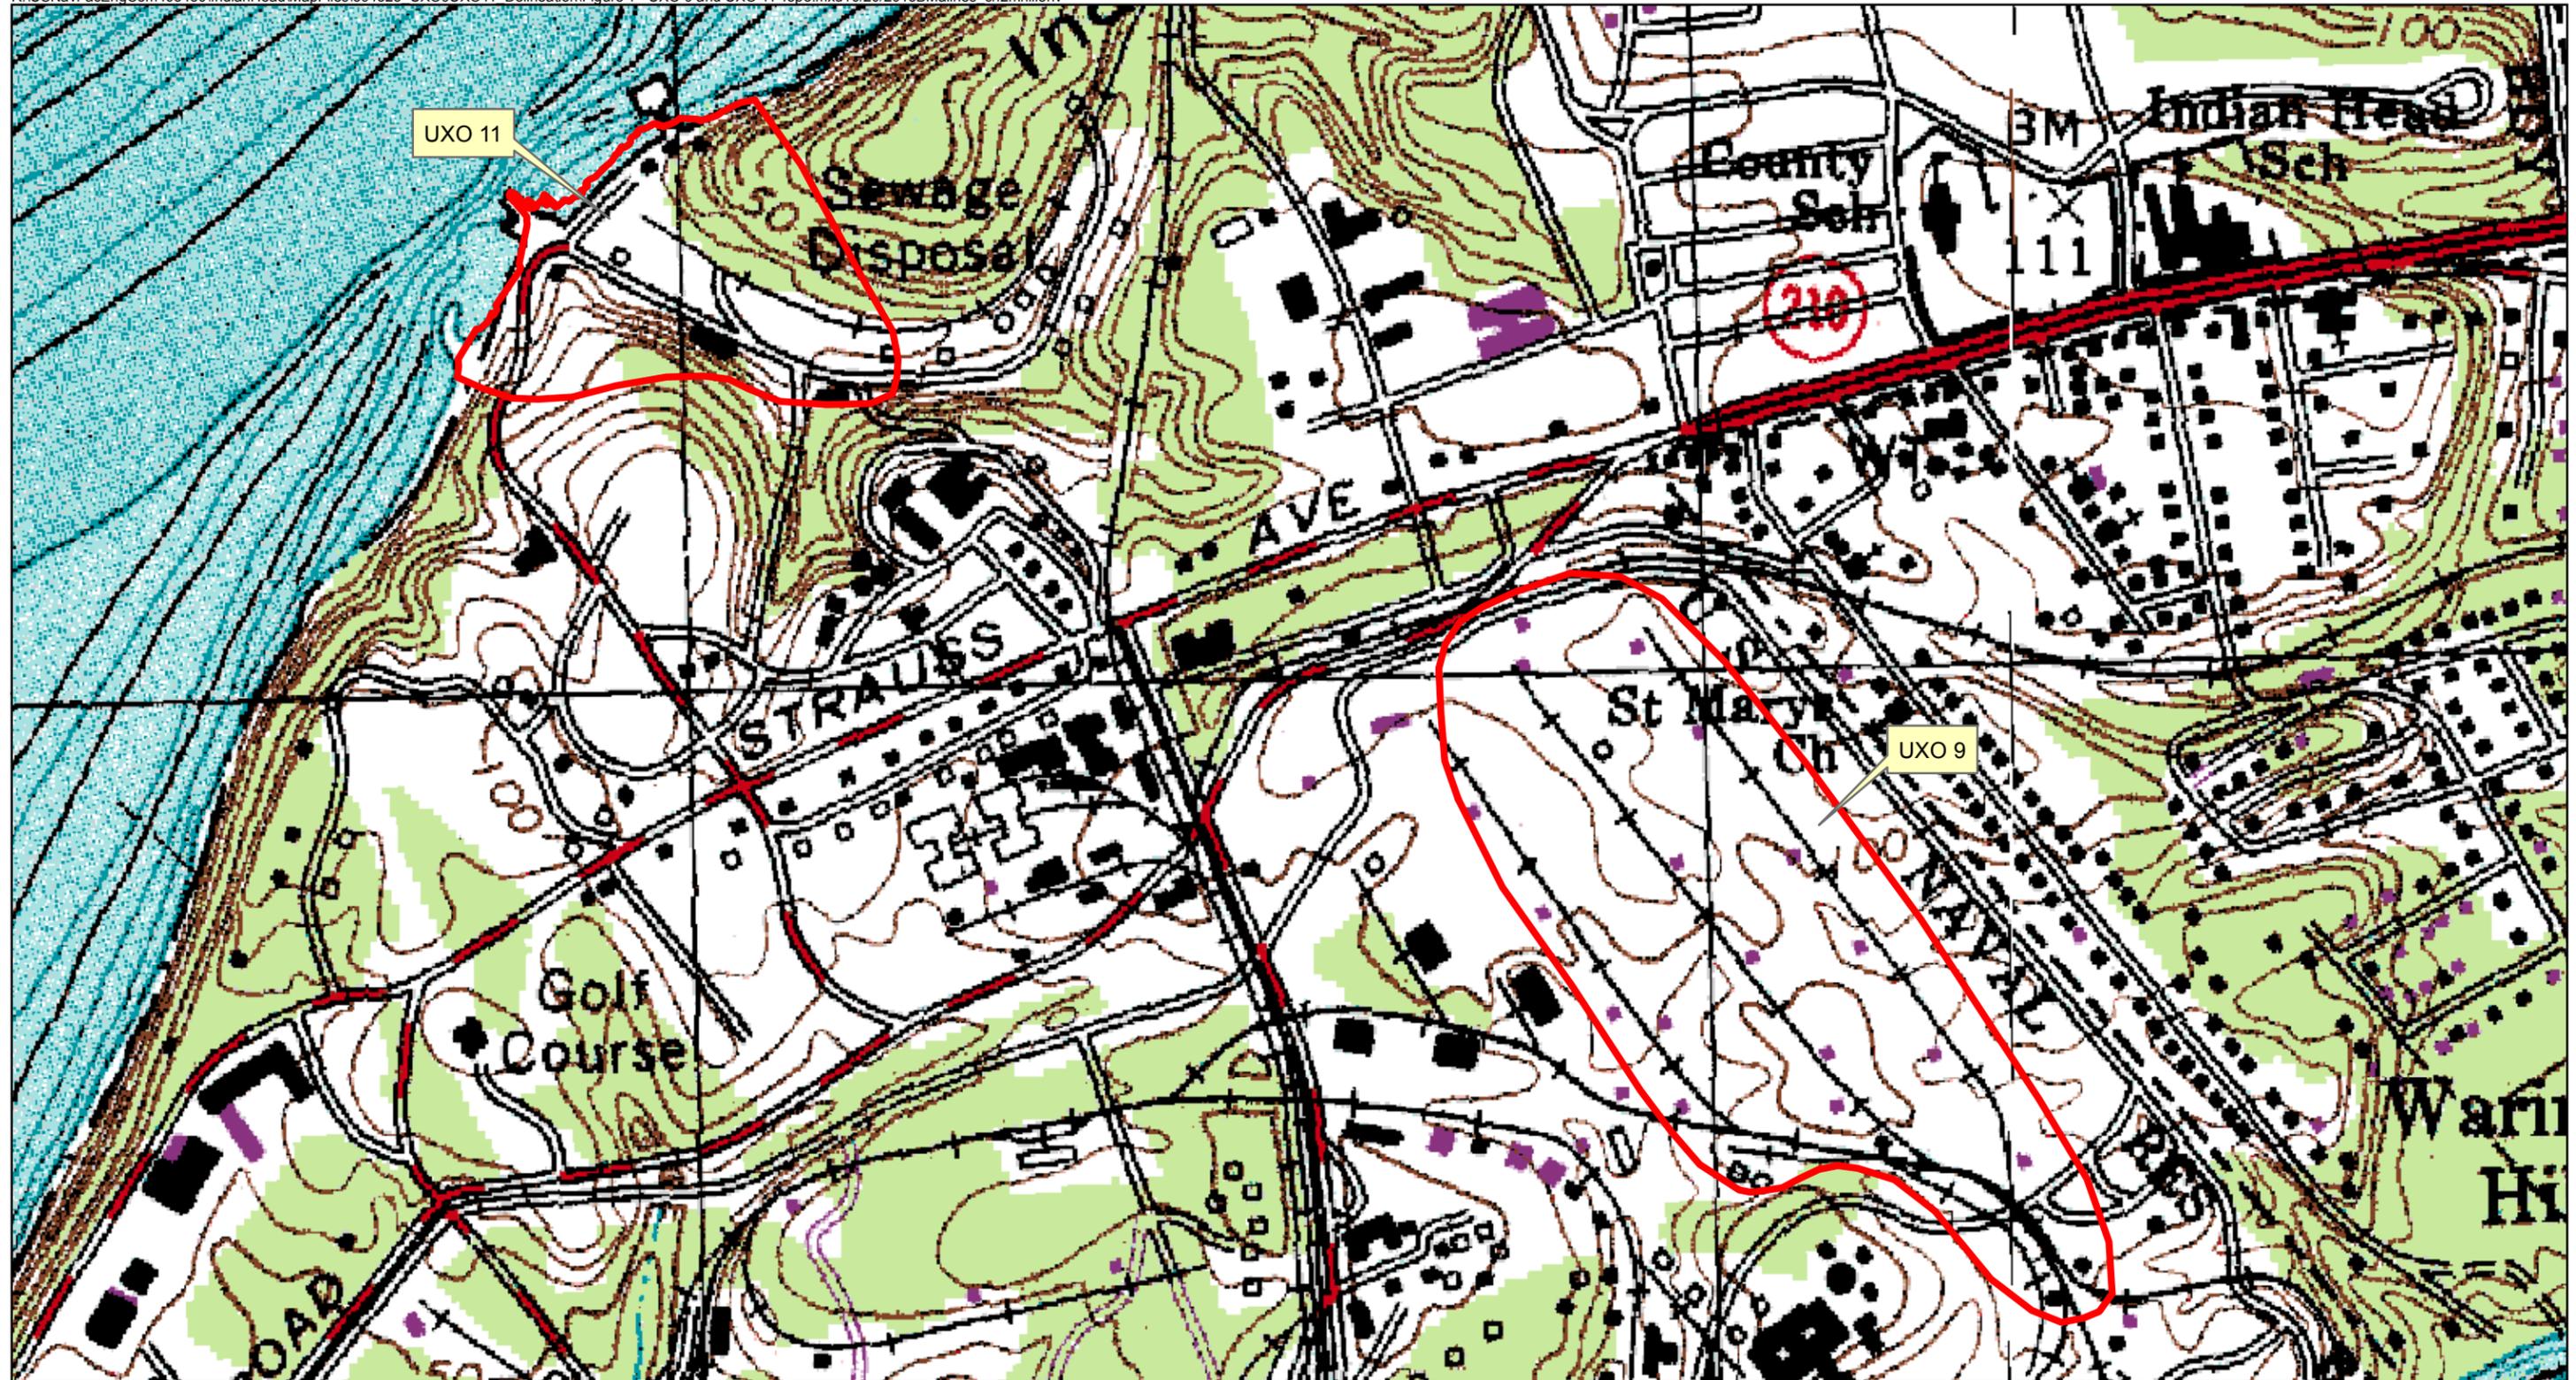
Figure 1
Topographic Map
Results of Wetland Delineation for UXOs 9 and 11
NSFIH, Indian Head, Maryland

The 1982 USGS topographic map (Figure 1) resulted in the following findings: (1) the presence of the Potomac River along the western boundary of UXO 11 and (2) no streams or surface waters within the boundaries of UXO 9 or UXO 11.

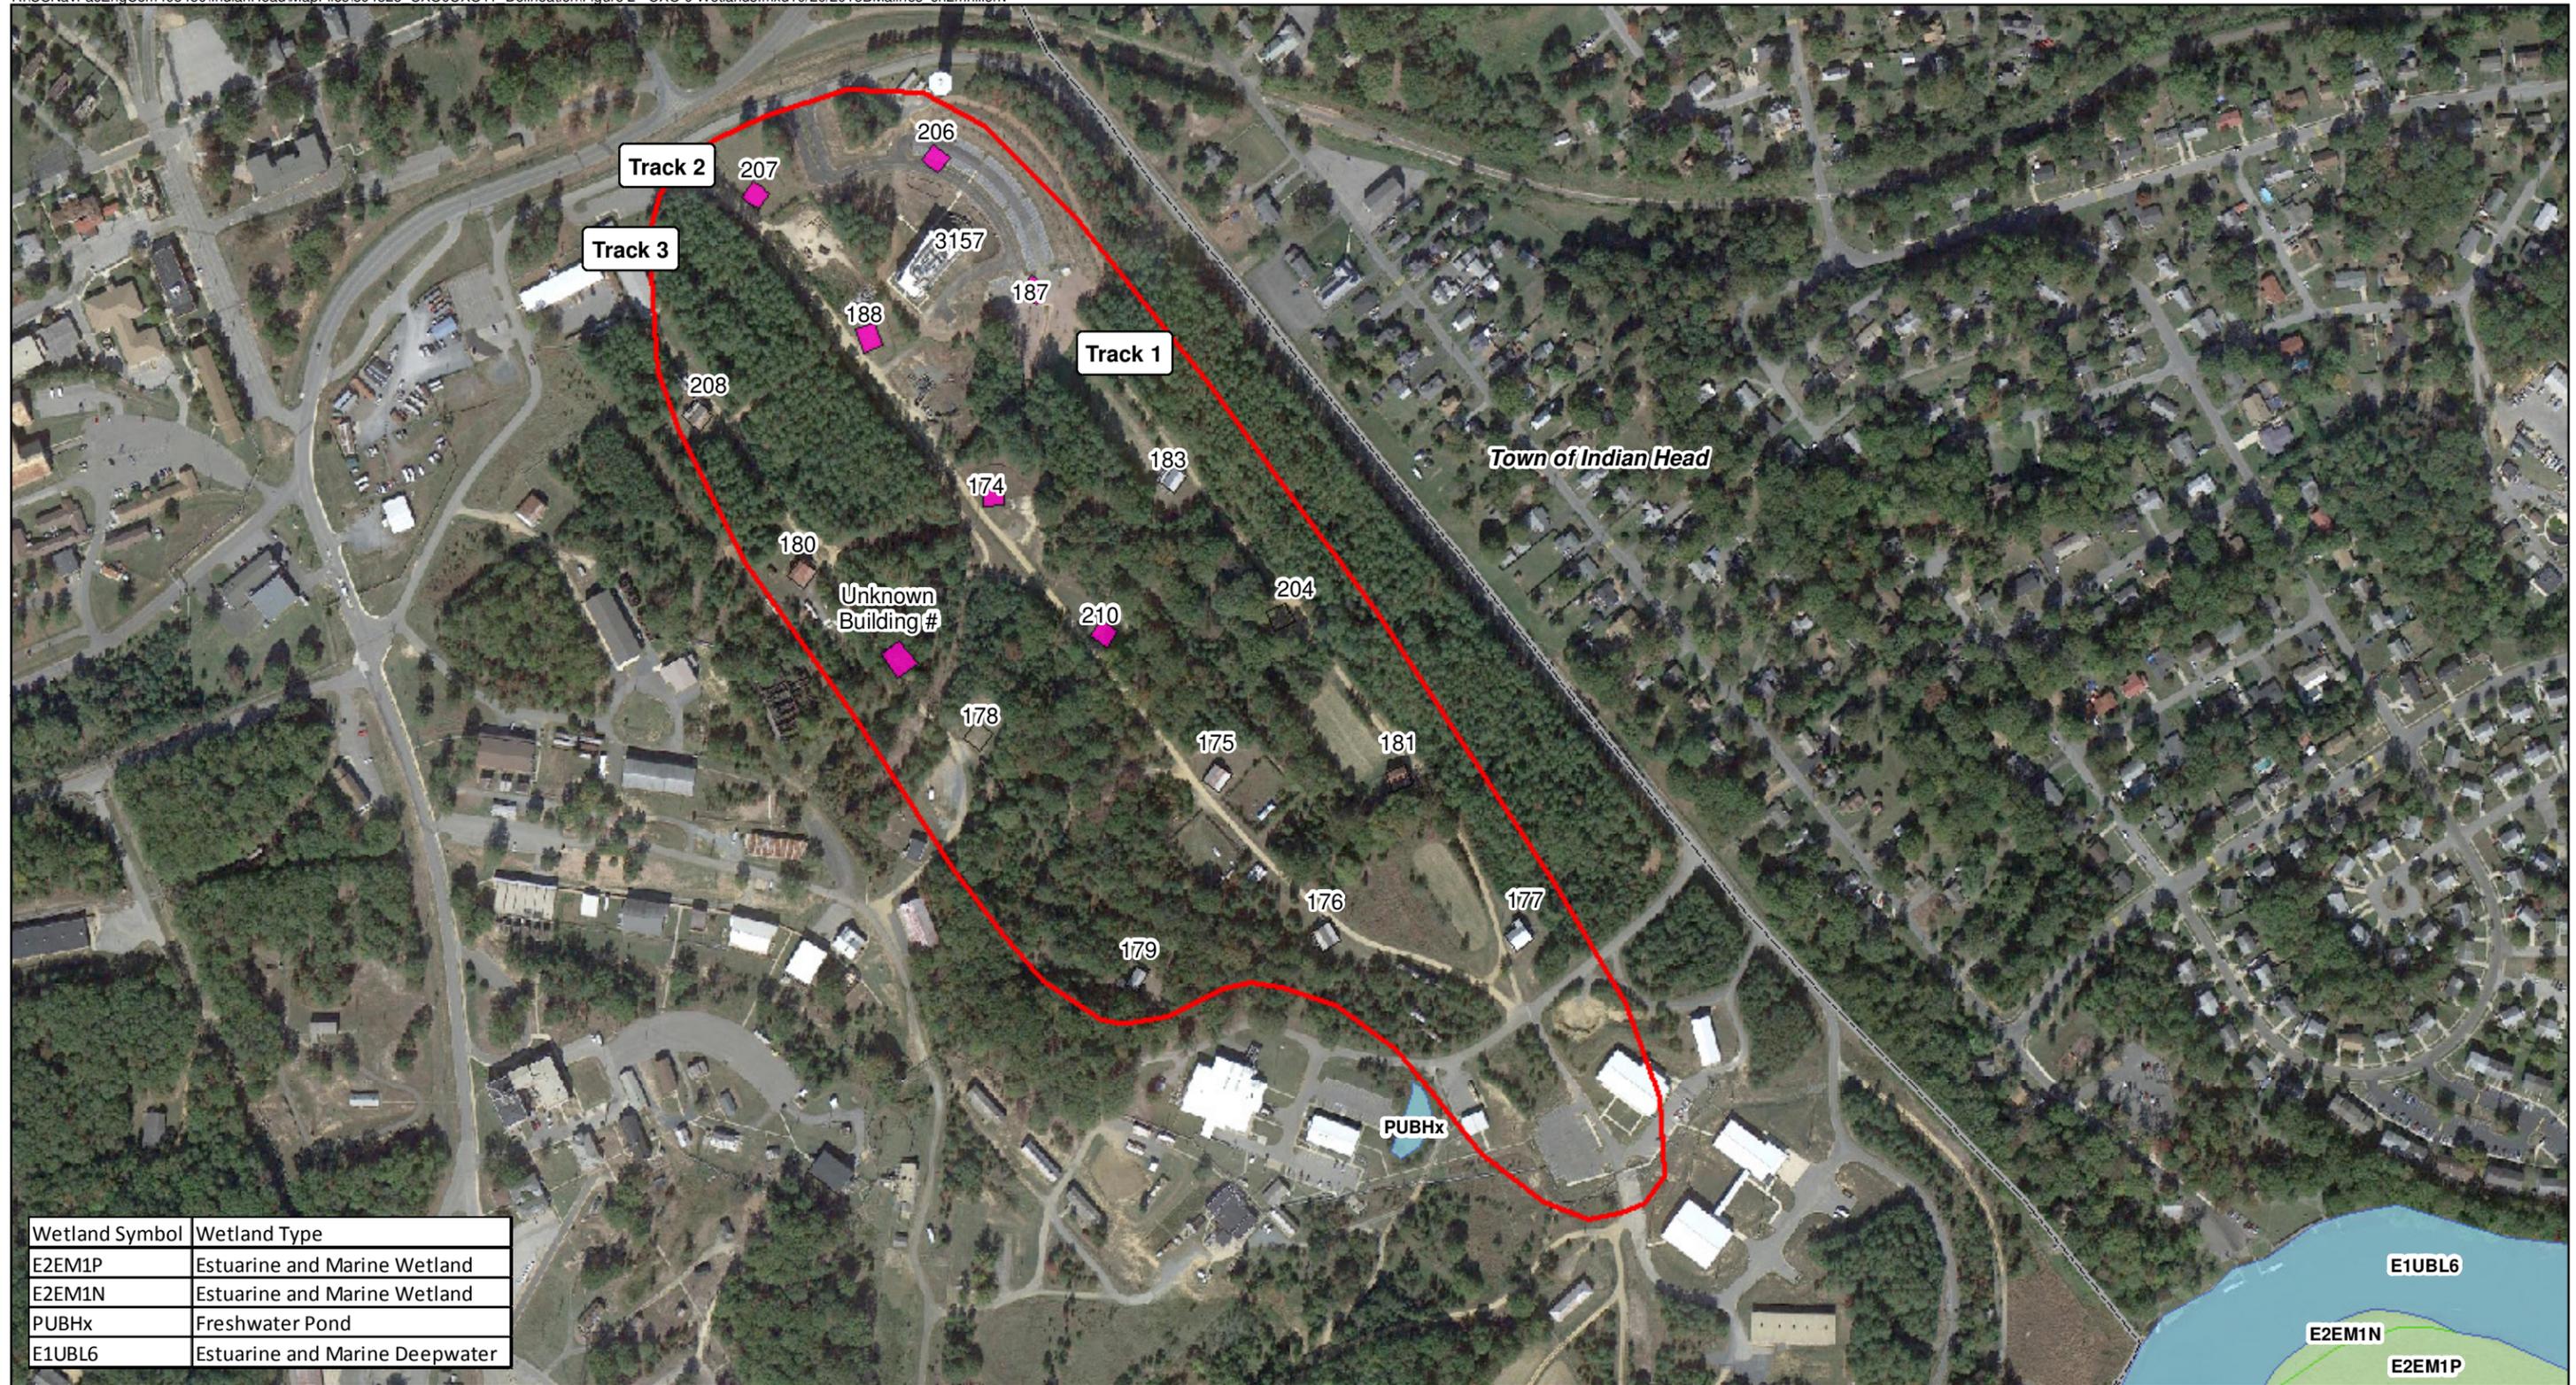
Figure 2
UXO 9 National Hydrography Dataset and National Wetlands Inventory
Results of Wetland Delineation for UXOs 9 and 11
NSFIH, Indian Head, Maryland

The presence of an NHD or NWI feature is not a definitive indicator that a wetland or waterbody is present, as the information is often outdated and cannot be field-verified. The NHD/NWI map for UXO 9 (Figure 2) shows that no features are mapped or depicted within the site boundary. In addition, a PUBHx – Palustrine, Unconsolidated Bottom, Permanently Flooded, Excavated area, or commonly referred to as a pond, is depicted along the southwestern boundary of UXO 9, outside the site boundary. The NHD/NWI map for UXO 11 (Figure 3) shows the surface water of the Potomac River, mapped as E1UBL6 – Estuarine and Marine Wetland and E1UBL6 - Estuarine and Marine Deepwater along the western boundary of the site.

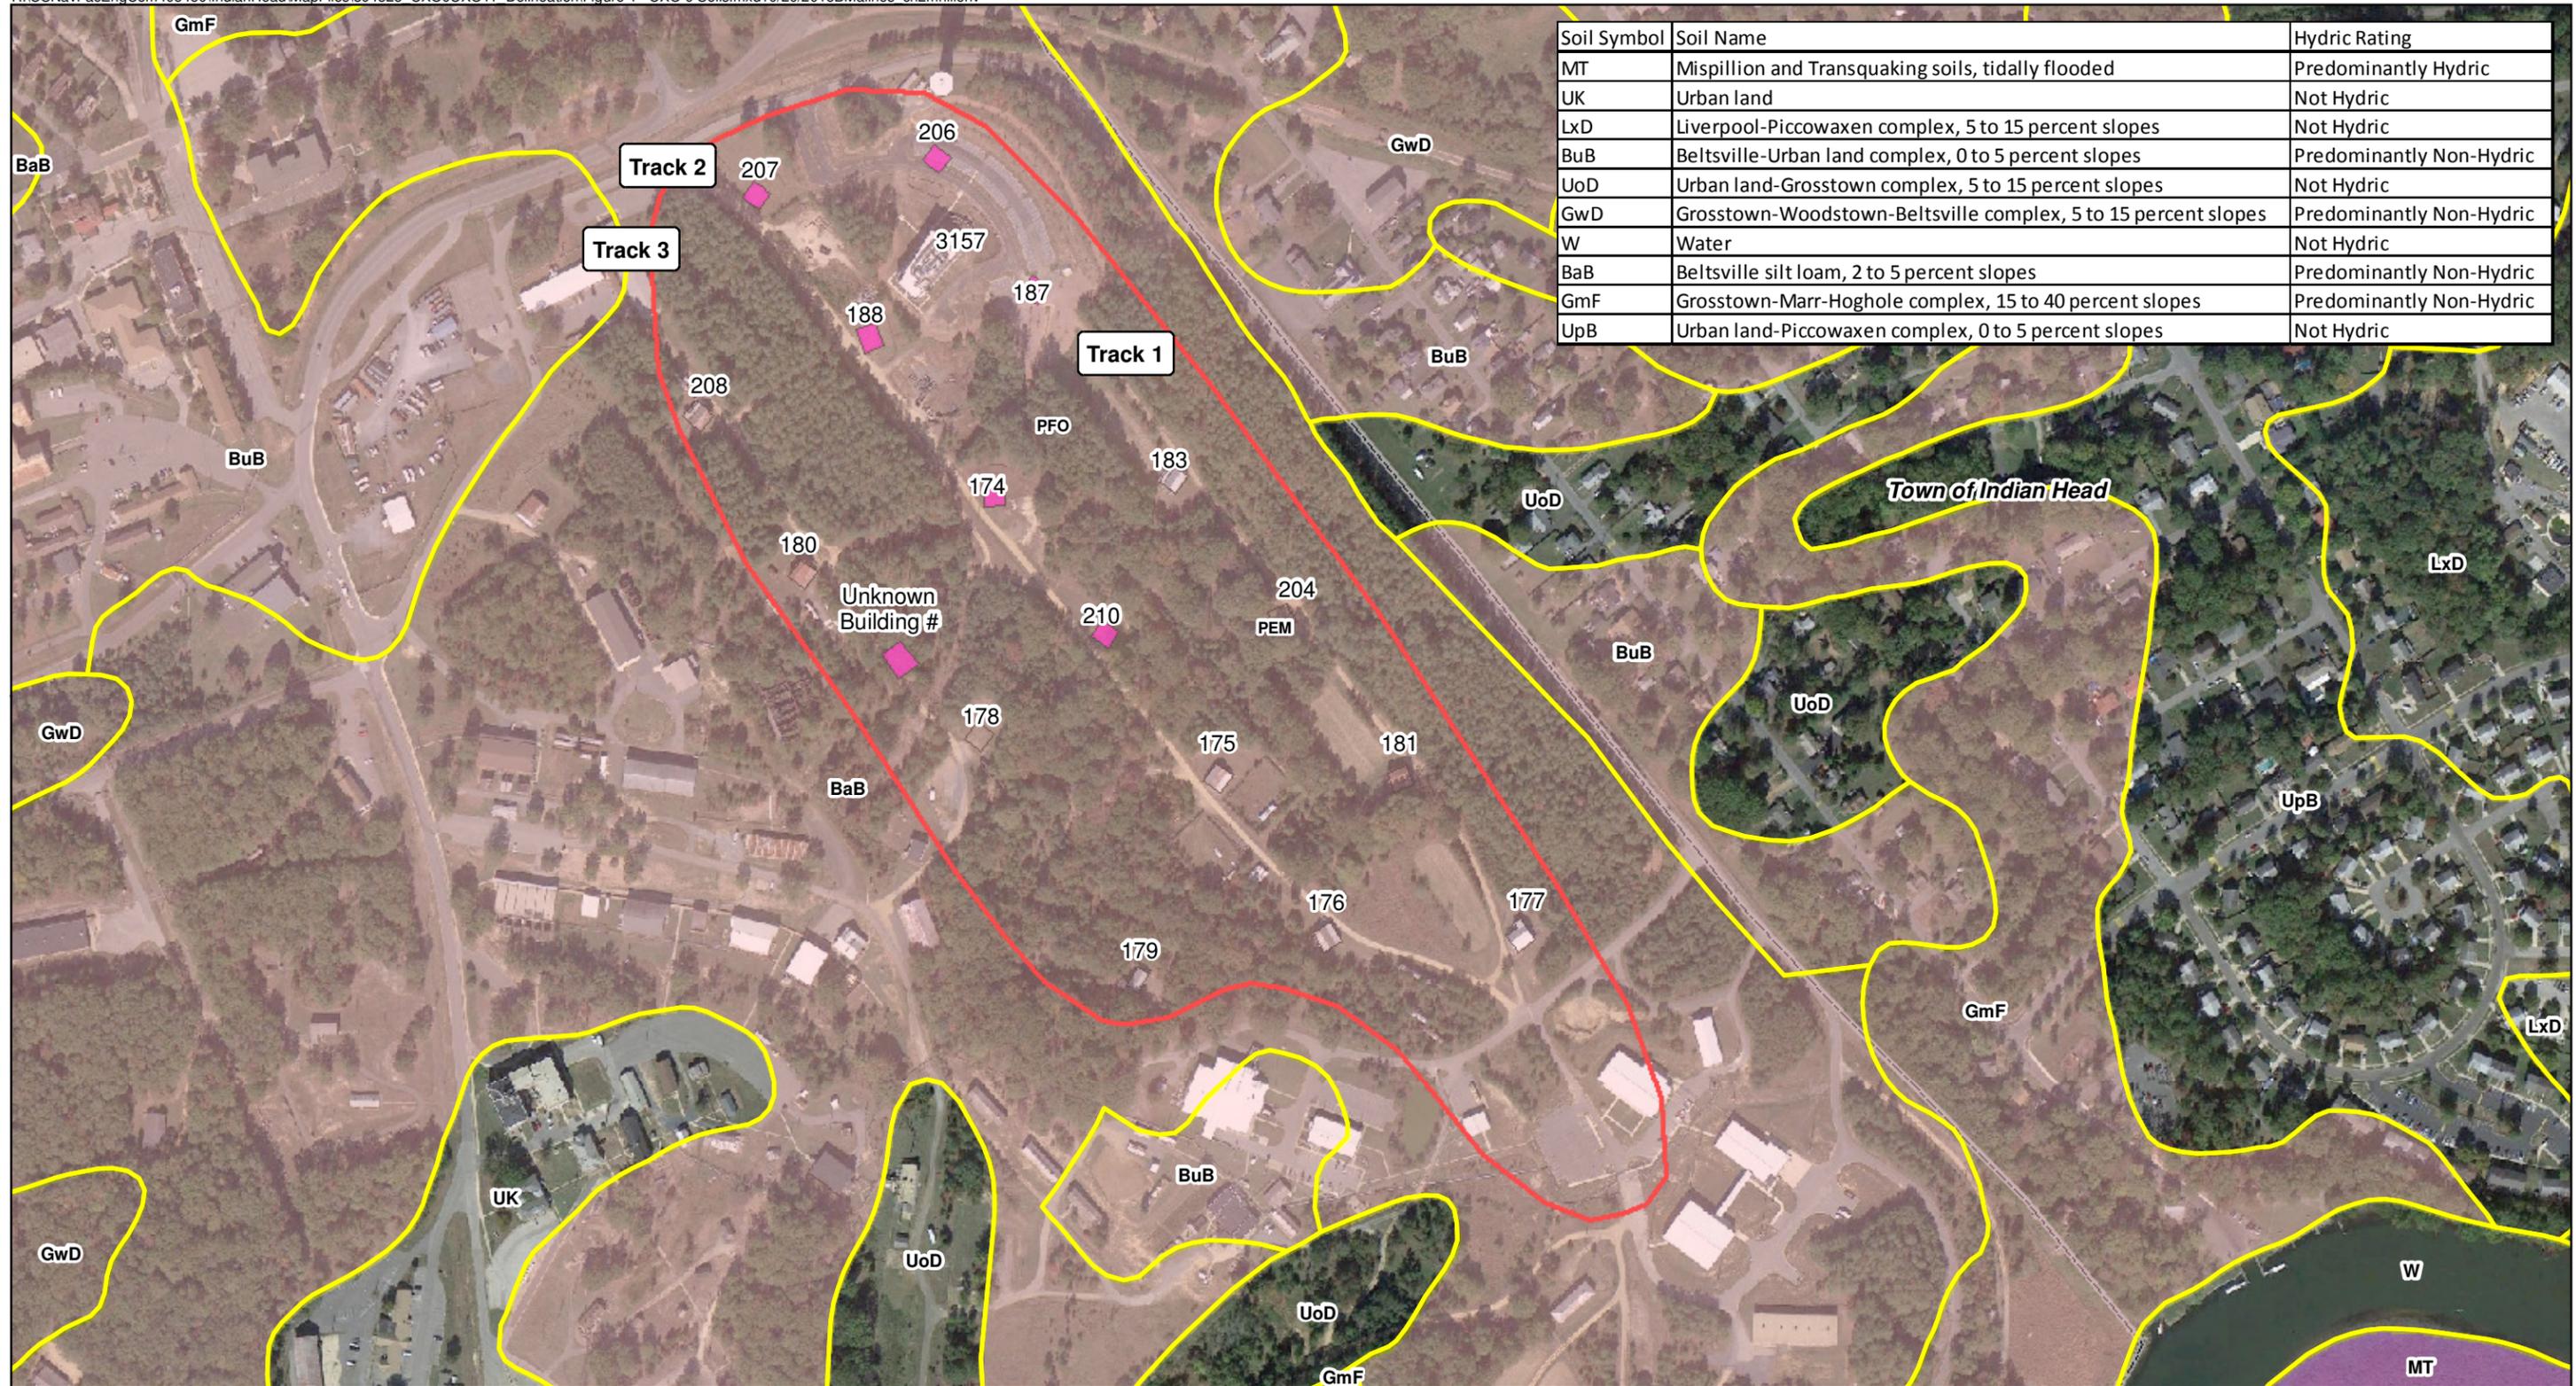
Figure 4
UXO 9 Soils Map
Results of Wetland Delineation for UXOs 9 and 11
NSFIH, Indian Head, Maryland

According to the USDA Web Soil Survey (USDA, 2013), UXO 9 is within the BaB – Beltsville Silt Loam, 2 to 5 percent slopes, and is listed as predominantly non-hydric soils (Figure 4). For UXO 11, seven soil map units are mapped within the environmental survey area (Figure 5). All of the soil map units are listed as either predominantly non-hydric or not hydric. Generally, soil units identified as hydric contain soils that indicate through their color and structure that they have experienced dominantly reducing (that is, oxygen poor) conditions, which are a result of inundation and/or saturation by water. Predominantly non-hydric soil units may contain hydric soil inclusions, but the majority of the unit is non-hydric. Soil units identified as non-hydric have no hydric soil components identified in the mapped soil unit. UXO 9 is located within the Marbury Run – Mattawoman Creek (USGS Hydrologic Unit Code 020700110102), and UXO 11 is within the Occoquan Bay-Potomac River (USGS Hydrologic Unit Code 020700100805) (EPA, 2014).

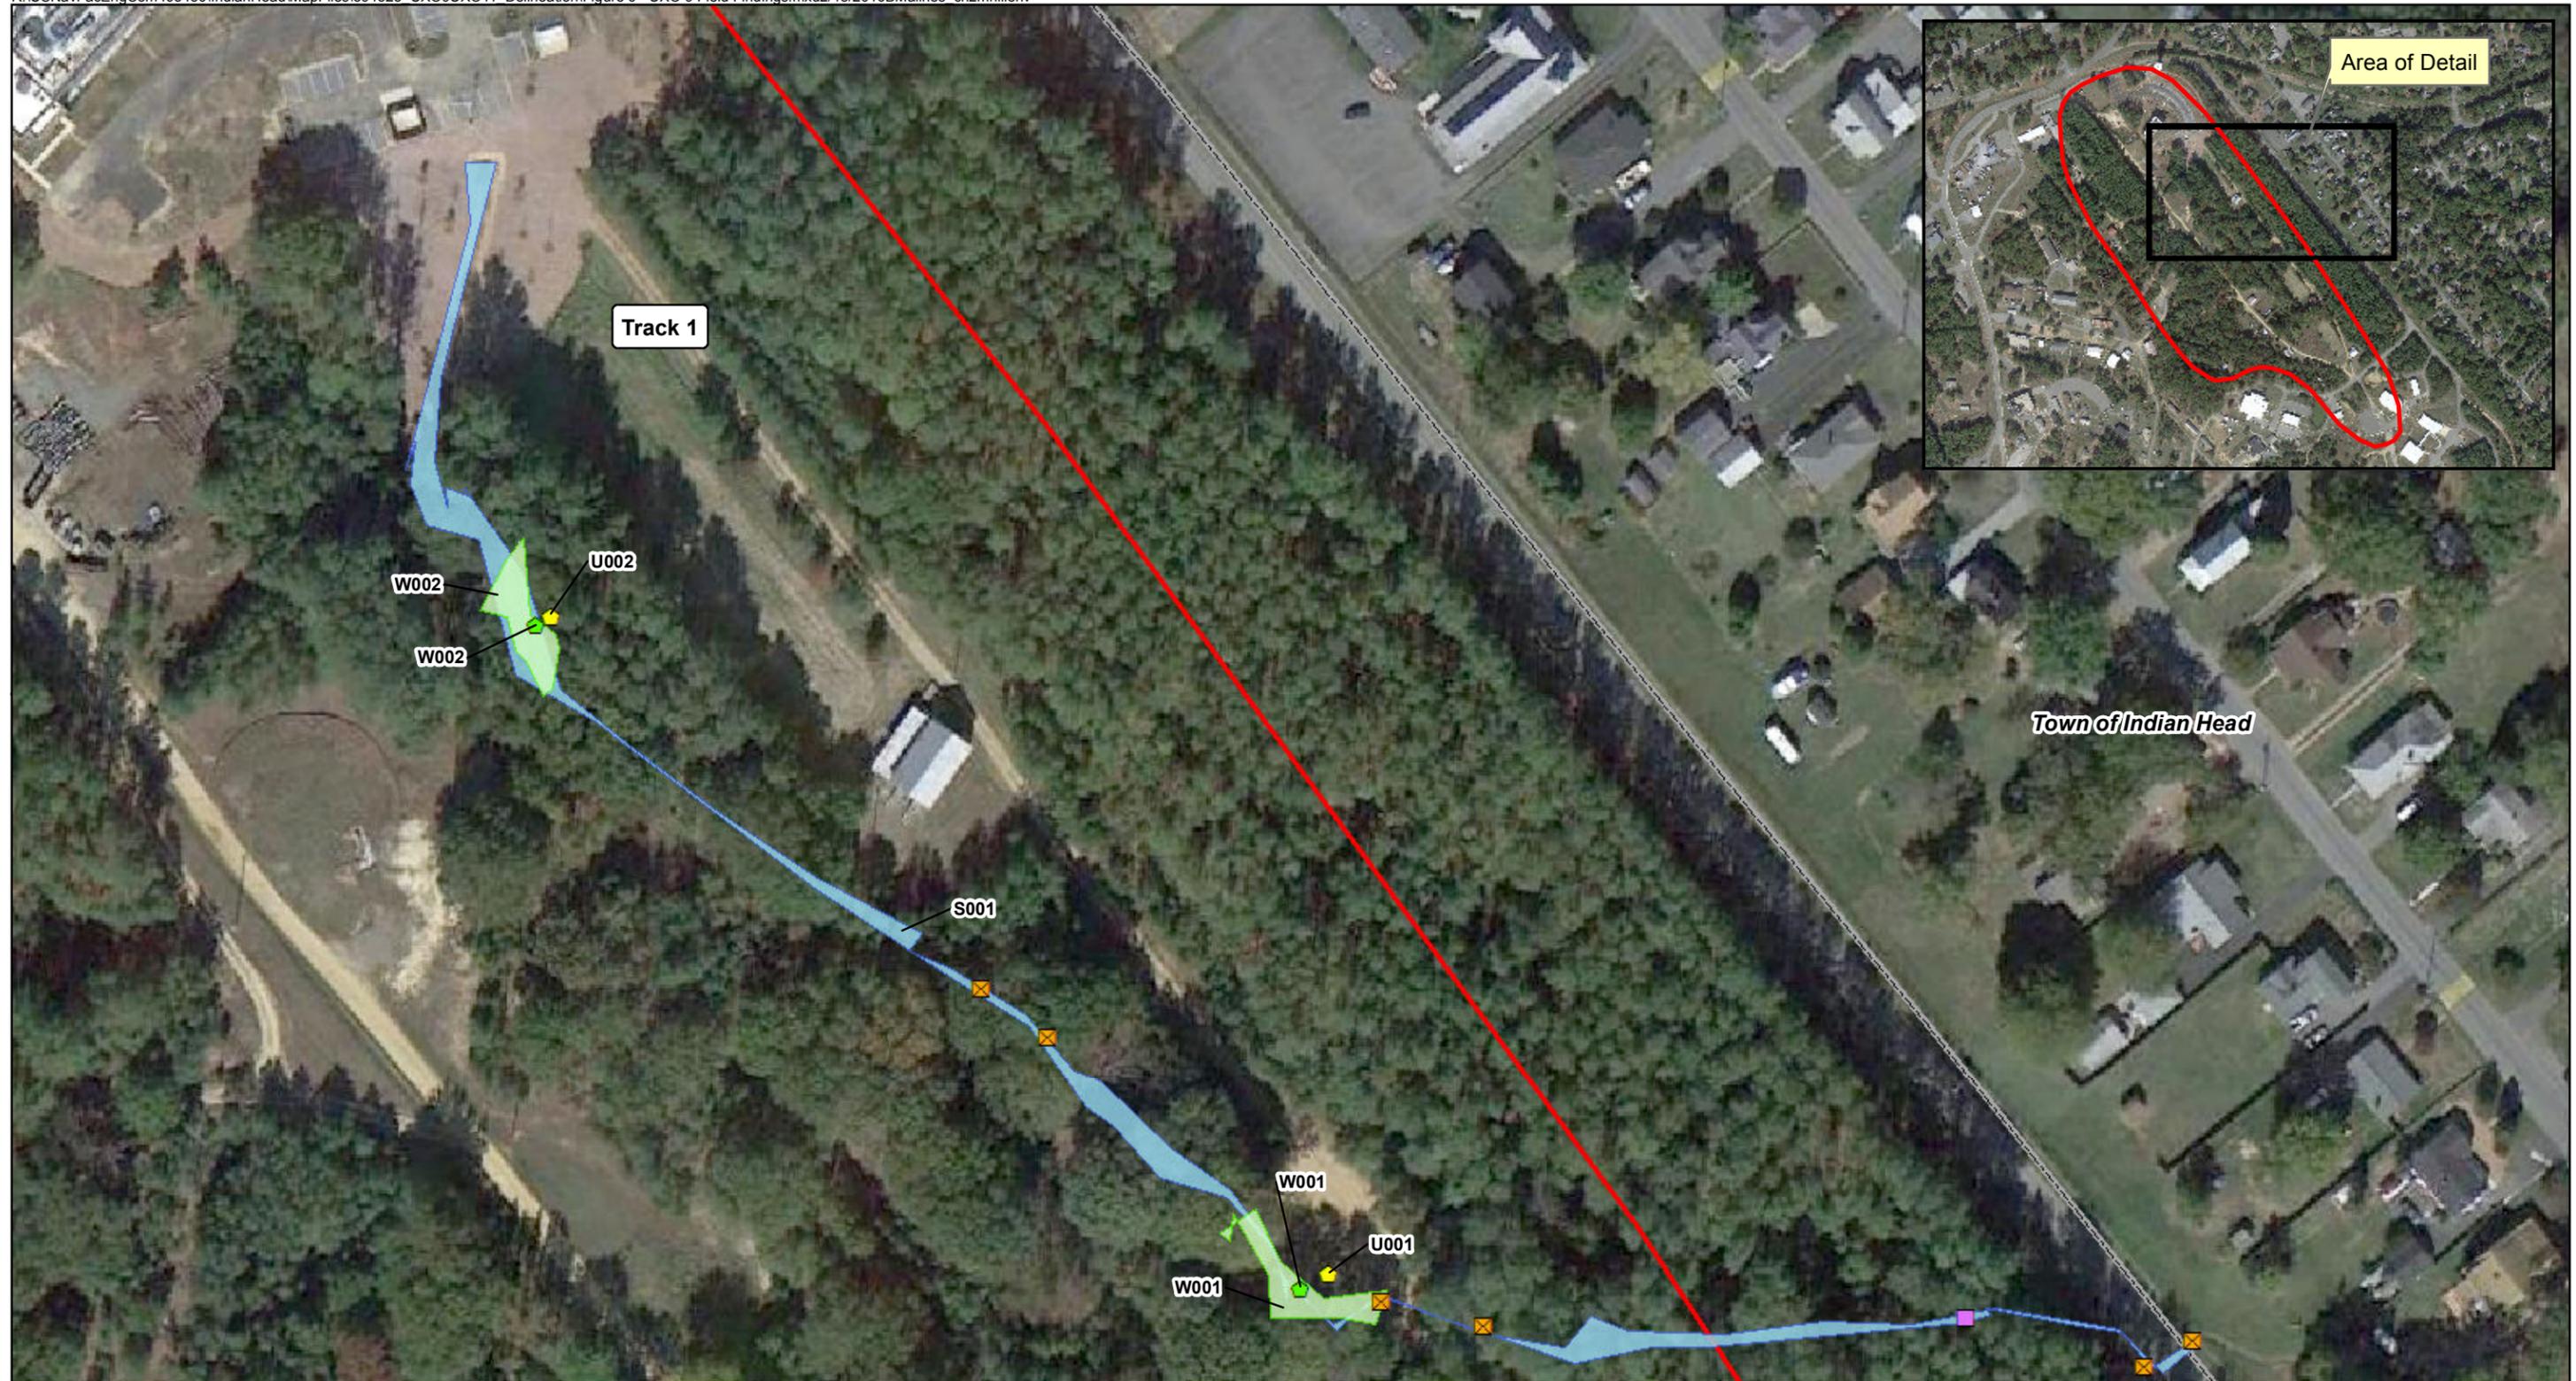
Figure 6
UXO 9 Wetland and Waterbody Delineation Map
Results of Wetland Delineation for UXOs 9 and 11
NSFIH, Indian Head, Maryland

Two wetlands (W001 and W002) and one waterbody (S001) were identified at UXO 9, and their locations are shown on Figure 6. A description of the wetlands and waterbody are provided below.

W001 is a palustrine emergent marsh (PEM), freshwater wetland dominated by an invasive herbaceous species Japanese stiltgrass (*Microstegium vimineum*; FAC), a common invader amongst disturbed sites, and common rush (*Juncus effusus*, OBL). The wetland is a ponded area located in an area where the ephemeral stream (S001), which was dry at the time of the delineation, flattens out near Track 1 (a dirt road), before entering a culvert and continuing as a channelized waterbody. Hydrology was confirmed by saturation. Soils appeared disturbed by the presence of mixed layers, glass, and debris, but the native layer under the disturbed soil layer appeared to be under reducing conditions. W001 displays vegetation, hydrology, and problematic hydric soils. Because of the abnormal site characteristics, the area does not meet the full criteria of a wetland but would be considered an atypical wetland subject to a jurisdictional call by USACE and MDE.

W002 is a palustrine forested (PFO) wetland within UXO 9 that was identified as a small ponded, seasonally flooded area within the confines of S001. The wetland was void of vegetation within the previously flooded area, but was surrounded on the fringe by willow oak (*Quercus phellos*; FACW) and American sweetgum (*Liquidambar styraciflua*; FAC), providing approximately 75 percent of the canopy cover for the wetland area. Hydrology was confirmed by saturation, and watermarks were evident. Hydric soils indicators were confirmed by a depleted matrix. W002 displays vegetation, hydrology, and hydric soils, which classify this area as a jurisdictional wetland.

S001 is an ephemeral stream within UXO 9. It was dry at the time of the delineation. S001 begins as a stormwater drainage swale exiting the parking lot around Building 3157. The stream has a discontinuous channel that flattens out within the two wetland areas. Near the eastern facility boundary, the stream returns to sheet flow for about 75 feet before entering a culvert along the eastern boundary of the base. S001 then exits the facility through the fence line as a grass-lined channel. The stream was dry at the time of the delineation, and the OHWM was approximately 4 feet wide. The substrate was primarily silts and vegetation. A waterbody data form is included as Attachment 2.

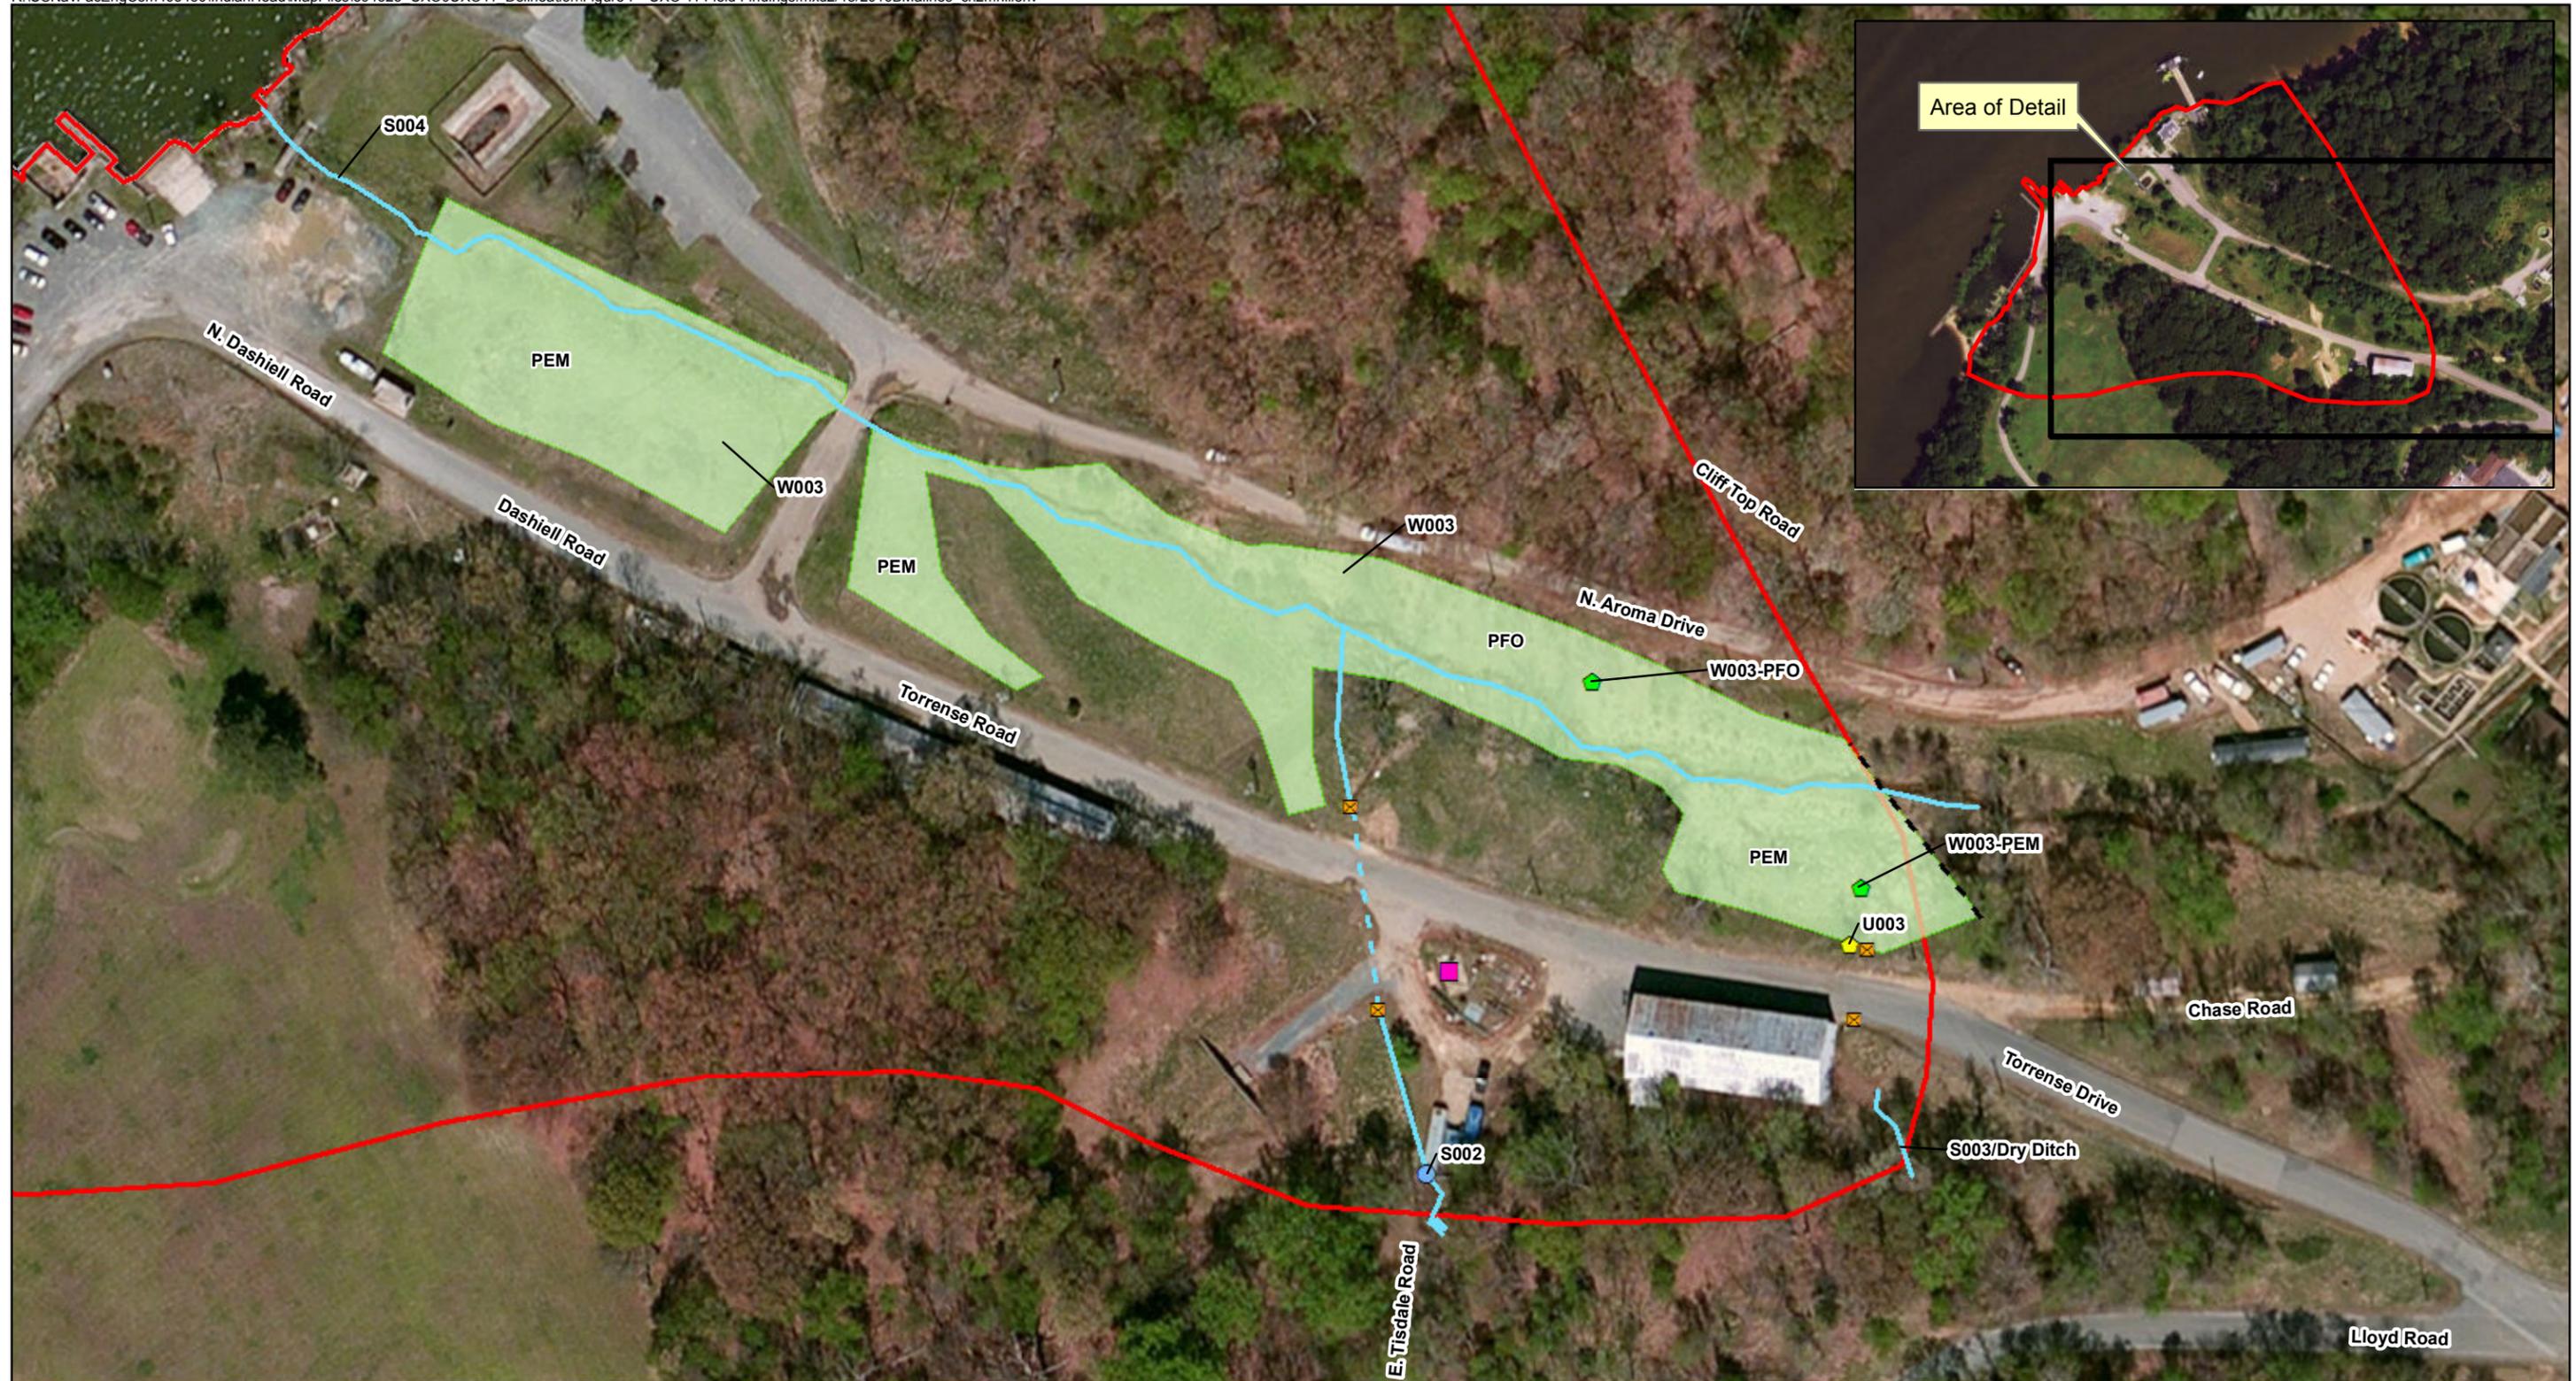
Figure 7
 UXO 11 Wetland and Waterbody Delineation Map
 Results of Wetland Delineation for UXOs 9 and 11
 NSFIIH, Indian Head, Maryland

One wetland (W003) and three waterbodies (S002, S003, and S004) were identified at UXO 11, and their locations are shown on Figure 7. A description of the wetland and waterbodies are provided below.

W003 is a large PEM/PFO wetland complex surrounding S004. The emergent portion of the wetland, on the southern side of the stream, was dominated by herbaceous vegetation consisting of dominant species of rice cutgrass (*Leersia oryzoides*; OBL), arrowleaf tearthumb (*Persicaria sagittata*; OBL), and wild mint

(*Mentha arvensis*; FACW). The canopy cover of the forested portion of the wetland, on the northern side of S004, was dominated by sweet gum (*Liquidambar styraciflua*), bald cypress (*Taxodium distichum*; which appeared to be planted), and pawpaw (*Asimina triloba*). Hydrology was confirmed by water-stained leaves. Hydric soils indicators were confirmed by a depleted matrix. W003 displays vegetation, hydrology, and hydric soils, which classify this area as a jurisdictional wetland.

S002 is an intermittent stream within UXO 11 that enters UXO 11 as it drains north from the hills into S004. Approximately one-third of the stream is enclosed within a culvert under the unnamed paved road shown on Figure 7. The stream banks were recently disturbed by the grading that occurred on the banks to improve stormwater drainage. Average water stream depth was approximately 2 inches at the time of delineation, and the stream width at the OHWM was approximately 2 feet wide. The substrate was primarily silts. A waterbody data form is included as Attachment 2.

S003 is an ephemeral stream /dry ditch within UXO 11 and was identified as a dry drainage/erosional feature that conveys stormwater during significant rain events. The stream has a discontinuous channel that leads to a stormwater culvert under the unnamed paved road that discharges into W003 (Figure 7). No channel was identified with W003. The stream was dry at the time of the delineation, and the OHWM was approximately 1.5 feet wide. The substrate was primarily silts. Because of the lack of continuous bed and banks, this dry channel likely would not be considered a jurisdictional resource. A waterbody data form is included as Attachment 2.

S004 is a perennial stream that bisects UXO 11 from east to west (Figure 4). The stream was part of a large stream/wetland complex and, based on field observations, had a perennial flow. The stream had a continuous channel that discharged directly into the Potomac River. Average stream depth was approximately 3 inches at the time of delineation, and the stream width at the OHWM was approximately 5 feet wide. The substrate was primarily gravel. A waterbody data form is included as Attachment 2.

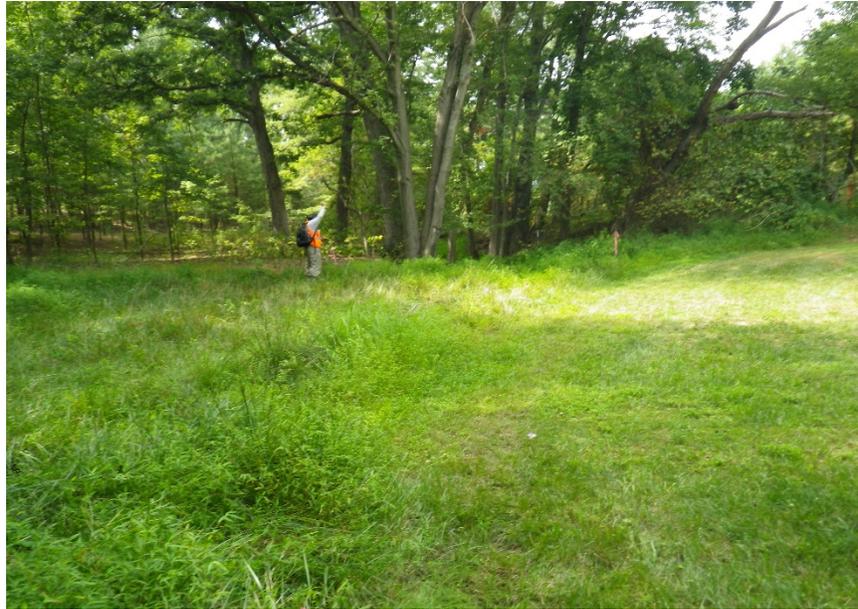
Photo 1 **Direction:** Northwest
Notes: W001 PEM.

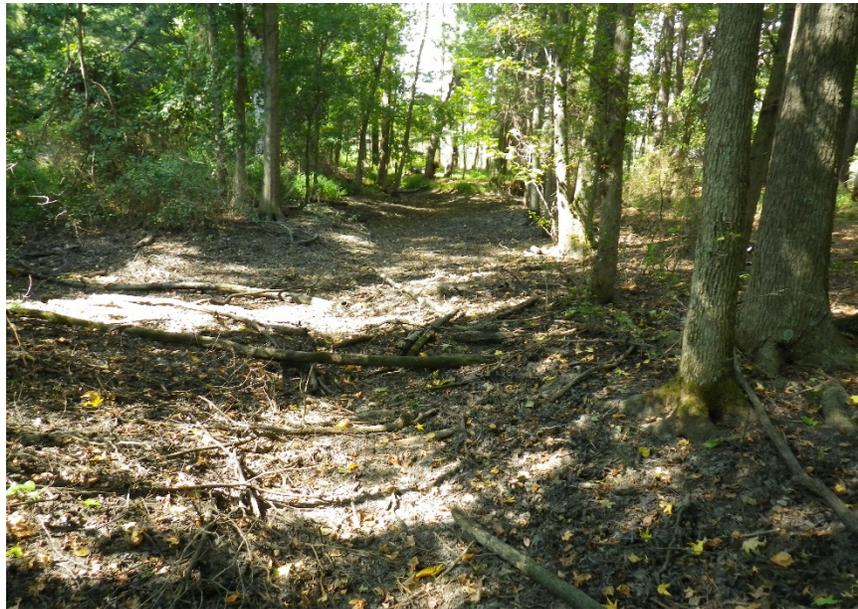
Photo 2 **Direction:** North
Notes: W002 PFO

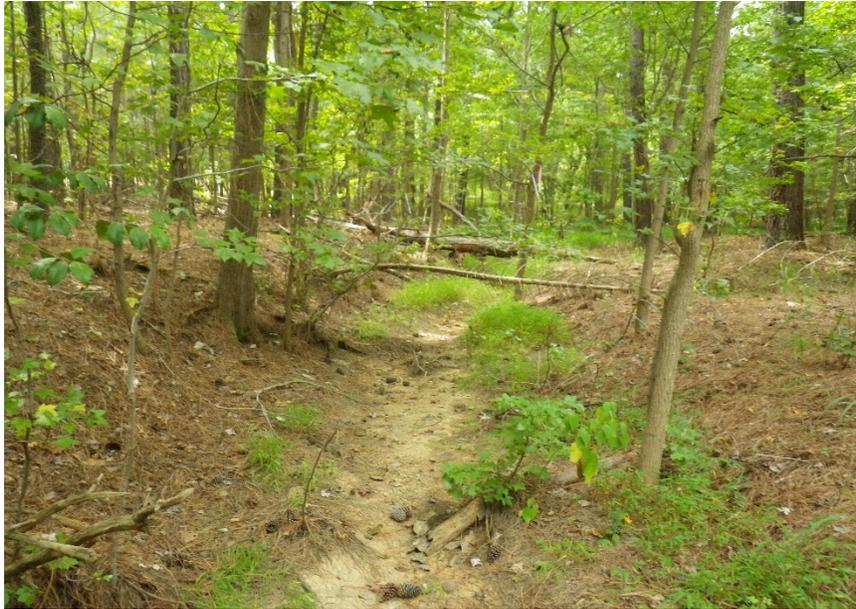
Photo 3 **Direction:** North
Notes: S001 – Approximate midpoint.

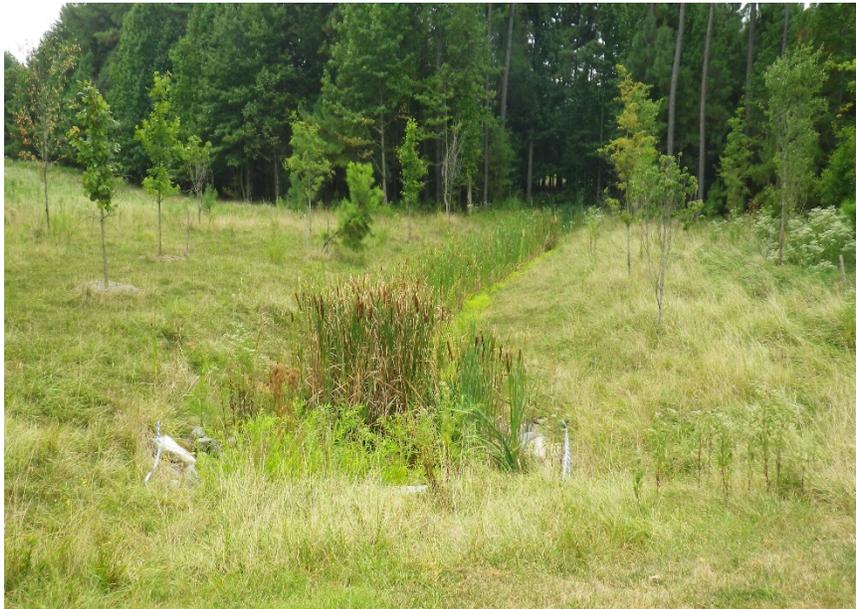
Photo 4 **Direction:** South
Notes: S001, as it exits stormwater drain from the parking lot.

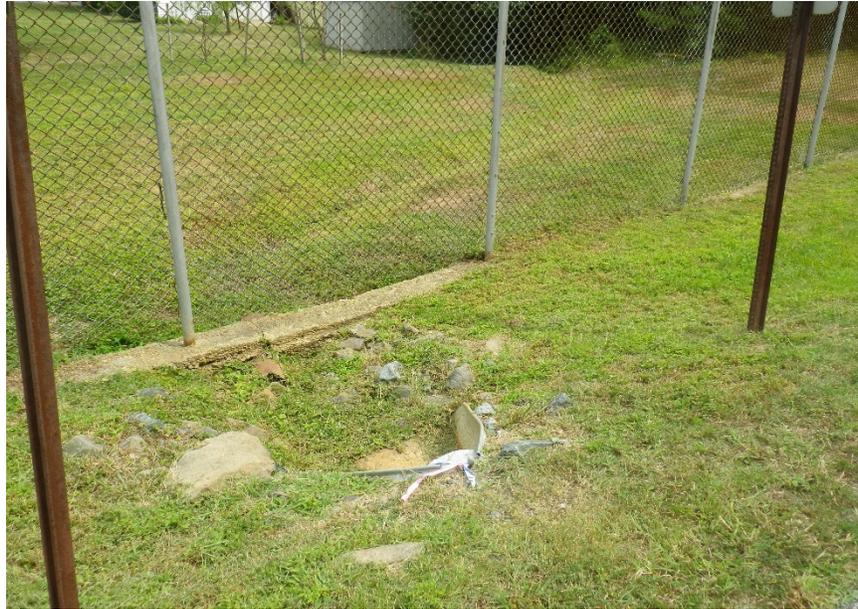
Photo 5 **Direction:** west
Notes: S001 exiting the facility.
