FINAL TECHNICAL MEMORANDUM FOR RESULTS OF WETLAND DELINEATION
UNEXPLODED ORDNANCE 9 AND 11 (UXO 9) (UXO 11) NSWC INDIAN HEAD MD
3/17/2016
CH2M HILL

Results of Wetland Delineation for UXOs 9 and 11, Naval Support Facility Indian Head, Indian Head, Maryland

PREPARED BY: Brian Colabella/CH2M HILL

DATE: March 17, 2016

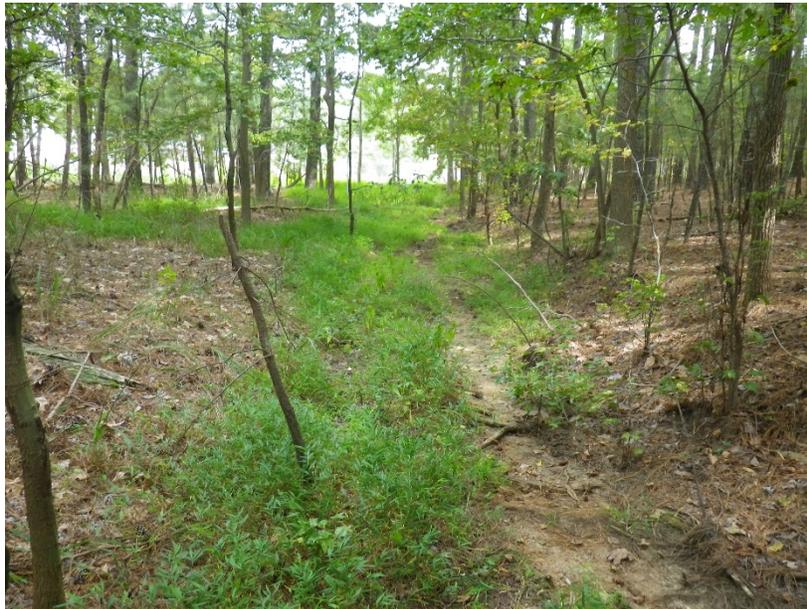
Photo 6 **Direction:** South
Notes: S001, near the edge of the site boundary.

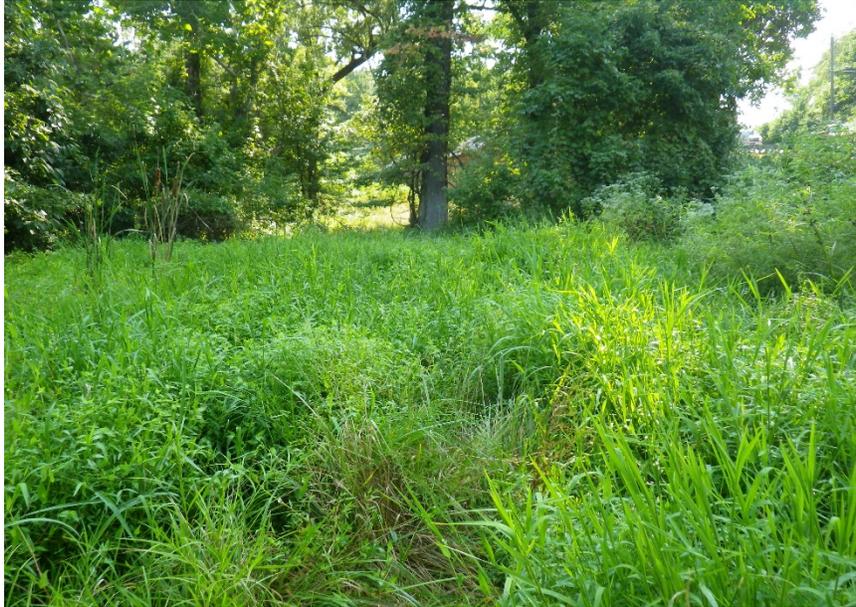
W003 is a large PEM/PFO wetland complex surrounding S004. The emergent portion of the wetland, on the southern side of the stream, was dominated by herbaceous vegetation consisting of dominant species of rice cutgrass (*Leersia oryzoides*; OBL), arrowleaf tearthumb (*Persicaria sagittata*; OBL), and wild mint

Photo 7 **Direction:** East
Notes: W003, PEM

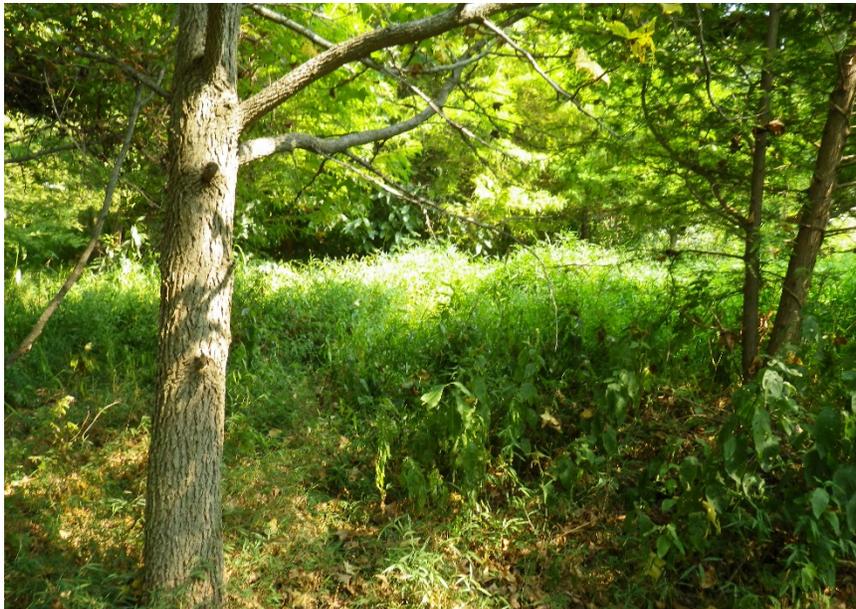
(*Mentha arvensis*; FACW). The canopy cover of the forested portion of the wetland, on the northern side of S004, was dominated by sweet gum (*Liquidambar styraciflua*), bald cypress (*Taxodium distichum*; which appeared to be planted), and pawpaw (*Asimina triloba*). Hydrology was confirmed by water-stained leaves. Hydric soils indicators were confirmed by a depleted matrix. W003 displays vegetation, hydrology, and hydric soils, which classify this area as a jurisdictional wetland.

Photo 8 **Direction:** south
Notes: W004, Forest Wetland area adjacent to S004.

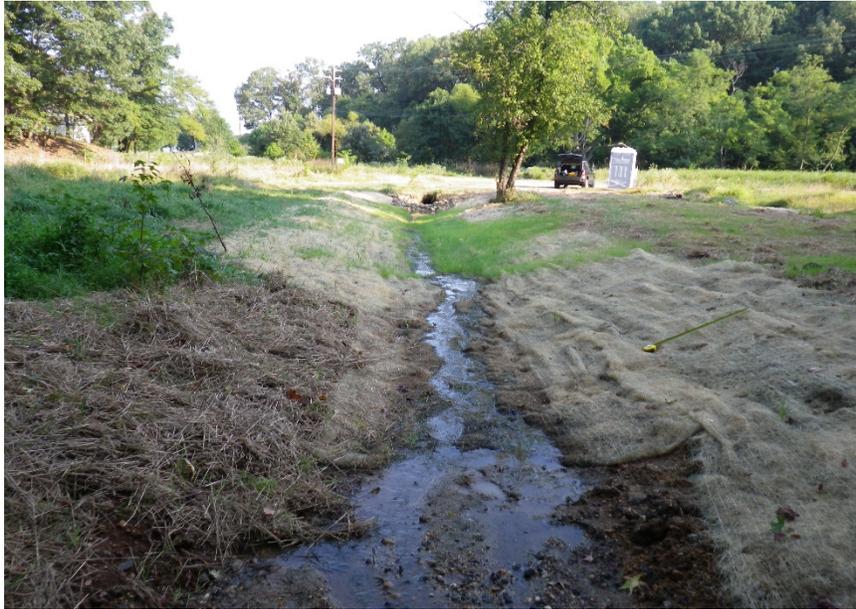
S002 is an intermittent stream within UXO 11 that enters UXO 11 as it drains north from the hills into S004. Approximately one-third of the stream is enclosed within a culvert under the unnamed paved road shown on Figure 7. The stream banks were recently disturbed by the grading that occurred on the banks to improve stormwater drainage. Average water stream depth was approximately 2 inches at the time of delineation, and the stream width at the OHWM was approximately 2 feet wide. The substrate was primarily silts. A waterbody data form is included as Attachment 2.

Photo 9 **Direction:** East
Notes: S002, Intermittent

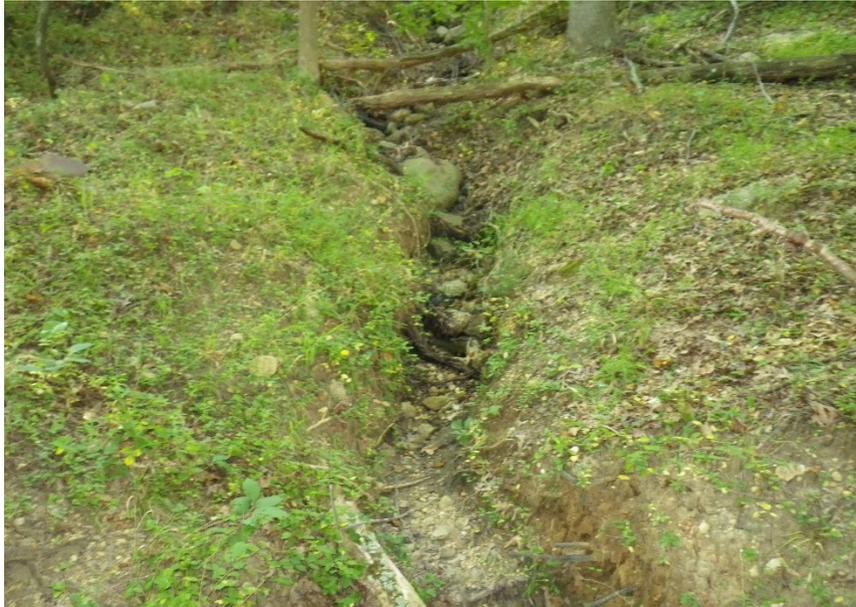
S003 is an ephemeral stream /dry ditch within UXO 11 and was identified as a dry drainage/erosional feature that conveys stormwater during significant rain events. The stream has a discontinuous channel that leads to a stormwater culvert under the unnamed paved road that discharges into W003 (Figure 7). No channel was identified with W003. The stream was dry at the time of the delineation, and the OHWM was approximately 1.5 feet wide. The substrate was primarily silts. Because of the lack of continuous bed and banks, this dry channel likely would not be considered a jurisdictional resource. A waterbody data form is included as Attachment 2.

Photo 10 **Direction:** south
Notes: S003. Ephemeral

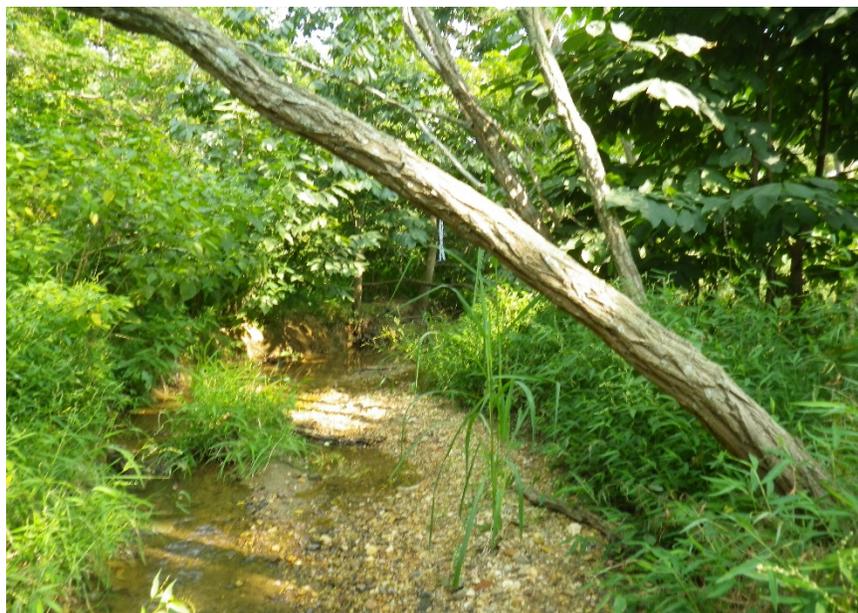
S004 is a perennial stream that bisects UXO 11 from east to west (Figure 4). The stream was part of a large stream/wetland complex and, based on field observations, had a perennial flow. The stream had a continuous channel that discharged directly into the Potomac River. Average stream depth was approximately 3 inches at the time of delineation, and the stream width at the OHWM was approximately 5 feet wide. The substrate was primarily gravel. A waterbody data form is included as Attachment 2.

Photo 11 **Direction: East**
Notes: S004, Perennial

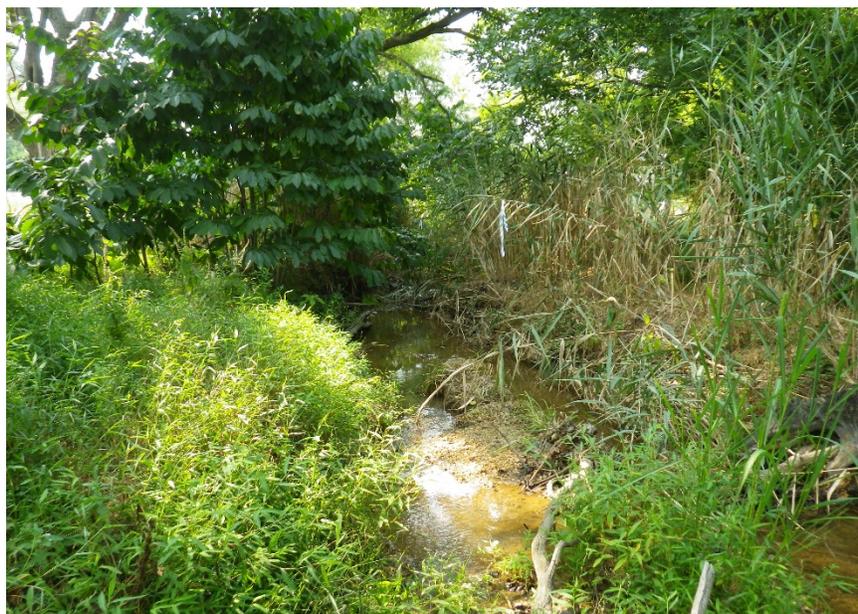
Photo 12 **Direction: West**
Notes: S004, Perennial
