RADIOLOGICAL REMEDIAL INVESTIGATION REPORT
Former Naval Station Puget Sound
Seattle, Washington

Contract No. N62470-08-D-1007
Task Order FZN4
Shaw Project No. 137165

May 2011

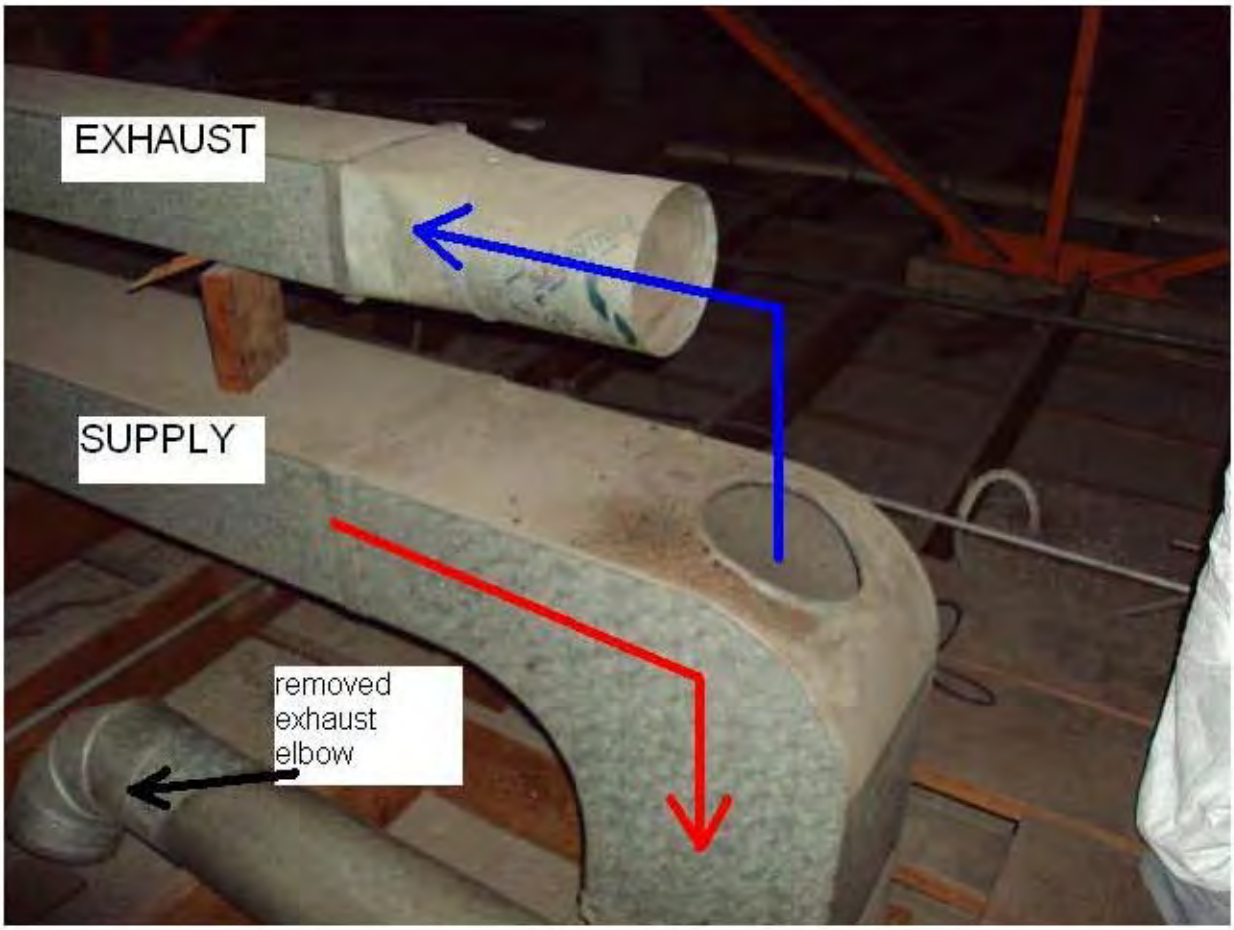
Figure 19
1941 Former Instrument Shop Ventilation System

- With the exception of the 1941 Instrument Shop ventilation system, no radiological contamination above project cleanup criteria was found on the ceiling or ceiling vents (Figure 19) in areas surveyed. The ventilation system exhaust ducts (accessed from the attic) are contaminated with levels exceeding project cleanup criteria. With the 1941 Instrument Shop ventilation being a closed-loop system, there is a potential that contamination exceeding project cleanup criteria extends to other areas of the ventilation system.

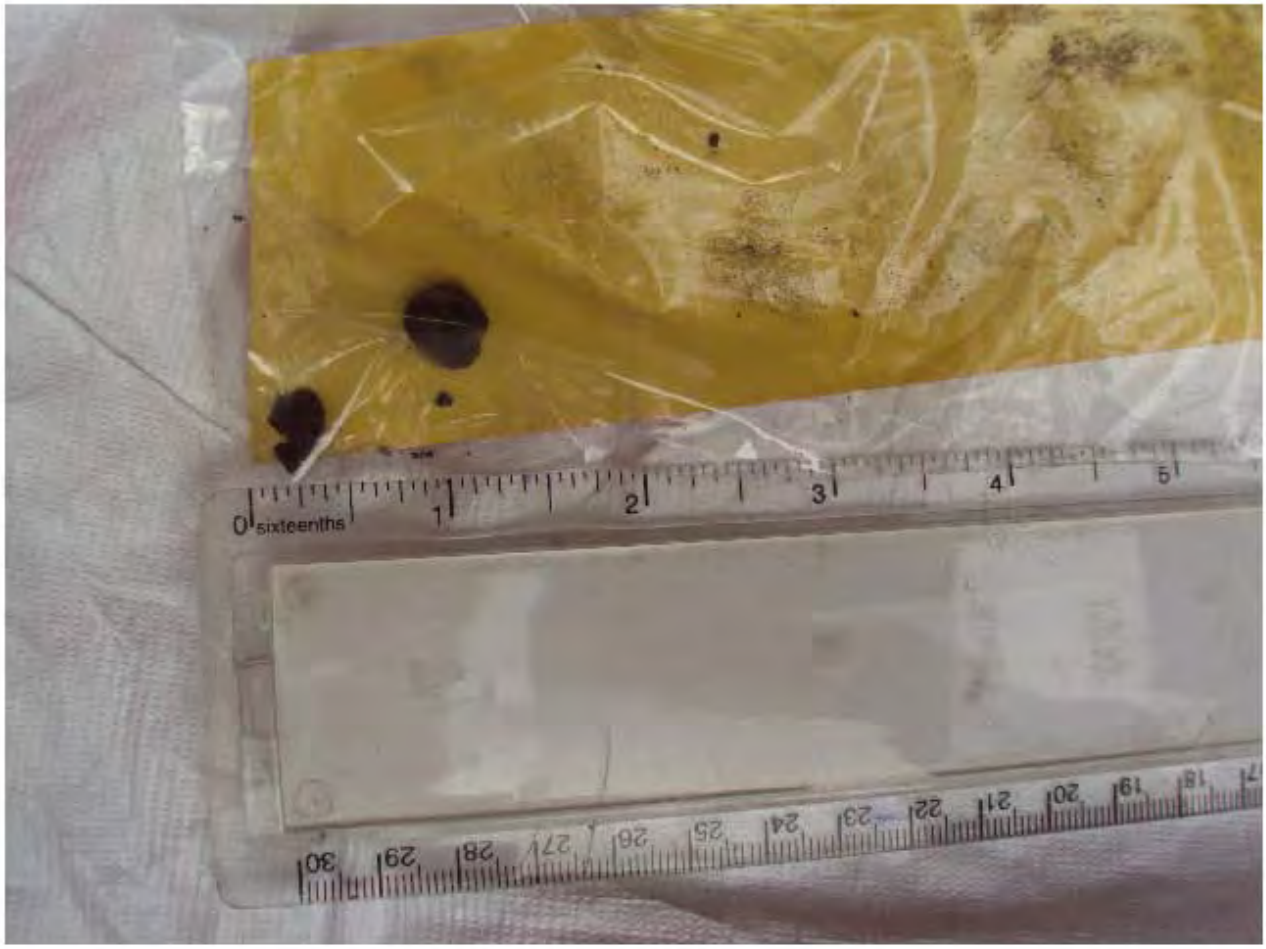
Figure 37
Object Recovered from Boring Number 60

On the southwest corner of Building 2, a small isolated hotspot was located within inches of the building wall. Boring B-60 was drilled at this location. The top 6 inches of soil was the only interval with elevated activity. Upon closer investigation of the soil, a small article (possibly a piece of aircraft instrumentation [Figure 37]) was discovered and removed (RSS-509) (Appendix B). A dose rate at 30 centimeters from the object was 10 microRoentgen per hour above background. The object was labeled as radioactive material and stored in the locked Radioactive Material Storage Area located on the first floor of Building 27. The top 6 inch interval was analyzed and exceeded the project cleanup criteria at 64.6 pCi/g Ra-226. After sampling, a scan of the borehole indicated that the soil exhibited background gamma levels. A sample from the 1.5 to 2 foot interval had a Ra-226 concentration below the project cleanup criteria.
