INSTALLATION RESTORATION PROGRAM
REMOVAL ACTION MEMORANDUM, SITE 6
OCTOBER 1993

MARINE CORPS BASE, CAMP LEJEUNE
NORTH CAROLINA

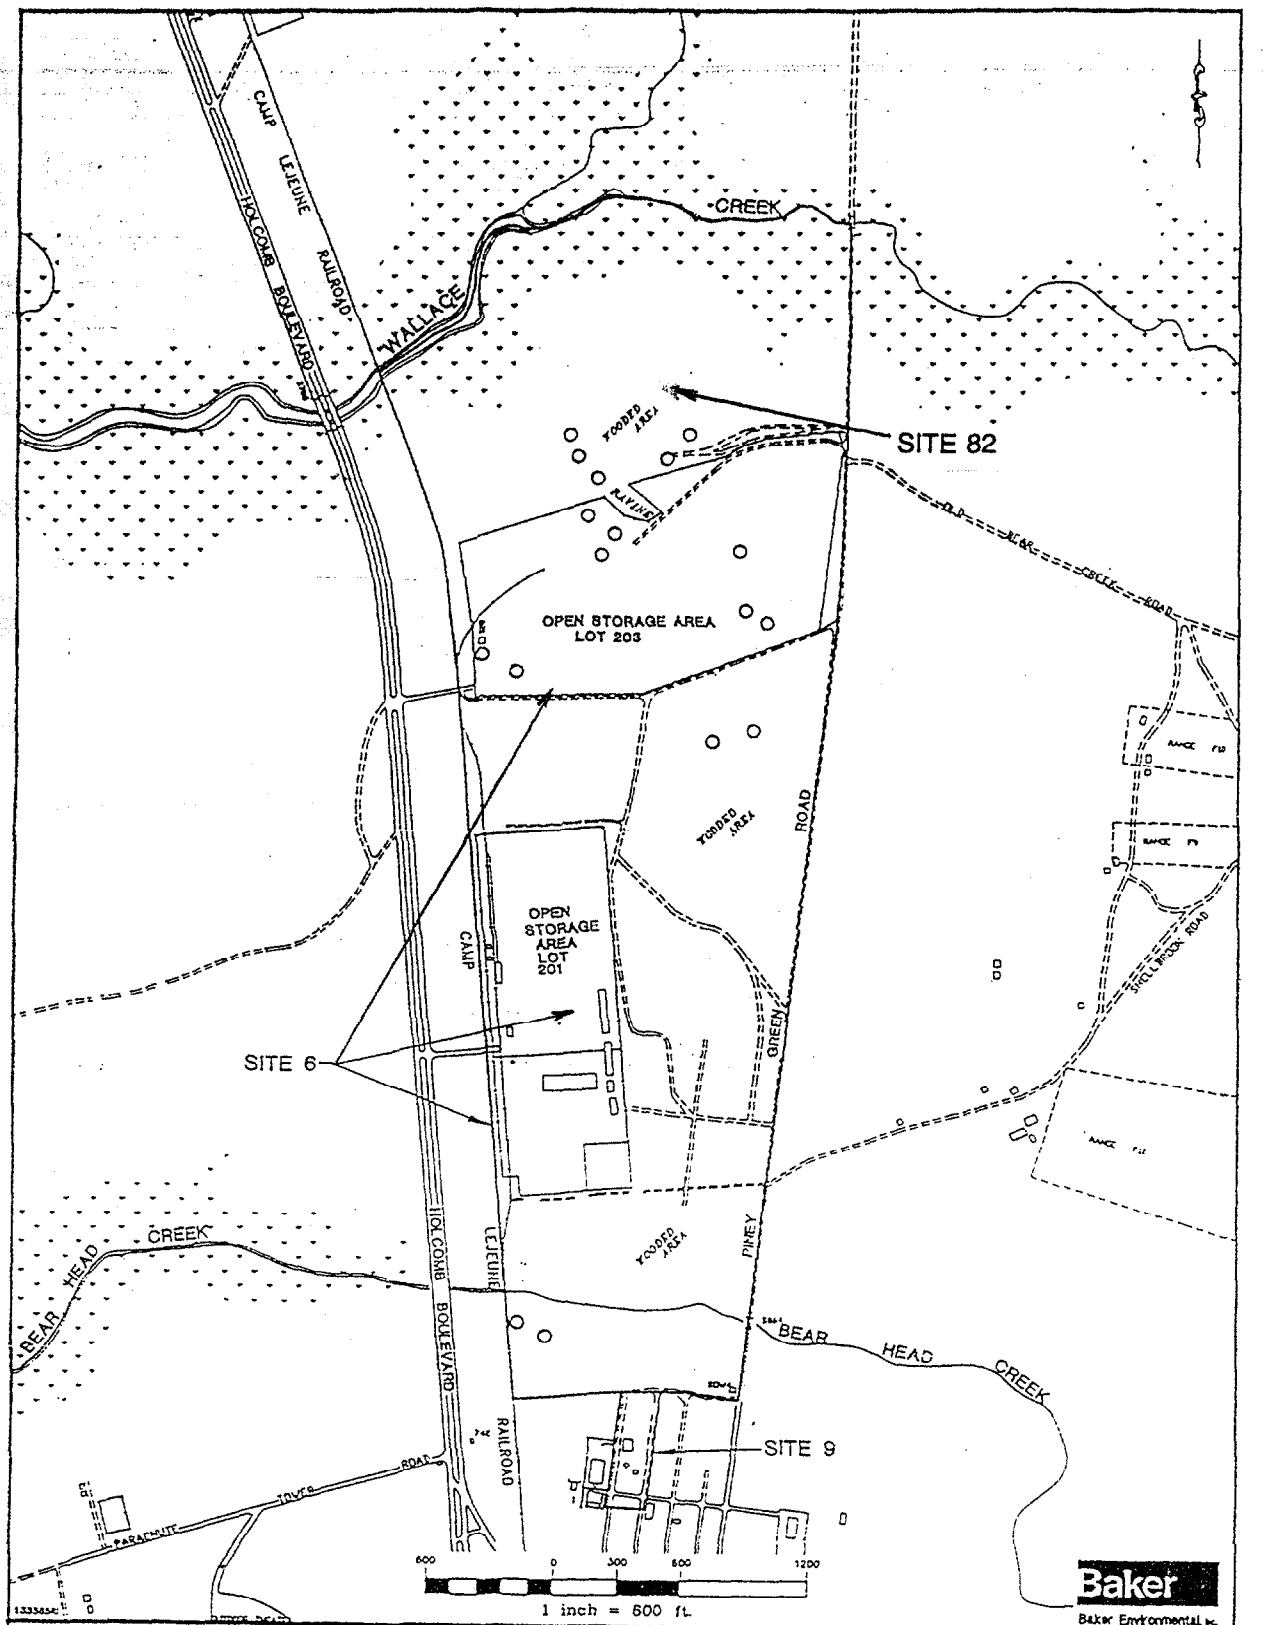
FIGURE 1 - 1
DRUM LOCATION MAP
SITE 6
REMEDIAL INVESTIGATION CTO-0133

Within Lot 203 approximately forty 55-gallon drums, five above ground storage tanks, and numerous smaller containers were identified. The majority of the drums were identified as containing lubricants, petroleum products, or corrosives. Five above ground storage tanks are also located in lot 203 and were labeled as containing diesel fuel, gasoline, and kerosene. 650 pint containers were identified as containing a polish compound.

There are five discrete areas that exist at Site 6 in which the drums are not within a secured area. The specific areas are located north and south of the fenced Lot 203 Storage Area. Composite samples collected from these drums were sampled for TCLP. Containers D055, D056 and D058 failed one or more of the RCRA characteristic or toxicity tests. The potential for exposure to personnel and wildlife on MCB Camp Lejeune does exist for the substances contained in these containers.

All identified drums located in Site 6 will be collected and staged. All drums containing product will be overpacked prior to transposition to the staging area. The above ground storage tanks (ASTs) will be drained of all remaining product and containerized for transportation and disposal. The product from the ASTs will be tested for BTU content and hazardous constituents to determine if the product can be sent to a fuel blending facility. The tanks will be rendered inert and transported to the processing cell for cutting and cleaning.

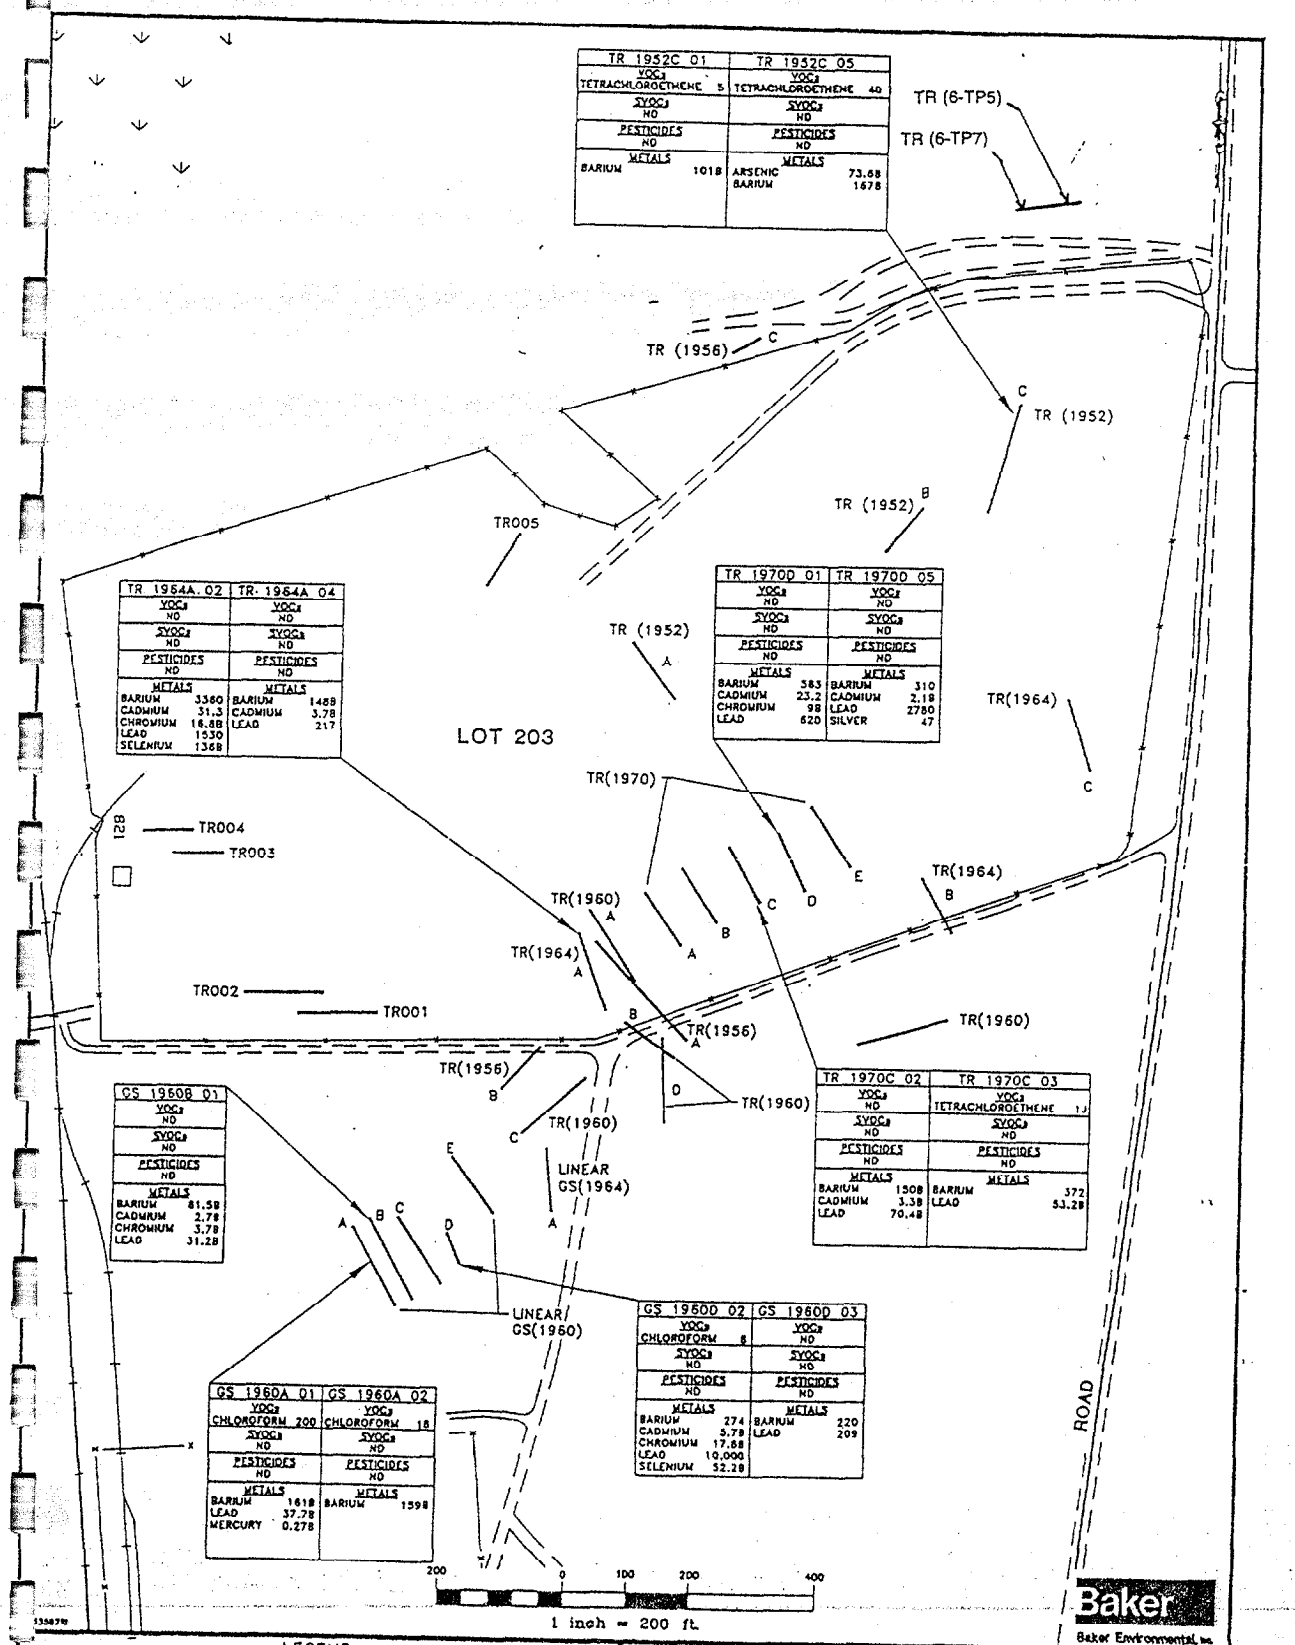
FIGURE 1 - 2
TEST PIT RESULTS
SITE 6
REMEDIAL INVESTIGATION CTO-0133

During the RI tests pits were dug to investigate past disposal practices. The test pits conducted at two areas located within Site 6 uncovered pits where containers were disposed of in the past. The tests pits located in the northwest corner of Site 6, TR (6-TP5) and TR (6-TP7), shown in Figure 1-2, contained material identified as no. 6 fuel oil. The test pits located south of lot 203, GS(1960D) and GS(1960E), contained small 5 gallon paint like pails.

Two of the test pits, GS-1960E and GS-1960D, located south of Lot 203 (Figure 1-2), contained 1 to 5 gallon containers which were in a deteriorated condition. Two samples were collected from test pit GS-1960D and analyzed for TCLP and Characteristics Waste; Ignitability, Corrosivity, and Reactivity. One of the samples taken contained low levels of chloroform and failed the TCLP for lead with a concentration of 10 mg/L versus the TCLP maximum leachate concentration of 5 mg/L. No samples were collected from test pit GS-1960E. The organic vapor analyzer (OVA) used during the excavation showed a reading of 3.0 ppm in the 2 to 4 feet range of the test pit. Based on the visual similarity of the material encountered at GS-1960D and GS-1960E, the analytical results for GS-1960D where used to assess GS-1960E, along with the OVA results.

Excavations at test pits north of Lot 203 revealed two areas, 6-TP5 and 6-TP7, which contained containers (1/2 gallon to 5 gallon) six feet below grade. Samples were collected from both test pits at the depths where the containers were encountered and analyzed for Full CLP TCL/TAL. One sample was collected of a greenish/blue material from one of the containers and analyzed for a petroleum identification. The results of the analyses indicated that the material from the containers is probably #6 fuel oil. Trace levels (below detection limits) of tetrachloroethene were detected in the sample taken from 6-TP5 along with low concentrations of pesticides. The sample collected and analyzed from 6-TP7 also showed low levels of pesticides.

There are two areas identified for excavation of 310 cubic yards of contaminated soil, drums and debris. The excavated material will be segregated (to the extent feasible) between drums, debris and soil, and transported to the appropriate staging cell. All intact drums will be overpacked and transported to the drum staging cell. Visual inspection will determine the immediate extent of the excavation; TCLP analysis of soils will be used to determine the extent of the soils excavation following the removal of all drums.
