Water Area Munitions Study

Lake Oberlin

Naval Surface Warfare Center Crane Division, Indiana

April 2005

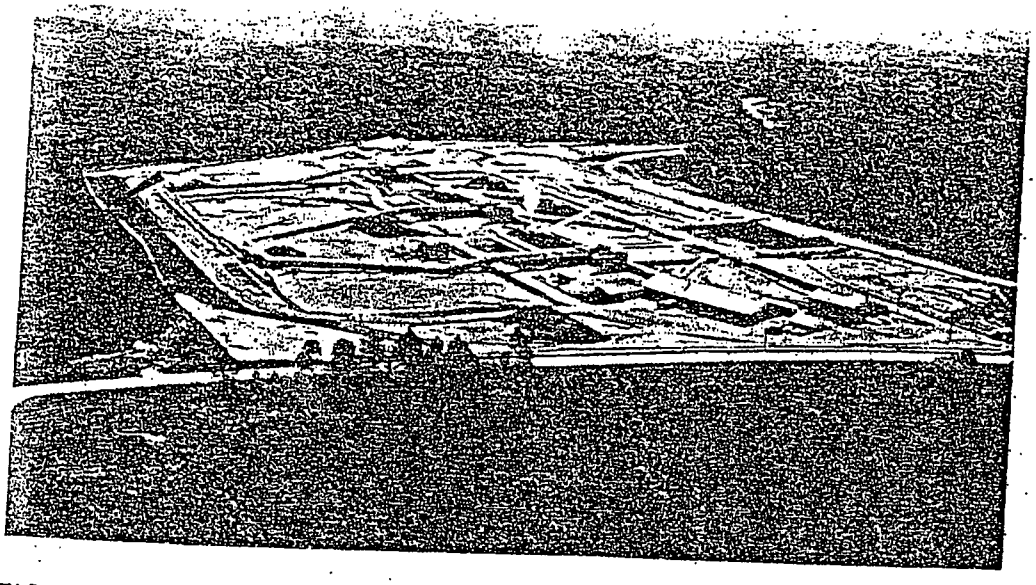
FIGURE II–1 ROCKEYE MANUFACTURING AREA, NWSC, CRANE, INDIANA (ARROW INDICATES POINT OF DISCHARGE OF RED WATER THROUGH FENCE AROUND ROCKEYE AREA)

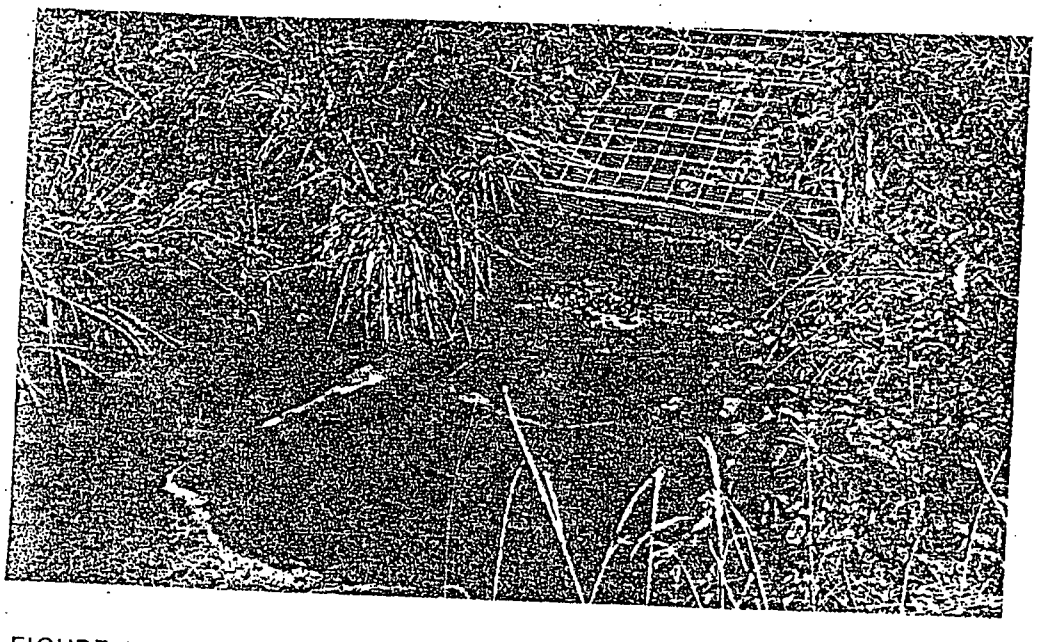
FIGURE II–2 RED WATER DISCHARGE POINT AT FENCE SURROUNDING THE ROCKEYE AREA

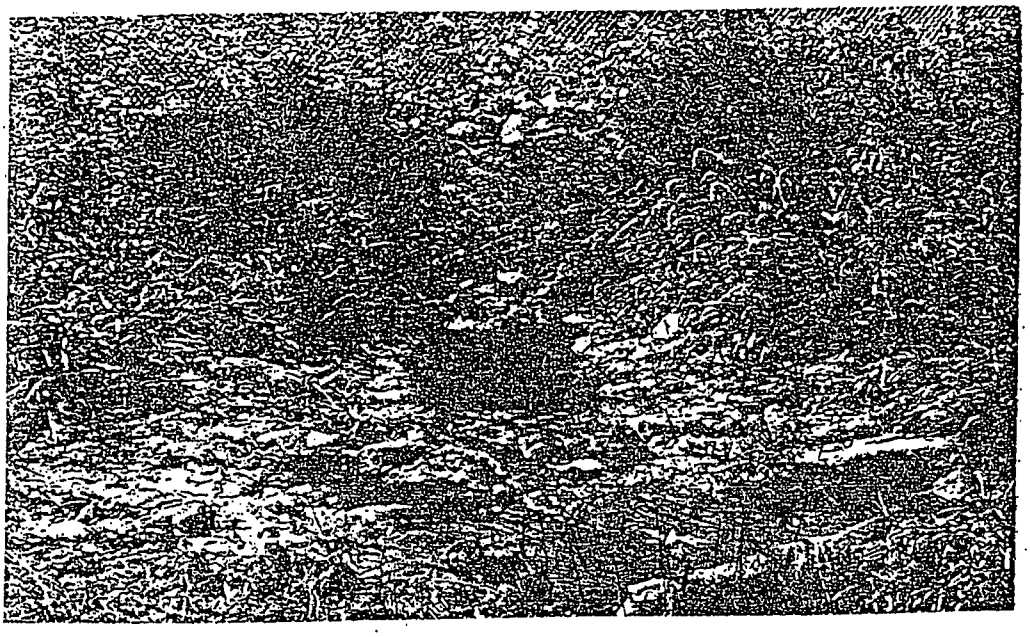
FIGURE II–3 RED WATER 50 YARDS DOWNSTREAM FROM ROCKEYE FENCE

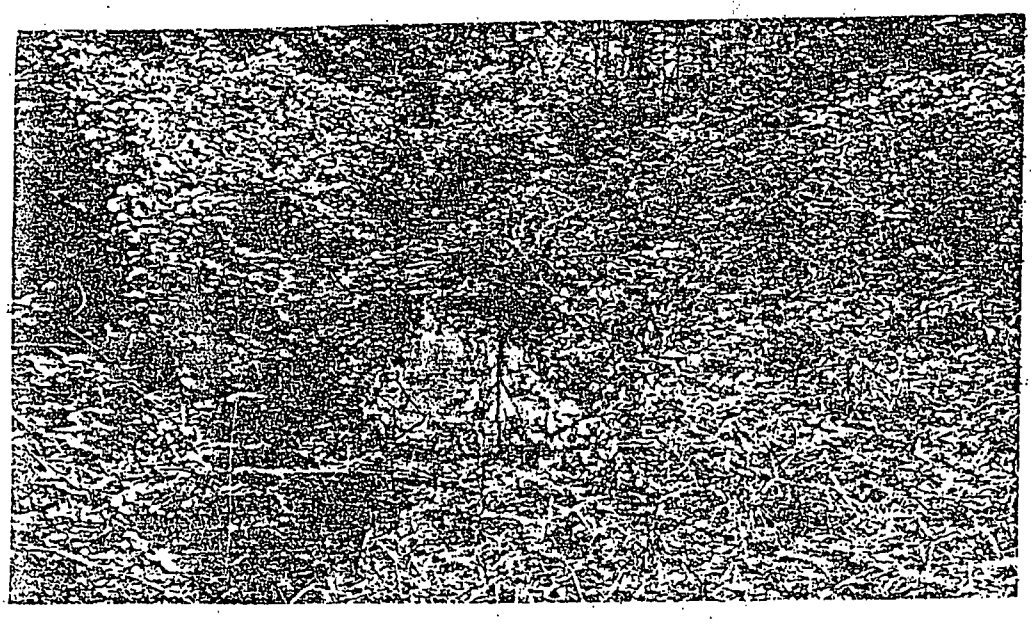
FIGURE II–4 RED WATER 200 YARDS DOWNSTREAM FROM ROCKEYE FENCE

Red water, indicative of TNT contamination, was observed by team members in the surface water drainage ditches on the northeastern side of the complex. This wastewater drainageway was followed by team members and red water was observed where the stream enters Sulphur Creek approximately 2 1/2 to 3 miles from its source. Although no water sampling and analysis of Sulphur Creek could be found in the records, concentrations of 150 to 200 parts per million (ppm) of TNT were reported in water samples taken in the drainageways near the complex. The vivid red color of the water shown in Figures II-2 through II-6 indicates a significantly high concentration of TNT in the stream even at the point of entering Sulphur Creek. It would be expected that this situation would become more critical as the workload increases and additional shifts are added. This complex presently employs a single shift of approximately 100 employees; however, as many as three full shifts have been employed in the past during peak times of national emergencies.

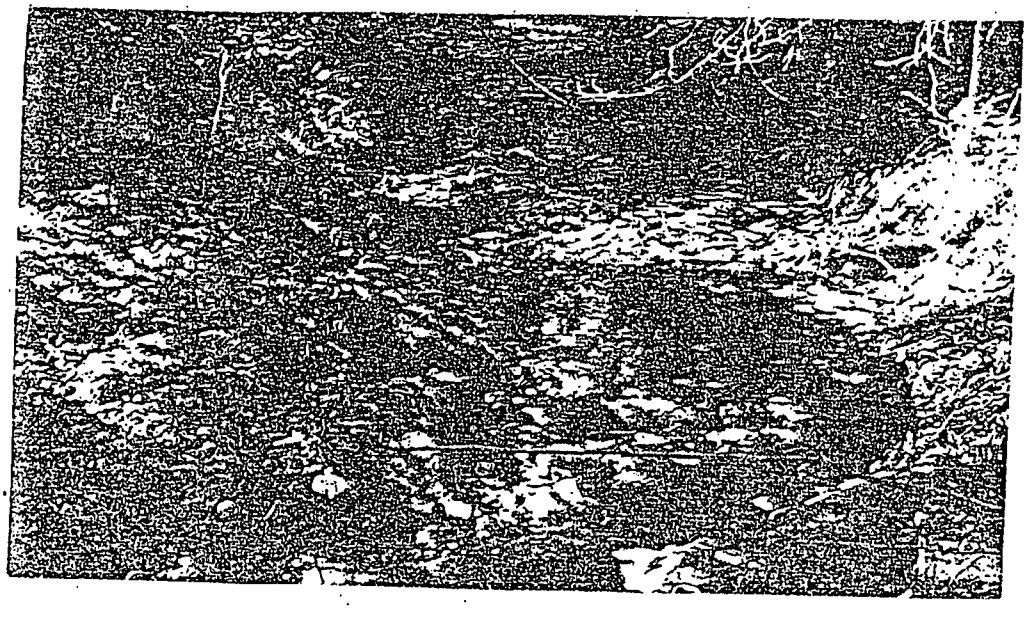
FIGURE II–6 RED WATER APPROXIMATELY ONE-HALF MILE DOWNSTREAM FROM ROCKEYE FENCE
