FINAL REPORT
FOR
REMOVAL OF MERCURY CONTAMINATED SOIL AND SEDIMENT
NAVAL SURFACE WARFARE CENTER
INDIAN HEAD, MARYLAND

May 15, 1995
Delivery Order 0010
OHM Project 15831FR

The following report shall serve as OHM Remediation Services Corp.'s (OHM) Contractor's Close-Out Report. This report includes the following information:

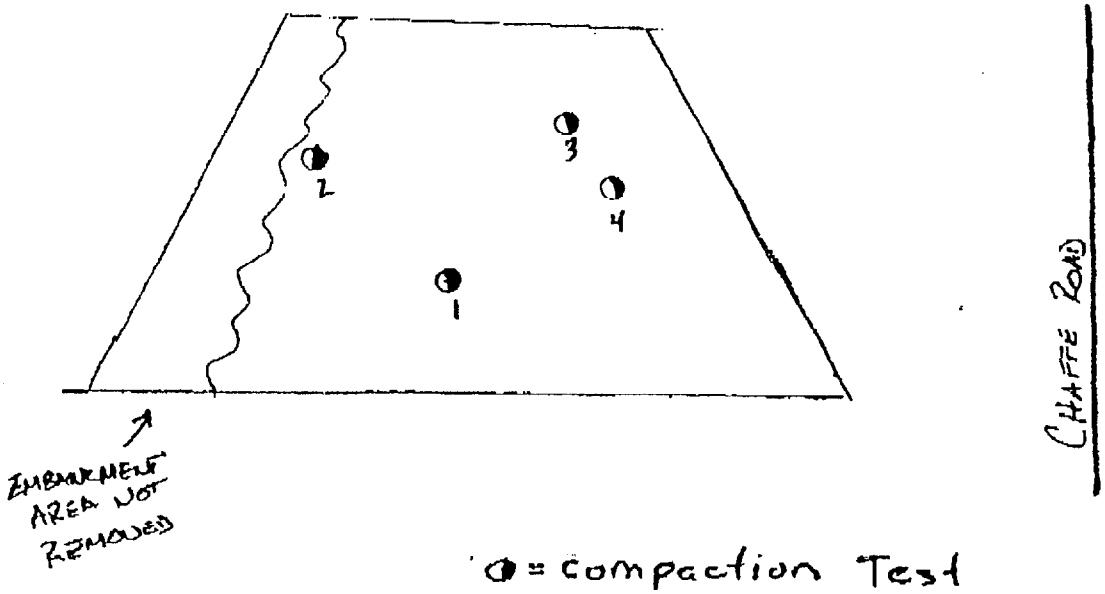
Four (04) in-place field density tests numbered 01 - 04 inclusive, were performed per ASTM D-2922 using a nuclear gauge on the embankment backfill. These tests were performed to determine the existing percent of compaction. All test results were within a range of eighty percent (80%) to ninety percent (90%) of compaction per ASTM D-698. These test locations are shown below.

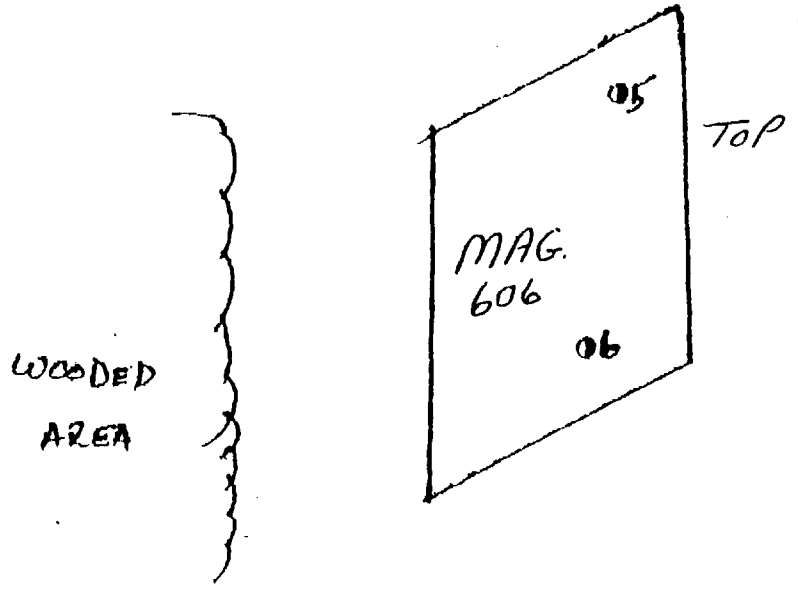
Two (02) in-place field density tests numbered 05 and 06, were performed per ASTM D-2922 using a nuclear gauge on the embankment backfill. Using a client supplied maximum dry density of 119.7 lbs./cu.ft., all tests achieved the required ninety-five percent of compaction per AASHTO T-180. These test locations are shown below.

THIS IS ON THE CLAY CAP PLACED OVER SOIL.

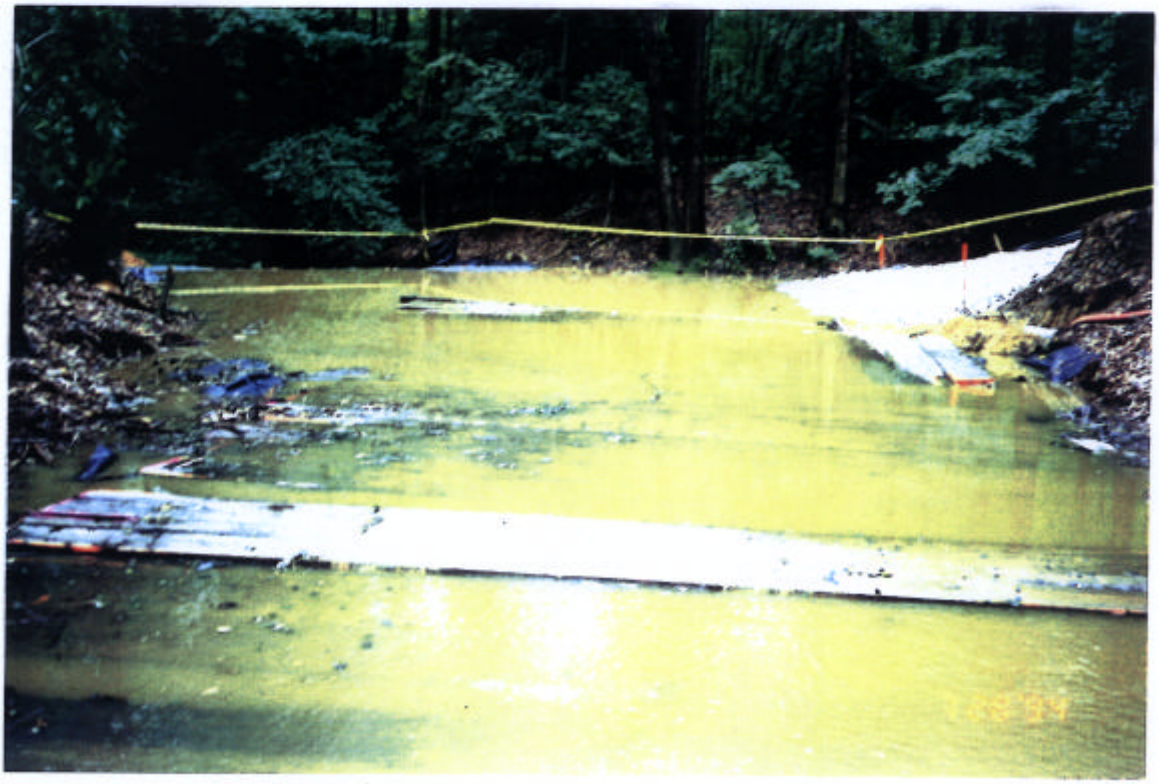
11: CONSTRUCTION SITE AFTER A HEAVY RAIN, JULY 1994
