**PWD Pensacola
Safety Investigation Board**

**BRAC-CSO Bachelor Housing
Project**

Prepared for RDML Slates

28 October 2011

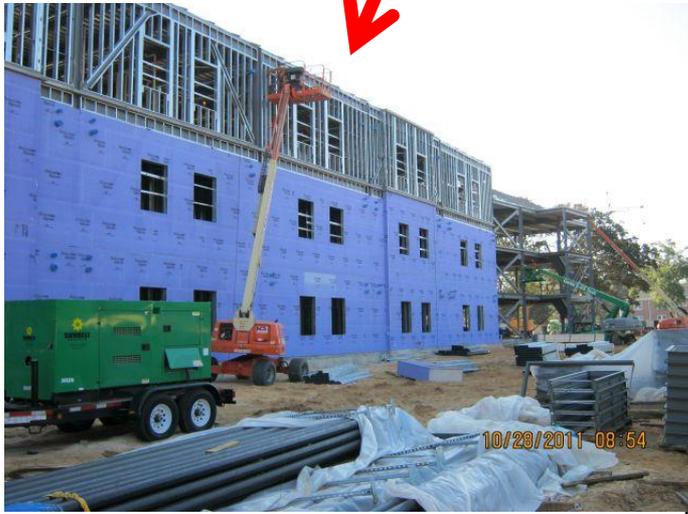
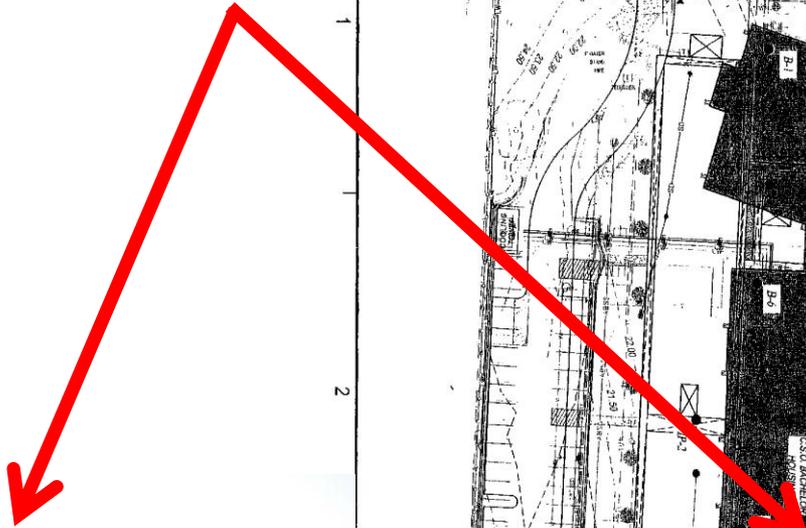
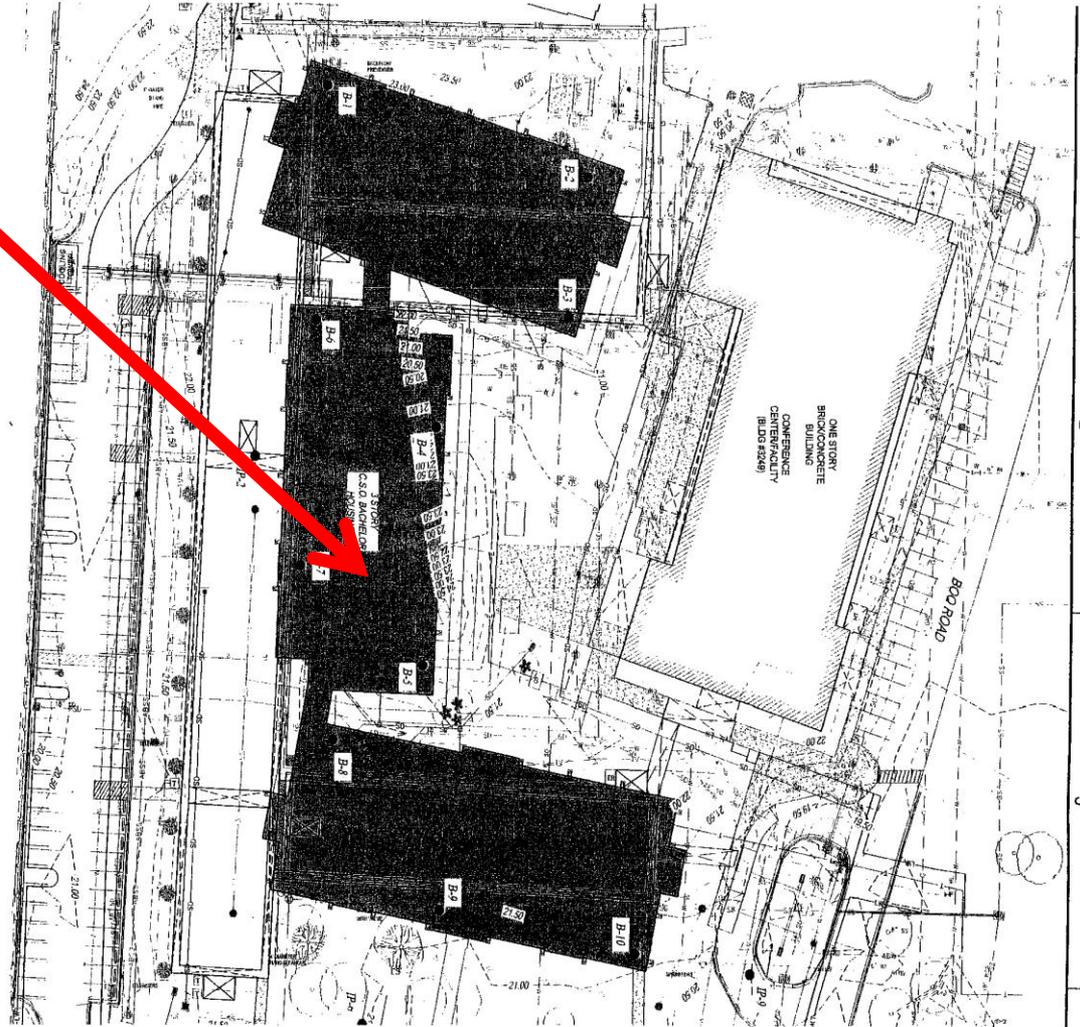
Mishap Site Drawing (Overhead View)

Location description: Attic of three-story Bachelor's Quarters.

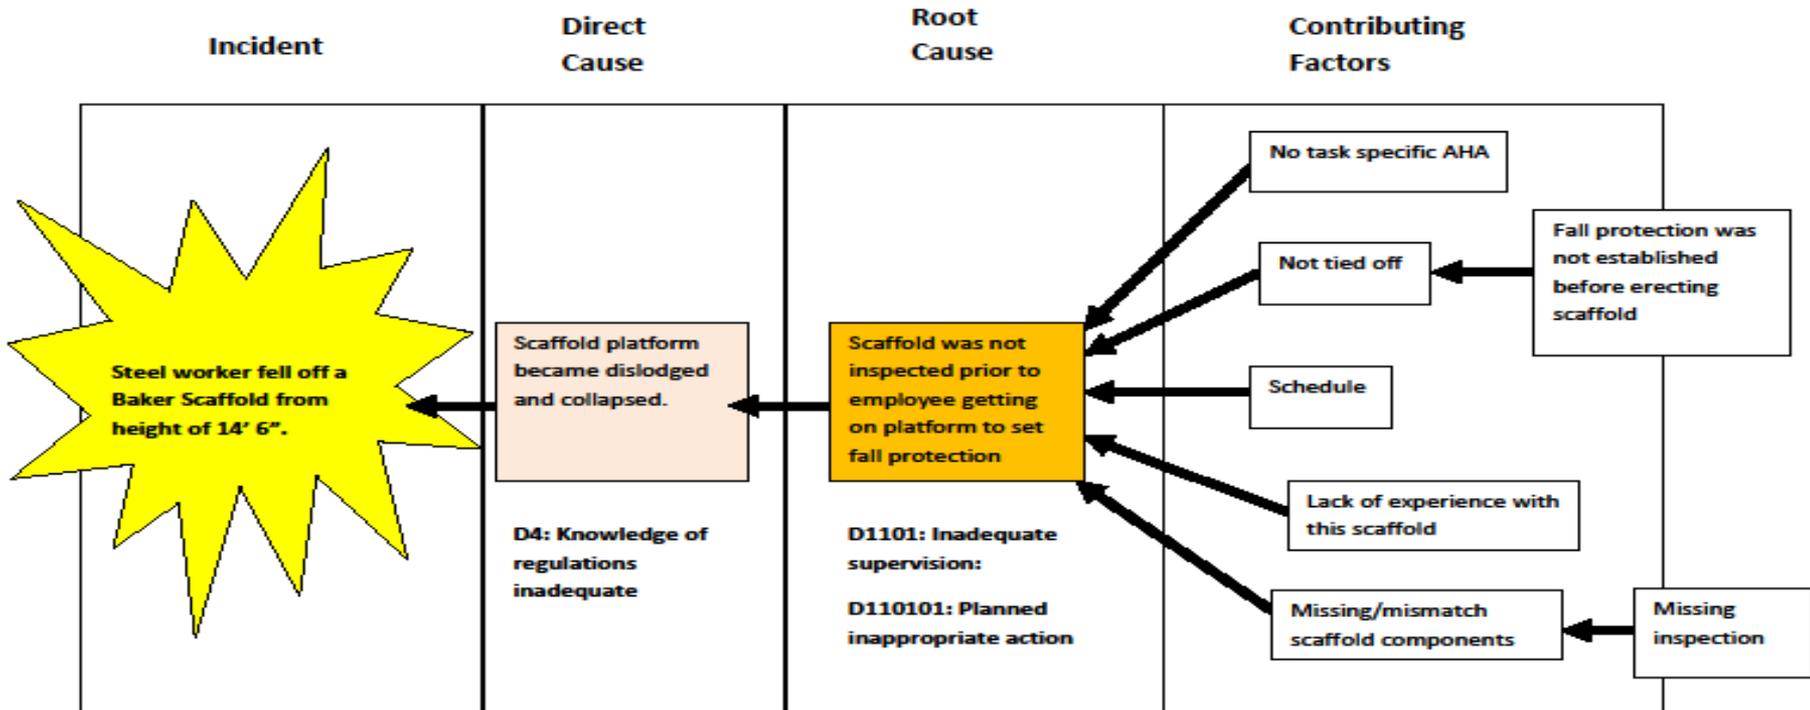
Incident Analysis

- Scaffold platform became dislodged and collapsed
 - Scaffold platform designed to set into channels on each side brace
 - Platform clips should be rotated to prevent platform from becoming dislodged
- **WARNING:** *Recheck platform to be sure it is properly seated within side brace channel and the platform clips are fully engaged before accessing.*
(Ref: Safety Rules and Instructions for UST Multipurpose Scaffold)
