RESTORATION AND MAINTENANCE PLAN FOR PETTIBONE CREEK RAVINE NS GREAT  
LAKES IL  
7/1/2000  
ENVIRONMENTAL QUALITY MANAGEMENT, INC.

**RESTORATION AND MAINTENANCE PLAN  
FOR PETTIBONE CREEK RAVINE  
NAVAL TRAINING CENTER,  
GREAT LAKES, ILLINOIS**

July 2000

**ATTACHMENT 1  
ANALYSIS AND RECOMMENDATIONS  
FOR SUBSTRATE INSTABILITY**

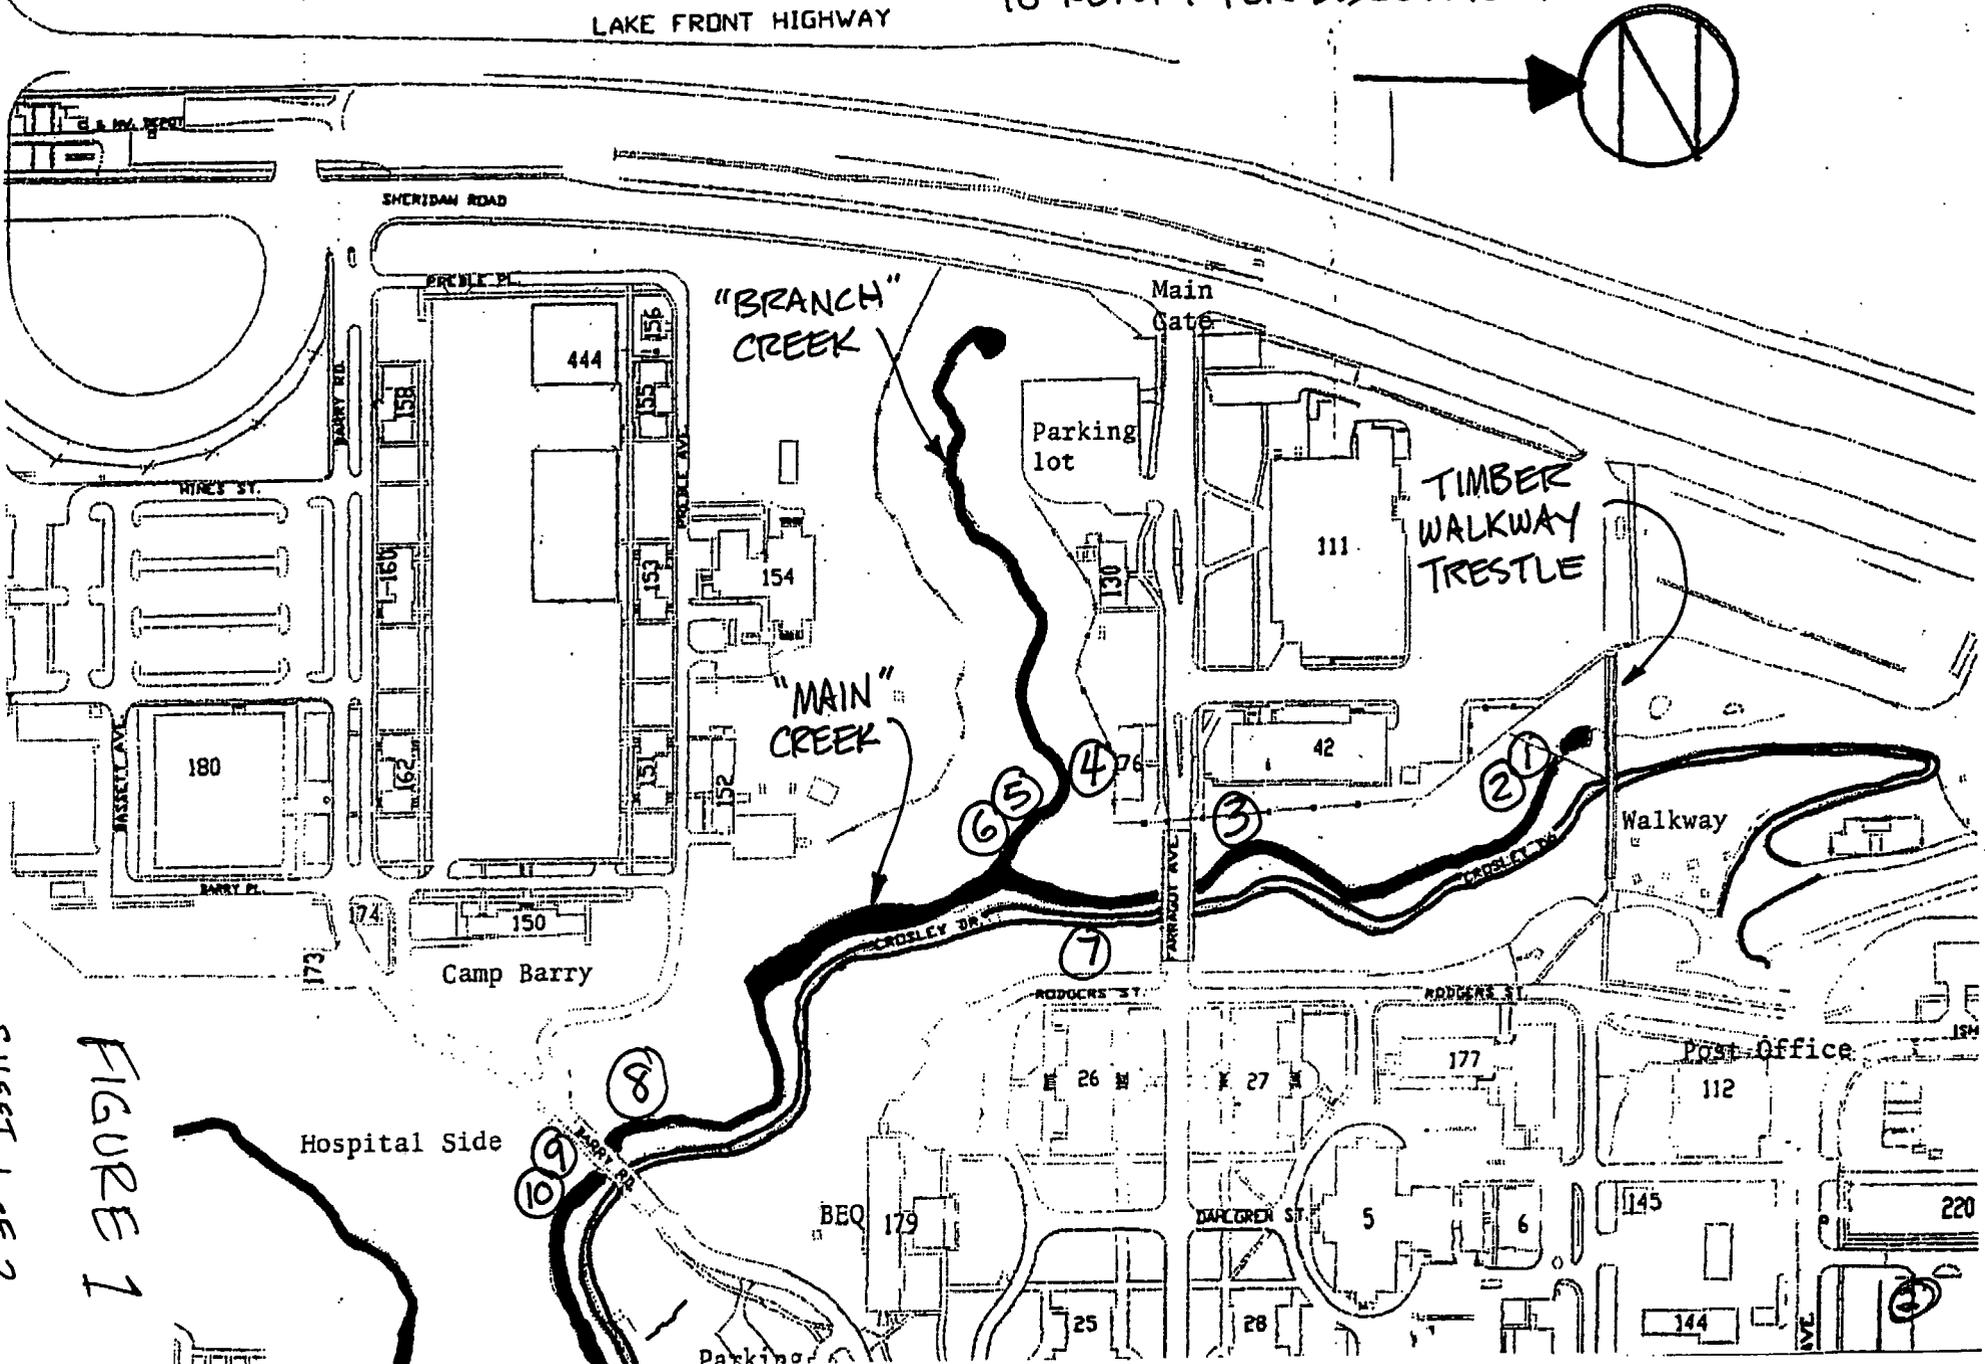
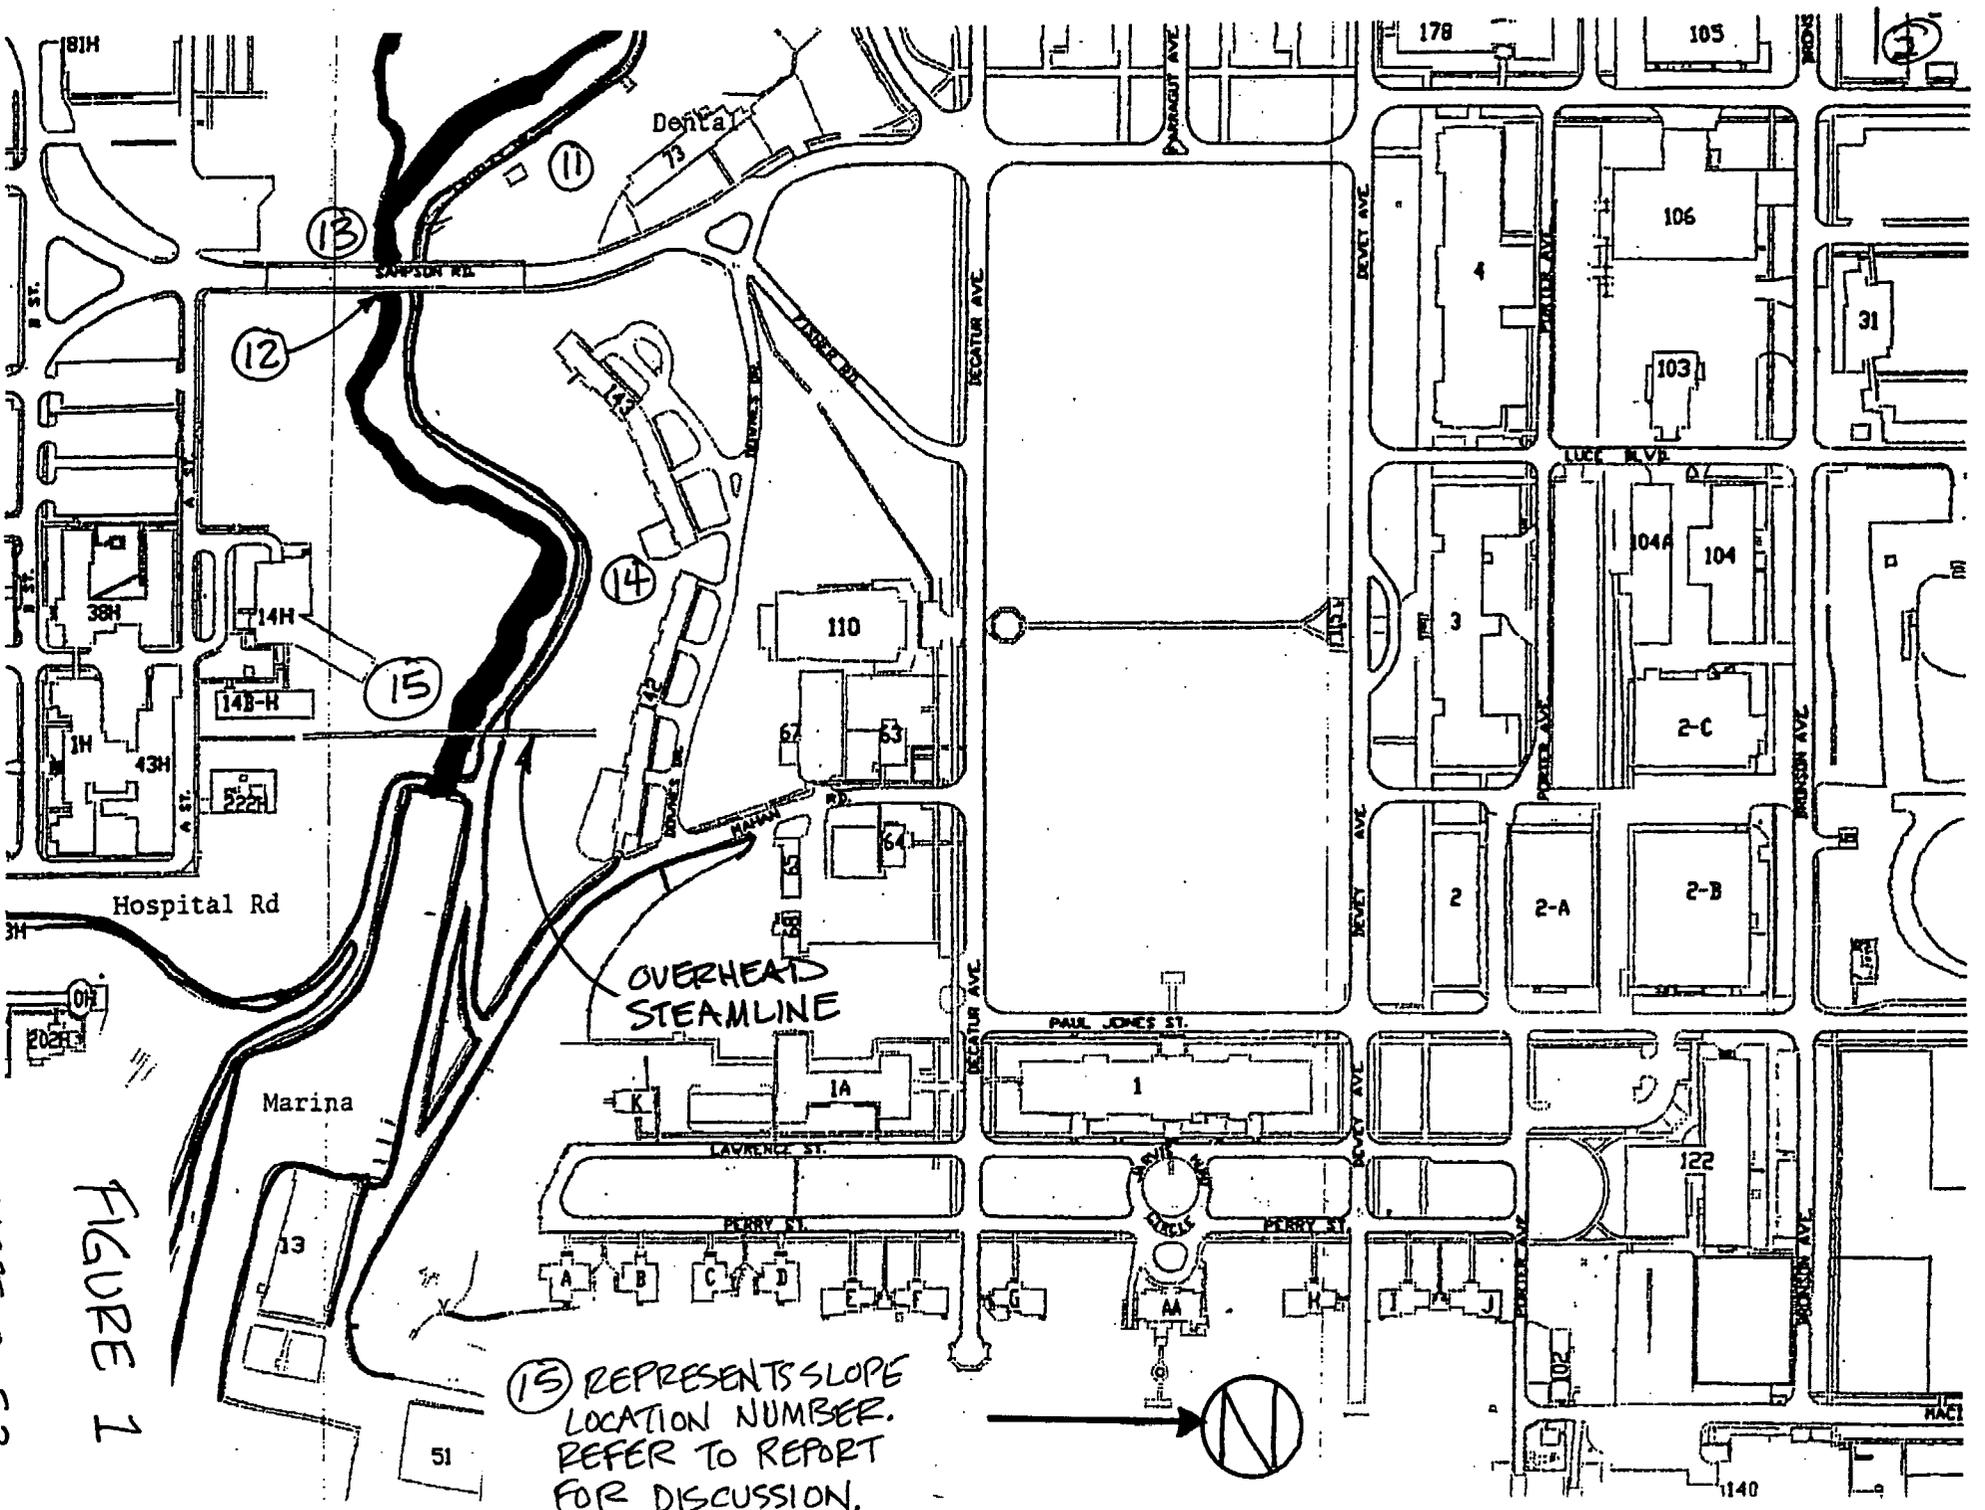
FIGURE 1

① REPRESENTS SLOPE LOCATION NUMBER. REFER TO REPORT FOR DISCUSSION.

15 REPRESENTS SLOPE LOCATION NUMBER. REFER TO REPORT FOR DISCUSSION.
