IR Site Inspections – 4th Quarter 2005

St. Juliens Creek Annex, Chesapeake, Virginia

DATE: January 5, 2006

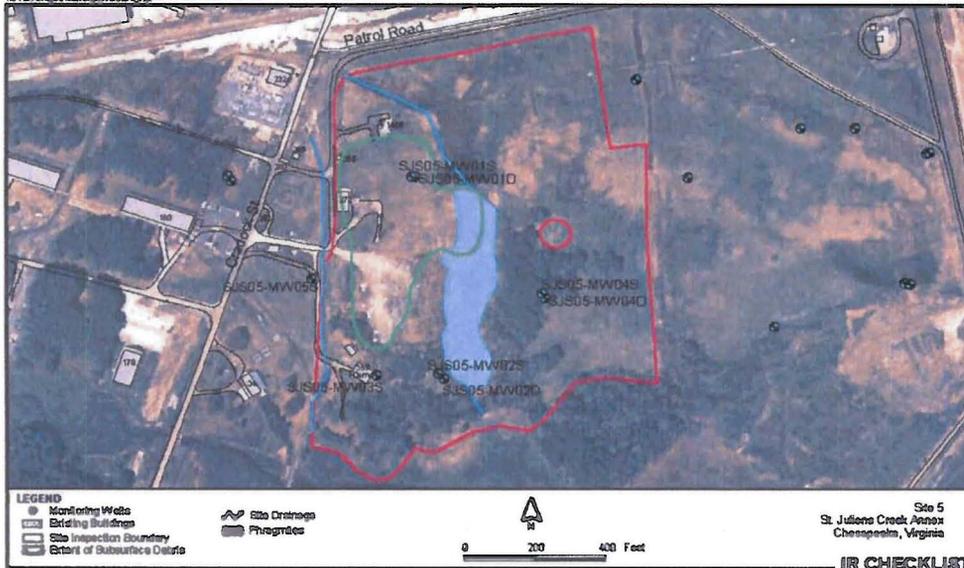
Site 5 - Burning Grounds
St. Juliens Creek Annex, Chesapeake, Virginia

No comments

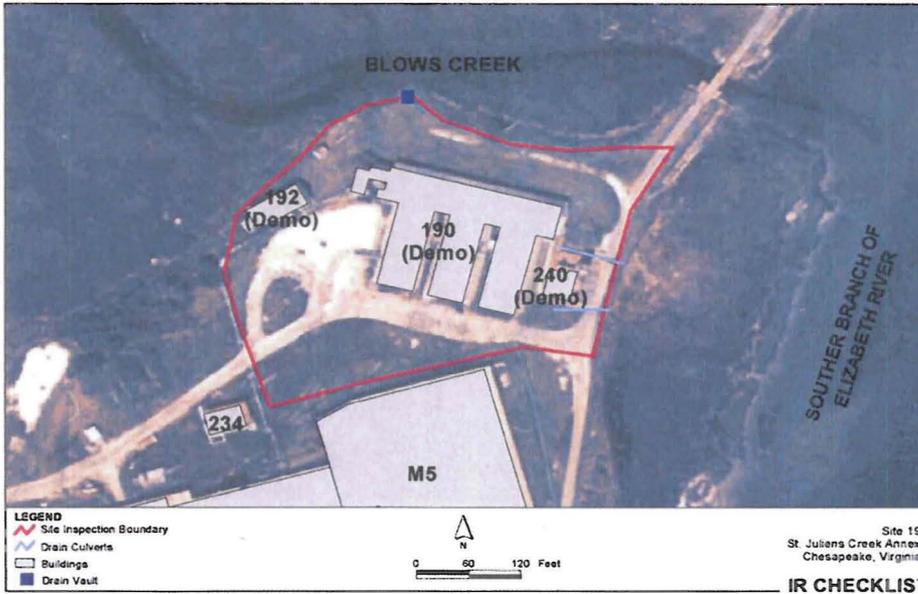
The site currently consists of an open field. Some potential surface soil metals contamination and subsurface soil polycyclic aromatic hydrocarbon (PAH) contamination is planned for removal. There is currently no fencing or signs posted.
