IR Site Inspections – 2nd Quarter 2007

St. Juliens Creek Annex, Chesapeake, Virginia

DATE: June 20, 2007

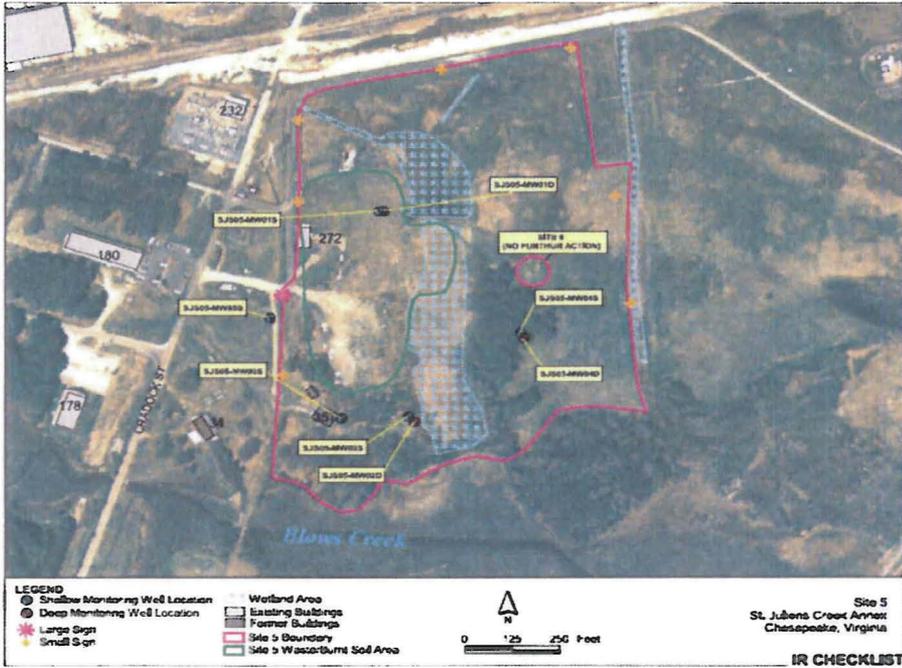
Site 5 - Burning Grounds

The site currently consists of an open field with the central portion overgrown with phragmites. A significant portion of the southwest area of the site is covered with a layer of gravel. Surface water at Site 5 drains either naturally or through unlined shallow man-made drainage ditches to tidally influenced Blows Creek, which eventually meets with the Southern Branch of the Elizabeth River. There are signs posted around the perimeter of the site.
