**NAVAL AIR STATION
FORT WORTH JRB
CARSWELL FIELD
TEXAS**

RCRA Permit Part B Number HW50289

SUMMARY OF PERMIT SITES

Prepared By
U.S. Army Corps Of Engineers
Fort Worth District

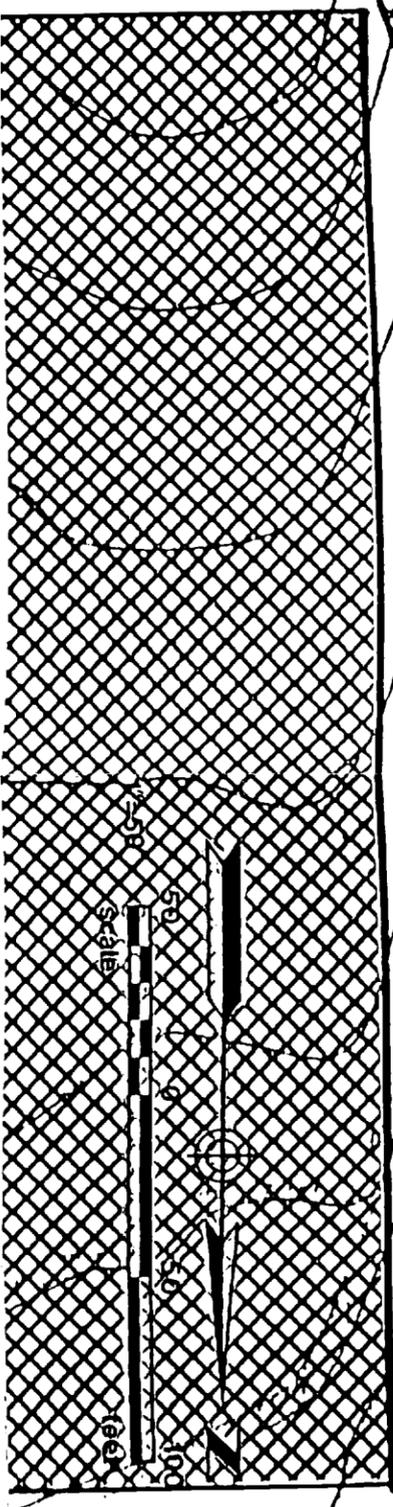
SWMU No. 18, Fire Training Area No. 1
Figure 3

SWMU No. 18 is located north of Landfill 5 and was the primary fire pit prior to 1963. The pit was gravel-lined, and had a low concrete curb around its perimeter and reportedly was adjacent to a small tributary of Farmers Branch. Several fire training exercises are reported to have taken place at this site each month, with waste oils and contaminated fuels being the primary flammable liquids used in the exercises. Small quantities of solvents are also reported to have been used in these exercises. The site now consists of a level, gravel-surfaced area on a drainage divide between an unnamed tributary of Farmers Branch and Farmers Branch.

Two upper zone monitor wells were installed at the site. Upper zone materials consist of surficial deposits of clayey silt with variable amounts of fine sand and gravel, underlain by sand and gravel deposits. The thickness of the upper zone is approximately 14 feet at both wells. Generally the surficial clay and silt deposits are five feet thick and the sand and gravel deposits are eight to ten feet thick. The bedrock is shale and limestone of the Goodland Formation. Ground water occurs in the upper zone materials underlying the site at depths ranging from six to nine feet.

was detected at the hand augered boring and at the up gradient monitor well (range 0.249 - 0.257 mg/Kg). All other parameters were found to be within normal limits.

It is recommended that the two wells should continue to be monitored, primarily due to their proximity to the TCE plume in the ground water south of the site. Monitoring parameters should include volatile organic compounds, metals, and general water quality parameters. Results of the Stage 2 investigation indicates that there is no further action necessary at this time for SWMU No. 18. A detailed request for no further action will be submitted at a later date.
