## **Wastewater Pretreatment Units Evaluation** (WWTP Pretreatments Units, Oil/Water Separators, and Grease Traps)

**U.S. Naval Station Roosevelt Roads  
Puerto Rico**

**Atlantic Division Naval Facilities  
Engineering Command  
Norfolk, VA**

**SEPTEMBER 2002**

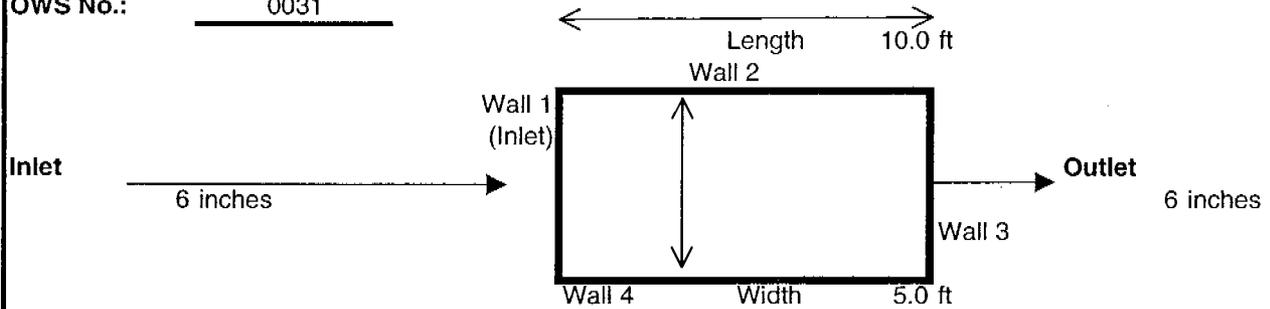
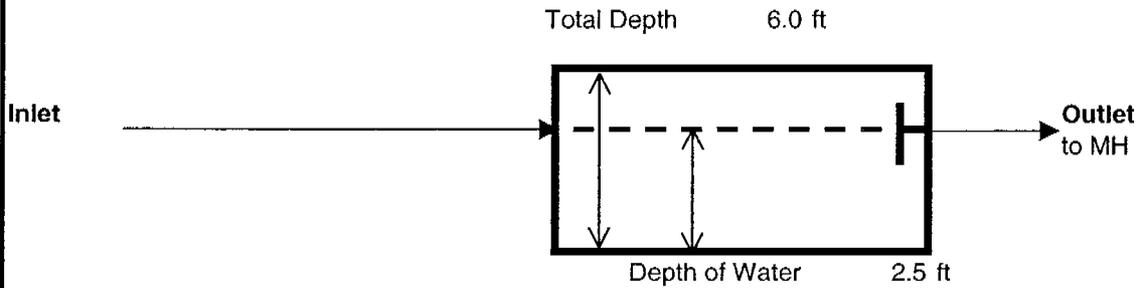
OWS No.: 0031

Overall concrete condition	Very Good
Wall 1	Very Good
Wall 2	Very Good
Wall 3	Very Good
Wall 4	Very Good
Base Slab	Good
Base/wall interface	Very Good

OWS services the truck wash.
PVC outlet tee cracked.
Some exposed aggregate (<5%).
Small amount of spalling (<5%).
275 Gallons of sludge removed

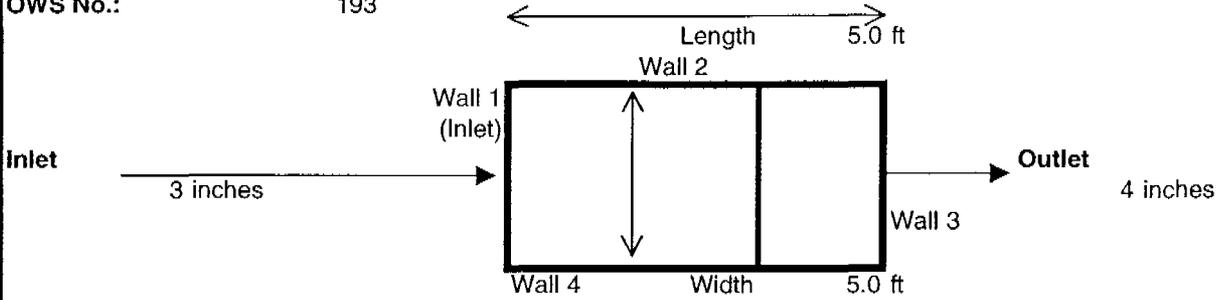
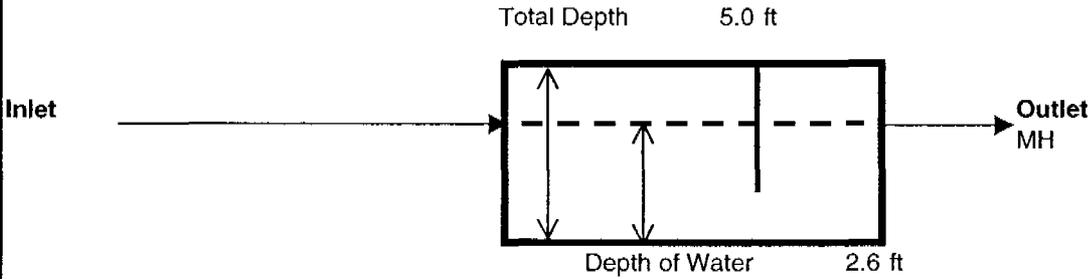
193

Overall concrete condition	Very Good
Wall 1	Very Good
Wall 2	Very Good
Wall 3	Very Good
Wall 4	Very Good
Base Slab	Very Good
Base/wall interface	Very Good

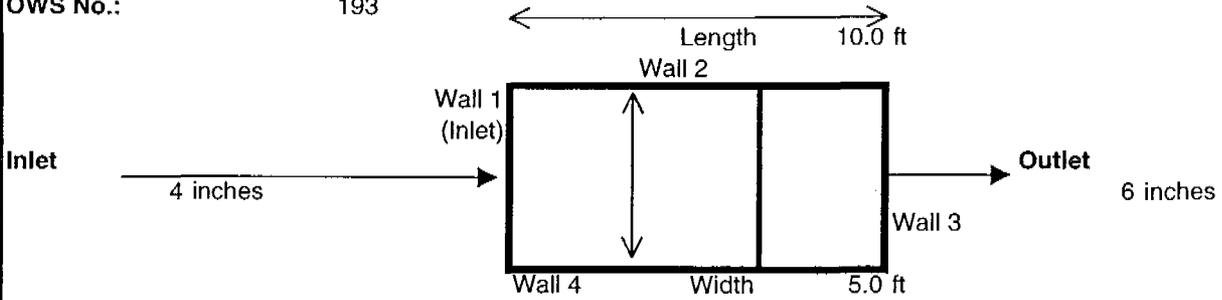
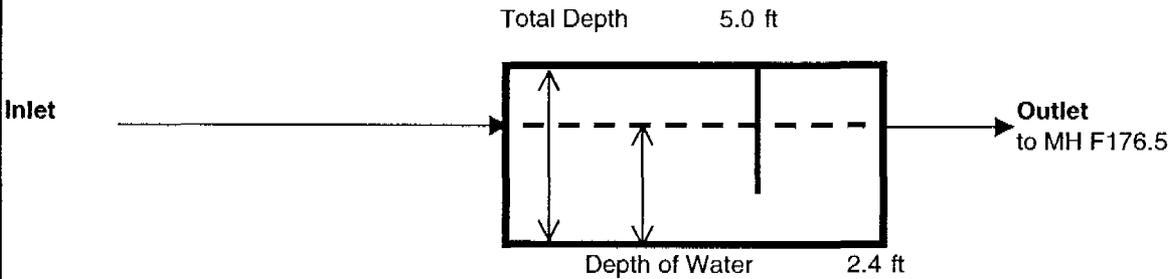
OWS No.: 193

Overall concrete condition	Very Good
Wall 1	Very Good
Wall 2	Very Good
Wall 3	Very Good
Wall 4	Very Good
Base Slab	Very Good
Base/wall interface	Very Good

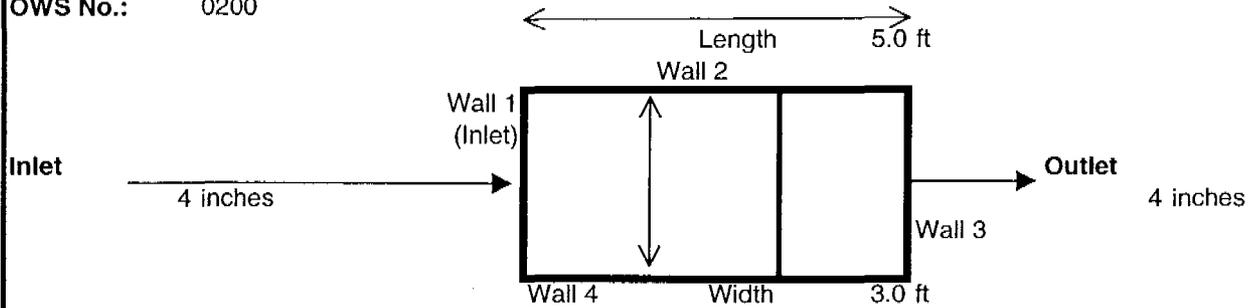
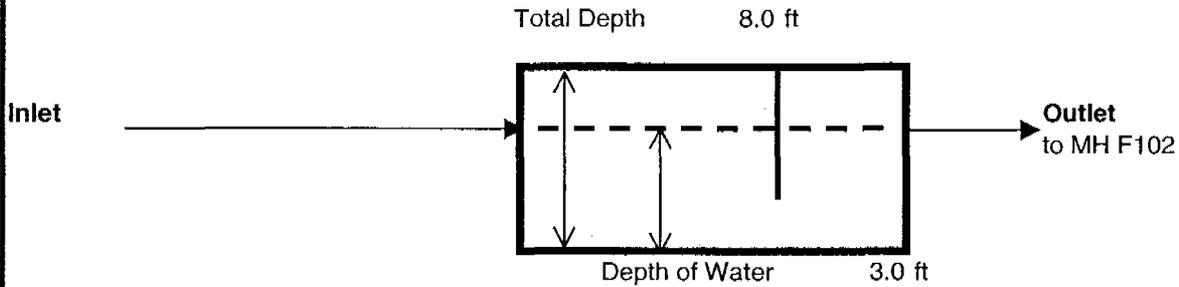
OWS No.: 0200

Overall concrete condition	Very Good
Wall 1	Very Good
Wall 2	Very Good
Wall 3	Very Good
Wall 4	Very Good
Base Slab	Very Good
Base/wall interface	Very Good

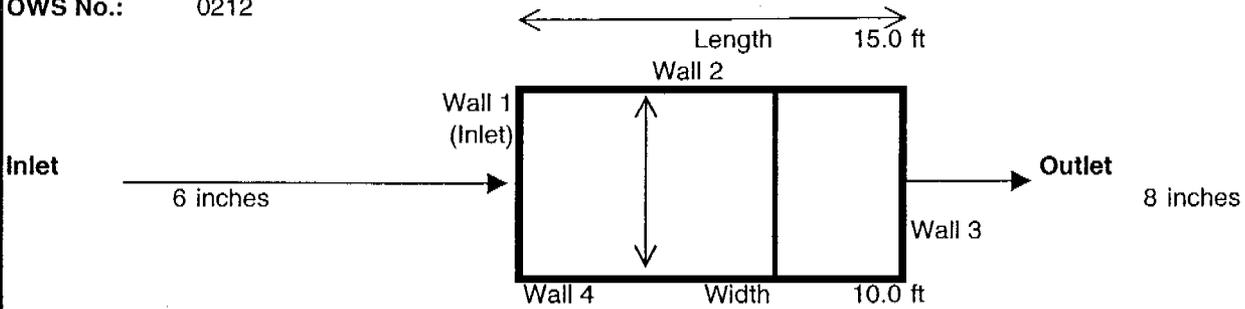
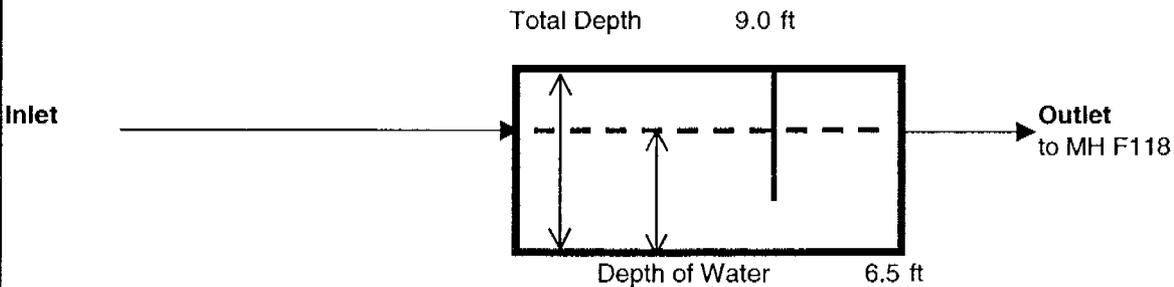
OWS No.: 0212

Overall concrete condition	Very Good
Wall 1	Very Good
Wall 2	Very Good
Wall 3	Very Good
Wall 4	Very Good
Base Slab	Very Good
Base/wall interface	Very Good

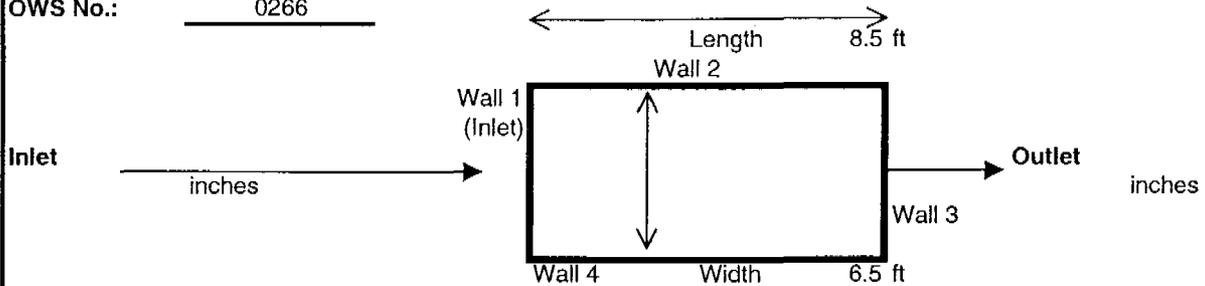
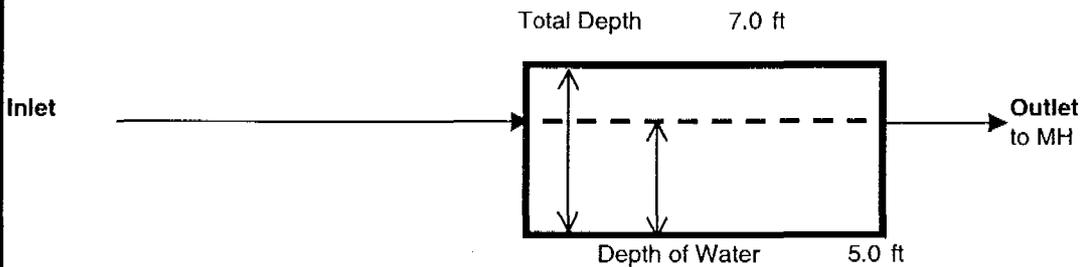
OWS No.: 0266

Inspected condition of concrete containment.
Prefabricated OWS inside concrete containment was not inspected.
Concrete containment dimensions are 14' L x 10' W x 9.3' D.
Recommend installing a Stage 1 sump similar to OWS-0799.
No sludge removed from this OWS

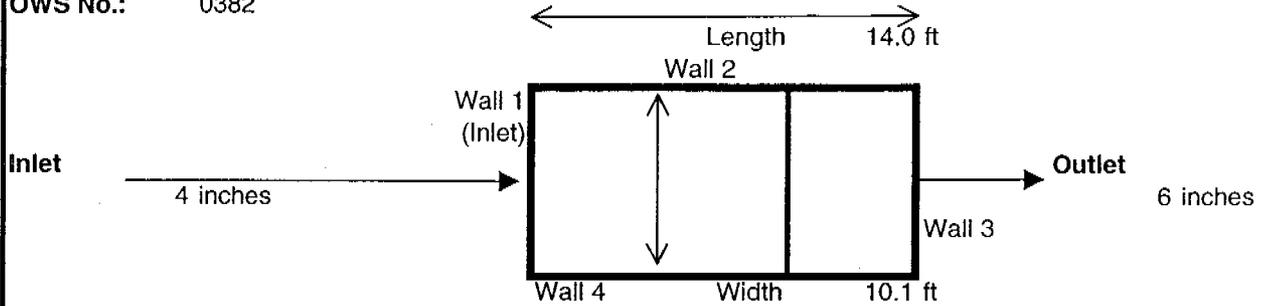
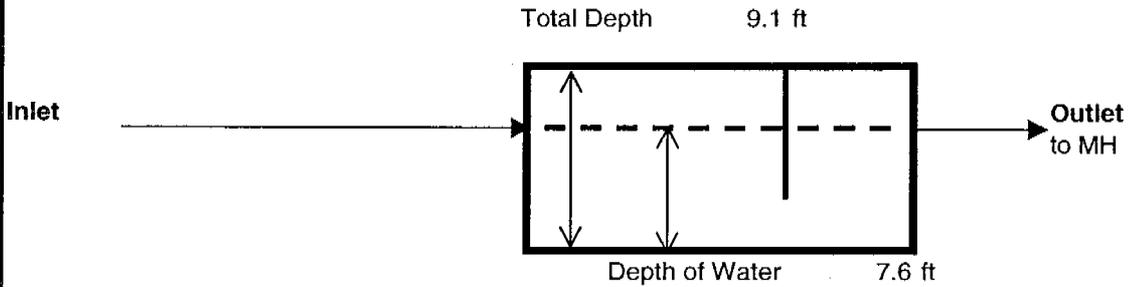
OWS No.: 0382

Overall concrete condition	Good
Wall 1	Good
Wall 2	Good
Wall 3	Good
Wall 4	Good
Base Slab	Good
Base/wall interface	Good

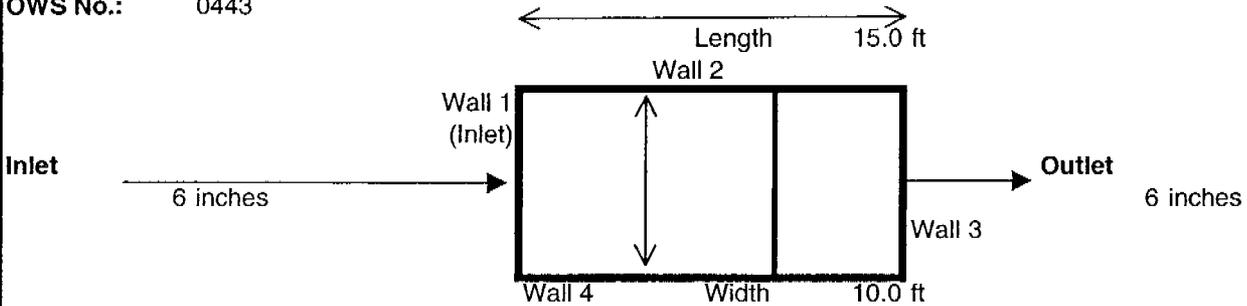
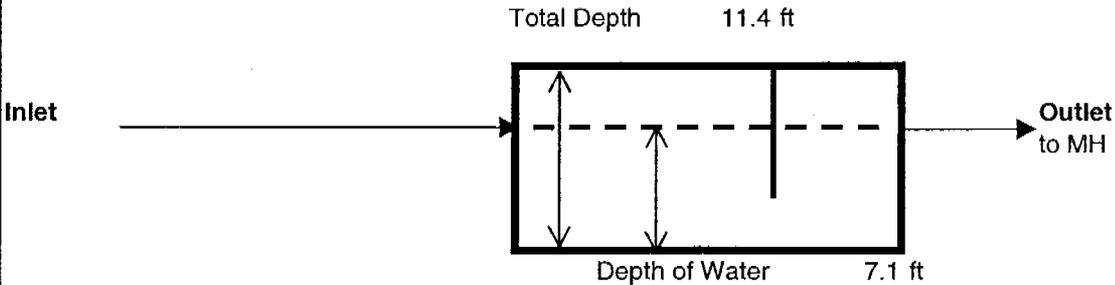
OWS No.: 0443

Overall concrete condition	Good
Wall 1	Good
Wall 2	Good
Wall 3	Good
Wall 4	Good
Base Slab	Good
Base/wall interface	Good

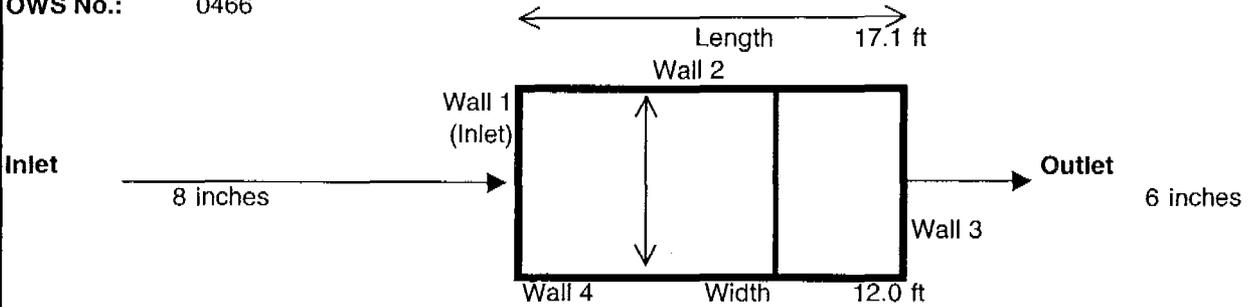
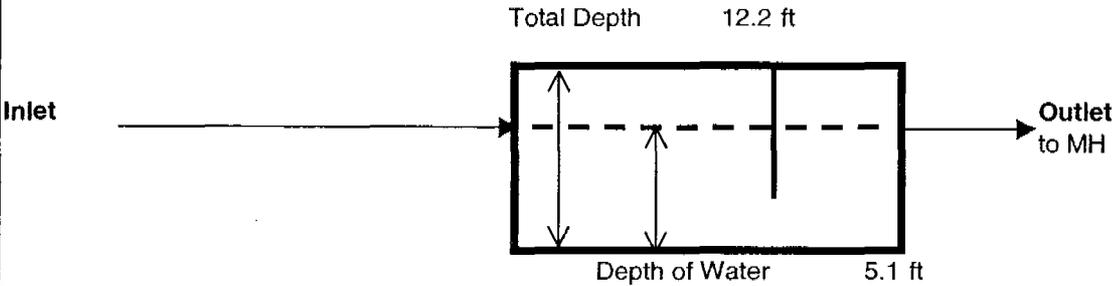
OWS No.: 0466

Overall concrete condition	Very Good
Wall 1	Very Good
Wall 2	Very Good
Wall 3	Very Good
Wall 4	Very Good
Base Slab	Very Good
Base/wall interface	Very Good

770 Gallons of sludge removed.
Inclined plate coalescer in very good condition

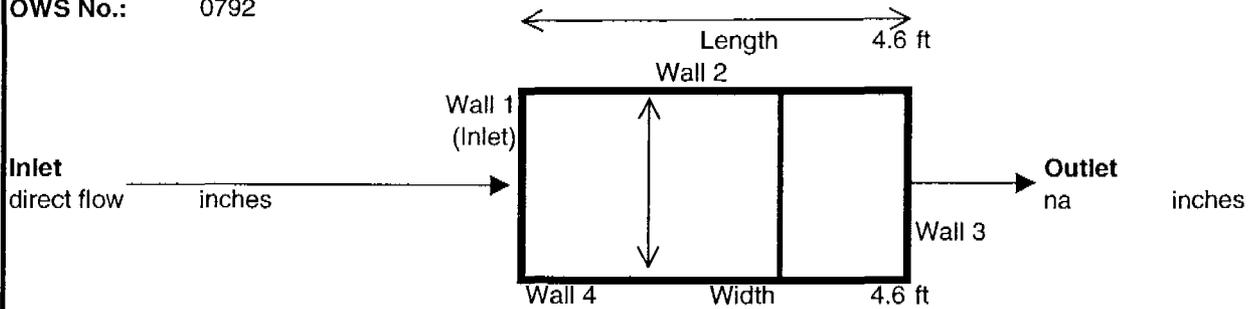
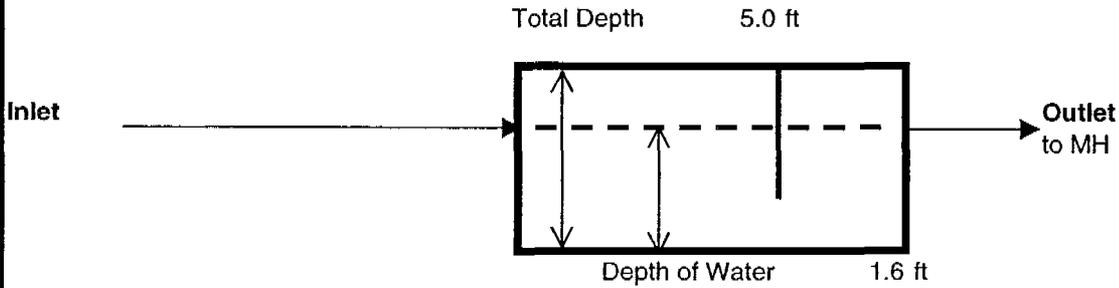
OWS No.: 0792

Overall concrete condition	Very Good
Wall 1	Very Good
Wall 2	Very Good
Wall 3	Very Good
Wall 4	Very Good
Base Slab	Very Good
Base/wall interface	Very Good

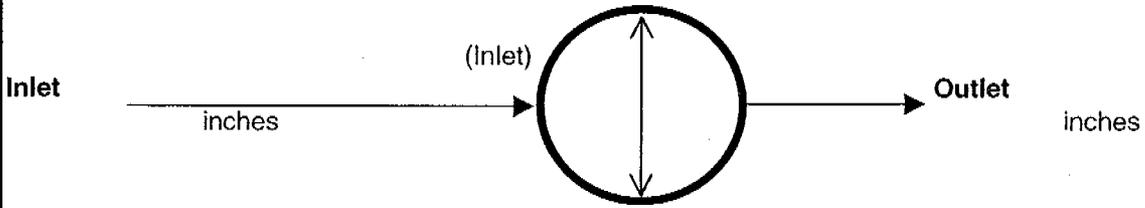
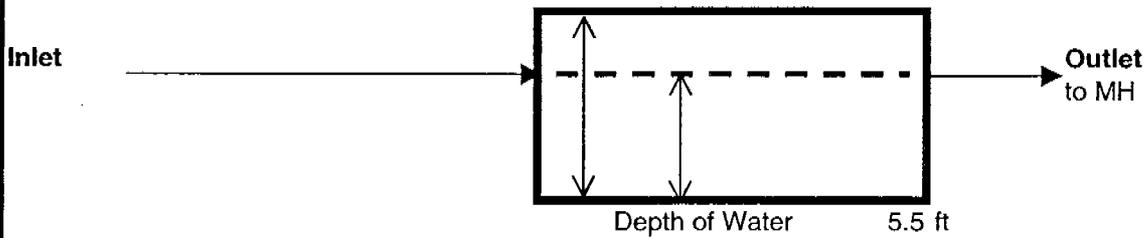
OWS No.: 0799

Overall concrete condition	Very Good
Wall	Very Good
Base Slab	not inspected
Base/wall interface	not inspected

Stage 1 is the manhole concrete was inspected
Two inlets were observed from the manway. Stage 1 wet well was not entered during cleaning and inspection.
Drainage from pier is controlled by an automatic valve. The automatic flow control valve was in the remote position during inspection

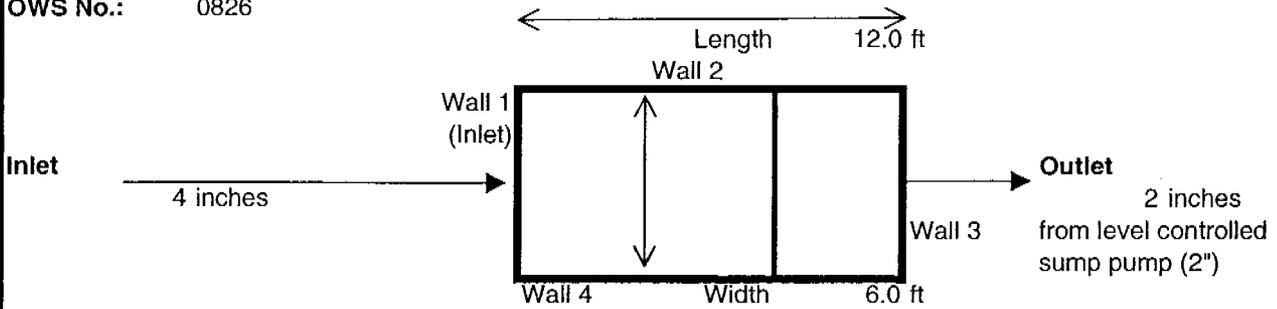
OWS No.: 0826

Overall concrete condition	Very Good
Wall 1	Very Good
Wall 2	Very Good
Wall 3	Very Good
Wall 4	Very Good
Base Slab	Very Good
Base/wall interface	Very Good

275 gallons of sludge removed (Eight 55 gallon drums)
Coalescer installed and in good condition. Walls are oily.

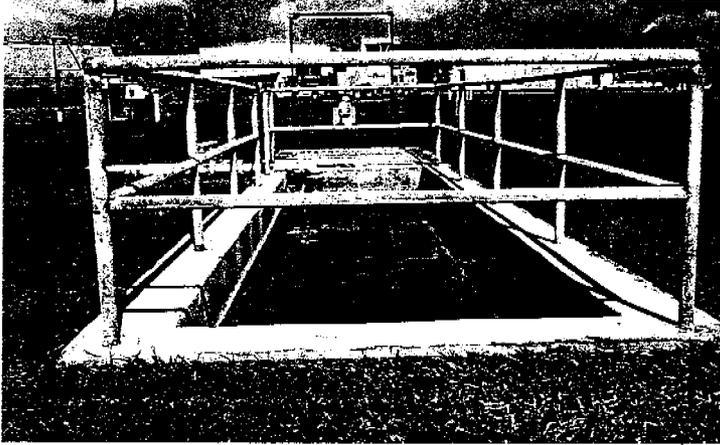
827

Overall concrete condition	Good
Wall 1	Good
Wall 2	Good
Wall 3	Good
Wall 4	Good
Base Slab	Good
Base/wall interface	Good

440 gallons of sludge ( 16 - 55 drums)
Some discoloration and cracking of concrete
Abandoned fire training area

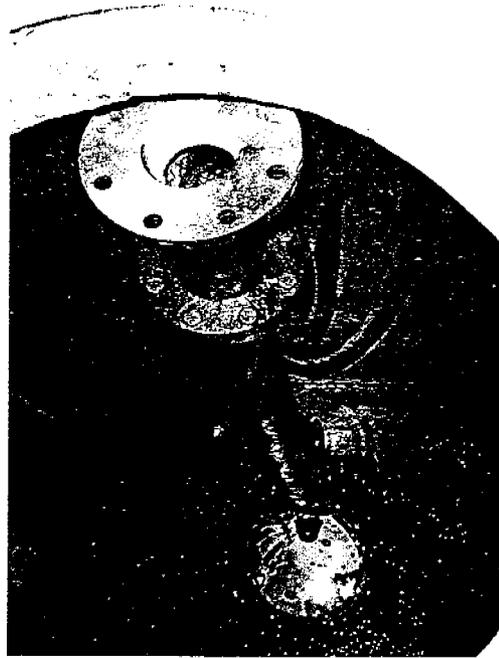
OWS No.: 0860

No sludge removed. Area used for spill containment. Small pin hole sized leak in one wall of OWS - continuous drainage of water from hole into OWS.

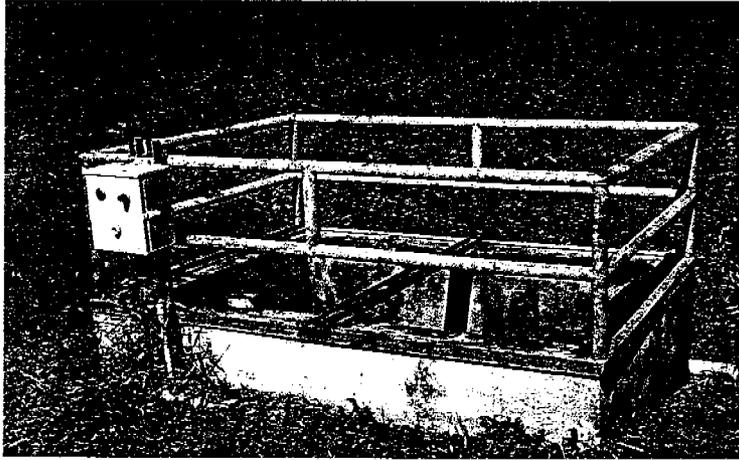
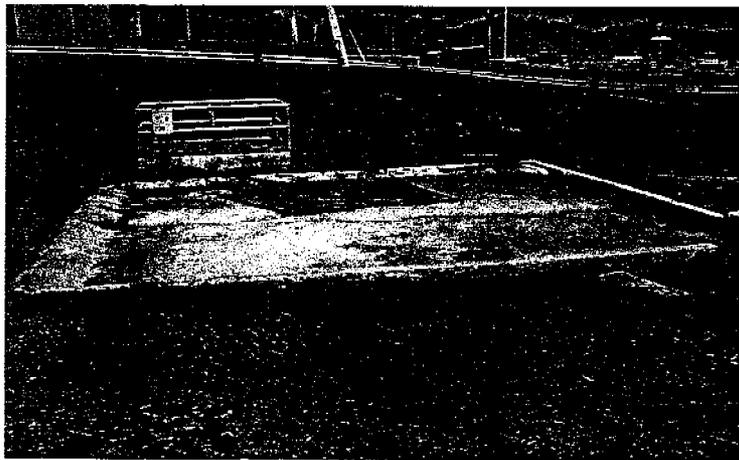
OWS No.: 1673

Overall concrete condition	Good to Very Good
Wall 1	Good to Very Good
Wall 2	Good to Very Good
Wall 3	Good to Very Good
Wall 4	Good to Very Good
Base Slab	Good to Very Good
Base/wall interface	Good to Very Good

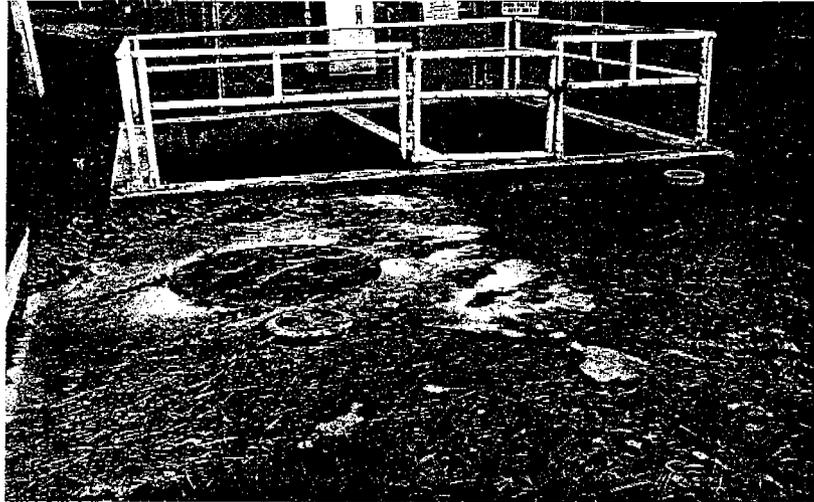
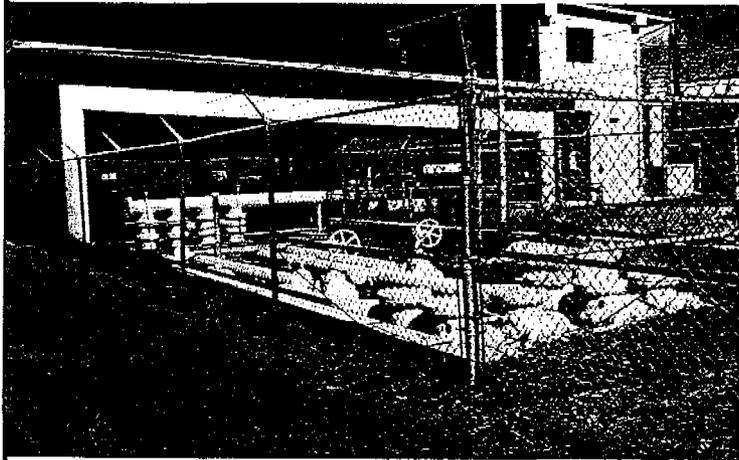
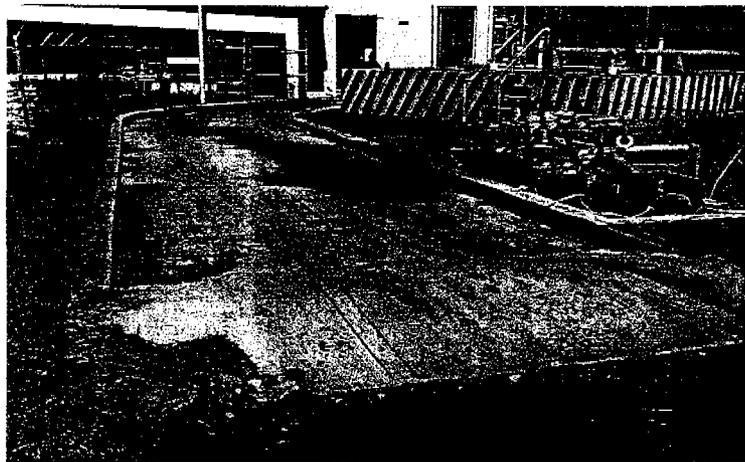
OWS No.: 1982

Overall concrete condition	Very Good
Wall 1	Very Good
Wall 2	Very Good
Wall 3	Very Good
Wall 4	Very Good
Base Slab	Very Good
Base/wall interface	Very Good

495 Gallons of sludge removed.
Inclined plate coalescer in very good condition.

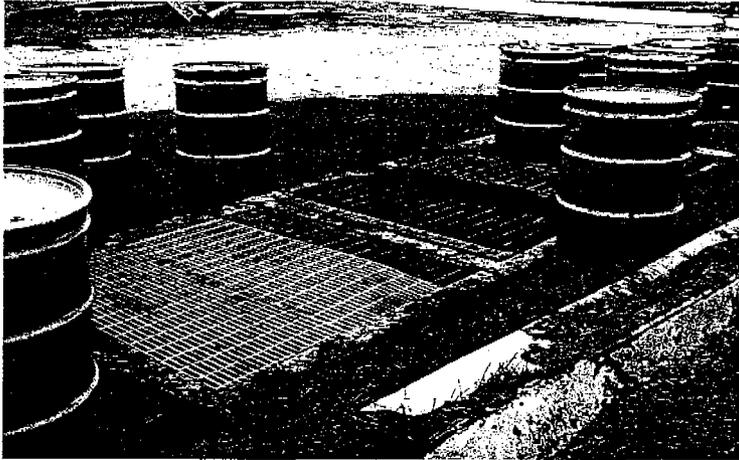
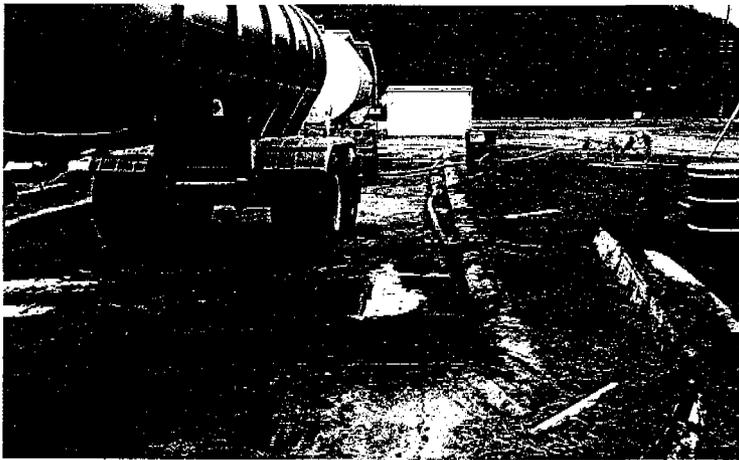
OWS No.: 1985

Overall concrete condition	Very Good
Wall 1	Very Good
Wall 2	Very Good
Wall 3	Very Good
Wall 4	Very Good
Base Slab	Very Good
Base/wall interface	Very Good

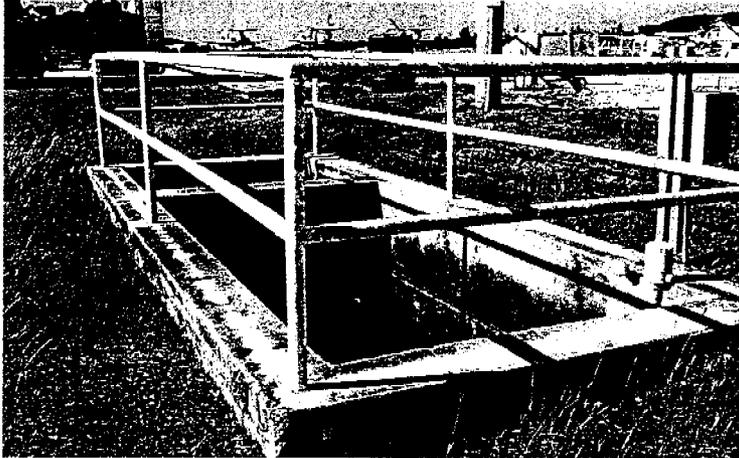
OWS No.: 2011

Overall concrete condition	Good
Wall 1	Good
Wall 2	Good
Wall 3	Good
Wall 4	Good
Base Slab	Good
Base/wall interface	Good

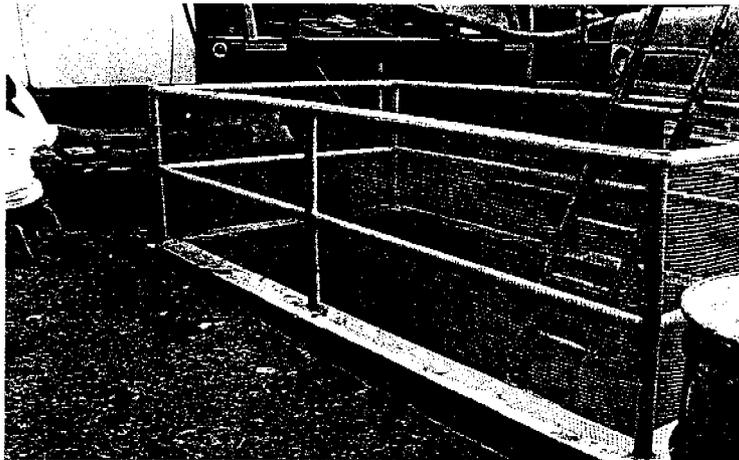
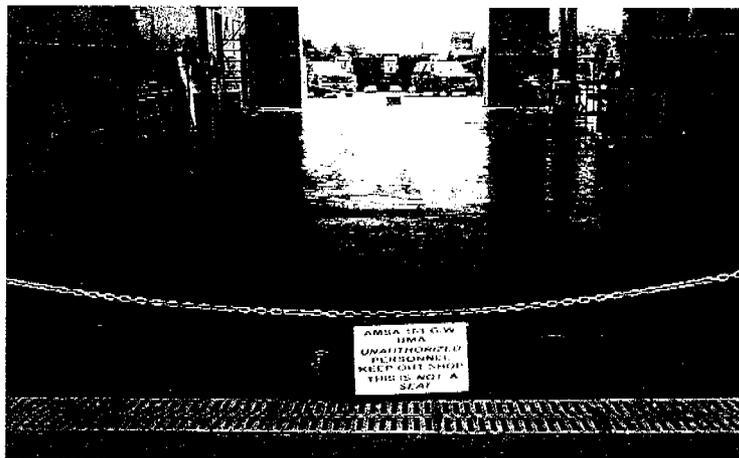
OWS No.: 2298

Overall concrete condition	Good
Wall 1	Good
Wall 2	Good
Wall 3	Good
Wall 4	Good
Base Slab	Good
Base/wall interface	Good

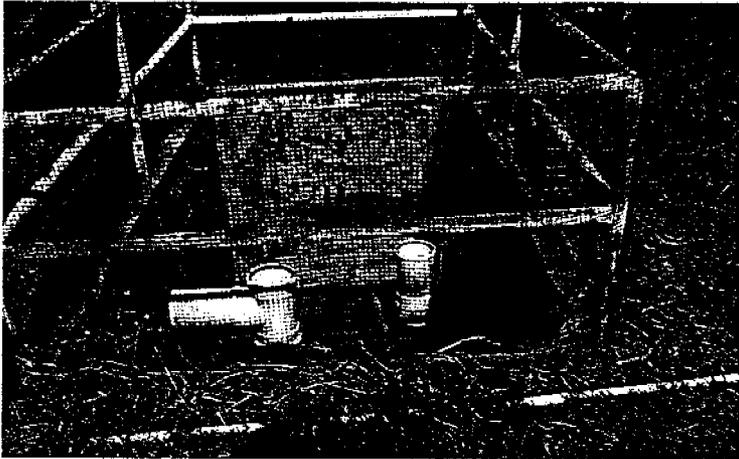
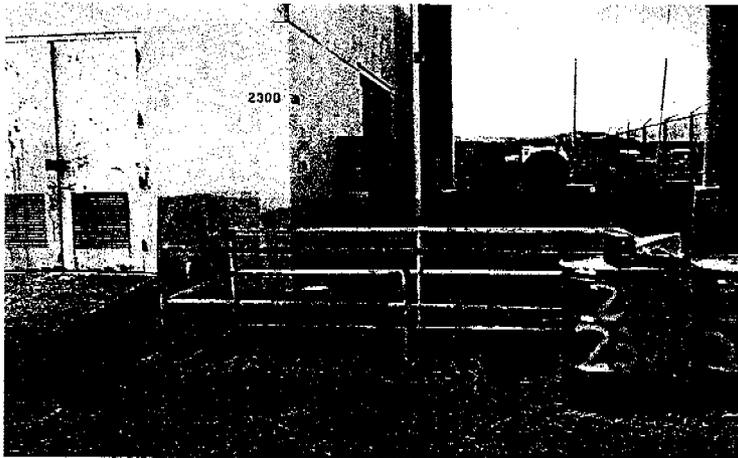
OWS No.: 2300

Overall concrete condition	Very Good
Wall 1	Very Good
Wall 2	Very Good
Wall 3	Very Good
Wall 4	Very Good
Base Slab	Very Good
Base/wall interface	Very Good

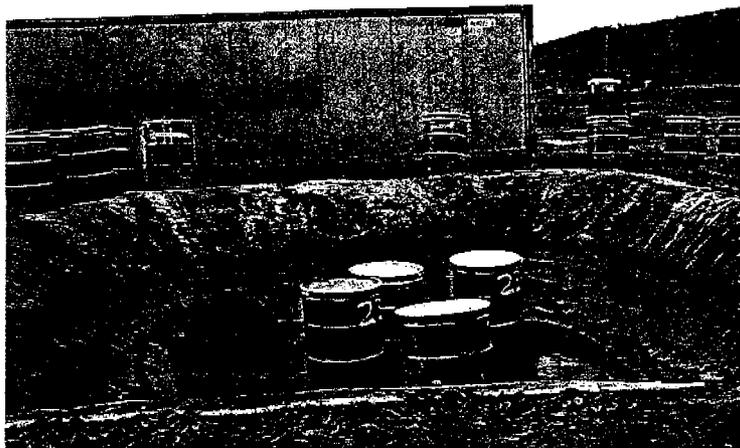
OWS No.: 2311

Overall concrete condition	Poor
Wall 1	Poor
Wall 2	Poor
Wall 3	Poor
Wall 4	Poor
Base Slab	Poor
Base/wall interface	Poor

1485 gallons of sludge removed (27 - 55 gallon drums)
Significant cracks in concrete - 6" to 24" long and intersecting

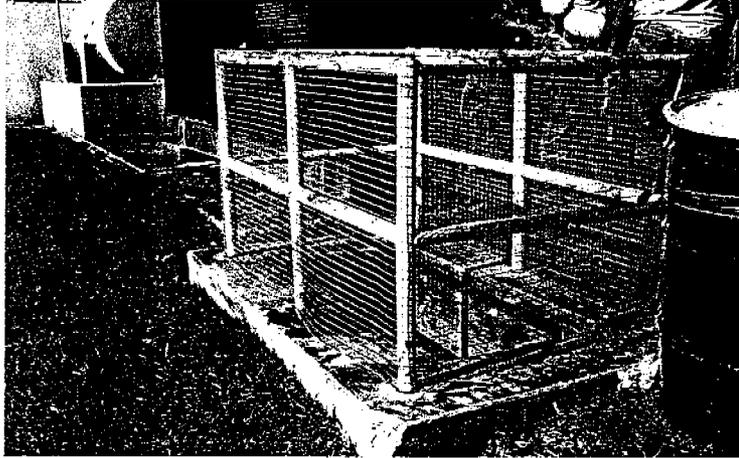
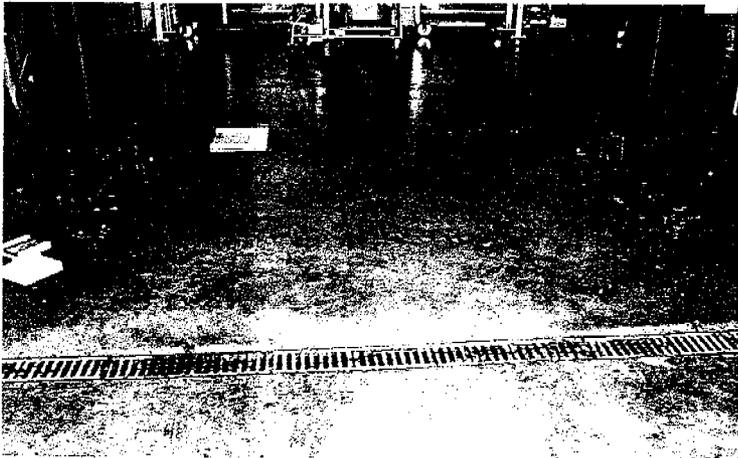
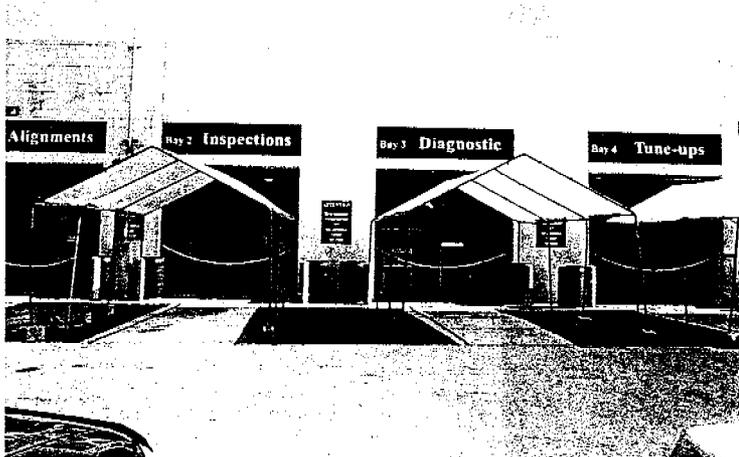
OWS No.: 2339-2

Overall concrete condition	Very Good
Wall 1	Very Good
Wall 2	Very Good
Wall 3	Very Good
Wall 4	Very Good
Base Slab	Very Good
Base/wall interface	Very Good

Human waste/sanitary napkins found in OWS when pumped out. When toilets are flushed in the building, water flows into OWS.

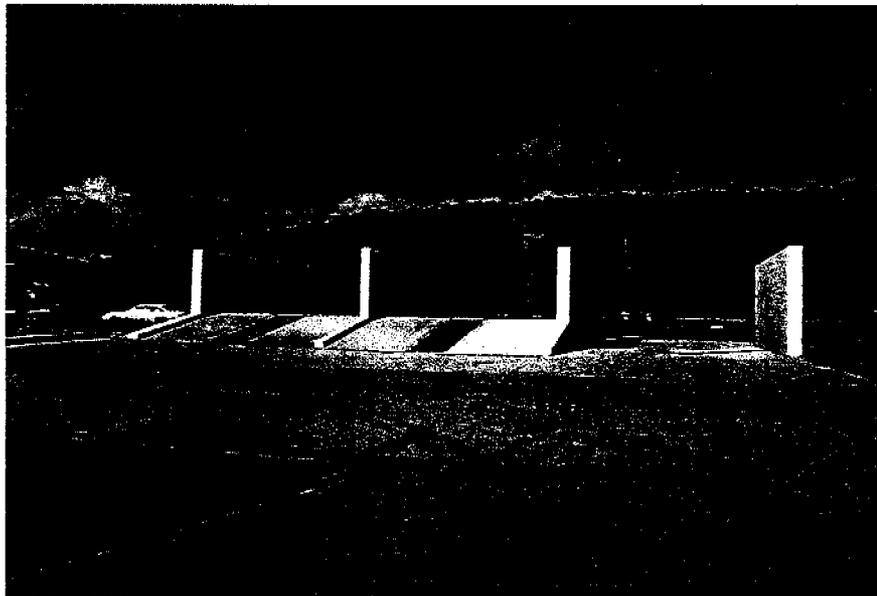
OWS No.: 2364

Steps in both OWSs in very good condition.
Inlet and outlet in good condition.
Small amount of spalling (< 1/4" deep) over less than 5% surface area.

Small amount of spalling of parging (<5%)
Steps in both OWSs in very good condition
Inlet and outlet in good condition

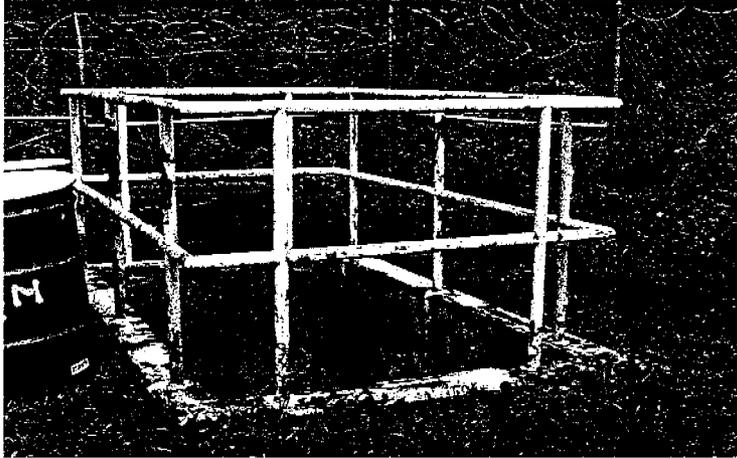
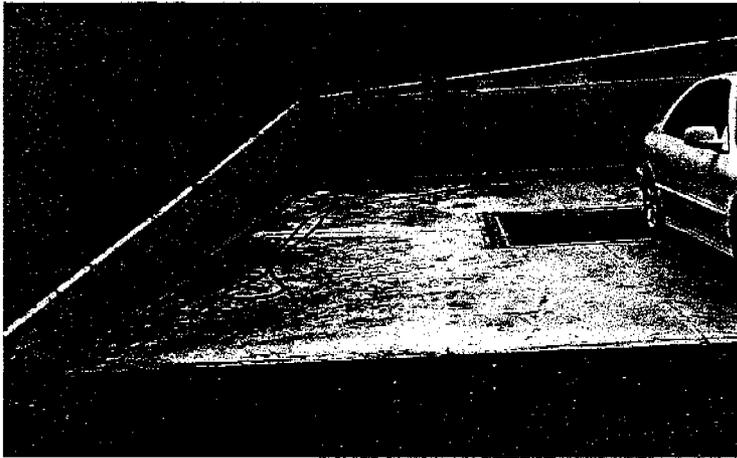
OWS No.: 2358

Overall concrete condition	Good to Very Good
Wall 1	Good to Very Good
Wall 2	Good to Very Good
Wall 3	Good to Very Good
Wall 4	Good to Very Good
Base Slab	Good to Very Good
Base/wall interface	Good to Very Good

110 gallons of sludge removed (Two - 55 gallon drums)
Minor cracking on top walls of OWS

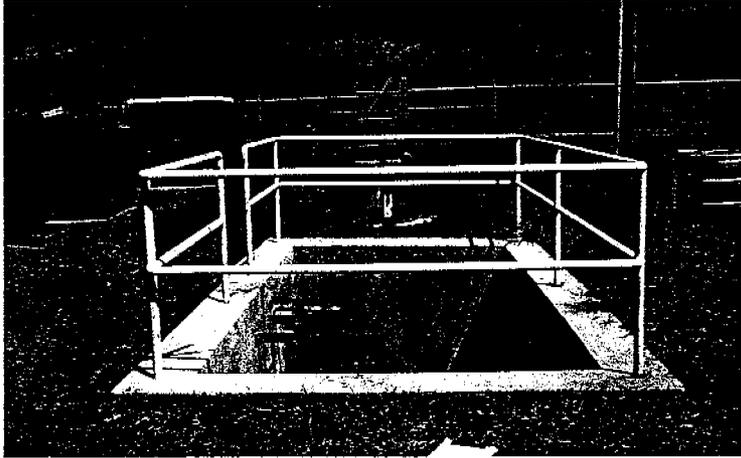
2431

Overall concrete condition	Very Good
Wall 1	Very Good
Wall 2	Very Good
Wall 3	Very Good
Wall 4	Very Good
Base Slab	Very Good
Base/wall interface	Very Good

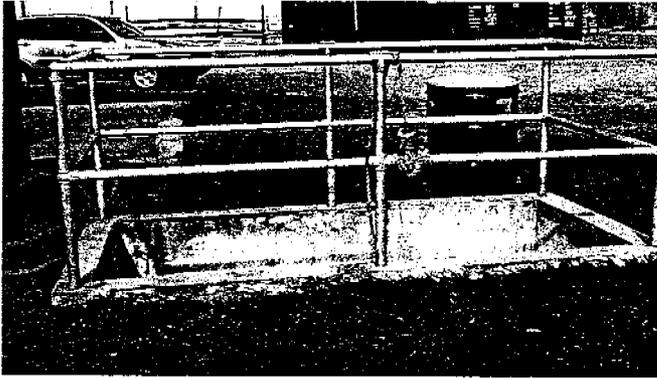
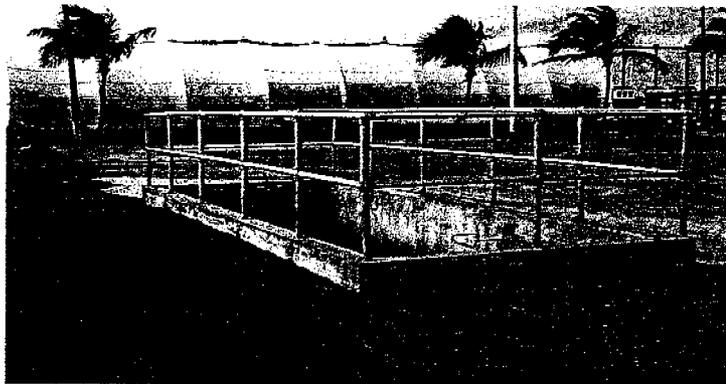
3137

If excessive, explain: Small berm missing on one side (west) of the wash area

Wash area drainage appears to be plugged. Water runs to sanitary sewer manhole
Ladder in very good condition
825 Gallons of sludge removed

Same notes as above
Ladder in very good condition
