Final  
**Asbestos Inspection Report**  
for

Naval Activity Puerto Rico  
Ceiba, Puerto Rico

Volume 5 of 7

Buildings 2004 through 2339

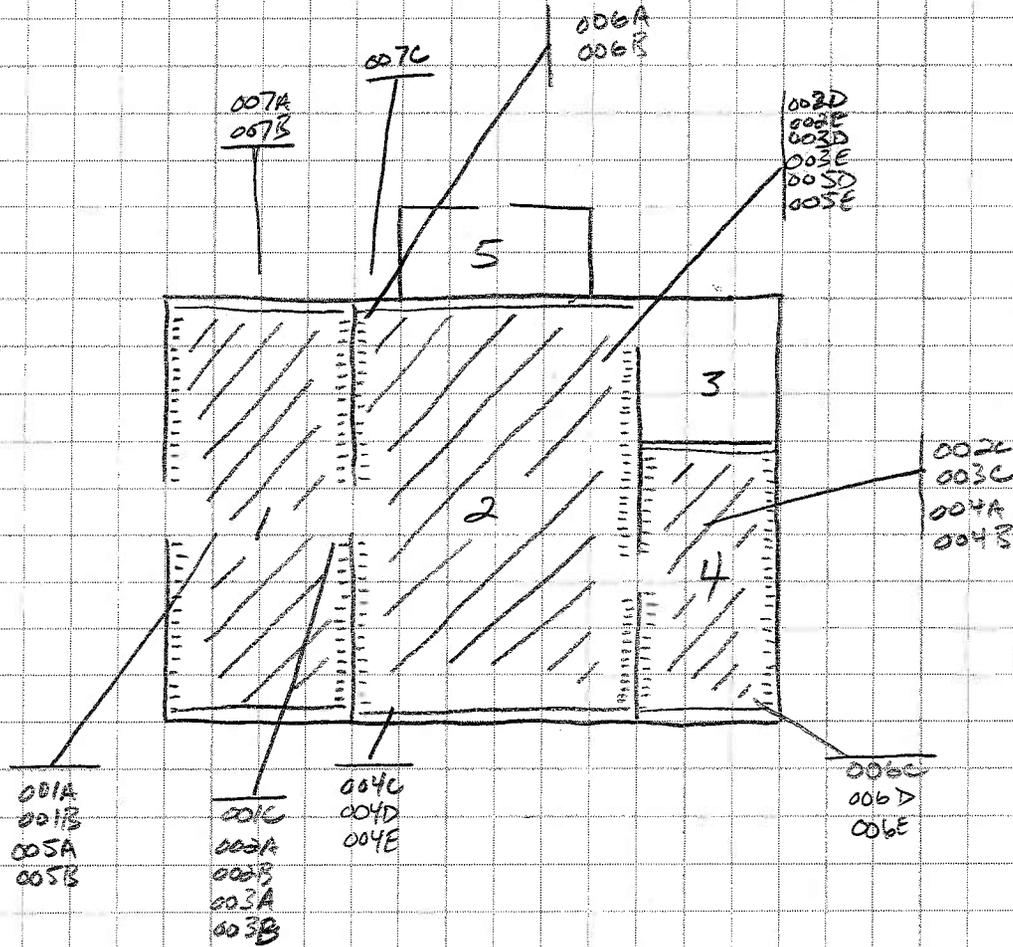
BUILDING #2007  
NAVAL ACTIVITY PUERTO RICO

Building 2007 is identified as “ASSP Maint Shop (ATWTF)” and is approximately 1,040 square feet in size. Seven suspect homogeneous materials were identified and sampled. Three materials, vinyl floor tile (Material #002), floor adhesive (Material #003), and cove base adhesive (Material #005), were found to be ACM. No friable, damaged, and accessible ACM was identified.

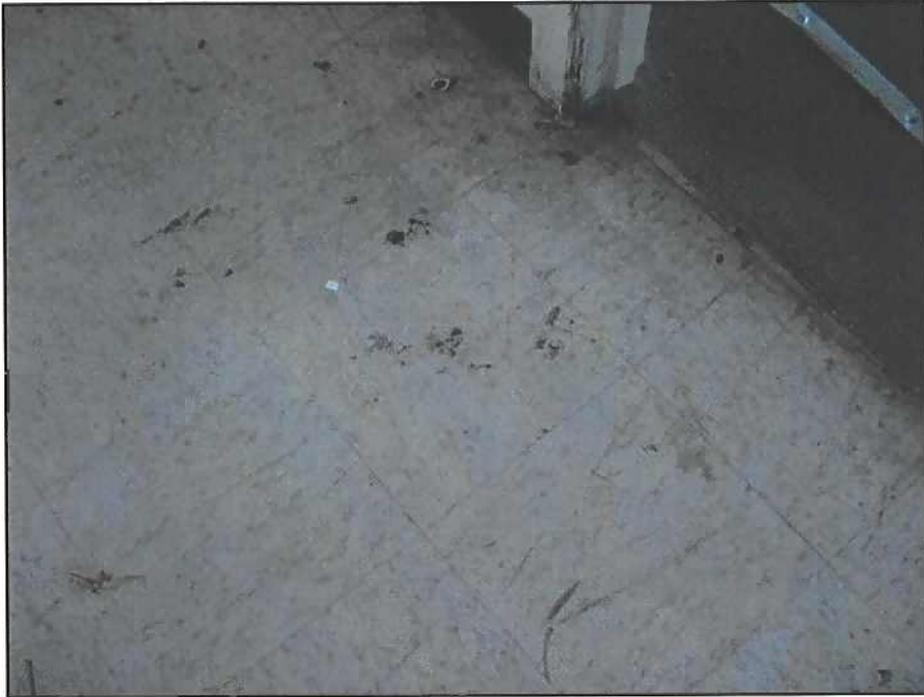
MATERIAL NUMBER	MATERIAL TYPE (MATERIAL DESCRIPTION)	ASBESTOS CONTENT	MATERIAL LOCATION(S)	FRIABLE	CONDITION	QUANTITY	COMMENTS
002	VINYL FLOOR TILE (1' X 1' WHITE WITH BEIGE STREAKS)	2% CH	1 2 4	No	UNDAMAGED	1,048 SF	THE ADHESIVE FOR THIS MATERIAL IS MATERIAL #003.
003	FLOOR ADHESIVE (BROWN, UNDER 1' X 1' WHITE WITH BEIGE STREAKS VINYL FLOOR TILE)	5% CH	1 2 4	No	UNDAMAGED	1,048 SF	THIS IS THE ADHESIVE FOR MATERIAL #002.
005	COVE BASE ADHESIVE (BLACK, UNDER 4" BLACK RUBBER COVE BASE)	4% CH	1 2 4	No	UNDAMAGED	210 LF

Vinyl floor tile (Material #002)

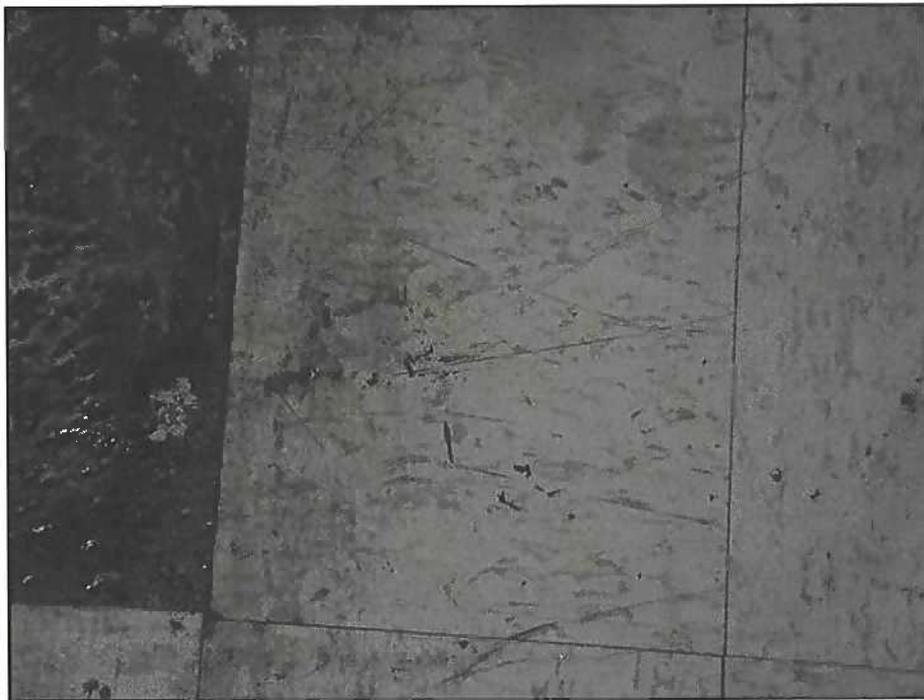
Floor adhesive (Material #003)

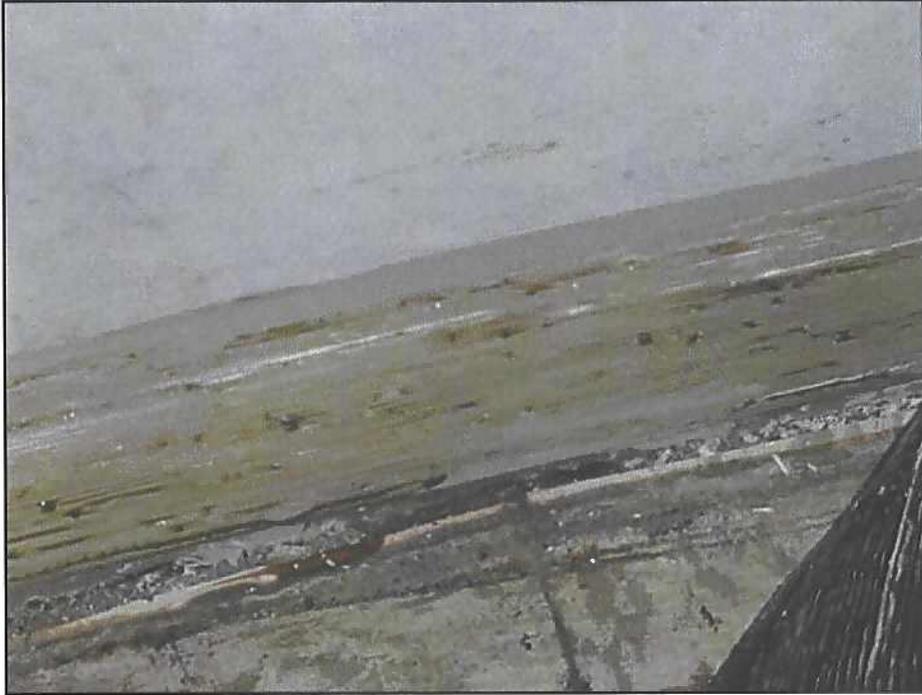
Cove base adhesive (Material #005)

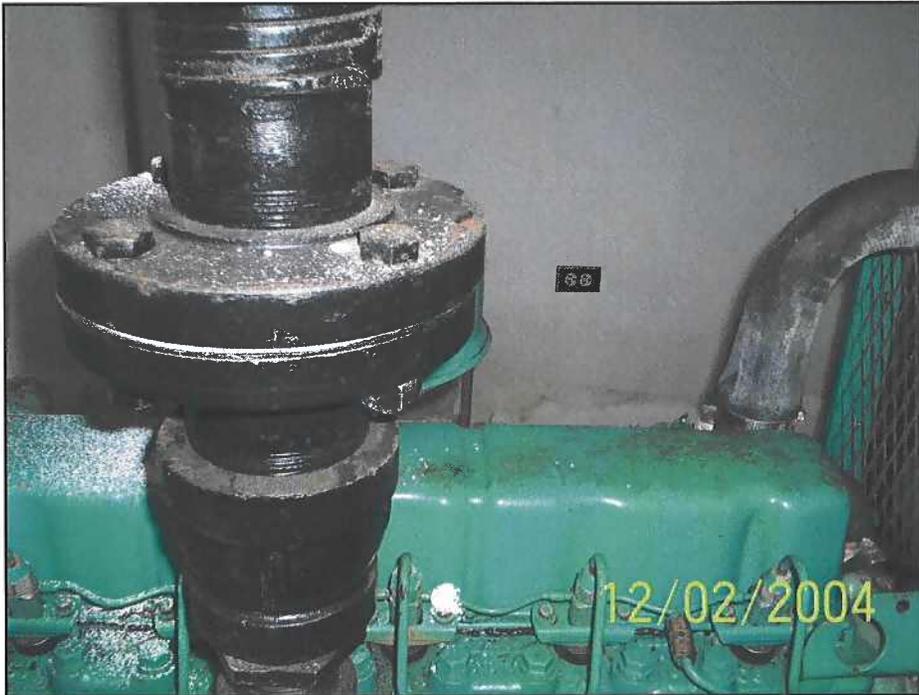
MATERIAL NUMBER	MATERIAL TYPE (MATERIAL DESCRIPTION)	ASBESTOS CONTENT	MATERIAL LOCATION(S)	FRIABLE	CONDITION	QUANTITY	COMMENTS
002	SHEET GASKET (BLACK)	35% CH	2016	No	UNDAMAGED	6 EA

Black sheet gasket (Material #002)

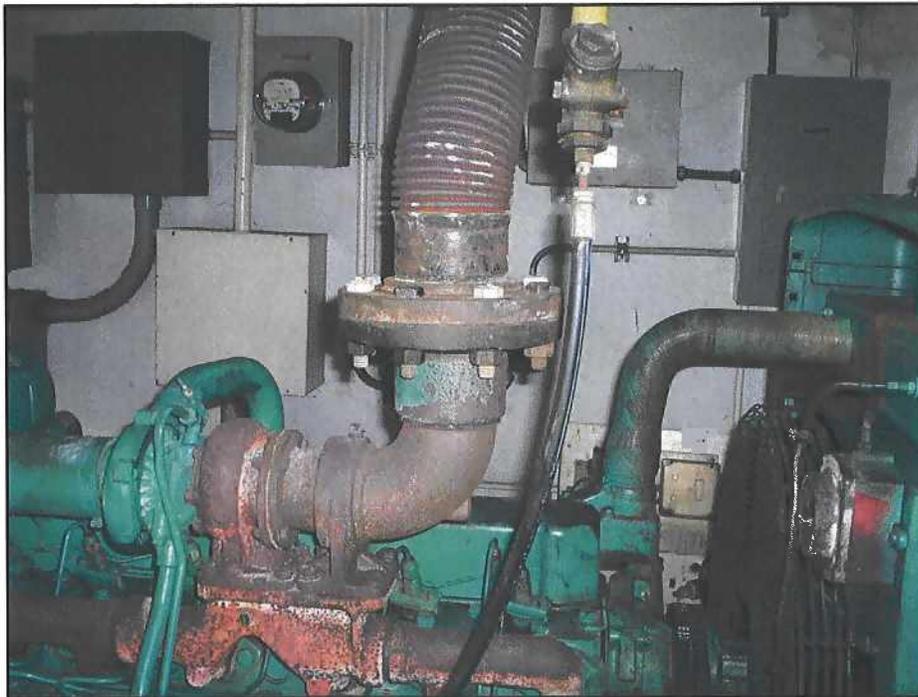
MATERIAL NUMBER	MATERIAL TYPE (MATERIAL DESCRIPTION)	ASBESTOS CONTENT	MATERIAL LOCATION(S)	FRIABLE	CONDITION	QUANTITY	COMMENTS
002	SHEET GASKET (BROWN)	60% CH	2021	No	UNDAMAGED	4 EA

Brown sheet gasket (Material #002)

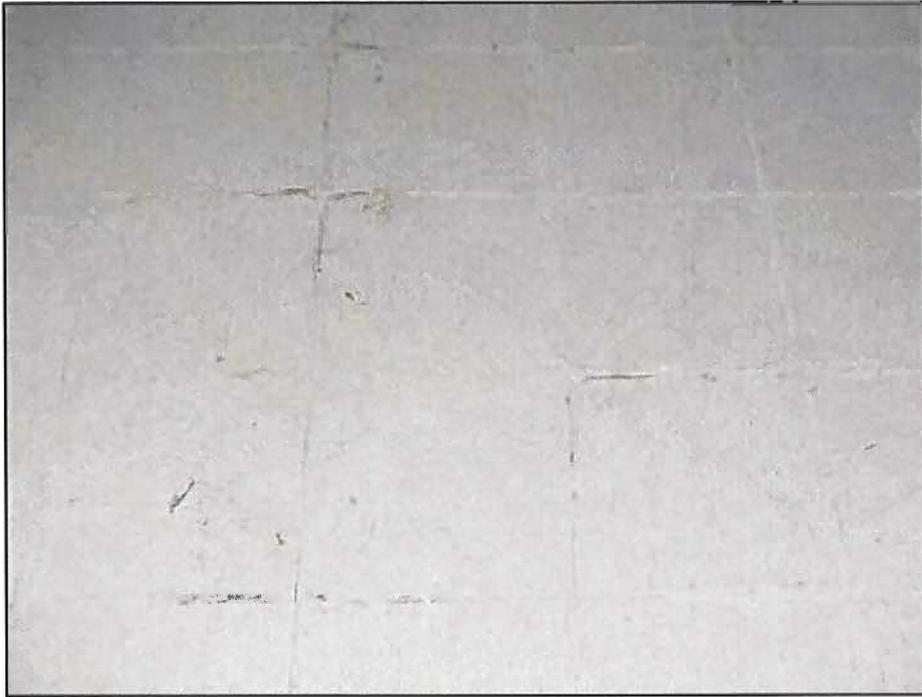
MATERIAL NUMBER	MATERIAL TYPE (MATERIAL DESCRIPTION)	ASBESTOS CONTENT	MATERIAL LOCATION(S)	FRIABLE	CONDITION	QUANTITY	COMMENTS
001	VINYL FLOOR TILE (1' X 1' WHITE)	8% CH	1 4	No	UNDAMAGED	800 SF

1'x1' white vinyl floor tile (Material #001)

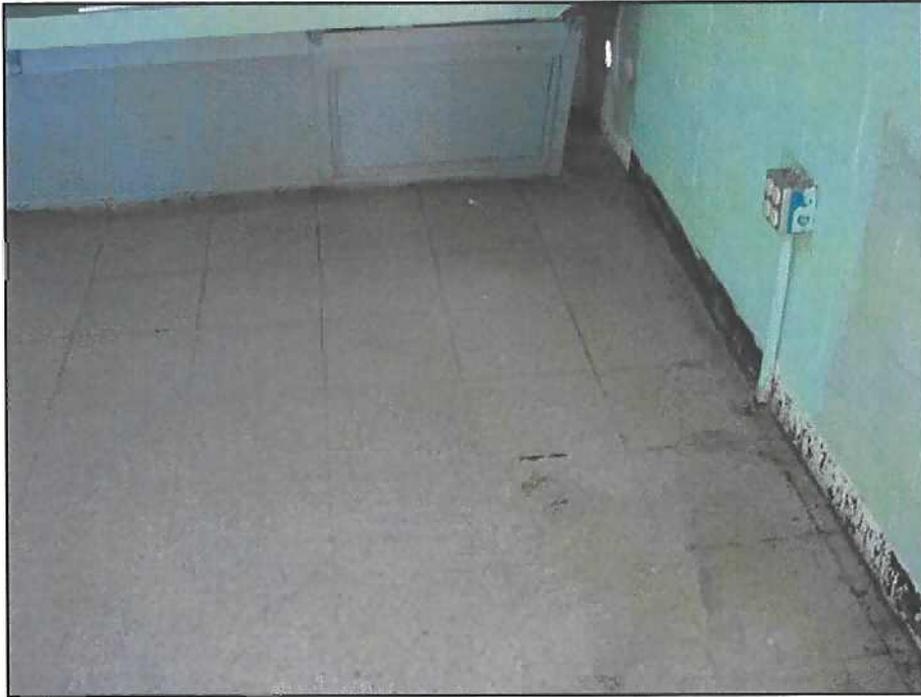
Vinyl floor tile (Material #001)

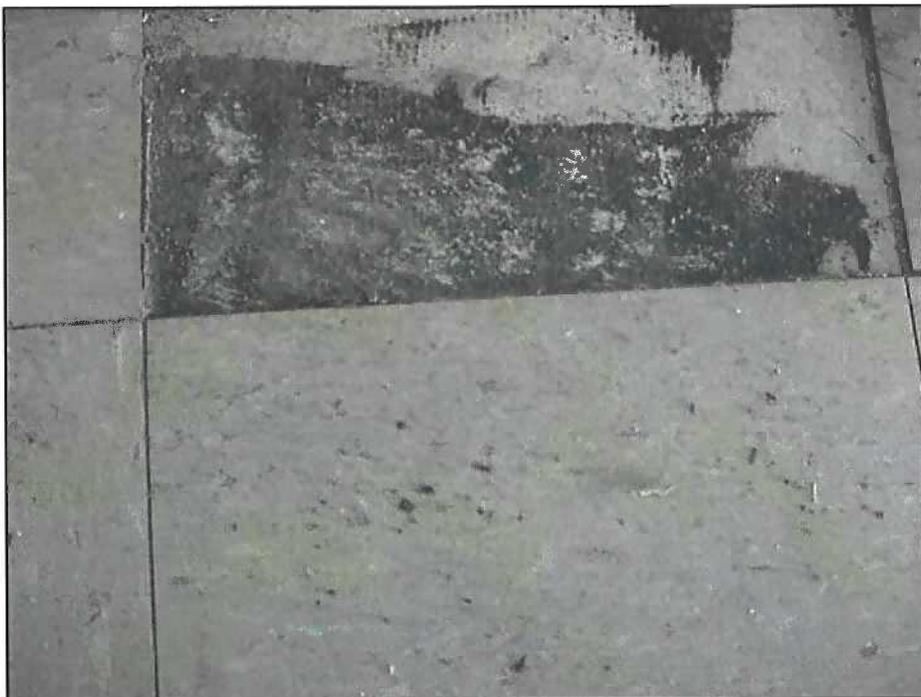
Floor adhesive (Material #002)

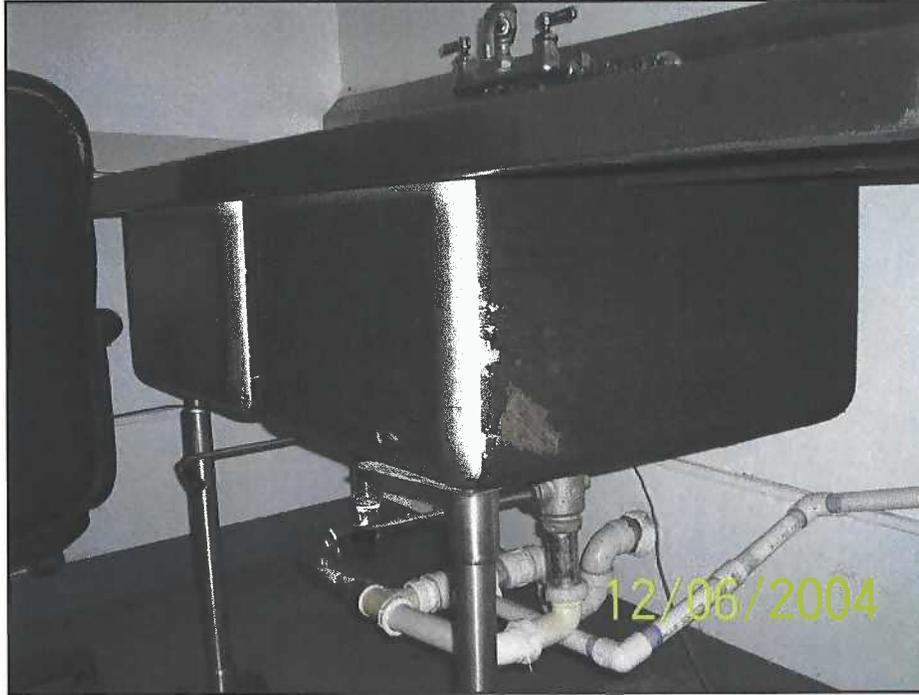
Building 2082 is identified as “Kennel” and is approximately 1,320 square feet in size. Five suspect homogeneous materials were identified and sampled. One material, a black spray-on sink coating (Material #005), was found to be an ACM. No friable, damaged, and accessible ACM was identified.

Black spray-on sink coating (Material #005)

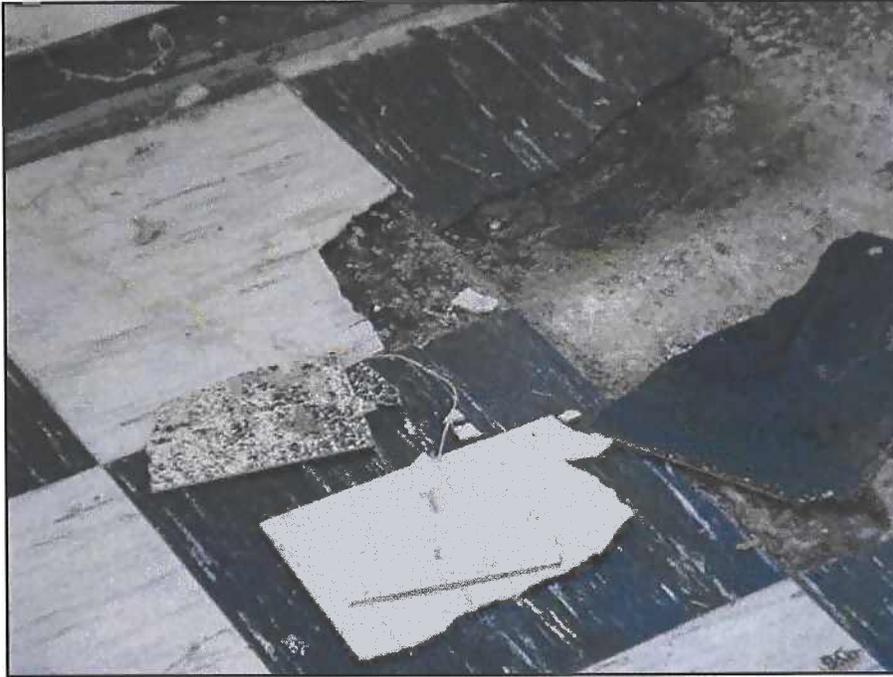
Building 2242 is identified as “Vacant” and is approximately 1,600 square feet in size. Eight suspect homogeneous materials were identified and sampled. Three materials, two types of vinyl floor tile (Materials #005 and #006) and floor adhesive (Material #007), were found to be an ACM. No friable, damaged, and accessible ACM was identified.

Vinyl floor tile (Materials #005 and #006) and floor adhesive (Material #007)

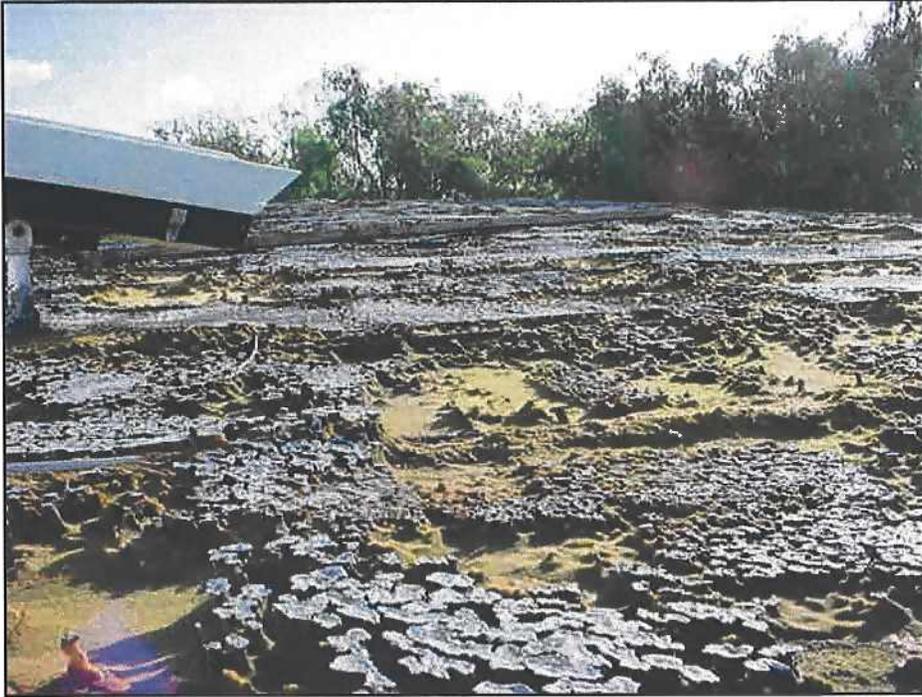
MATERIAL NUMBER	MATERIAL TYPE (MATERIAL DESCRIPTION)	ASBESTOS CONTENT	MATERIAL LOCATION(S)	FRIABLE	CONDITION	QUANTITY	COMMENTS
001	ASPHALTIC ROOFING MATERIALS (BLACK TAR OVER FOAM)	Layer 1 7% CH Layer 2 ND	ROOF	No	SIGNIFICANT DAMAGE	1,166 SF

Damaged black roofing tar (Material #001)

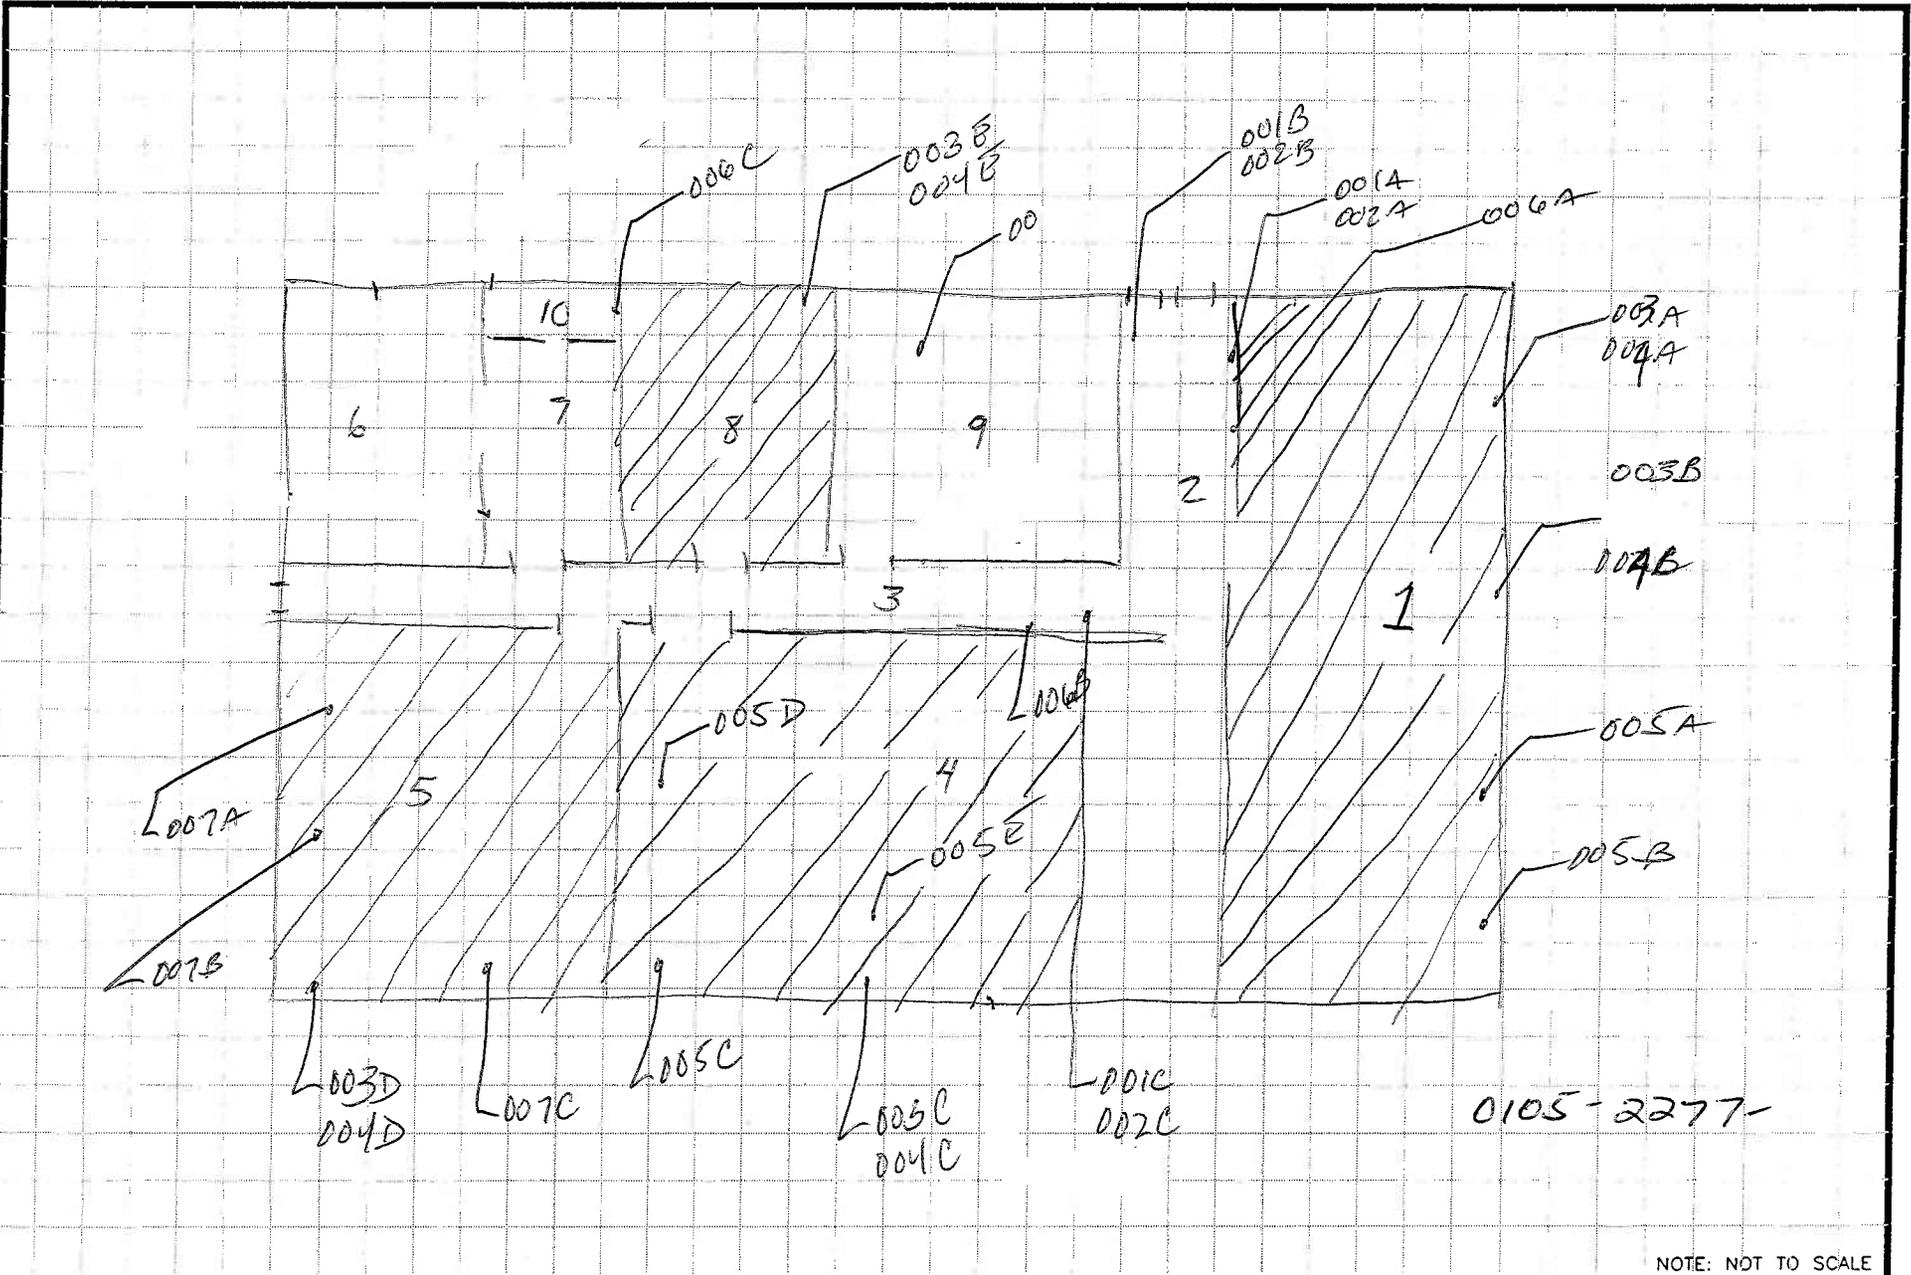
BUILDING # 2277  
NAVAL ACTIVITY PUERTO RICO

MATERIAL NUMBER	MATERIAL TYPE (MATERIAL DESCRIPTION)	ASBESTOS CONTENT	MATERIAL LOCATION(S)	FRIABLE	CONDITION	QUANTITY	COMMENTS
004	FLOOR ADHESIVE (BLACK, UNDER 003)	8% CH	1 4 5 8	No	UNDAMAGED	2,932 SF

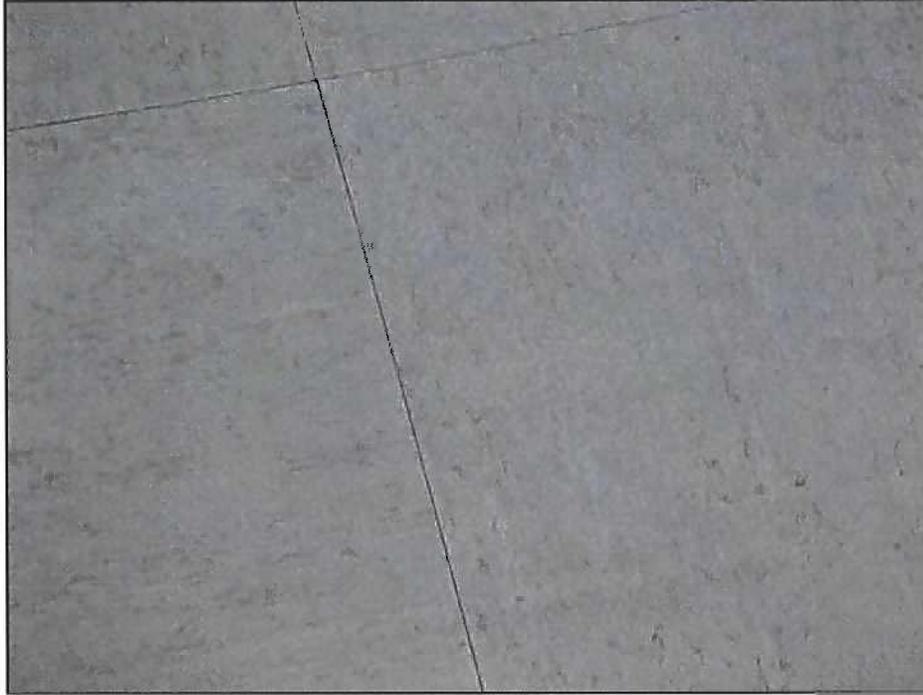
1' x 1' tan with brown streaks vinyl floor tile (Material #003) over ACM floor adhesive (Material #004)

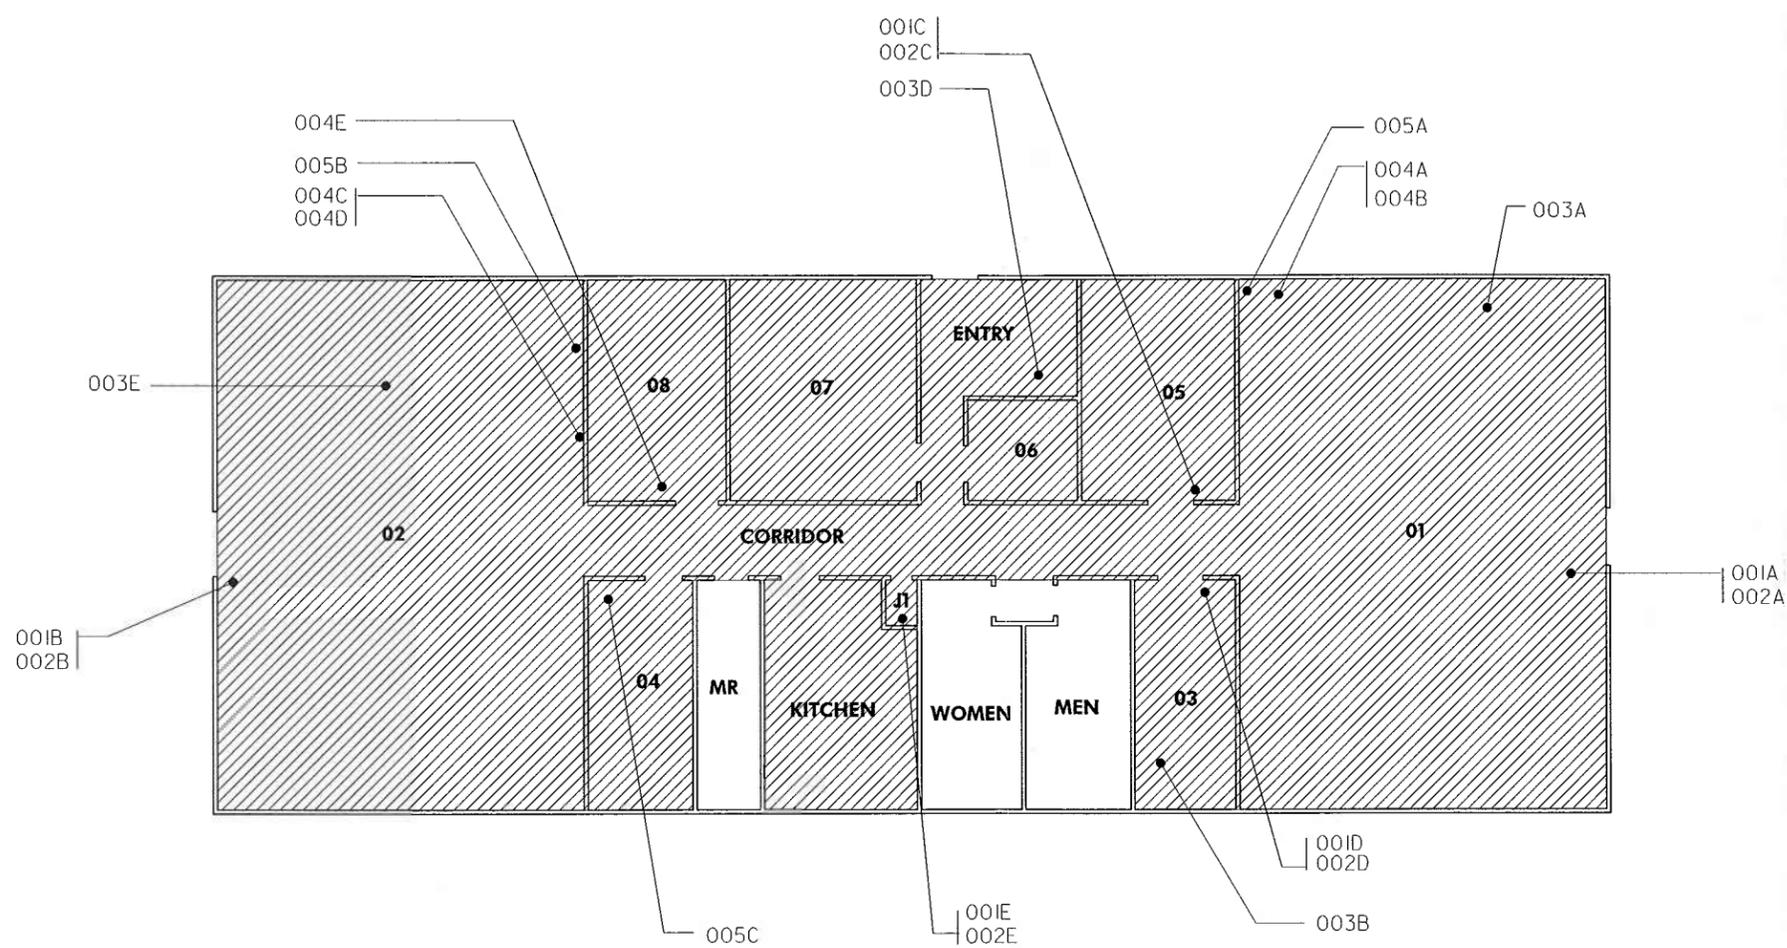
NOTE: ROOFING MATERIAL IS AN ASSUMED ACM.

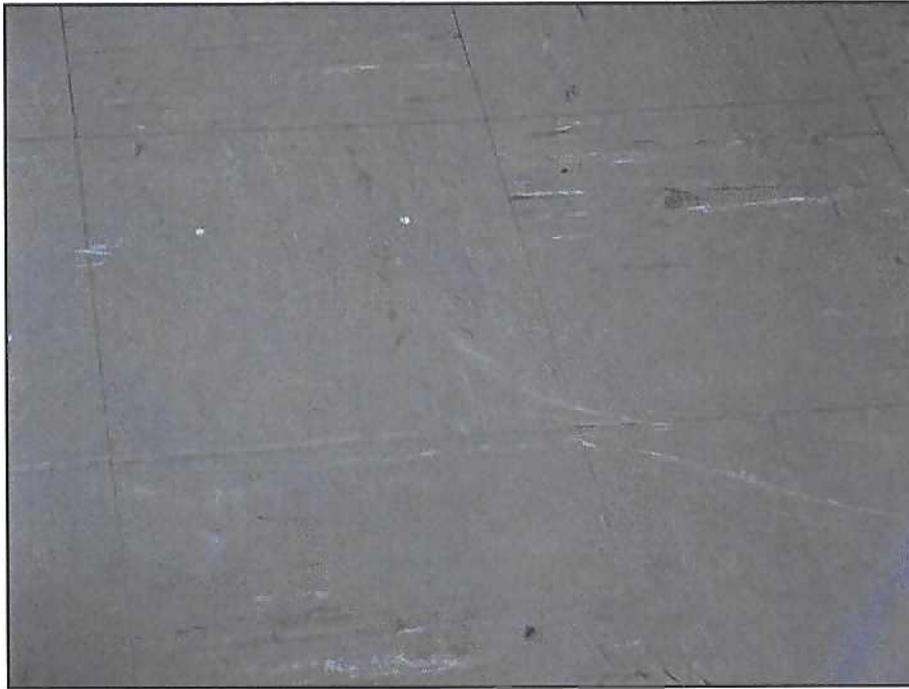
MATERIAL NUMBER	MATERIAL TYPE (MATERIAL DESCRIPTION)	ASBESTOS CONTENT	MATERIAL LOCATION(S)	FRIABLE	CONDITION	QUANTITY	COMMENTS
002	FLOOR ADHESIVE (BLACK, UNDER 001)	3% CH	01 02 03 04 05 06 07 08 CORRIDOR ENTRY J1 KITCHEN	No	UNDAMAGED	4,402 SF	
006	ASPHALTIC ROOFING MATERIALS (ROOFING MATERIAL)	ASSUMED ACM	ROOF	No	UNDAMAGED	4,612 SF	THIS MATERIAL COULD NOT BE SAFELY SAMPLED, AND WAS THEREFORE ASSUMED ACM.

1'x1' tan with orange, brown, and white streaks vinyl floor tile over ACM floor adhesive (Material #002)

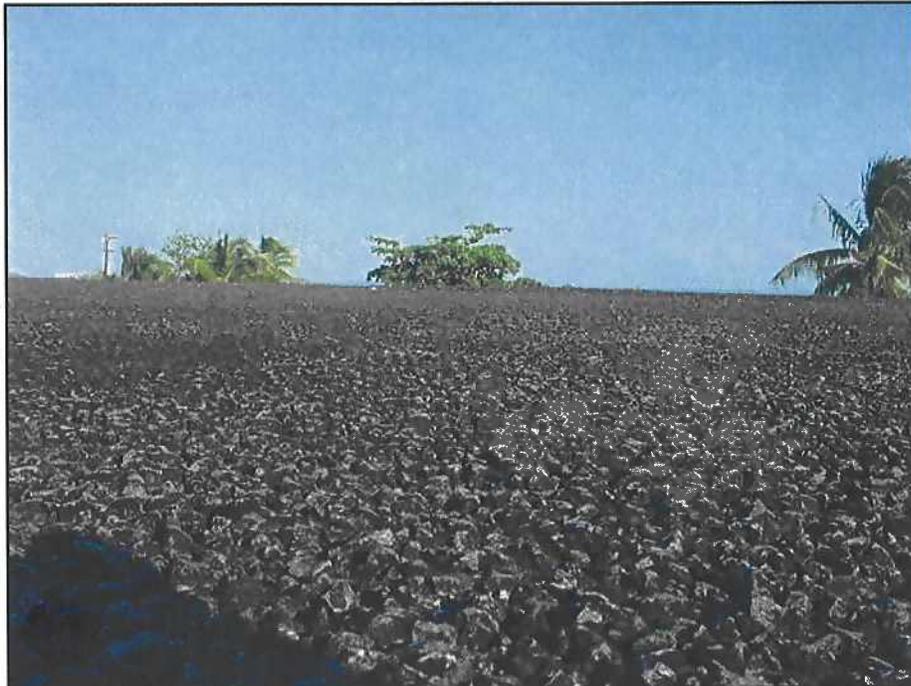
Asphaltic roofing material (Material #006)

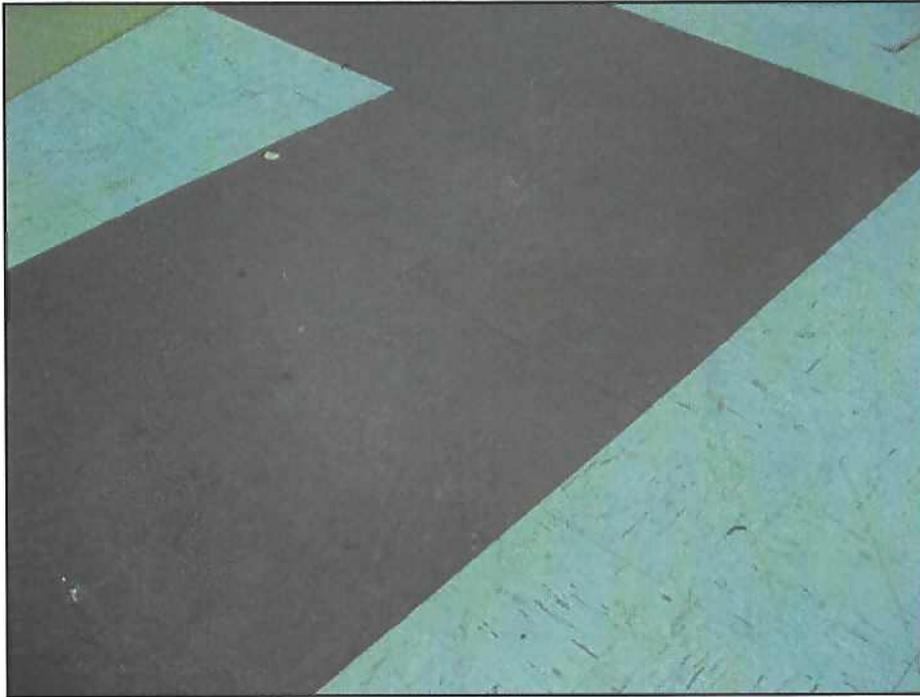
MATERIAL NUMBER	MATERIAL TYPE (MATERIAL DESCRIPTION)	ASBESTOS CONTENT	MATERIAL LOCATION(S)	FRIABLE	CONDITION	QUANTITY	COMMENTS
004	FLOOR ADHESIVE (BLACK AND TAN, UNDER 003)	Layer 1 ND Layer 2 4% CH	6	No	UNDAMAGED	110 SF	THIS IS THE ADHESIVE FOR MATERIAL #003.
006	FLOOR ADHESIVE (BLACK, UNDER 003 AND 005)	6% CH	6	No	UNDAMAGED	170 SF	THIS IS THE ADHESIVE FOR MATERIAL #005.
007	VINYL FLOOR TILE (1' X 1' TAN WITH BROWN STREAKS)	2% CH	1	No	UNDAMAGED	1,600 SF	THE ADHESIVE FOR THIS MATERIAL IS MATERIAL #008.

Vinyl floor tile (Materials #003 and #005) associated with ACM floor adhesives (Materials #004 and #006)

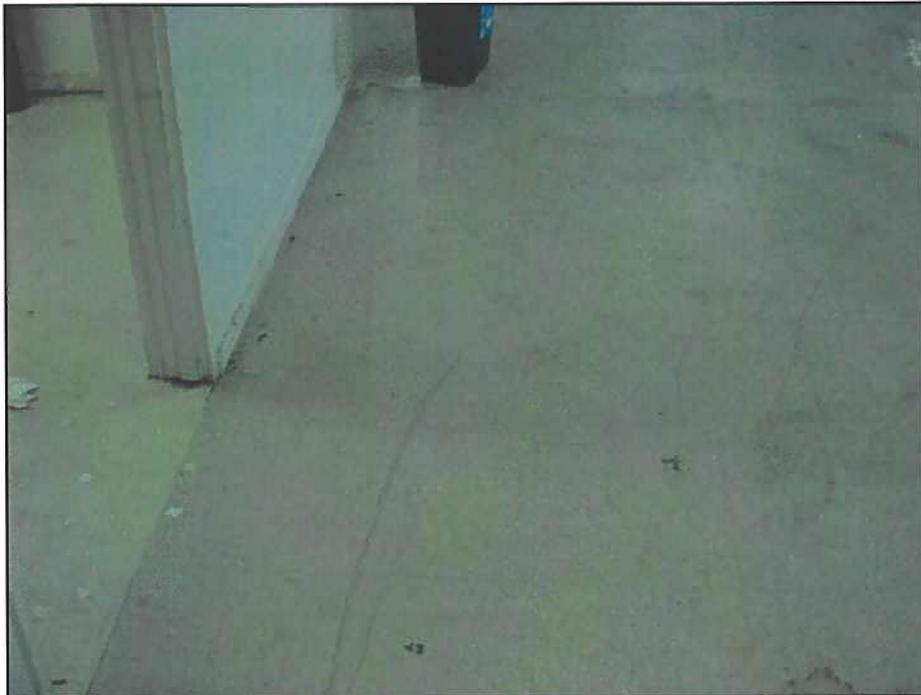
Vinyl floor tile (Material #007)

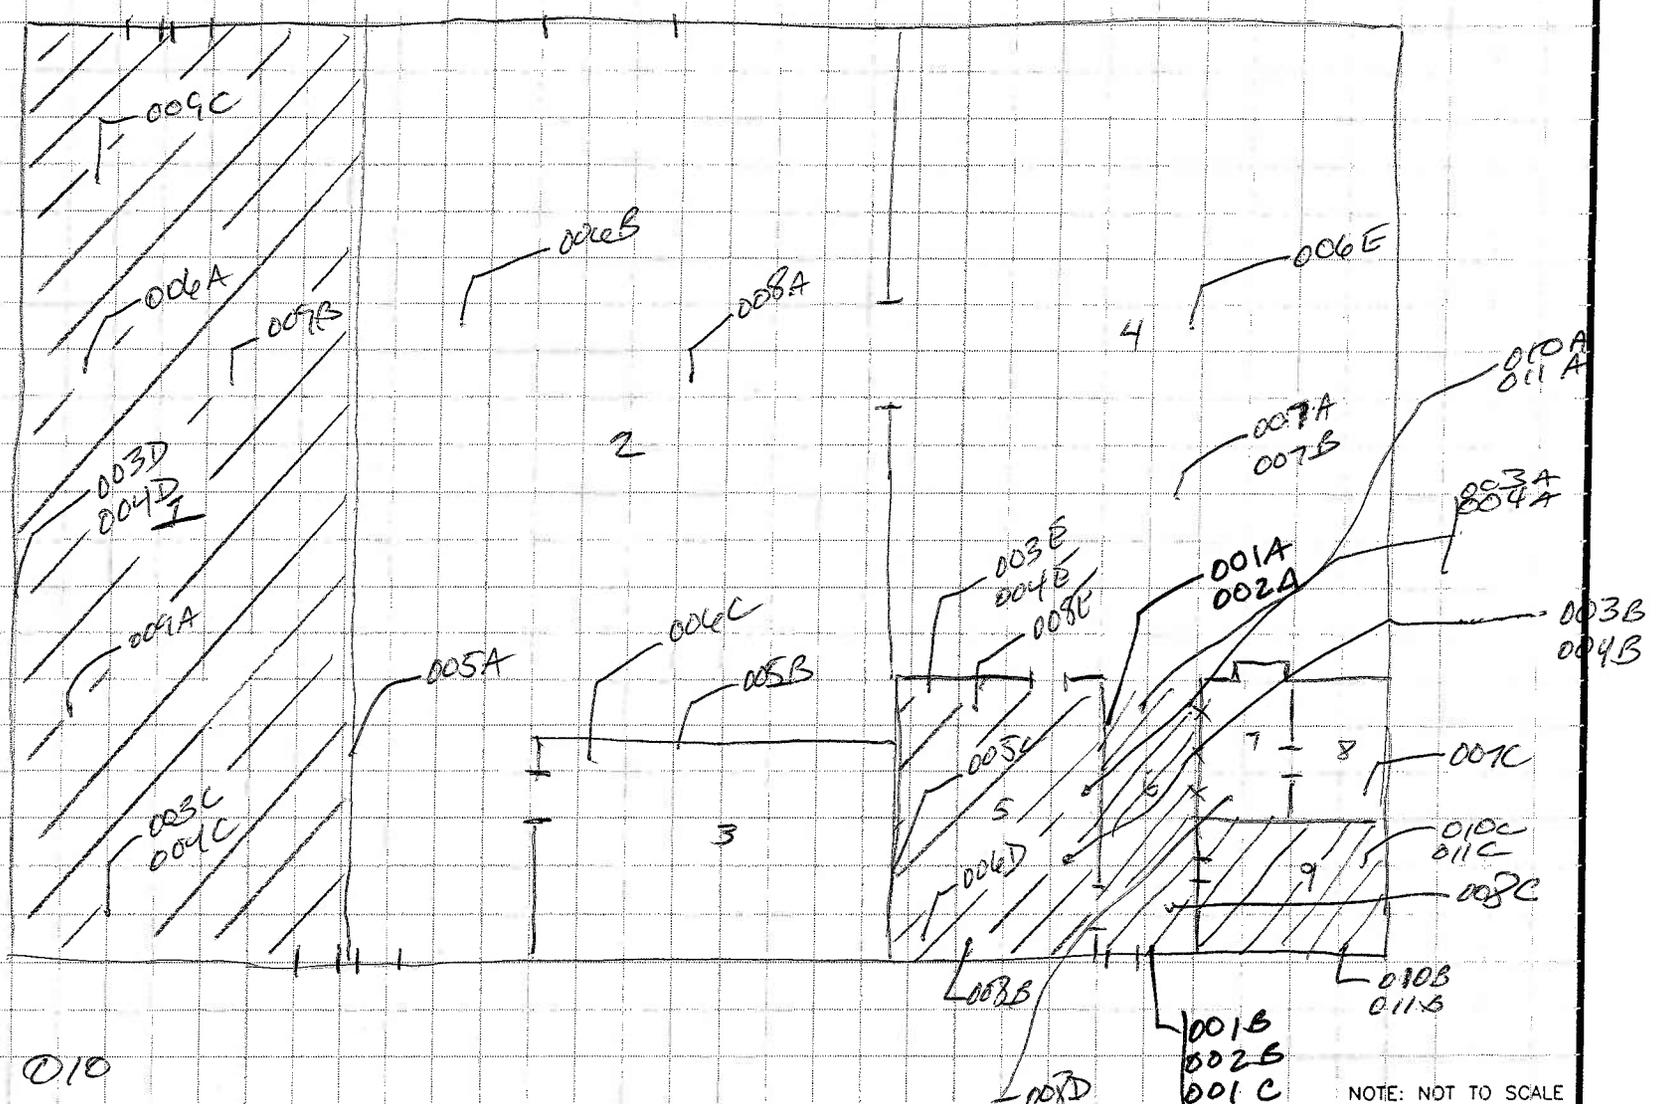
MATERIAL NUMBER	MATERIAL TYPE (MATERIAL DESCRIPTION)	ASBESTOS CONTENT	MATERIAL LOCATION(S)	FRIABLE	CONDITION	QUANTITY	COMMENTS
004	FLOOR ADHESIVE (BLACK, UNDER 003)	8% CH	1 5	No	UNDAMAGED	1,034 SF	
011	FLOOR ADHESIVE (BLACK, UNDER 010)	Layer 1 ND Layer 2 8% CH	6 9	No	UNDAMAGED	160 SF

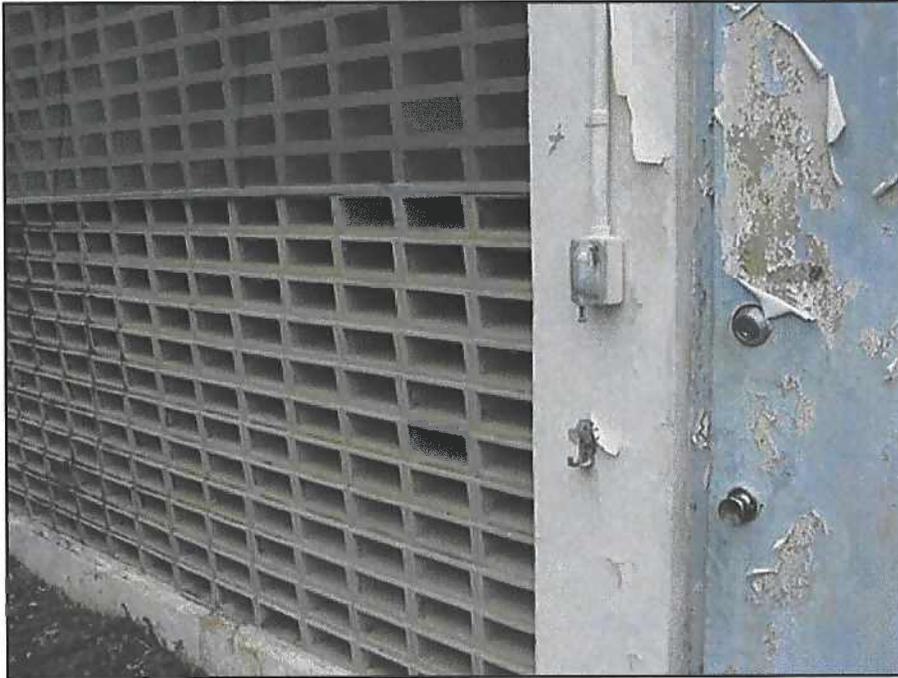
MATERIAL NUMBER	MATERIAL TYPE (MATERIAL DESCRIPTION)	ASBESTOS CONTENT	MATERIAL LOCATION(S)	FRIABLE	CONDITION	QUANTITY	COMMENTS
013	CEMENT WALL (CEMENTITIOUS BLOCKS)	12 % CH	EXTERIOR	No	UNDAMAGED	1,034 SF

Cementitious Blocks (Material #013)

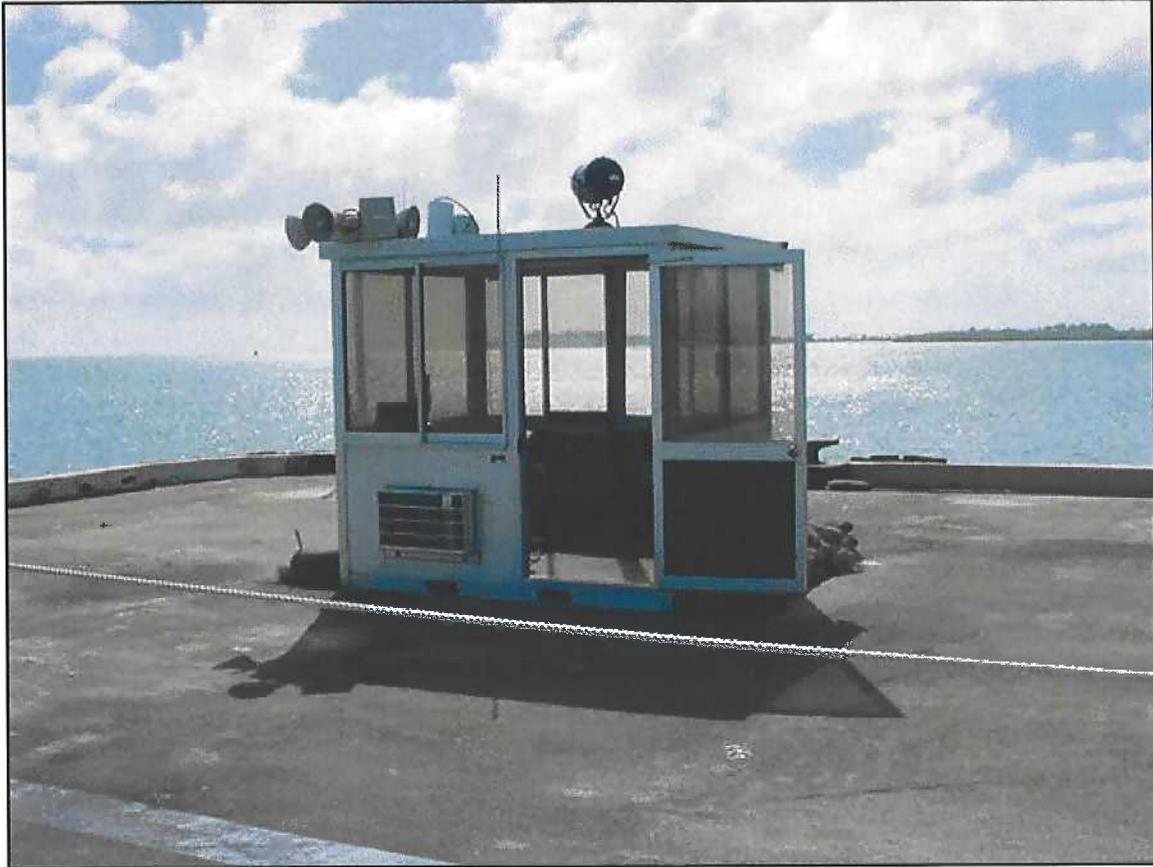
## BUILDING 2310

Building 2310 is identified as “Shelter by Pier 3 Bldg 799” and is approximately 190 square feet in size. No suspect materials were identified. Therefore, no sampling was conducted.

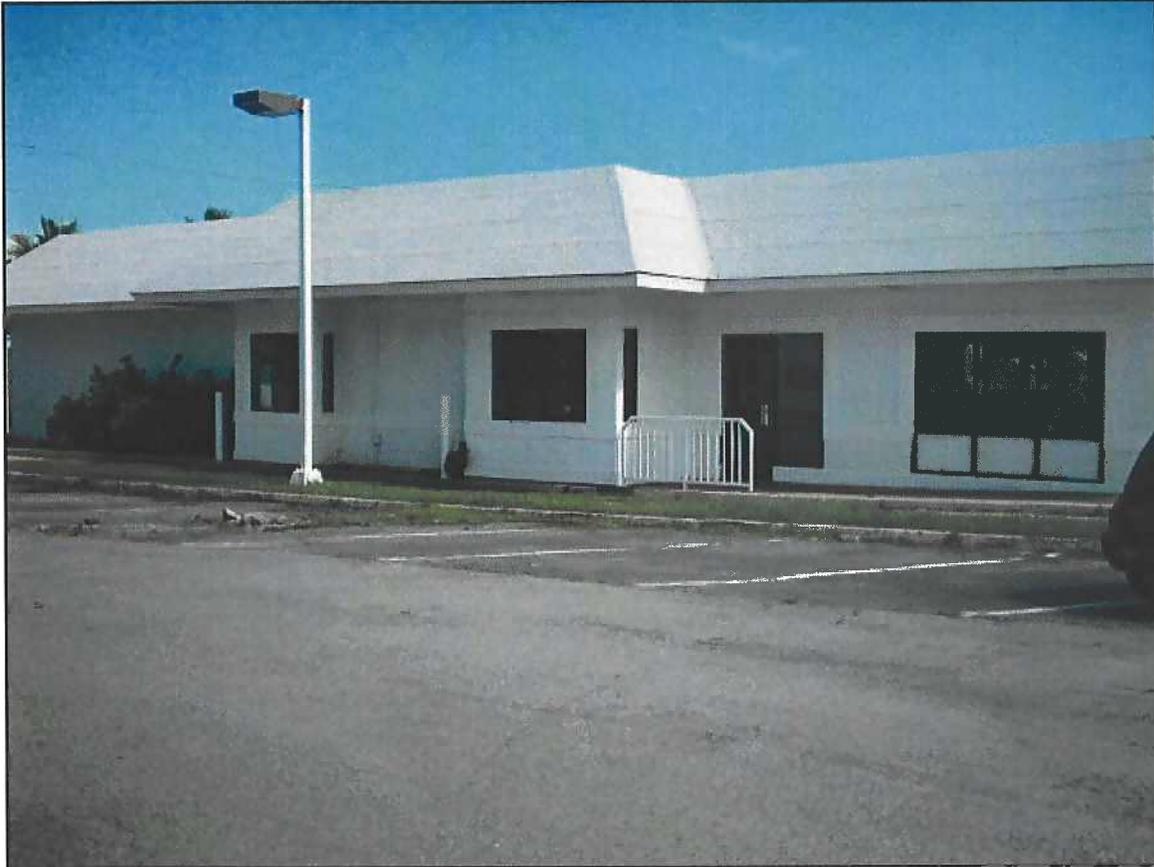
## BUILDING 2313

Building 2313 is identified as “McDonald’s” and is approximately 4,500 square feet in size. Six suspect homogeneous materials were identified and sampled. None of these materials were found to be ACM.

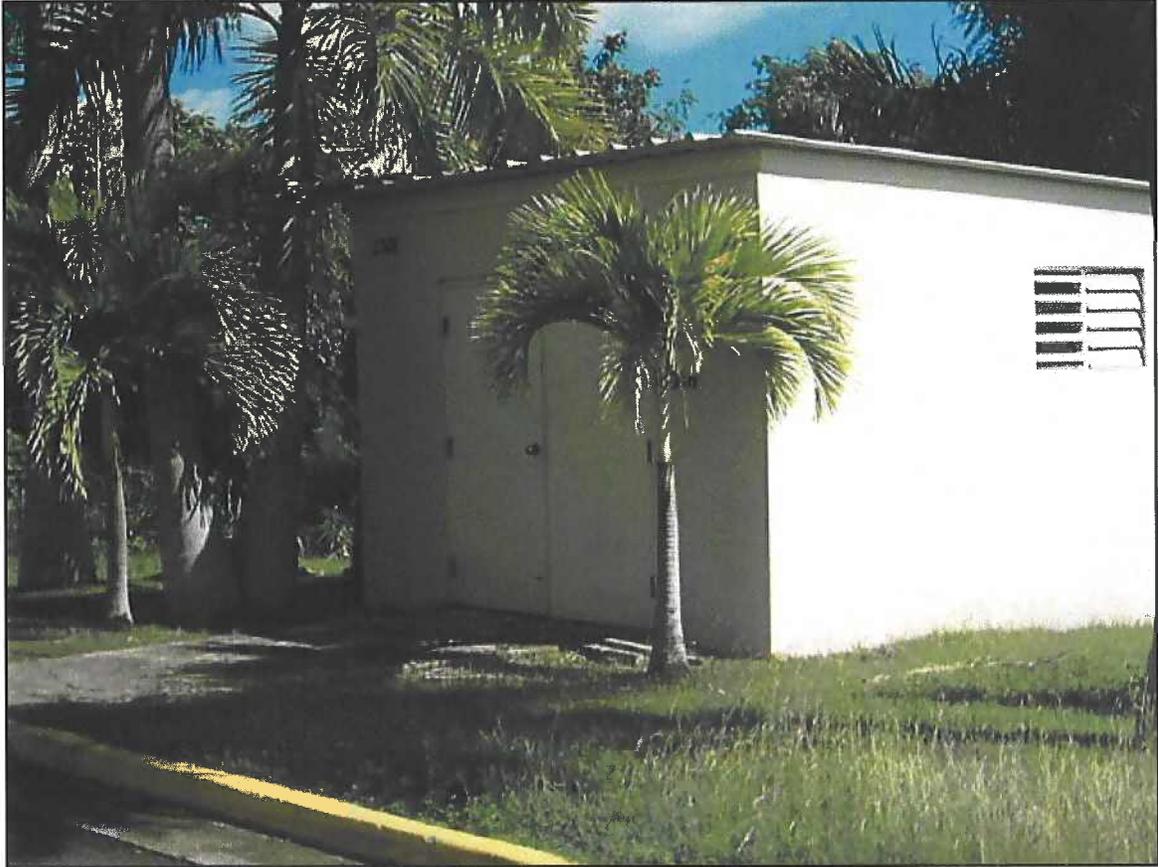
## BUILDING 2318

Building 2318 is identified as “Navy Lodge Storage Shed” and is approximately 160 square feet in size. No suspect materials were identified. Therefore, no sampling was conducted.
