Final  
**Asbestos Inspection Report**  
for

Naval Activity Puerto Rico  
Ceiba, Puerto Rico

Volume 5 of 7

Buildings 2004 through 2339

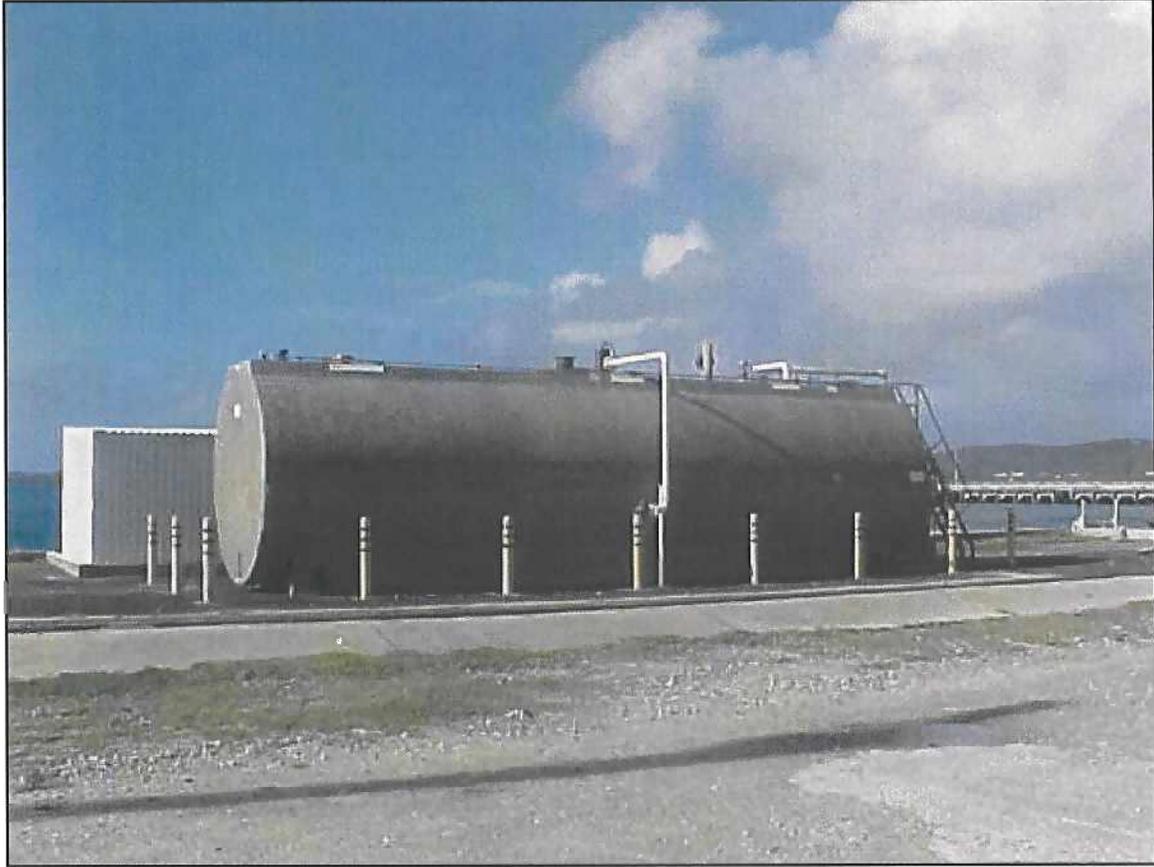
## BUILDING 2330

Building 2330 is identified as “Oil Spill Stge by B2252” and is approximately 2,500 square feet in size. No suspect materials were identified. Therefore, no sampling was conducted.

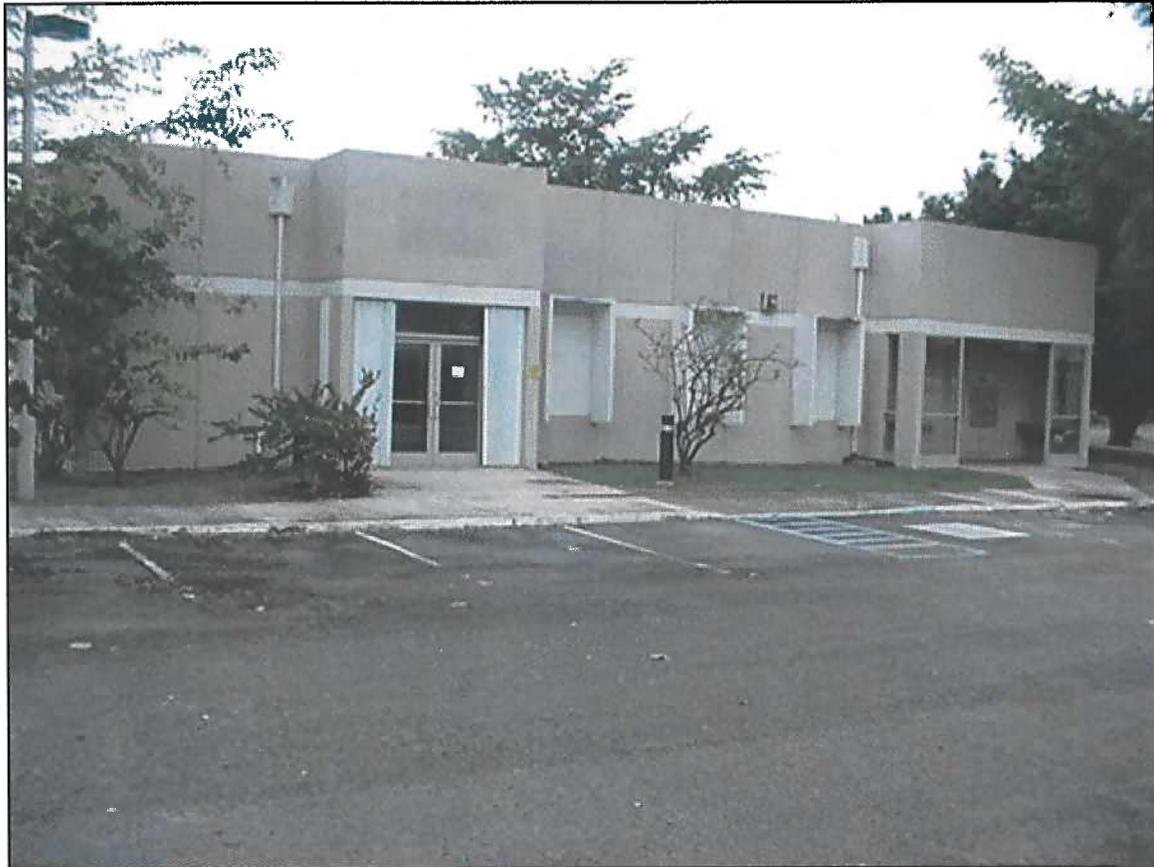
## BUILDING 2336

Building 2336 is identified as “NFCU” and is approximately 2,880 square feet in size. Ten suspect homogeneous materials were identified and sampled. None of the materials were found to be ACM.
