# THE CRANE CORNER

## *Navy Crane Center Technical Bulletin*

40th Edition Web Version - December 2003

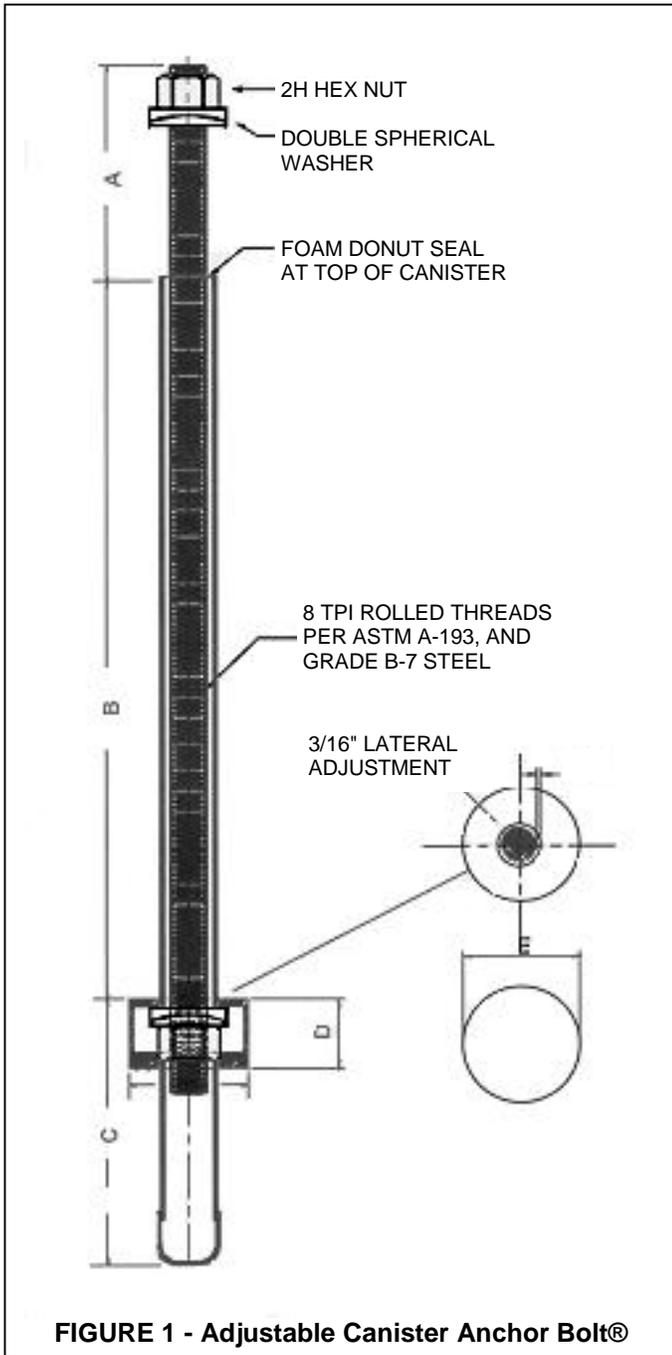
**FIGURE 1 - Adjustable Canister Anchor Bolt®**

The details of this Adjustable Canister Anchor Bolt are depicted in figure 1. This bolt assembly as embedded in the concrete foundation includes a threaded rod inside a plastic tubing with a steel housing near the bottom. The steel housing contains a 2H hex nut and self-aligning double spherical washer. Another 2H hex nut with a self-aligning double spherical washer is used to secure the equipment at the upper (protruding) end. The threaded rod conforms to ASTM A193, grade B steel with a tensile strength of 125 ksi with rolled threads and, according to the manufacturer, the loss of preload from seating or relaxation is greatly reduced since the entire bolt length is free to stretch.

A recently introduced anchor bolt assembly features an engineered design that reportedly compensates for the inherent difficulties of such field installations. The bolt assembly includes an oversized canister and steel housing with a nut and double spherical washer. The canister fit is sufficiently loose to allow 3/16-inch lateral and 2-degree angular adjustment. Additionally, the canister extends below the steel housing so that the bolt can also be adjusted vertically. The vertical adjustability provides the option to temporarily recess the bolt below the surface using a 3/8-inch hex drive and slide the base plate or other component to its mounting position.
