ENVIRONMENTAL BUILDING SURVEY AND SUBSURFACE SOIL INVESTIGATION
BUILDING 220 NS GREAT LAKES IL
2/23/2005
ENVIRONMENTAL DESIGN INTERNATIONAL INC

ENVIRONMENTAL BUILDING SURVEY AND SUBSURFACE SOIL INVESTIGATION

Great Lakes Naval Training Center
Building 220
Great Lakes, Illinois

Project # 421.022

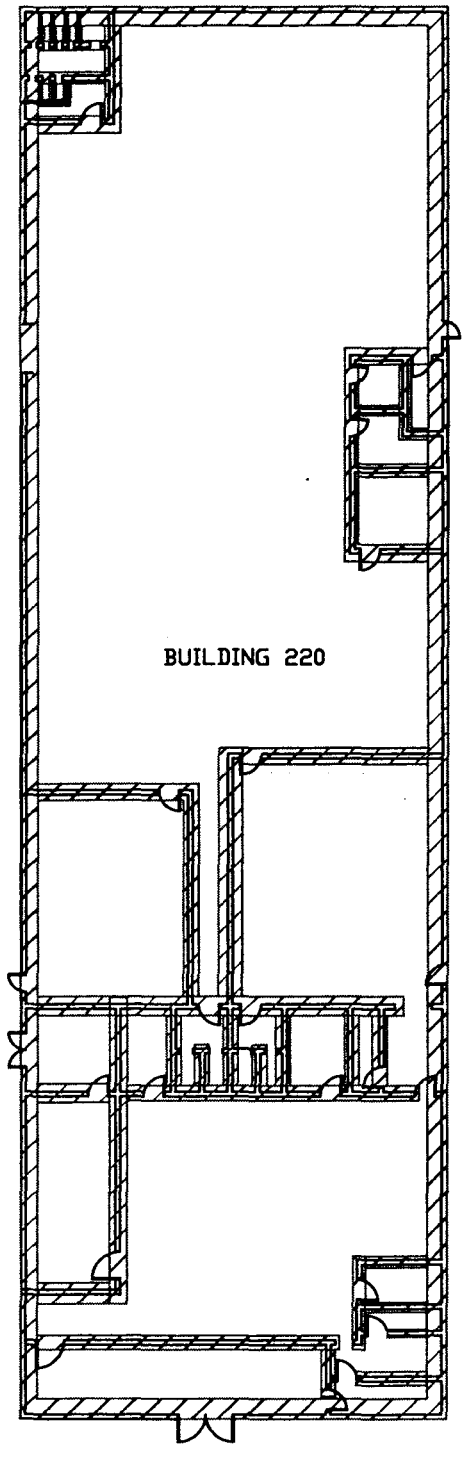
An estimated 40,000 square feet (SF) of transite wallboard was observed throughout the building's interior. An estimated 30,000 SF of transite panels were observed on the exterior of the building. Thermal pipe insulation was observed in the safe room, upper room and north pipe room (a total of 7,500 LF). Approximately 850 hard fittings were observed throughout the building. A small area of 1' x 1' ceiling tile above the drop ceiling in the back office was observed. All ACM was observed to be in good condition.

Title: INTERIOR TRANSITE PANELS	Issued: 2/07/05	Drawn by: S.V.	Figure: 1
Site: GREAT LAKES NAVAL CENTER: BUILDING 220	Revised:	EDI proj. no. 421.022.02	Scale: Not to scale
Client: TENG & ASSOCIATES

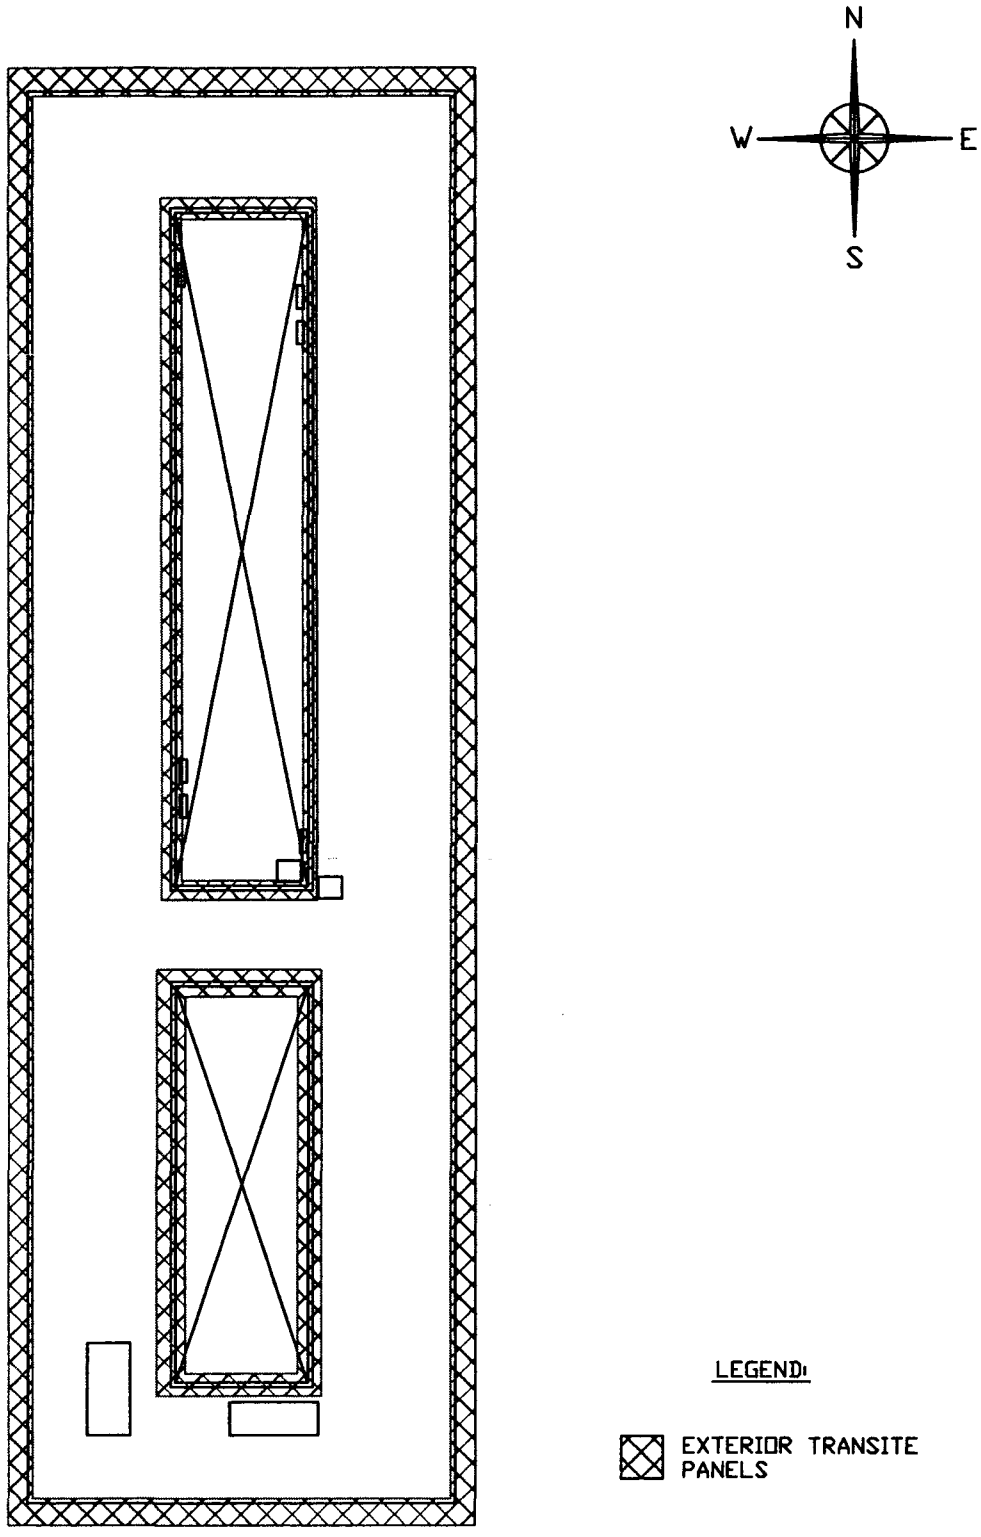
Title:	LOCATION OF EXTERIOR ASBESTOS MATERIALS	Issued: 2/07/05	Drawn by: S.V.	Figure: 2
Site:	GREAT LAKES NAVAL CENTER: BUILDING 220	Revised:	EDI proj. no. 421.022.02	Scale: Not to scale
Client:	TENG & ASSOCIATES

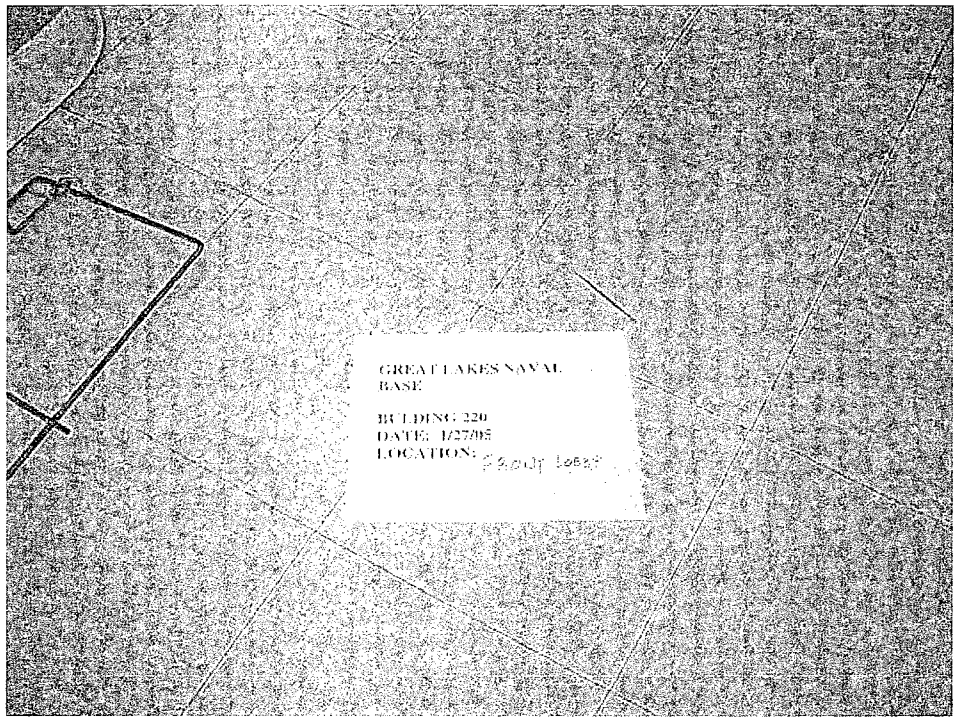
FRONT LOBBY
12"X12" FLOOR TILE
AND MASTIC

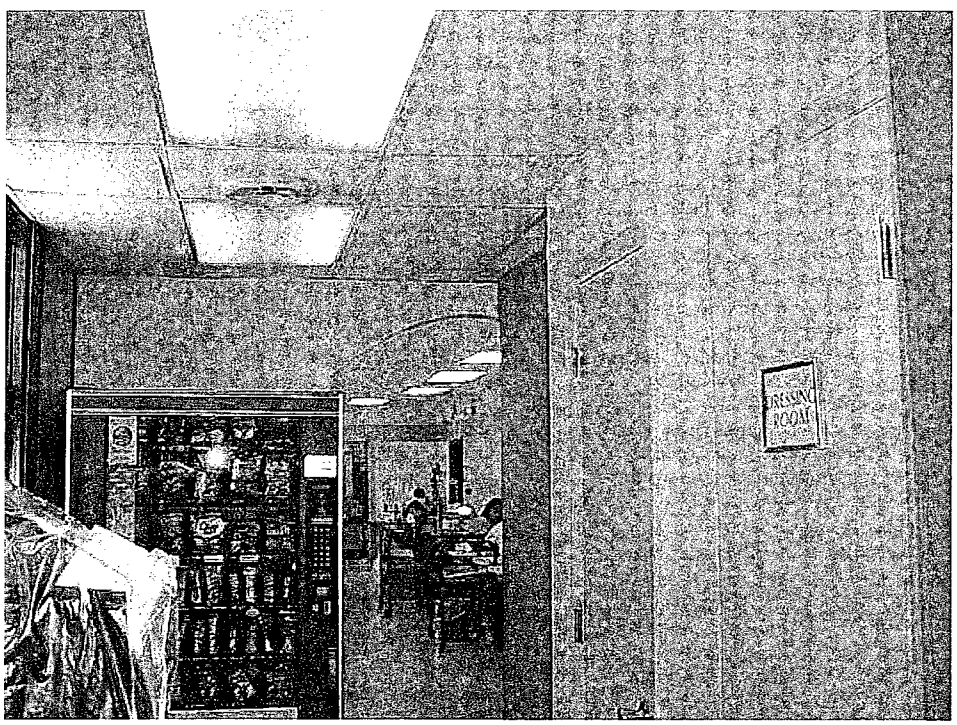
SEWING ROOM
Drywall
2 x 4 Ceiling Tile

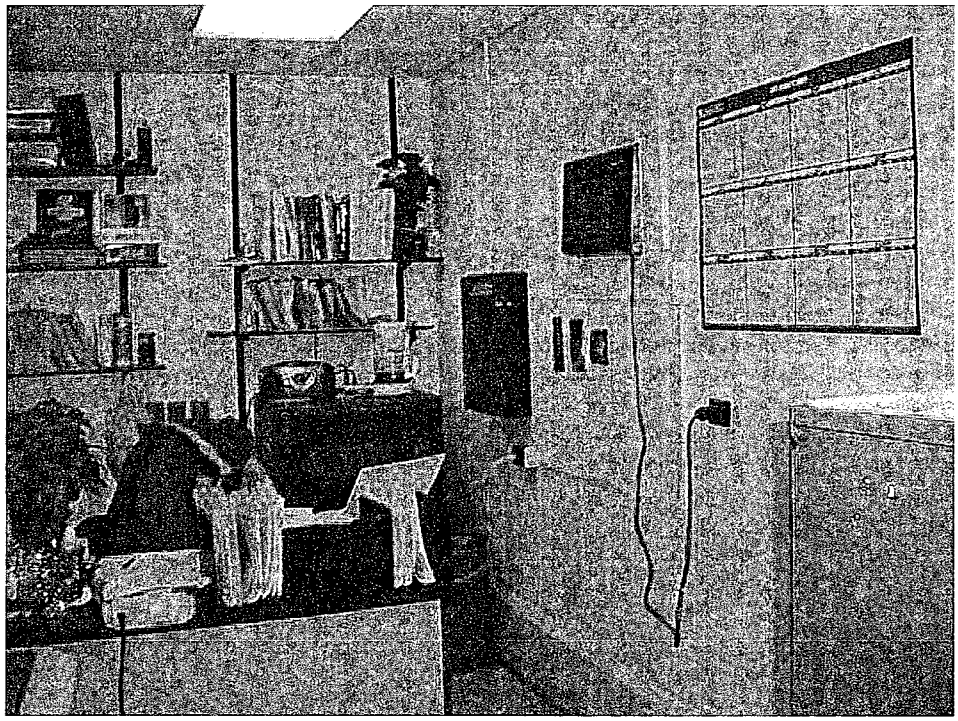
BACK OFFICE
Dry Wall

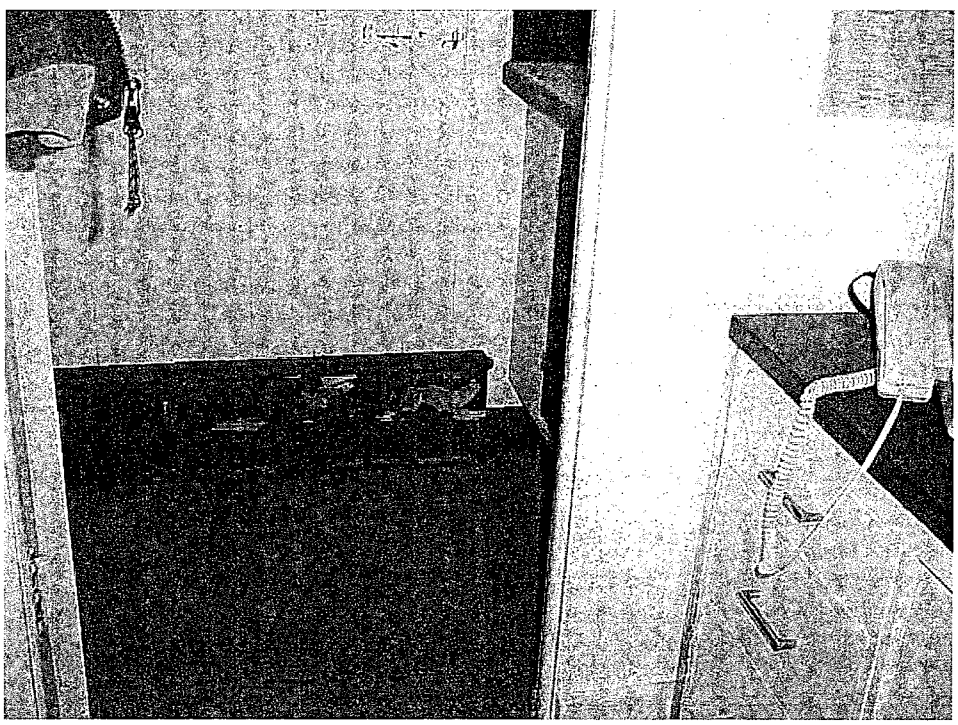
BACK OFFICE
REST ROOM
Brown Carpet and Mastic

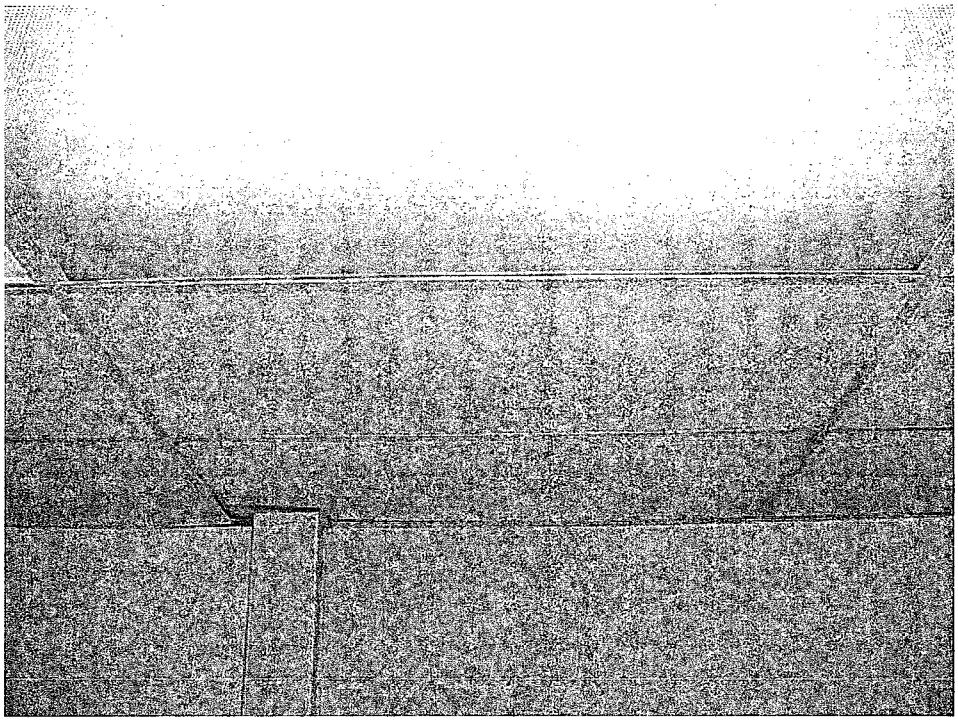
SUSPENDED CEILING
ABOVE OFFICE
AREAS

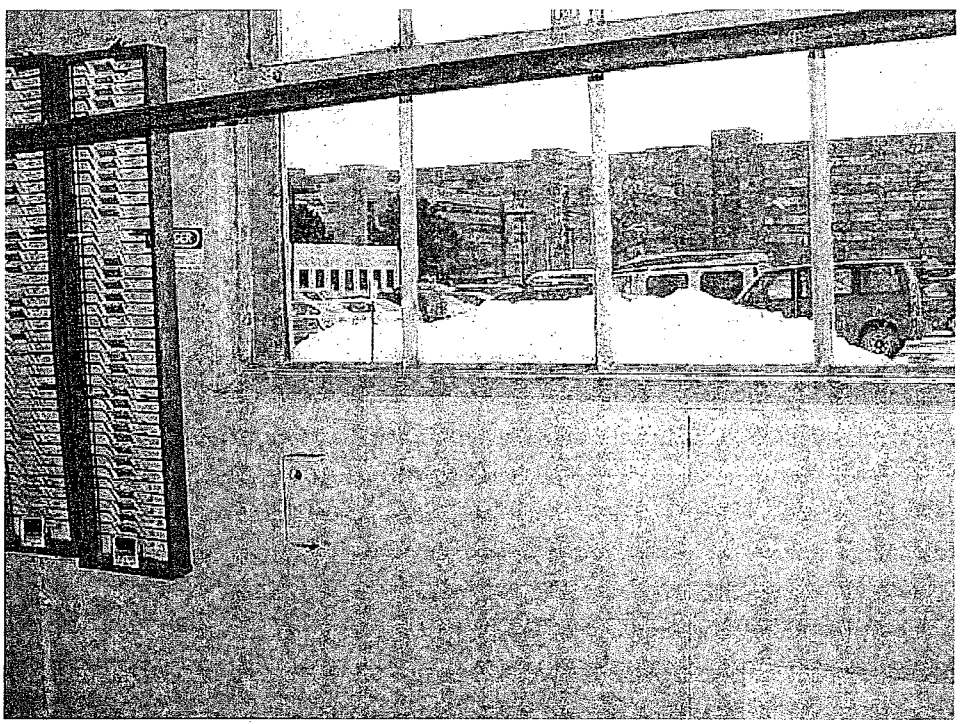
TRANSITE LINED
WALLS (THROUGHOUT)

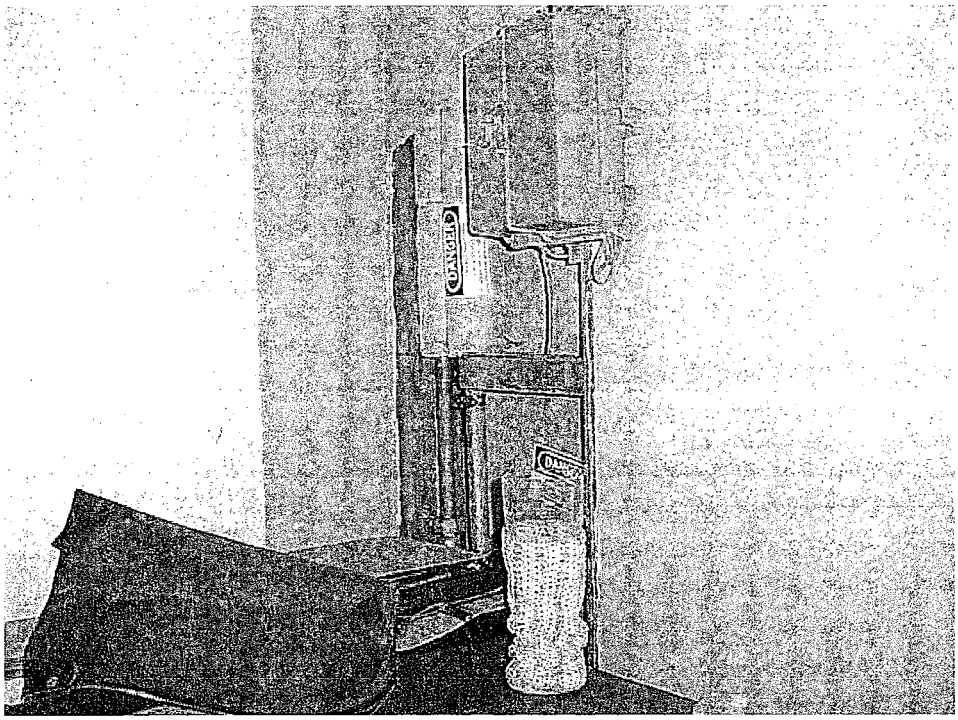
SAFE ROOM - TYPICAL WALL SECTION

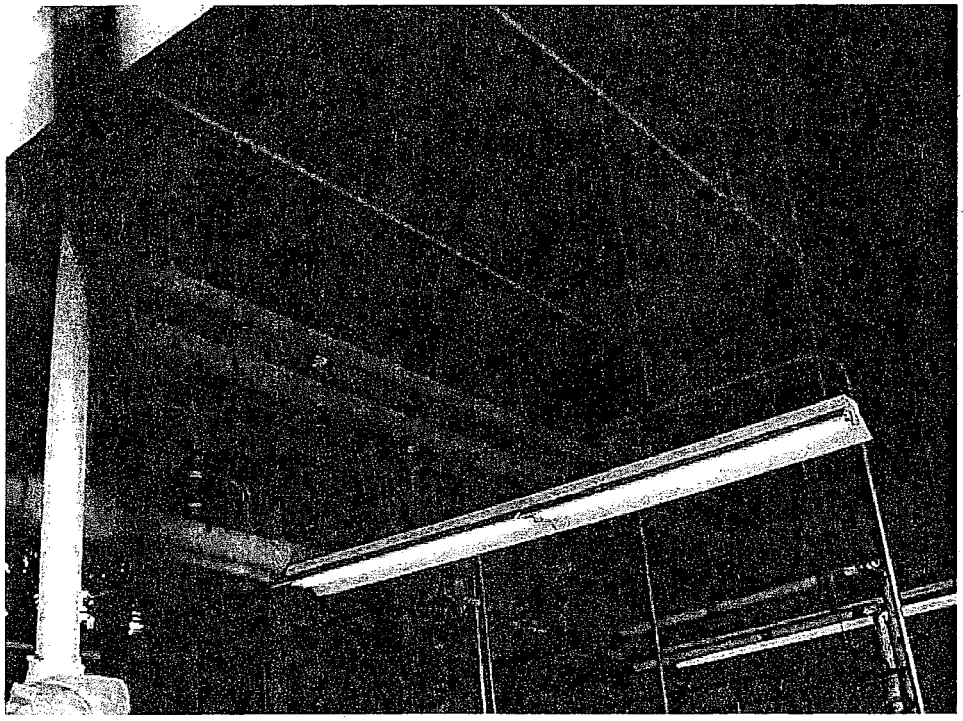
WAREHOUSE AREA WITH ACM INSULATED PIPES ABOVE

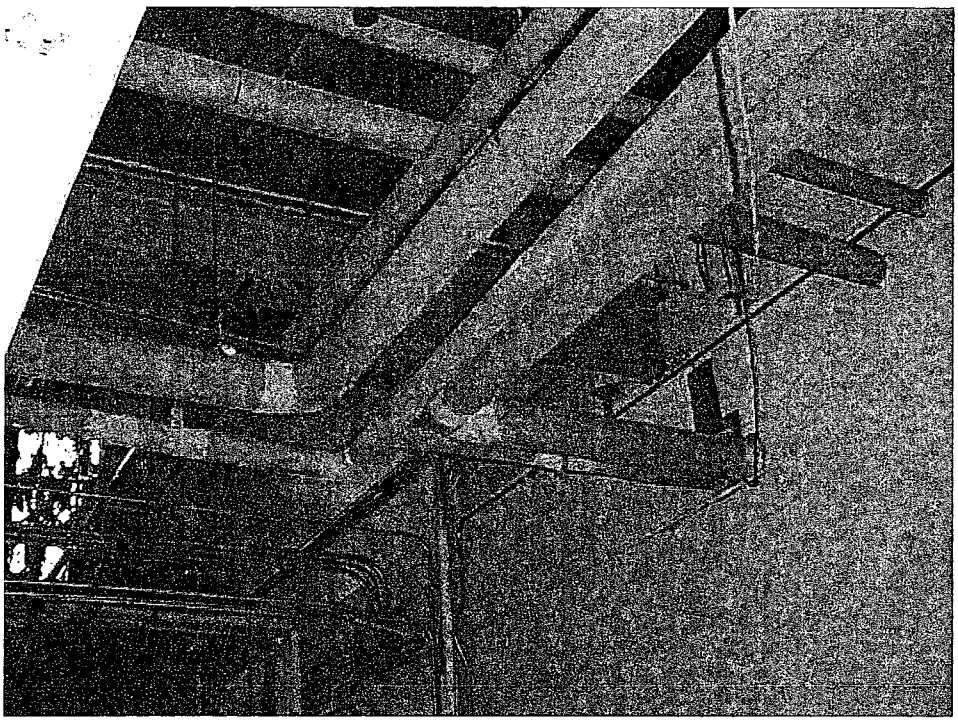
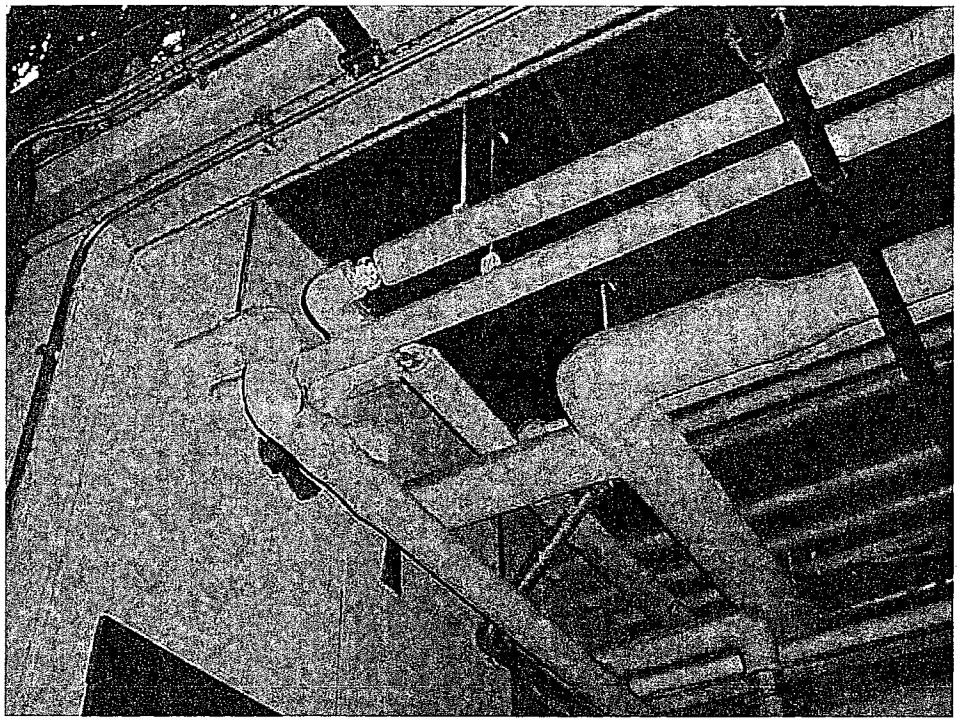
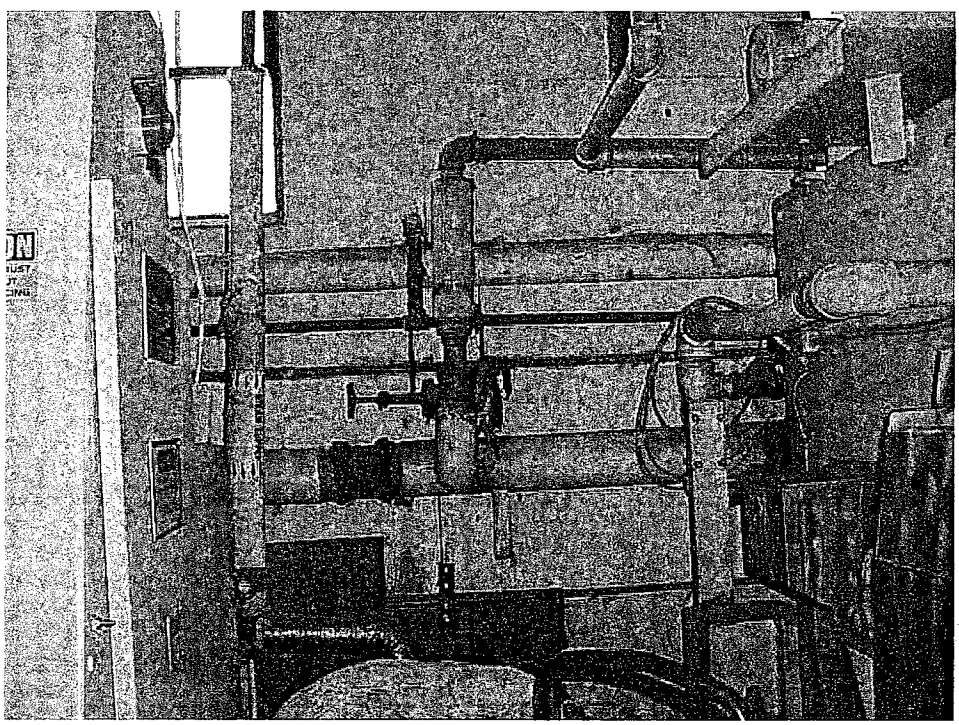
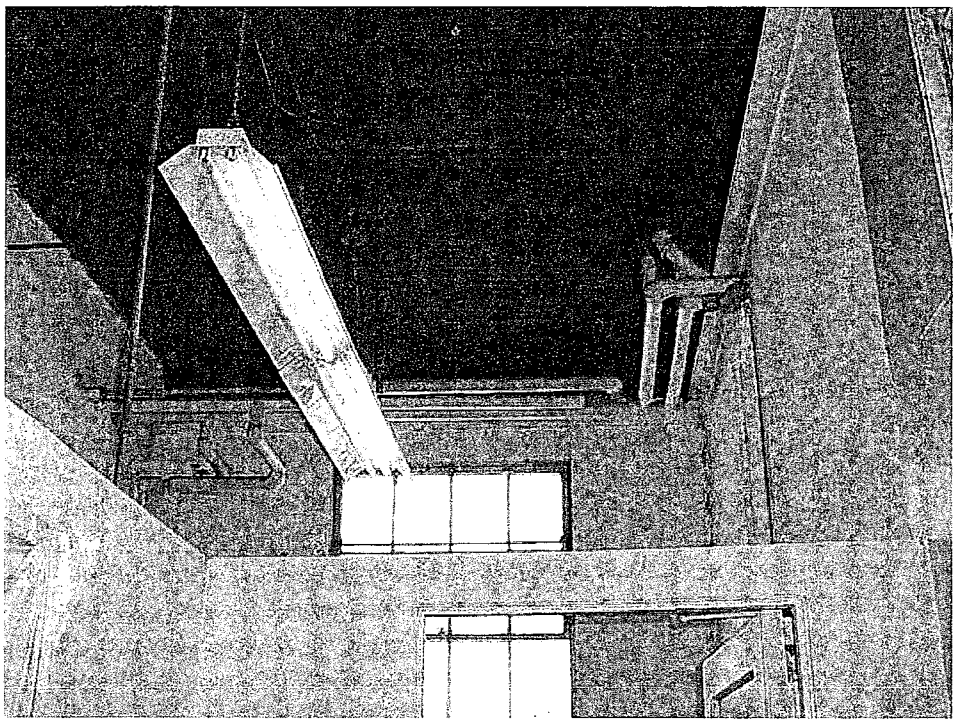
WAREHOUSE PIPING

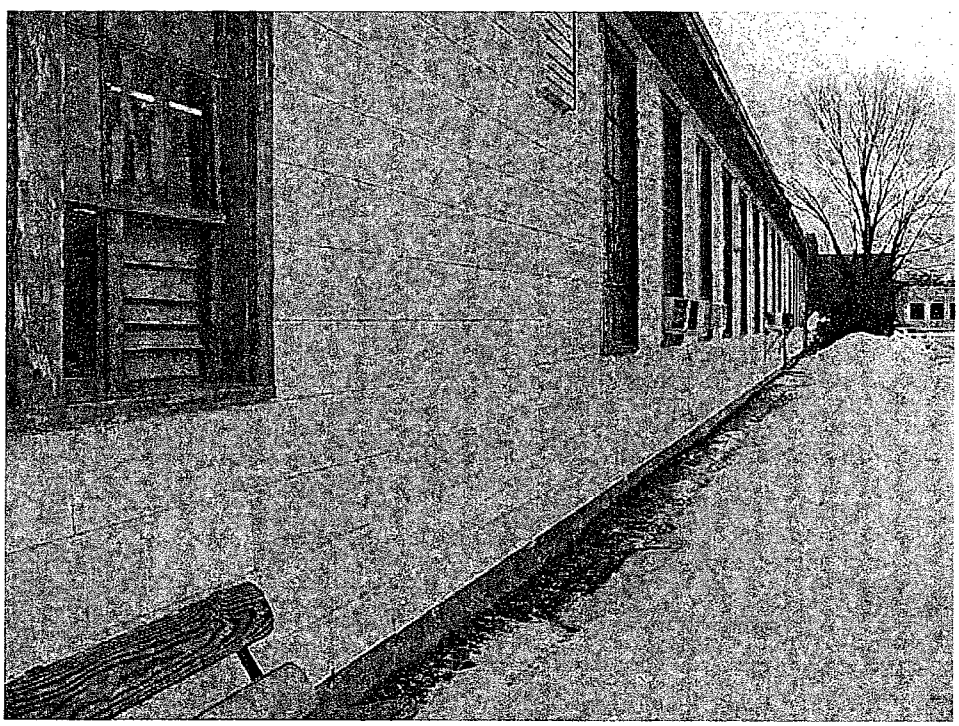
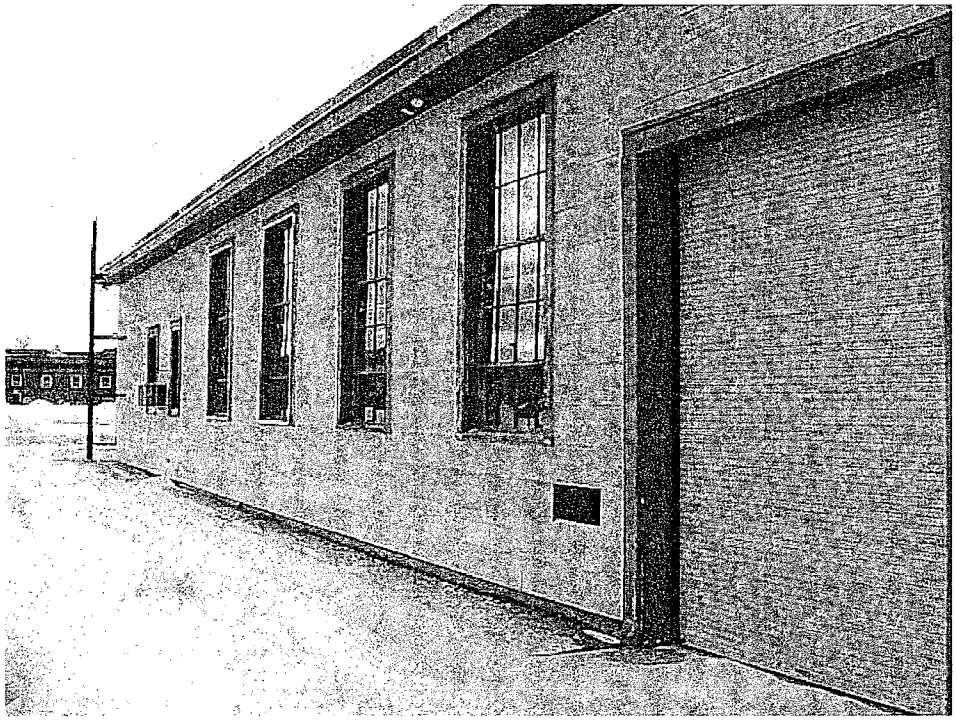
EXTERIOR TRANSITE

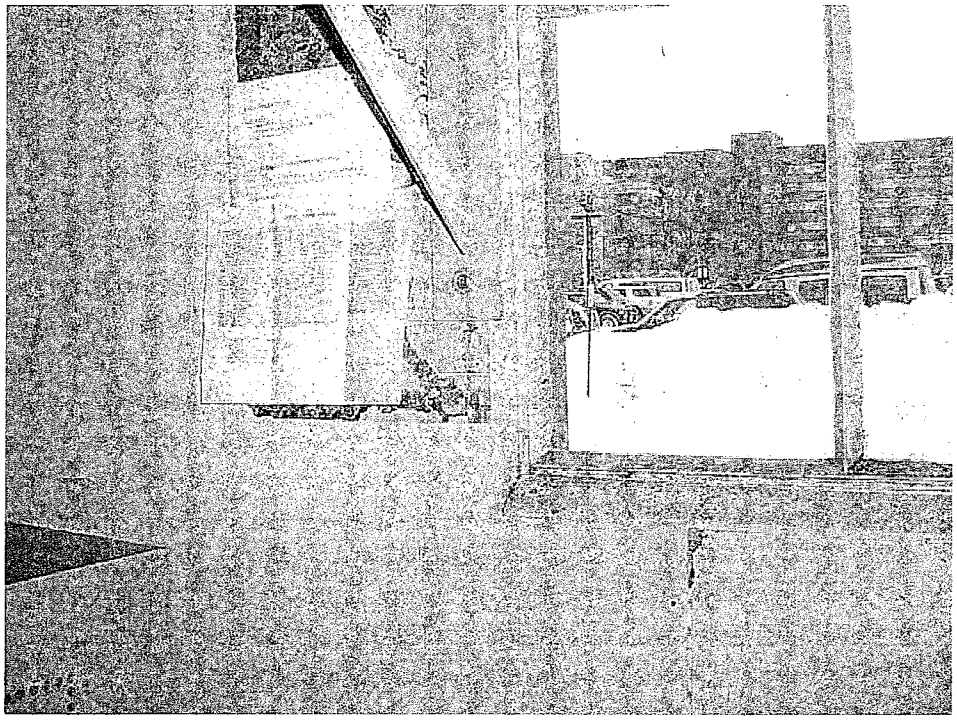
INTERIOR TRANSITE

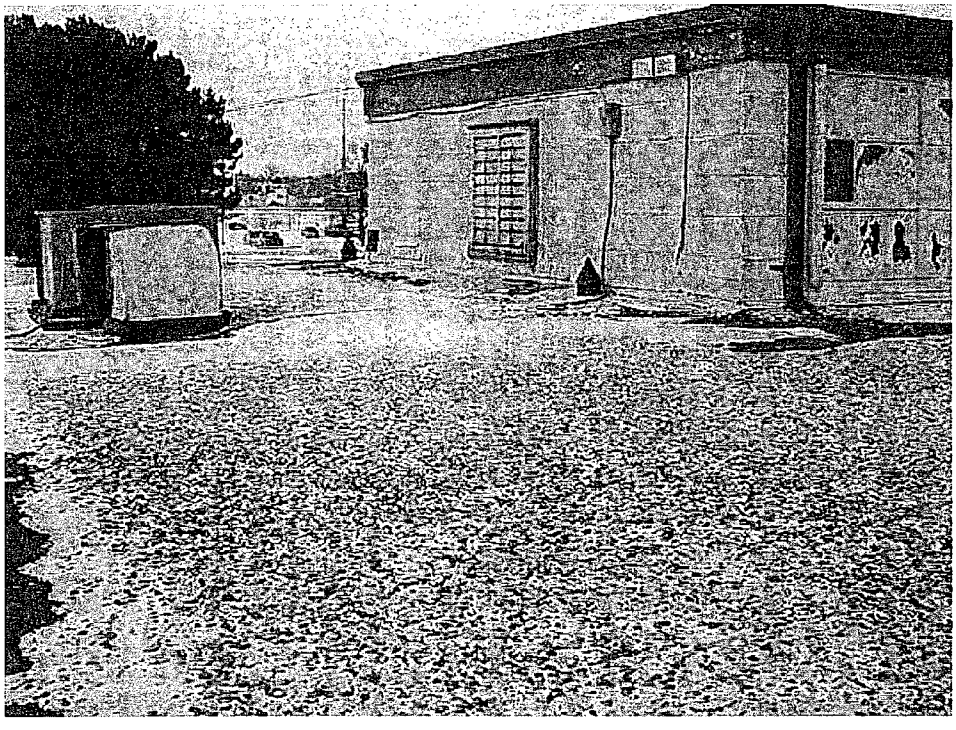
EXTERIOR TRANSITE AND ROOFING MATERIALS

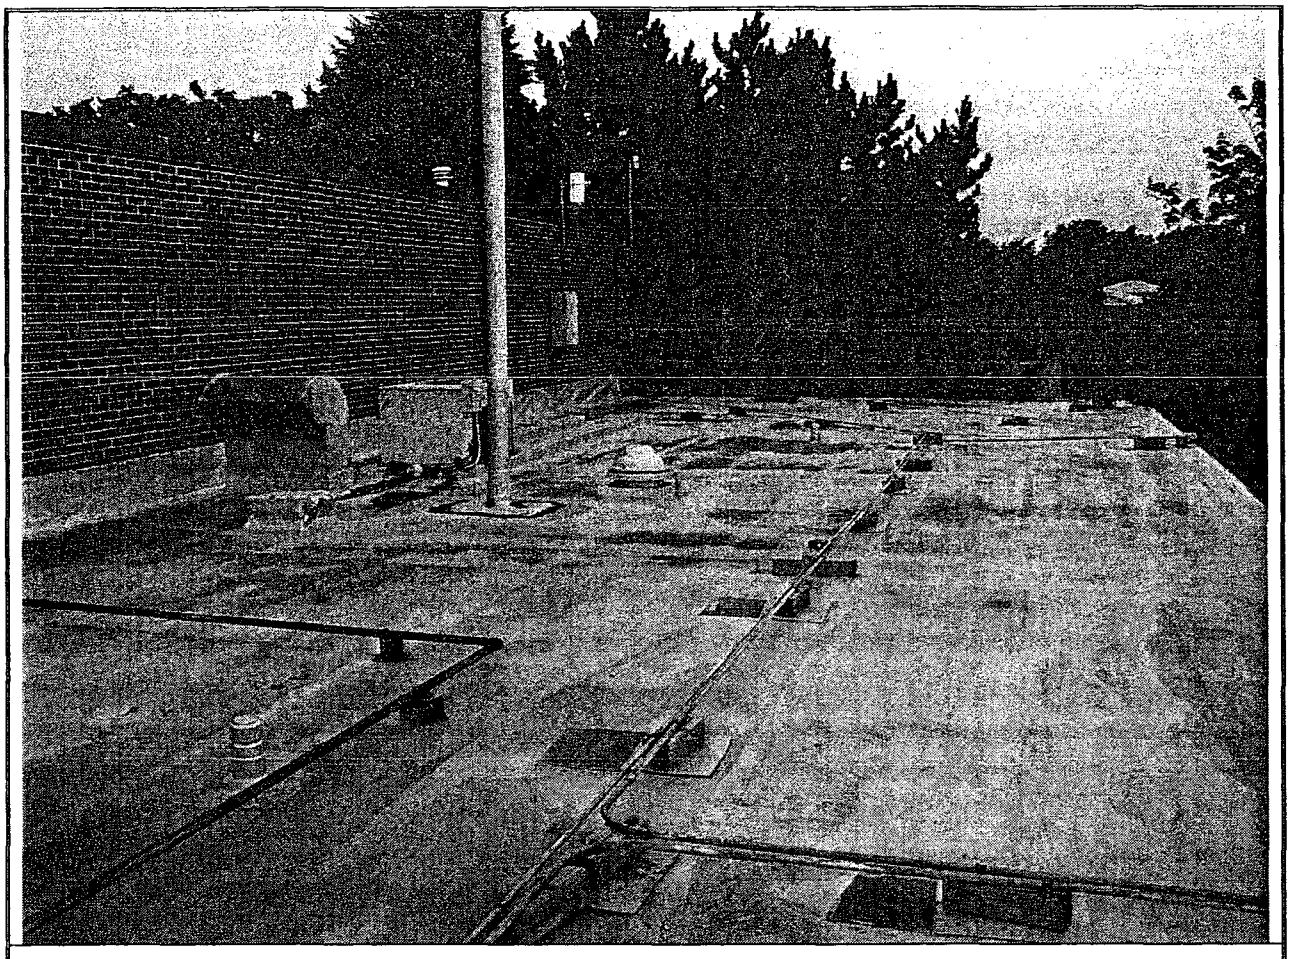
Right Section/East Elevation of the Roof

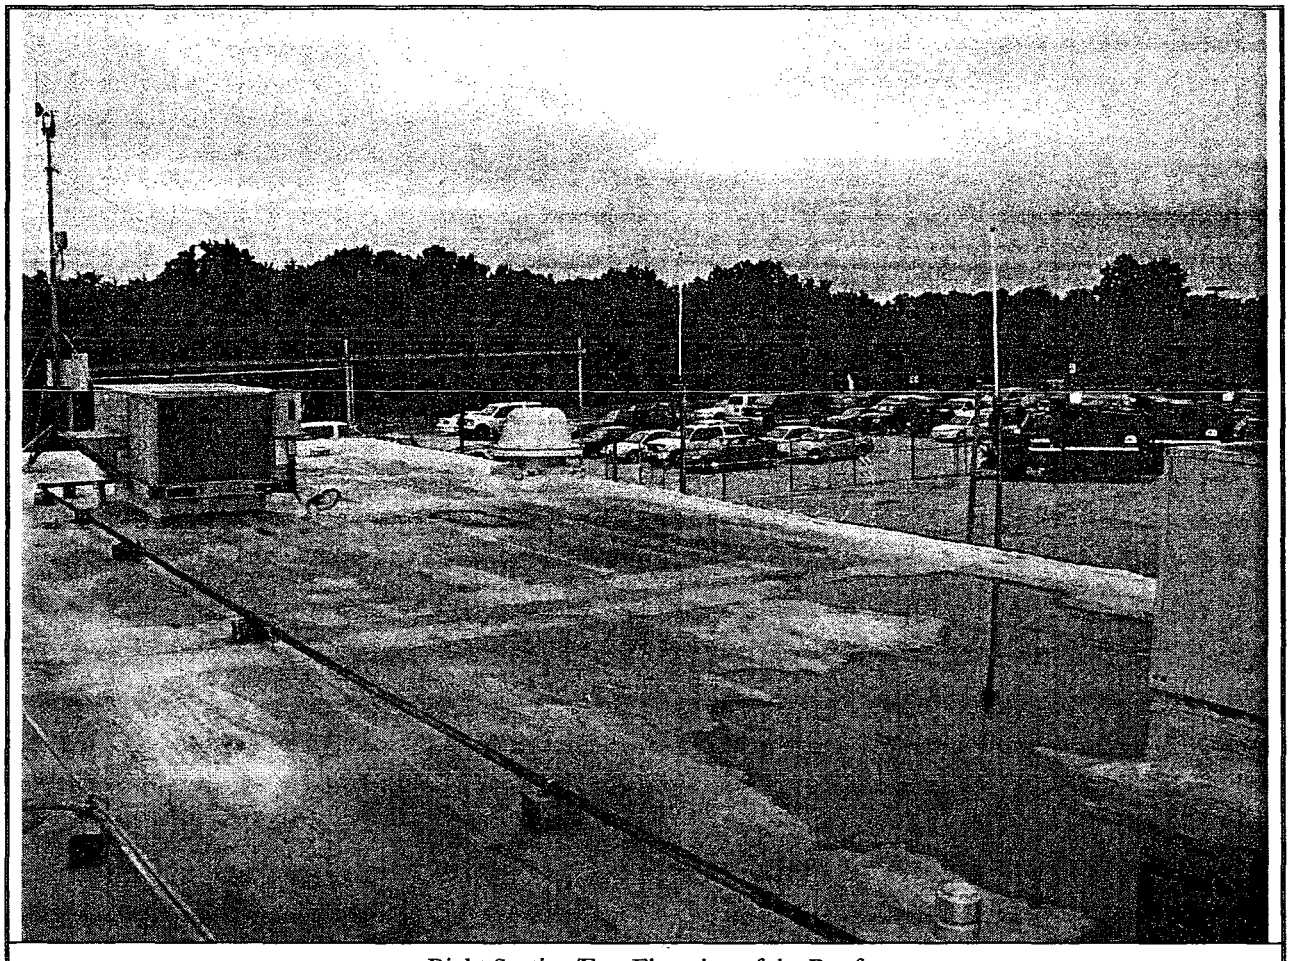
Right Section/East Elevation of the Roof

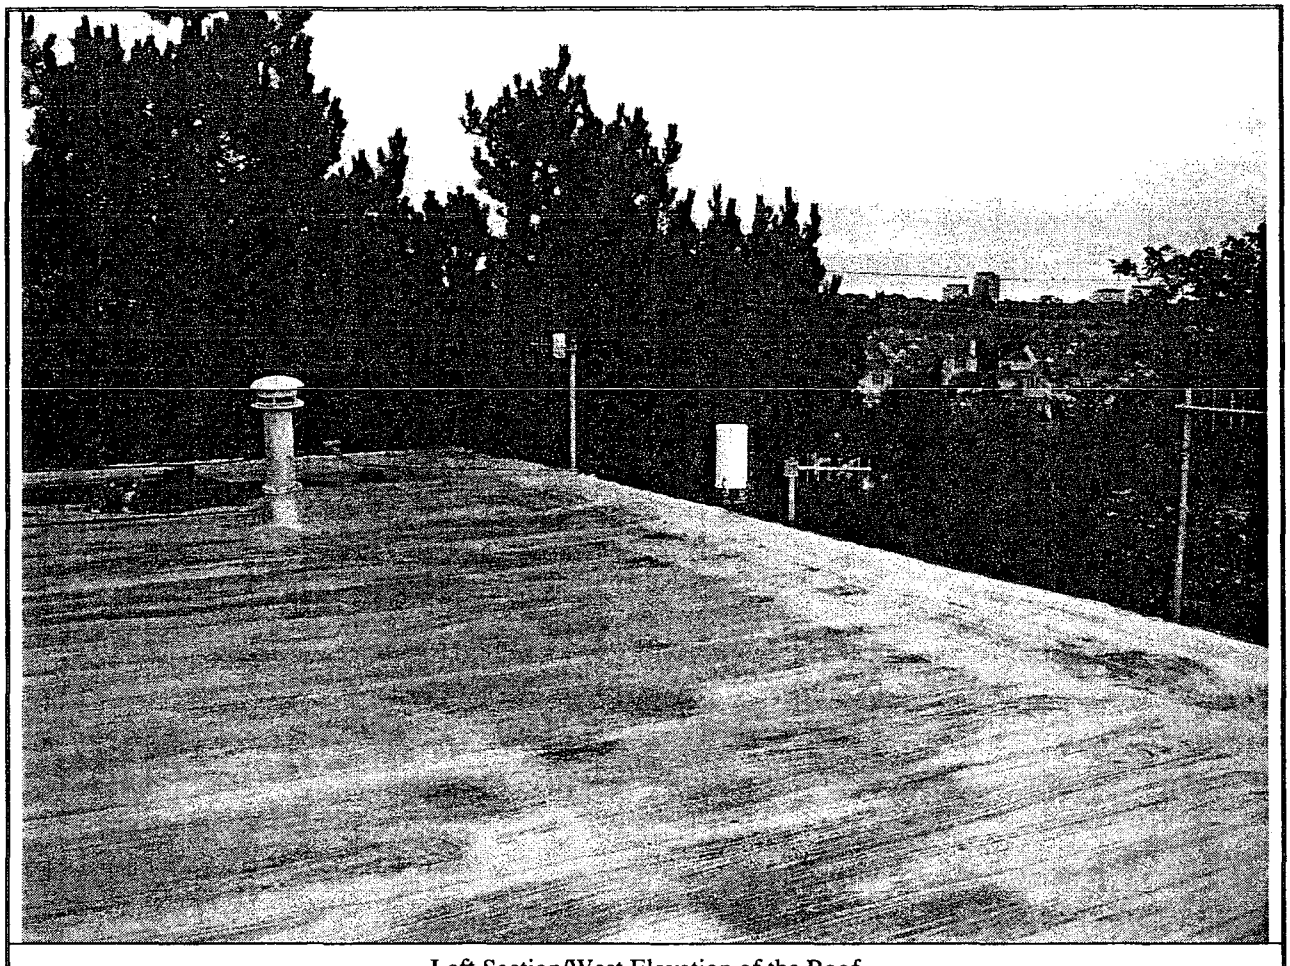
Left Section/West Elevation of the Roof

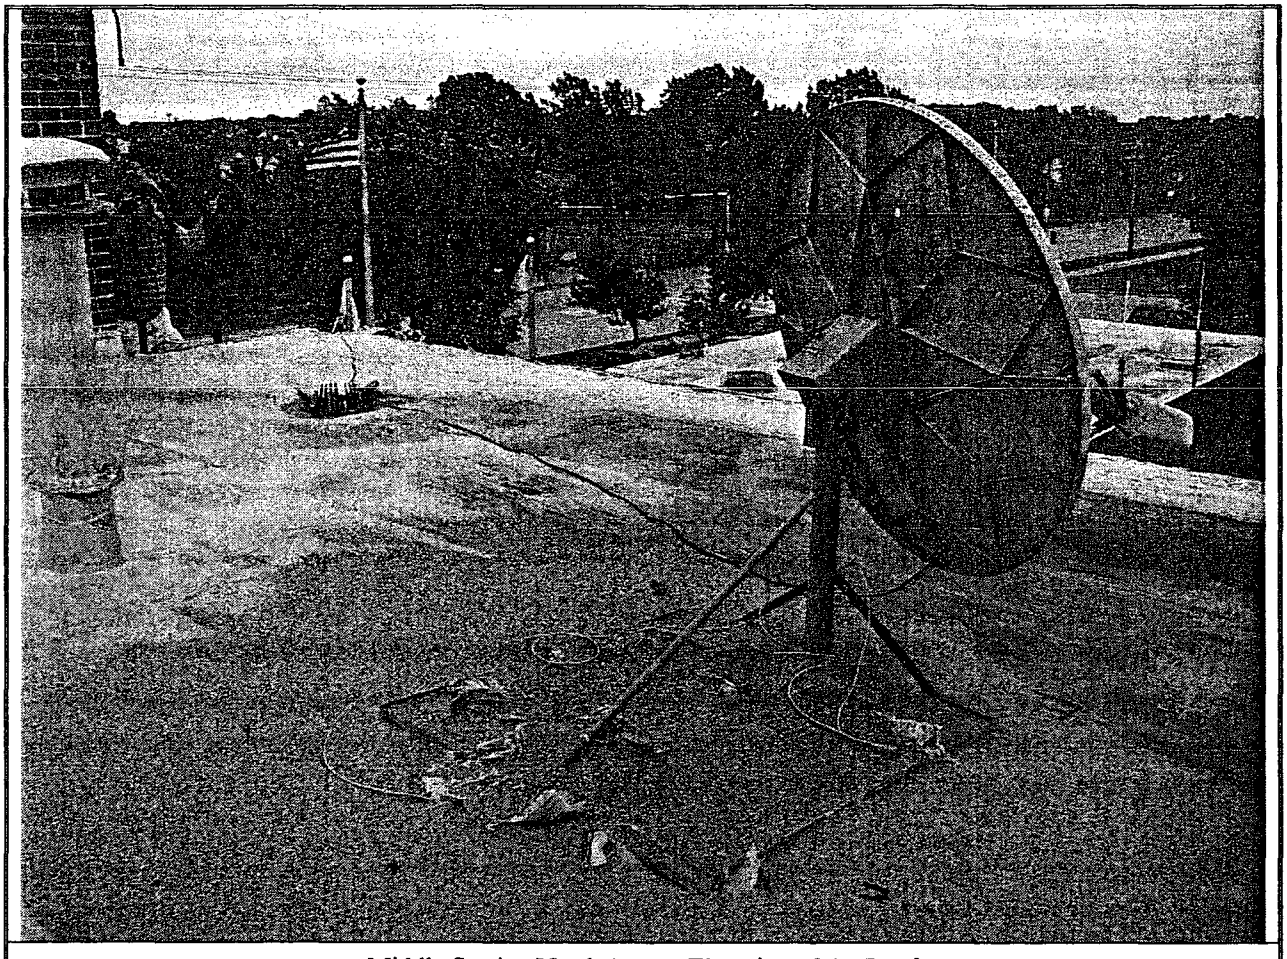
Middle Section/North (centertElevation of the Roof

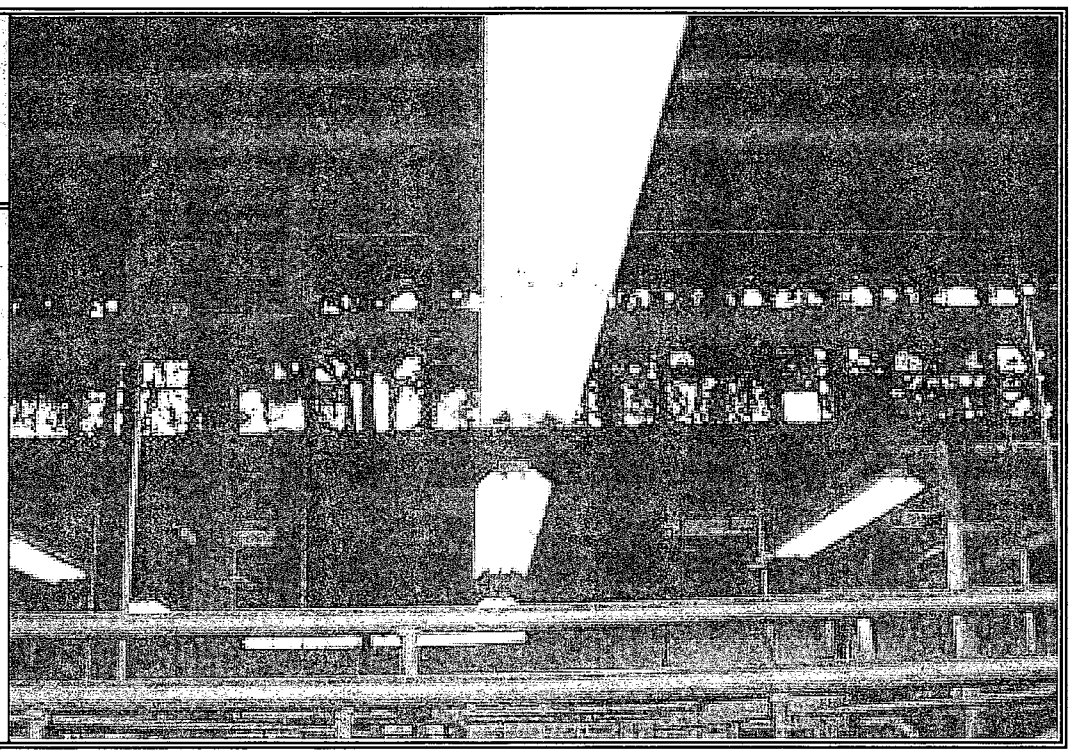
PHOTO #1

Older electrical equipment including some ballasts have contained PCBs. The Toxic Substance Control Act of 1987 includes PCBs as a toxic substance. Regulations 40 CFR Part 761 is the PCBs spill cleanup policy for spills, leaks, or uncontrolled releases, such that could occur during demolition activities.

View of fluorescent light ballasts observed throughout Building 220

Various chemicals were observed on the subject property. Since demolition activities are planned for the property, the hazardous materials described in this section should be properly packaged, transported, and disposed of in accordance with regulatory compliance.

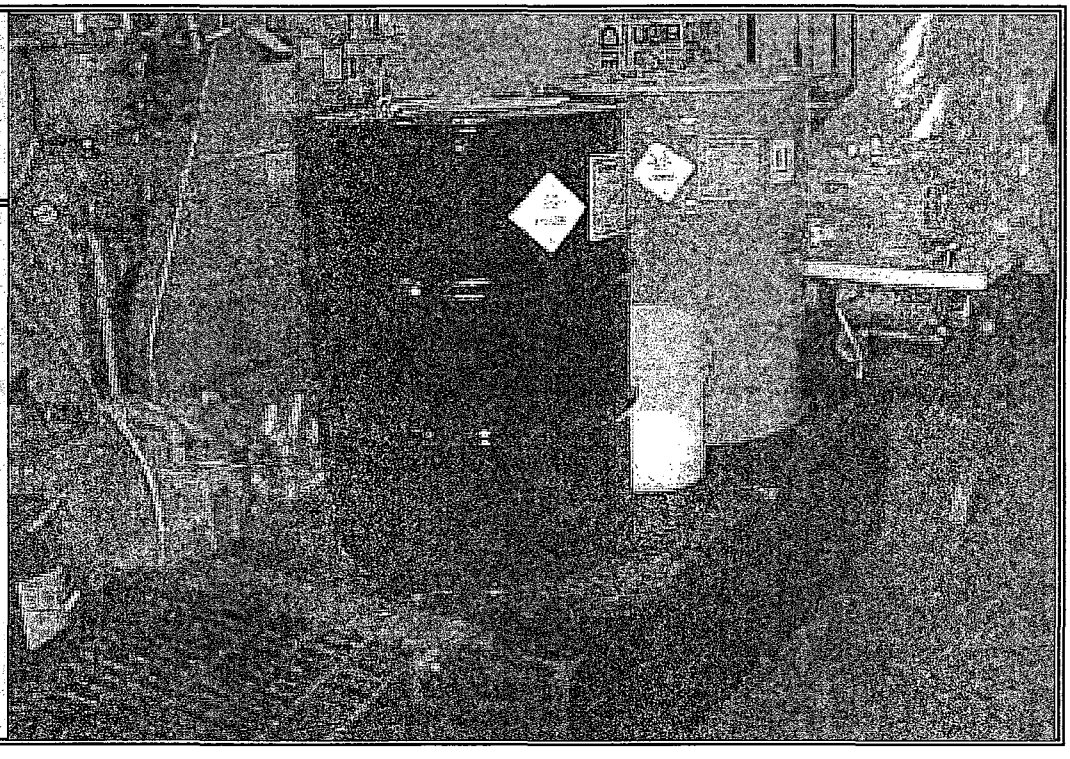
PHOTO #3

View of two 55-gallon steel drums of waste tetrachloroethylene (PERC) observed with secondary containment

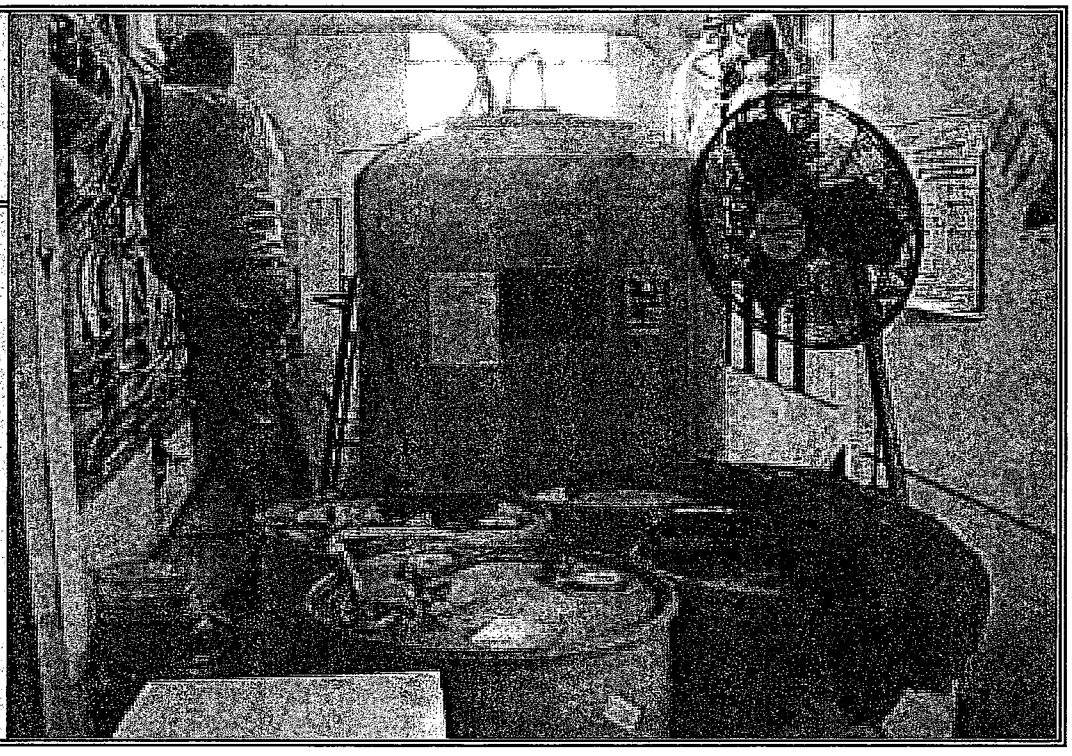
PHOTO #5

View of 55-gallon drums of Oxy-Plus (hydrogen peroxide) and 300-gallon plastic AST

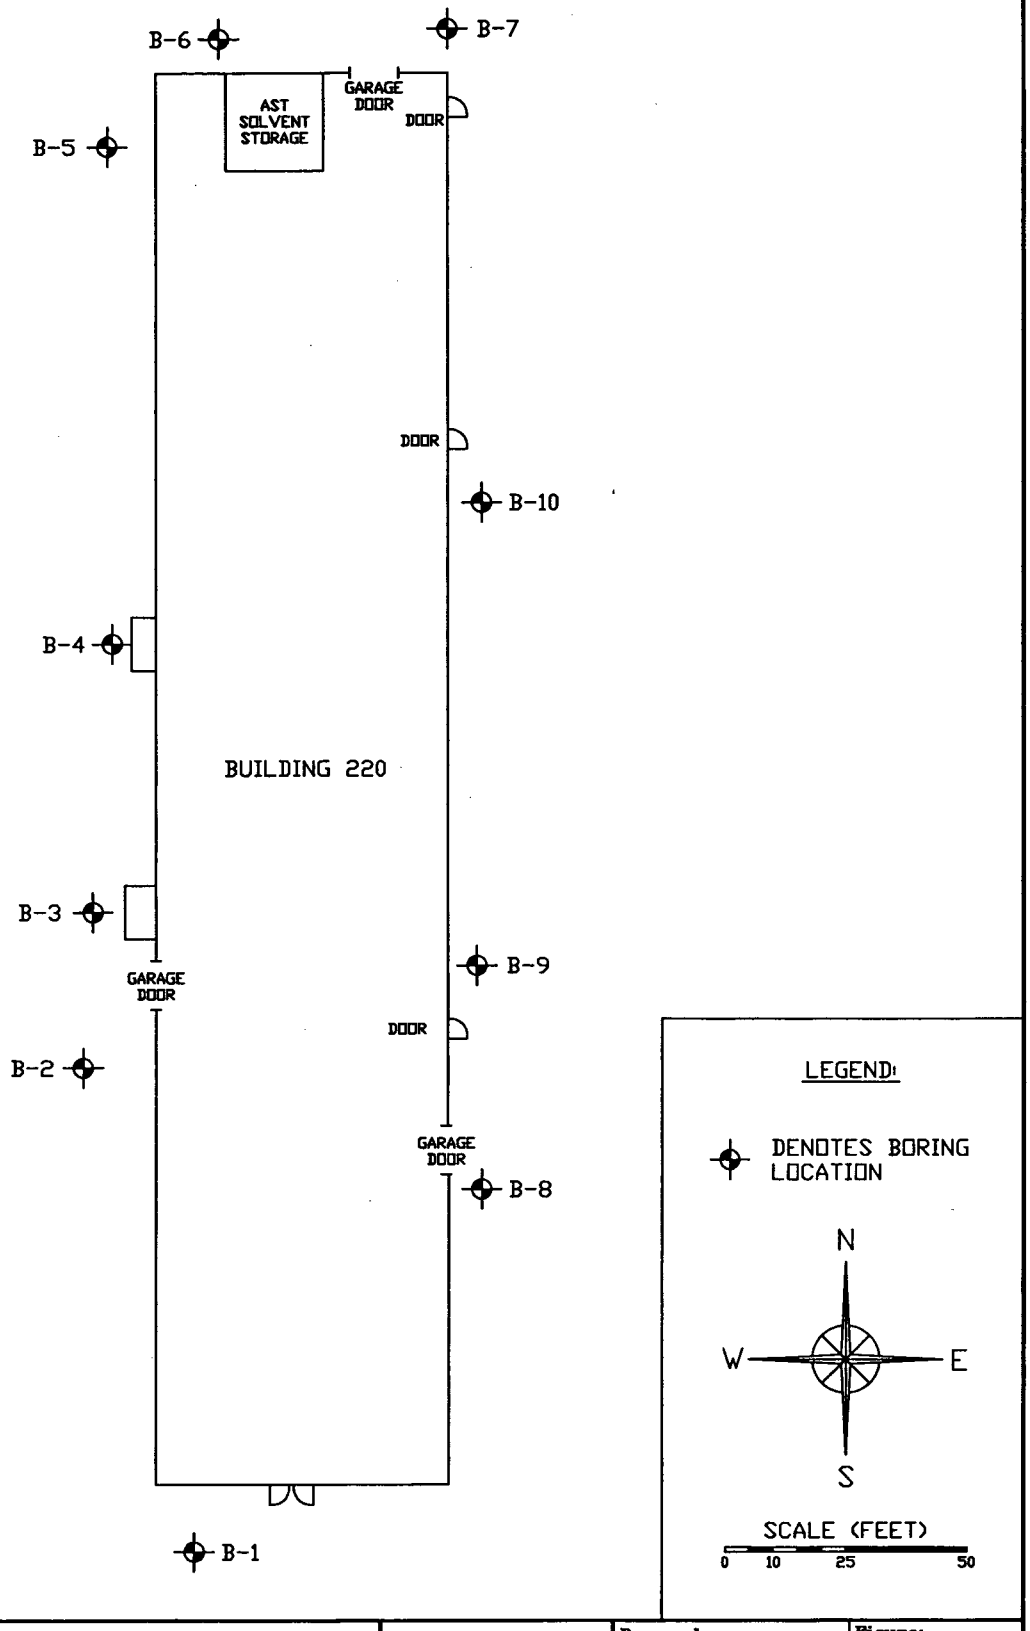
Soil samples were collected from a total of ten soil borings advanced to a maximum depth of 12 feet (ft) below ground surface (bgs). Soil boring locations are presented in Appendix D.1. Generally, soil samples were collected at shallow depths to investigate spills and near surface impacts. Deeper samples were analyzed to investigate contaminant migration and vertical extent of contamination on the subject property. Generally, PID readings were 0.0 ppm for each interval. Moist soils were observed at varying depths. This is believed to be in part due to recent snowmelt infiltrating the subsurface. The following is a description of soil boring locations and characteristics. Soil boring logs with complete descriptions are presented in Appendix D.4.

Title:	SITE MAP SHOWING BORING LOCATIONS	Issued: 2/07/05	Drawn by: BH	Figure: D.1
Site:	GREAT LAKES NAVAL CENTER: BUILDING 220	Revised:	EDI proj. no. 421.022.03	Scale: See Above
Client:	TENG & ASSOCIATES
