# THE CRANE CORNER

## *Navy Crane Center Technical Bulletin*

47th Edition Web Version - September 2005

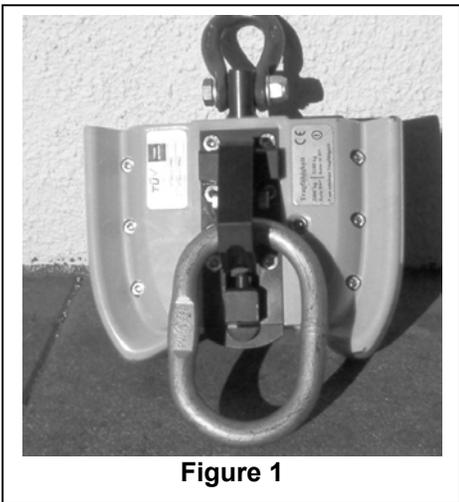
Figure 1

A remotely operated device allows release of the load from a safe distance. The device is comprised of a hydraulic lock and a battery powered control unit. It is operated by a battery powered radio remote control with a range of 300 feet on a frequency of 458.800 to 459.175 MHz. The device is suspended from the crane (hoist) hook and is designed to engage/release a ring (master link) of a sling assembly. The device is shown in figure 1 and the operator's remote control in figure 2.

The hydraulic lock includes features that prevent inadvertent/unintentional release of the load. To release the hydraulic lock - the ring must be unloaded (load set down), the safety button depressed, and then the release button depressed - all in

that sequence. A manual bypass for release is provided as a back-up in case of remote release malfunction. The device is rated at 6,900 pounds, with a design factor of 4.0.

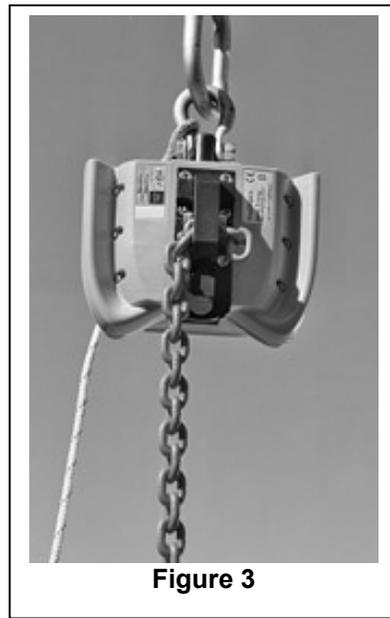
Figure 3

There are two other versions of this device offered - both rated at 4,400 pounds. One (shown in figure 3) is designed to engage a link of a chain sling, but otherwise its operation is identical to the ring type. The other device is intended for underwater operation. It does not include the remote controls, but releases the load (either ring or chain) by setting it down.
