ENVIRONMENTAL BUILDING SURVEY AND SUBSURFACE SOIL INVESTIGATION
BUILDING 220 NS GREAT LAKES IL
2/23/2005
ENVIRONMENTAL DESIGN INTERNATIONAL INC

ENVIRONMENTAL BUILDING SURVEY AND SUBSURFACE SOIL INVESTIGATION

Great Lakes Naval Training Center
Building 220
Great Lakes, Illinois

Project # 421.022

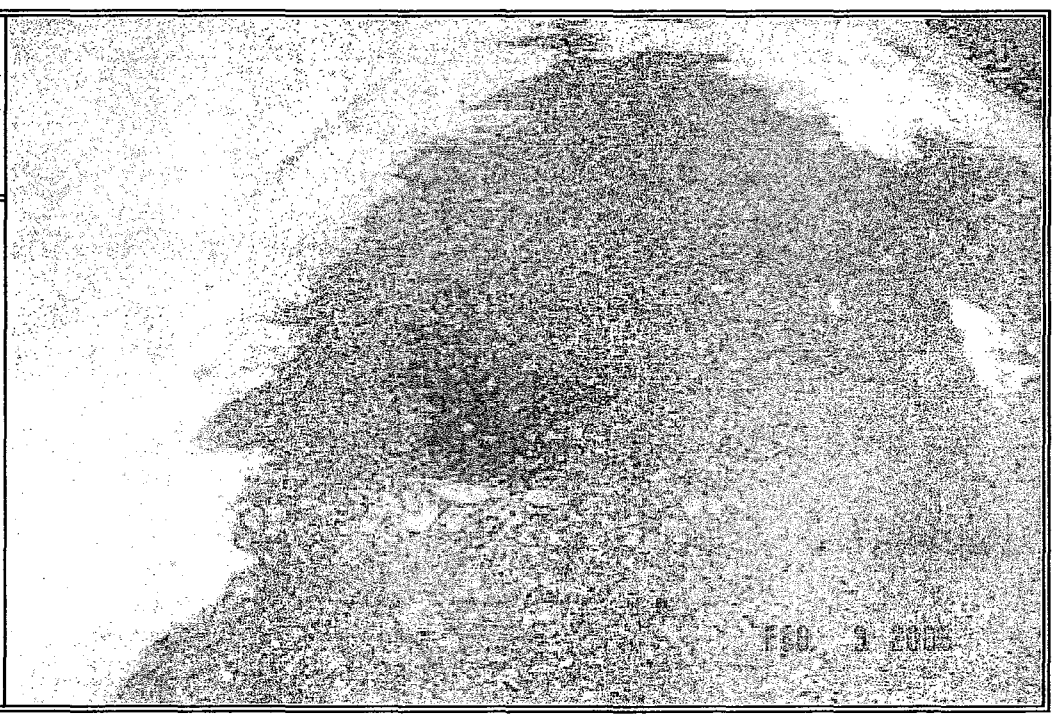
Soil boring B-6 was advanced 7 ft north of Building 220 and 13 ft east of the west wall. The soil boring was advanced near a stained gravel area on the north side of the building just west of a garage door. The subsurface generally consisted of sand and gravel from 0 to 2 feet followed by clayey silts and silts to a termination depth of 12 ft bgs. Moist soils were observed throughout the boring. Saturated soils were observed from 8 to 10 ft bgs. The soil samples chosen for analysis were collected at 3 and 8 ft bgs.

Proj: 421.022.03 Date: 2/4/05 Photographed By: Hilary Janousek Description: View of stained gravel near the garage door located on the north side of Building 220 (near soil boring B-6) PHOTO #2

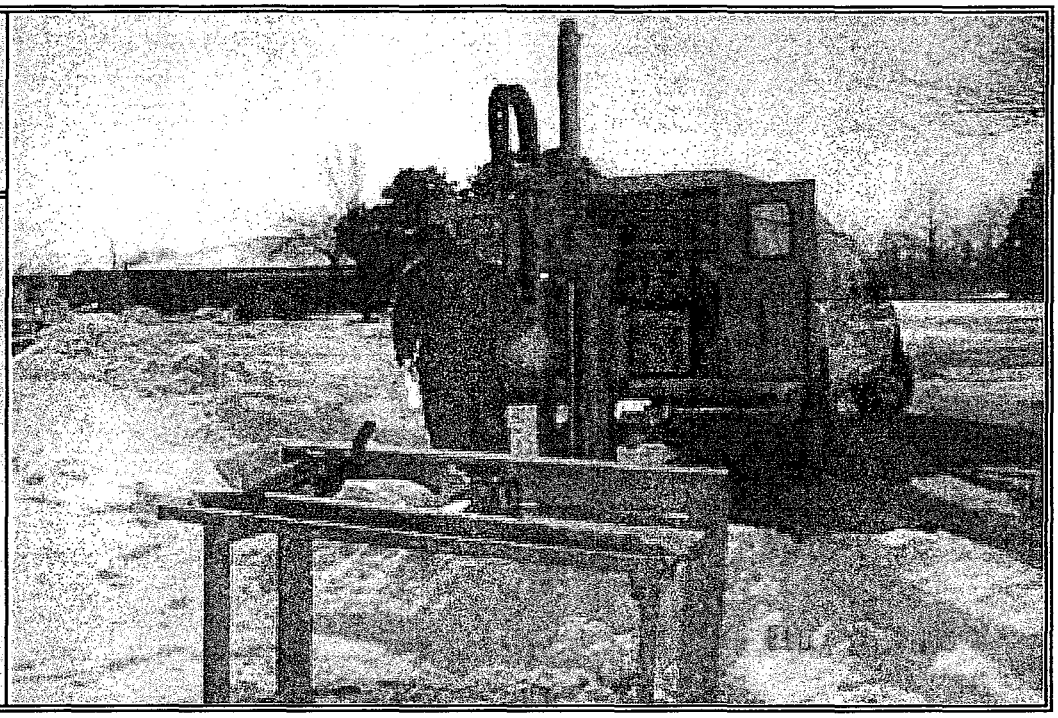
PHOTO #4

Description:
View of drilling activities along the east side of the building

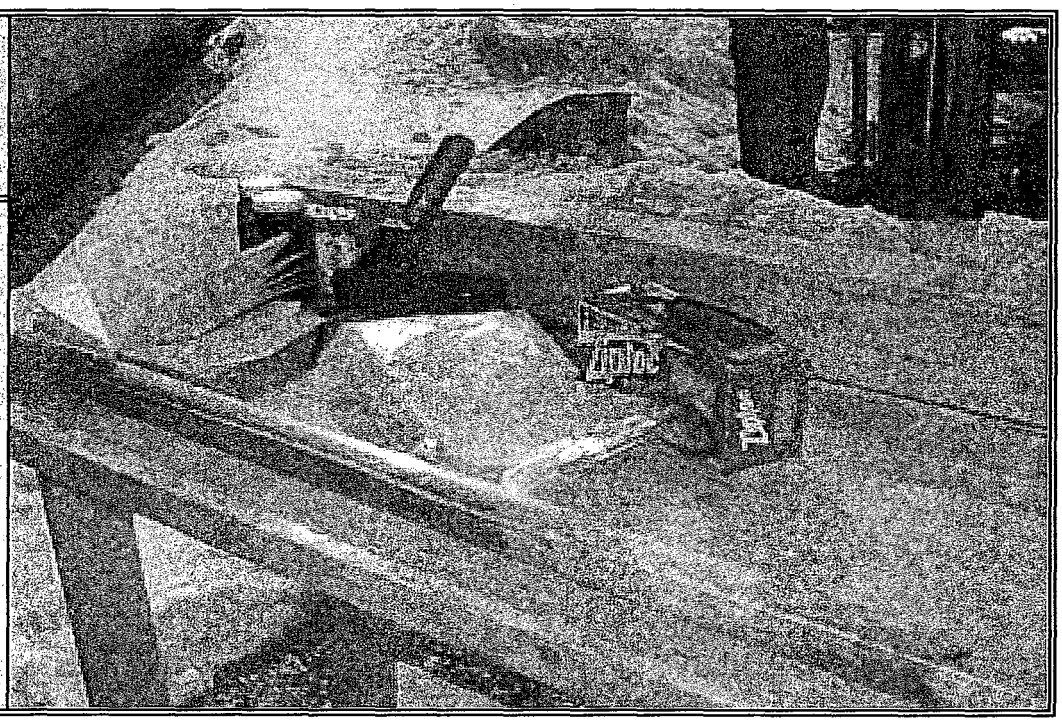
Description: View of soil core, log book and other sampling equipment PHOTO #5
