THE CRANE CORNER

Navy Crane Center Technical Bulletin

49th Edition Web Version - March 2006

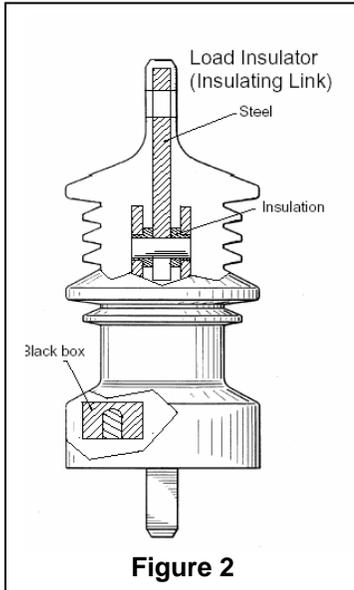
Figure 2

An alternate design of the link that serves the same purpose but has a steel load path and built-in diagnostics, is also available. Figure 1 shows the exterior view of the link, and figure 2 shows cross-sections of its key elements. The steel straps and pins are insulated from each other by dielectric flanged bushings and then encased in a dielectric molded housing. It includes a diagnostic "black box" monitoring system designed to:

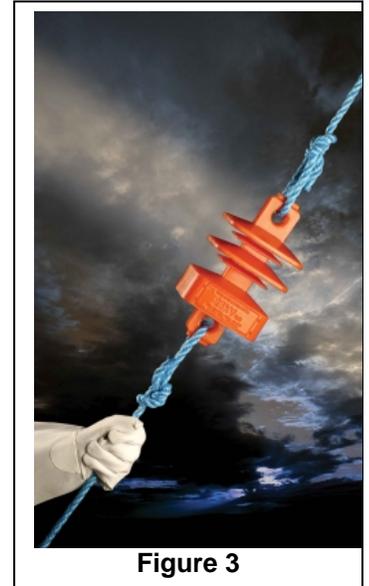
Figure 3

In load handling operations there is also the danger of lethal electric shock through damp or dirty tag lines. To eliminate this hazard, another version of the link is provided for that purpose. It is similar to the load insulating link but is smaller, weighs 3 pounds, and has no diagnostic "black box". This link is tied into the tag line as shown in figure 3. It is important to note that neither of these links, nor the fiberglass type described in the previous column, are lightning proof. ■
