SAMPLING AND ANALYSIS OUTLINE FOR BUILDING 626 NAS CECIL FIELD FL

SAMPLING AND ANALYSIS REPORT

BUILDING 626

NAVAL AIR STATION CECIL FIELD
JACKSONVILLE, FLORIDA

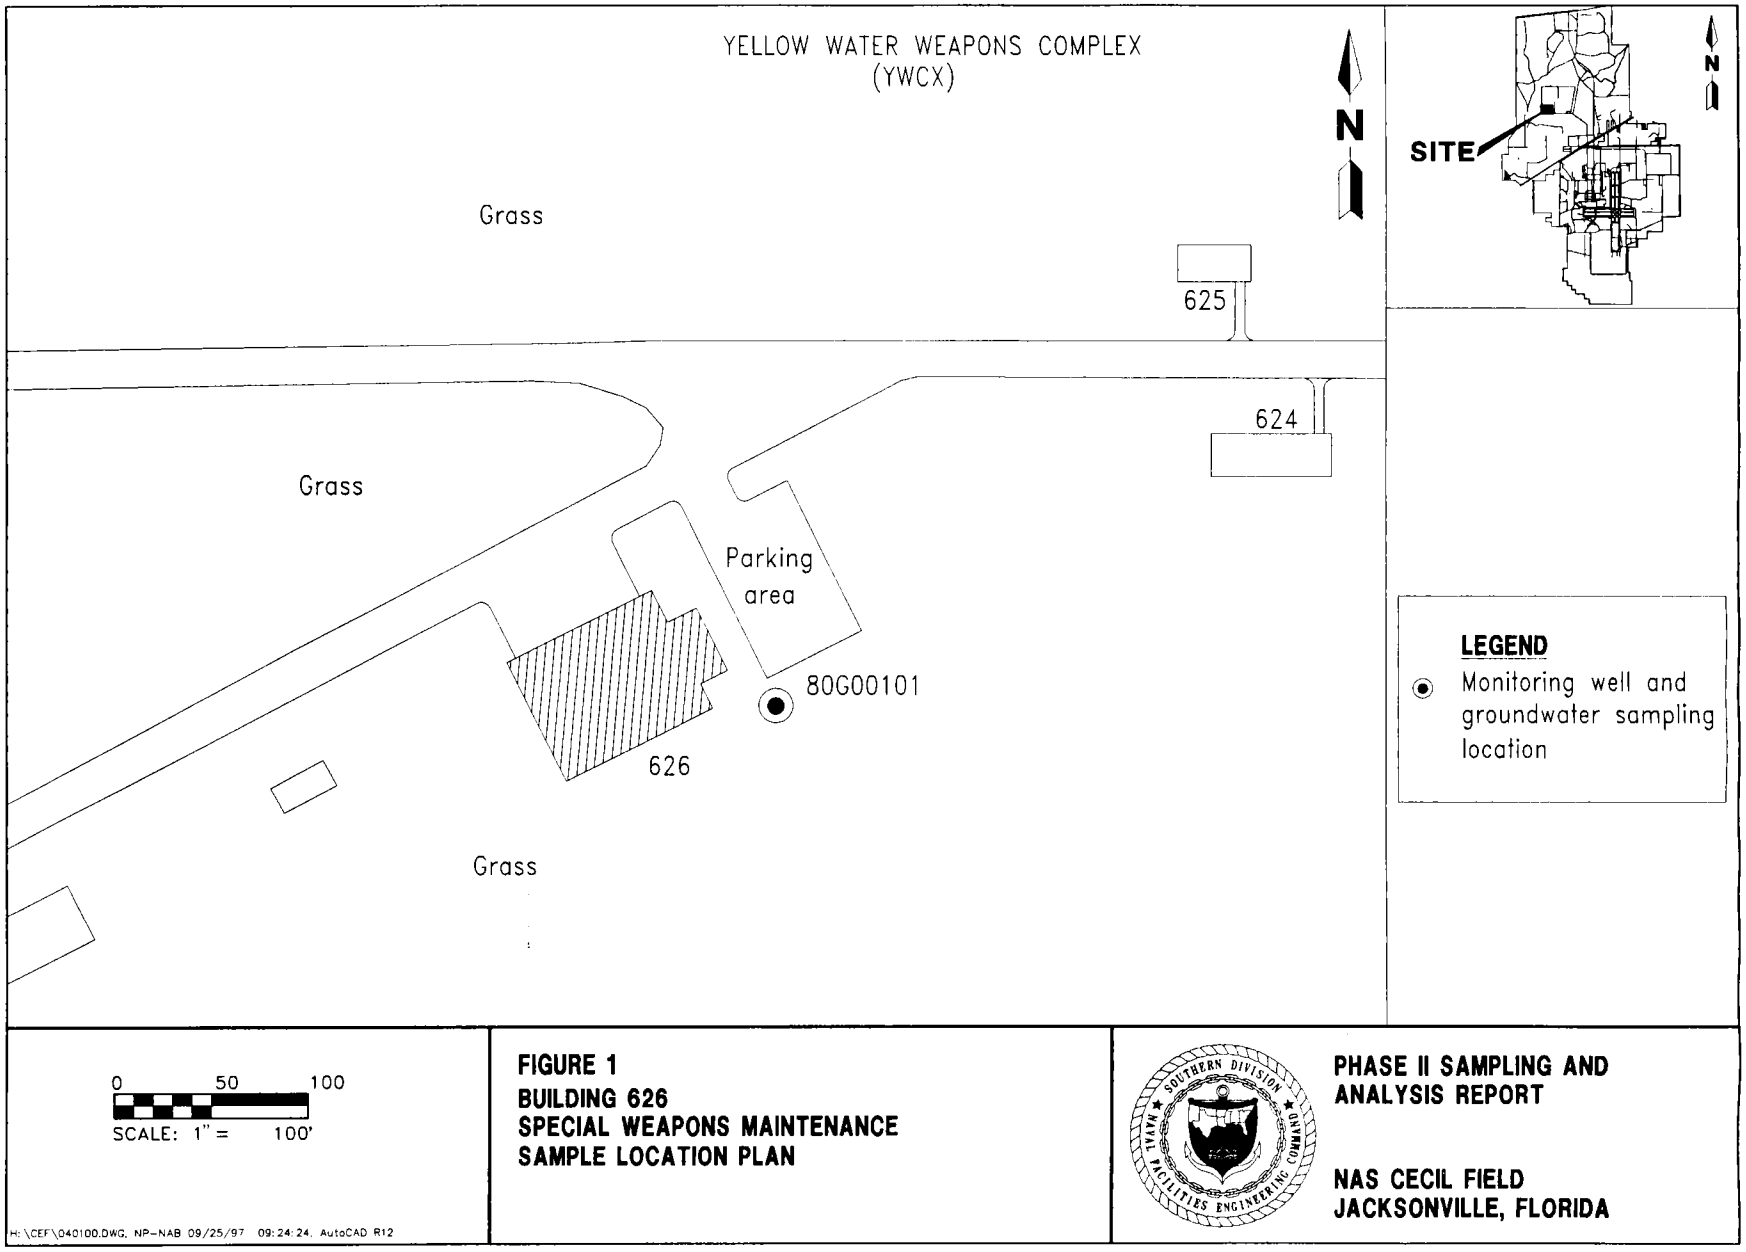
FIGURE 1
BUILDING 626
SPECIAL WEAPONS MAINTENANCE
SAMPLE LOCATION PLAN

The groundwater monitoring well was installed downgradient of the general location of the alleged solvent releases east of Building 626. The well was installed to a depth of 14 feet below land surface. One groundwater sample was collected and analyzed for the full Contract Laboratory program suite of target compound list (TCL) organics and target analyte list (TAL) inorganics. A general site plan indicating the location of the monitoring well is presented on Figure 1. The soil boring log is included in Appendix A.
