# THE CRANE CORNER

## *Navy Crane Center Technical Bulletin*

57th Edition –March 2008

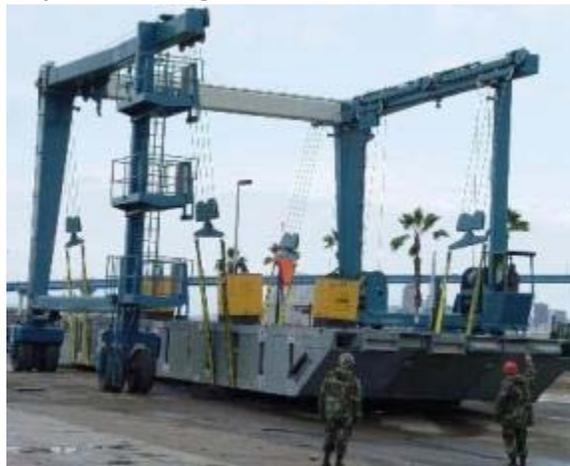
Navy Crane Center recently provided quality assurance on a 150-ton capacity mobile boatlift for Amphibious Construction Battalion One (ACB-1) in Coronado, San Diego, California. This diesel powered, rubber tired, hydraulic gantry crane is designed to lift and carry portable bridge sections over extended distances. This crane was the final unit of a Naval Facilities Engineering Command contract that replaced outdated equipment with five 150-metric ton mobile boat hoists for the Navy Lighterage Program. One unit was delivered to Blount Island, FL, two units to Little Creek, VA, and two units to Coronado, CA. Similar to the previous four units, the delivery of components, assembly, and testing of the mobile boat hoist in Coronado went smoothly. ■
