REMEDATION PLAN NS GREAT LAKES IL  
12/16/2005  
MACTEC ENGINEERING AND CONSULTING, INC

## **REMEDIATION PLAN**

Prepared for:  
Midwest Military Communities, LLC  
1615 L Street NW, Suite 400  
Washington, DC 20036

December 16, 2005

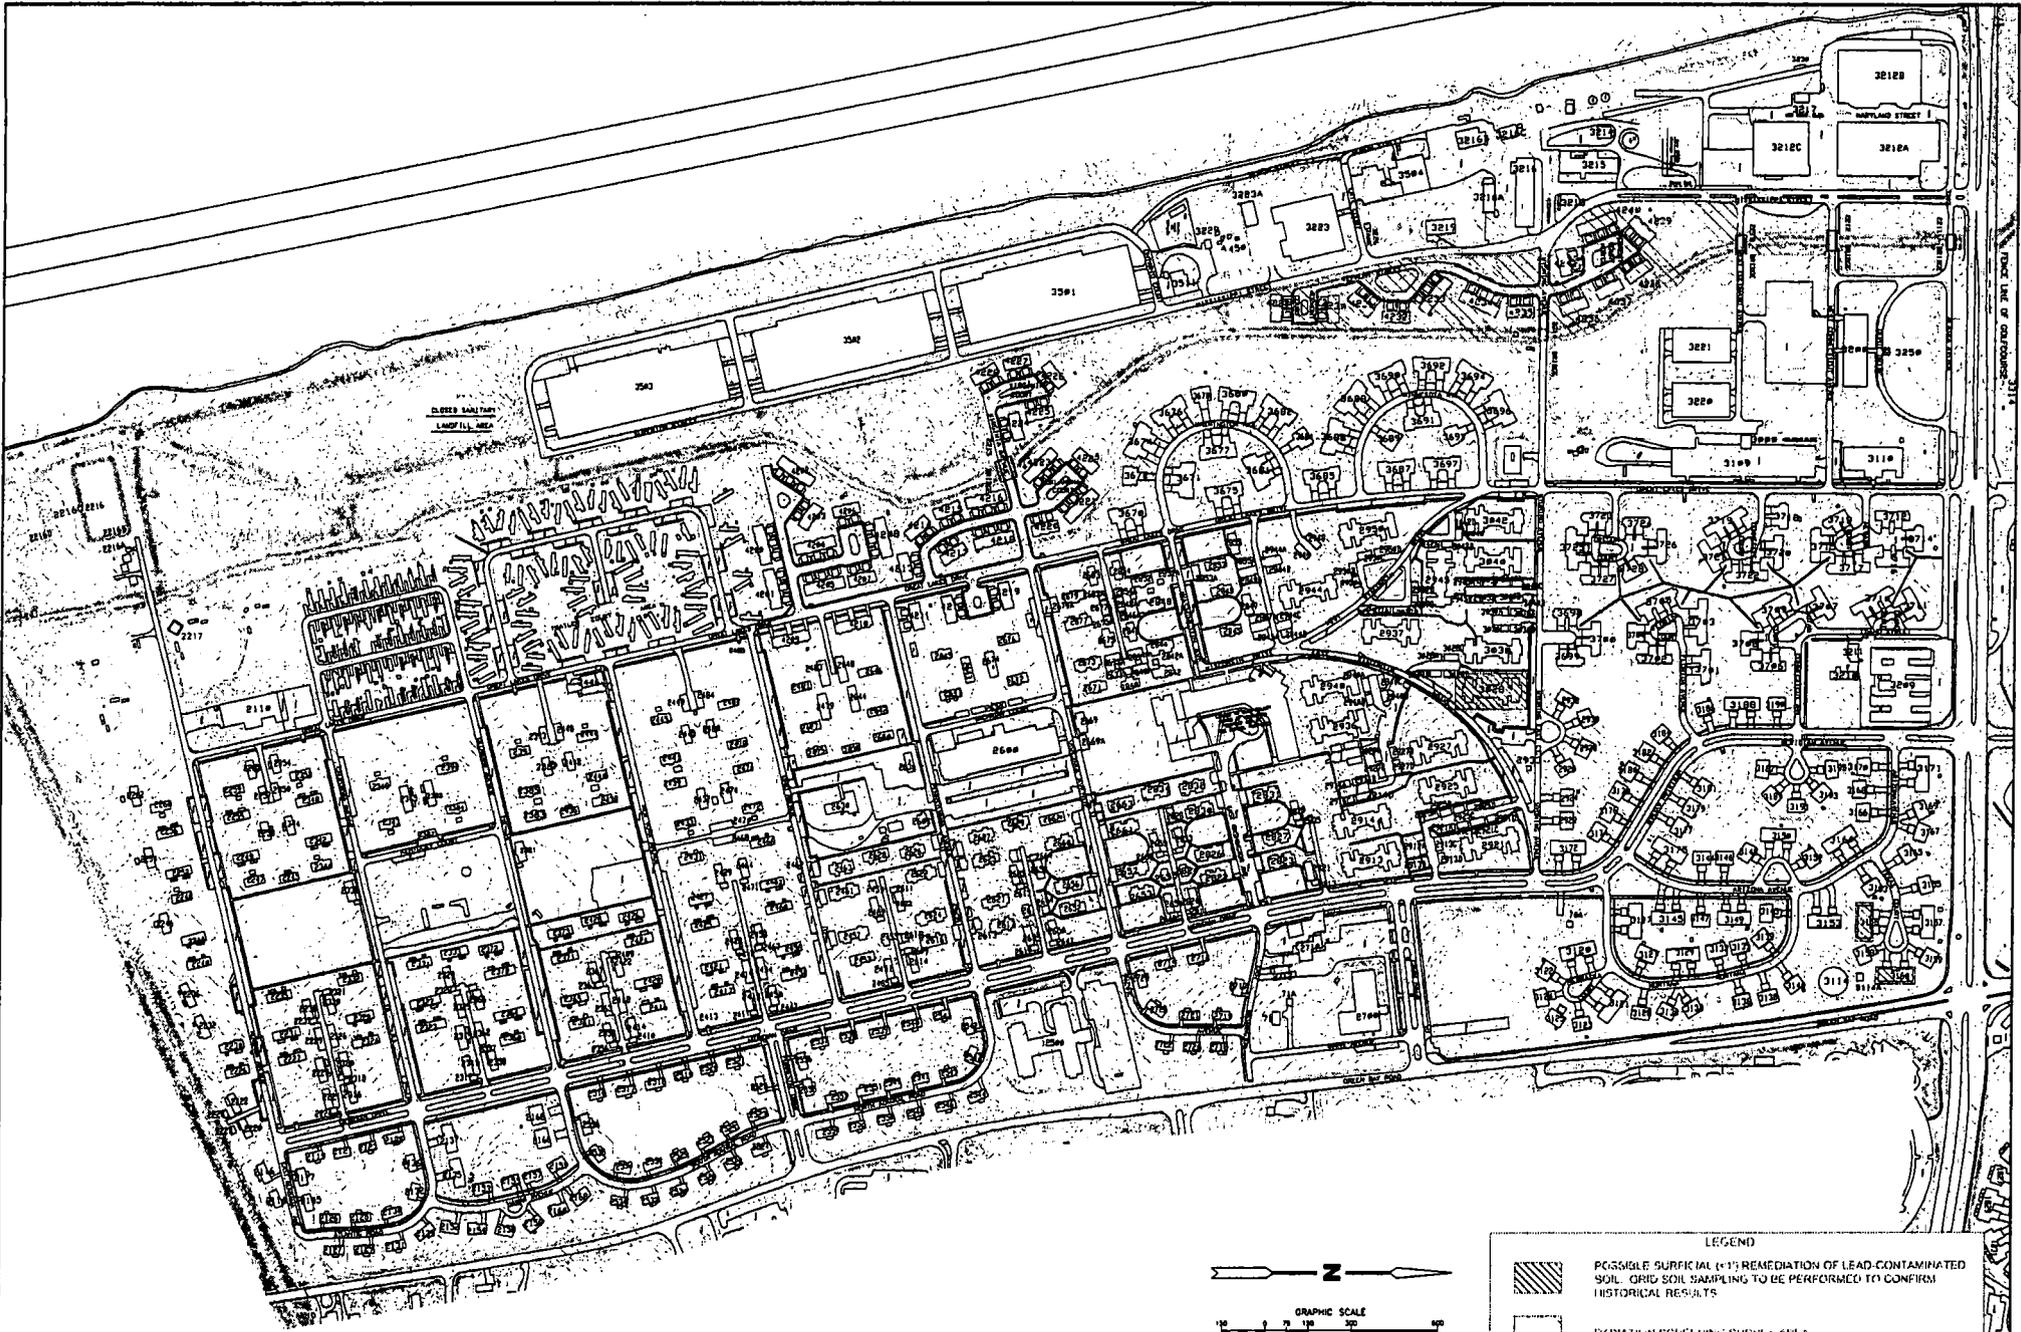
**FORRESTAL VILLAGE  
 REMEDIATION PLAN**

LEGEND	
	POSSIBLE SURFICIAL (± 1") REMEDIATION OF LEAD-CONTAMINATED SOIL. GRID SOIL SAMPLING TO BE PERFORMED TO CONFIRM HISTORICAL RESULTS
	RADIATION SCREENING SURVEY AREA

Previous soil sample analytical results for lead were detected above applicable TACO soil objectives (ingestion pathway) in surficial soils at Buildings 3028, 3156, and 3160D at Forrestal Village. The age and condition of the buildings suggests that the lead-contaminated soil is due to lead-based paint from the exterior of the buildings and is therefore, assumed to be limited to the area immediately adjacent to the buildings. The precise location and depth of the previous samples is not known, therefore, additional sampling will be performed at these buildings to verify the previous results. In the event that the previously elevated lead levels are confirmed at these locations, remedial action will be performed. Remediation at these locations entails excavation of approximately 6 cubic yards of soil adjacent to the buildings to an assumed depth of 0.5 feet bgs. The excavated material will be transported by a properly licensed trucking company and disposed of at a facility with the appropriate permits to accept such material. Following removal of the required quantity of soil, post-excavation samples will be collected along the sidewalls and the bottom of the excavated area for lead analysis. Sample results will be obtained on a 24-hour turnaround time basis so that if additional excavation is required, it can be implemented expeditiously. Steel fence posts and orange safety fencing will be erected around the perimeter of the excavation when work is deferred to await soil sample results. The soil sample analytical results will be compared with applicable TACO soil objectives to determine whether additional soil excavation is warranted. When comparison of sample results to TACO soil objectives indicates that the lead-contaminated soil has been removed, the excavated areas will be backfilled with clean topsoil and the disturbed ground surfaces will be restored.

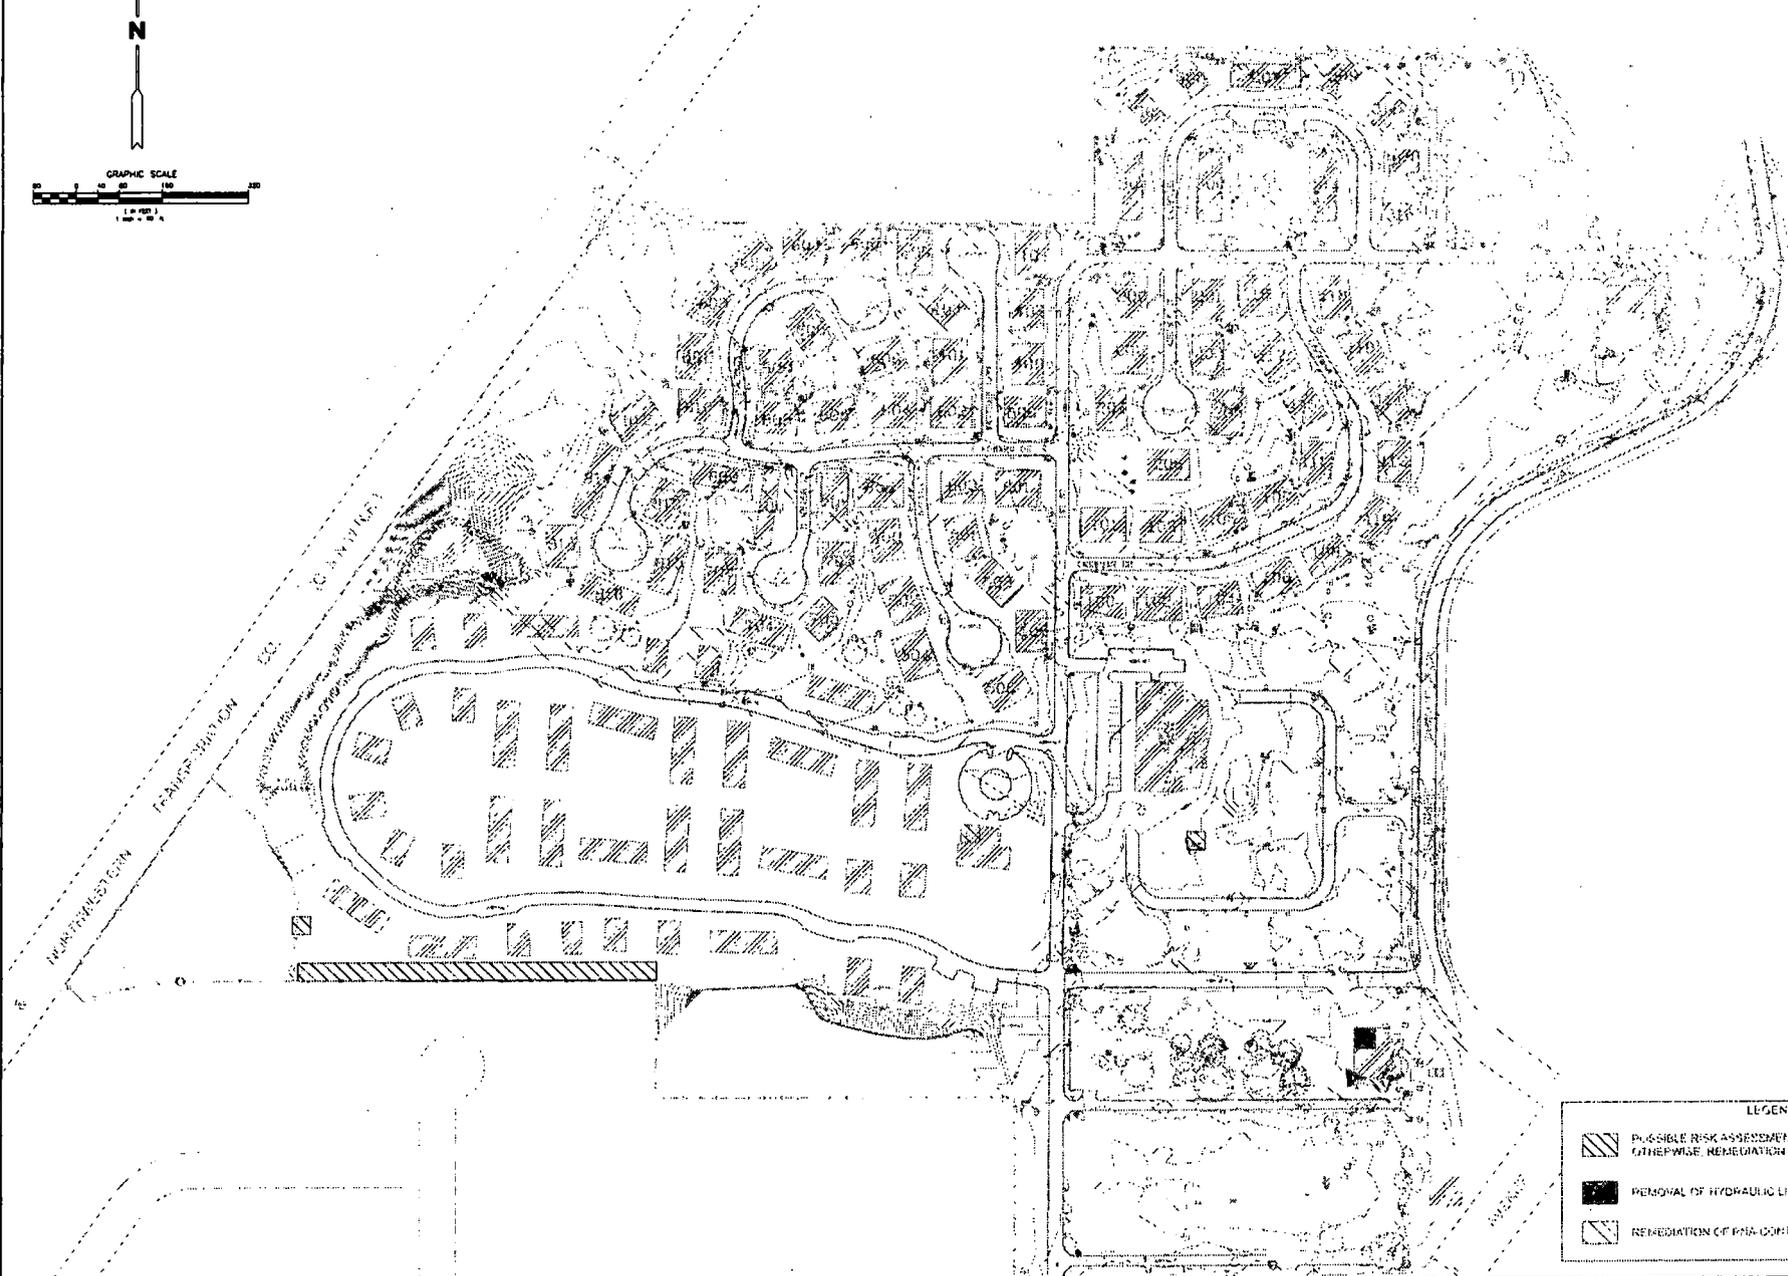
REMOVAL OF HYDRAULIC LIFTS AND OIL/WATER SEPARATOR

Soil samples collected in the lift area will be analyzed for hydraulic oil indicator parameters as specified in the IEPA Leaking Underground Storage Tank (LUST) regulations: benzene, toluene, ethylbenzene, and xylenes (BTEX), PNA, and barium. Soil samples collected in the OWS area will be analyzed for the volatile and semi-volatile organic and metal parameters as specified in the IEPA LUST regulations for used oil. Sample results will be obtained on a 24-hour turnaround time basis so that if excavation is required, it can be implemented expeditiously. Steel fence posts and orange safety fencing will be erected around the perimeter of the excavation when work is deferred to await soil sample results. The soil sample analytical results will be compared with applicable TACO soil objectives to determine whether additional soil excavation is warranted. When comparison of sample results to TACO soil objectives indicates that the contaminated soil has been removed adequately, then the excavated areas will be backfilled with clean, imported fill material and the disturbed ground surfaces will be restored.

Concentrations of PNAs were detected above applicable TACO soil objectives (ingestion pathway) in a soil sample collected at a depth of 0.25 foot in an oil-stained area adjacent to the Glenview Housing Office (Building 901). Because of the assumed limited quantity of soil affected in this area, remediation of this soil will be performed. Remediation at this location entails excavation of approximately 4 cubic yards of soil adjacent to a concrete pad and sidewalk to an assumed depth of 1 foot. The excavated material will be transported by a properly licensed trucking company and disposed of at a facility with the appropriate permits to accept such material. Following removal of the required quantity of soil, post-excavation samples will be collected along the sidewalls and the bottom of the excavated area for analysis of PNAs. Sample results will be obtained on a 24-hour turnaround time basis so that if additional excavation is required, it can be implemented expeditiously. Steel fence posts and orange safety fencing will be erected around the perimeter of the excavation when work is deferred to await soil sample results. The soil sample analytical results will be compared with applicable TACO soil objectives to determine whether additional soil excavation is warranted. When comparison of sample results to TACO soil objectives indicates that the PNA-contaminated soil has been removed, the excavated areas will be backfilled with clean topsoil and the disturbed ground surfaces will be restored.

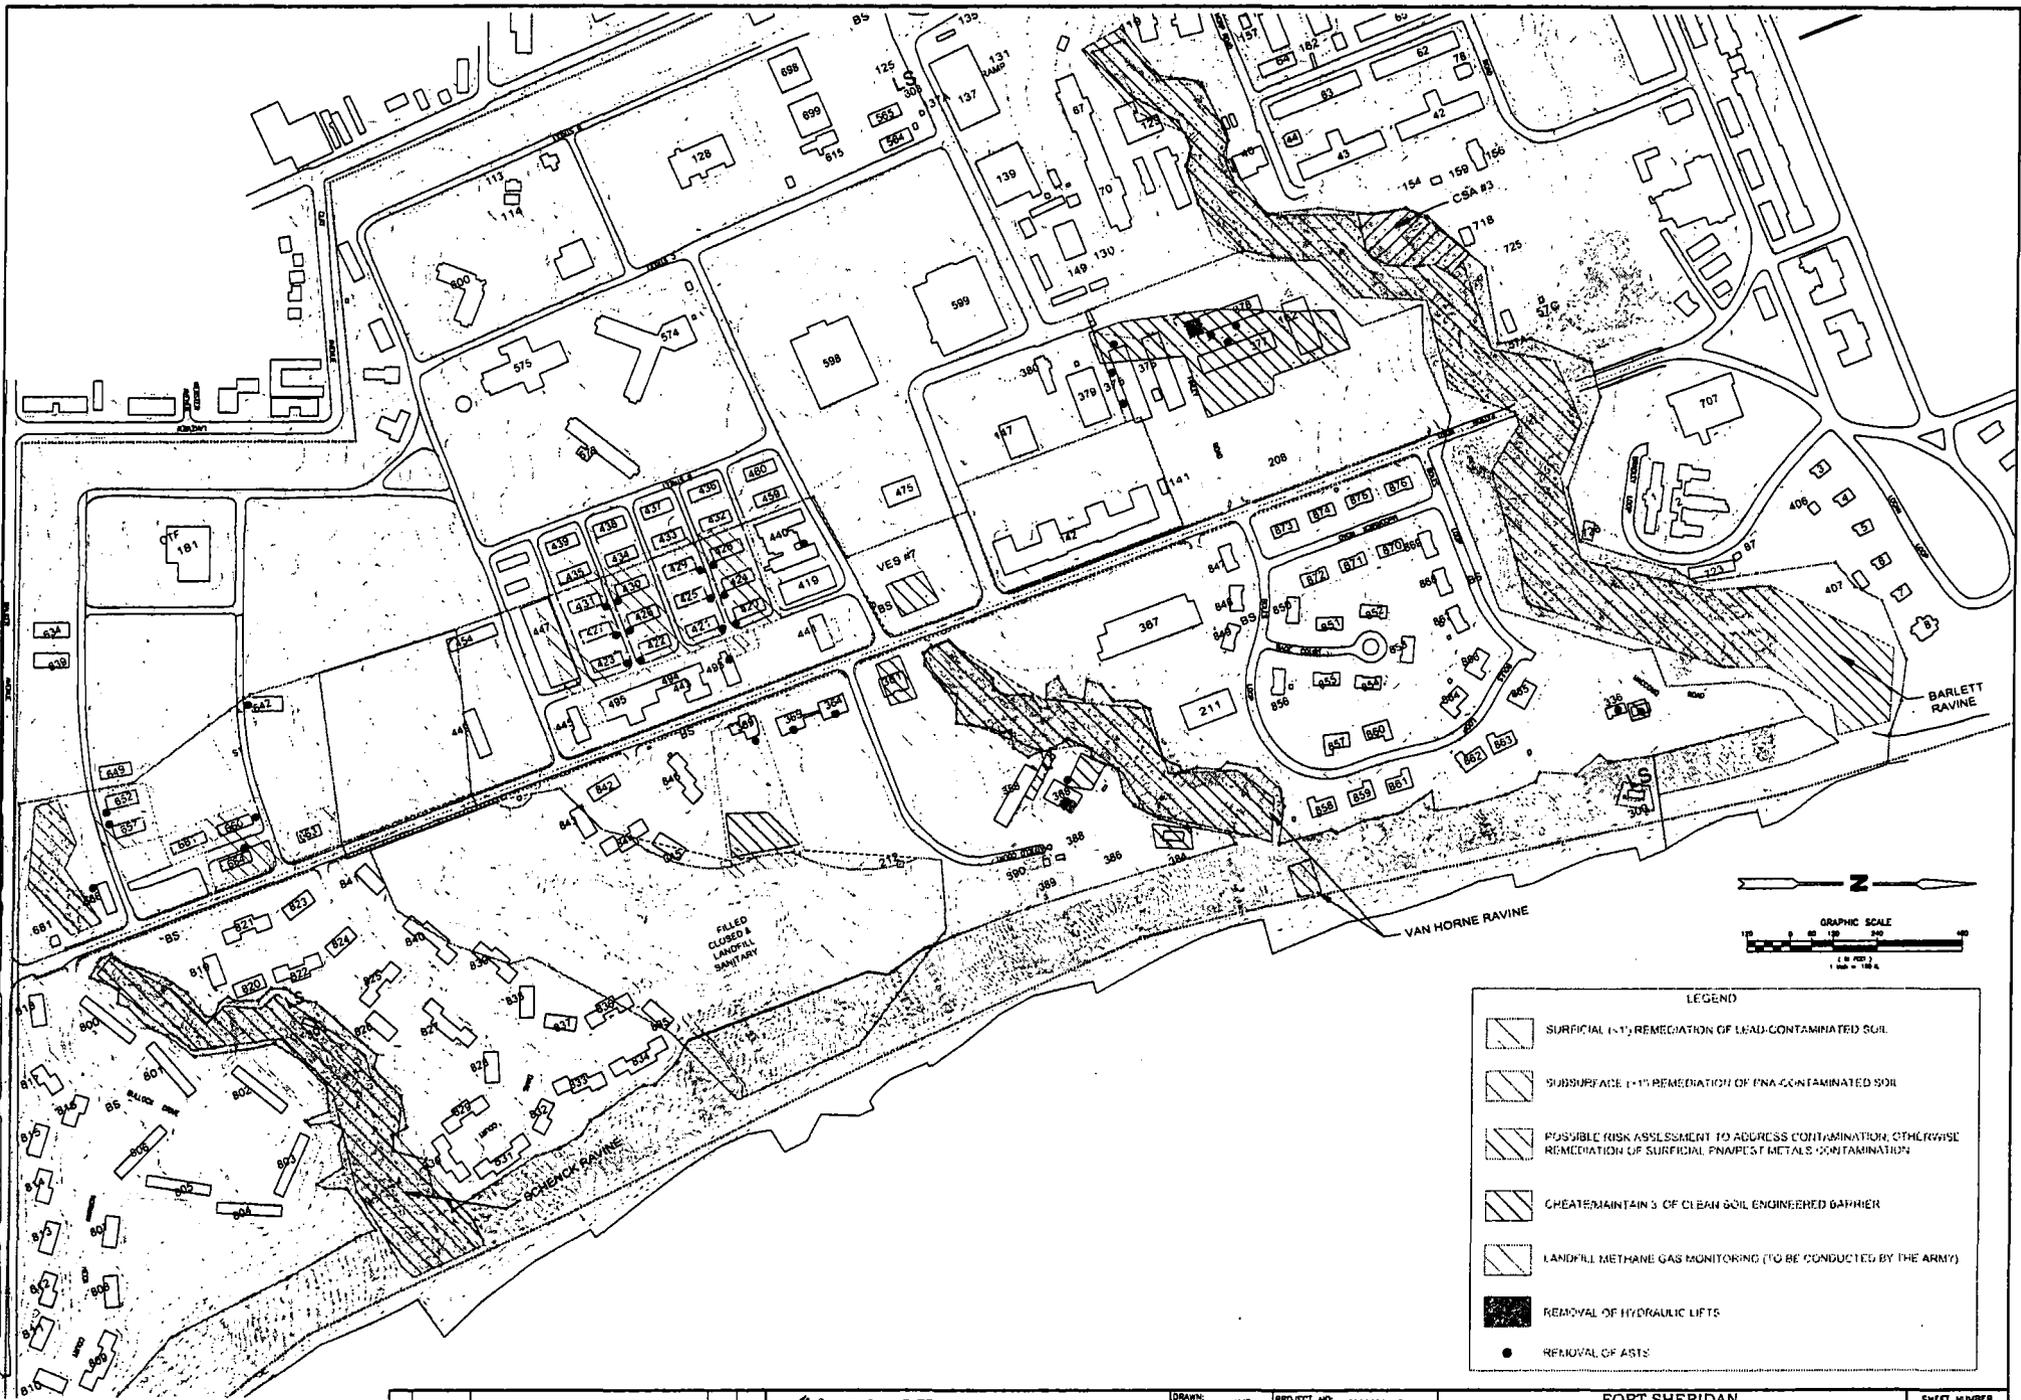
**FORT SHERIDAN  
 REMEDIATION PLAN**

SURFICIAL (0-12") REMEDIATION OF LEAD-CONTAMINATED SOIL
	SUBSURFACE (1-12") REMEDIATION OF PNA-CONTAMINATED SOIL
	POSSIBLE RISK ASSESSMENT TO ADDRESS CONTAMINATION, OTHERWISE REMEDIATION OF SURFICIAL PNA/PST METALS CONTAMINATION
	CREATE/MAINTAIN 3' OF CLEAN SOIL ENGINEERED BARRIER
	LANDFILL METHANE GAS MONITORING (TO BE CONDUCTED BY THE ARMY)
	REMOVAL OF HYDRAULIC LIFTS
	REMOVAL OF ASTS

Concentrations of lead were detected above applicable TACO soil objectives (ingestion pathway) in surficial soil samples collected adjacent to commercial buildings (400 and 600 series) located west of Patten Road at Fort Sheridan. The age and condition of the buildings suggests that the lead-contaminated soil is due to lead-based paint from the exterior of the buildings and is therefore assumed to be limited to the area immediately adjacent to the buildings. The portion of Fort Sheridan where the 600 series commercial buildings are located will be sold and remediation of the lead-contaminated soil in these areas will be the responsibility of the new owner. However, site grading in the area near the 400 series commercial series buildings is planned which is likely to disturb the lead-contaminated surficial soil in this area. Therefore, remediation of the lead-contaminated surficial soil will be performed prior to site grading at these locations. Remediation entails excavation of approximately 55 cubic yards of soil adjacent to the buildings to an assumed depth of 0.5 feet bgs adjacent to the buildings. The detected lead concentrations in soil samples suggest that the excavated material may need to be handled and disposed as hazardous waste. The excavated material will be transported by a properly licensed trucking company and disposed of at a facility with the appropriate permits to accept such material. Following removal of the required quantity of soil, post-excavation samples will be collected along the sidewalls and the bottom of the excavated area for analysis of lead. Sample results will be obtained on a 24-hour turnaround time basis so that if additional excavation is required, it can be implemented expeditiously. Steel fence posts

part of the demolition of this building, the subfloor components of the hydraulic lifts will be removed and disposed of offsite. During lift removal, if any hydraulic oil remains in the lift troughs or lift cylinders, it will be removed and disposed offsite by a properly licensed trucking company and disposed of at a facility with the appropriate permits to accept such material. Also during removal of the lifts, additional visual soil assessment will be performed of the resultant excavation. Depending on the depth and extent of any visible evidence of soil impact observed during lift removal, the impacted soil may be immediately excavated and disposed offsite. The excavated material will be transported by a properly licensed trucking company and disposed of at a facility with the appropriate permits to accept such material. In that case, post-excavation soil samples will be collected along the sidewalls and the bottom of the excavated area for analysis. If the potential of more extensive impacted soil is indicated, additional soil sampling may be performed to help characterize the extent of the soil impacts prior to further excavation.
