# Brown & Root Environmental

Subject: Submittal of Responses to RIDEM Comments dated May 29, 1997

Attached are responses to the second set of comments received from the Rhode Island Department of Environmental Management on the Draft Site Assessment Screening Evaluation (SASE) report. These comments were actually an evaluation of our responses to the first set of comments, and were received by the Navy on May 30, 1997.

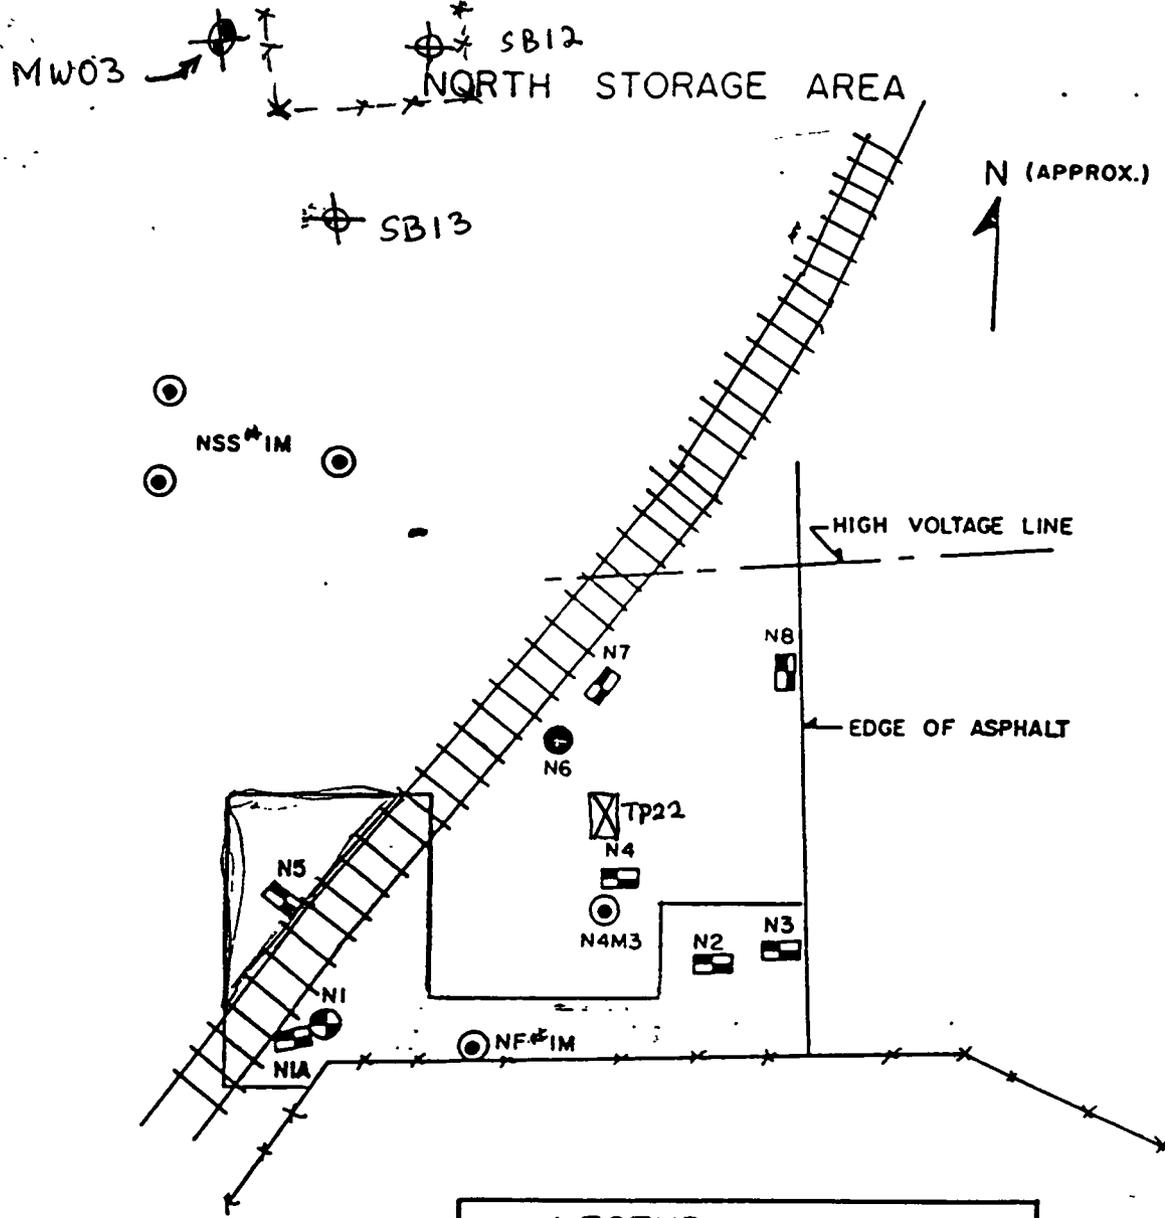
FIGURE 3:

*Regarding the historic conditions of the site, the reviewer is asked to refer to the response to Comment No. 1. The map in question has been attached to this response letter. It shows the location of test pits, borings and monitoring wells as located to the best of our ability considering the lack of existing benchmark features on the site.*

*This figure shows that the sample stations that were selected during the development of the work plan and used during the field work are appropriate for the determination of conditions of the subsurface based on the previous records of the site.*
