# Abstract of a Mishap

**Mishap Type:** *Crushed by falling steel beam*  
**Injury:** *Fatality*  
**Type of Work:** *Steel Erection*  
**Equipment:** *Forklift & Scissor Lift*

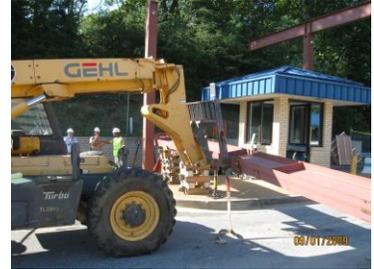
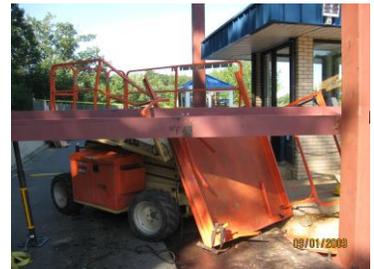
- ◆ An approximately 70 foot long steel “I” beam suspended by a nylon sling from a material handling forklift fell on an employee directly under the load working from a scissor lift when the overloaded nylon sling failed (broke).

- ◆ Lack of contractor supervisory oversight for safe procedures of employees on the worksite.
- ◆ Employee positioned under the load.
- ◆ Wrong equipment for the job – should have used a crane or other equipment or forklift with greater capacity with beam resting on top of forks versus suspended by a nylon sling supported by one of the forks.

- ◆ High hazard work activities should be constantly supervised and adequately planned out to assure safe work practices are utilized at all times.
- ◆ Assure proactive quality assurances to validate controls are in place for high hazard work operations - particularly those occurring after normal work hours.
- ◆ Contractors should provide sufficient evidence of an effective written safety program before work begins.
