# Safety Alert

## *Pier high mast lighting structural failure*

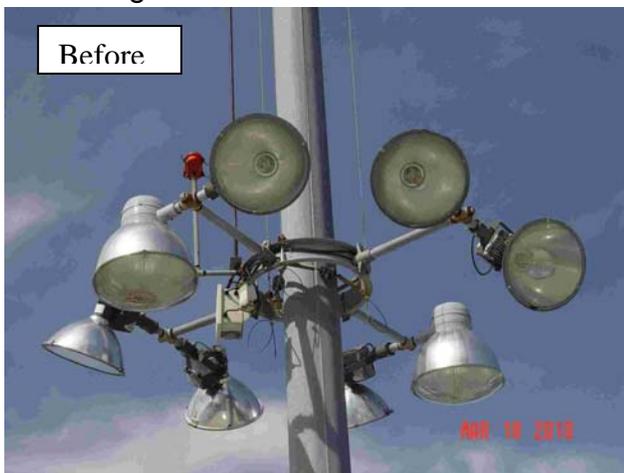
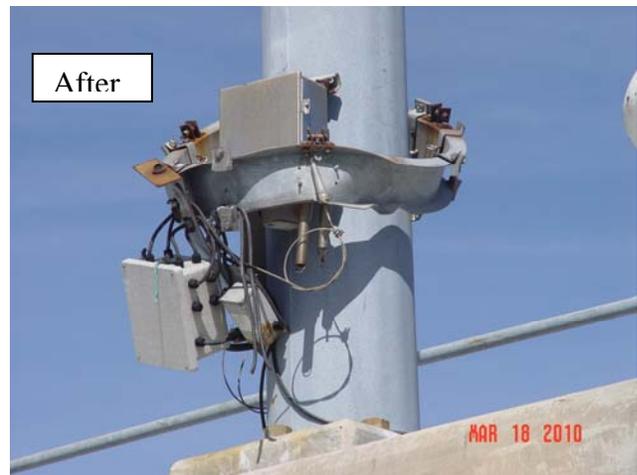
**CONCERN:** Mast lighting systems at Naval Station Norfolk have experienced an apparent defect where the latching mechanism fractures at the top of the mast light assembly prematurely. These fractured latching arms can then fray associated support cables which support the light ring. Once the support cables fray to a critical point, the entire light ring assembly can fall catastrophically - which has occurred. A subsequent investigation at Naval Station Norfolk pier high mast lighting has revealed additional lights of various designs similarly affected by latching mechanism fracture and cable fray. Many of the latching mechanisms inspected were reported to have a clearly improved design however, and did not exhibit signs of wear or failure.

**INDIRECT CAUSE:** The cable was incorrectly tightened causing retraction of the cable.

**LESSONS LEARNED/RECOMMENDATION:** Inspect high mast light systems for latching mechanism fracture/cracking. Visually inspect support cables for signs of wear and fray. While not involved in the failure, it is also recommended that the inspection include (1) a visual examination of the internal master cable for signs of wear as it retracts/coils and (2) a visual examination of the high mast pole splice for any signs of cracking, particularly for systems that have been in operation for a number of years. Any latching mechanism or cable failures noted during inspection should result in the light ring being lowered to ground until repairs can be made (or if pole splice cracking is observed the pole taken down). In some case it may be acceptable to provide temporary safety strapping between the light ring and mast pole with engineering consultation to facilitate continued light use until permanent repairs can be made.
