LESSONS LEARNED

In-house UV Exposure, PWD Panama City, Flash Burn/UV Skin Burn, Bldg 354

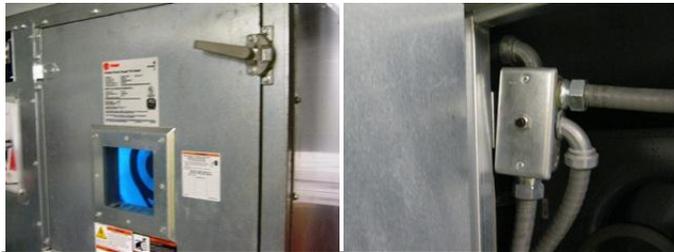
UV Light Shown on Pressure Sensor Switch

Lessons Learned: Follow NAVFAC SE SOP's, PWD PC JHA's (once updated), and manufacturer's written procedures. Deploy proper PPE at the worker level per training and warning signs posted. If written procedures do not meet work performance requirements stop work and affect change to prevent injury or illness. Follow the principles of ORM.

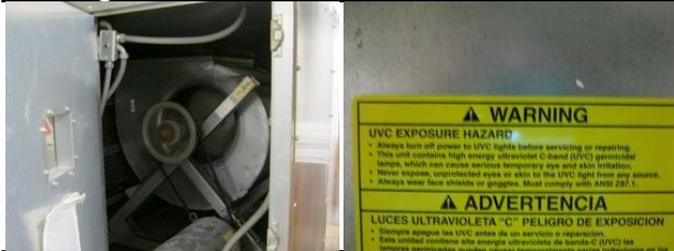
Internal live Parts One of three labels

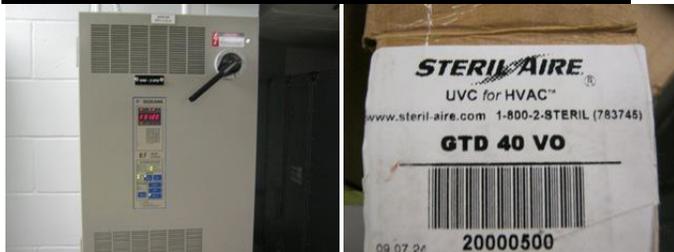
AHU Disconnect Type Bulb
