**Final  
Work Plan for  
Groundwater Baseline Investigation at  
U.S. Navy's Eastern Maneuver Area  
Vieques Island, Puerto Rico**

**Department of the Navy  
Atlantic Division  
Naval Facilities Engineering Command**

February 2001

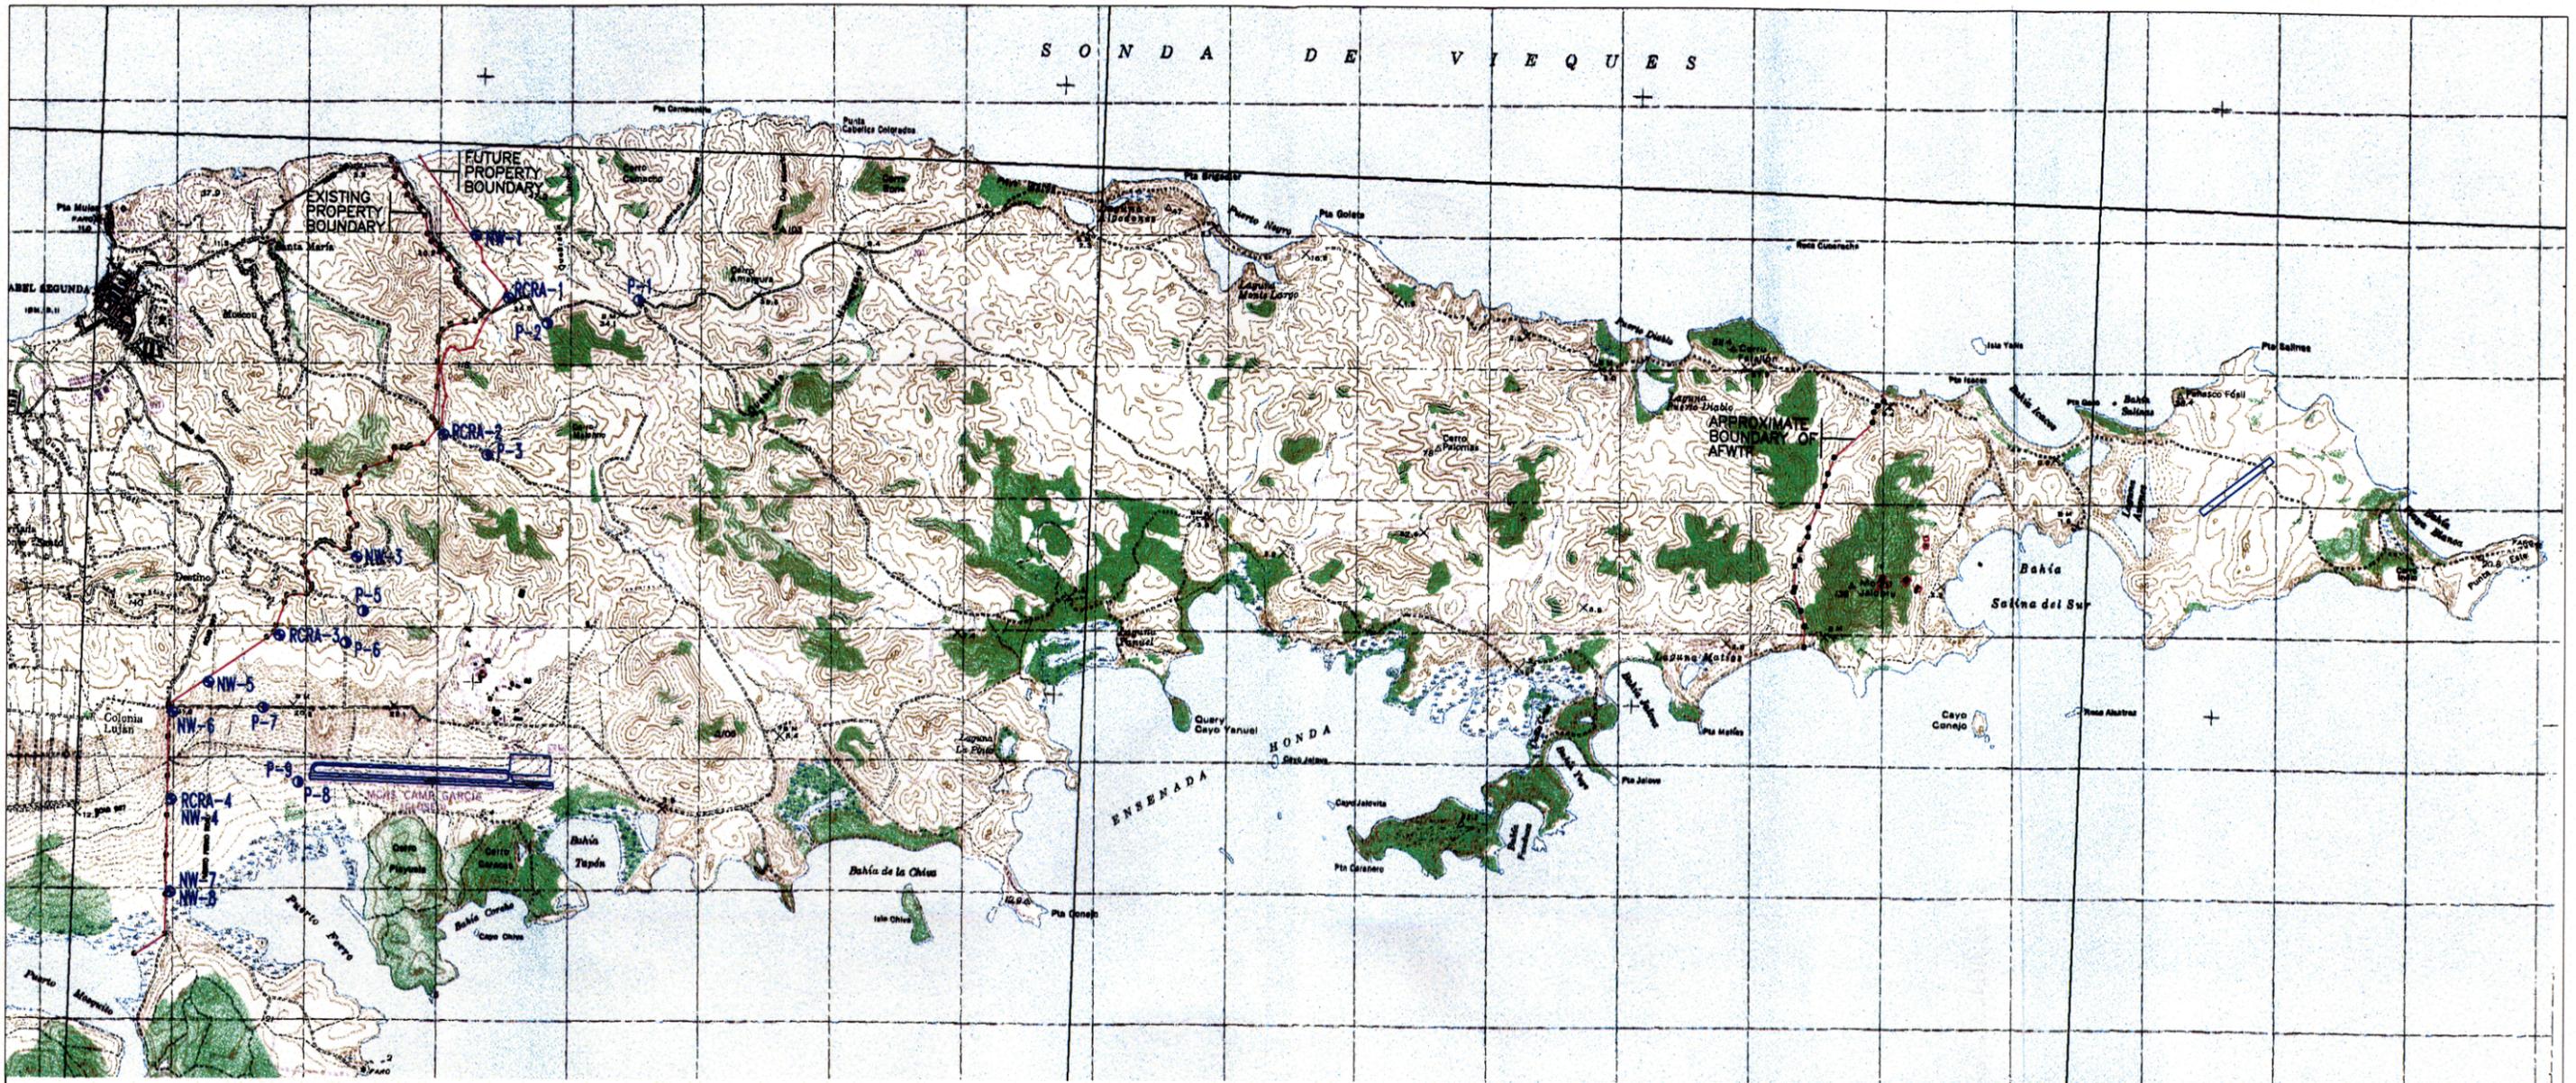
**Figure 1-2**  
**MONITORING WELL AND PIEZOMETER LOCATIONS**  
 Atlantic Fleet Weapons Training Facility, Vieques Island

WELL No.	WELL DESCRIPTION	DATE CONSTRUCTED	CASING DIA.(IN)	WELL ELEVATION (FT, AMSL)	DEPTH OF WELL (FT)	DEPTH TO WATER (FT)
NW-1	Navy Well	8/14/99	2	114.1 <sup>(2)</sup>	134	101.2
NW-3	Navy Well	8/6/99	2	354.4 <sup>(2)</sup>	197	118.5
NW-4	Navy Well	8/17/99	2	36.0 <sup>(2)</sup>	80	37.3
NW-5	Navy Well	8/10/99	2	107.8 <sup>(2)</sup>	118	36.0
NW-6	Navy Well	8/12/99	2	90.7 <sup>(2)</sup>	144	52.7
NW-7	Navy Well	8/17/99	2	4.1 <sup>(2)</sup>	81	5.4
NW-8	Navy Well	8/3/99	2	4.2 <sup>(2)</sup>	15	4.9
P-1	Piezometer	8/25/99	2	145.1 <sup>(2)</sup>	186	132.0
P-1	Piezometer	8/18/99	2	116.3 <sup>(2)</sup>	102	61.9
P-3	Piezometer	8/19/99	2	232.8 <sup>(2)</sup>	165	82.4
P-5	Piezometer	8/19/99	2	296.8 <sup>(2)</sup>	144	80.2
P-6	Piezometer	8/19/99	2	192.6 <sup>(2)</sup>	180.5	102.9
P-7	Piezometer	8/14/99	2	68.0 <sup>(2)</sup>	94	53.1
P-8	Piezometer	8/4/99	2	21.3 <sup>(2)</sup>	32	24.9
P-9	Piezometer	8/18/99	2	21.6 <sup>(2)</sup>	86	24.8

RCRA-1	RCRA well	8/18/99	2	101.2 <sup>(2)</sup>	64	49.3
RCRA-2	RCRA well	8/8/99	2	257.5 <sup>(2)</sup>	64	40.0
RCRA-3	RCRA well	8/14/99	2	153.9 <sup>(2)</sup>	69	55.4
RCRA-4	RCRA well	8/11/99	2	36.1 <sup>(2)</sup>	49.5	37.3

In accordance with the Consent Order, the Navy will submit to USEPA the results of the "baseline" groundwater investigation along the western perimeter of the Navy Facility in a Groundwater Investigation Report. The baseline groundwater investigation shall be designed to "establish baseline groundwater quality, regional groundwater flow patterns along the western perimeter of the Navy Facility, and to determine whether activities at the Navy's Facility have impacted groundwater at the western perimeter of the Facility; and if such impacts are indicated, are they currently, or in the future, likely to migrate offsite into the non-Navy owned areas of Vieques Island" The baseline investigation is to include the sampling of the four wells shown on Figure 1-2 as monitoring wells RCRA-1, RCRA-2, RCRA-3 and RCRA-4.

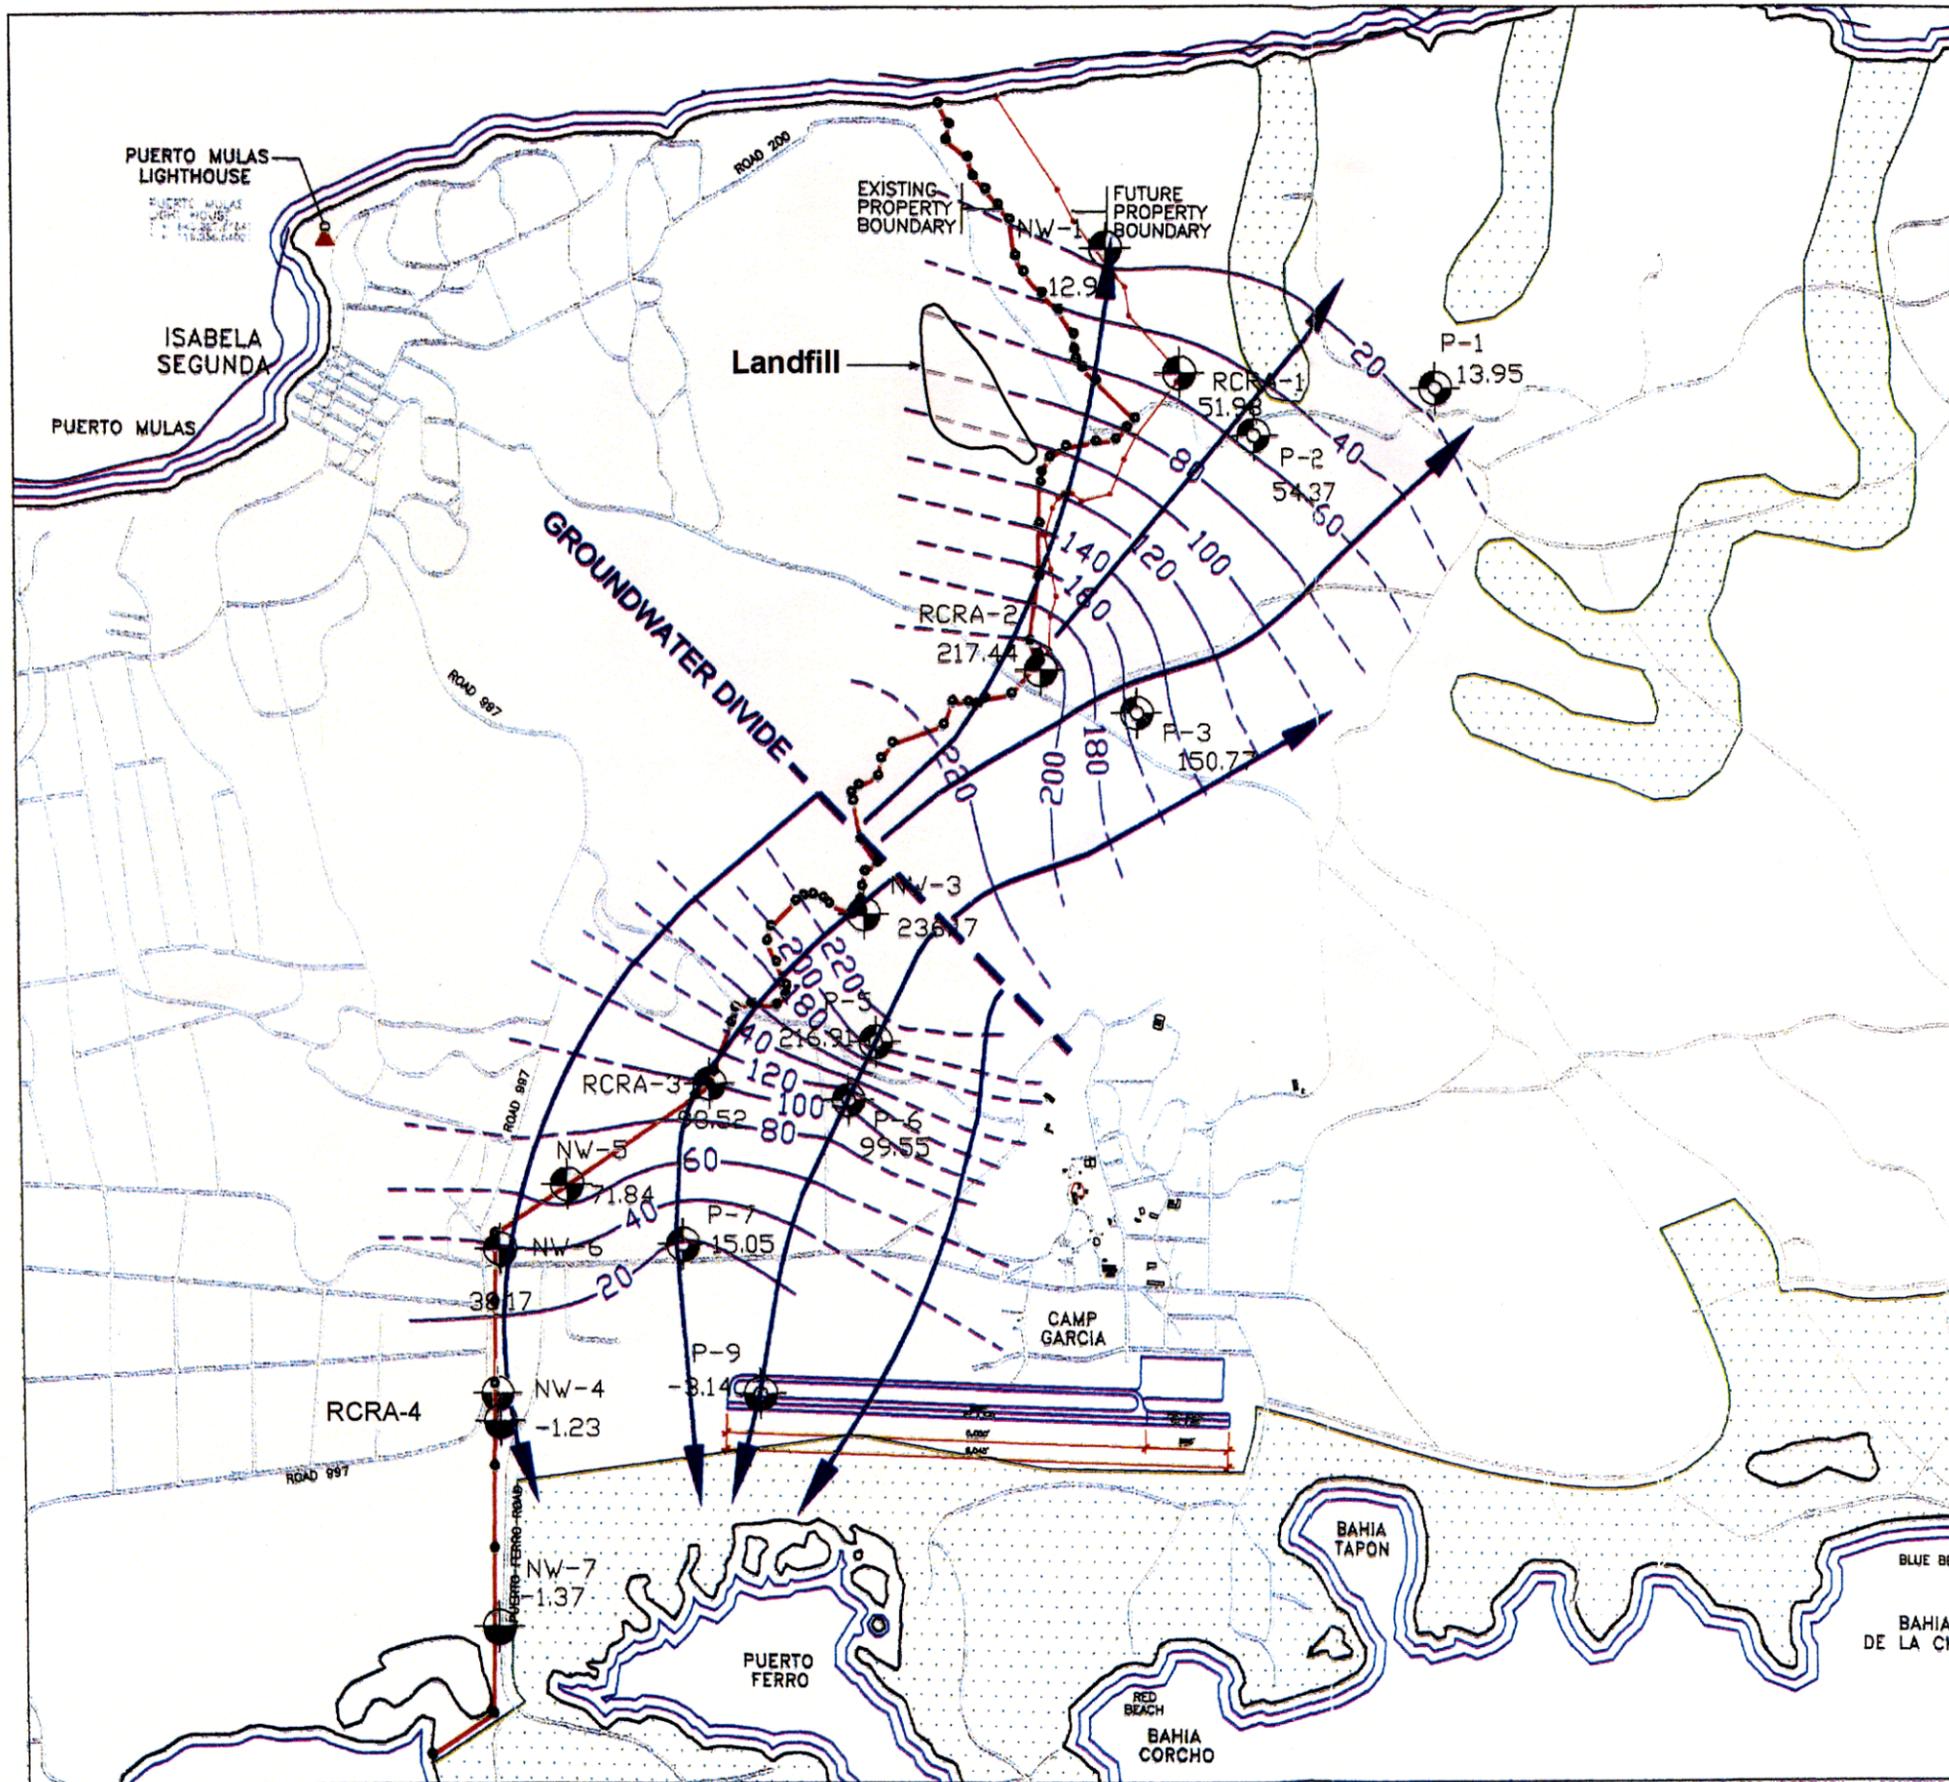
**Figure 1-3**  
**GROUNDWATER CONTOUR MAP**  
 Vieques Island, Puerto Rico **CH2MHILL**

As part of the previous Hydrogeologic Investigation, groundwater elevation measurements were recorded on August 26, 1999 and are presented in Figure 1-3. The depth to groundwater within the bedrock ranged from approximately 36 feet at NW-5 to 131 feet at P-1. The groundwater elevations of the bedrock are significantly higher than the elevations where groundwater was encountered during drilling. This would indicate that the bedrock formation is under artesian conditions. The groundwater elevation data for the bedrock indicates that a groundwater flow divide exists within the bedrock at the approximate north/south mid point of the island: at the location of well NW-3 (see Figure 1-3). Generally, groundwater north of well NW-3 flows north toward the Atlantic Ocean and groundwater south of NW-3 flows south toward the Caribbean Sea.

The thickness of the unconsolidated layer decreases northward from wells NW-7 and NW-8 (Figure 1-3) located along the Caribbean shoreline to well NW-3, located at the highest elevation within the study area. Likewise, the thickness of the unconsolidated layer increases again northward from NW-3 toward NW-1 located near the Atlantic Ocean shoreline (Baker, 1999).

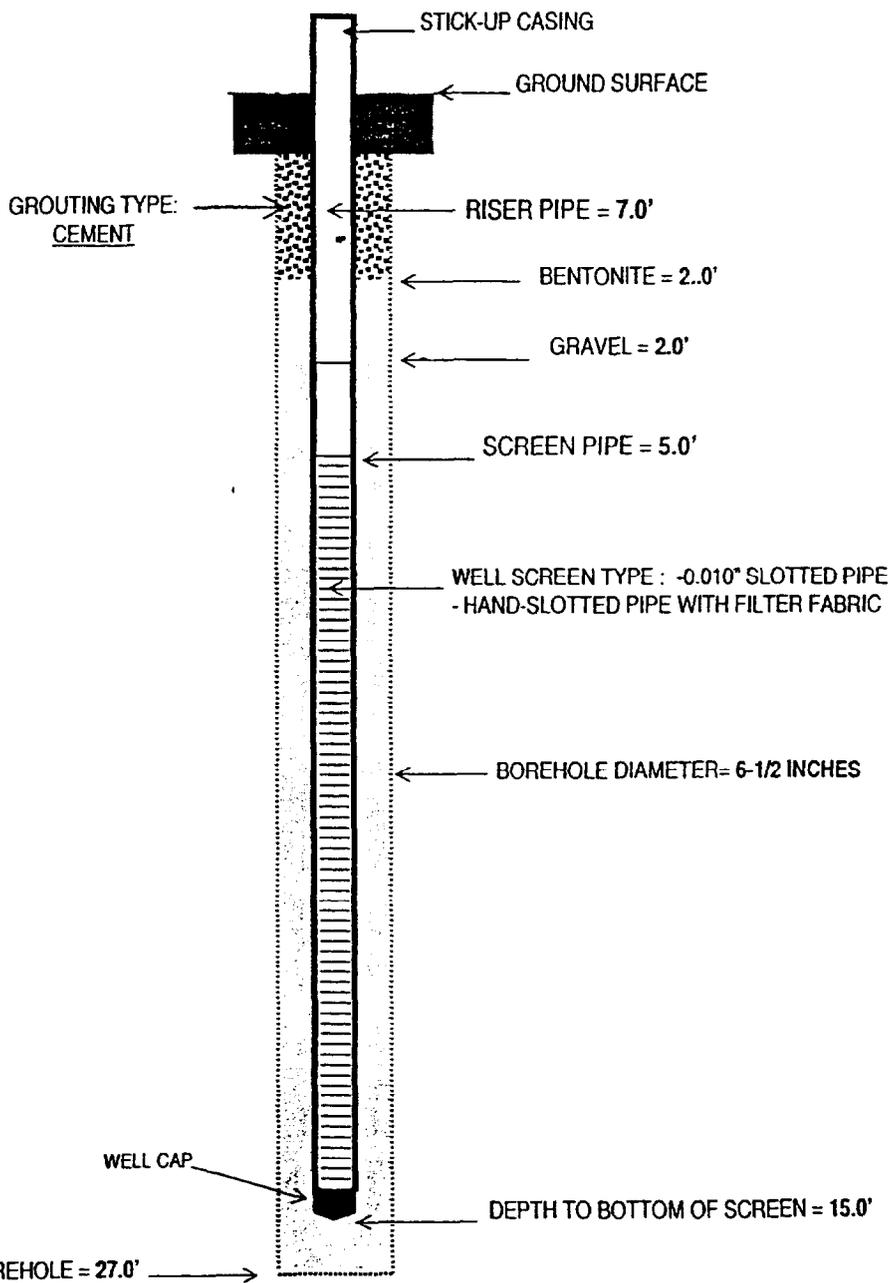
## WELL CONSTRUCTION DETAIL

- CONCRETE PAD 3x3 FEET AND FOUR 3" DIAMETER BLANK STEEL PROTECTIVE PIPE.

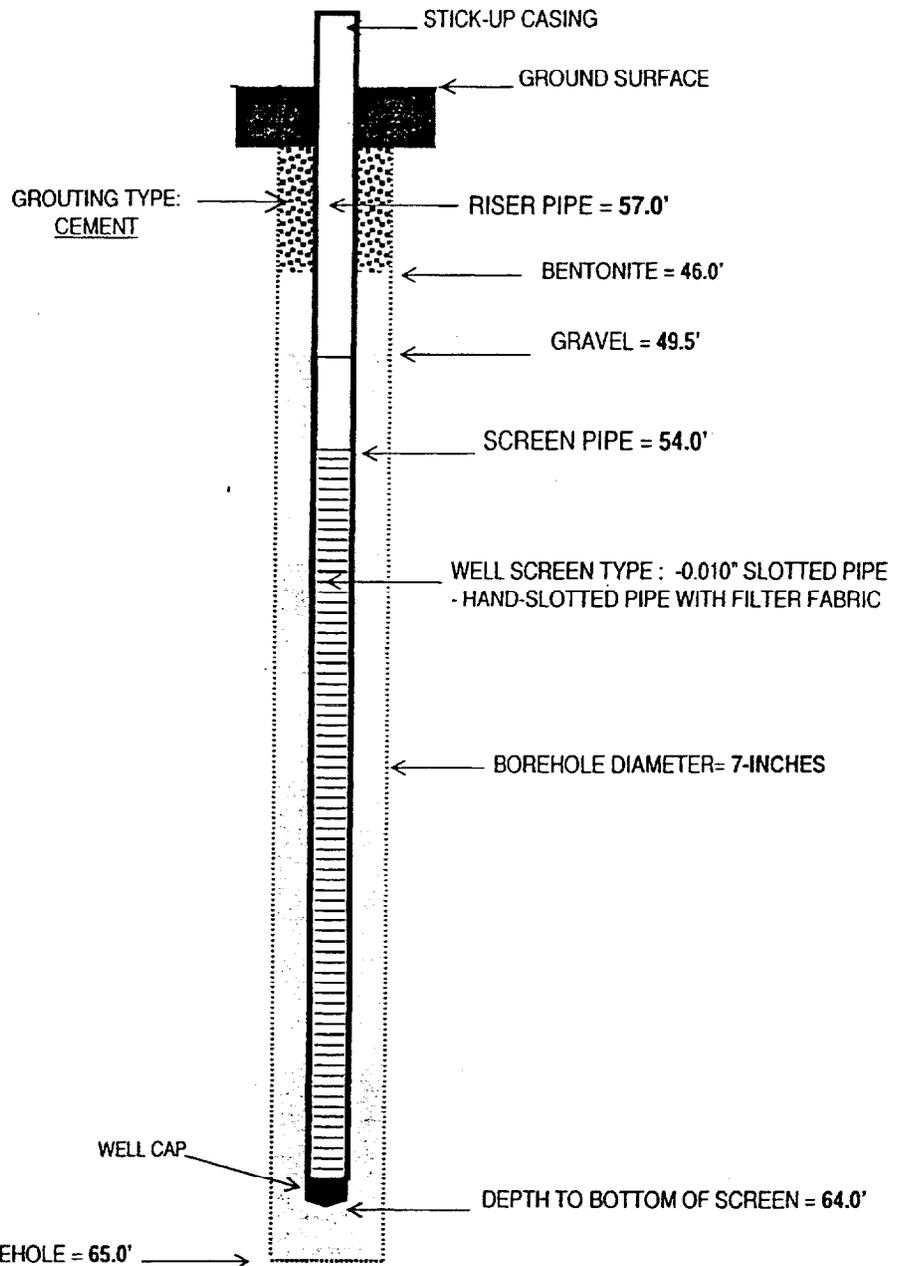
## WELL CONSTRUCTION DETAIL

- CONCRETE PAD 3x3 FEET  
AND FOUR 3" DIAMETER  
BLANK STEEL PROTECTIVE  
PIPE.

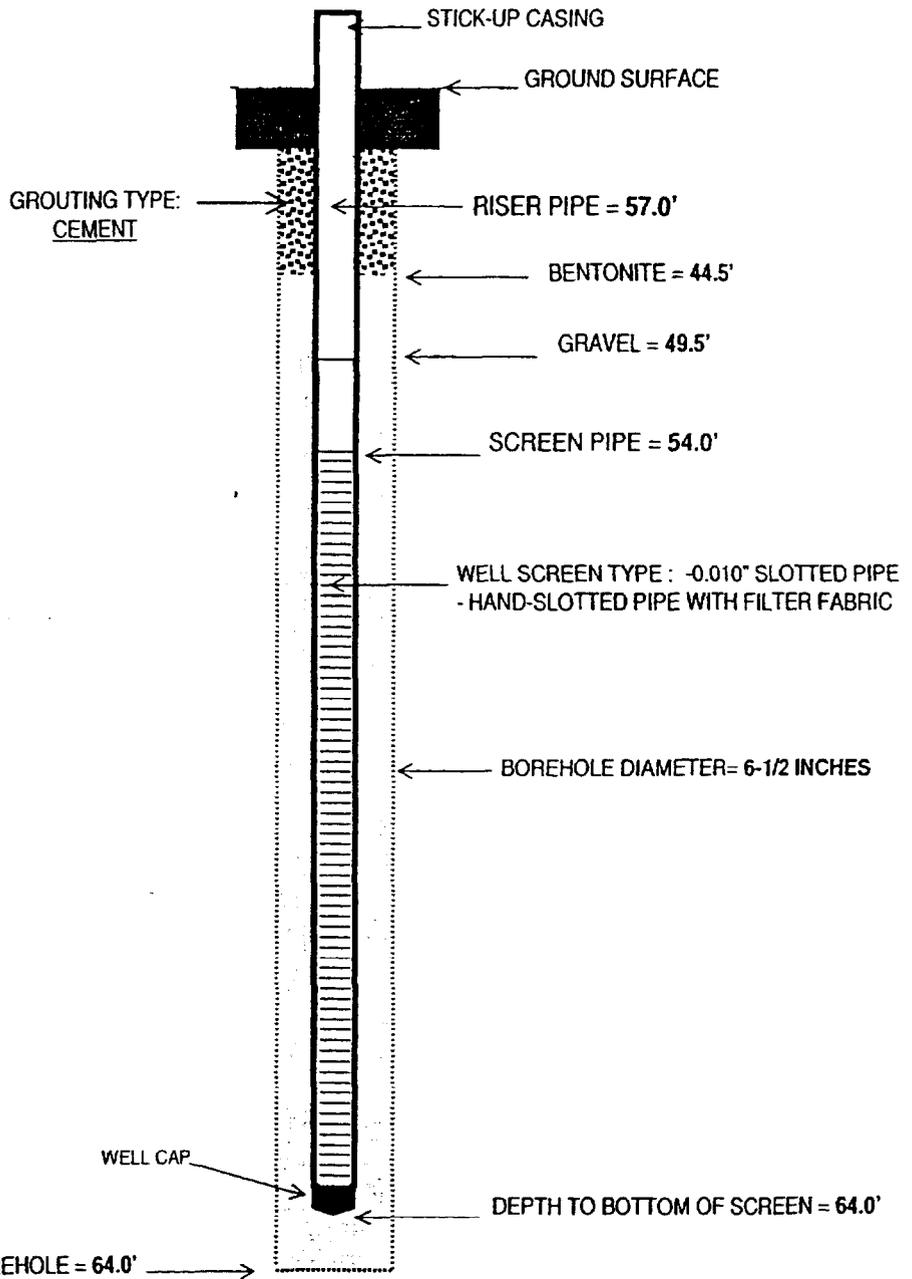
## WELL CONSTRUCTION DETAIL

- CONCRETE PAD 3x3 FEET AND FOUR 3" DIAMETER BLANK STEEL PROTECTIVE PIPE.

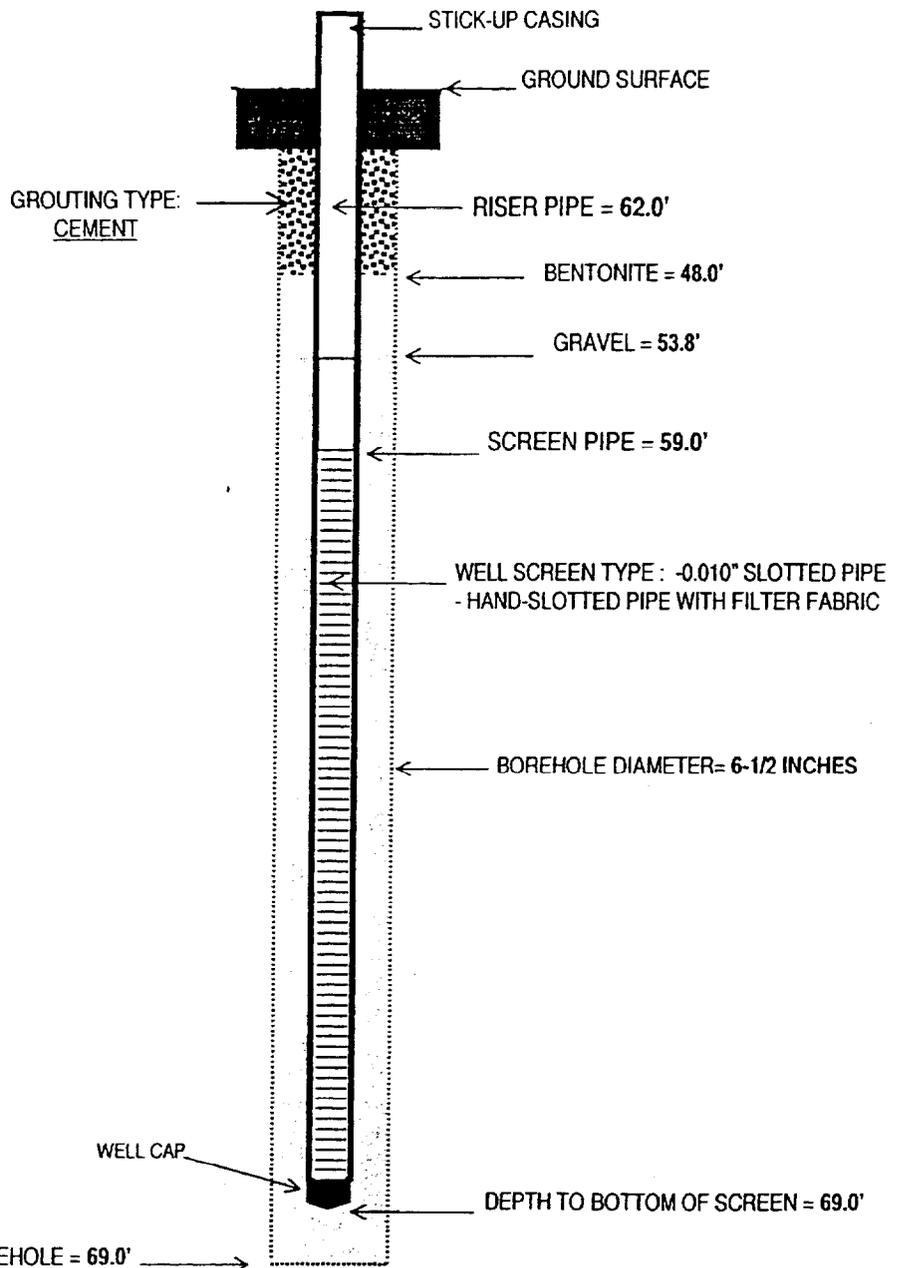
## WELL CONSTRUCTION DETAIL

- CONCRETE PAD 3x3 FEET AND FOUR 3" DIAMETER BLANK STEEL PROTECTIVE PIPE.

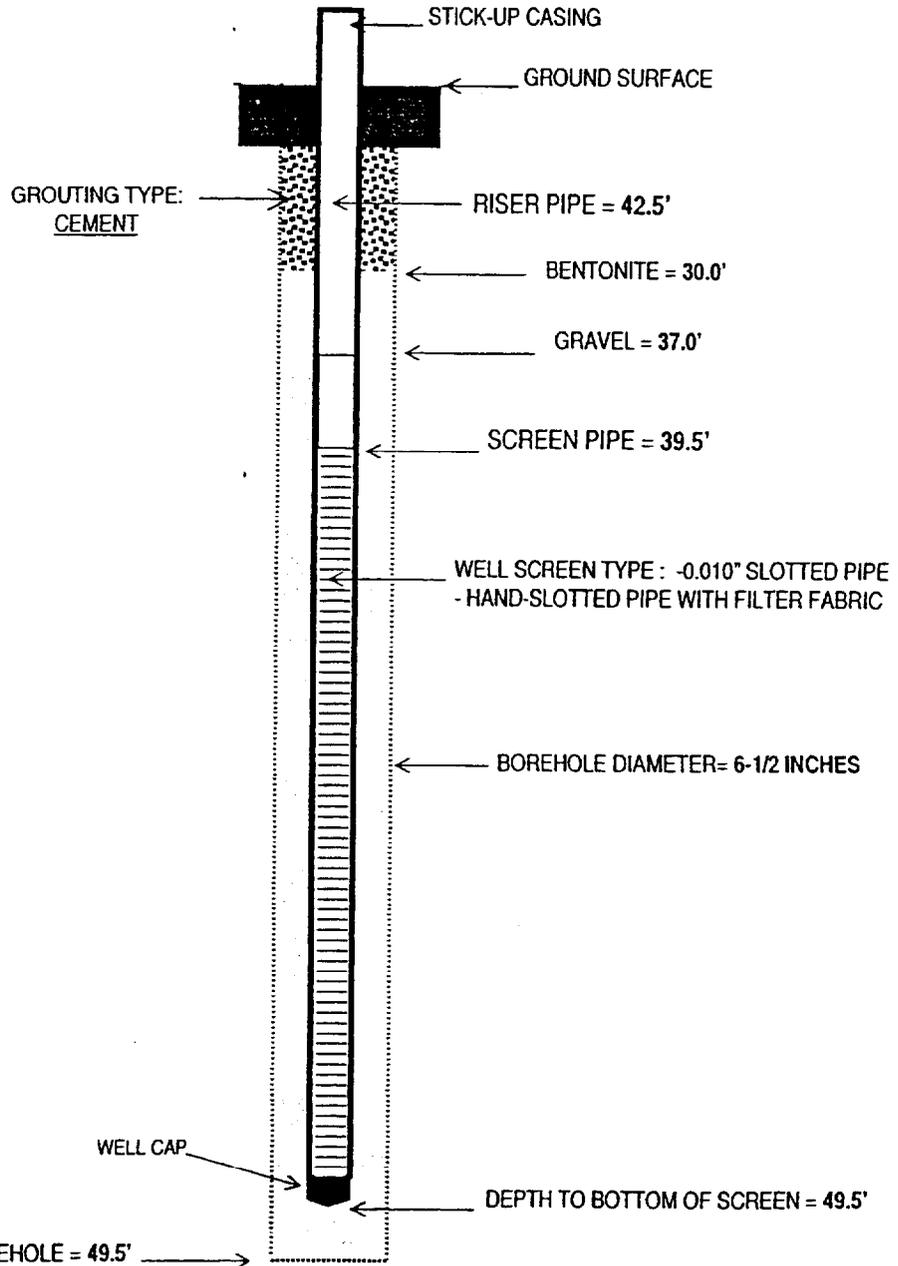
- CONCRETE PAD 3x3 FEET AND FOUR 3" DIAMETER BLANK STEEL PROTECTIVE PIPE.

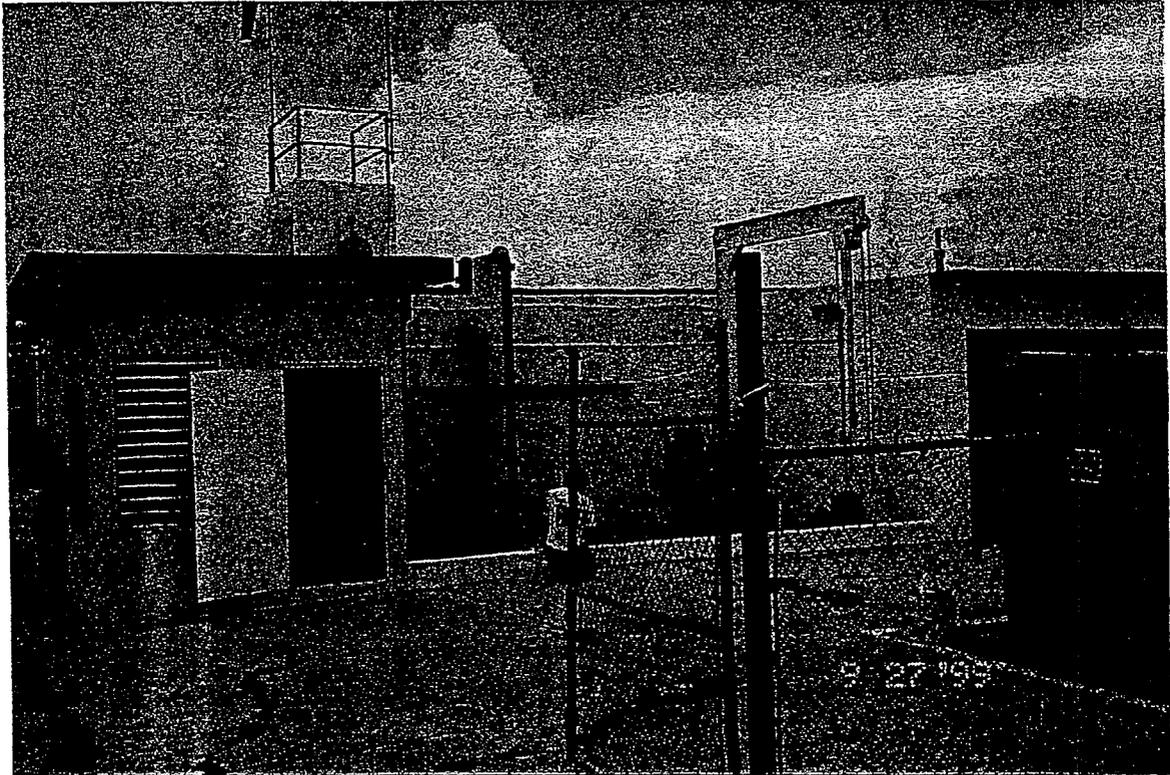
Photo # 1: The potable water from the Rio Blanco filter plant is pumped to the Arcadia tank.

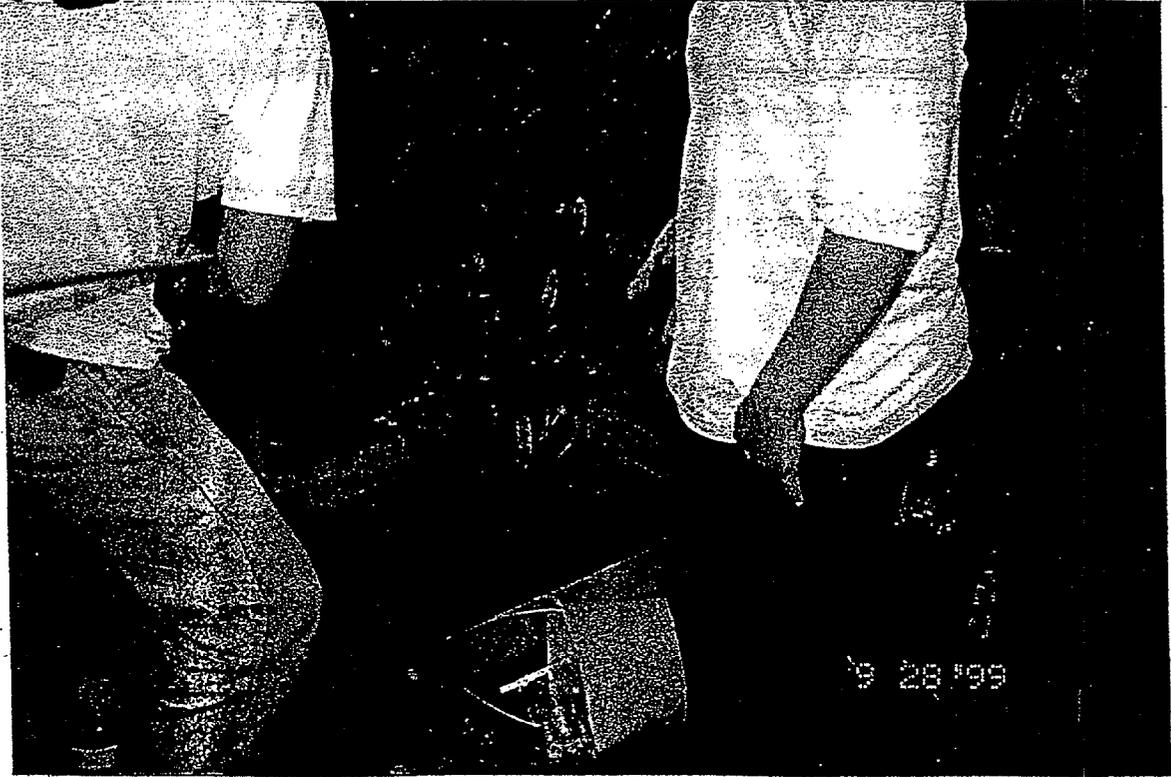
Photo # 5: [redacted] well (located on the north side of the Vieques), is not readily accessible.
