Project No. 760798
March 1995

Report

Environmental Conditions Sites 5 and 17, U.S. Marine Corps Air Station Cherry Point, North Carolina

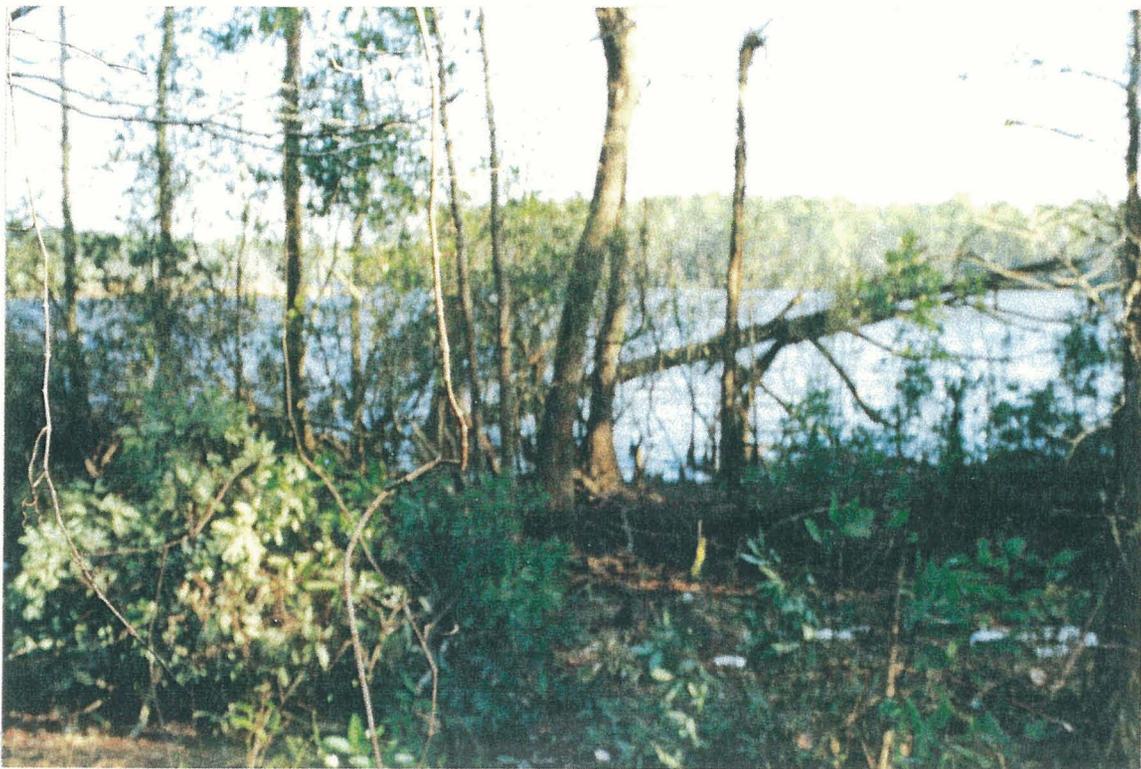
Photo 2 Wetland Vegetation, Slocum Creek in the Background (Site 5)

IT conducted a wetland investigation in November 1993, and, based on the findings, the area immediately adjacent to Slocum Creek is identified as a palustrine broad-leafed deciduous forested wetland. The canopy of wetland was dominated by sweetgum (*Liquidambar styraciflua*) and pond cypress (*Taxodium distichum*), with groundsel trees (*Baccharis hamifolia*) common in the understory (Photos 1, 2, and 3).

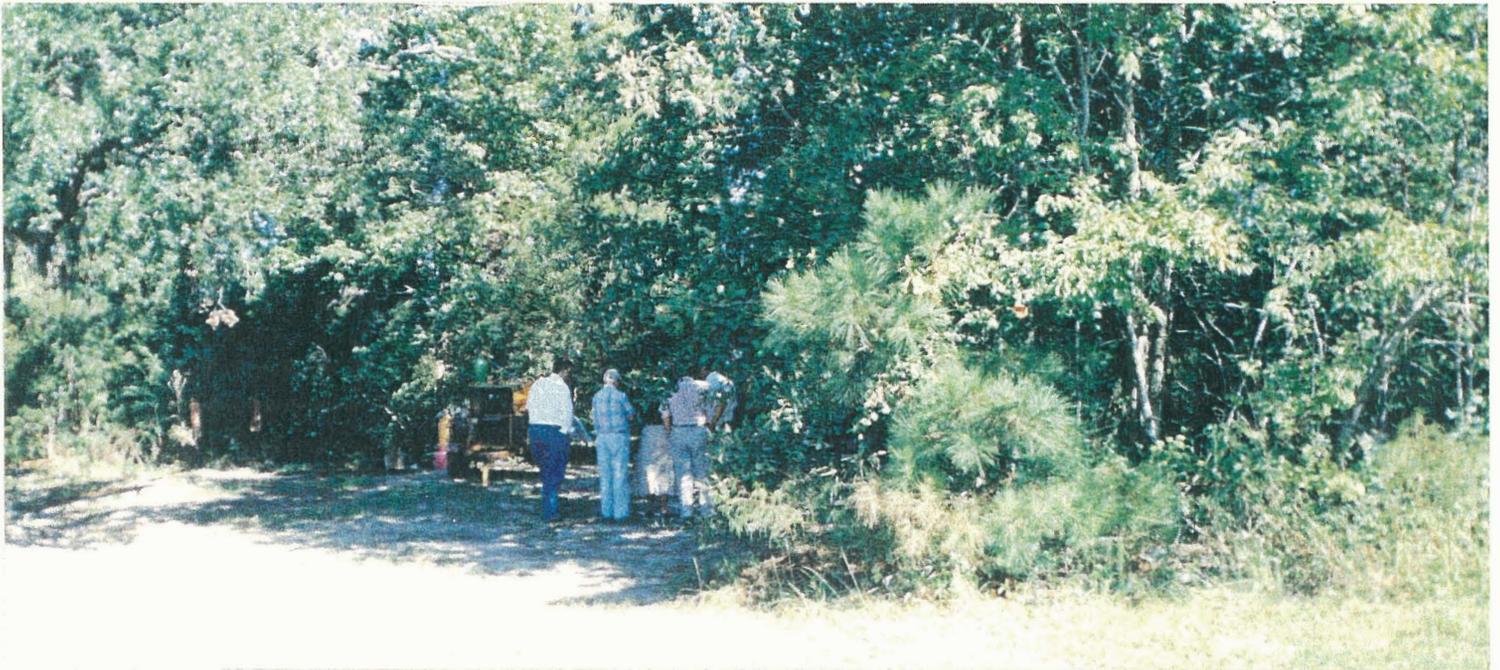
The vegetation within the upland area has underbrush consistent with a deciduous forest, with several large oaks and few pines (Photo 4).

Photo 4 Upland Vegetation, PCB Spill Area in Front of Personnel (Site 5)

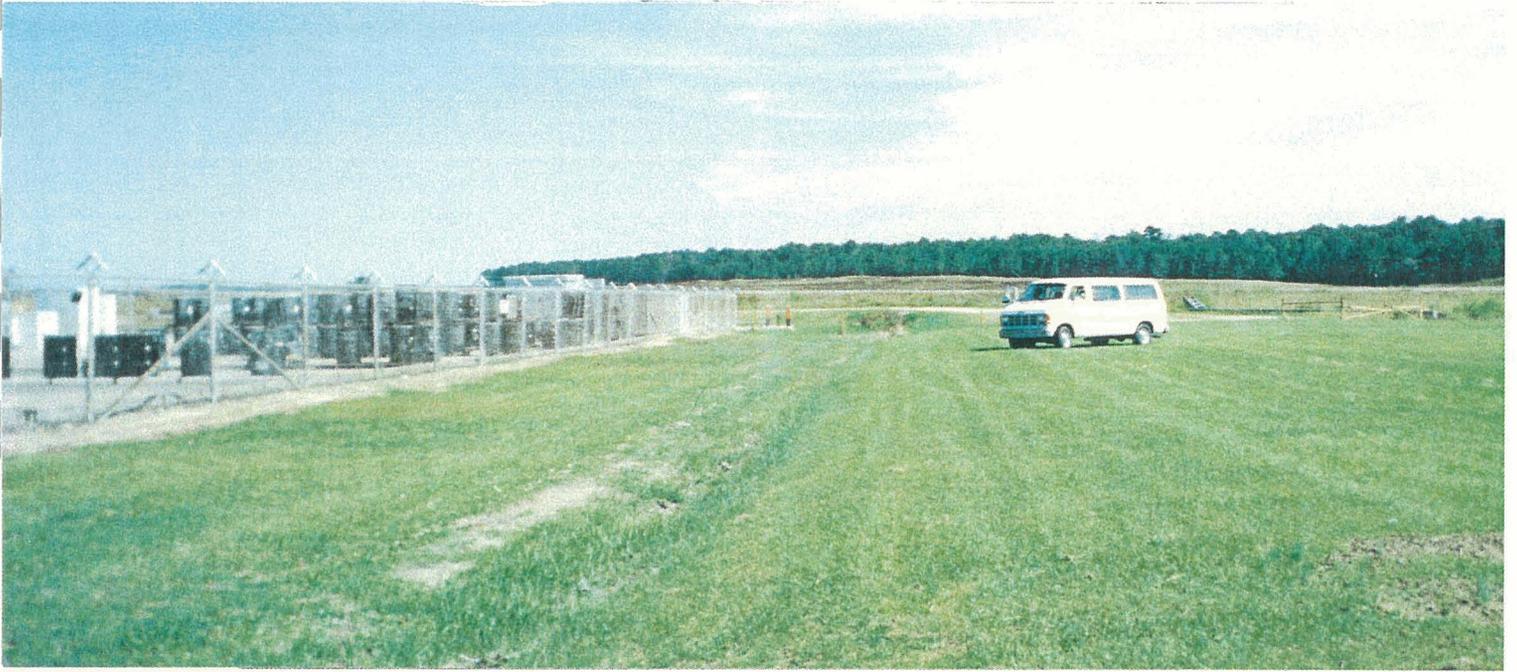
The DRMO is used as a storage area, including the storage of transformers. It was reported that PCB-containing transformers were emptied into the drainage swale from 1961 to 1968.

Site 17 is a grassed open area with no other vegetation (Photo 5).

Photo 5 Grassy Area, the Areas of Spill are to the Left of the Swale Along the DRMO Concrete Pad (Site 17)
