FINAL INTERIM MEASURES REPORT FOR SOLID WASTE MANAGEMENT UNIT 23 (SWMU
23) BATTERY SHOP BUILDING 36 NSA CRANE IN
9/1/2015
TETRA TECH

Final Interim Measures Report for SWMU 23 - Battery Shop Building 36, Naval Support Activity Crane, Indiana

**DRAFT FINAL
INTERIM MEASURES REPORT
SWMU 23 – BATTERY SHOP BUILDING 36**

**NAVAL SUPPORT ACTIVITY CRANE
CRANE, INDIANA**

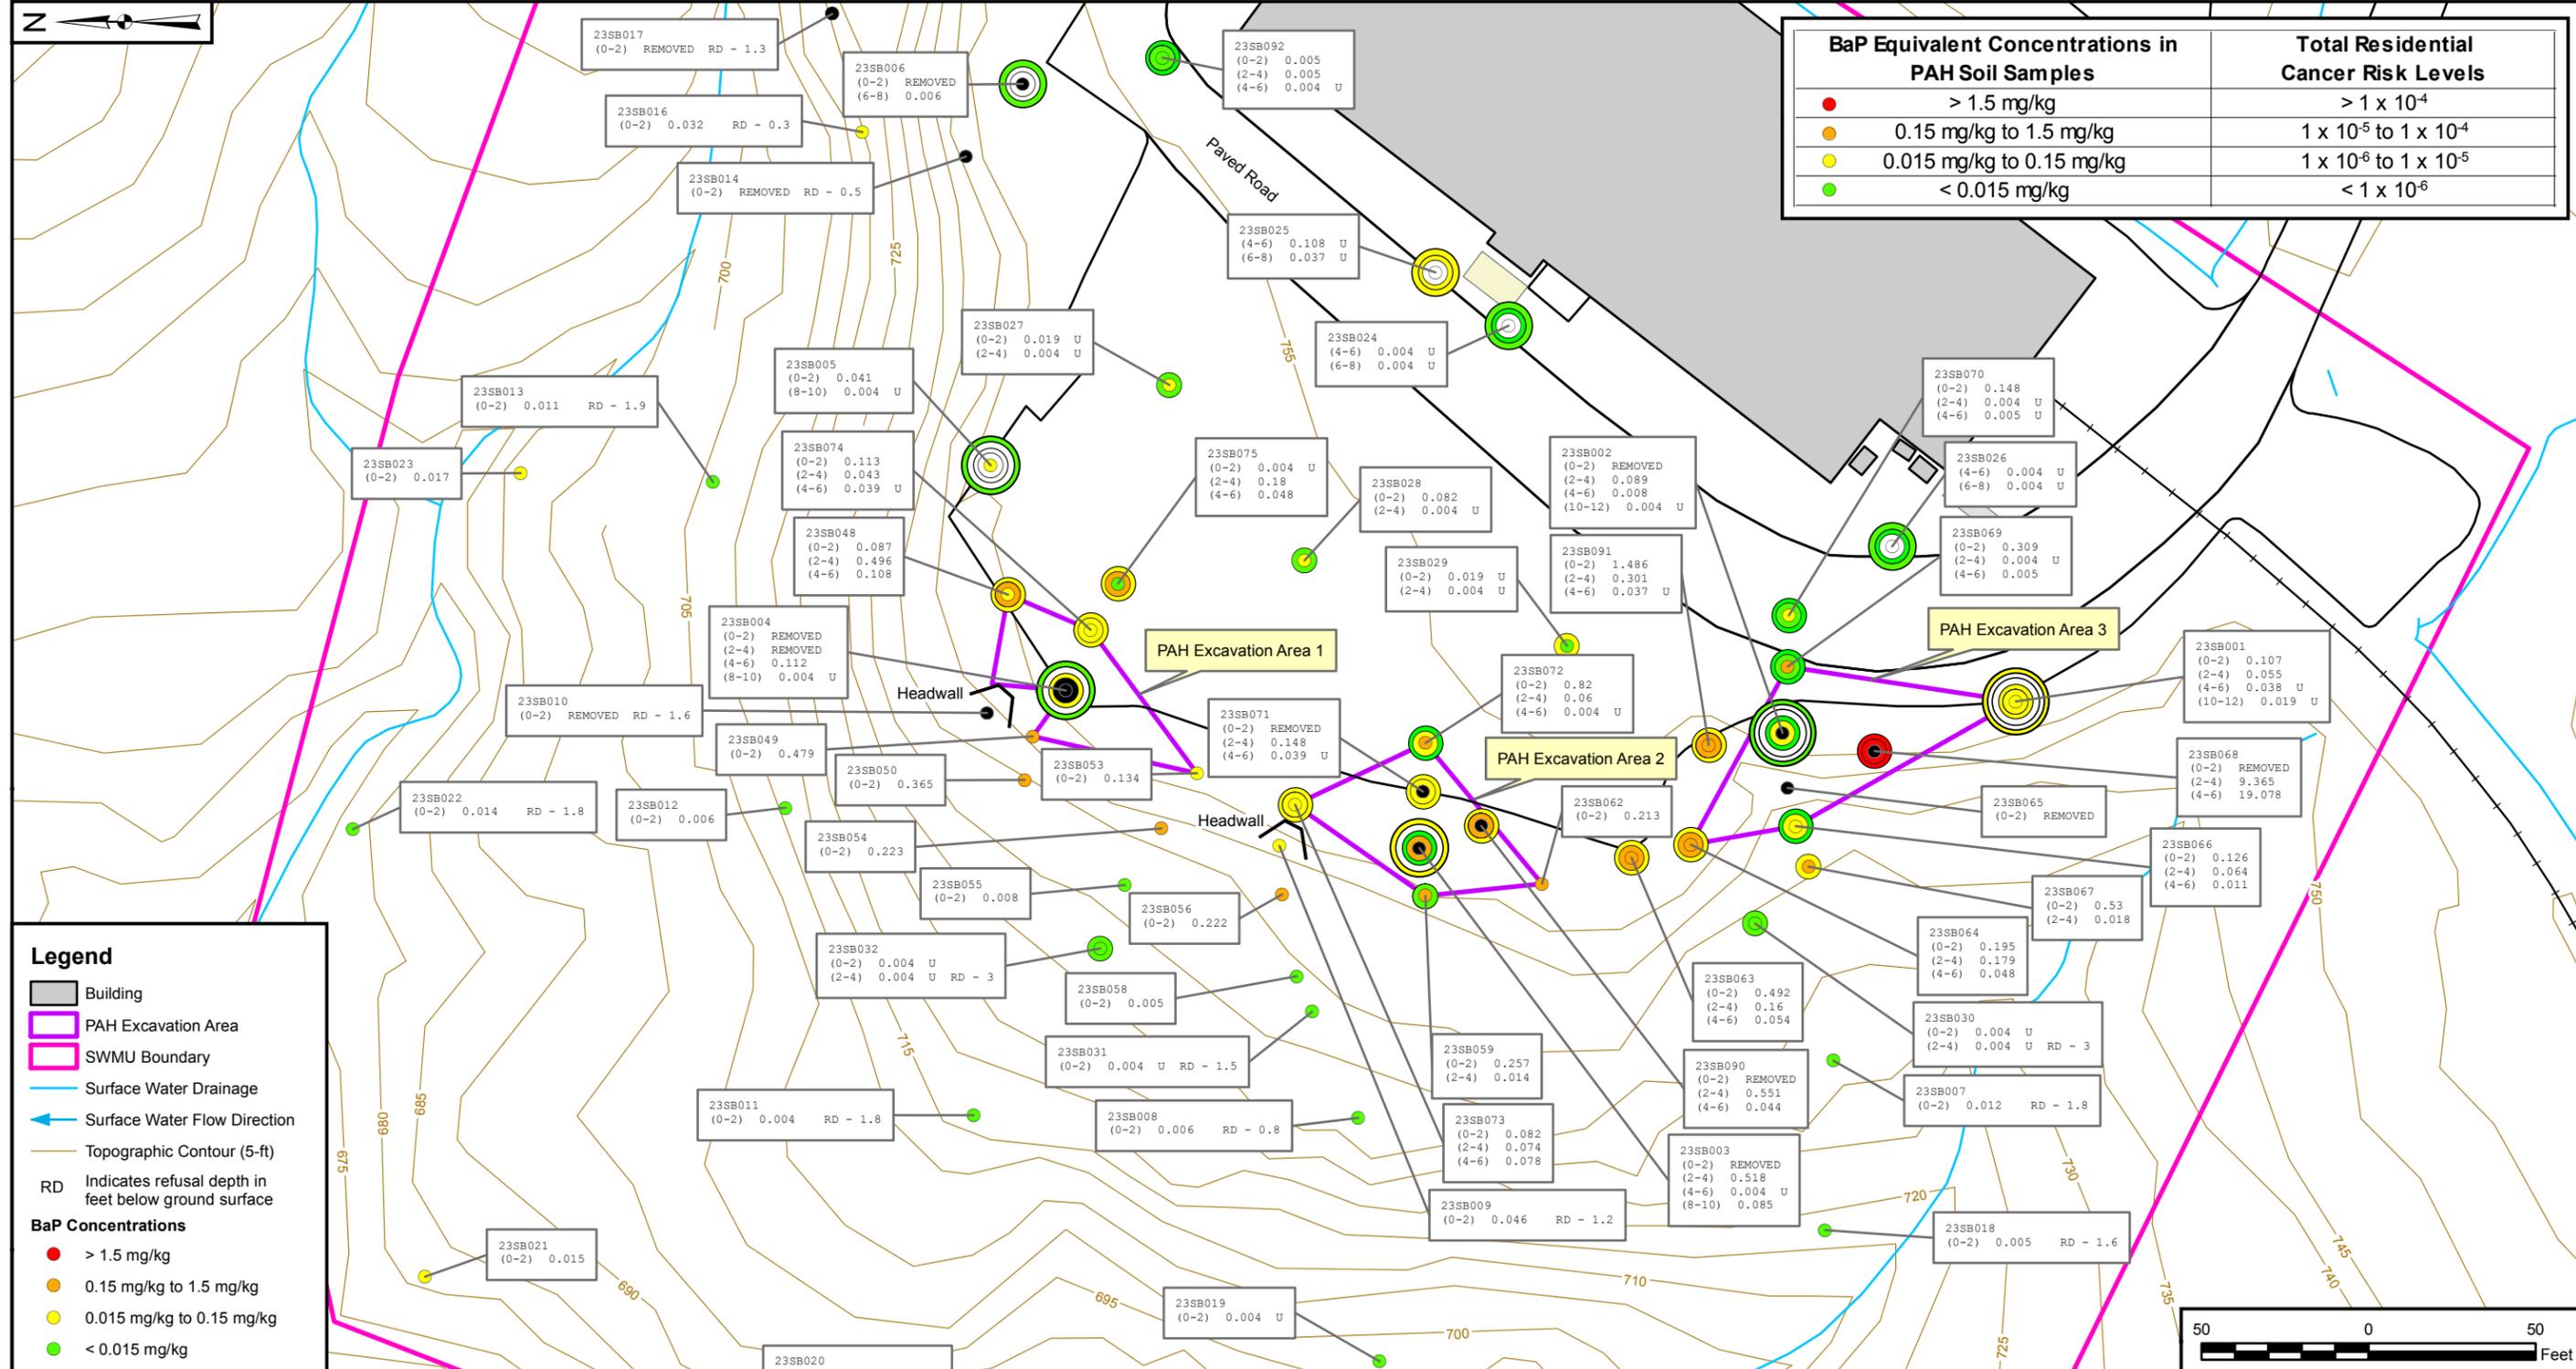
BaP Equivalent Concentrations in PAH Soil Samples	Total Residential Cancer Risk Levels
● > 1.5 mg/kg	> 1 x 10 ⁻⁴
● 0.15 mg/kg to 1.5 mg/kg	1 x 10 ⁻⁵ to 1 x 10 ⁻⁴
● 0.015 mg/kg to 0.15 mg/kg	1 x 10 ⁻⁶ to 1 x 10 ⁻⁵
● < 0.015 mg/kg	< 1 x 10 ⁻⁶

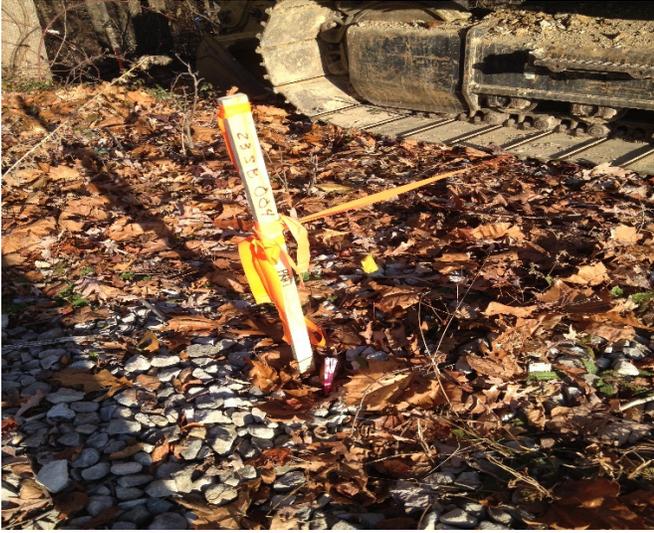
Photo A-1: Typical survey stake (excavation node) for marking extent of excavation area.

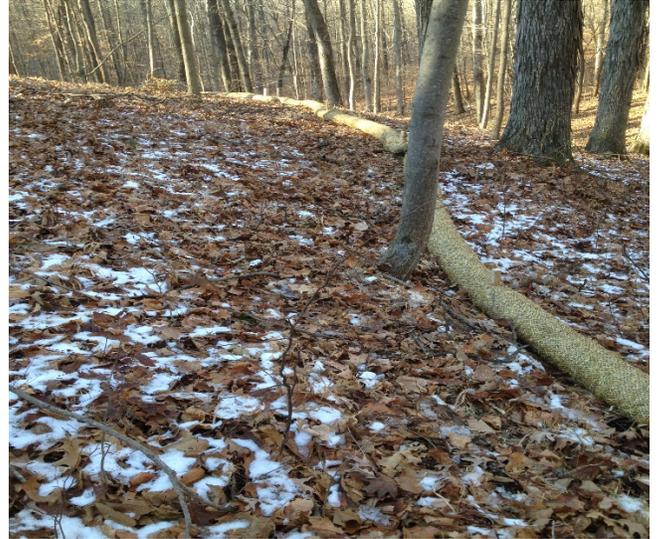
Photo A-2: Straw wattles placed around the down slope perimeter of the site for erosion control purposes.

Final erosion control measures consisted of maintaining the straw wattles which were anchored along the down slope boundaries of the project work areas. The wattles chosen for SWMU 23 were biodegradable, which allowed them to be left in place.

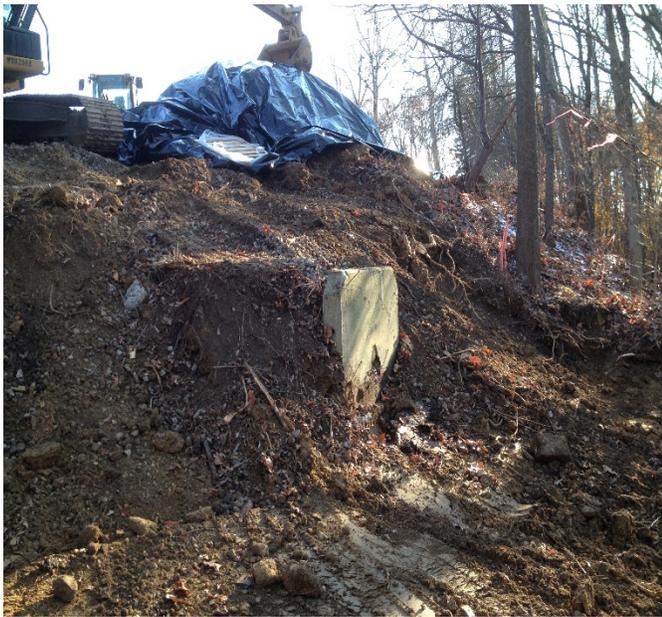
Photo A-3: Excavation around an existing headwall within Lead Area 1. Soil stockpiled in PAH Area 1.

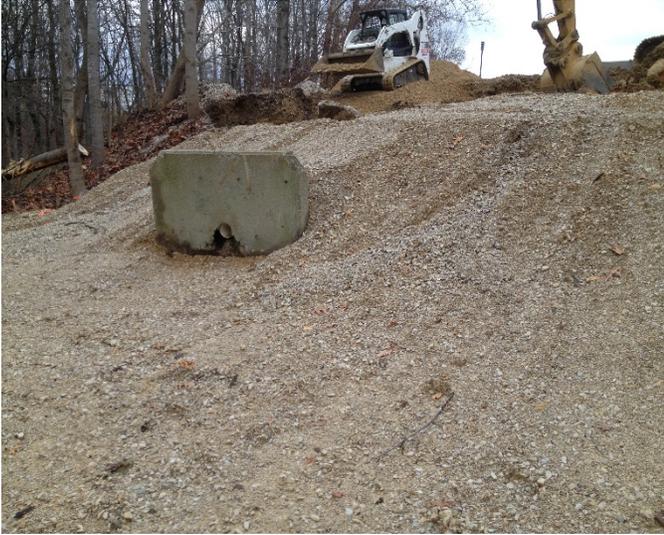
Date: 11/24/14	View: Northeast	Photographer: J. Goerd
Photo A-5: Backfill material being placed around the existing headwall in Lead Area 1.

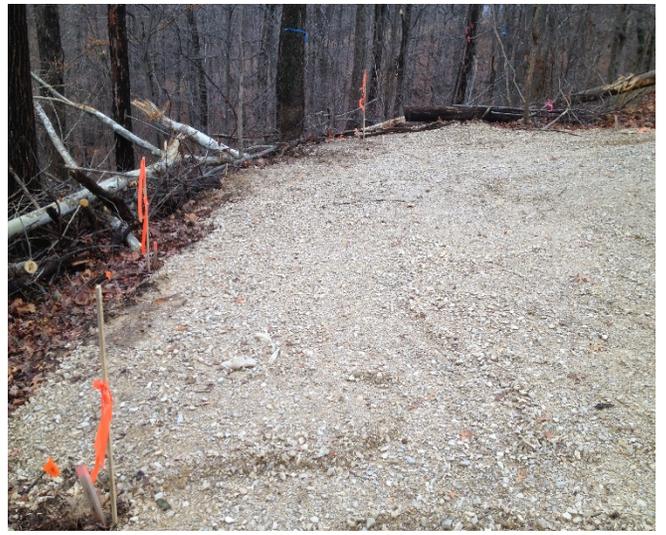
Date: 11/24/14	View: North	Photographer: J. Goerd
Photo A-6: Backfill material to grade within Lead Area 1.

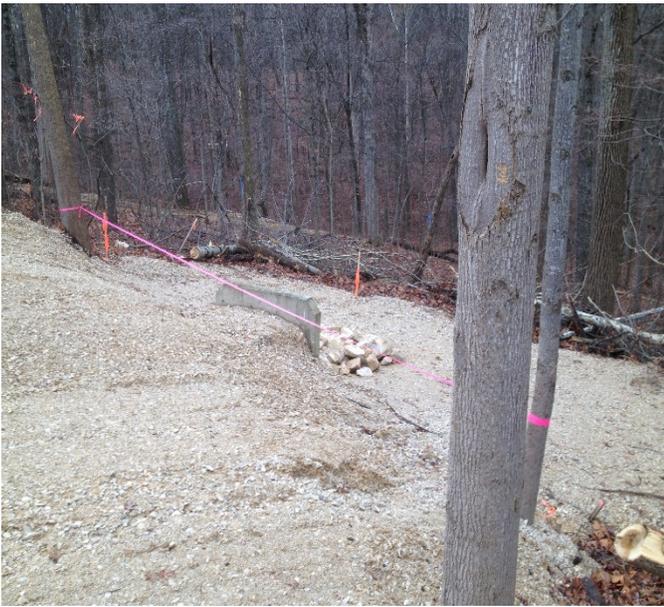
Date: 12/10/14	View: West	Photographer: J. Goerd
Photo A-7: Final grade in Lead Area 1. Also showing larger rocks placed in front of headwall for stabilization.

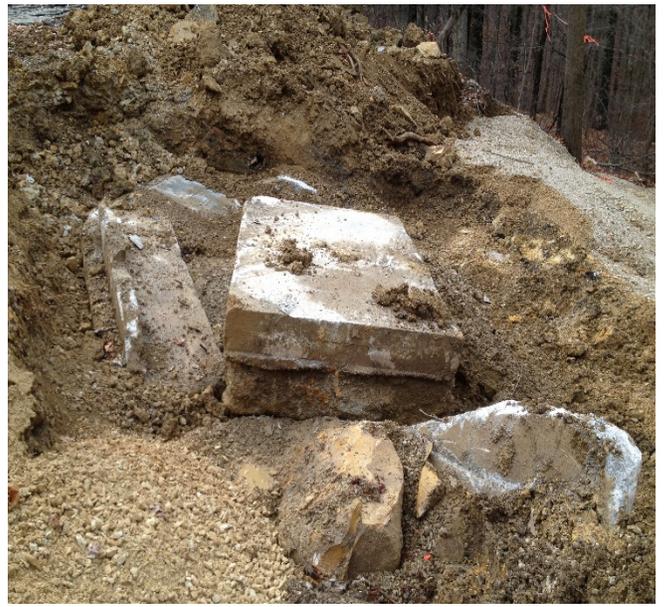
Date: 11/24/14	View: West	Photographer: J. Goerd
Photo A-8: Large pieces of concrete unearthed during excavation activities within PAH Area 1.

of the NSA Crane PWD FEAD, the few large pieces of concrete, which were hand cleaned of all attached soil, were replaced within the excavation to help stabilize the steep bank of the hillside.

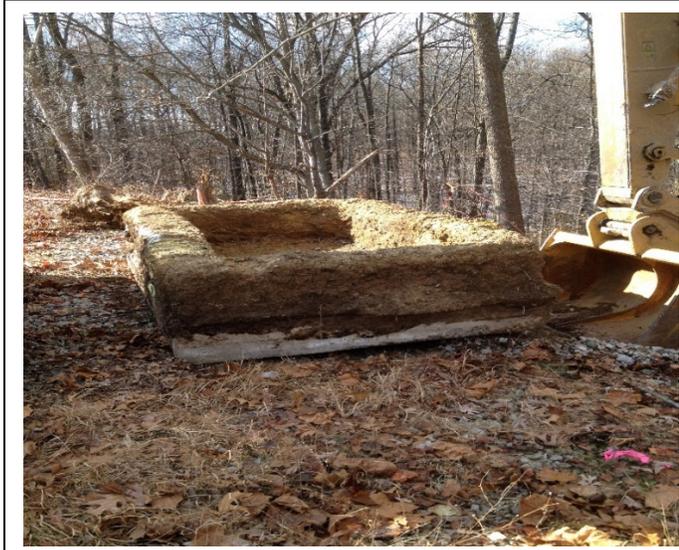
Photo A-9: Large concrete slab unearthed from PAH Area 1 with an approximate 16-inch footer around its perimeter. Slab is shown upside down.

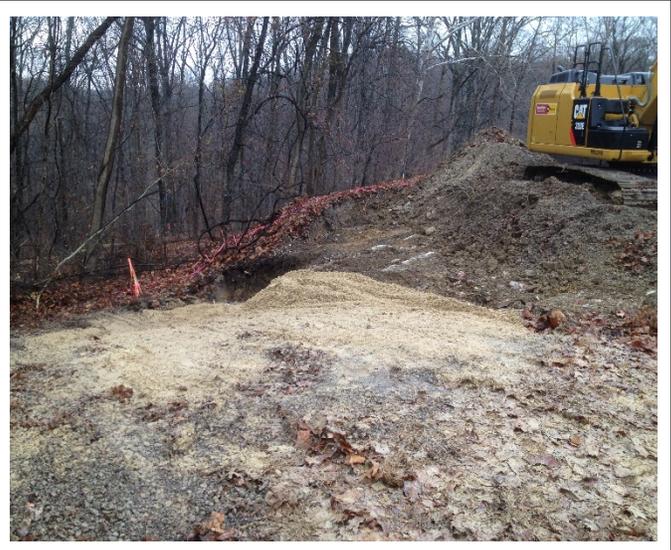
Photo A-10: Excavation activities within PAH Area 2.

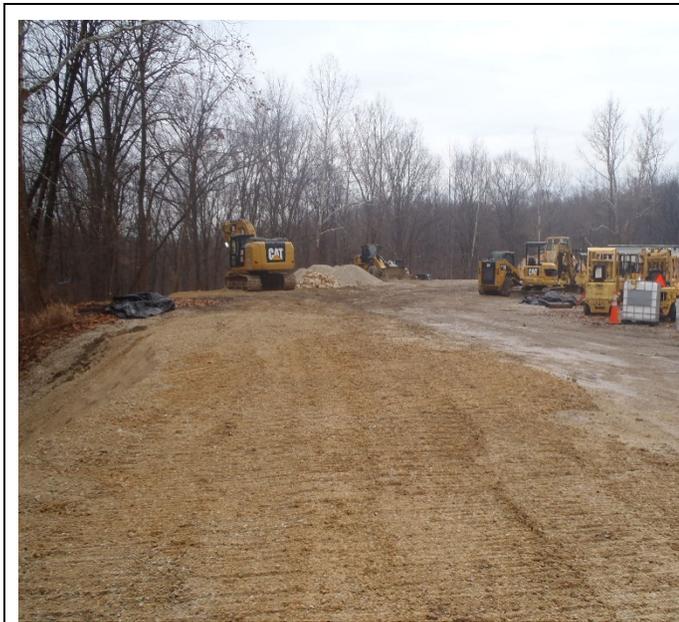
Photo A-11: Backfilling of PAH Area 2.

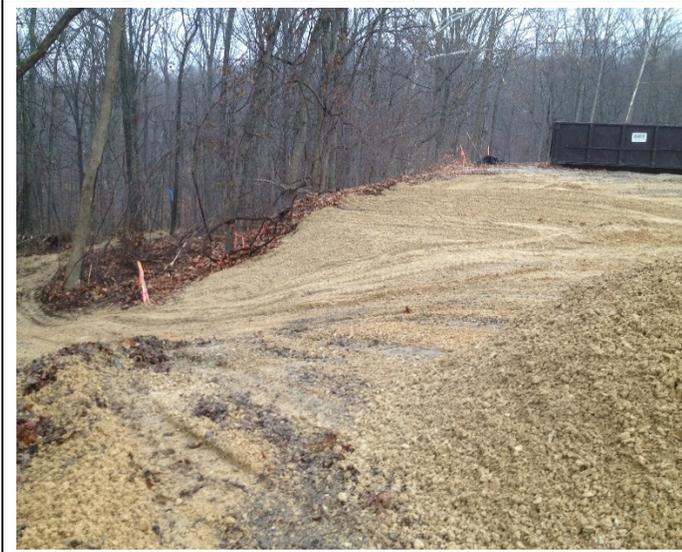
Photo A-13: PAH Area 2 with area to the left showing path leading down to Lead Area 3.

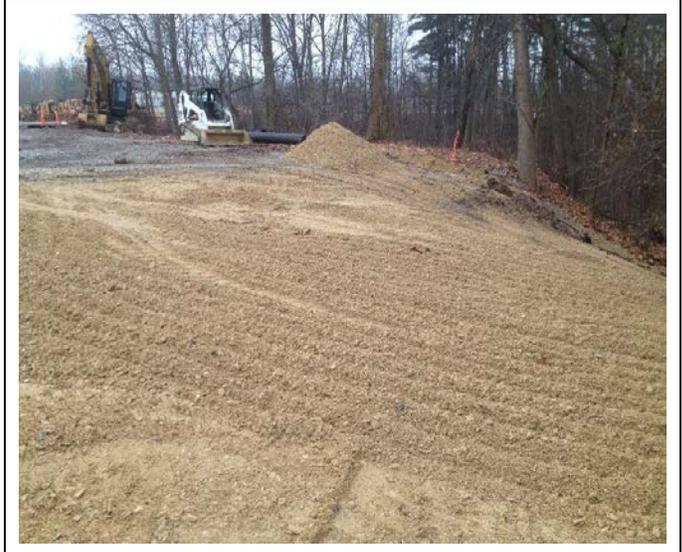
Photo A-14: Final grade of PAH Area 2.

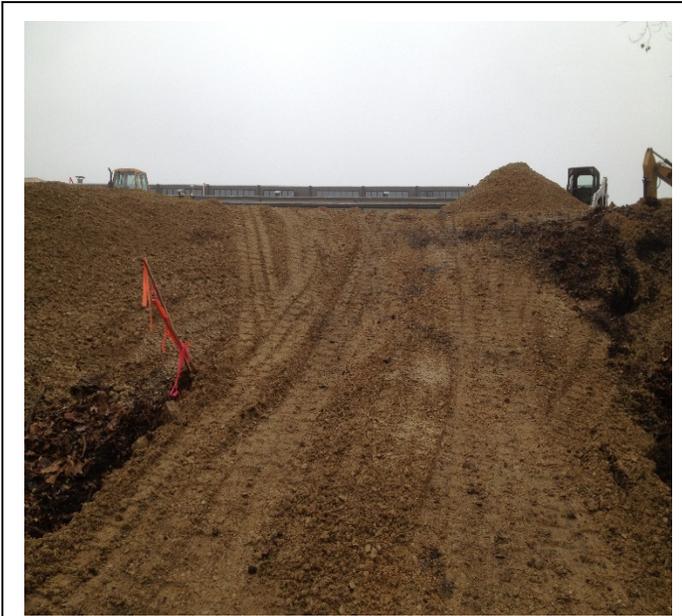
Photo A-15: Path leading down to Lead Area 3 originating from PAH Area 2.

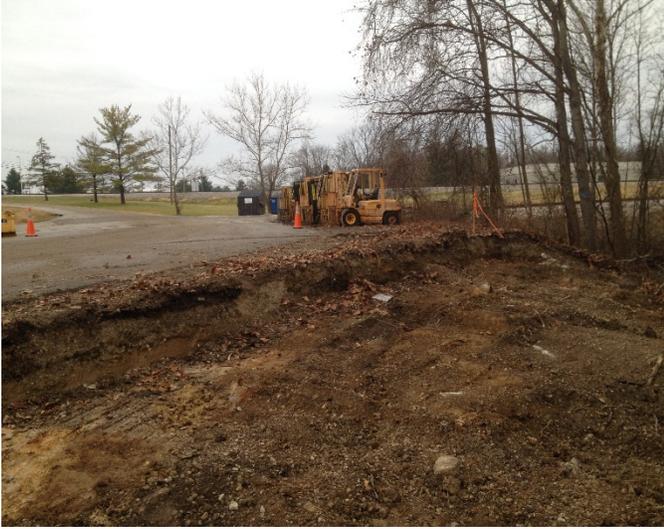
Photo A-17: Southwest wall of PAH Area 3.

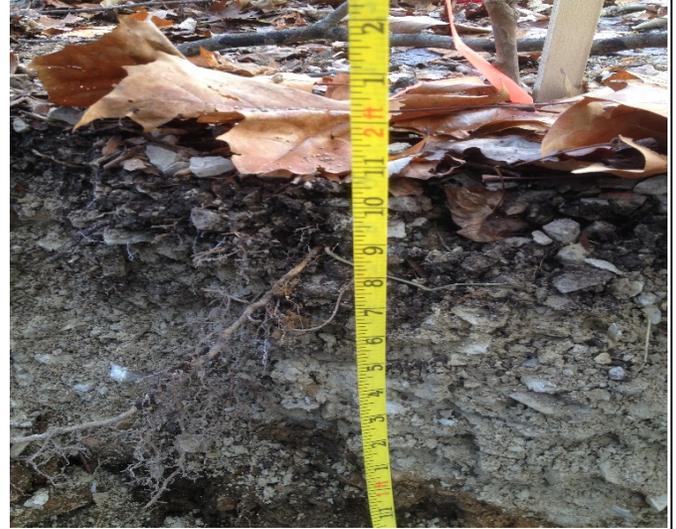
Photo A-18: Measurement of 2-foot excavation wall within PAH Area 3.

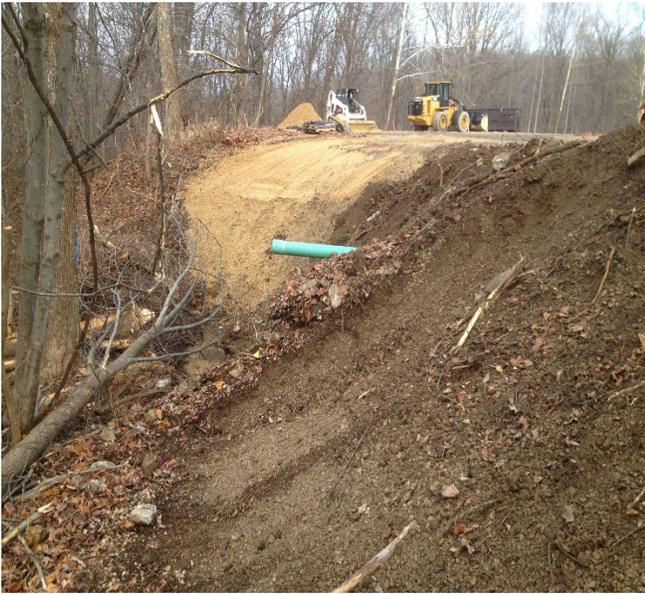
An approximate 6-inch storm drain pipe terminated within the excavation of PAH Excavation Area 3 (Photo A-19 in Appendix A). The pipe was left in place, and VRHK carefully removed the soil around it. Backfill was immediately placed around the pipe after excavation in that area was completed to ensure that the pipe was not damaged. The entire excavation was backfilled with #53 crushed stone as soon as the excavation was complete.

Photo A-19: Initial backfill being placed within PAH Area 3 showing drain pipe.

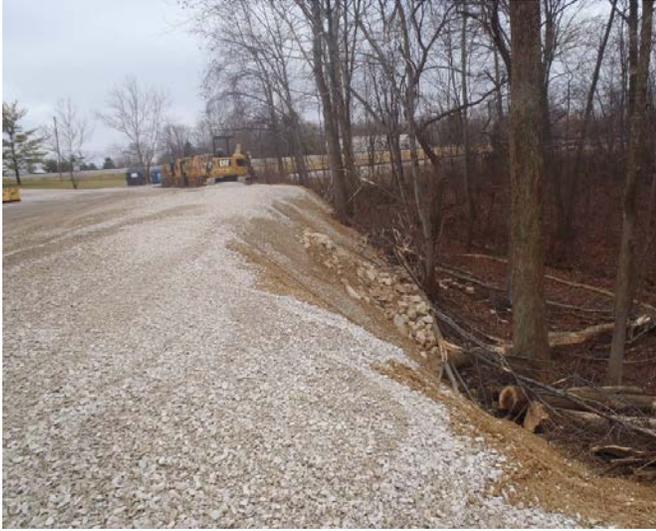
Photo A-21: View of PAH Area 3 after placement of larger gravel.

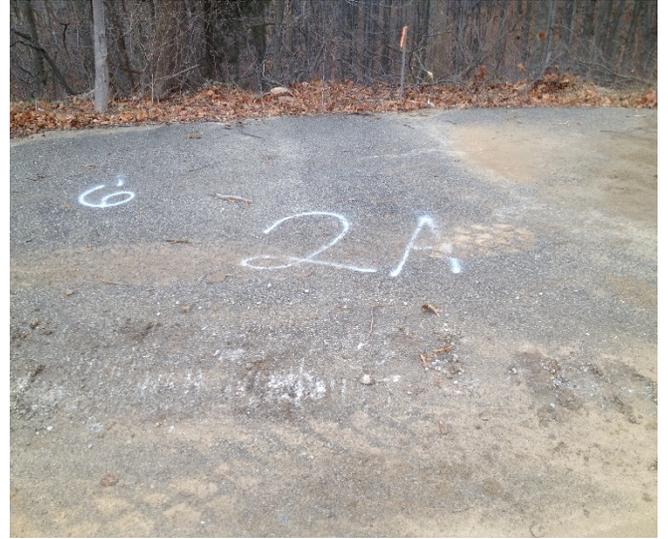
Photo A-22: Condition of asphalt in Lead Area 2 prior to initiating excavation activities to 6-foot depth.

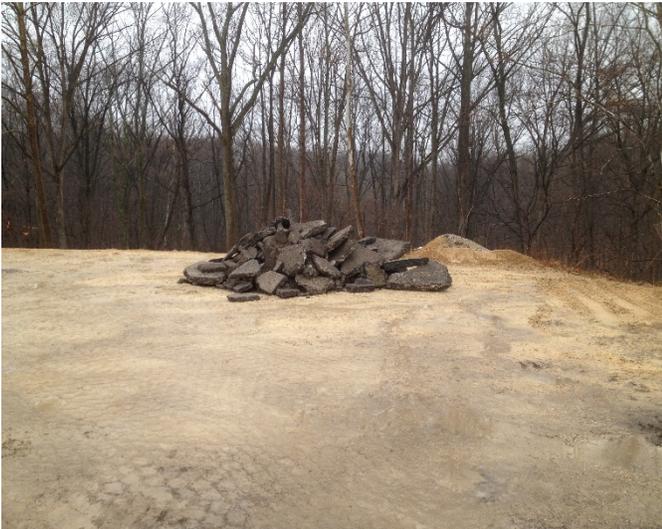
Photo A-23: Asphalt removed from Lead Area 2 and stockpiled prior to excavation.

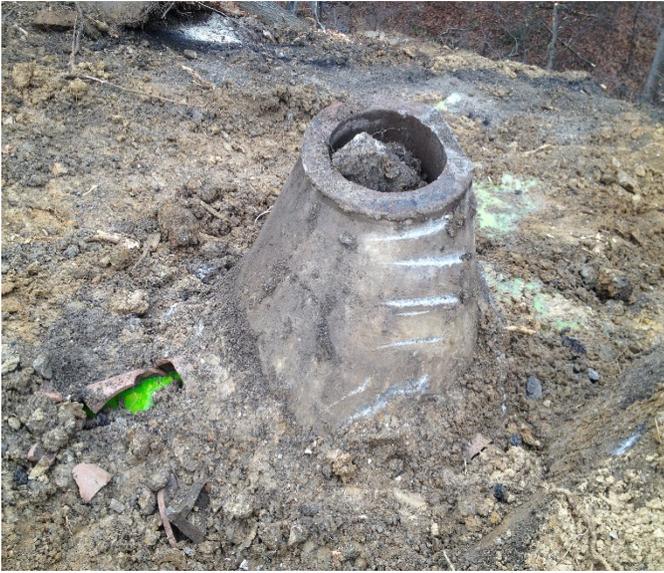
was still active (Photo A-25 in Appendix A, and NAVFAC Drawing Number 2009997 in Appendix E). The vitrified clay pipe leading into the manhole from the southern excavation wall approximately 12 feet away had been damaged, and Public Works began replacement of this section of pipe. A small portion of the outfall pipe, which leads to a nearby lift station, was also slightly damaged and was repaired. It was then discovered that the bottom of the manhole had a large crack in the bottom; therefore, Public Works decided to replace the entire manhole with a new one (Photo A-26 in Appendix A). This work took approximately 1 day, and was completed while waiting for the Lead Excavation Area 2A confirmation samples analytical results; consequently, no down time to VRHK resulted from the manhole replacement.

Photo A-25: Dye test performed on manhole in Lead Area 2 by NSA Crane personnel indicating it is still active.

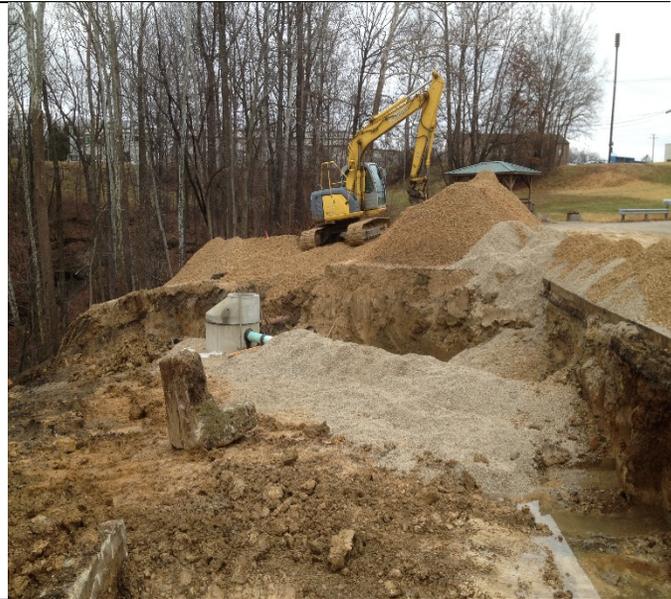
Photo A-26: Manhole was raised to current grade and new piping connected to inlet and outlet prior to backfilling Lead Area 2.

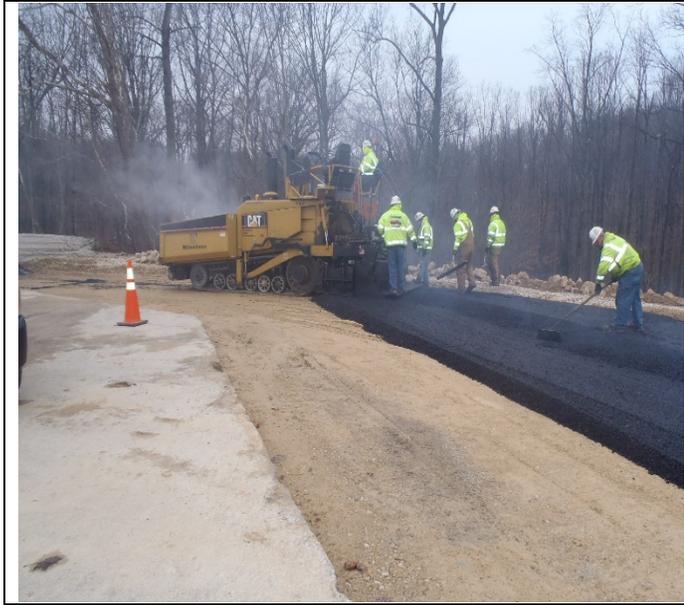
Photo A-29: Applying asphalt in Lead Area 2.

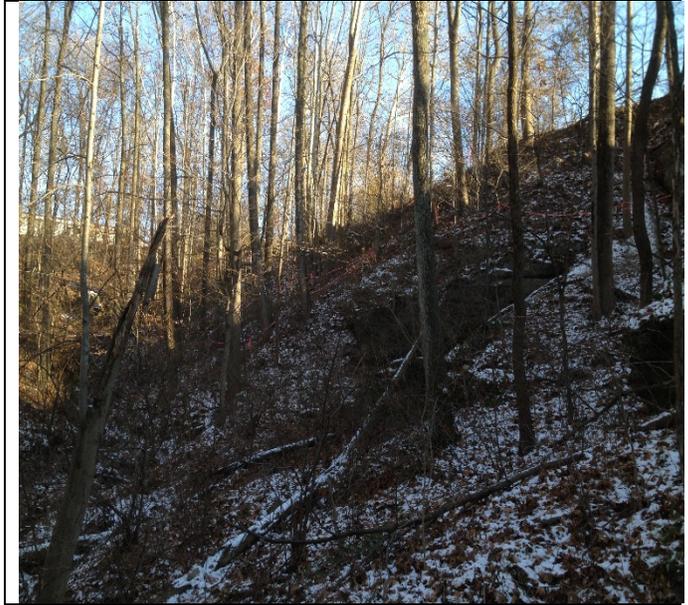
Photo A-30: Lead Area 3 prior to initiating excavation activities.

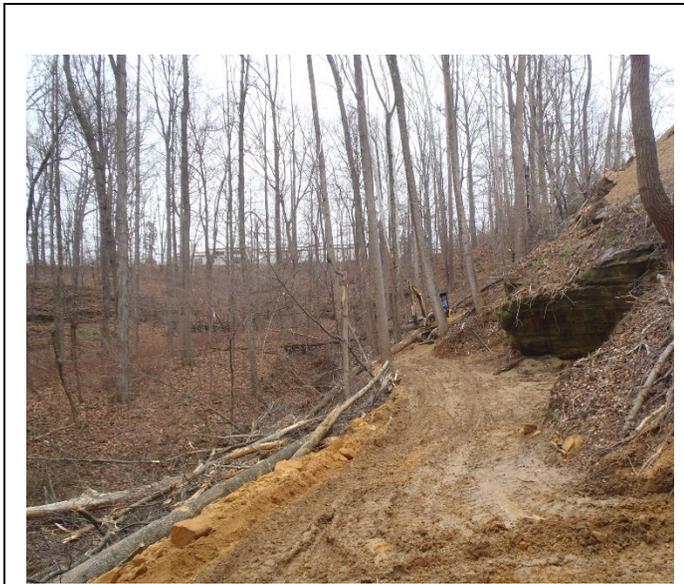
Photo A-31: Path leading from PAH Area 2 to Lead Area 3.

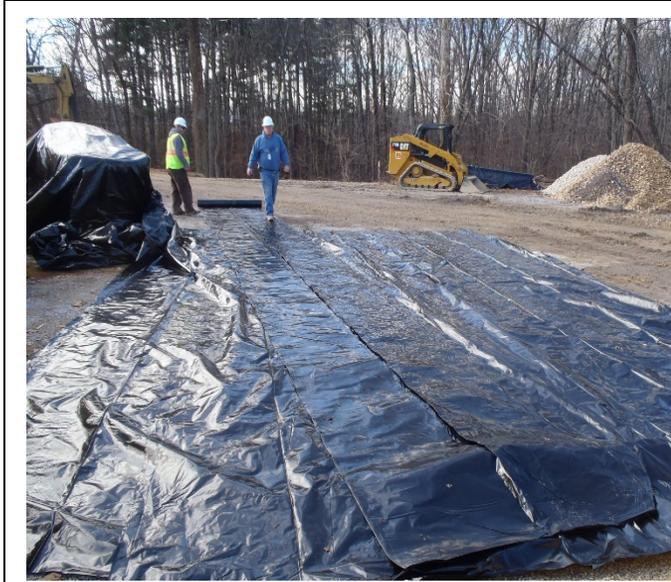
Photo A-33: Covering asphalt with thick plastic sheeting prior to placing soil excavated from Lead Area 3.

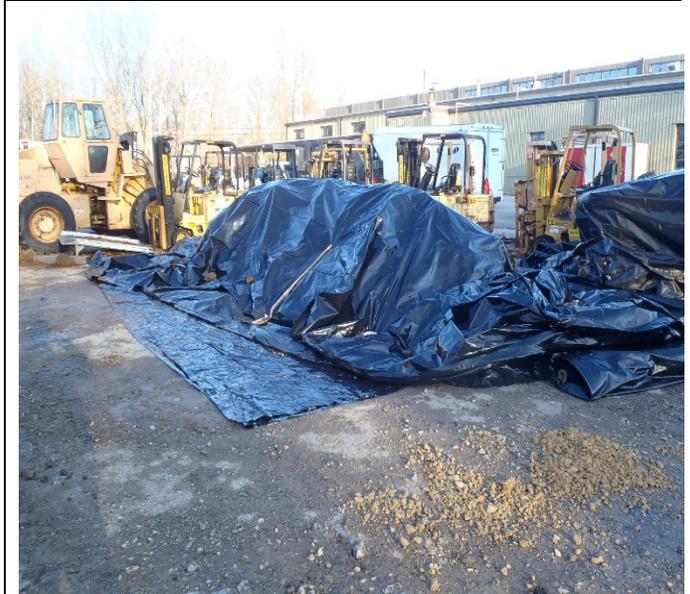
Photo A-34: Stockpiled soil from Lead Area 3 staged on plastic sheeting and covered overnight.

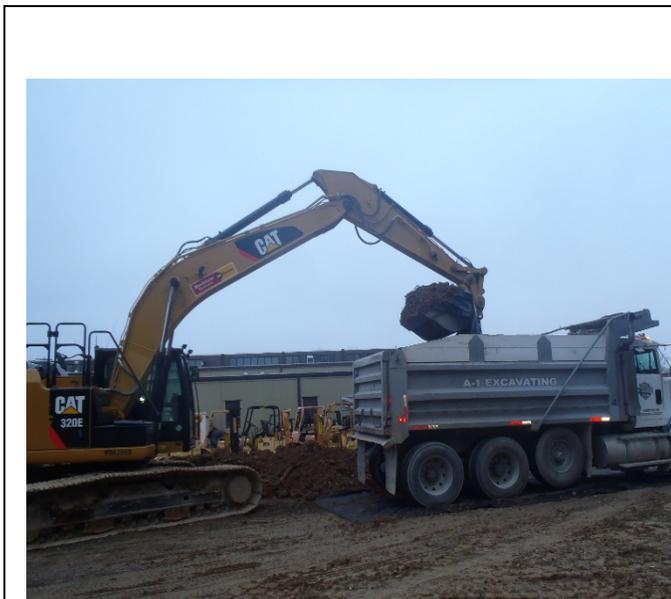
Photo A-35: Transferring Lead Area 3 soil from stockpile to truck.

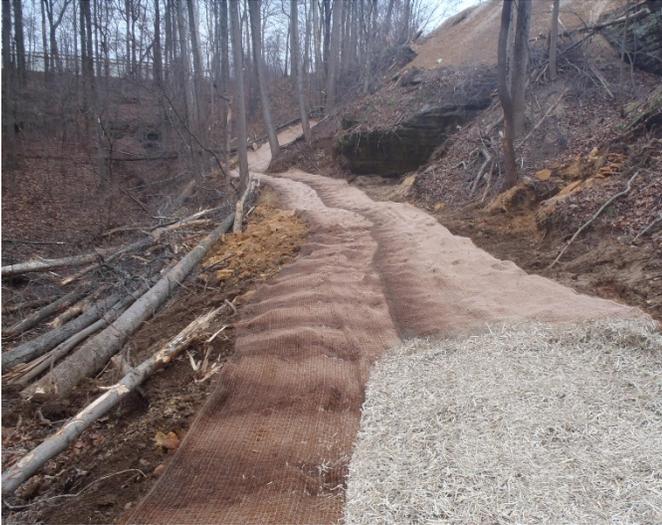
Photo A-37: Straw matting being placed on path which lead to Lead Area 3.

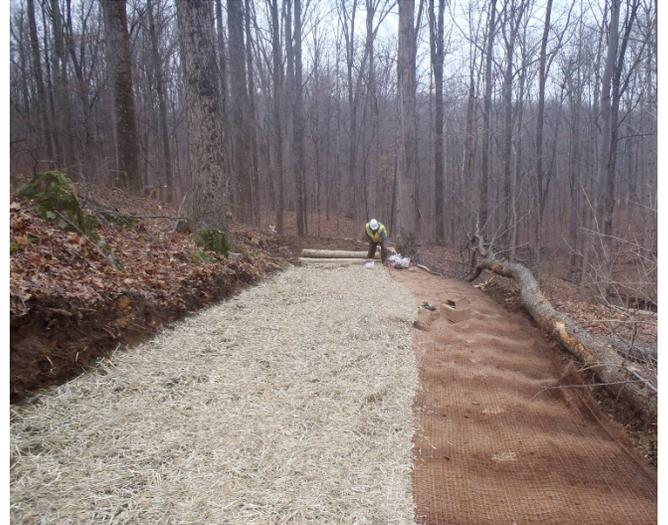
Photo A-38: Straw matting being placed on path which lead to Lead Area 3.

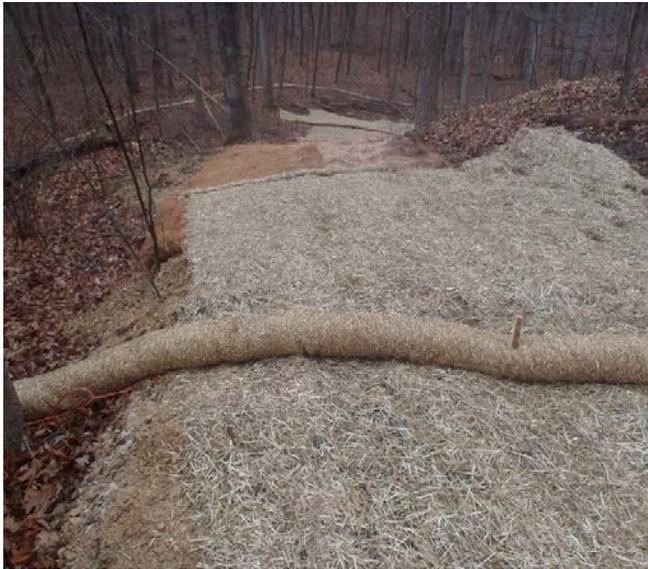
Photo A-39: Straw matting on path originating from PAH Area 2.

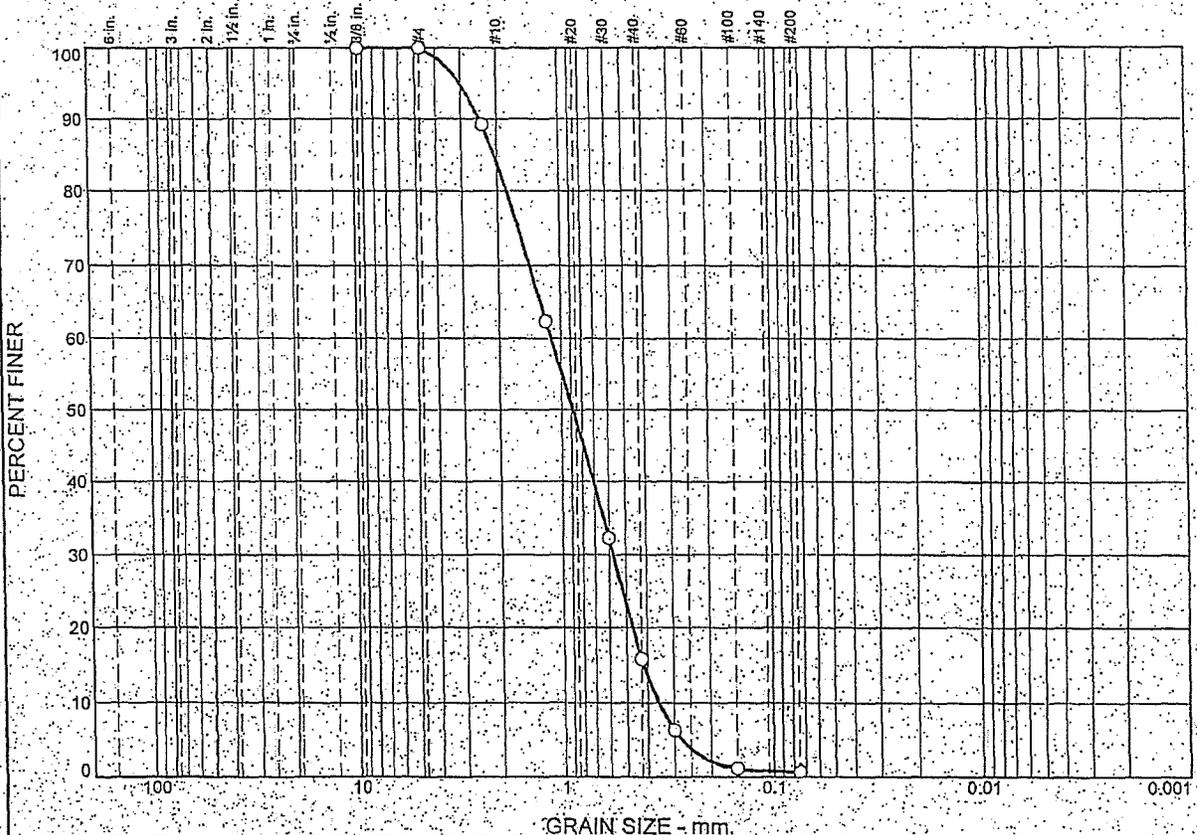
GRAIN SIZE DISTRIBUTION REPORT

% +3"	% Gravel		% Sand			% Fines			
		Coarse	Fine	Coarse	Medium	Fine	Silt	Clay		
○	0.0	0.0	0.0	16.1	68.1	15.1	0.7			
×	LL	PL	D ₈₅	D ₆₀	D ₅₀	D ₃₀	D ₁₅	D ₁₀	C _c	C _u
○			2.0671	1.1159	0.8822	0.5730	0.4163	0.3556	0.83	3.14
Material Description							USCS	AASHTO		
○ #23 Sand / #4 SBF							SP			
Project No: 160642 Client: VCNA Prairie Project: Bloomfield Location: Bloomfield							Remarks: ○ No, 200 Decant % Loss: 0.6			
BOWSER-MORNER, INC.										
Dayton, Ohio

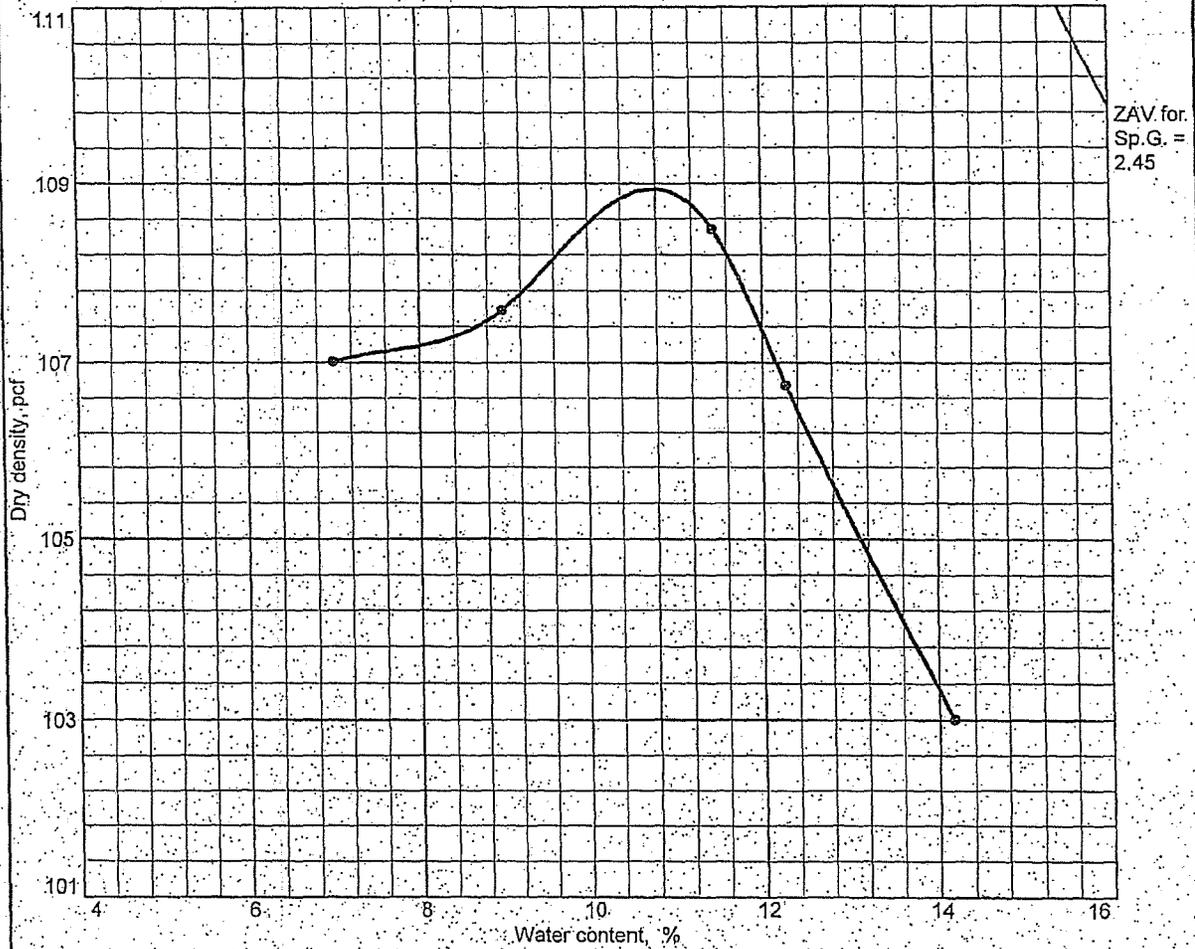
PROCTOR TEST REPORT

TEST RESULTS	MATERIAL DESCRIPTION
Maximum dry density = 108.9 pcf	#23 Sand / #4 SBF
Optimum moisture = 10.8 %	
Project No. 160642 Client:	Remarks: Date Received: 1-15-13
Project: Bloomfield	
Location: Bloomfield	
BOWSER-MORNER, INC.	
Dayton, Ohio	Curve No.: 1301-5573

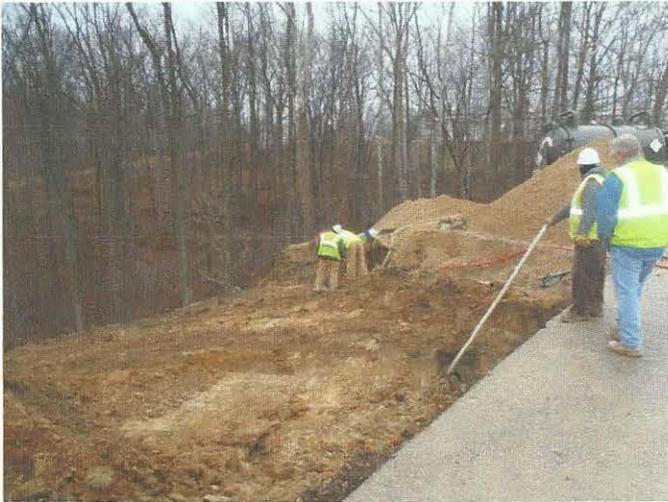
Vacuum truck being used to remove material from inside of the manhole in need of repair.

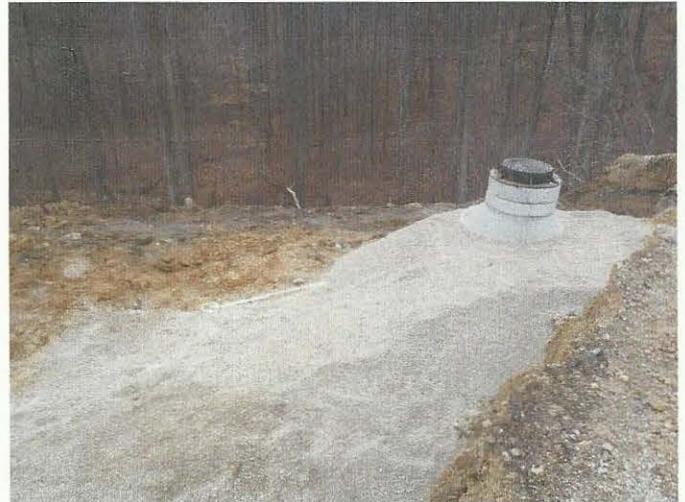
Sewer line and manway cleanout have been repaired and are ready for backfill.

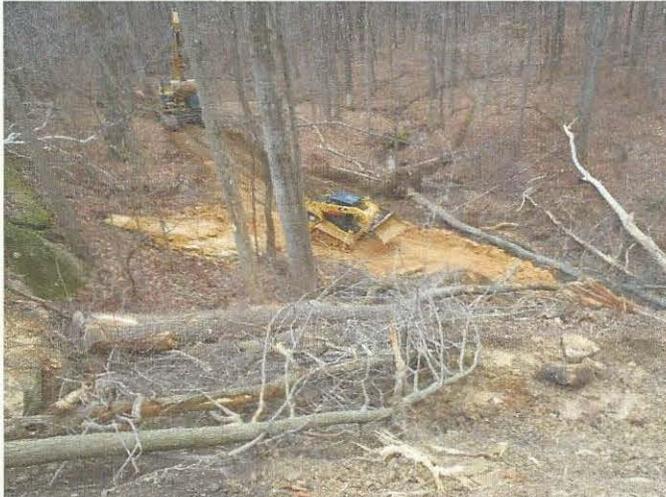
Pathway to Lead Area 3 is nearly complete. Some areas of soft soil were encountered as expected from the heavy rains over the past weekend.

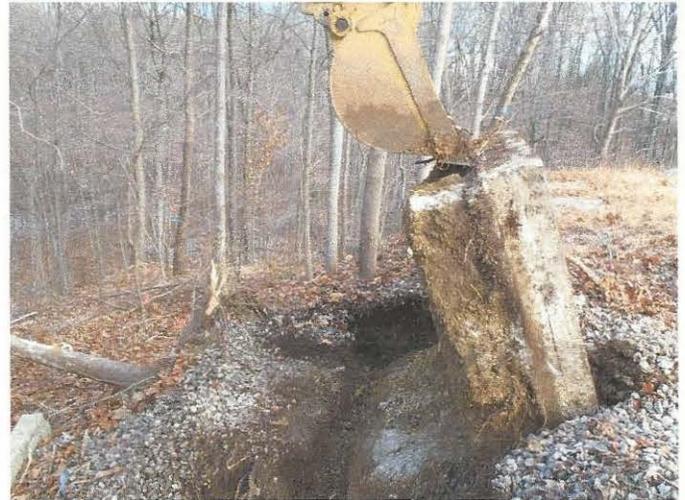
Large slab of concrete found at Lead Area 1.

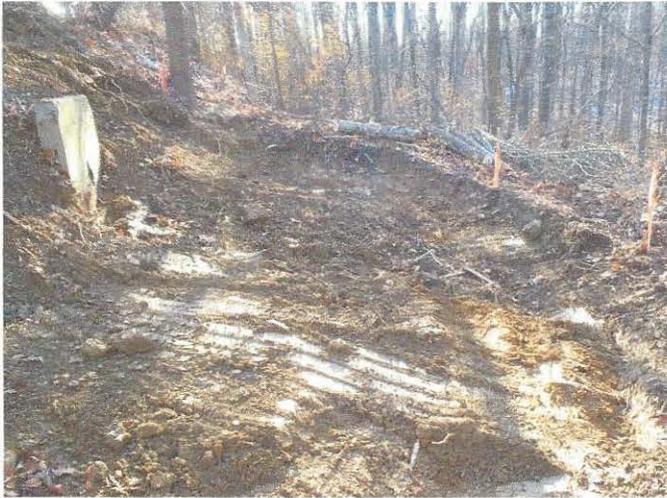
Lead Area 1 completely excavated to 2 ft BGS.

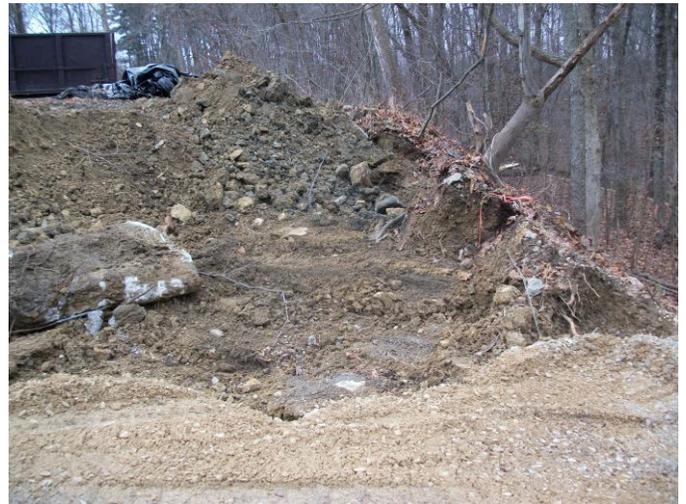
PAH Area 1 excavation with large block of concrete material in the excavation area.

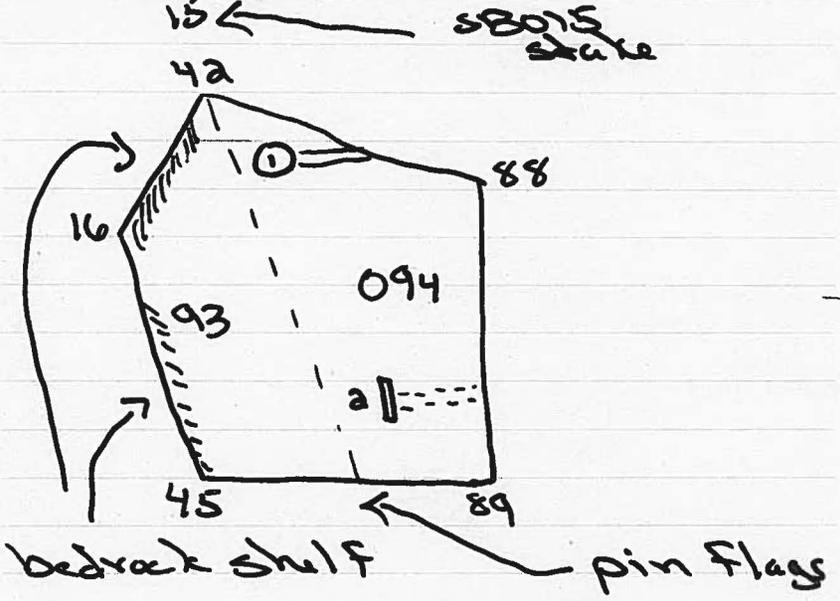
- 1) manhole
- 2) concrete header
- * Both of which were ~ 2 ft below current grade.
