REPORT OF PHASE 2 ENVIRONMENTAL SITE ASSESSMENT NSTC GREAT LAKES IL
12/14/2005
MACTEC ENGINEERING AND CONSULTING INC

**REPORT OF PHASE II
ENVIRONMENTAL SITE ASSESSMENT
NAVSTA GREAT LAKES
NAVAL REGION MIDWEST FAMILY
HOUSING PRIVATIZATION**

MACTEC Project No. 3205050441.01

December 14, 2005

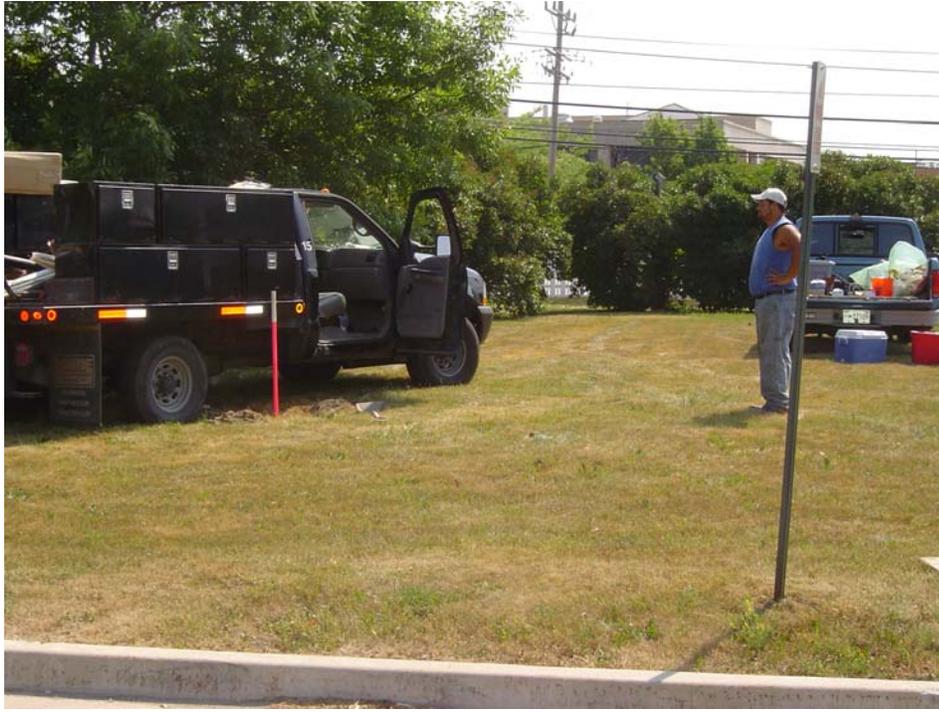
The Navy reported that this UST has been removed and that no release from the UST was observed. However, the Navy also reported that approximately 200 gallons of product were released from storage in an aboveground storage tank, pending disposal by the tank removal contractor, during the removal activities. The Navy indicated that the tank removal contractor will clean up the spill and collect confirmatory samples. MACTEC recommends that those sample results be requested and evaluated by Forest City to verify that this spilled area has been adequately remediated. Otherwise, MACTEC does not recommend any further action at this location.

Photo No. 1: View of UST location on Montana Street

- Onsite UST at 3134 Montana Ave: The Navy reported that this UST has been removed and that no release from the UST was observed. However, the Navy also reported that approximately 200 gallons of product were released from storage in an aboveground storage tank, pending disposal by the tank removal contractor during the removal activities. The Navy indicated that the tank removal contractor will clean up the spill and collect confirmatory samples. MACTEC recommends that those sample results be requested and evaluated by Forest City to verify that this spilled area has been adequately remediated. Otherwise, MACTEC does not recommend any further action at this location.

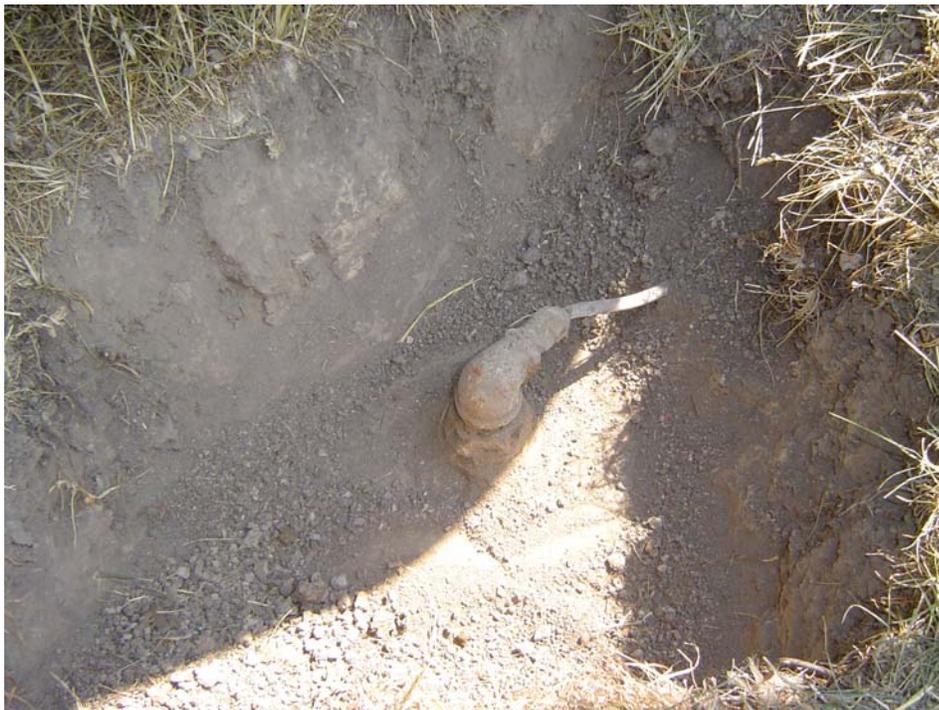
Photo No. 2: UST at Montana Street

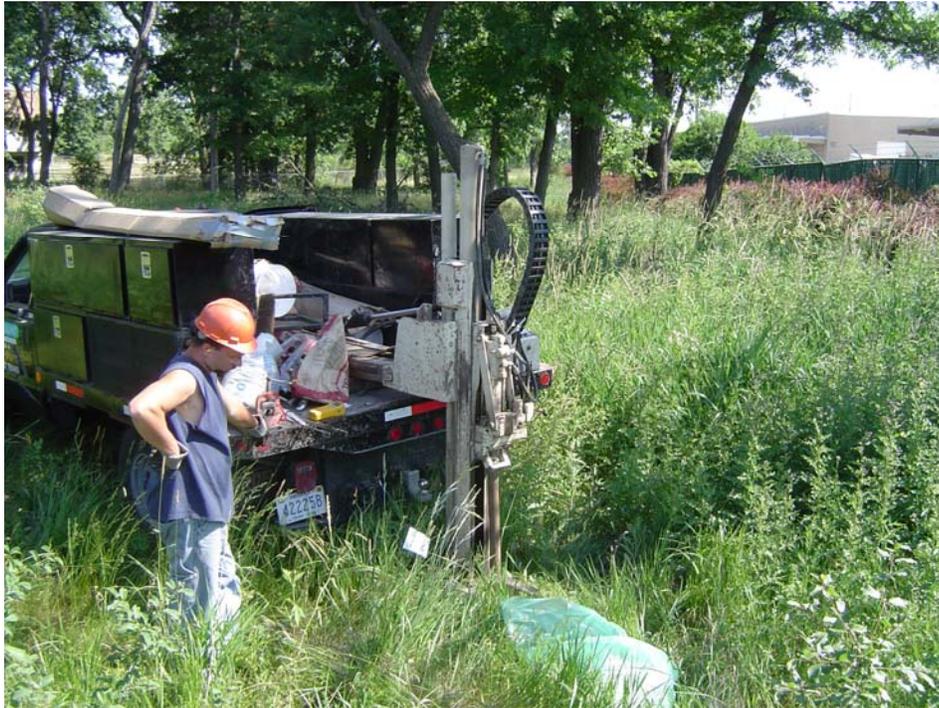
Individual wells were monitored by attaching a piece of flexible tubing to a fitting on each wellhead and recording methane, carbon dioxide and oxygen readings at approximately one minute intervals for a length of 1 to 15 minutes. When monitoring was completed, the flexible tubing was removed and a PVC slip cap was replaced on top of the well.

Photo No. 3: Installing methane monitoring well GV20

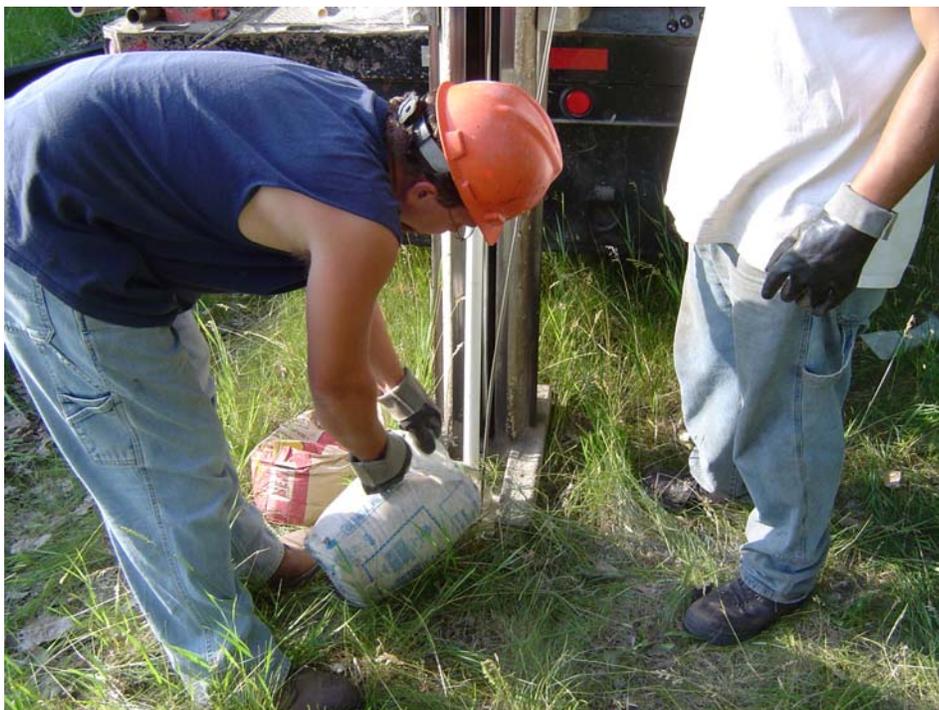
Photo No. 4: Placing sand and bentonite in methane monitoring well

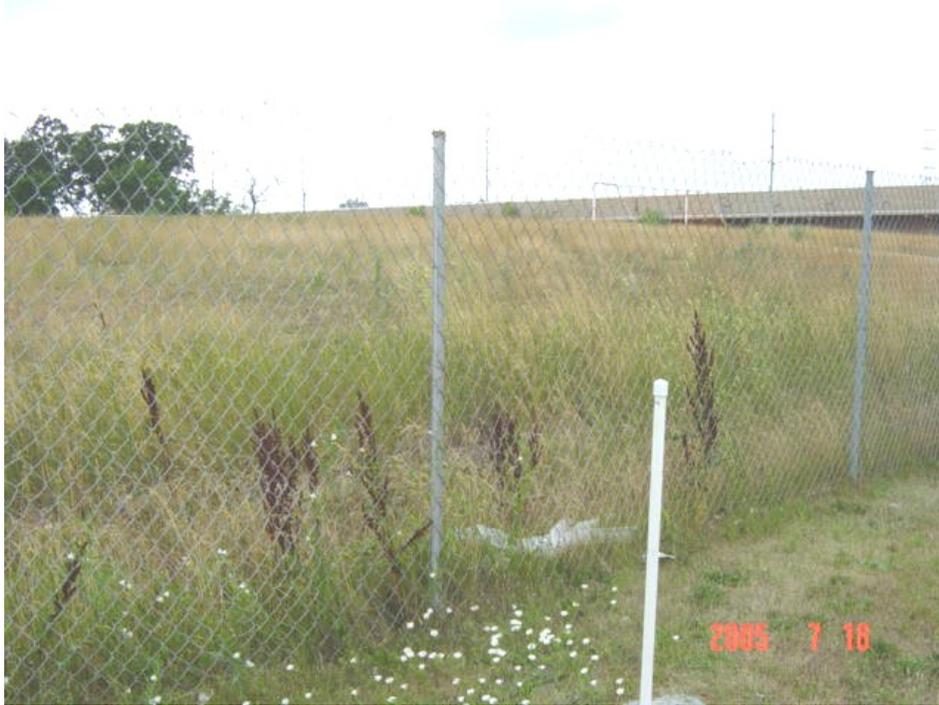
The Navy's regional Environmental Manager has verbally indicated that a passive methane venting system is in place and will be upgraded by the Navy who plans also to install a new surficial soil cap over the landfill cap at the Forrestal Village Landfill. MACTEC recommends that Forrest City monitor the upgrades to the passive venting system and installation of the landfill cap. Otherwise, no further action at this location is recommended at this time. Because the recently detected methane (in GV-16) is on the south side of the Forrestal Village Landfill which will be at some distance from the newly constructed housing units, and based on the information provided by the Navy indicating that it is planning to upgrade the existing passive venting system to capture methane produced on the south side of the landfill, MACTEC does not believe the methane detected presents a risk to future housing occupants.

Photo No. 5: Forrestal Village Landfill showing methane monitoring well

IR Site 2 - Forrestal Village Landfill (Onsite): The Navy's regional Environmental Manager has verbally indicated that a passive methane venting system is in place and will be upgraded by the Navy who plans also to install a new surficial soil over the landfill cap at the Forrestal Village Landfill. MACTEC recommends that Forrest City monitor the upgrades to the passive venting system and installation of the landfill cap. Otherwise, MACTEC does not recommend any further action at this location. Because the recently detected methane (in GV-16) is on the south side of the Forrestal Village Landfill which will be at some distance from the newly constructed housing units, and based on the information provided by the Navy indicating that it is planning to upgrade the existing passive venting system to capture methane produced on the south side of the landfill, MACTEC does not believe the methane detected presents a risk to future housing occupants.

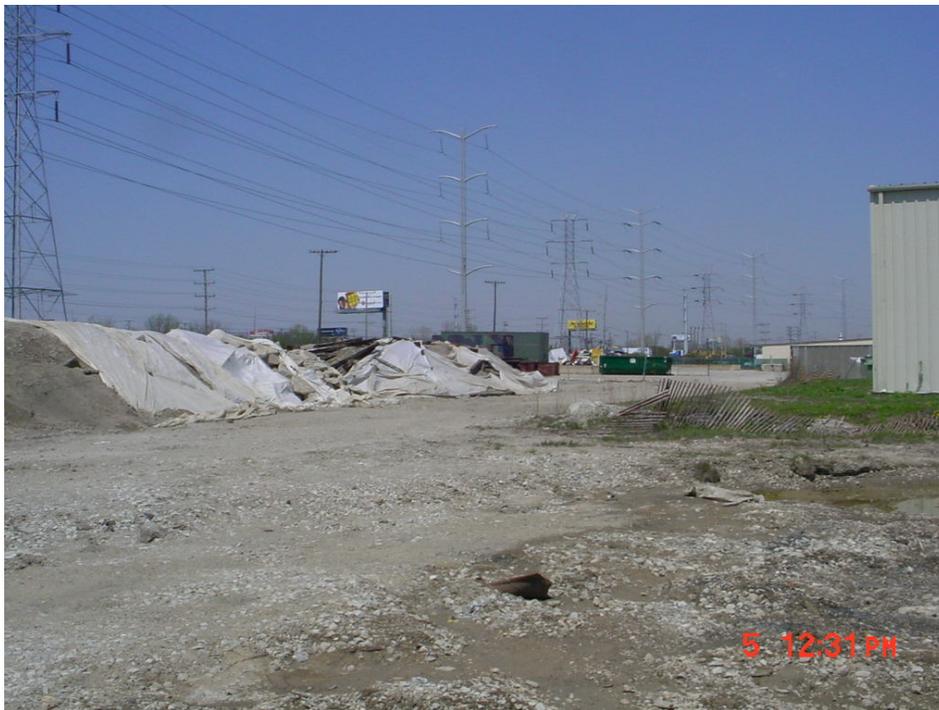
During the 1950's through the 1980's, the Defense Reutilization Material Office maintained a yard for recycled metals. The operation consisted of crushing scrap metal and sending it to a recycler. The recycled metals included radium-containing equipment. It is possible that radium-containing equipment remains buried in this area. Elevated levels of radium in the soil were found to be at 750,000 counts per minute (cpm), while background is approximately 5,000 cpm. These areas have been identified by the Navy as Installation Restoration sites 18 and 20. According to the report entitled *Draft Work Plan for Radiological Remediation and Final Status Survey at Great Lakes Naval Training Center, Great Lakes, Illinois*, dated November 21, 2001, prepared by Cabrera Services, Inc. (Cabrera), this area was used to store monazite sand, a thorium-bearing material. The Monazite Sand Area was investigated by the Nuclear Regulatory Commission and Cabrera. According to the *Environmental Baseline Survey, Public / Private Venture Housing Privatization, Naval Station Great Lakes, Great Lakes, Illinois* prepared for NAVAL Facilities Engineering Command, Southern Division, dated March 2004, the Radium-Contaminated Soil Area is undergoing remediation. During the performance of the Phase II ESA, the Navy verbally indicated that Cabrera was continuing the remediation of these areas, but also indicated that some of the monazite sand material could have been used as fill material near a storm sewer outfall to Skokie Ditch east of IR Sites 18 and 20.

Photo No. 6: Monazite sand area

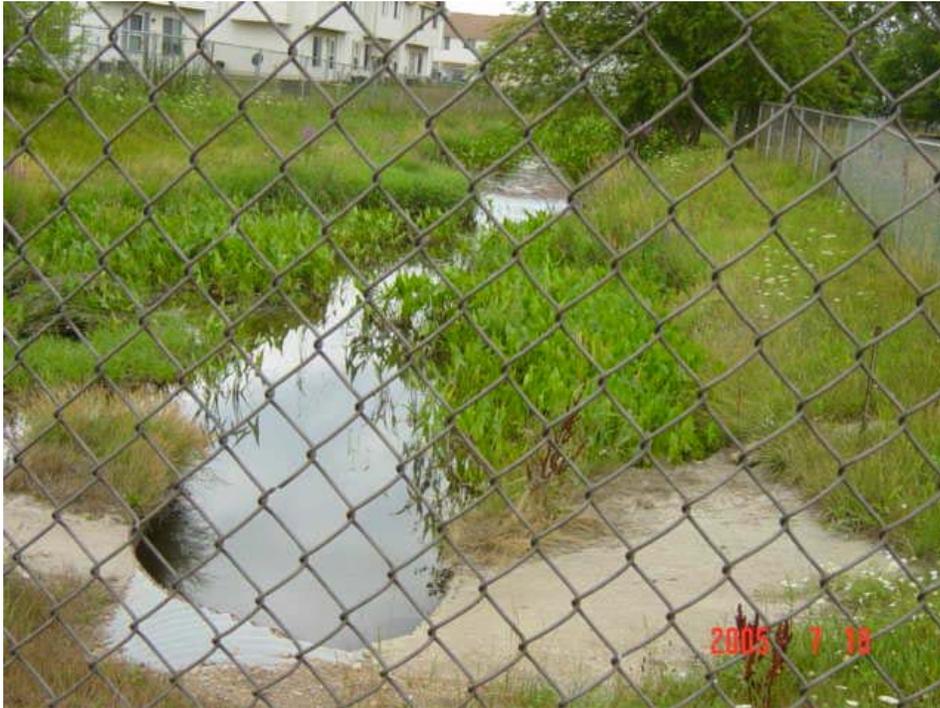
Skokie Ditch showed that the sediments are impacted with elevated concentrations of radioactivity (thorium). Soil samples collected were found to have concentrations of radioactivity more than 20 times the United States Nuclear Regulatory Commission's published surface soil screening values and elevated gamma screening values. The elevated concentrations of thorium in the soil raised a concern that such concentrations might be more widespread.

Photo No. 7: Skokie Ditch, looking south

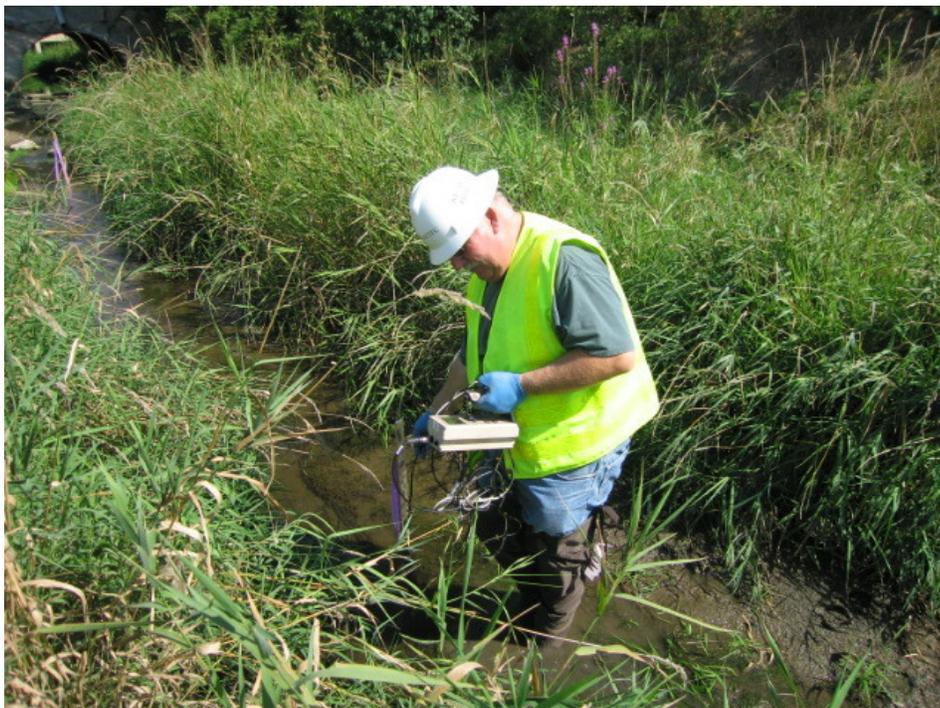
Photo No. 8: Radiation Survey in Skokie Ditch

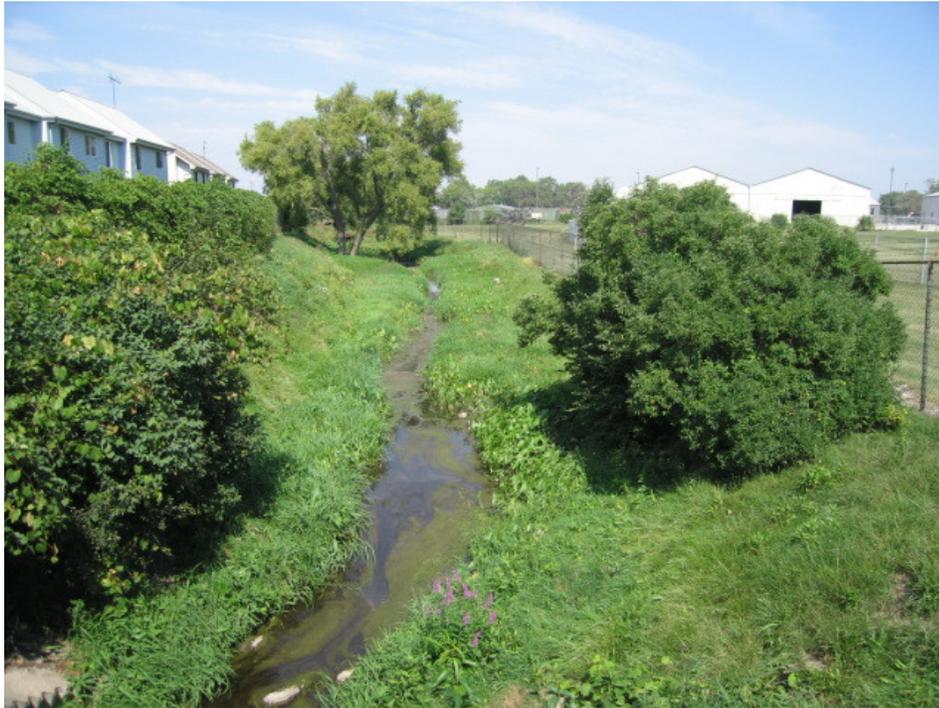
Photo No. 9: Looking north along Skokie Ditch

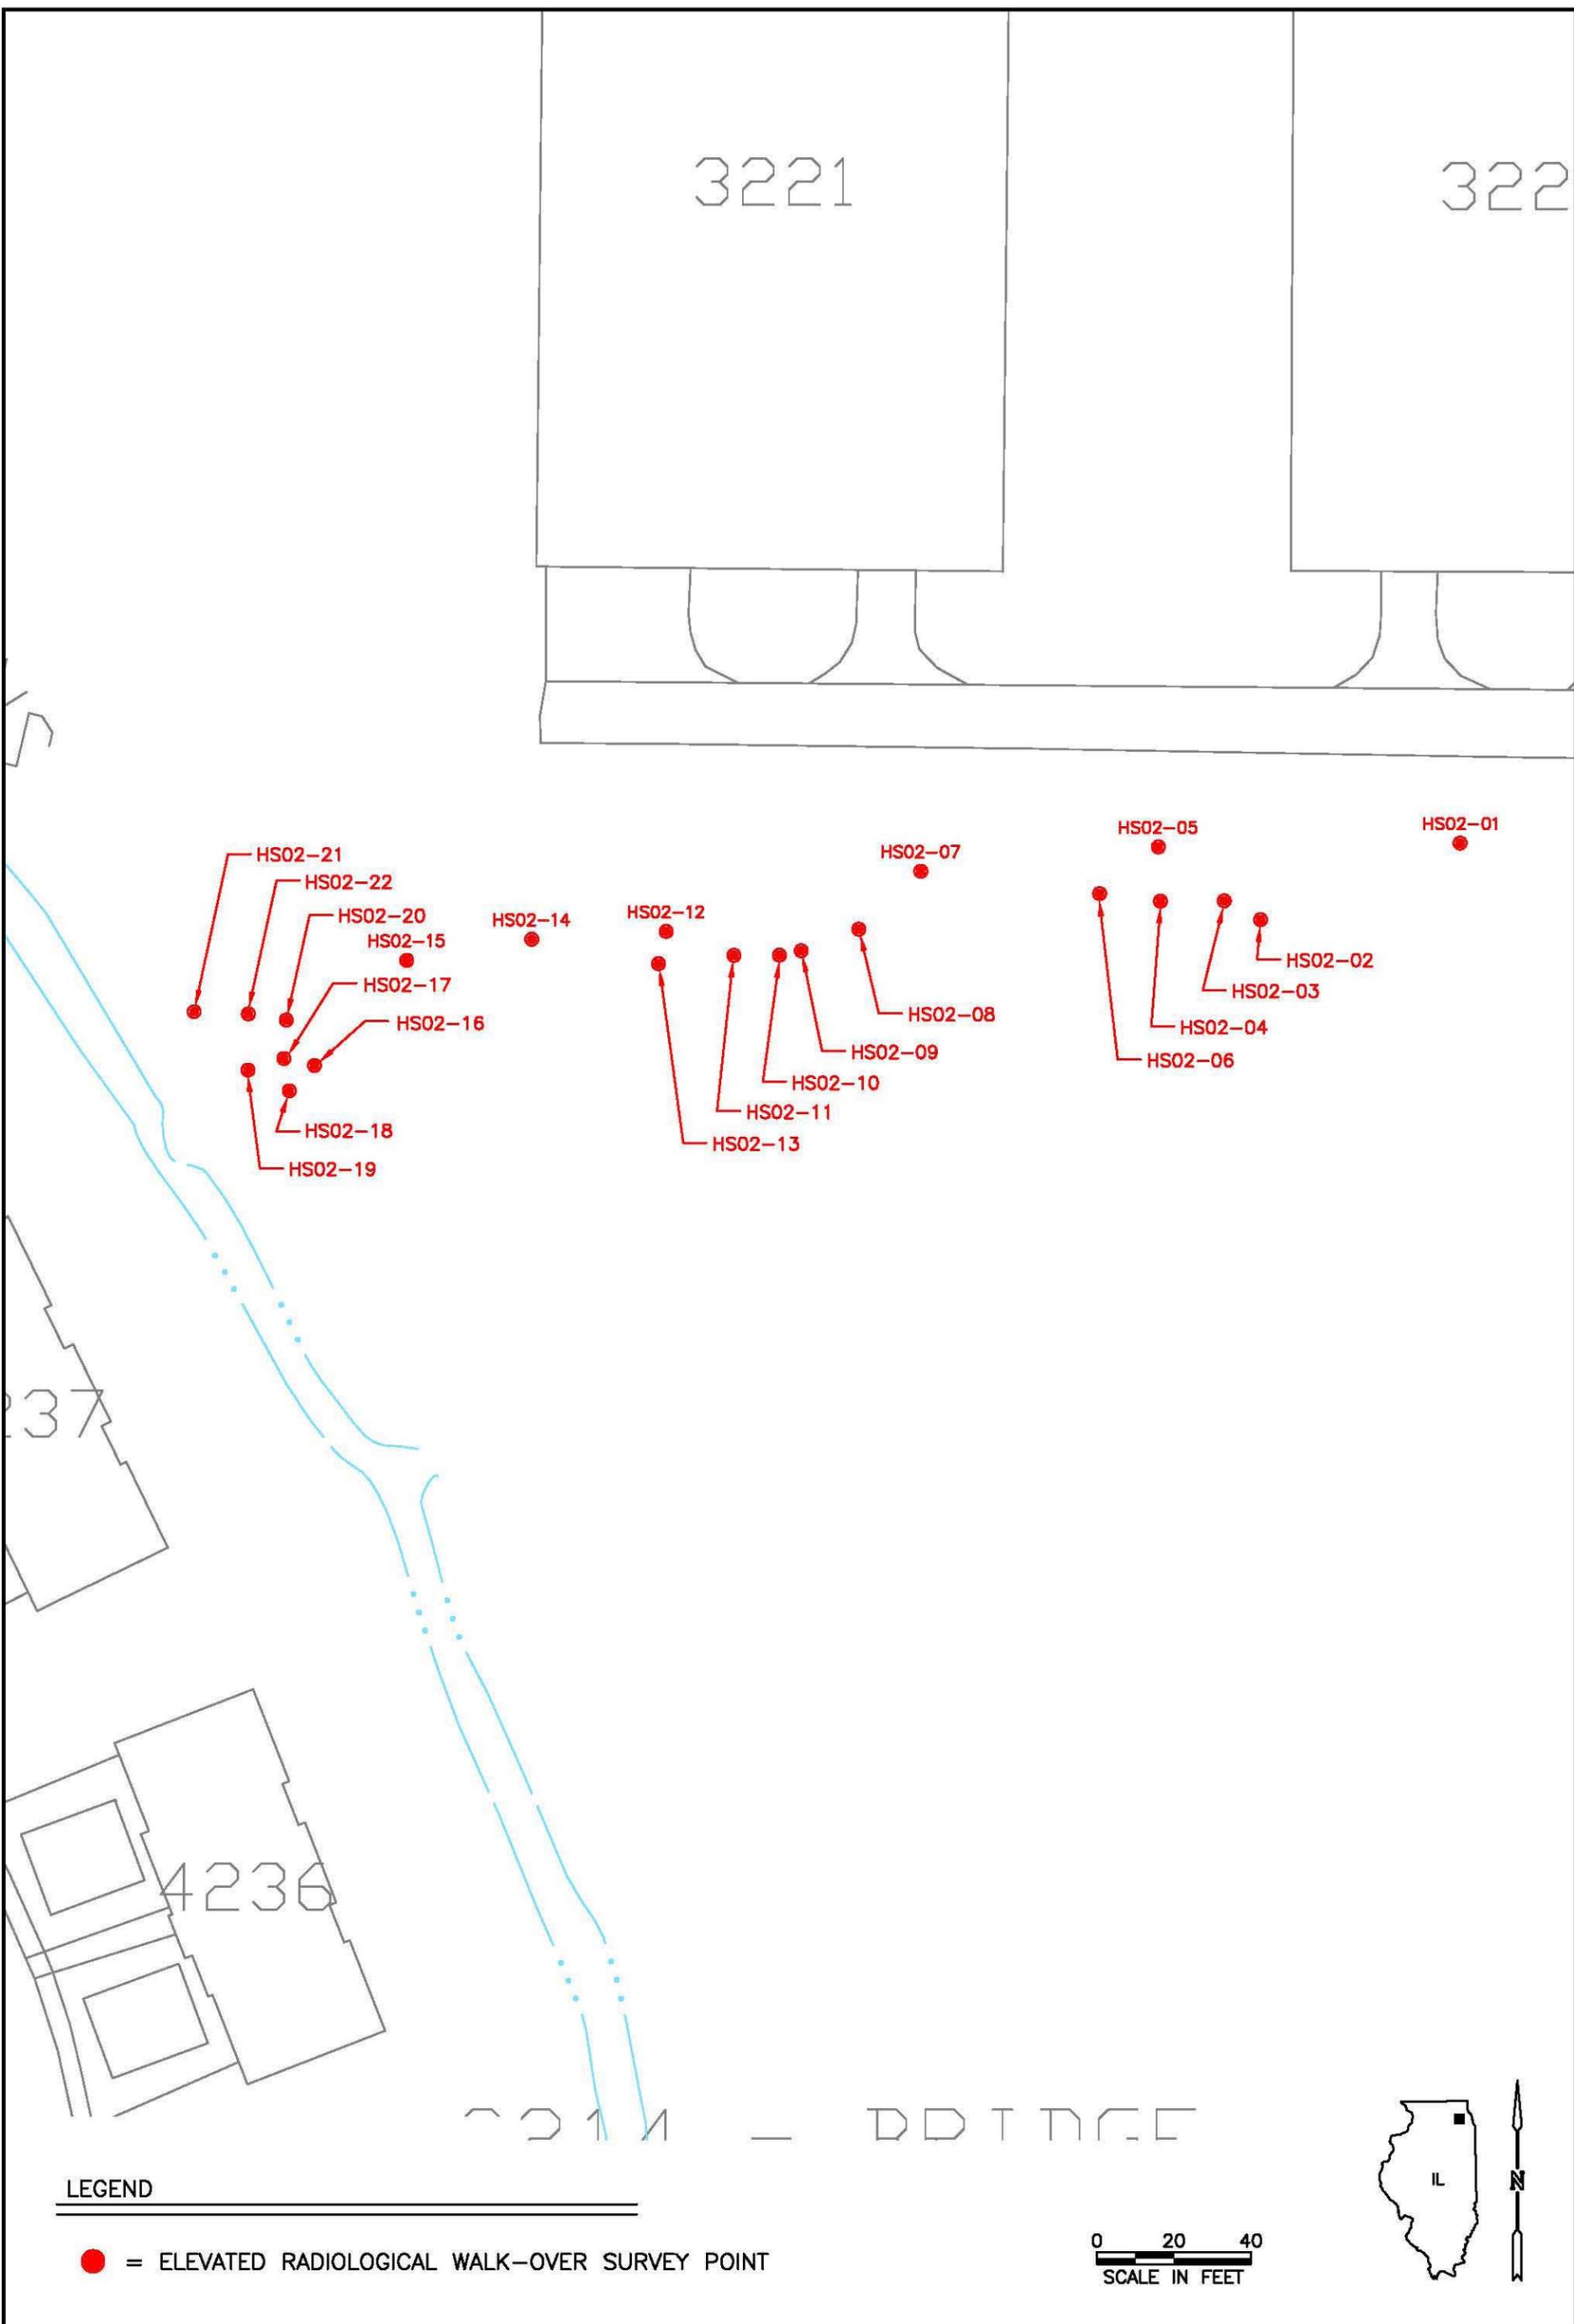
ELEVATED RADIOLOGICAL WALK-OVER
SURVEY LOCATIONS
Navy Property at Forrestal Village
Great Lakes, IL

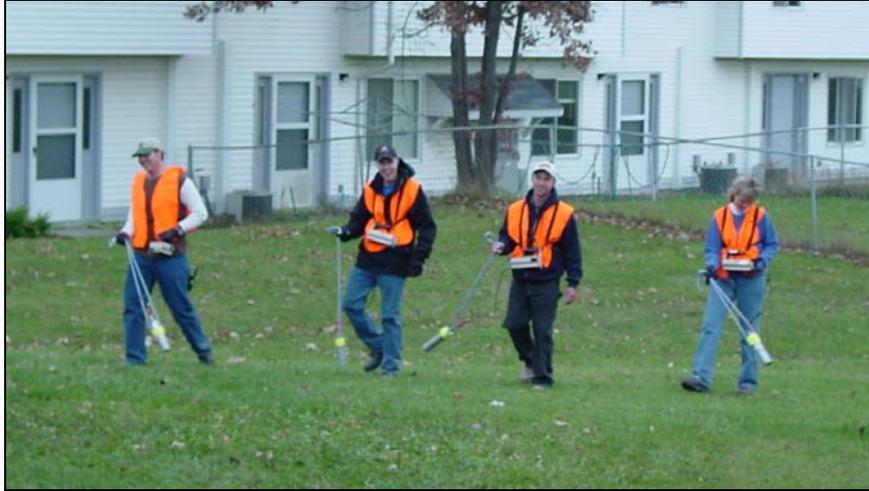
Figure 10 Walk-Over Gamma Survey

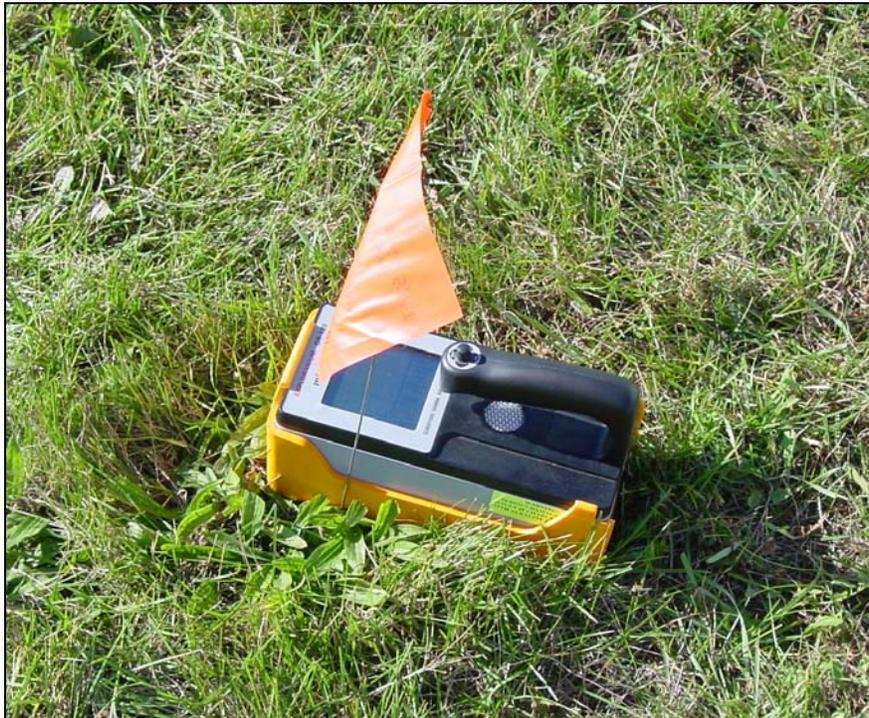
Figure 11 Exploranium GR-130 Gamma Spectrometer

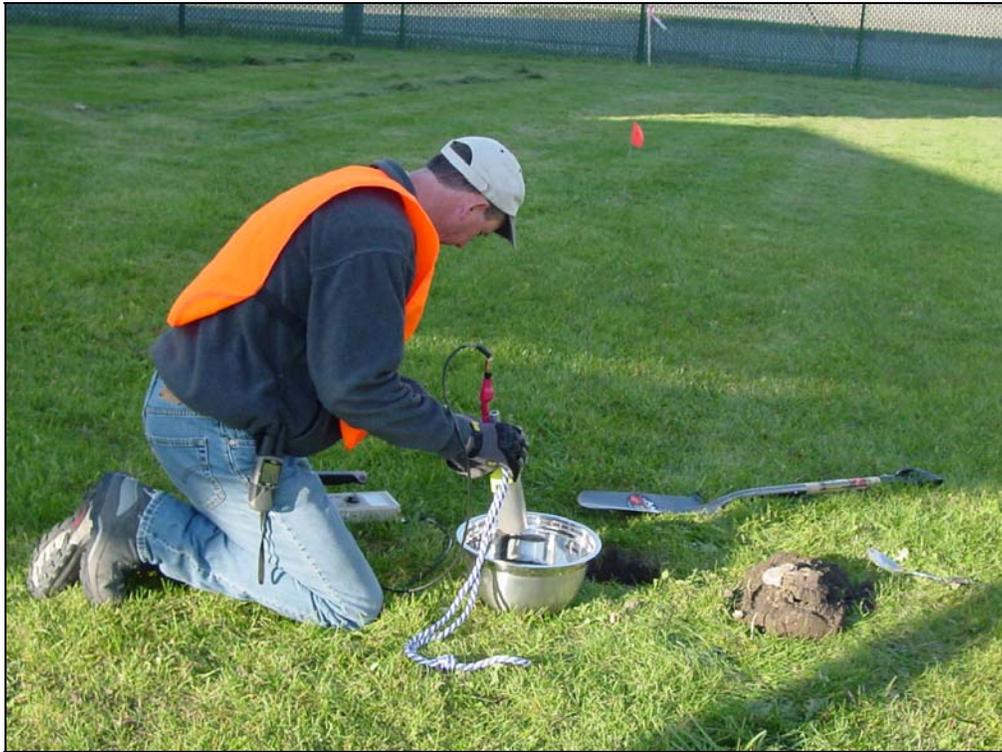
Figure 12 Collecting Soil Volumetric Sample

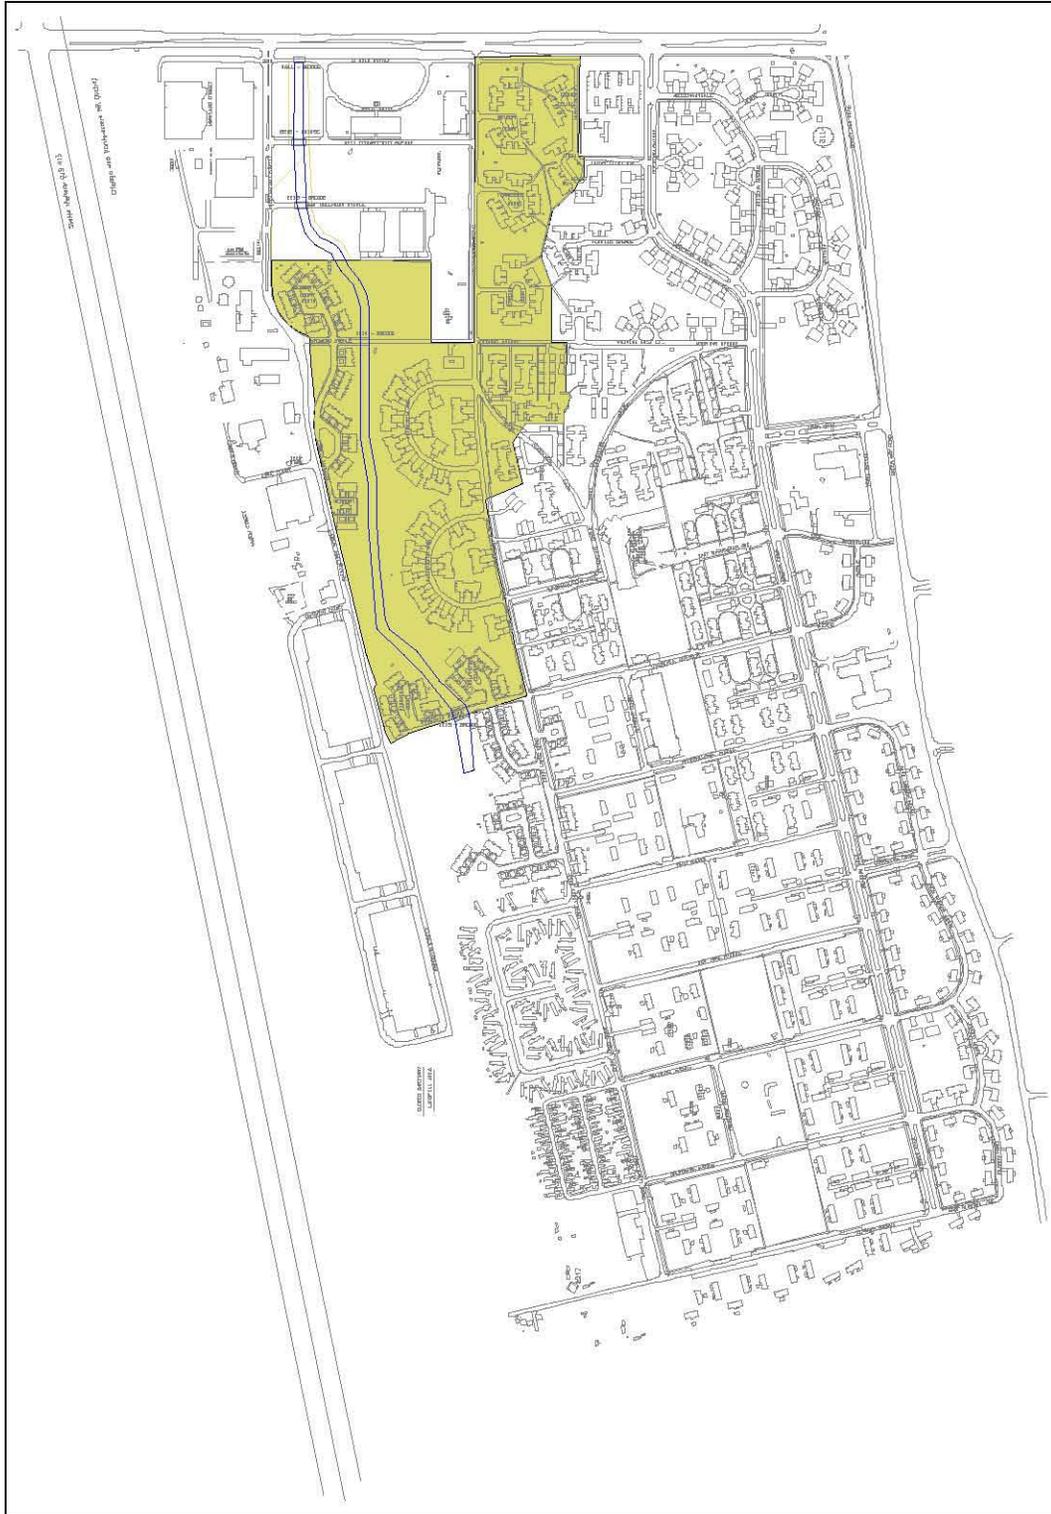
The 282-acre Site is located within the Forrestal Village Military Housing Unit, NAVSTA Great Lakes, Great Lakes, Illinois. The PIRS Work Plan applies to an area of approximately 52 acres extending to the east and south of the areas where radiological impacts were previously detected (Figure 1-1). This survey area is designated as the Phase 1 area.

Figure 1-1 Forrestal Village, Phase 1 Survey Area (shaded)

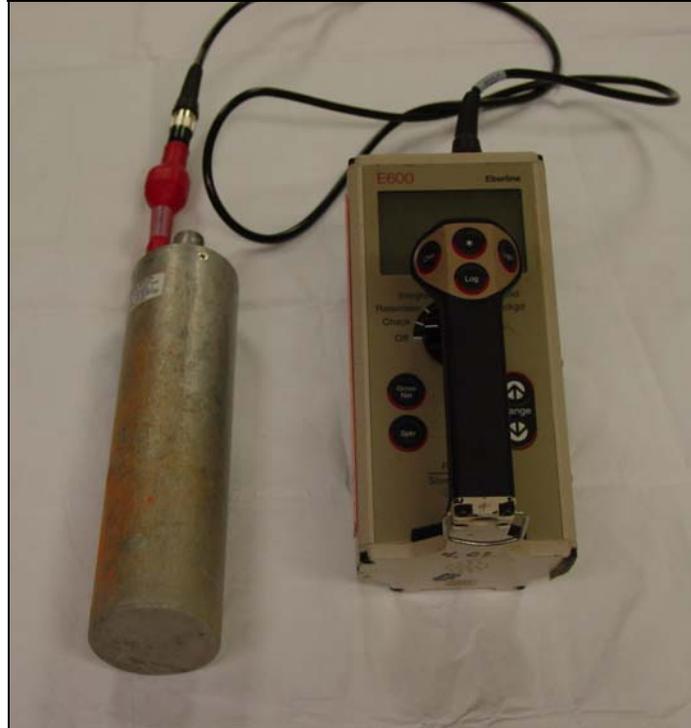
The walkover survey will be performed using industry-standard portable radiation monitoring equipment (e.g., sensitive 2-inch by 2-inch sodium iodide [NaI] detector coupled with Eberline's E600 instrument) (Figure 1-2) capable of measuring photon (gamma) emissions associated with thorium and radium progeny. During the walkover surveys, static one-minute counts will be performed and logged at locations where radiological impacts are suspect or encountered.

Figure 1-2 Eberline E600 and 2x2 NaI Detector

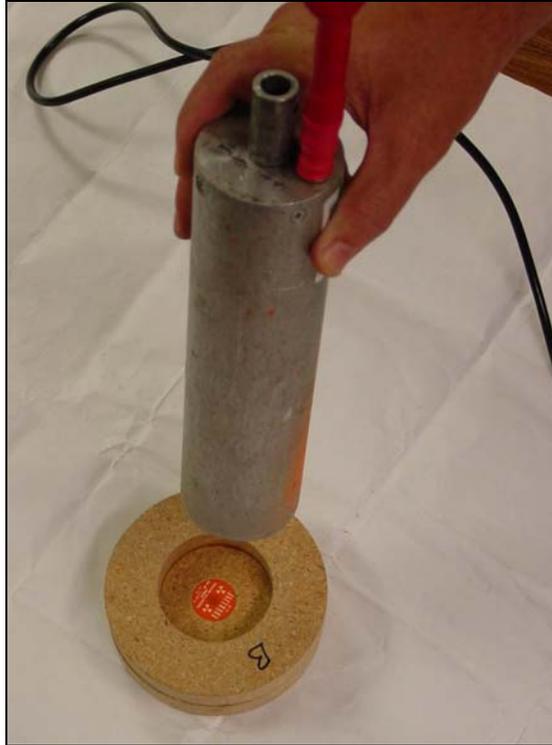
At the beginning and end of each day, survey instrumentation will be response checked with a radioactive check source to ensure it is working properly (Figure 4-1). Instruments that do not “pass” daily response checks will be removed from service and repaired prior to placement back in service. Instrument response checks will be performed in accordance with the applicable MACTEC Radiation Protection Operating (RPO) procedure.

Figure 4-1 Instrument Response Check

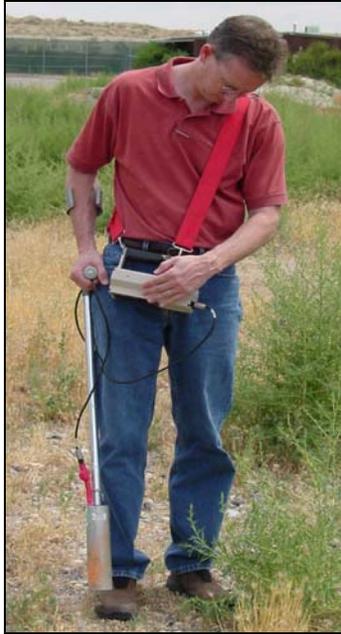
The walkover survey will be performed by teams of survey personnel using radiation detection instrumentation, described in Section 4.2.1. The walkover survey is performed by walking over a designated survey area at a nominal rate (approximately 1 mile per hour) with the instrument detector approximately 1 to 2 inches above the ground surface. The detector is moved in a side-to-side motion in front of the surveyor as the surveyor progresses forward (Figure 4-2).

Figure 4-2 Walkover Survey Technique
