Final  
**Five-Year Review Report**

St. Juliens Creek Annex  
Chesapeake, Virginia

Prepared for  
**Department of the Navy**  
Naval Facilities Engineering Command  
Mid-Atlantic

**May 2010**

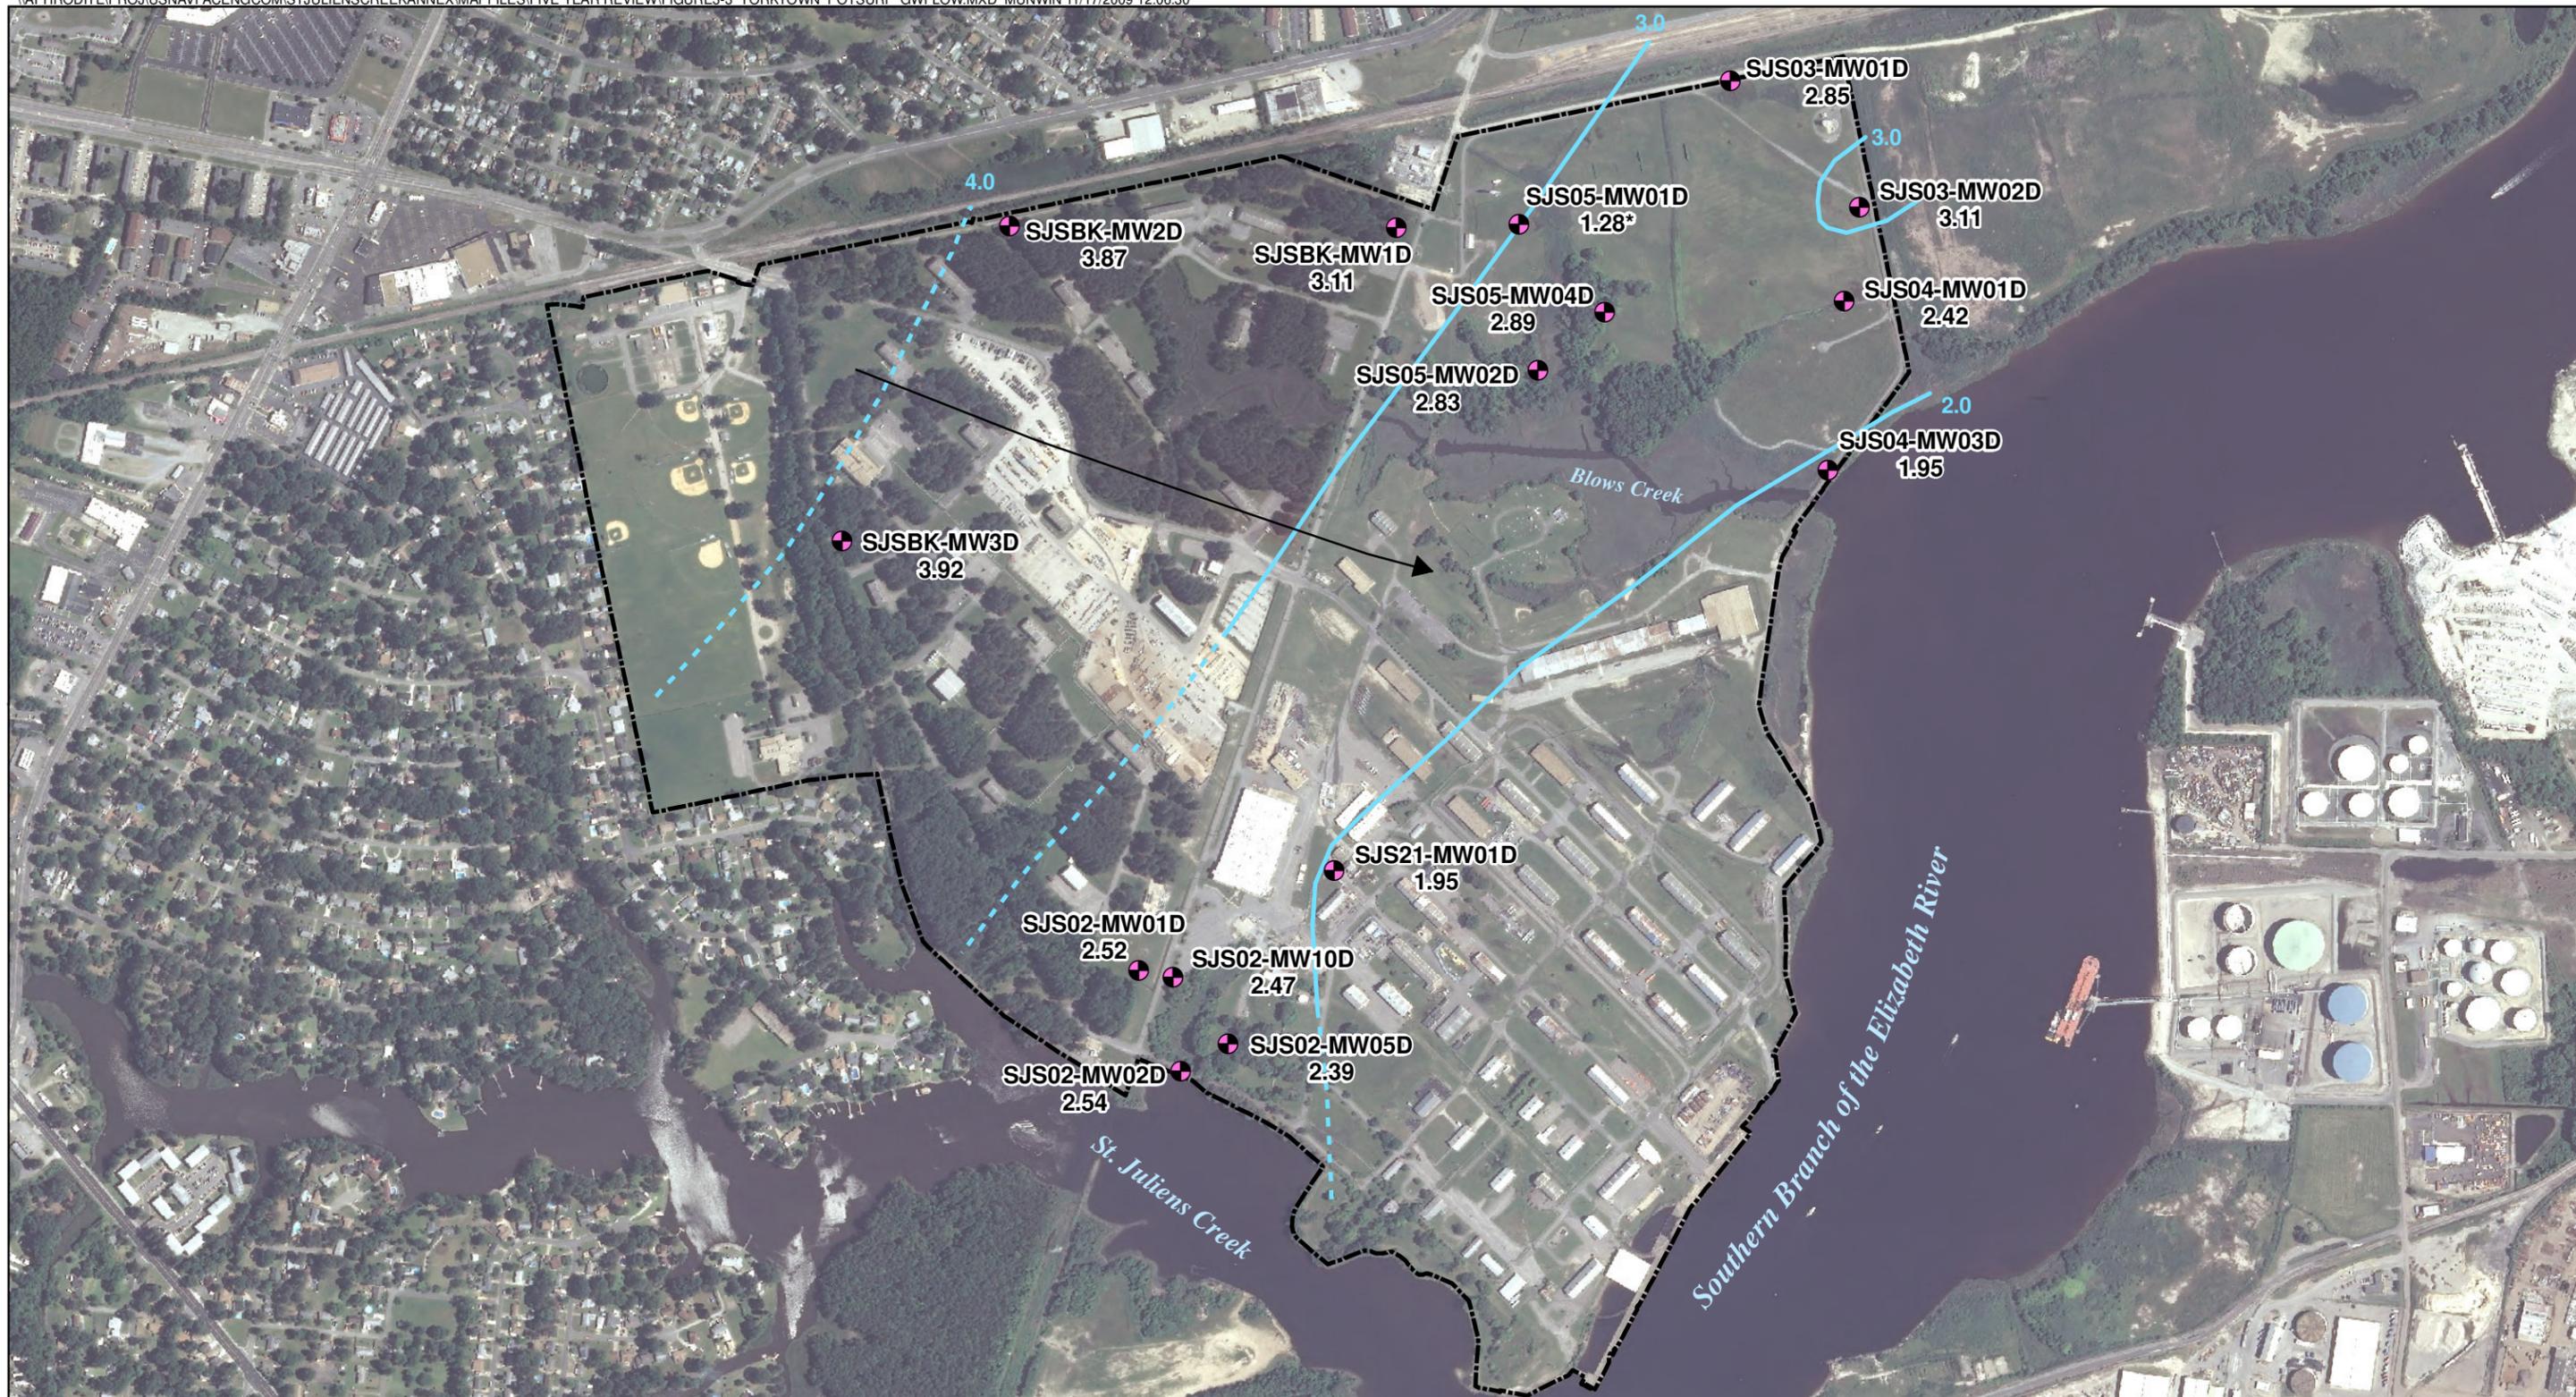
Figure 3-3  
Yorktown Aquifer Potentiometric Surface  
and Groundwater Flow Map  
Five-Year Review Report  
St. Juliens Creek Annex  
Chesapeake, Virginia

- SJCA Boundary
- Yorktown Aquifer Monitoring Well
- Yorktown Potentiometric Surface Contour (April 2005)
- Inferred Potentiometric Surface Contour

- Groundwater Flow Direction
- 3.0 Groundwater Elevation
- \* Not used for contouring

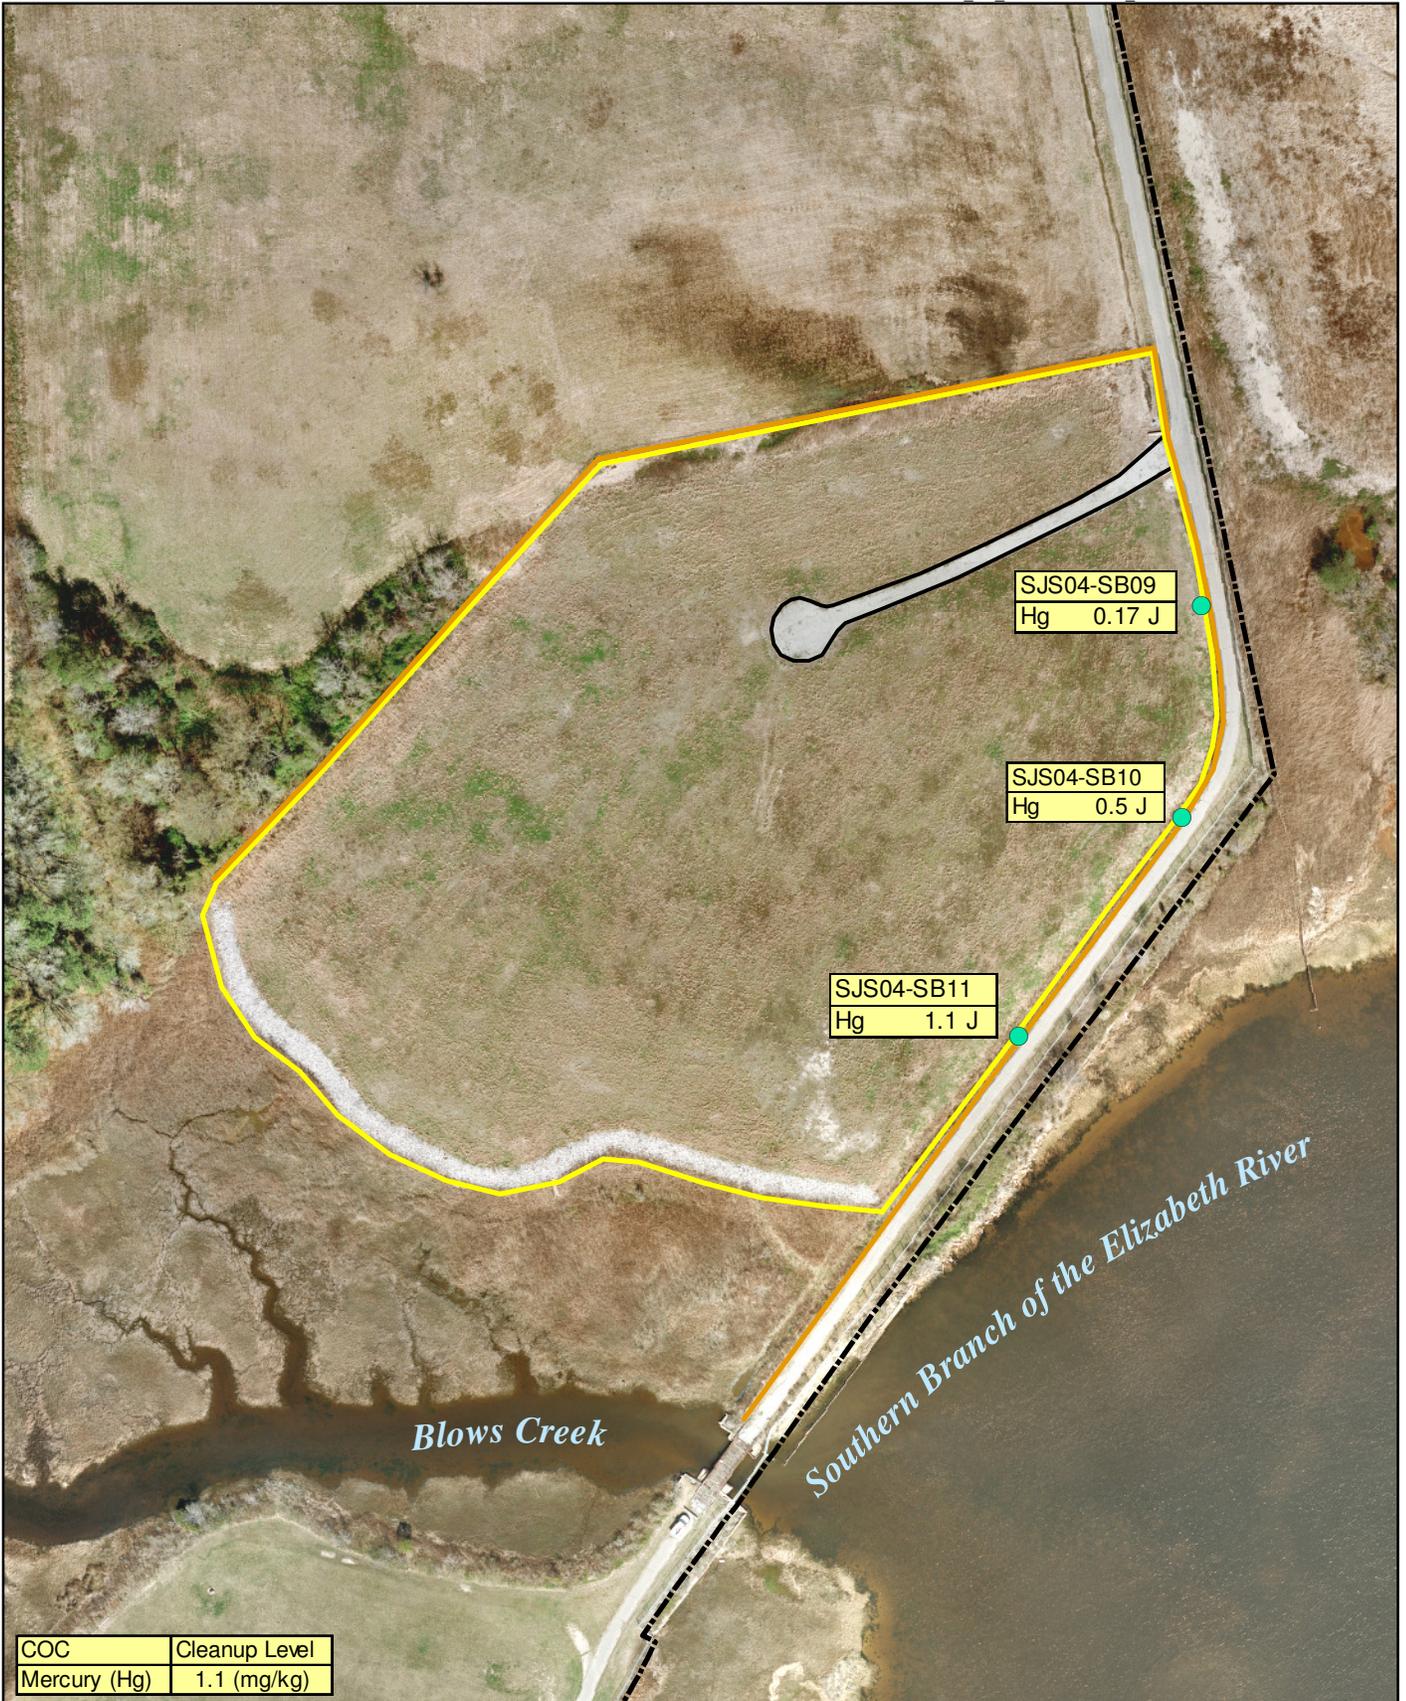
Figure 3-4  
Sediment Confirmation Sample Results  
Five-Year Review Report  
St. Juliens Creek Annex  
Chesapeake, Virginia

COC	Cleanup Level
Mercury (Hg)	1.1 (mg/kg)

- Installation of a minimum 2-foot soil cover graded to a minimum of 2% slopes to promote drainage and reduce infiltration.
- Removal and offsite disposal of 1foot of sediment from the floor and sidewalls of the eastern drainage ditch adjacent to the landfill and extending through the wetland to Blows Creek to prevent direct contact of human and ecological receptors with mercury in sediment. The one foot excavation depth and lateral extent was based on pre-confirmation samples collected from one to two feet bgs for mercury analysis and compared to the cleanup level. The cleanup level was based on the site-specific background 95% UTL for dredge fill (CH2M HILL, October 2001). Confirmation sample results are shown on [Figure 3-4](#).

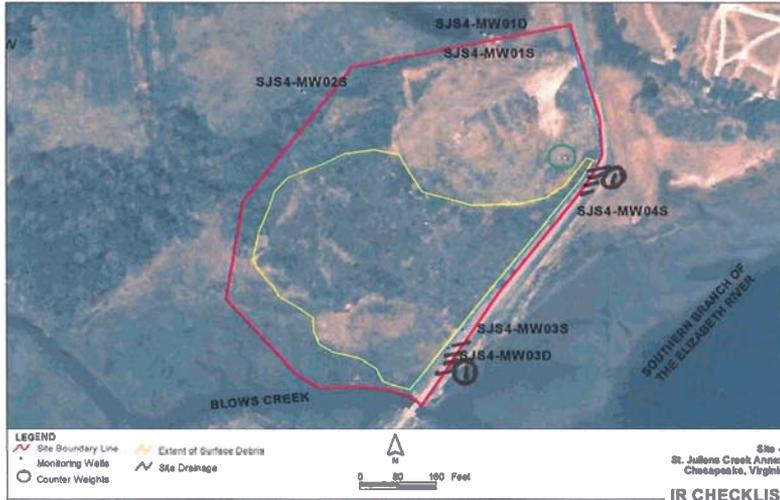
① Road needs repair - Quest. 3

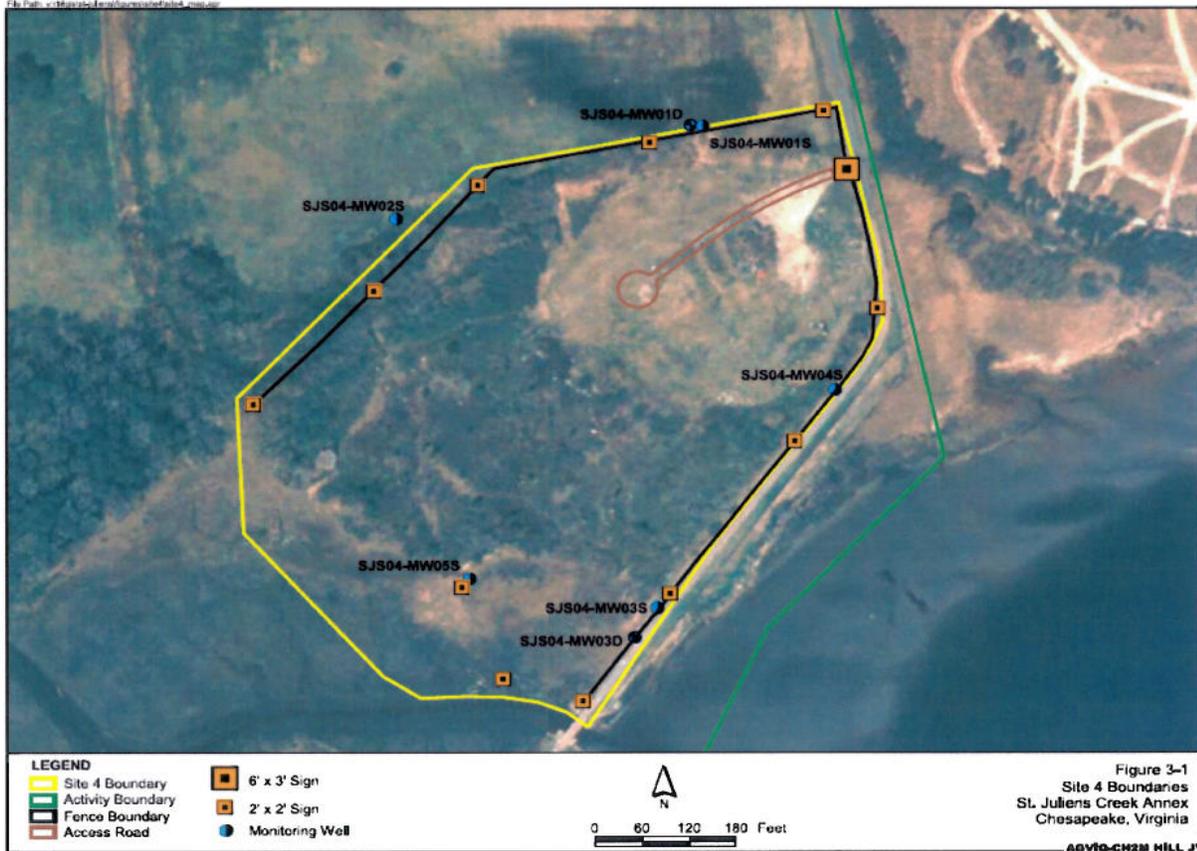
*Note: signs were in good condition - question #5*

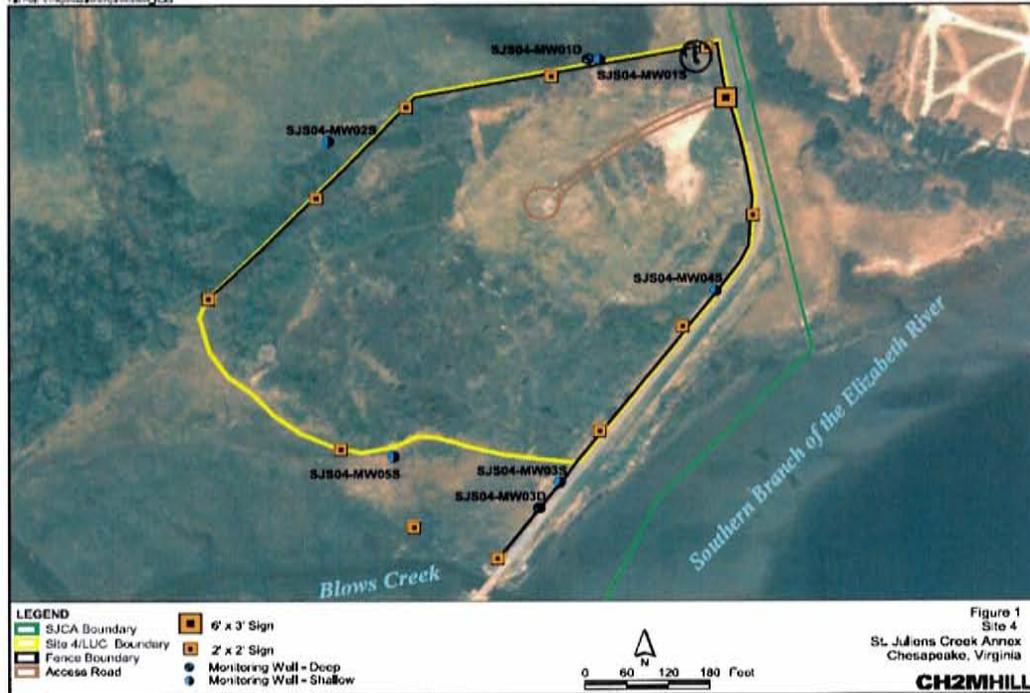
Comments: (Provide related question number for each comment)  
 ① WATER POOLED IN LOCATION MARKED. CULVERT AT OUTLET OF SITE 3 DRAINAGE DITCH IS CLOGGED/ DOES NOT OUTLET. RECOMMEND FIXING CULVERT TO PREVENT POOLING OF WATER AT LANDFILL TOE. COULD AFFECT INTEGRITY OF COVER OVER TIME.

Several bare areas in the vegetation were identified in June 2006. The areas were re-seeded in June 2007 and vegetative re-growth has been successful. In September 2006, surface water was observed pooling in the northeast corner of the site as a result of the culvert from the Site 3 drainage ditch having no identifiable outlet. The culvert was replaced in June 2007 and built up sediment was removed from the drainage ditch to prevent pooling of water against the landfill, which may have impacted the integrity of the cover over time. Tire ruts created on the soil cover during the November 2006 voluntary groundwater monitoring event were regraded and reseeded in June 2007 and vegetative re-growth was successful.

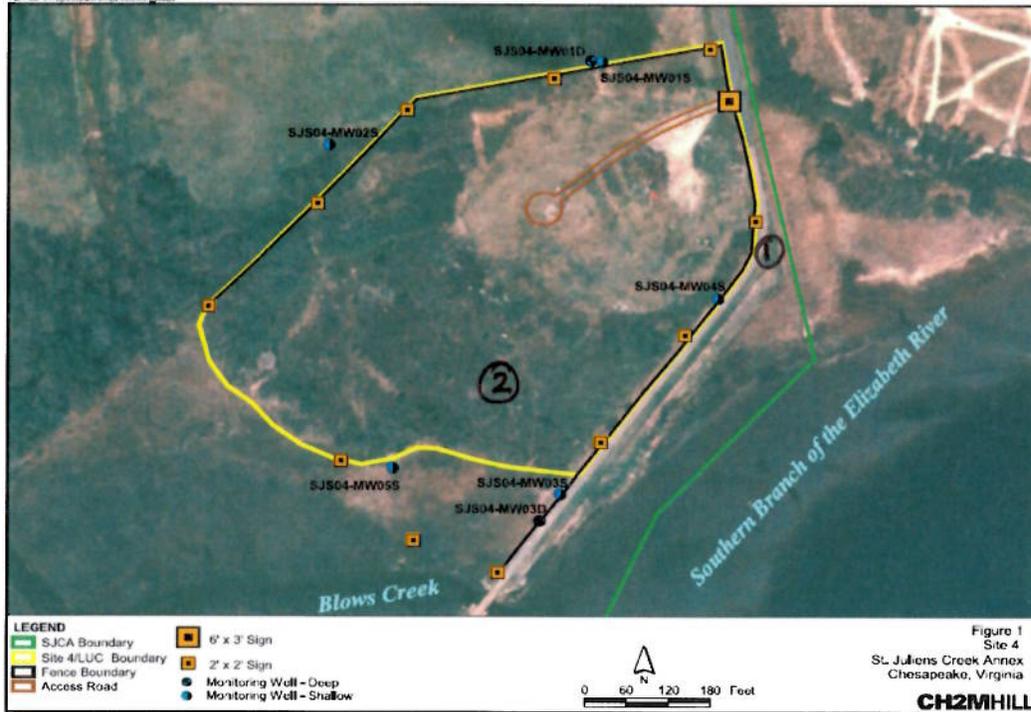
- ① DEBRIS (WOOD, CHAIRS) OBSERVED ADJACENT TO SITE - QUESTION 3
- ② OCCASSIONAL BARE SPOTS - VEG. GROWTH OBSERVED.

Throughout the inspections, the monitoring wells, signs, fencing, riprap landfill toe, and drainage ditches have remained in good condition. Several items of debris were reported along the edge of perimeter road and quickly removed following the site inspections. No signs of unauthorized intrusive activities, investigation-derived waste (IDW) storage, or dumping within the site have been observed. Additionally, no signs of erosion have been reported during the inspections.

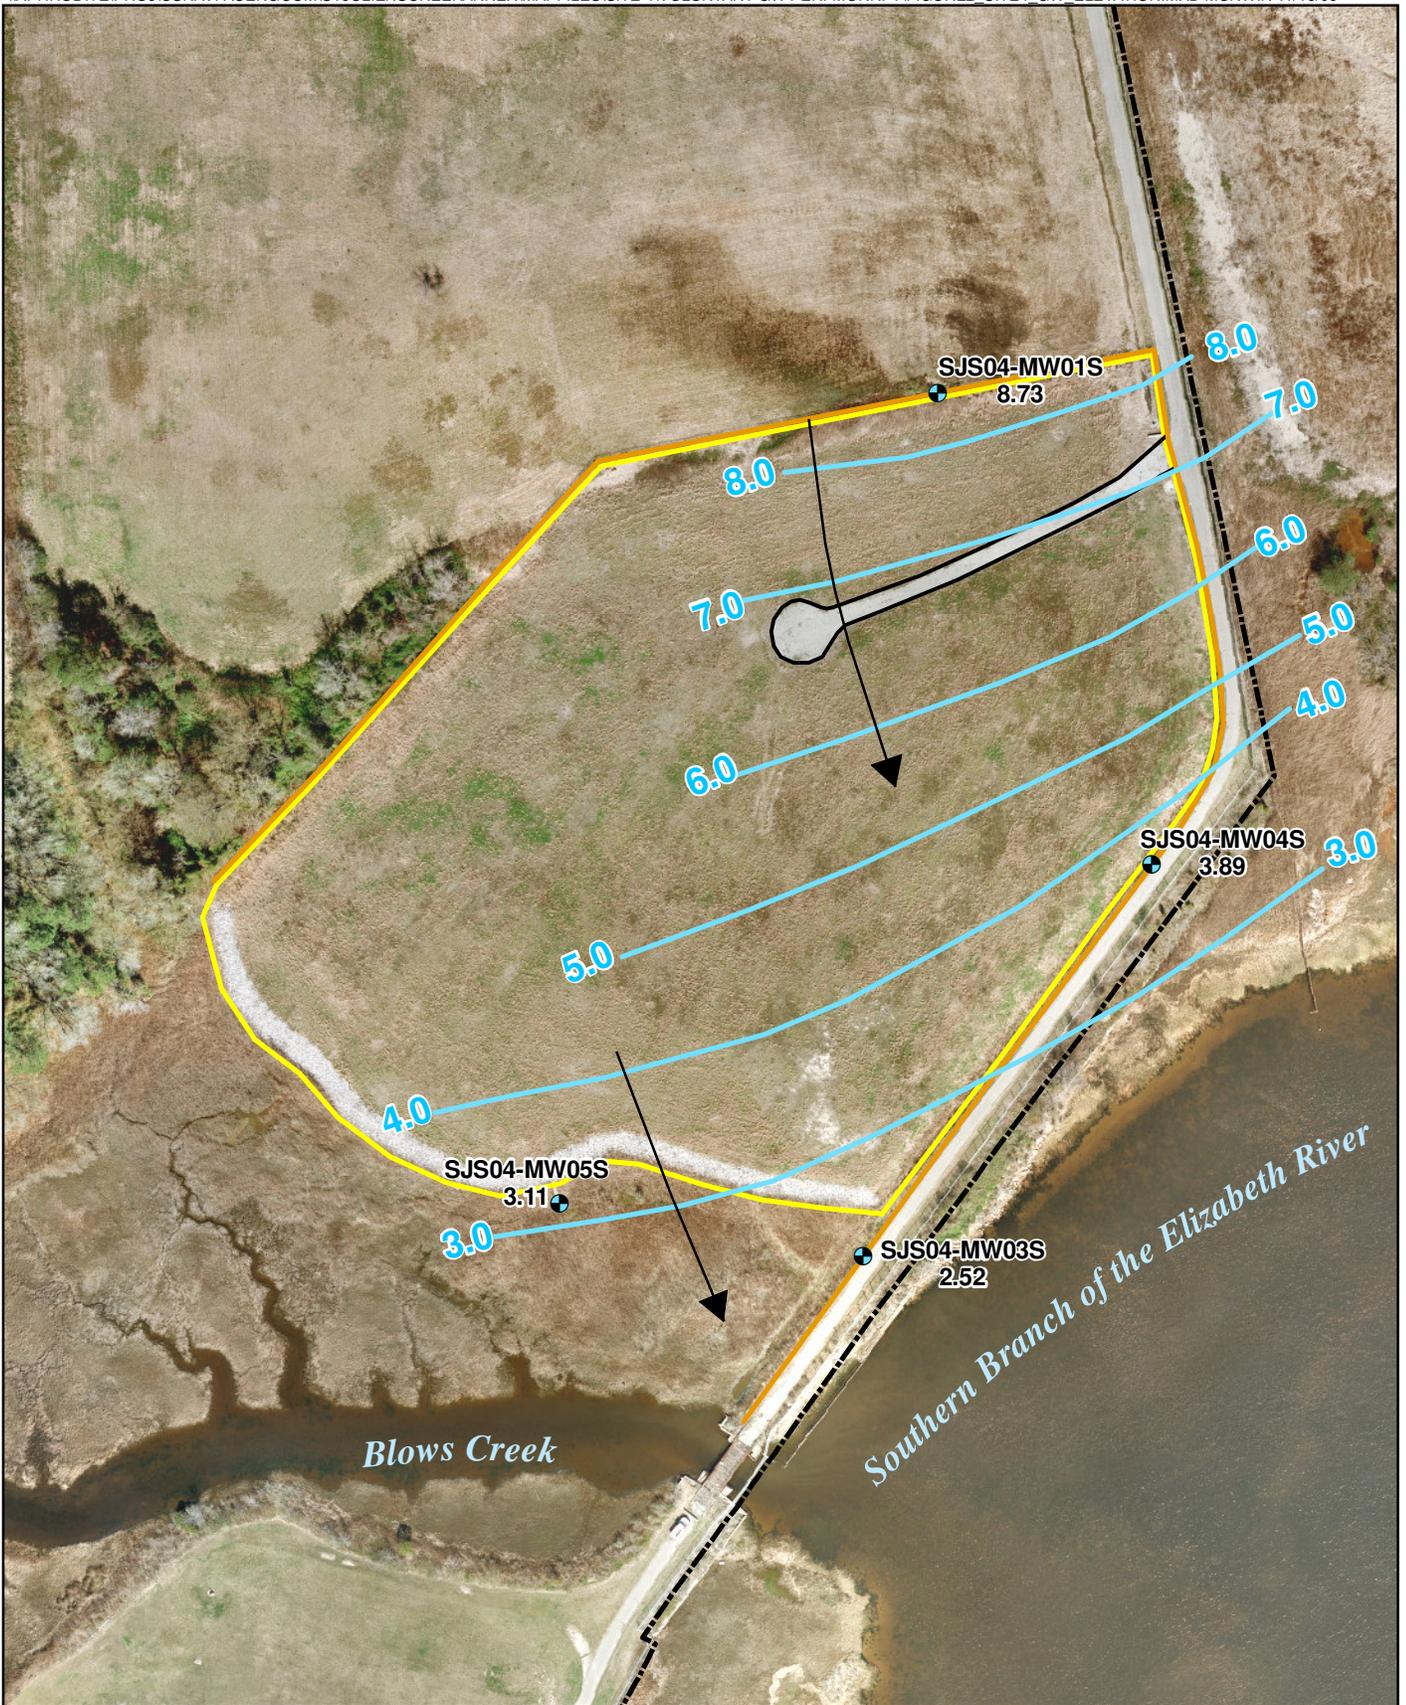
Figure 2  
 Columbia Aquifer Groundwater Surface Elevations  
 Site 4 Voluntary Groundwater  
 Monitoring Report Addendum  
 St. Juliens Creek Annex  
 Chesapeake, Virginia

- Shallow Monitoring Well
- SJCA Boundary
- Site/LUC Boundary
- Fence
- Access Road
- General Flow Direction
- Potentiometric Surface Contours (August 2009)
- 3.0 Groundwater Elevation (feet above mean sea level)

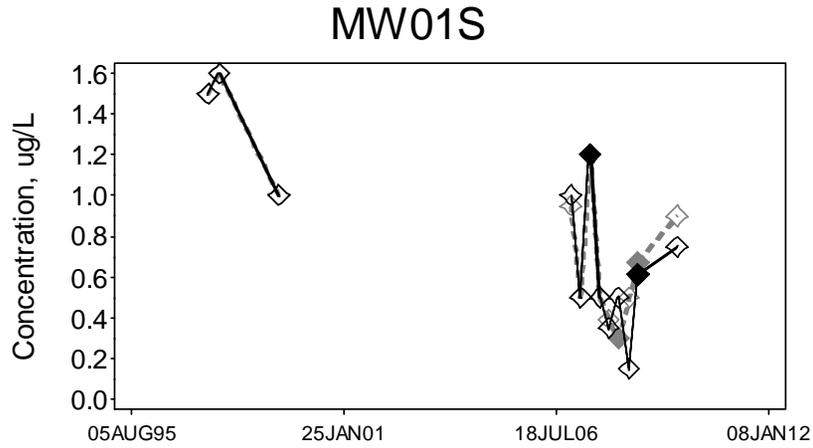
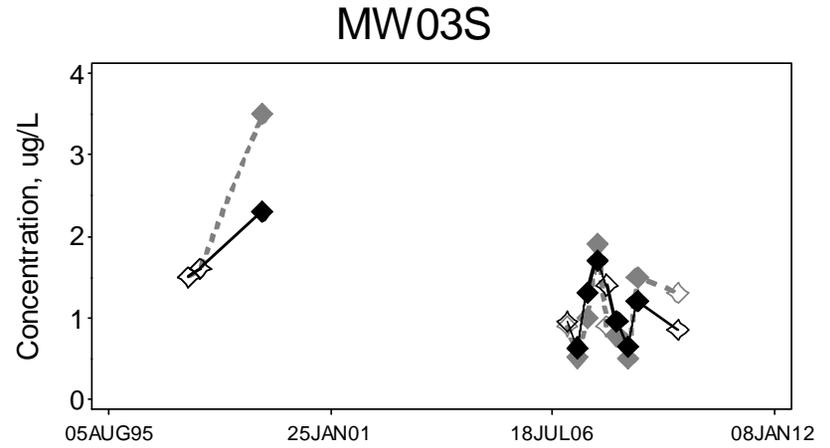
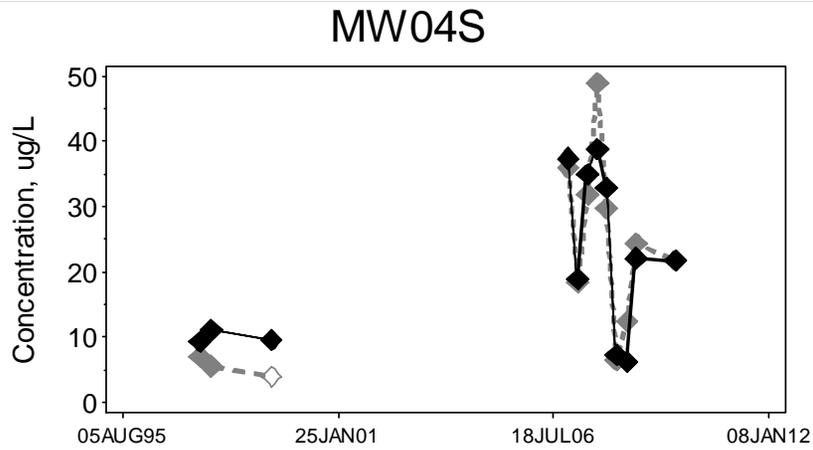
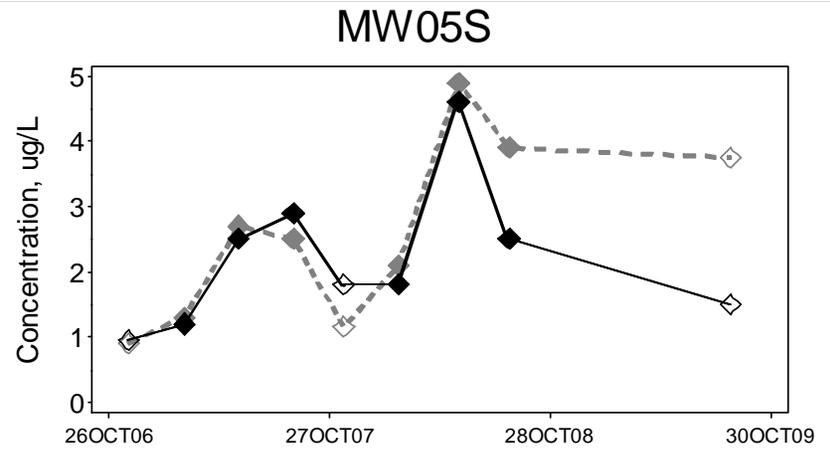
**Figure 6: Time Plots of Arsenic Concentrations**

Black Solid Line Represents Total Concentration; Gray Dashed Line Represents Dissolved Concentrations  
 Open Symbols Represent Non-Detect Values
