FINAL SITE MANAGEMENT PLAN FOR FISCAL YEARS 2014 AND 2015 NWS YORKTOWN
VA
11/1/2013
CH2M HILL

**Site Management Plan
Fiscal Years 2014—2015**

**Naval Weapons Station Yorktown
Yorktown, Virginia**

Contract Task Order WE73

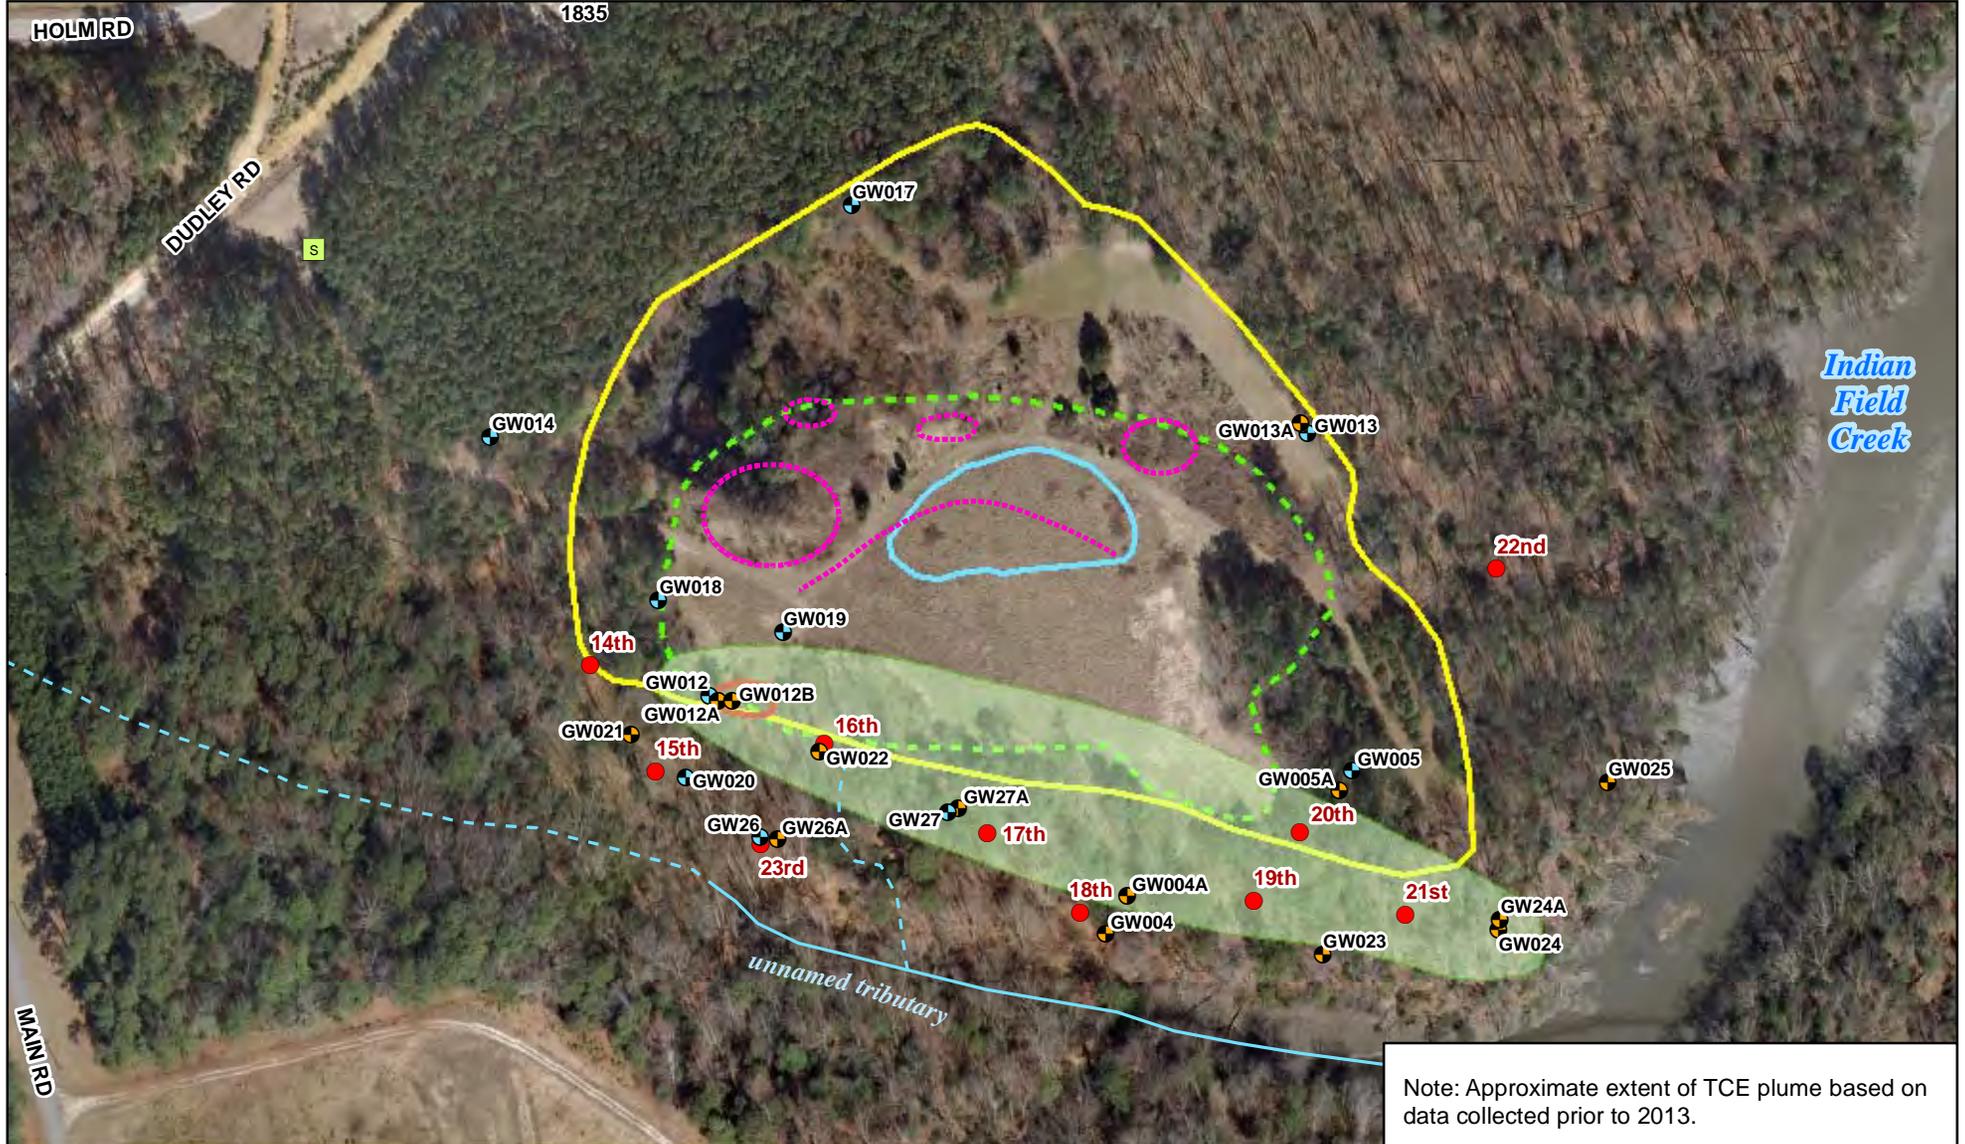
Figure 3-1
 Site 1 - Dudley Road Landfill
 Site Management Plan for FY 2014 to 2015
 WPNSTA Yorktown
 Yorktown, Virginia

- Site Sign
- Columbia Aquifer Monitoring Well
- Yorktown-Eastover Aquifer Monitoring Well
- MIP Locations
- Tributary
- - Intermittent Tributary
- - - Interpreted (Geophysical Survey) Northern Extent of Main Disposal Area (Roy F. Weston, Inc., 1993)
- Approximate Extent of TCE Plume
- Approximate Area of Excavation of Arsenic Contaminated Soil
- Landfill Area with New Cap (2001 Remedial Action, OHM)
- Study Area Boundary

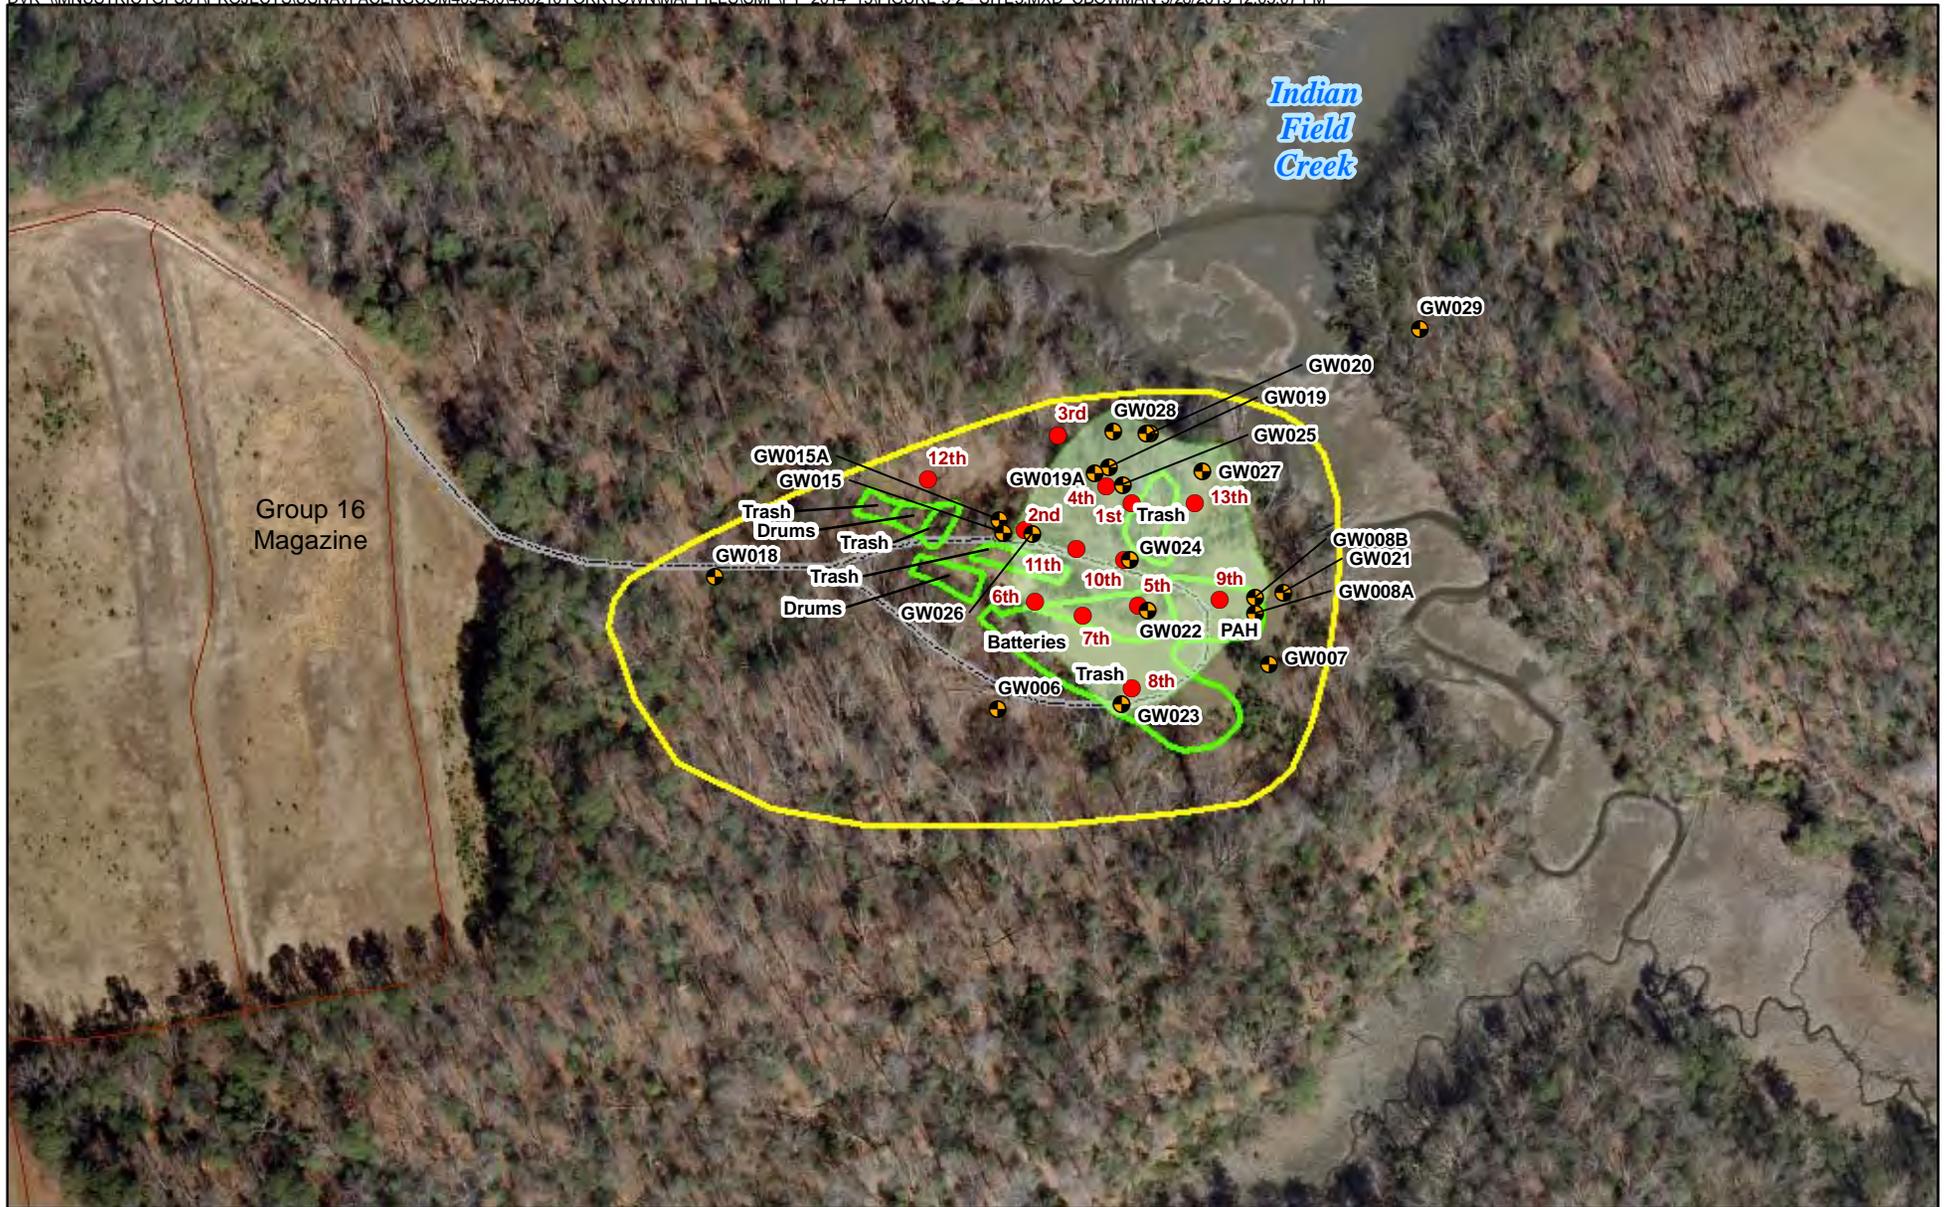
Figure 3-2
 Site 3 - Former Group 16 Magazine Landfill
 Site Management Plan for FY 2014 to 2015
 WPNSTA Yorktown
 Yorktown, Virginia

- Yorktown Monitoring Wells
- MIP Locations
- Landfill Access Road
- Approximate Extent of TCE Plume
- 1999 Soil and Waste Removal Area
- Study Area Boundary

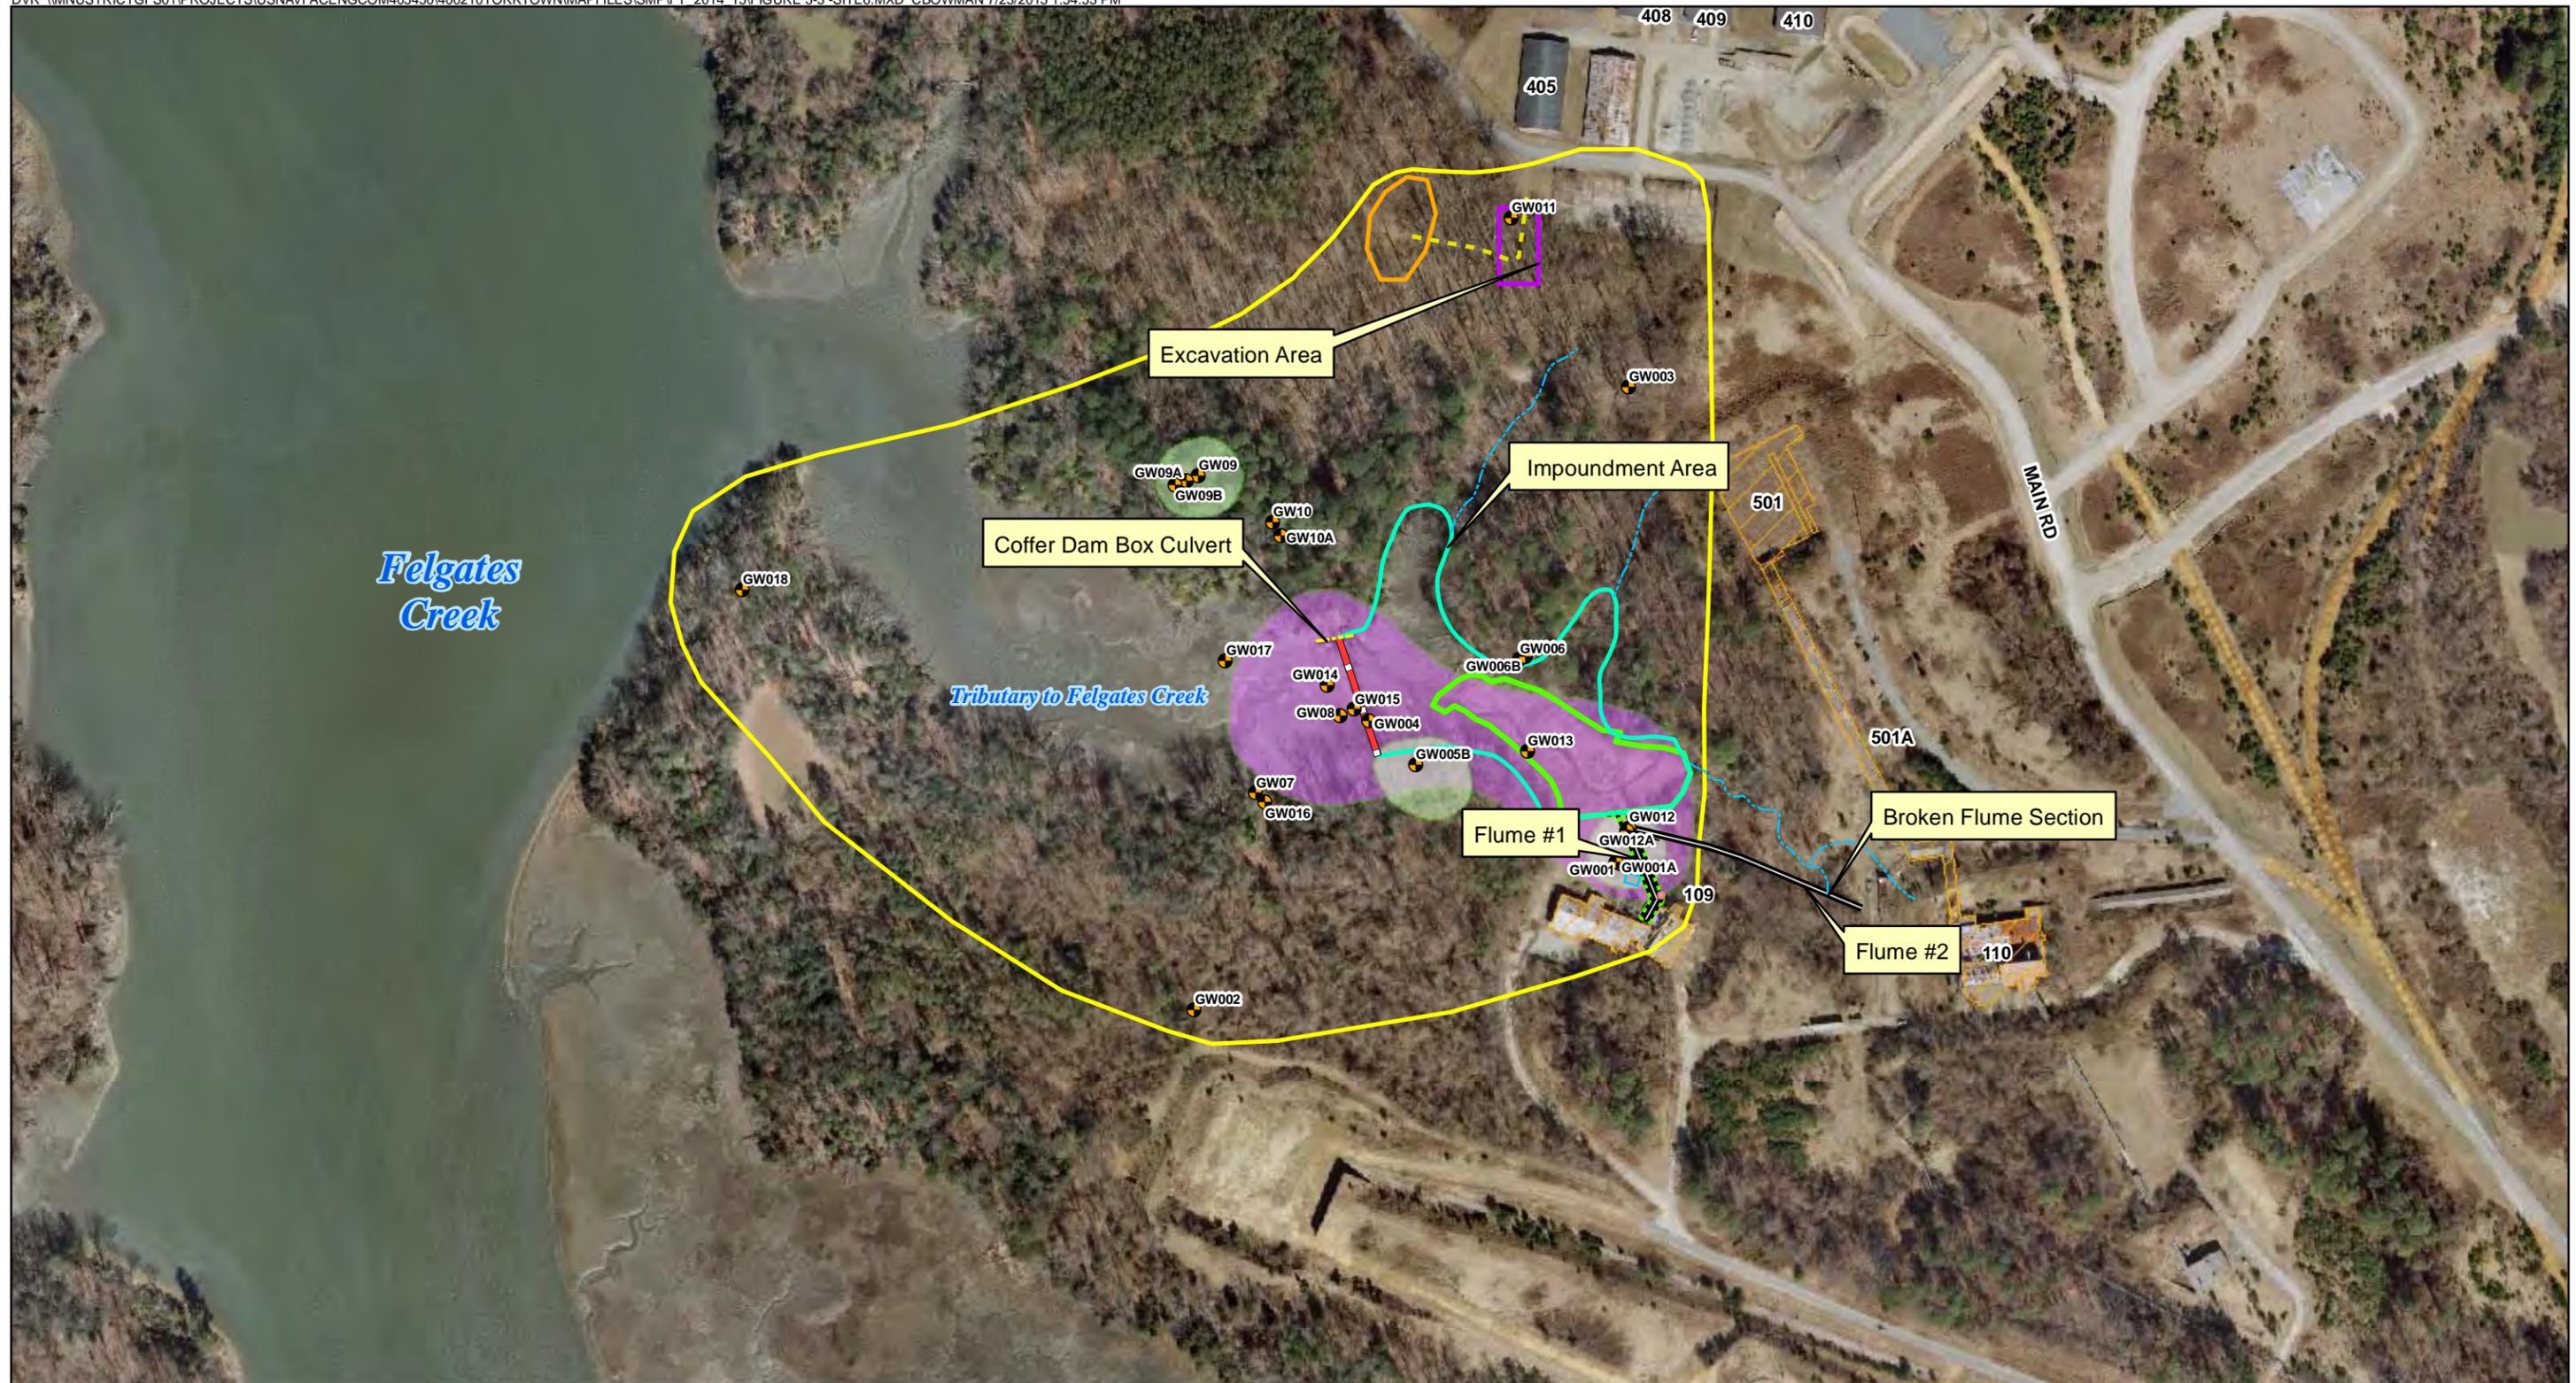
Figure 3-3
 Site 6 - Explosives Contaminated Wastewater Impoundment
 Site Management Plan for FY 2014-2015
 WPNSTA Yorktown
 Yorktown, Virginia

- Legend**
- Yorktown Monitoring Wells
 - Approximate Drainage
 - - - Approximate Location of Access Road
 - Impoundment Area/Inferred LUC Boundary
 - Coffer Dam
 - Oil/Water Treatment Unit (OWTU)
 - Carbon Adsorption Tower
 - 1998 & 2007 Removal Area
 - Cleared Area
 - Excavation Area/Inferred LUC Boundary
 - Flume Area
 - Demolished Building
 - Site 6 Study Area Boundary (under review)
 - Approximate Extent of TCE Plume
 - Approximate Extent of RDX Plume

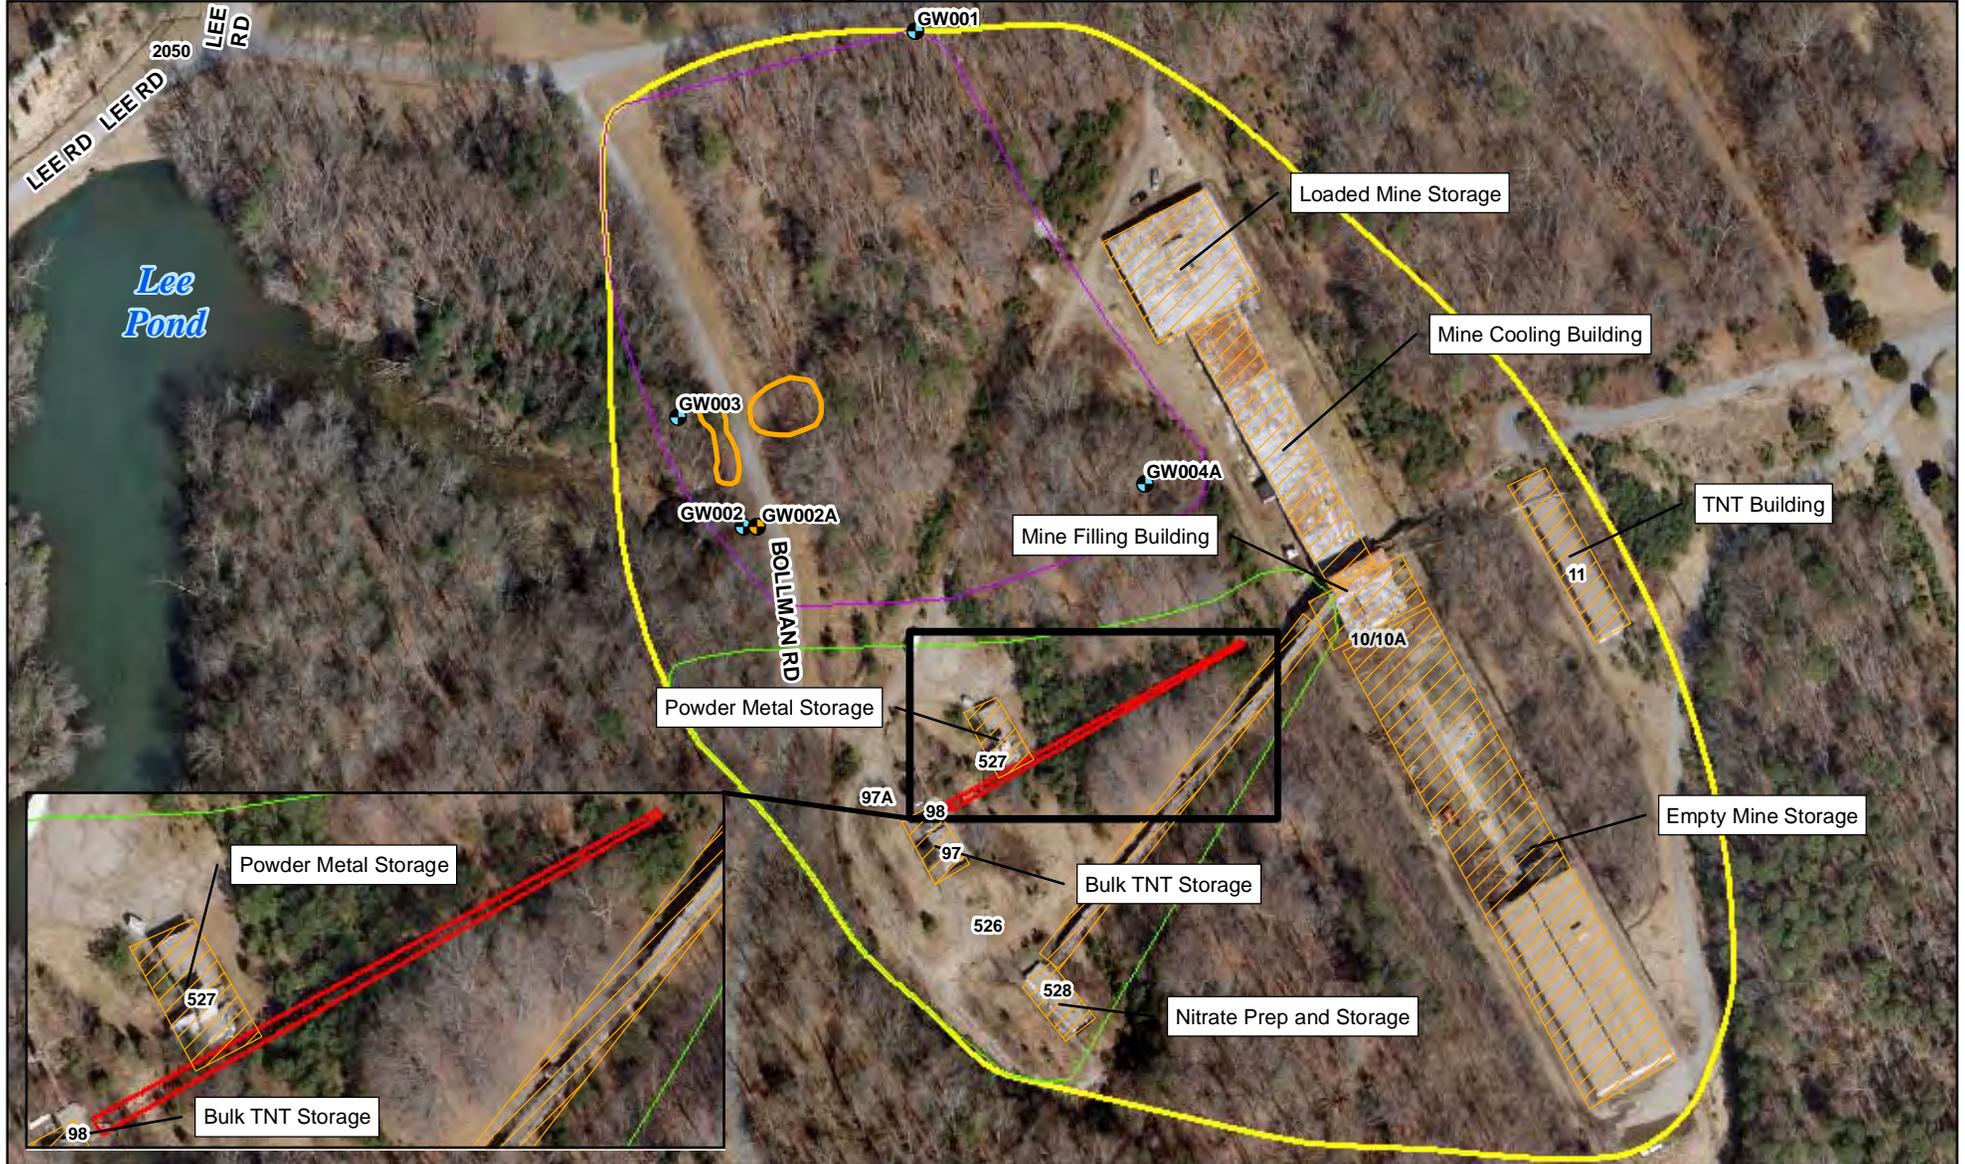
Figure 3-6
 Site 9 - Plant 1 Explosives Contaminated
 Site Management Plan for FY 2014 to 2015
 WPNSTA Yorktown
 Yorktown, Virginia

- Cornwallis-Cave Aquifer Monitoring Wells
- Yorktown-Eastover Monitoring Wells
- Site 19 Original Study Area Boundary
- Site 9 Original Study Area Boundary
- ▨ Inferred Soil LUC Area
- Current Site 9 & 19 Study Area Boundary
- ▨ Approximate Area of December 1994 Removal Action
- ▨ Former Site Structures (demolished 2010-2012)

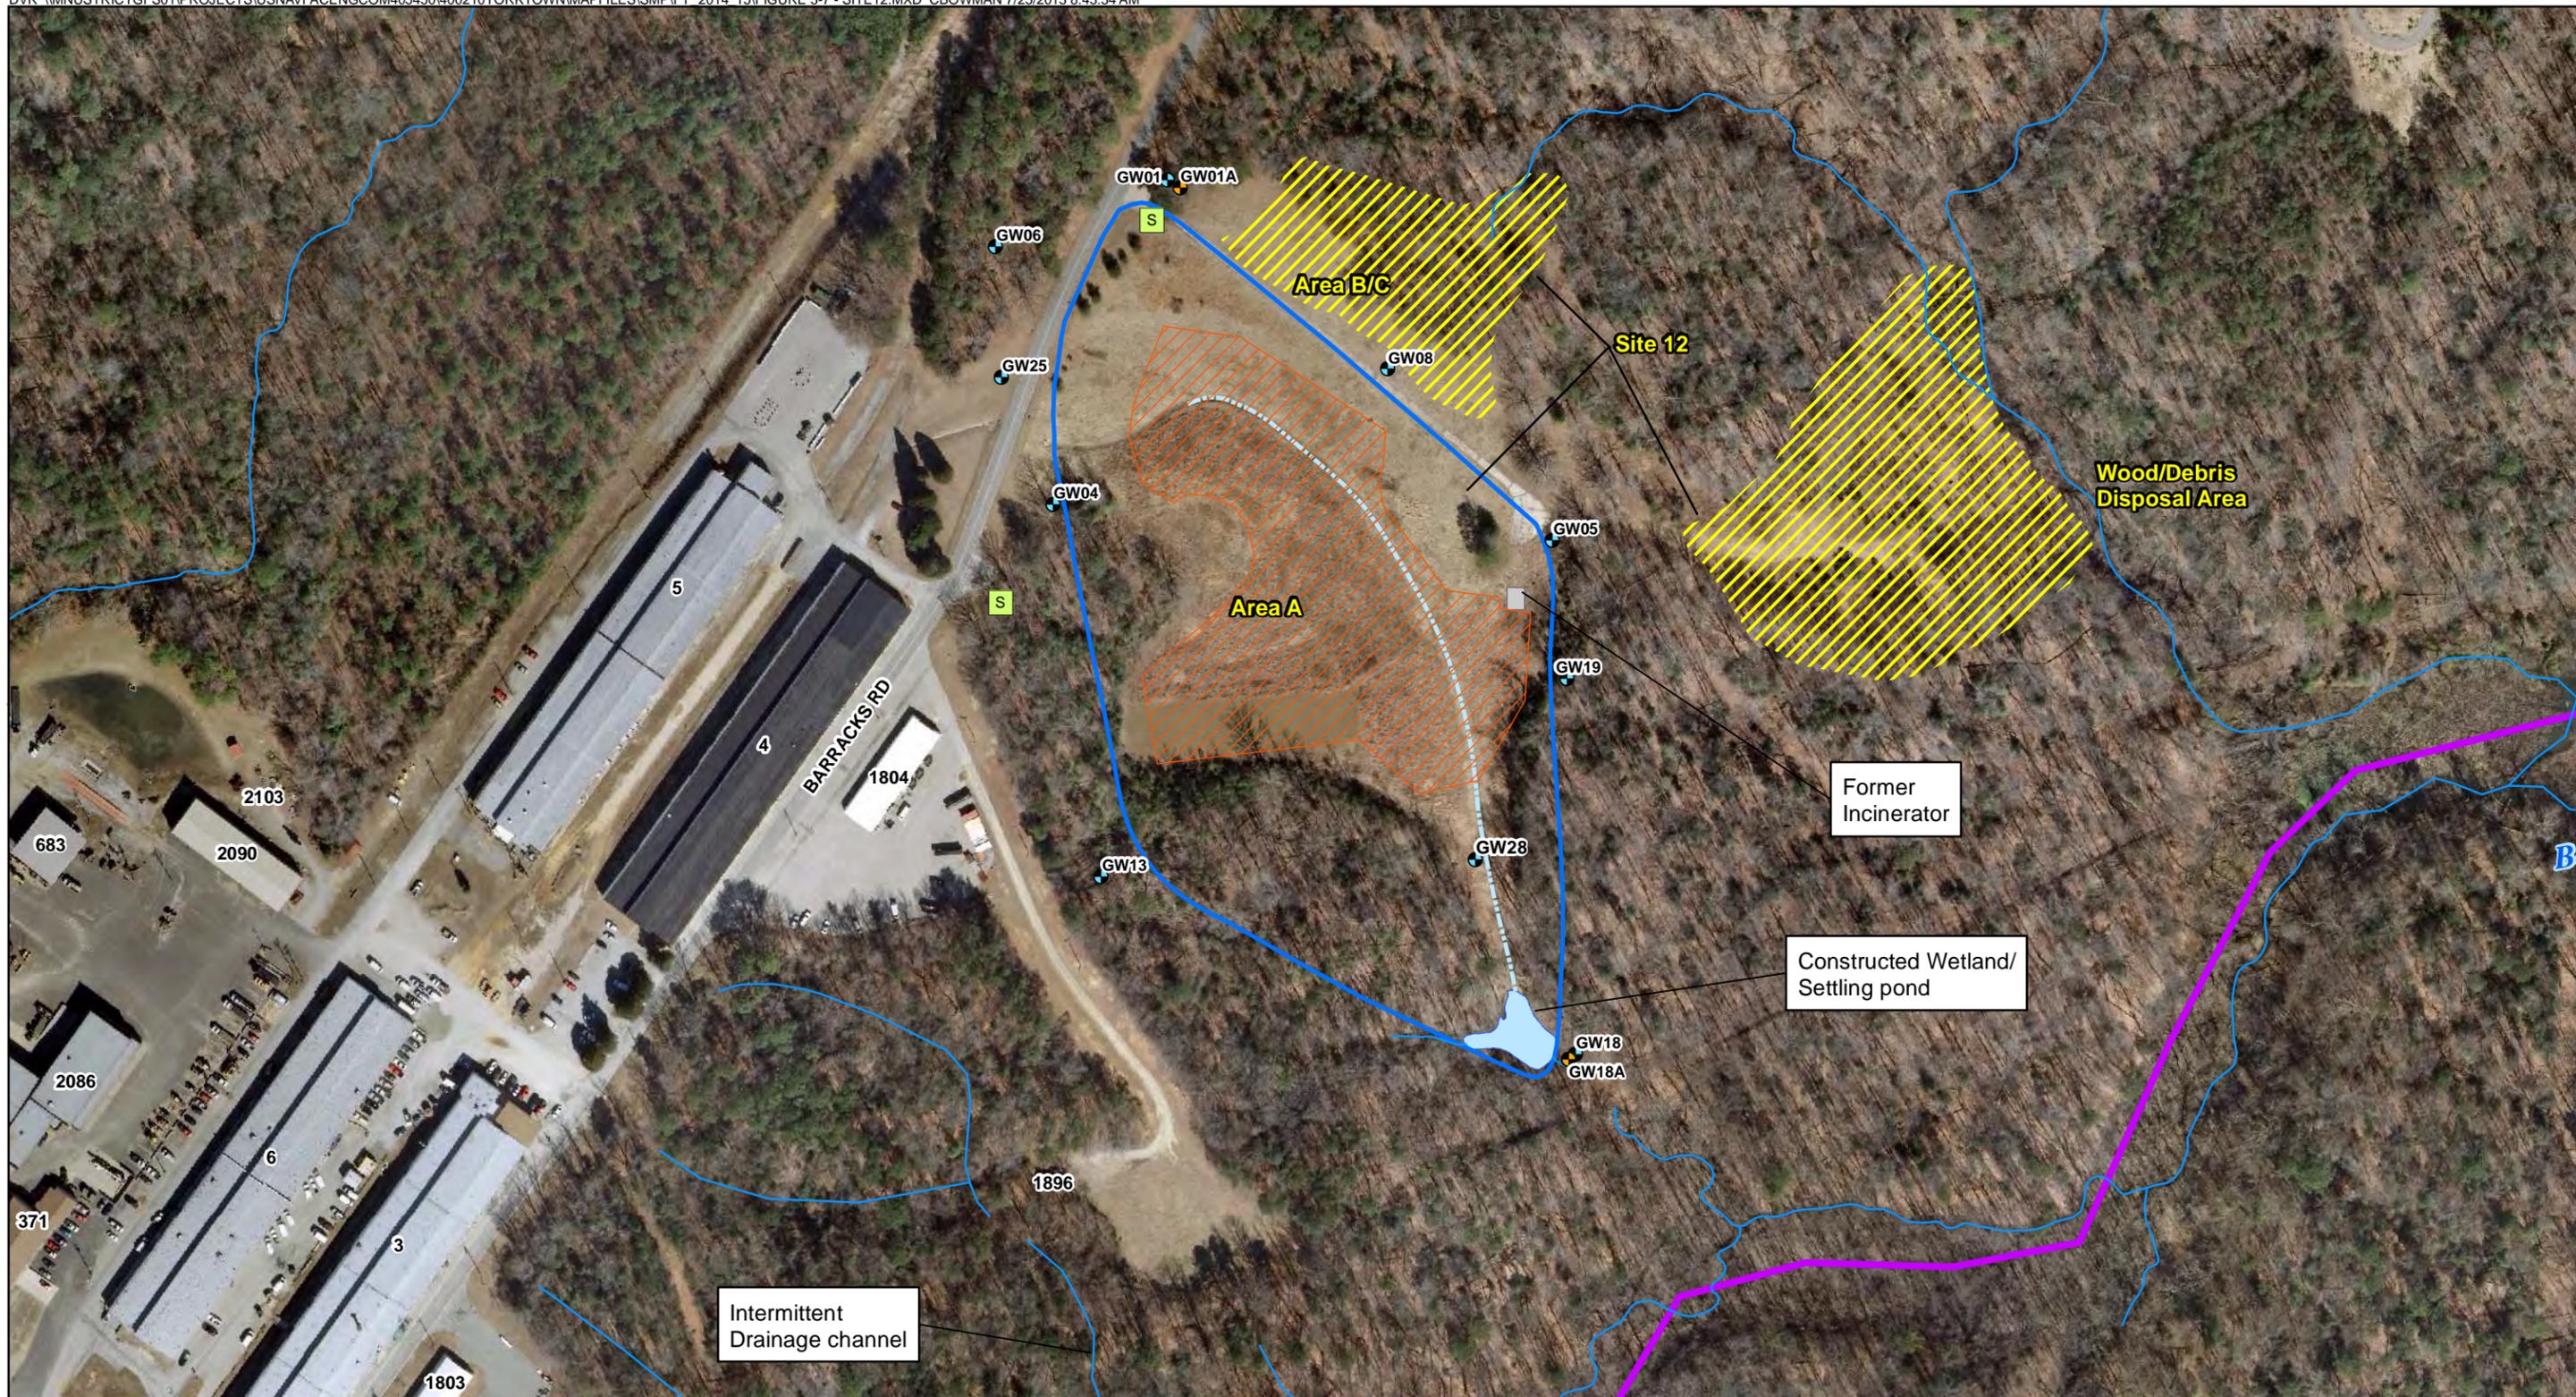
Figure 3-7
Site 12 - Barracks Road Landfill
Site Management Plan for FY 2014 to 2015
WPNSTA Yorktown
Yorktown, Virginia

- Legend**
- Site Sign
 - Yorktown-Eastover Monitoring Well
 - Cornwallis Cave Monitoring Well
 - WPNSTA Boundary
 - Area A Groundwater LUC
 - Extent of Landfill Cap (installed in 1997) and Area A Soil LUC
 - Approximate NFA Areas

LUC Requirement: Maintain cap, prevent residential development, and prohibit potable use of groundwater.

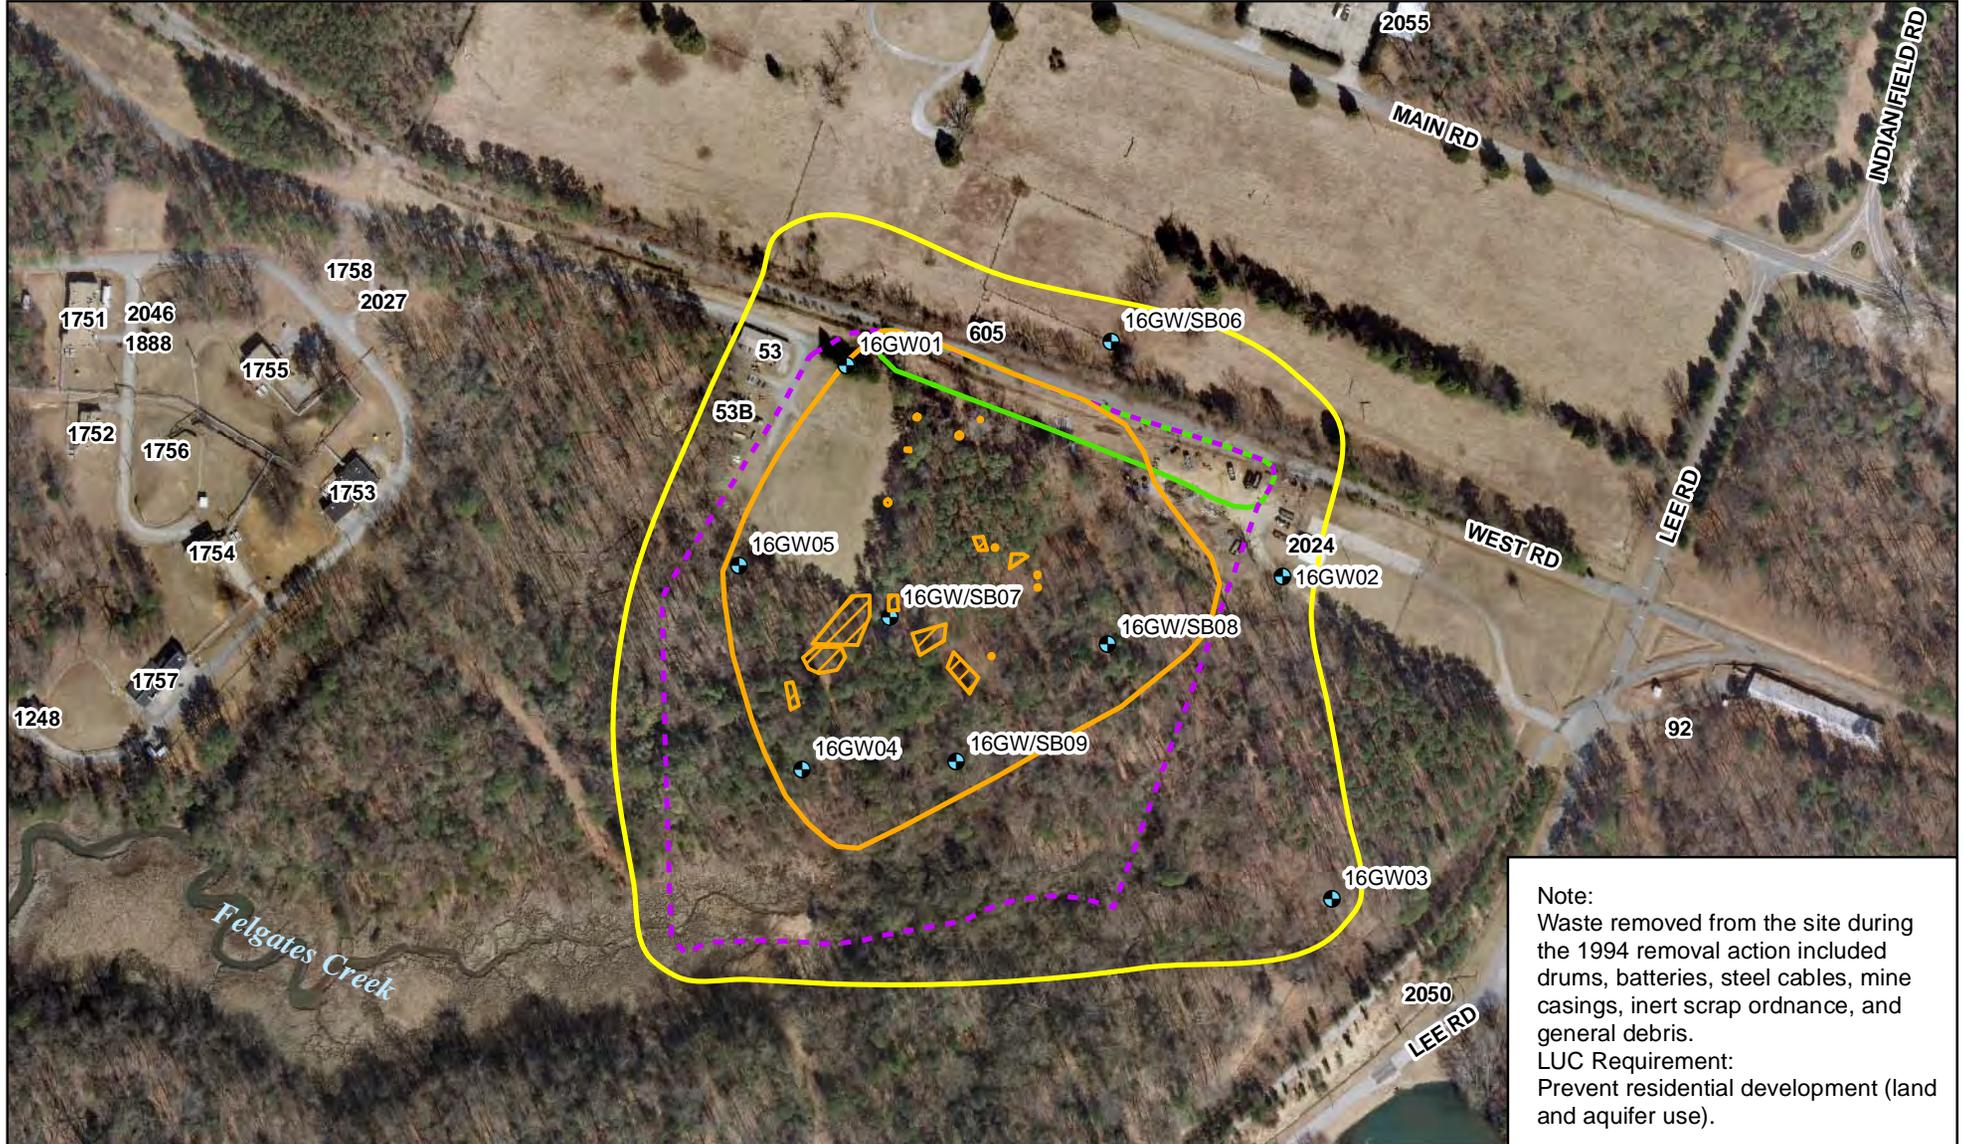
Figure 3-8
 Site 16/SSA 16 - West Road Landfill
 Site Management Plan for FY 2014 to 2015
 WPNSTA Yorktown
 Yorktown, Virginia

Note:
 Waste removed from the site during the 1994 removal action included drums, batteries, steel cables, mine casings, inert scrap ordnance, and general debris.
 LUC Requirement:
 Prevent residential development (land and aquifer use).

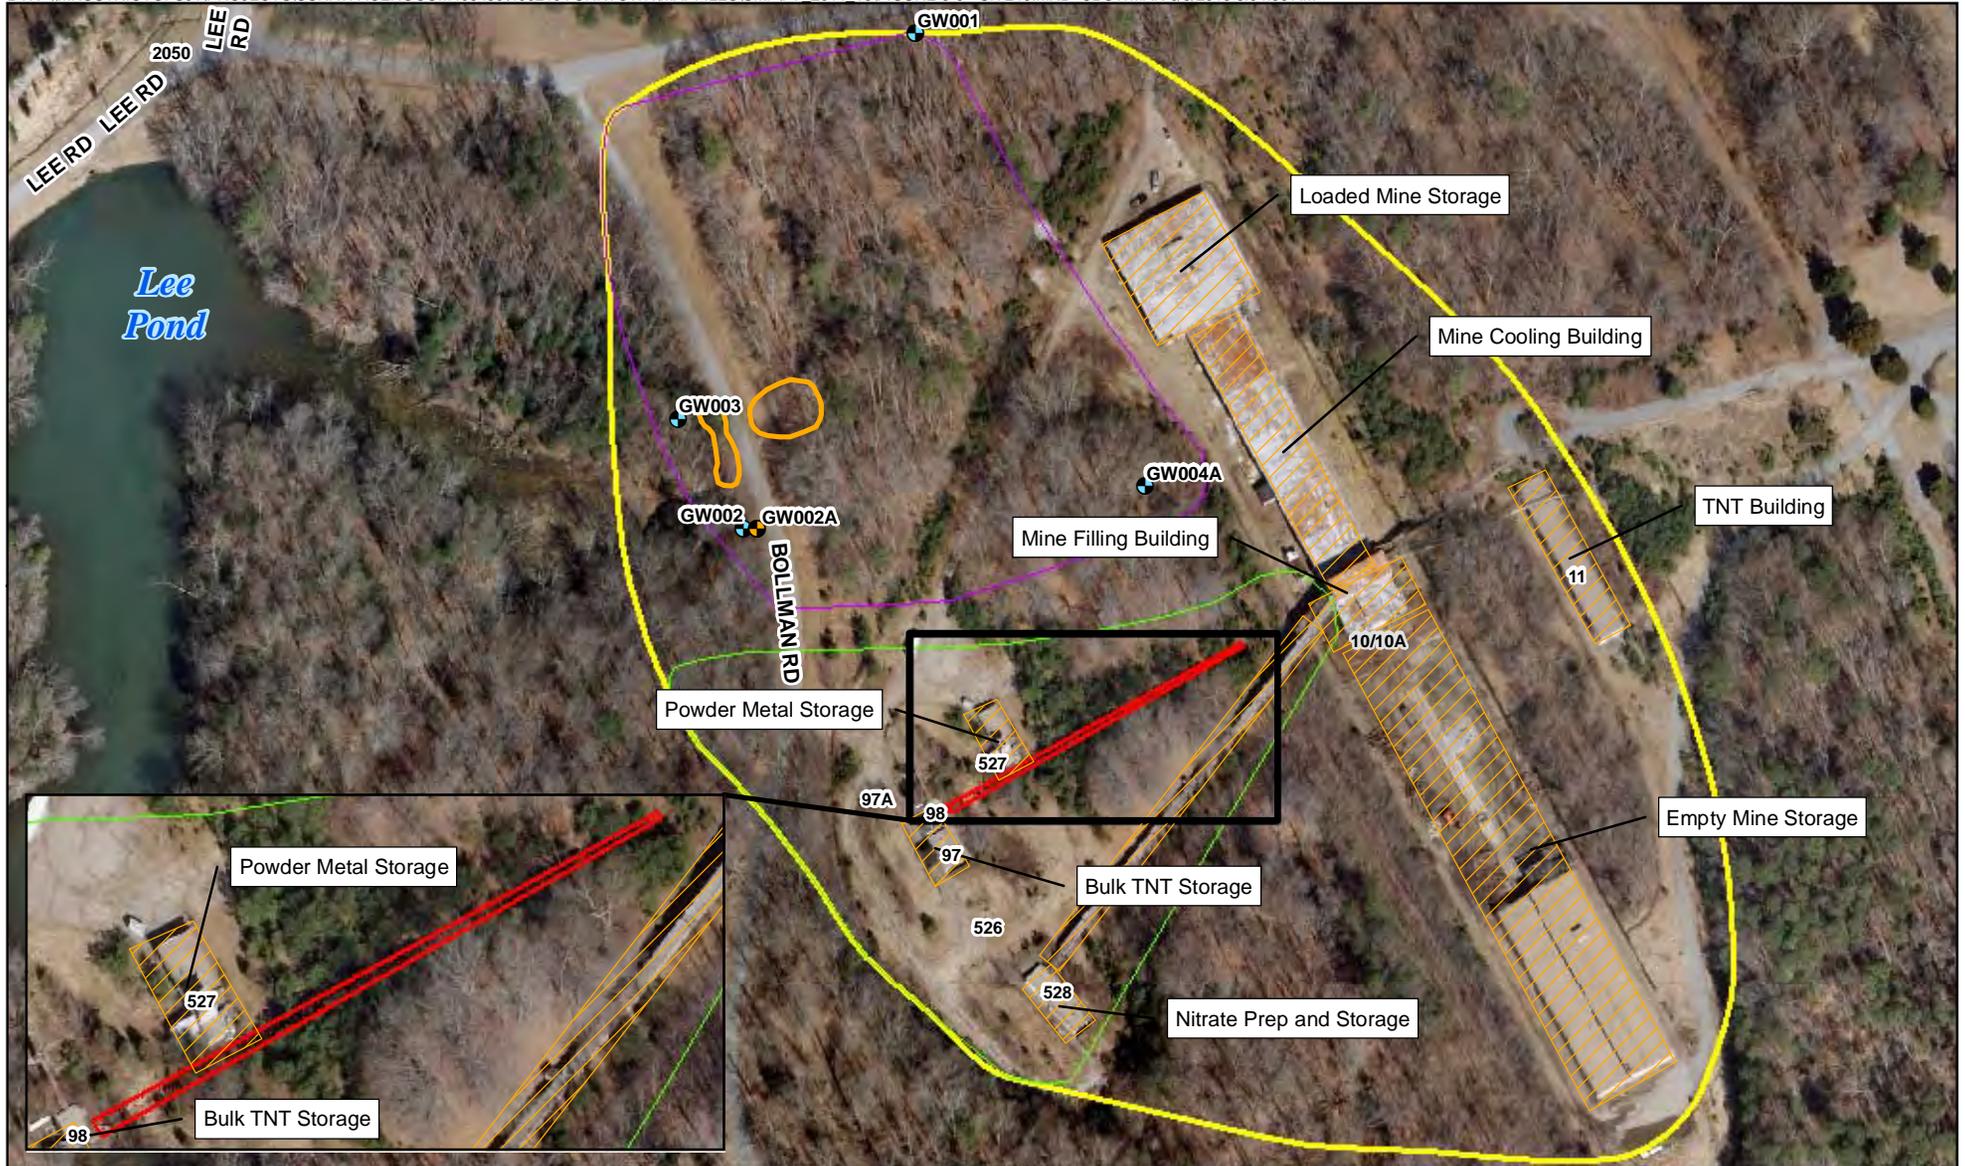
Figure 3-9
 Site 19 - Conveyor Belt Soils at Building 10
 Site Management Plan for FY 2014 to 2015
 WPNSTA Yorktown
 Yorktown, Virginia

- Cornwallis-Cave Aquifer Monitoring Wells
- Yorktown-Eastover Monitoring Wells
- Site 19 Original Study Area Boundary
- Site 9 Original Study Area Boundary
- Inferred Soil LUC Area
- Current Site 9 & 19 Study Area Boundary
- Approximate Area of December 1994 Removal Action
- Former Site Structures (demolished 2010-2012)

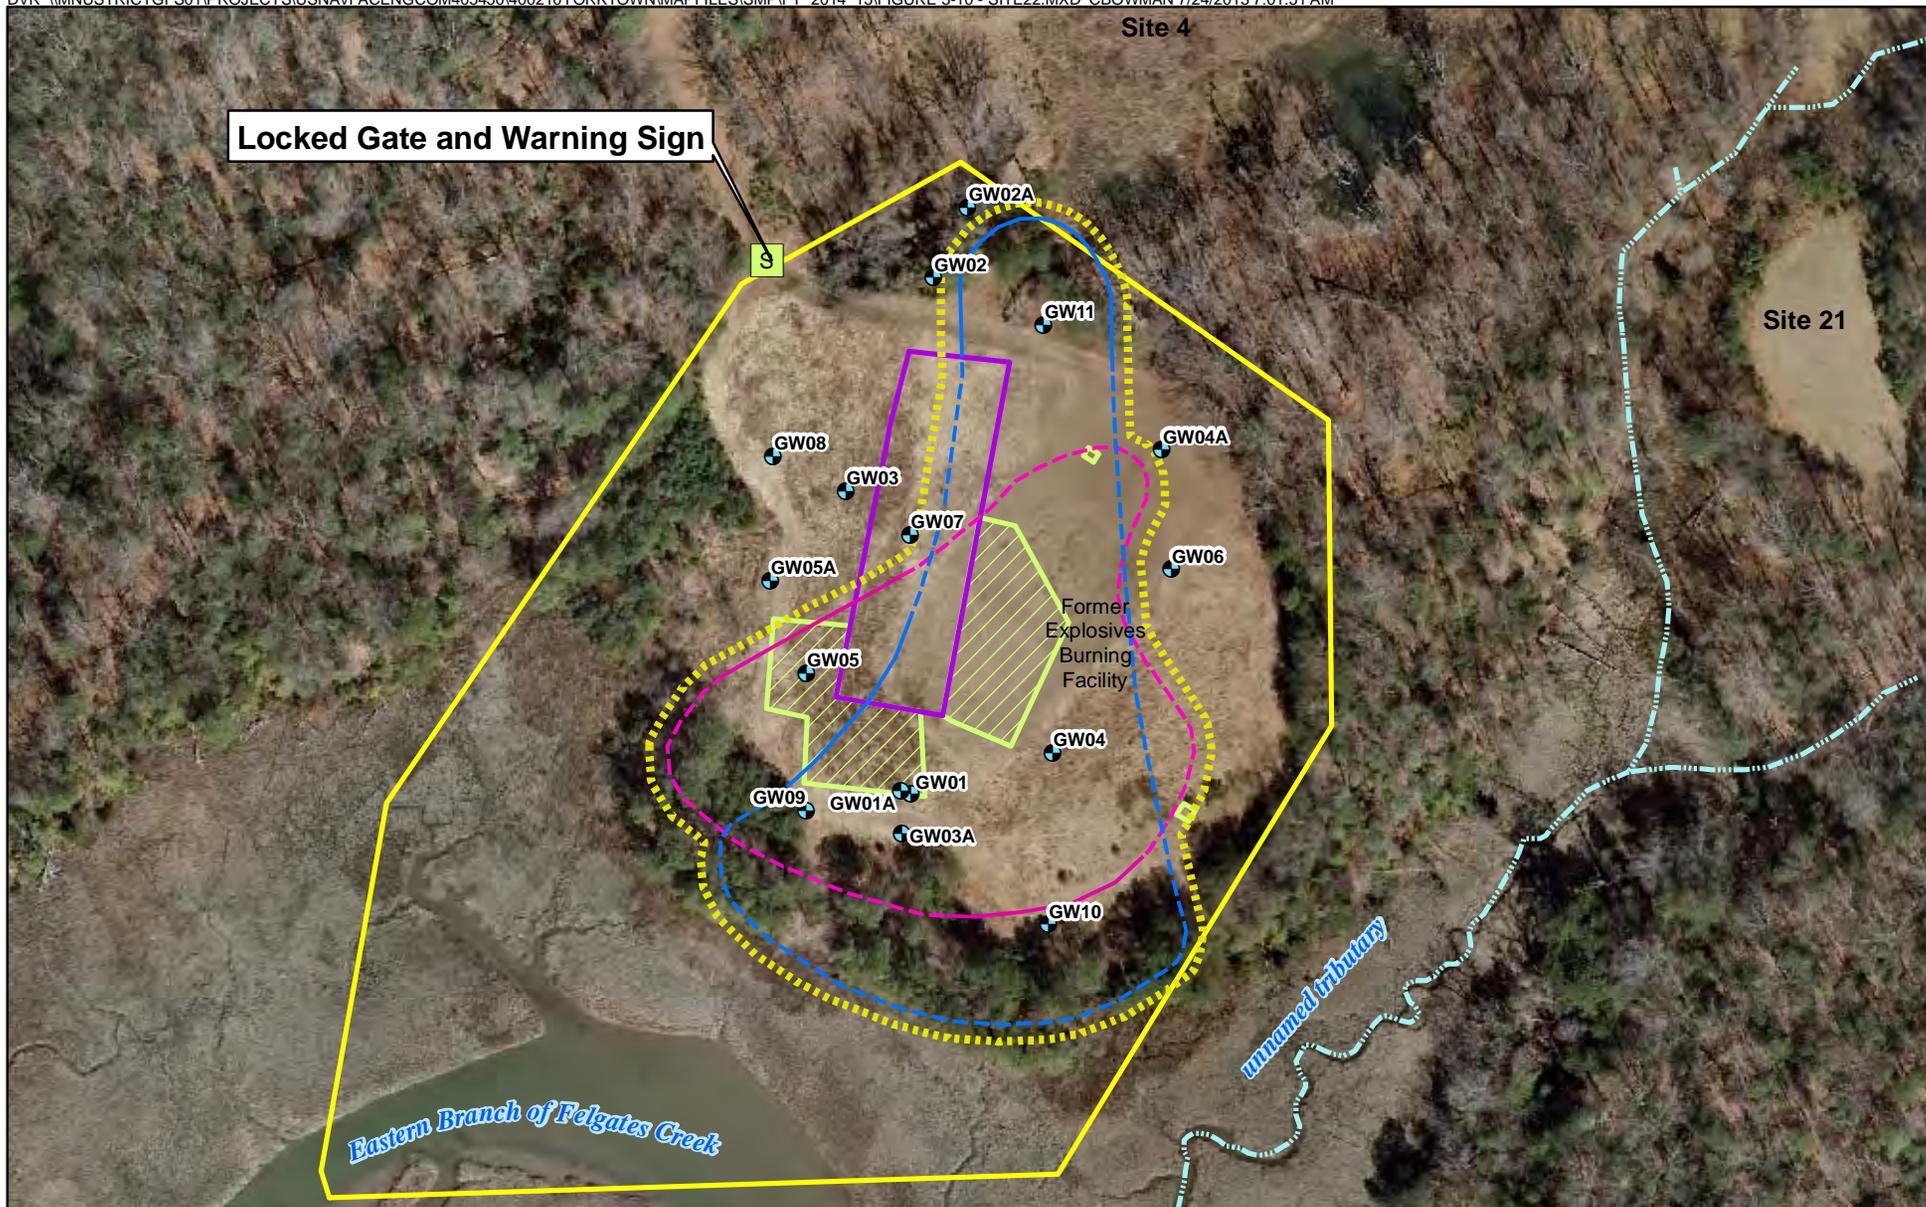
Figure 3-10
Site 22 - Burn Pad
Site Management Plan for FY 2014 to 2015
WPNSTA Yorktown
Yorktown, Virginia

- S Site Sign
- Monitoring Well
- Approximate Extent of TCE in Groundwater
- Approximate Extent of RDX in Groundwater
- Drainage
- Groundwater LUC Boundary
- Study Area Boundary
- Former Biocell Location
- / / / / / Removal Action Area (2003)
