FINAL SITE MANAGEMENT PLAN FOR FISCAL YEARS 2014 AND 2015 NWS YORKTOWN
VA
11/1/2013
CH2M HILL

**Site Management Plan
Fiscal Years 2014—2015**

**Naval Weapons Station Yorktown
Yorktown, Virginia**

Contract Task Order WE73

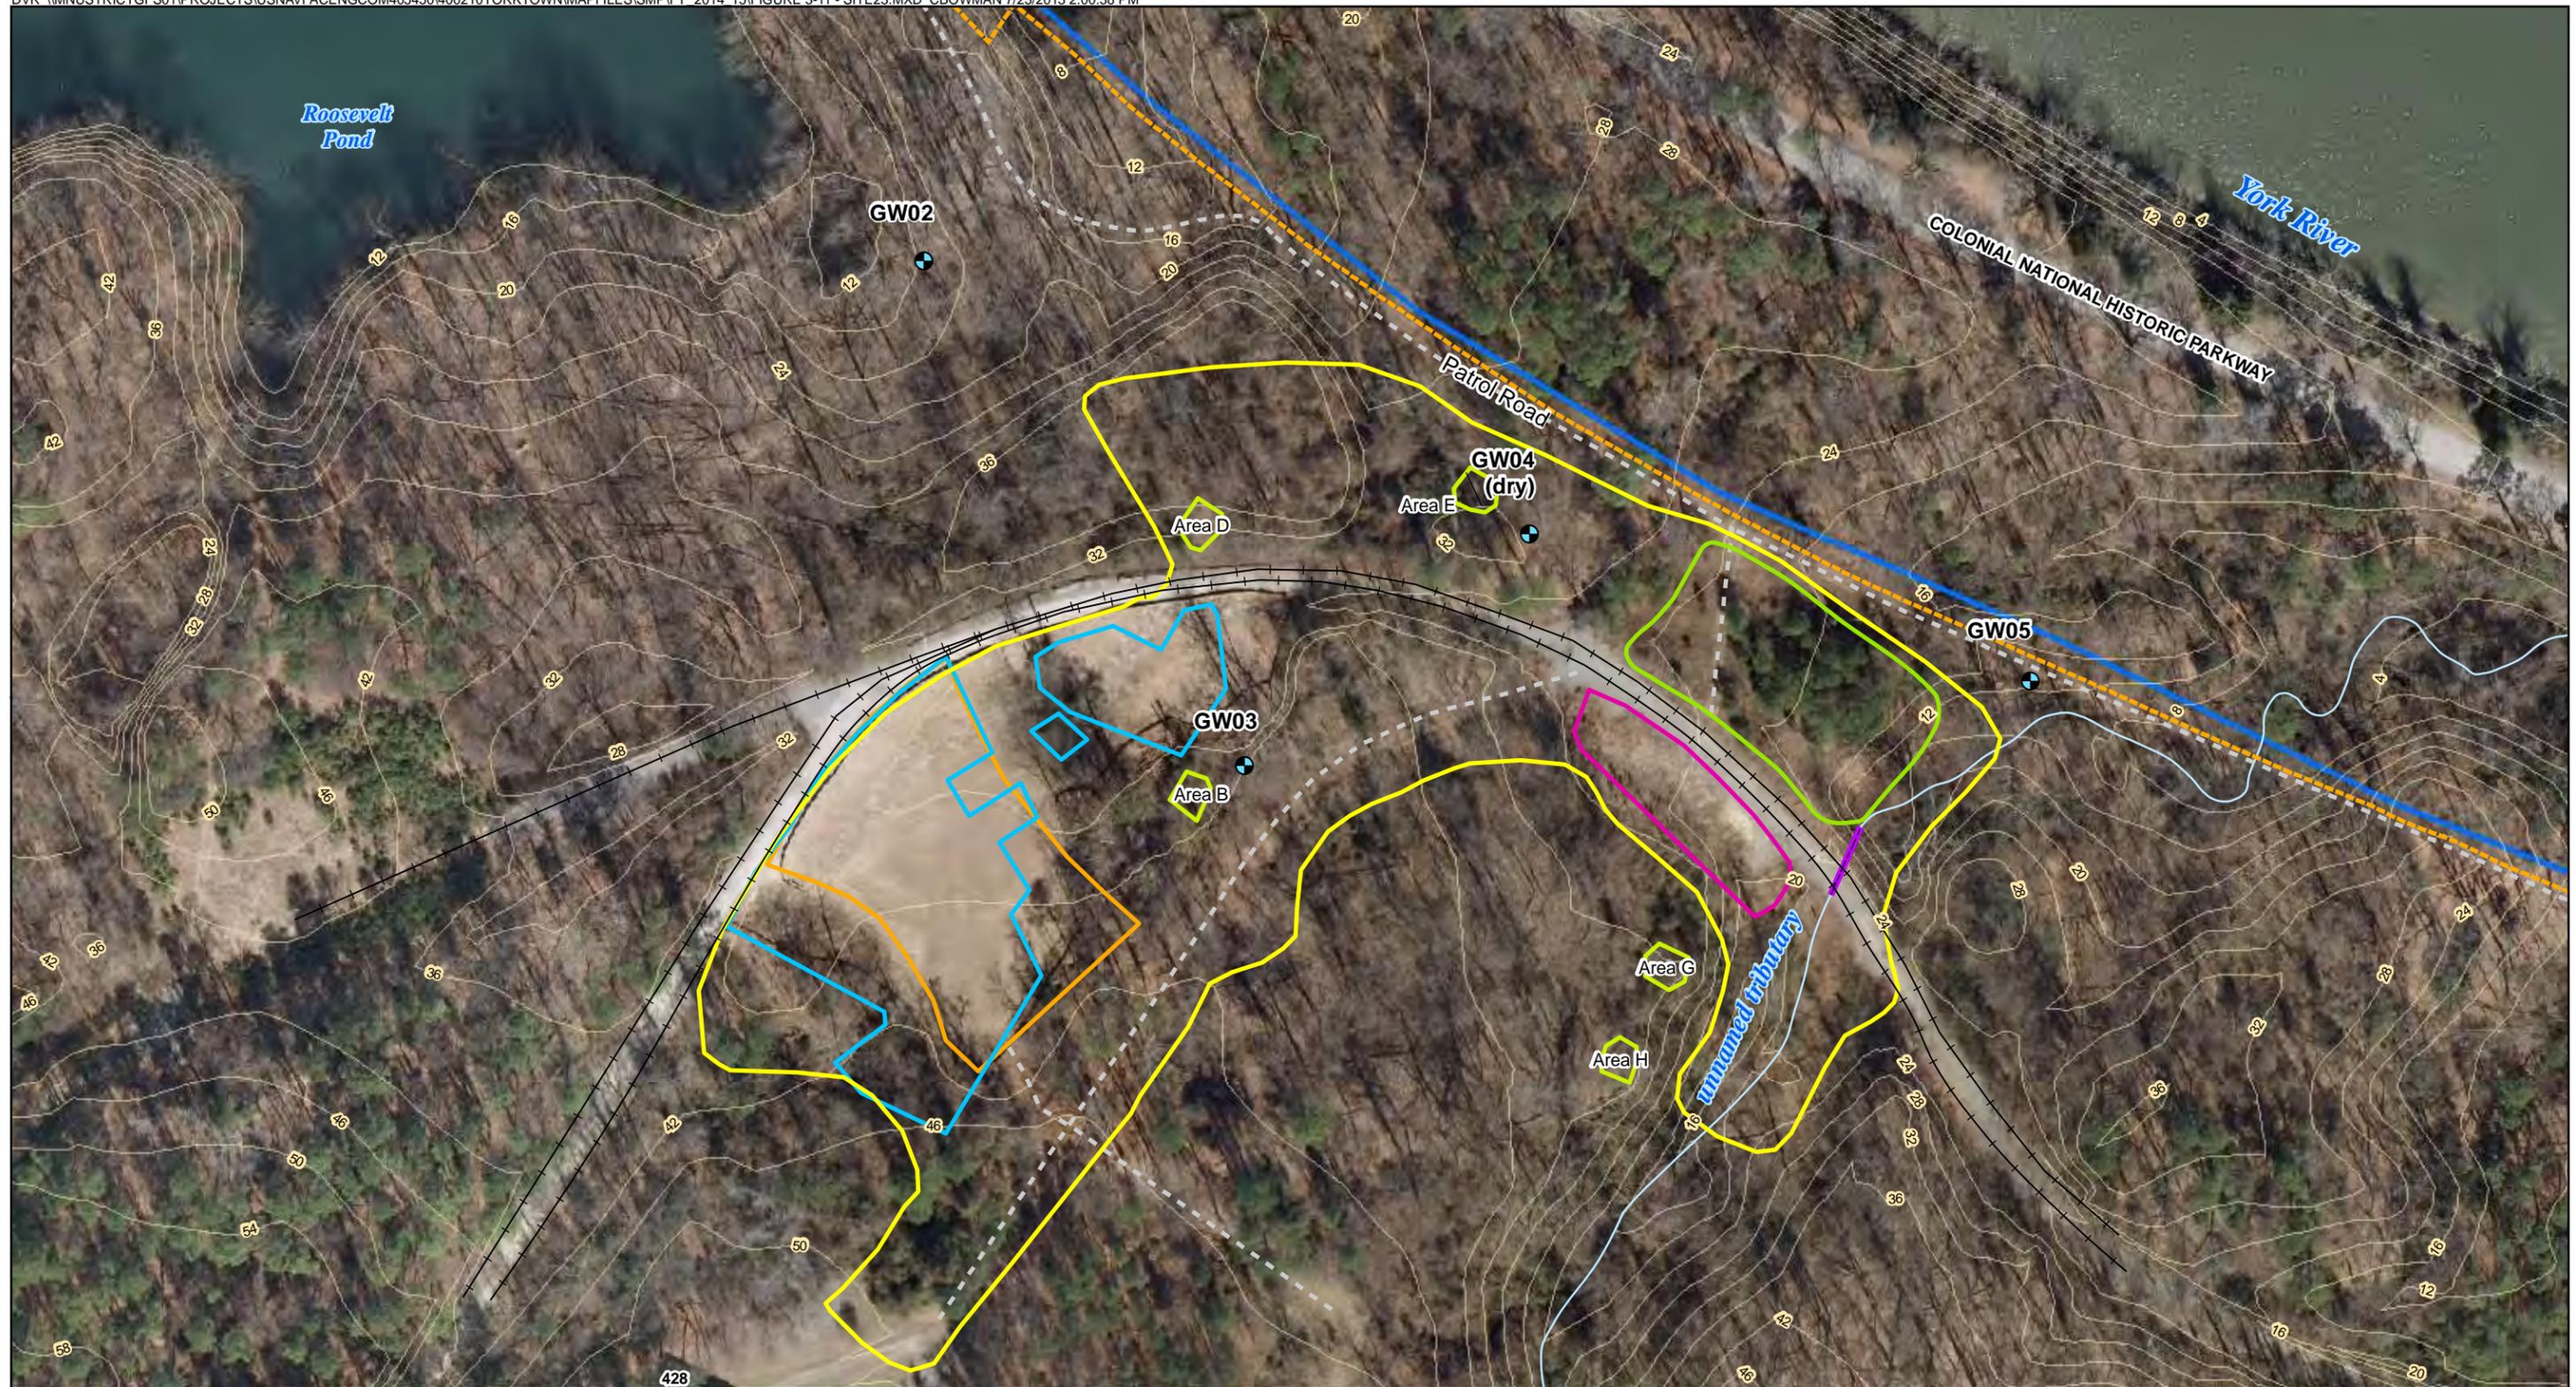
Figure 3-11
 Site 23 - Building 428 Teague Road Disposal Area
 Site Management Plan for FY 2014 to 2015
 WPNSTA Yorktown
 Yorktown, Virginia

- Legend**
- Monitoring Well
 - Fence
 - Surface Water Centerline
 - Elevation Contour (4 ft interval)
 - Former Railroad
 - 18" Corrugated Metal Pipe
 - Unpaved Road
 - Approximate Extent of Surface Debris Removal Area
 - Other Removal Areas
 - 2003 (J.A. Jones) Soil Removal Area
 - 1994 (OHM) Surface Debris Removal and Soil/Debris Removal Area
 - 2004 (UNITEC) Soil Removal Area
 - 2009 (Shaw) Soil/Debris Removal Area
 - WPNSTA Boundary

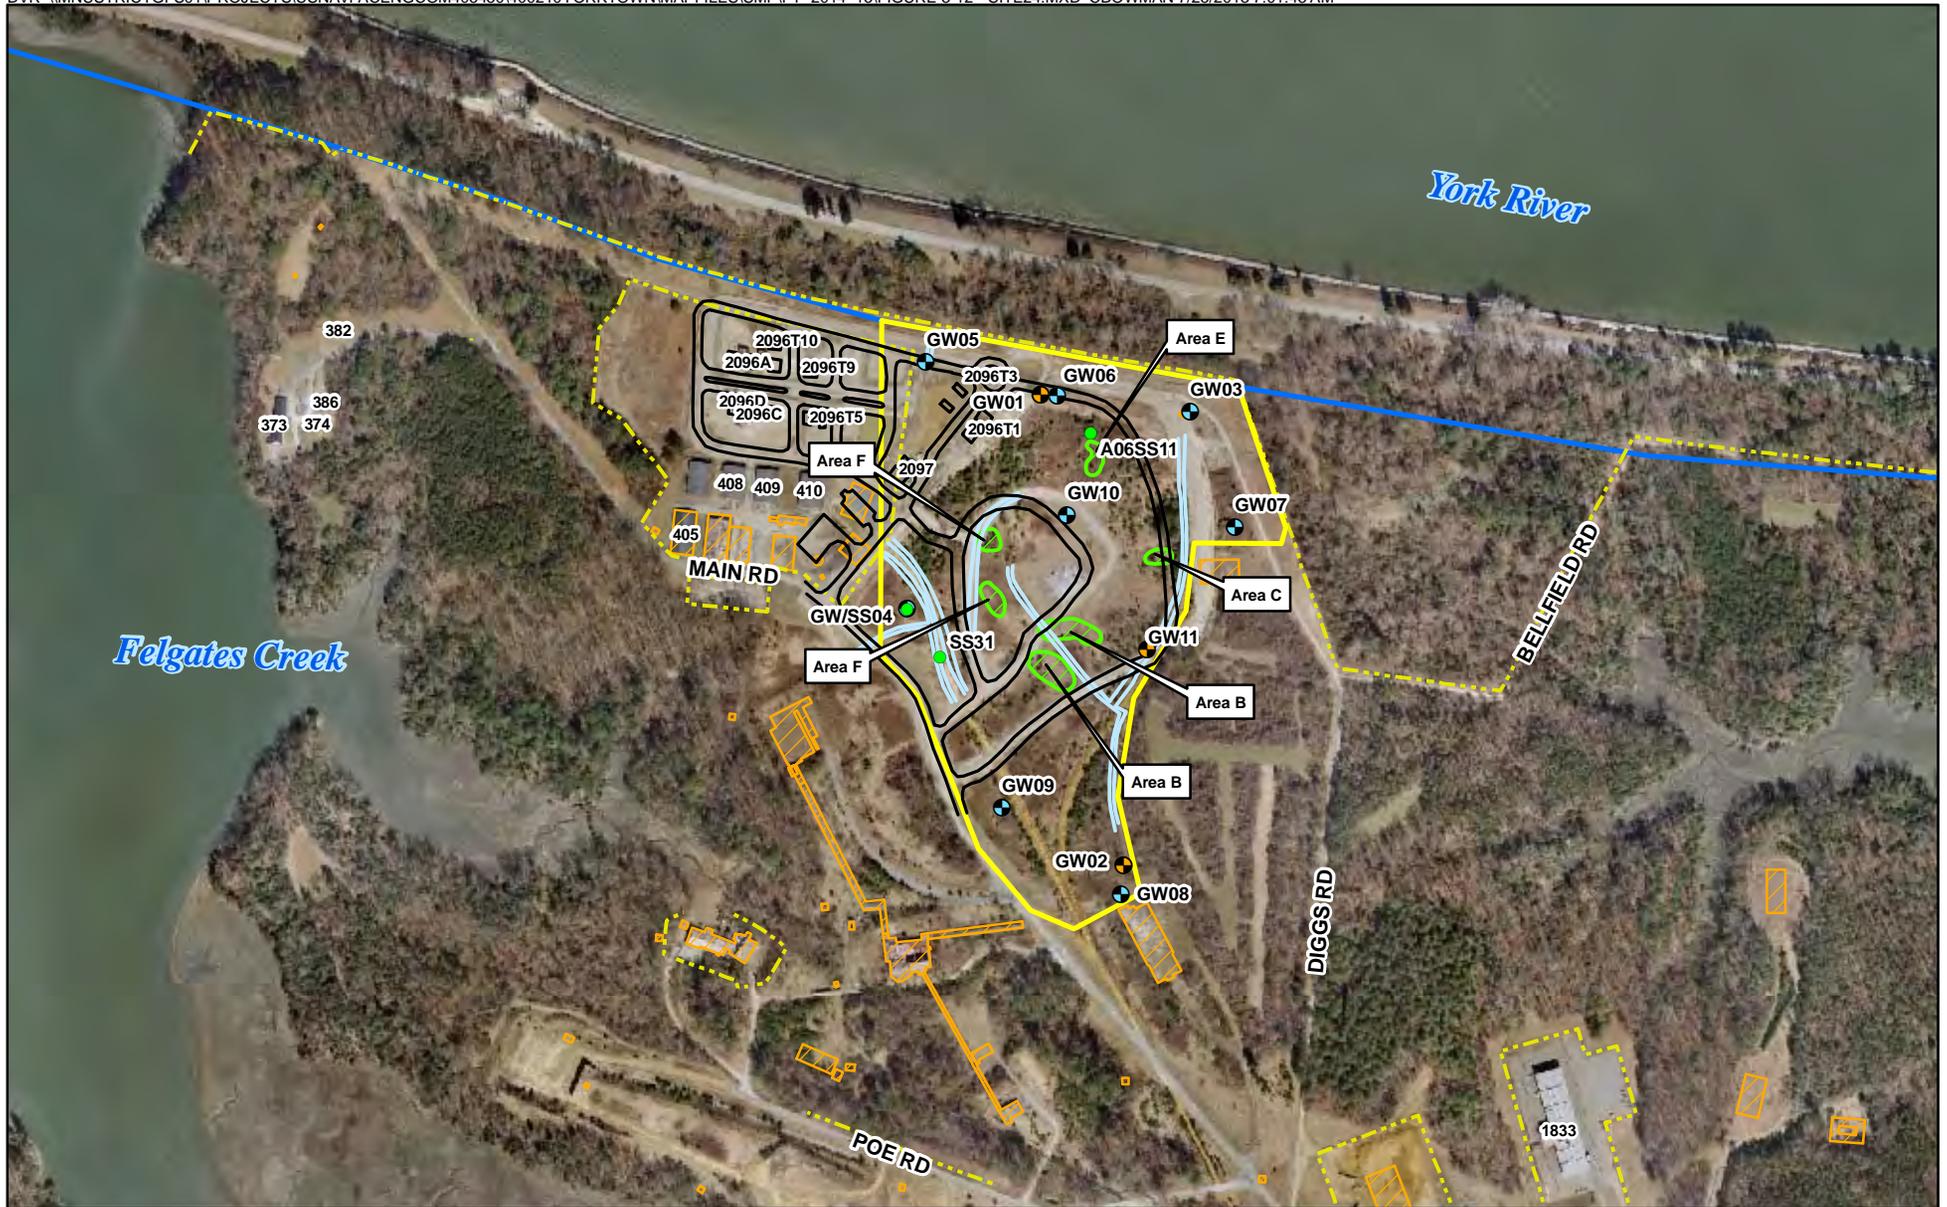
Figure 3-12
Site 24 - Aviation Field
Site Management Plan for FY 2014 to 2015
WPNSTA Yorktown
Yorktown, Virginia

- Ecological Screening Value Exceedance Locations
- Monitoring Well (Yorktown-Eastover Aquifer)
- Monitoring Well (Columbia Aquifer)
- JIEDDO Battle Course
- Site 24 Study Area Boundary (former SSA 6 Helicopter Landing Pad)
- Drainage Swales
- Fences
- Waste Areas
- Former Building
- WPNSTA Boundary

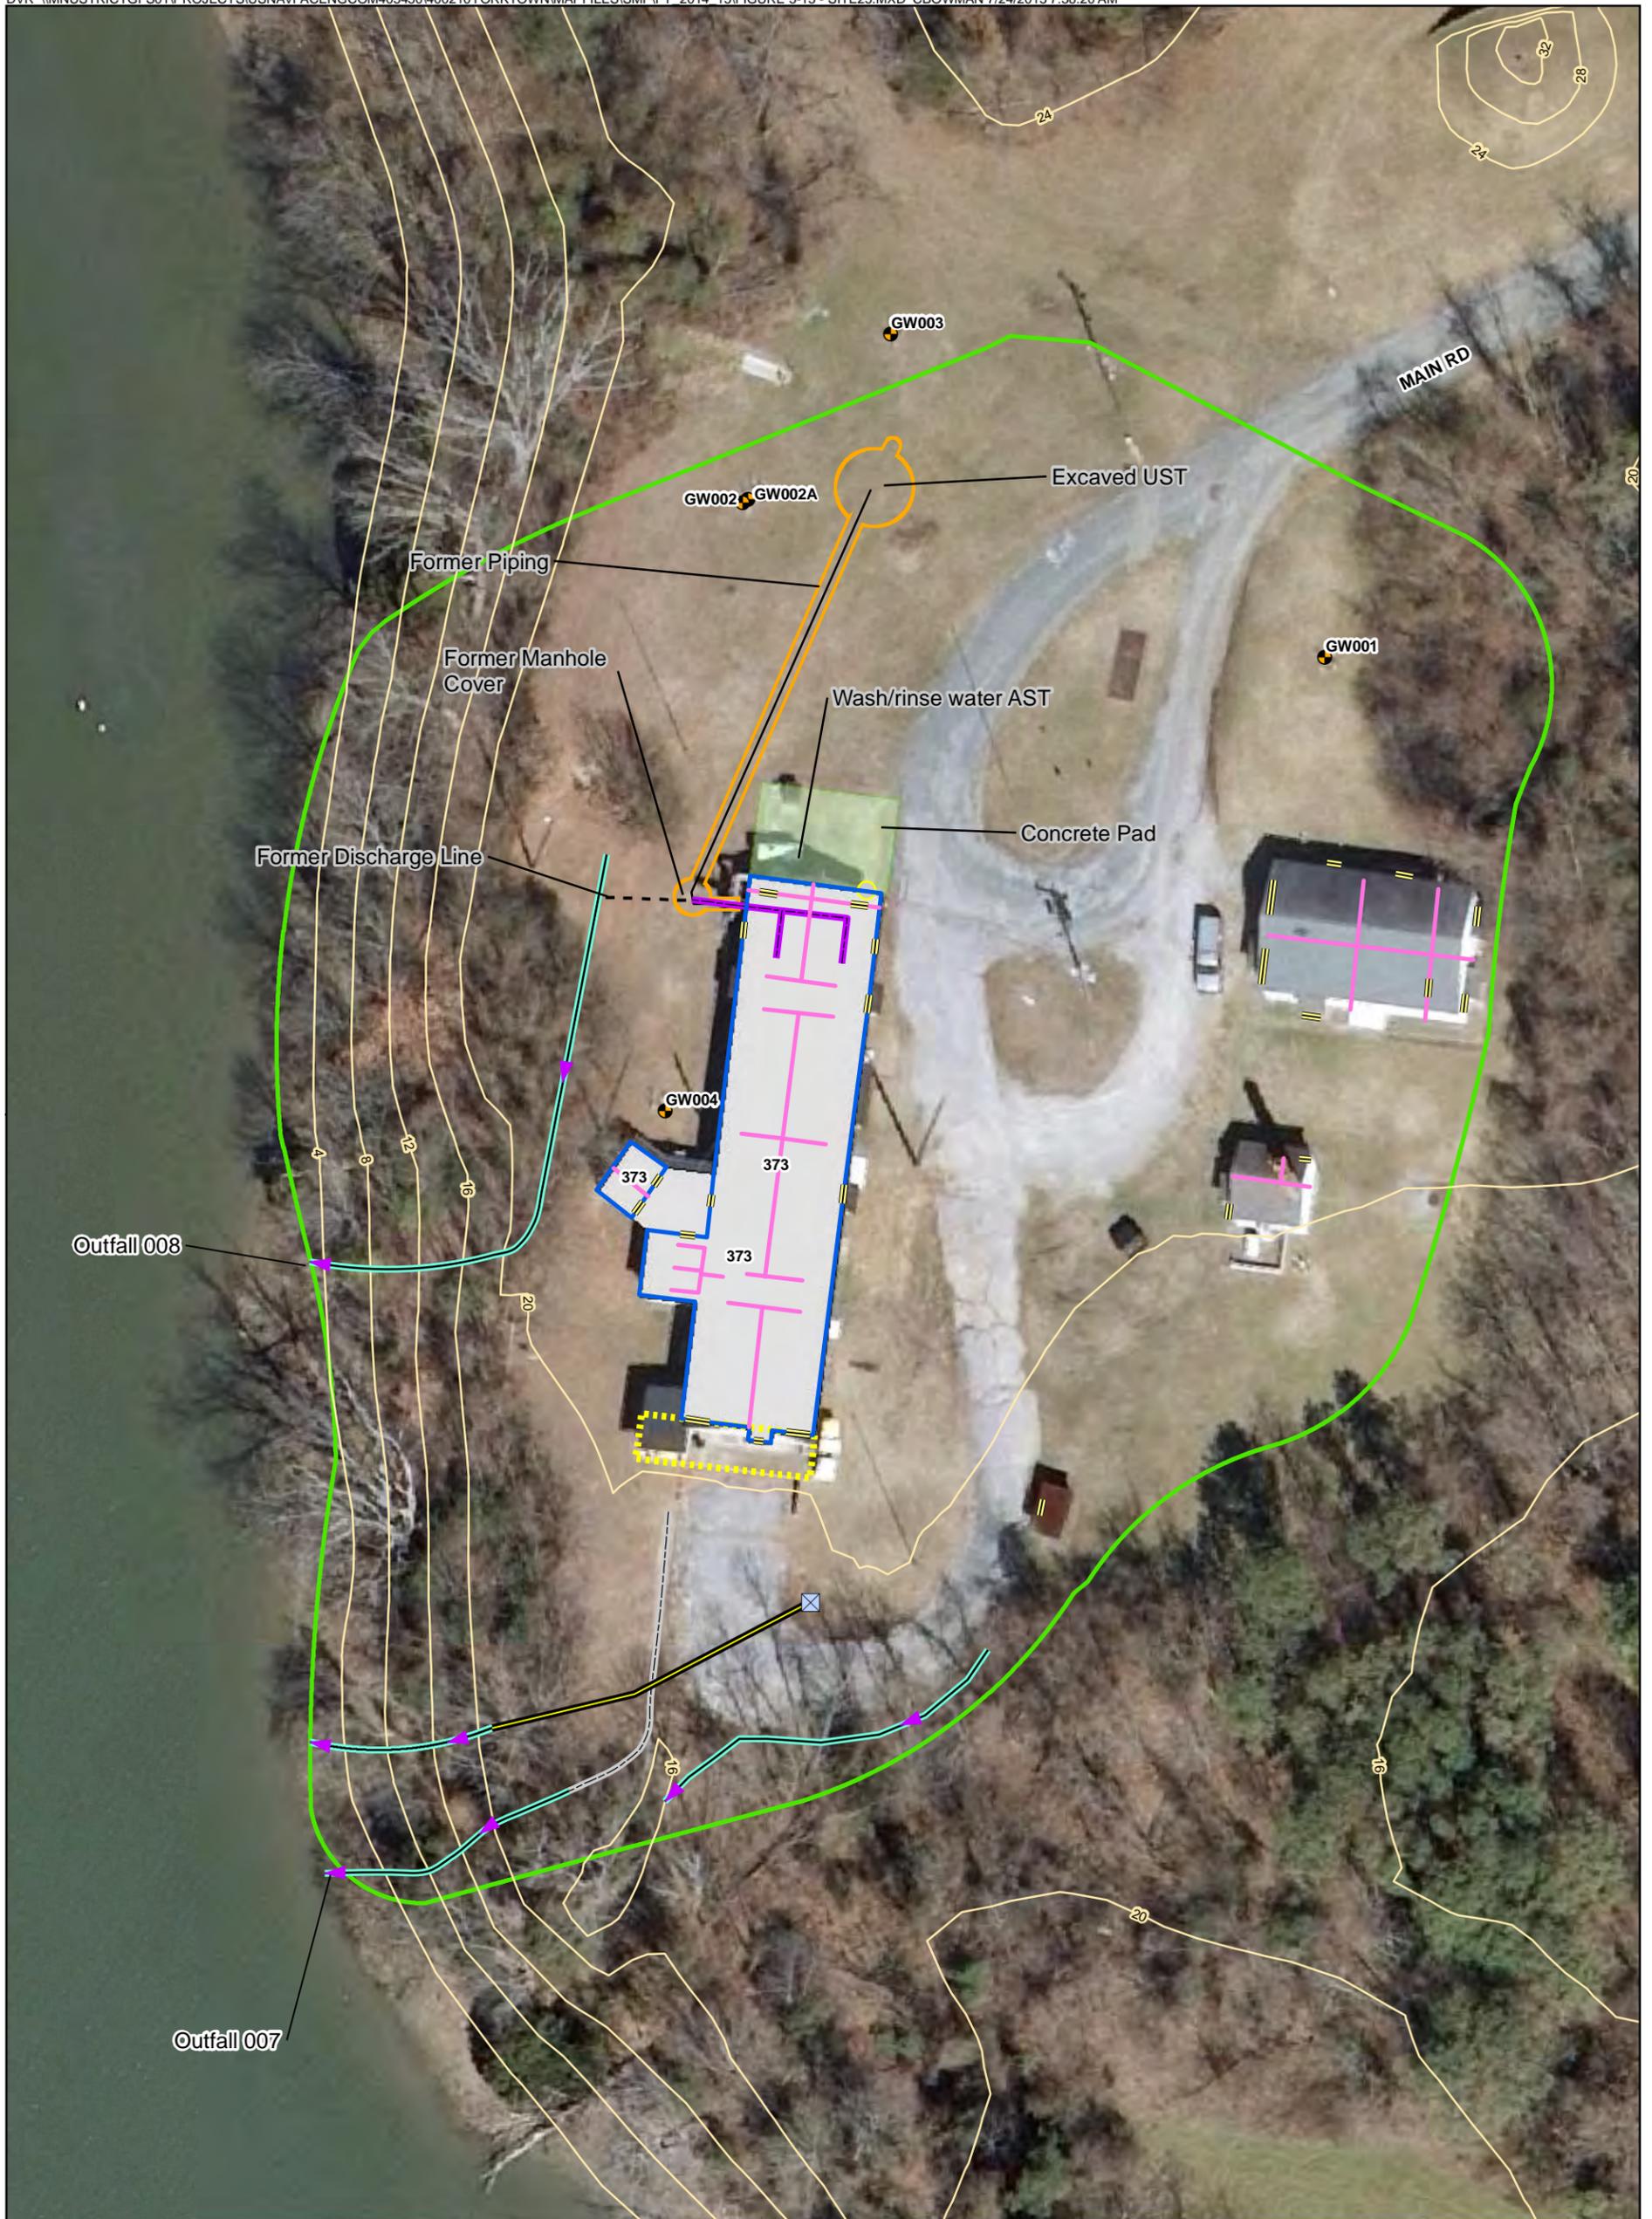
Figure 3-13
 Site 25 - Building 373 Rocket Plant
 Site Management Plan for FY 2014 to 2015
 WPNSTA Yorktown
 Yorktown, Virginia

- Monitoring Well (unconfined Yorktown-Eastover Aquifer)
- ⊠ Drop Inlet
- ▬ Door
- ▬ Wall
- - Former Discharge Line
- ▬ Building 373 Drainage Trench
- ▬ Elevation Contour (4 ft interval)
- ▬ 12" Buried Corrugated Pipe
- ▬ Concrete-lined Drainage Swale
- ▬ Dirt-lined Drainage Swale
- ▬ Limits of 1996 Excavation (excavation included UST, UST piping, and associated soils)
- ▭ Study Area Boundary
- ▭ Loading Dock
- ▭ Buildings
- ▭ Building Exterior Wall
- Concrete Tank

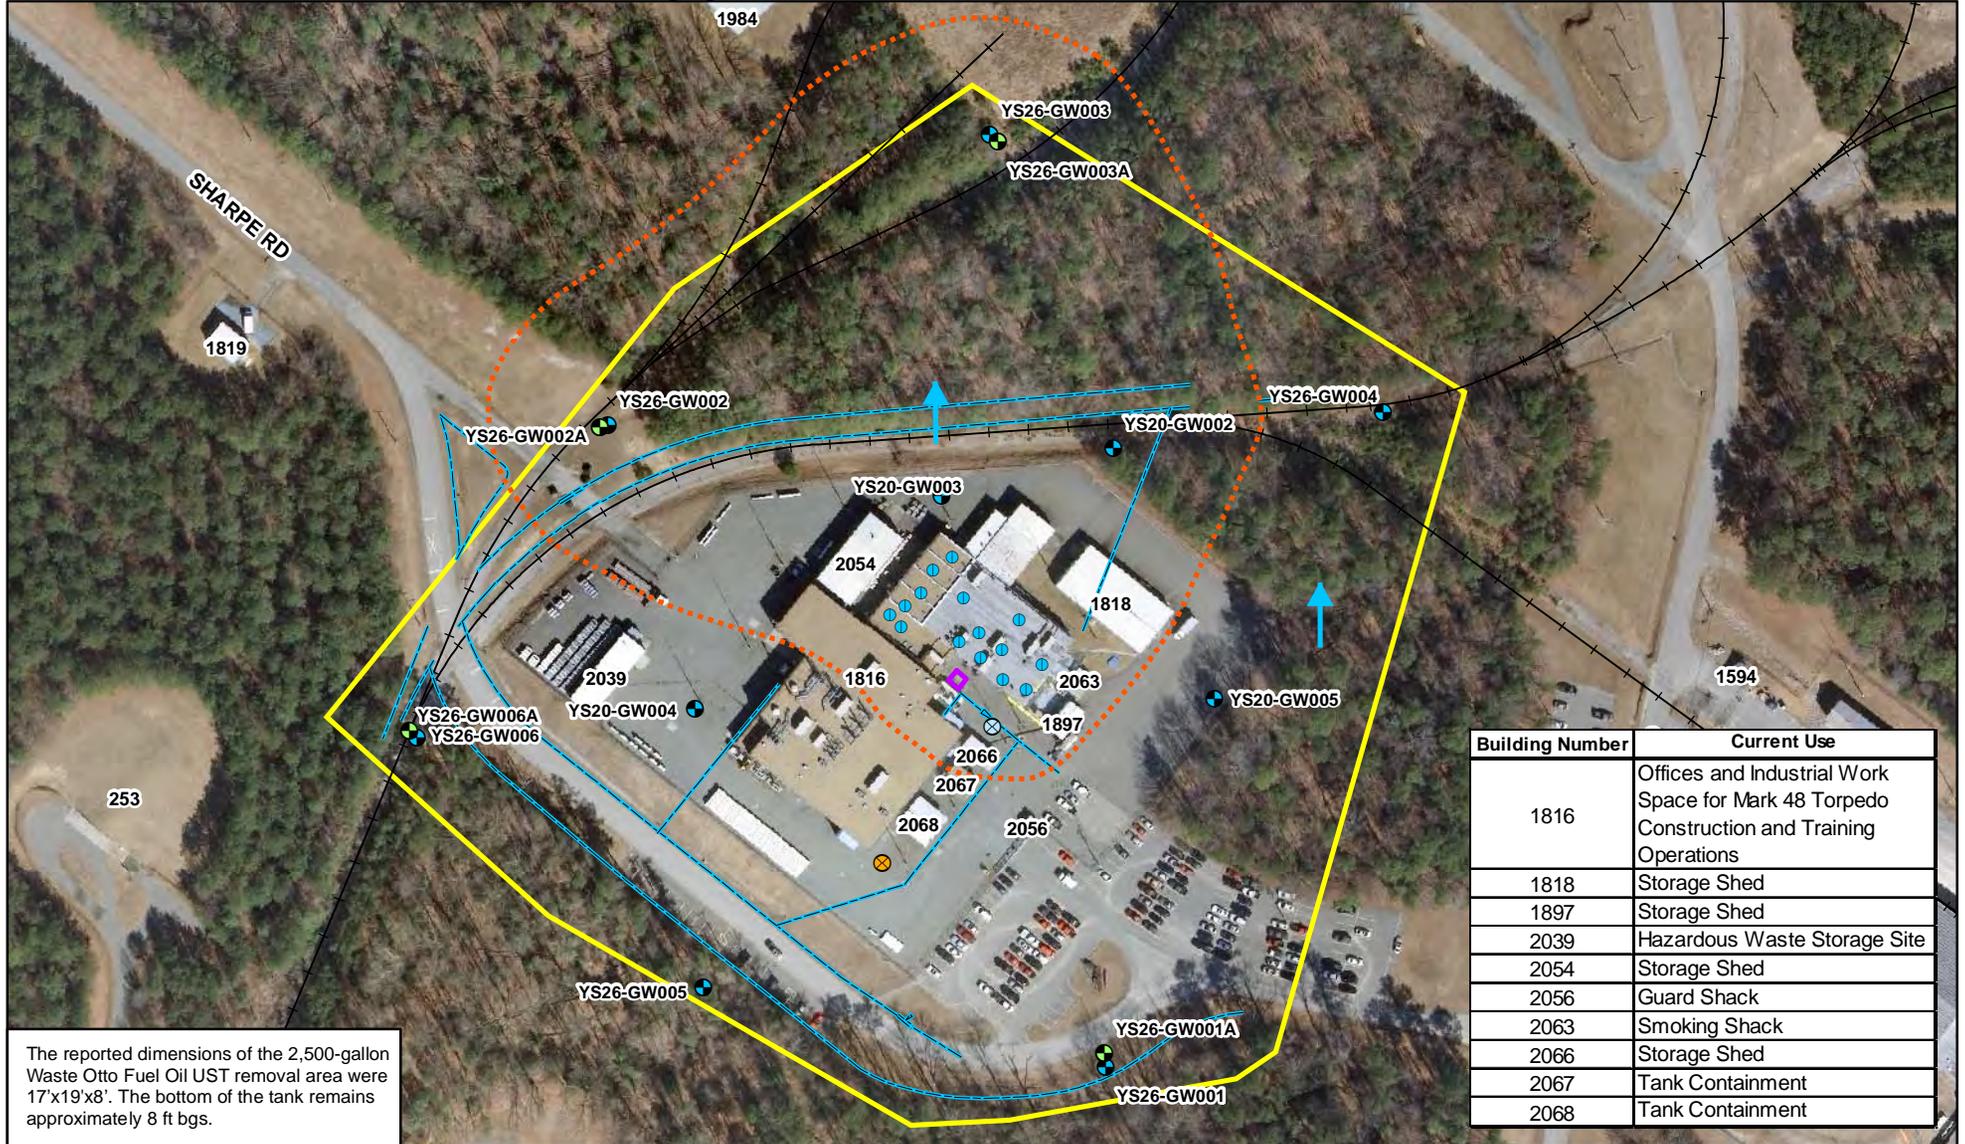
Figure 3-14
 Site 26 - Building 1816 Mark 47 Waste Otto Fuel Tank
 Site Management Plan for FY 2014 to 2015
 WPNSTA Yorktown
 Yorktown, Virginia

The reported dimensions of the 2,500-gallon Waste Otto Fuel Oil UST removal area were 17'x19'x8". The bottom of the tank remains approximately 8 ft bgs.

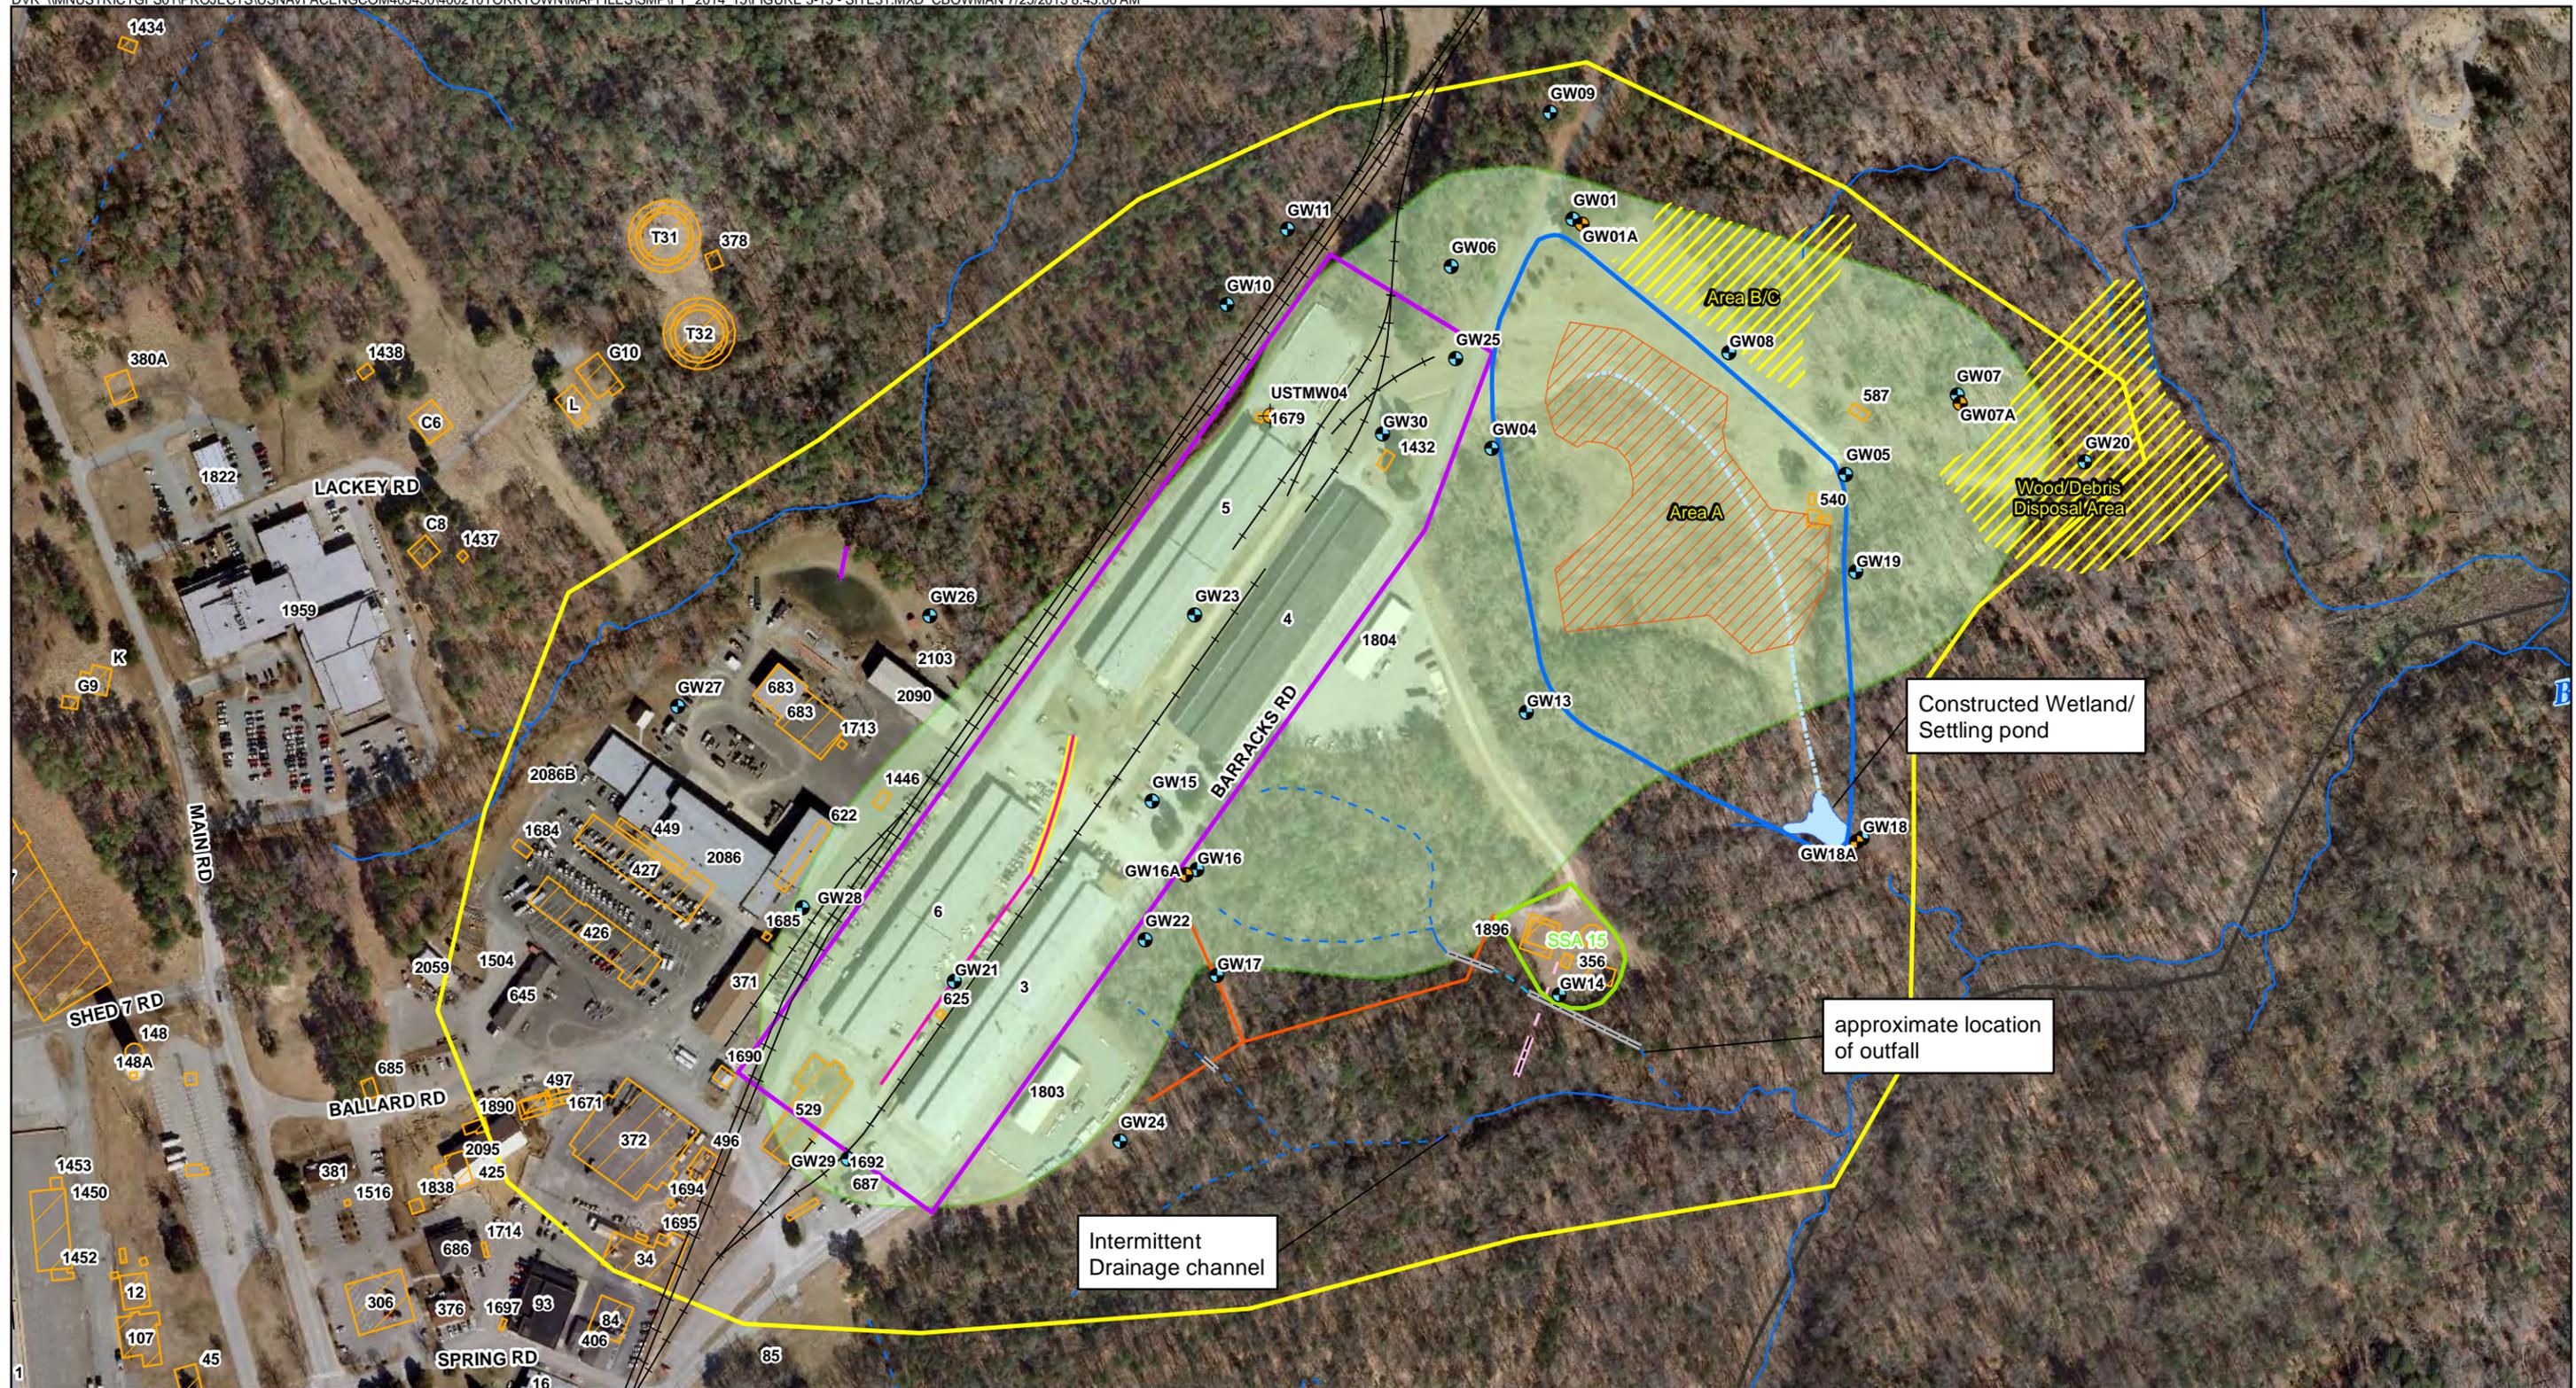
Figure 3-15
Site 31 - Barracks Road Landfill Industrial Area
Site Management Plan for FY 2014 to 2015
WPNSTA Yorktown
Yorktown, Virginia

- Legend**
- Site 31**
- Yorktown-Eastover Monitoring Well
 - Cornwallis Cave Monitoring Well
 - UST Well
 - Trilock Block Drainage Ditch
 - Railroad
 - surface_water_body_area
 - Former Drainage Ditch Location - not graded over
 - Drainage Ditch Location
 - Underground Former Treatment Plant Discharge Pipe
 - Exposed Former Treatment Plant Discharge Pipe
 - Sanitary Sewer Easement
 - Storm Water Conveyance
 - Demolished Building
 - Approximate IR Site 12 Boundary

- SSA 15 Boundary
 - WPNSTA Boundary
 - Study Area Boundary
 - Site 31 Bararcks Road Industrial Area
- Site 12**
- Area A Groundwater LUC
 - Extent of Landfill Cap (installed in 1997) and Area A Soil LUC
 - Approximate NFA Areas
 - Approximate Extent of TCE Plume

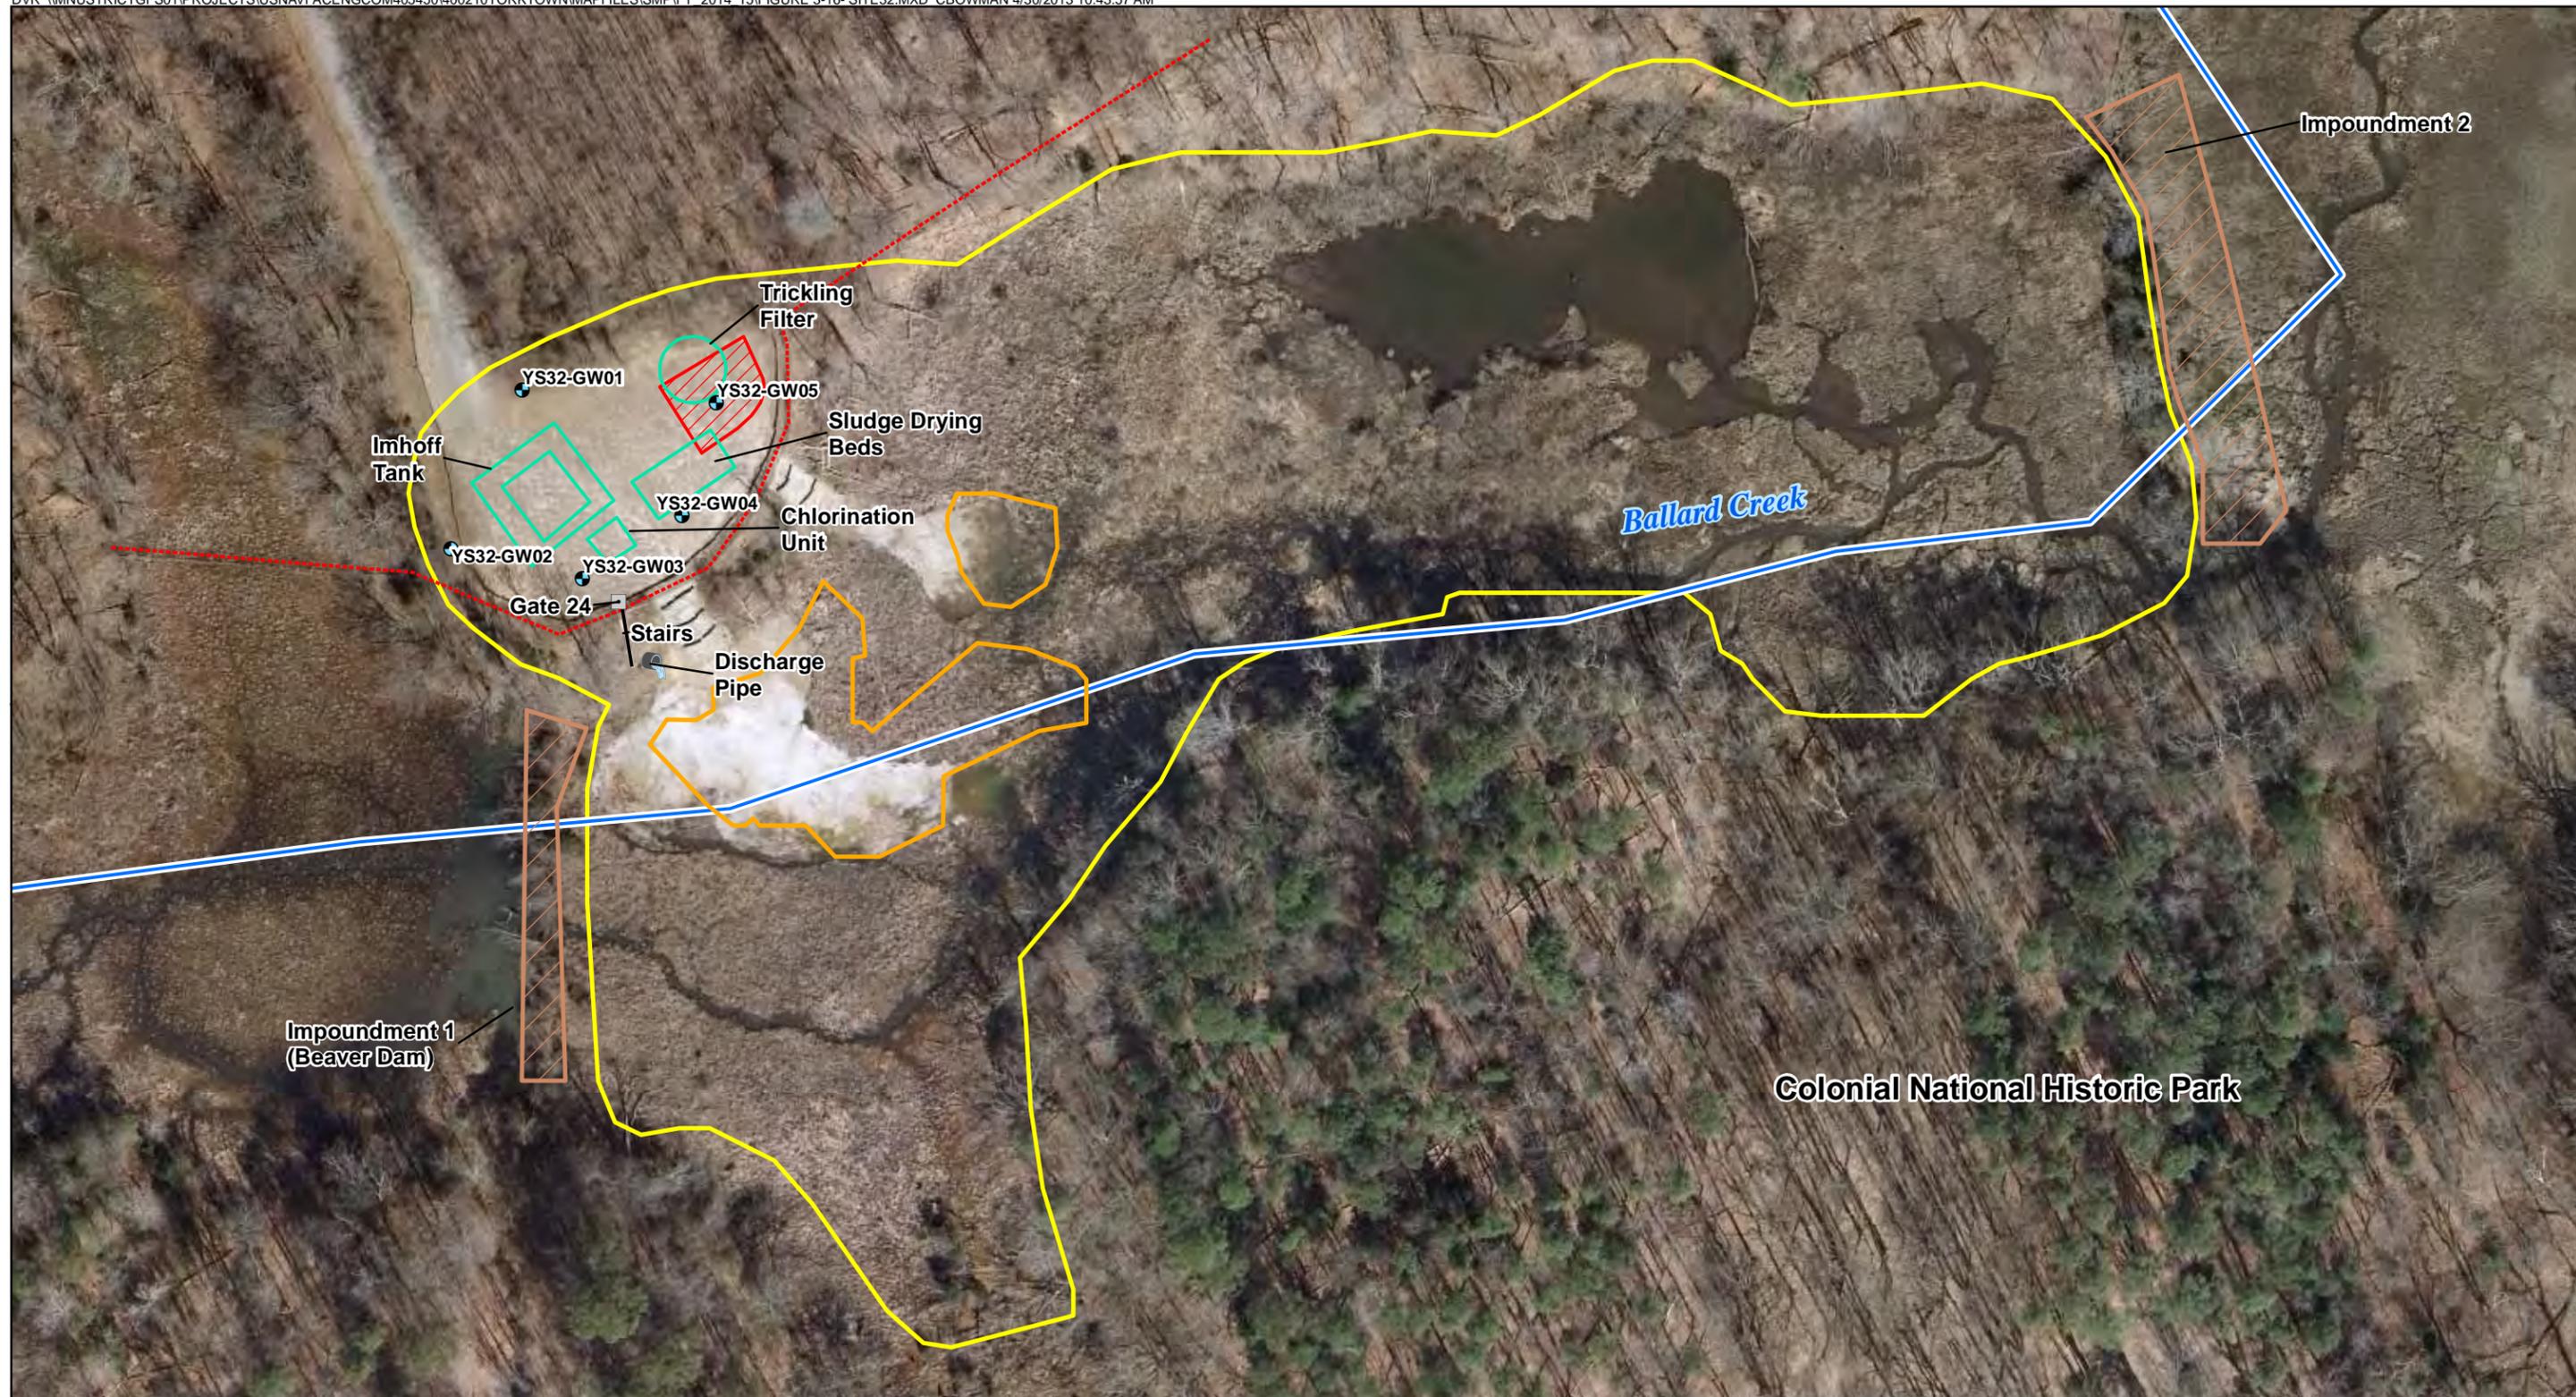
Figure 3-16
 Site 32 - Wetlands Downgradient of Beaver Pond
 Site Management Plan for FY 2014 to 2015
 WPNSTA Yorktown
 Yorktown, Virginia

- Legend**
- Monitoring Well Location
 - ⦿ discharge pipe 10 in
 - gate 24
 - ⋯ Fence
 - Former Structures
 - ▭ Impoundment Area
 - ▭ Property Boundary Line
 - ▨ 2009 Removal Area Mixing Cell
 - ▭ Extent of 2009 Sediment Removal
 - ▭ Study Area Boundary

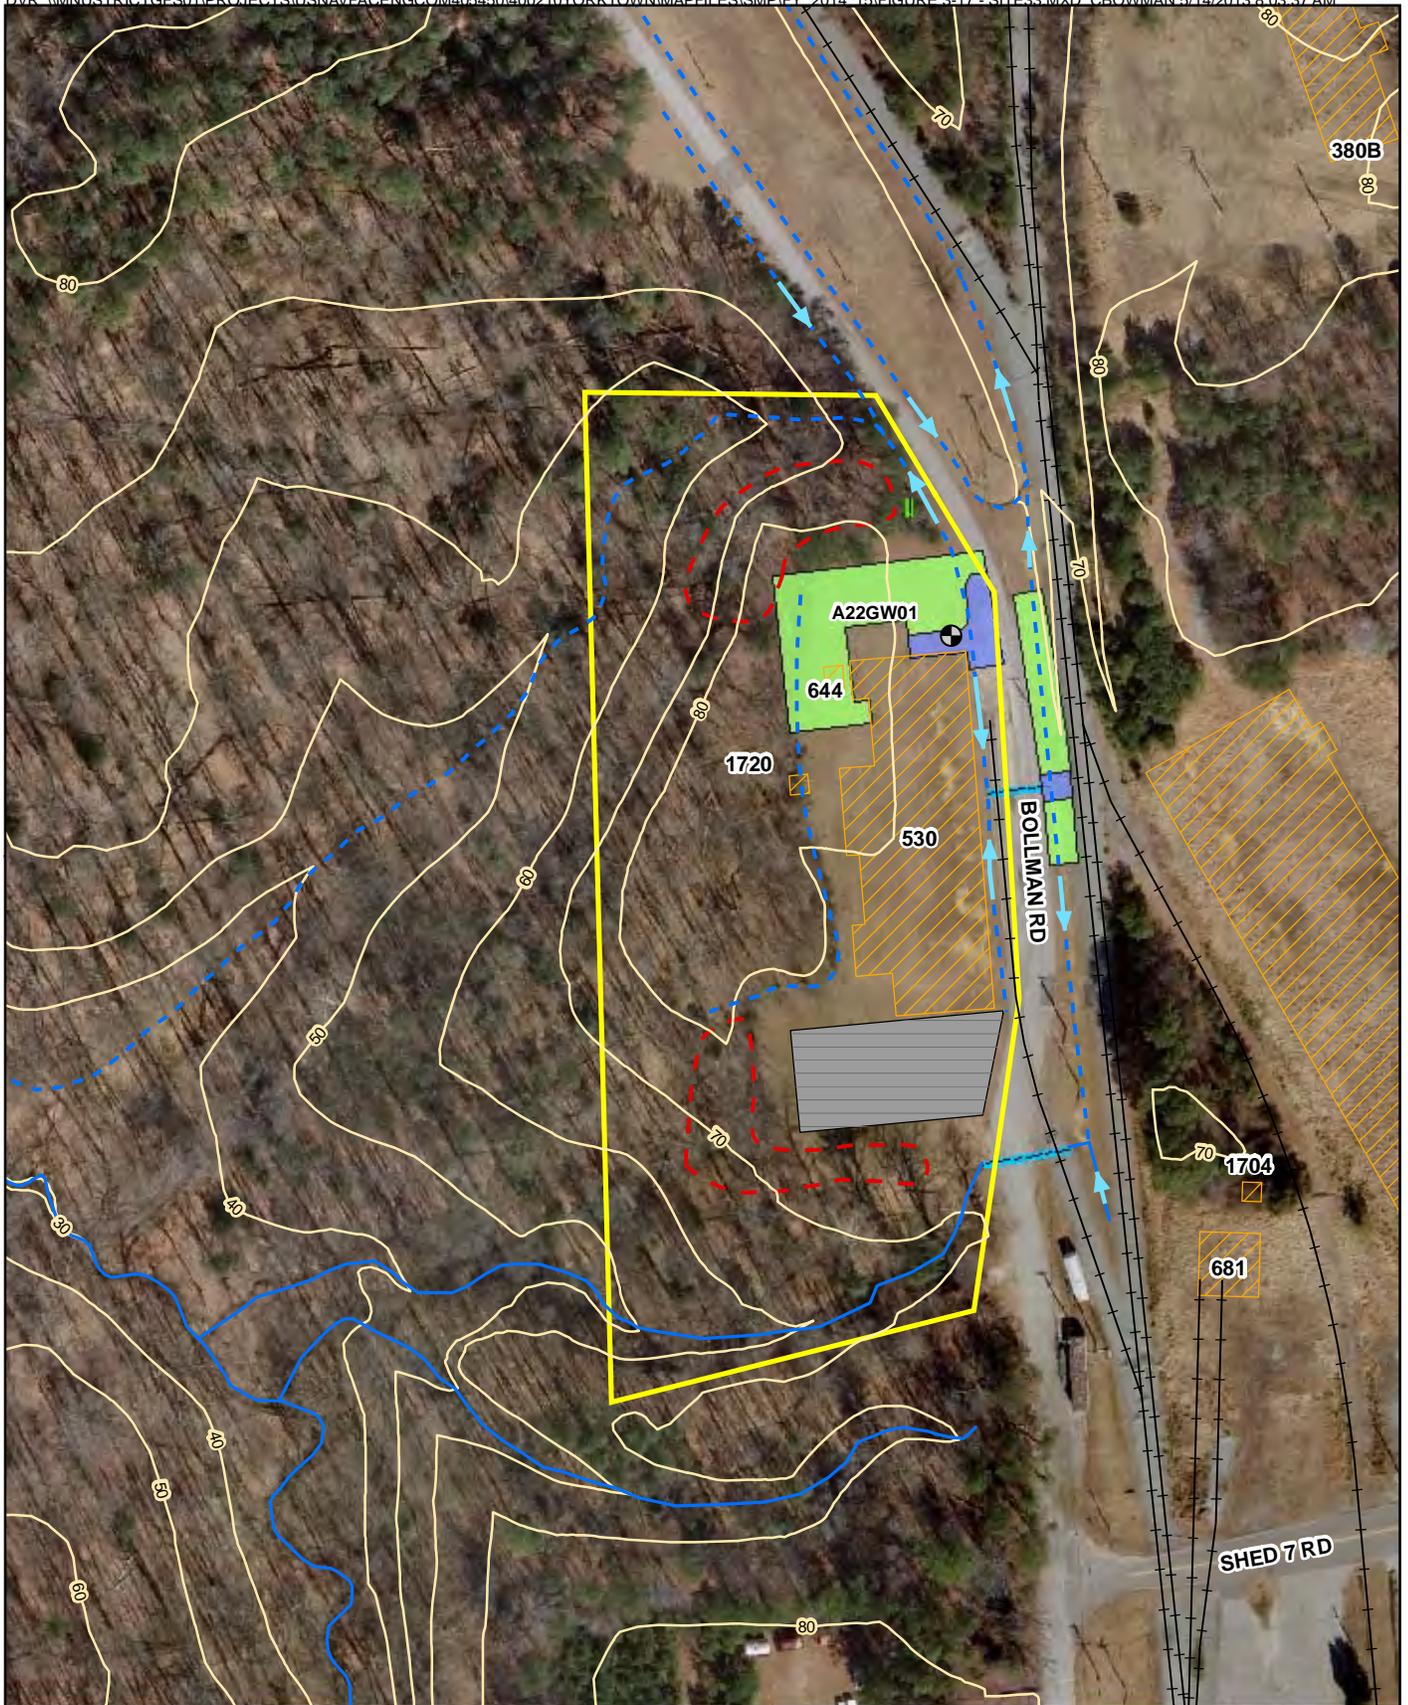
Figure 3-17
 Site 33 - Sand Blasting Grit Pile
 Site Management Plan for FY 2014 to 2015
 WPNSTA Yorktown
 Yorktown, Virginia

- ⊕ Abandoned Monitoring Well
- Culvert
- Discharge Pipe of Unknown Origin
- Drainage Flow Direction
- Drainage Ditch
- - Intermittent Drainage Ditch
- Former Railroad
