FINAL SITE MANAGEMENT PLAN FOR FISCAL YEARS 2014 AND 2015 NWS YORKTOWN
VA
11/1/2013
CH2M HILL

**Site Management Plan
Fiscal Years 2014—2015**

**Naval Weapons Station Yorktown
Yorktown, Virginia**

Contract Task Order WE73

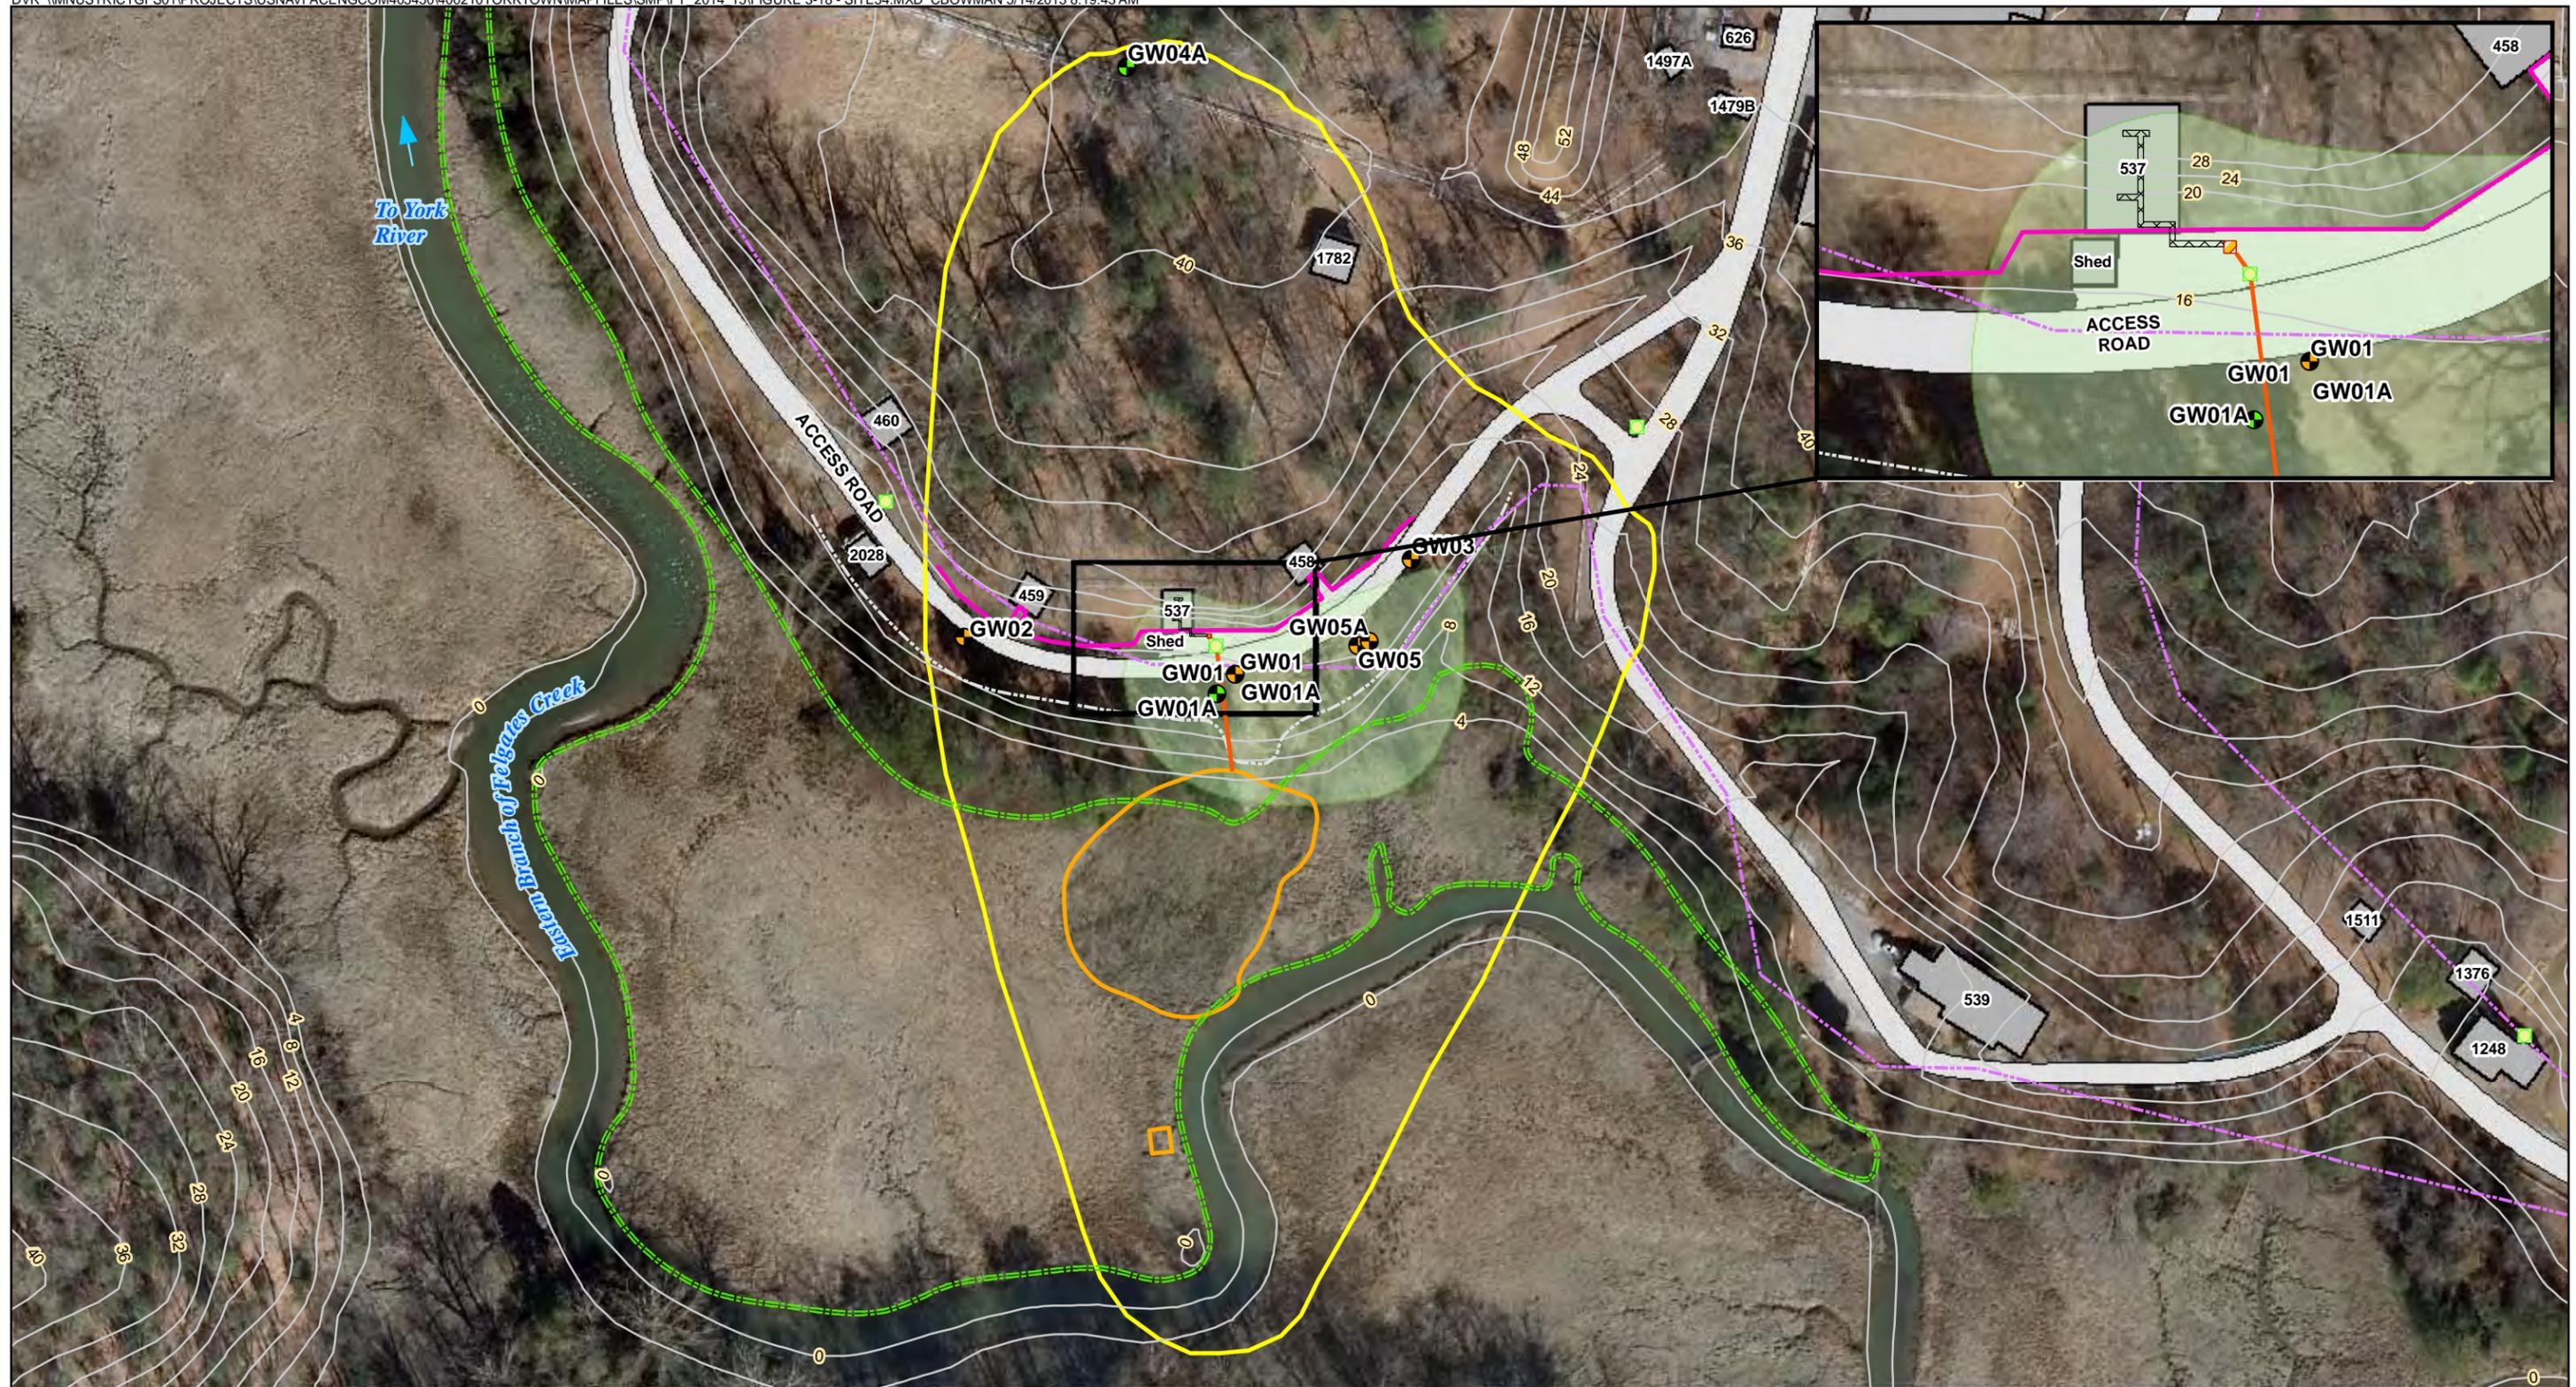
Figure 3-18
 Site 34 - Building 537 Discharge to Felgates Creek
 Site Management Plan for FY 2014 to 2015
 WPNSTA Yorktown
 Yorktown, Virginia

- Legend**
- Drop Inlet
 - Discharge Pipe
 - Approximate Retaining Wall Location
 - Wastewater Force Main
 - Top of Slope
 - Terrain Elevation Contour (4 ft interval)
 - Approximate Wetlands Boundary
 - Building 537 Weir Box
 - Building 537 Building Concrete Ditch
 - Buildings
 - Paved Area
 - 2007 Removal Action
 - Approximate Extent of TCE Plume

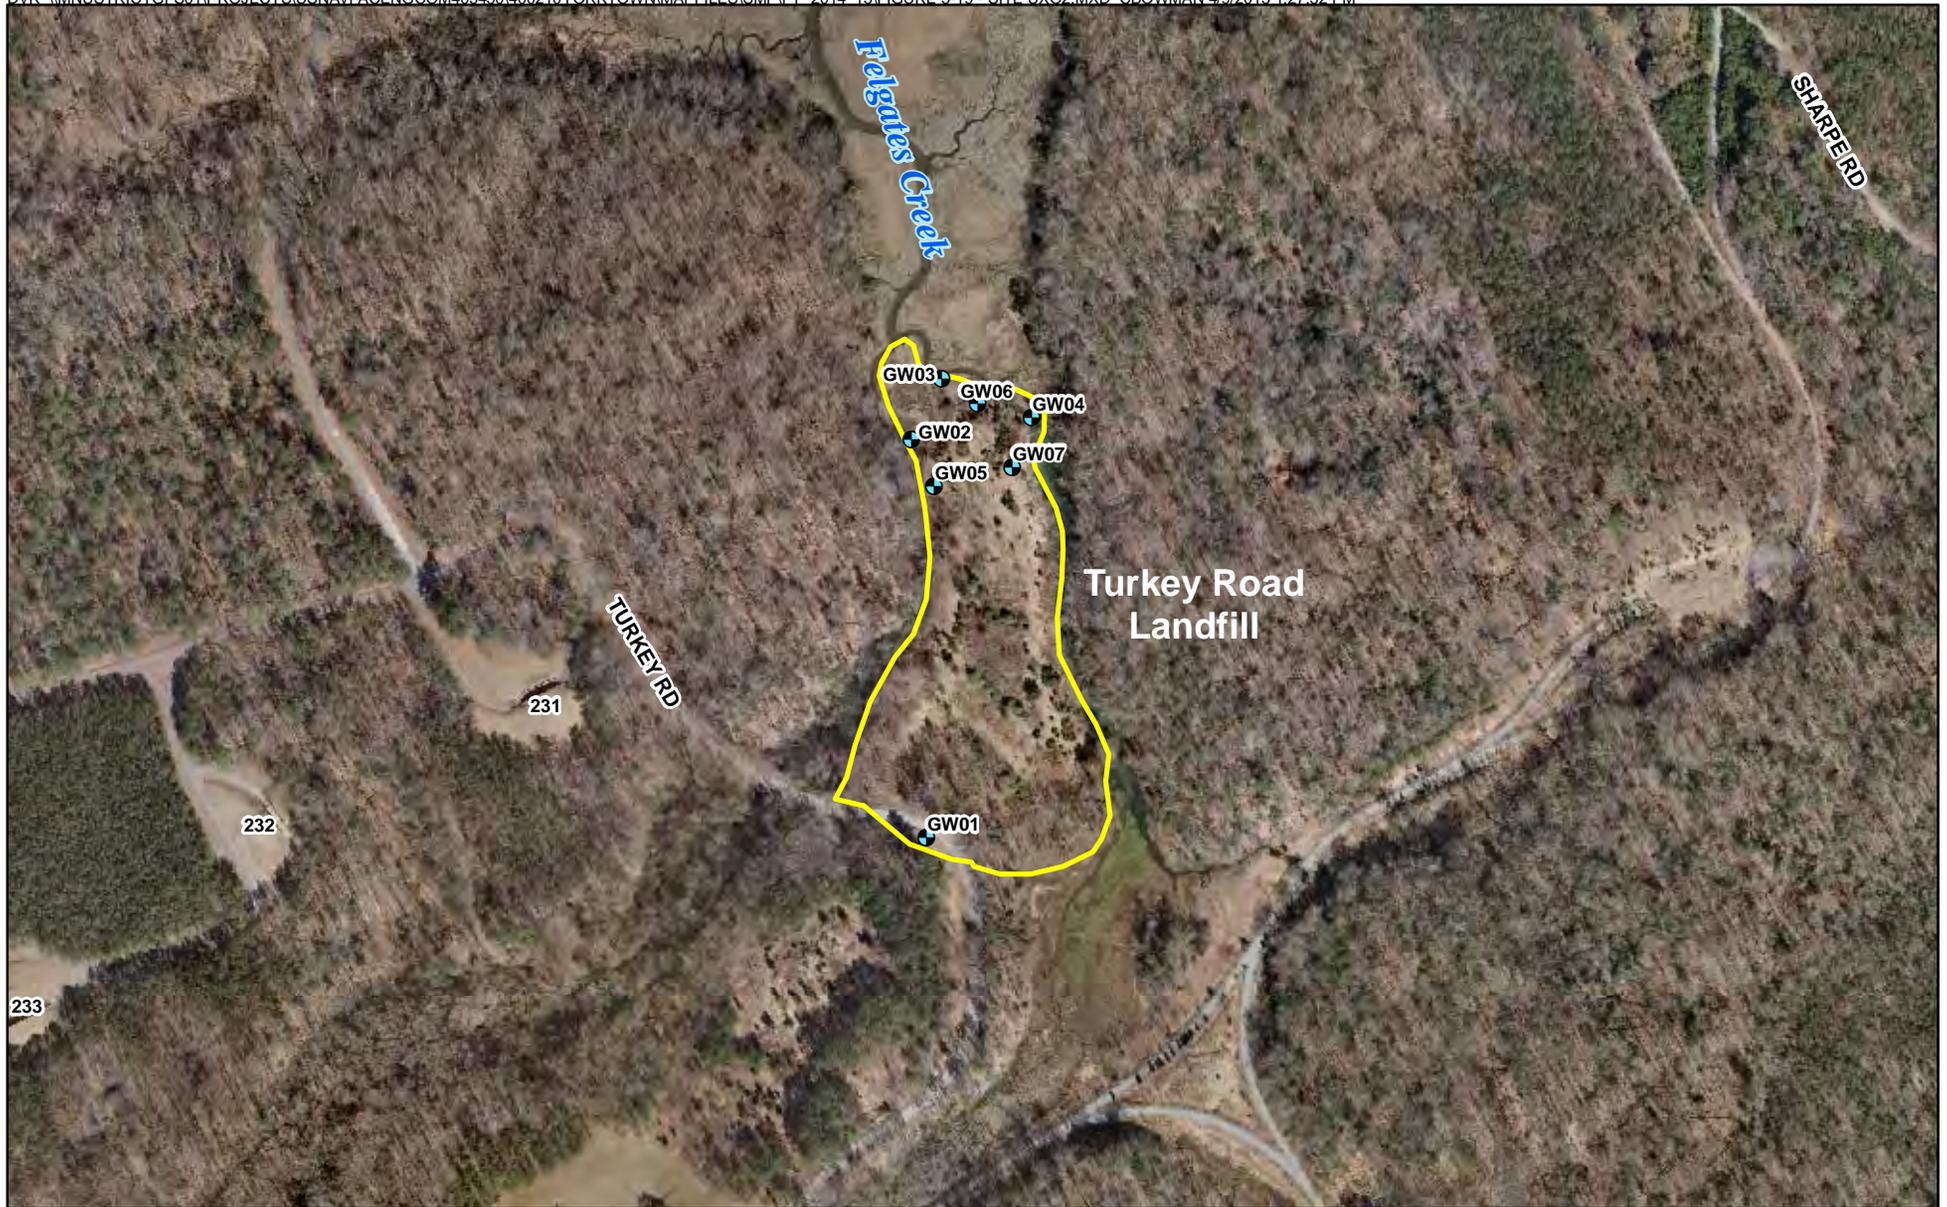
Figure 3-19
UXO 2 - Turkey Road Landfill
Site Management Plan for FY 2014 to 2015
WPNSTA Yorktown
Yorktown, Virginia

- Monitoring Well
- ▭ Study Area Boundary
