FINAL INSTALLATION RESTORATION PHASE 2 CONFIRMATION QUANTIFICATION STAGE  
1 VOLUME 1 NAS FORT WORTH TX  
10/1/1986  
RADIAN CORPORATION

**INSTALLATION RESTORATION PROGRAM  
PHASE II - CONFIRMATION/QUANTIFICATION  
STAGE 1  
VOLUME 1 - FINAL REPORT**

**CARSWELL AFB, TEXAS**

**OCTOBER 1986**

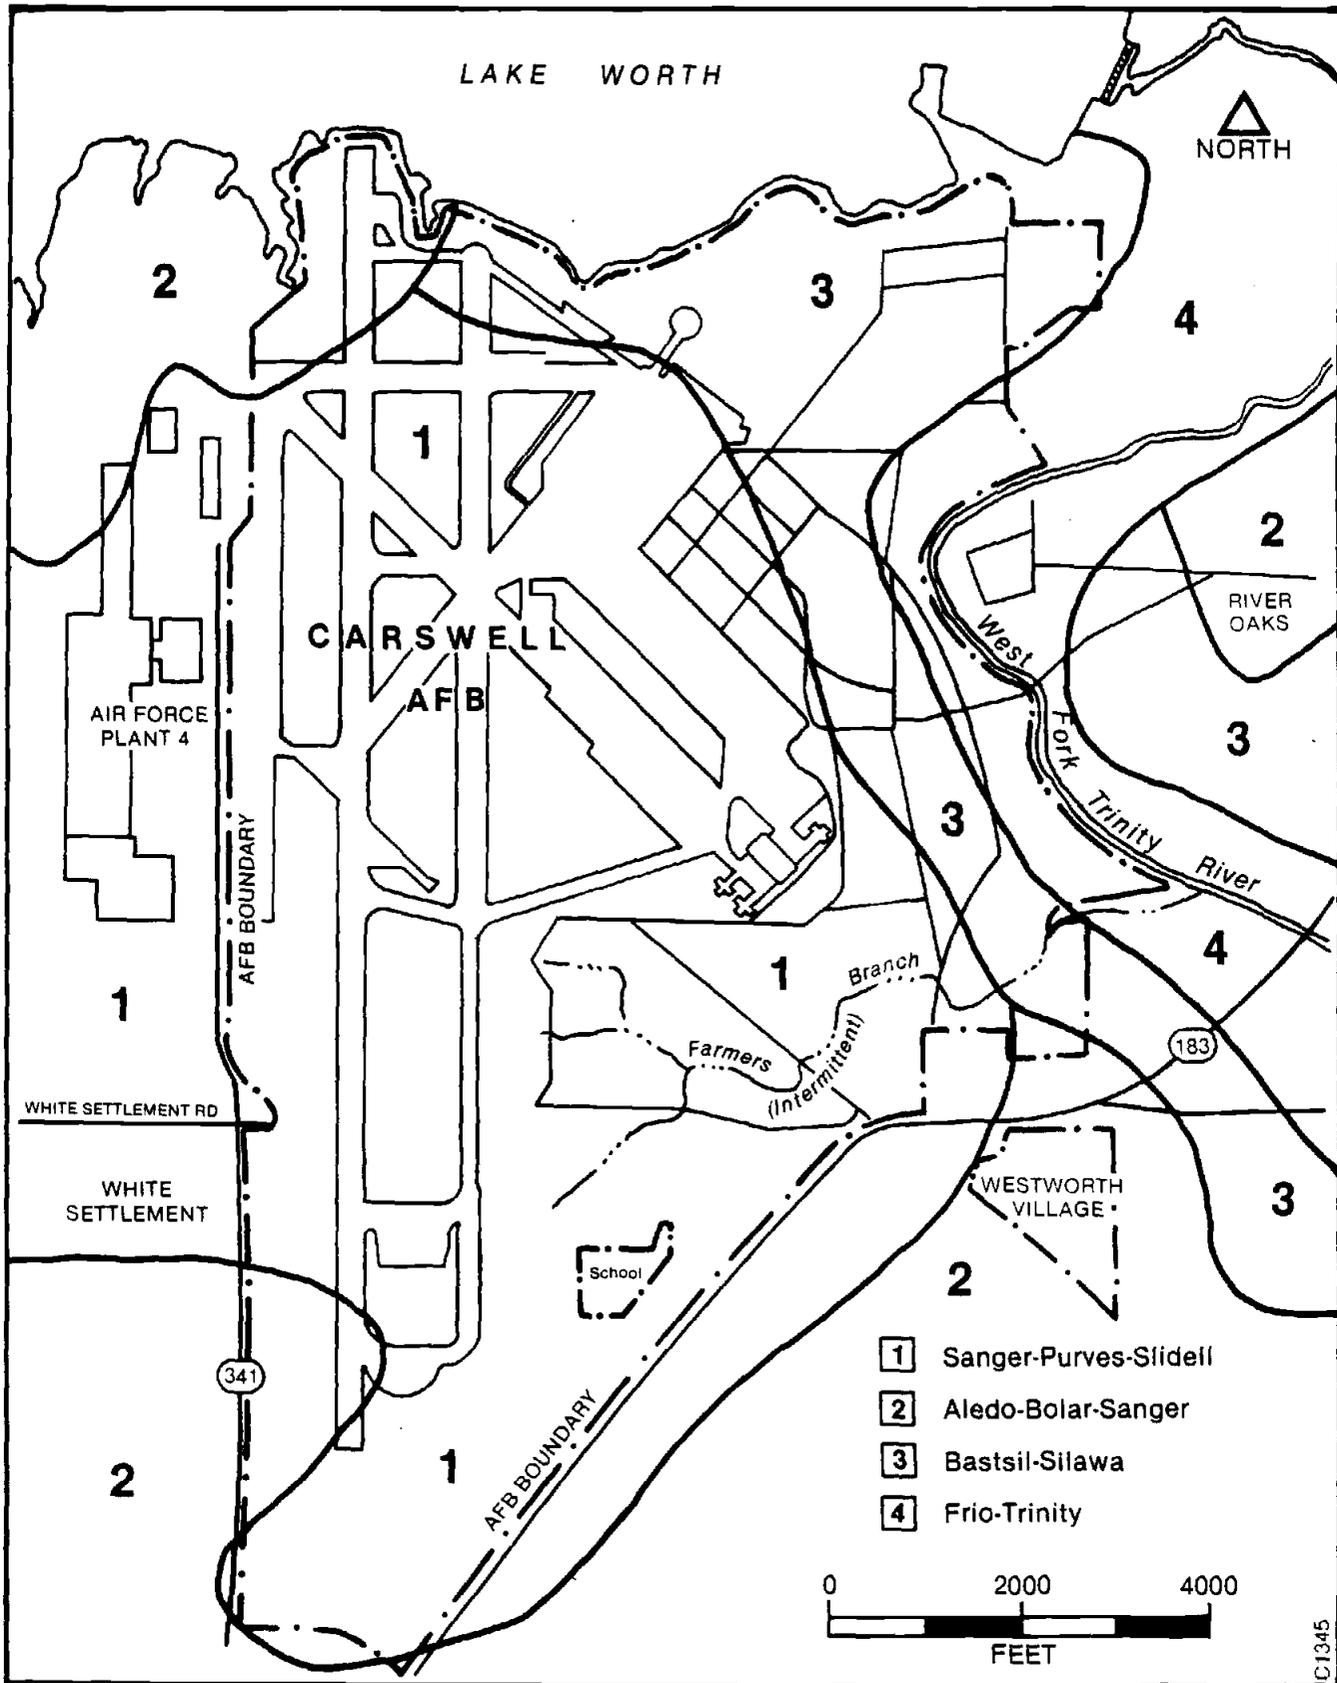
Figure 2-2. Soils Association Map, Carswell AFB, Texas.

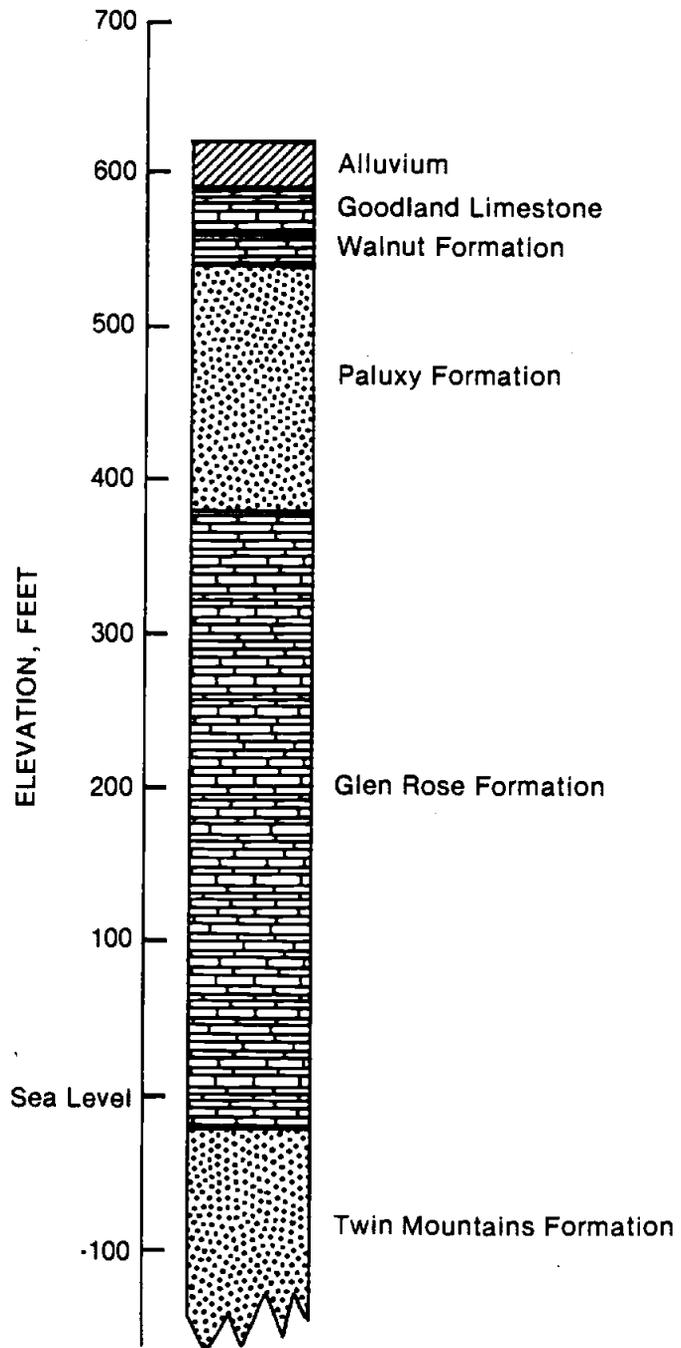
Figure 2-3. Stratigraphic Column at Carswell AFB, Texas.

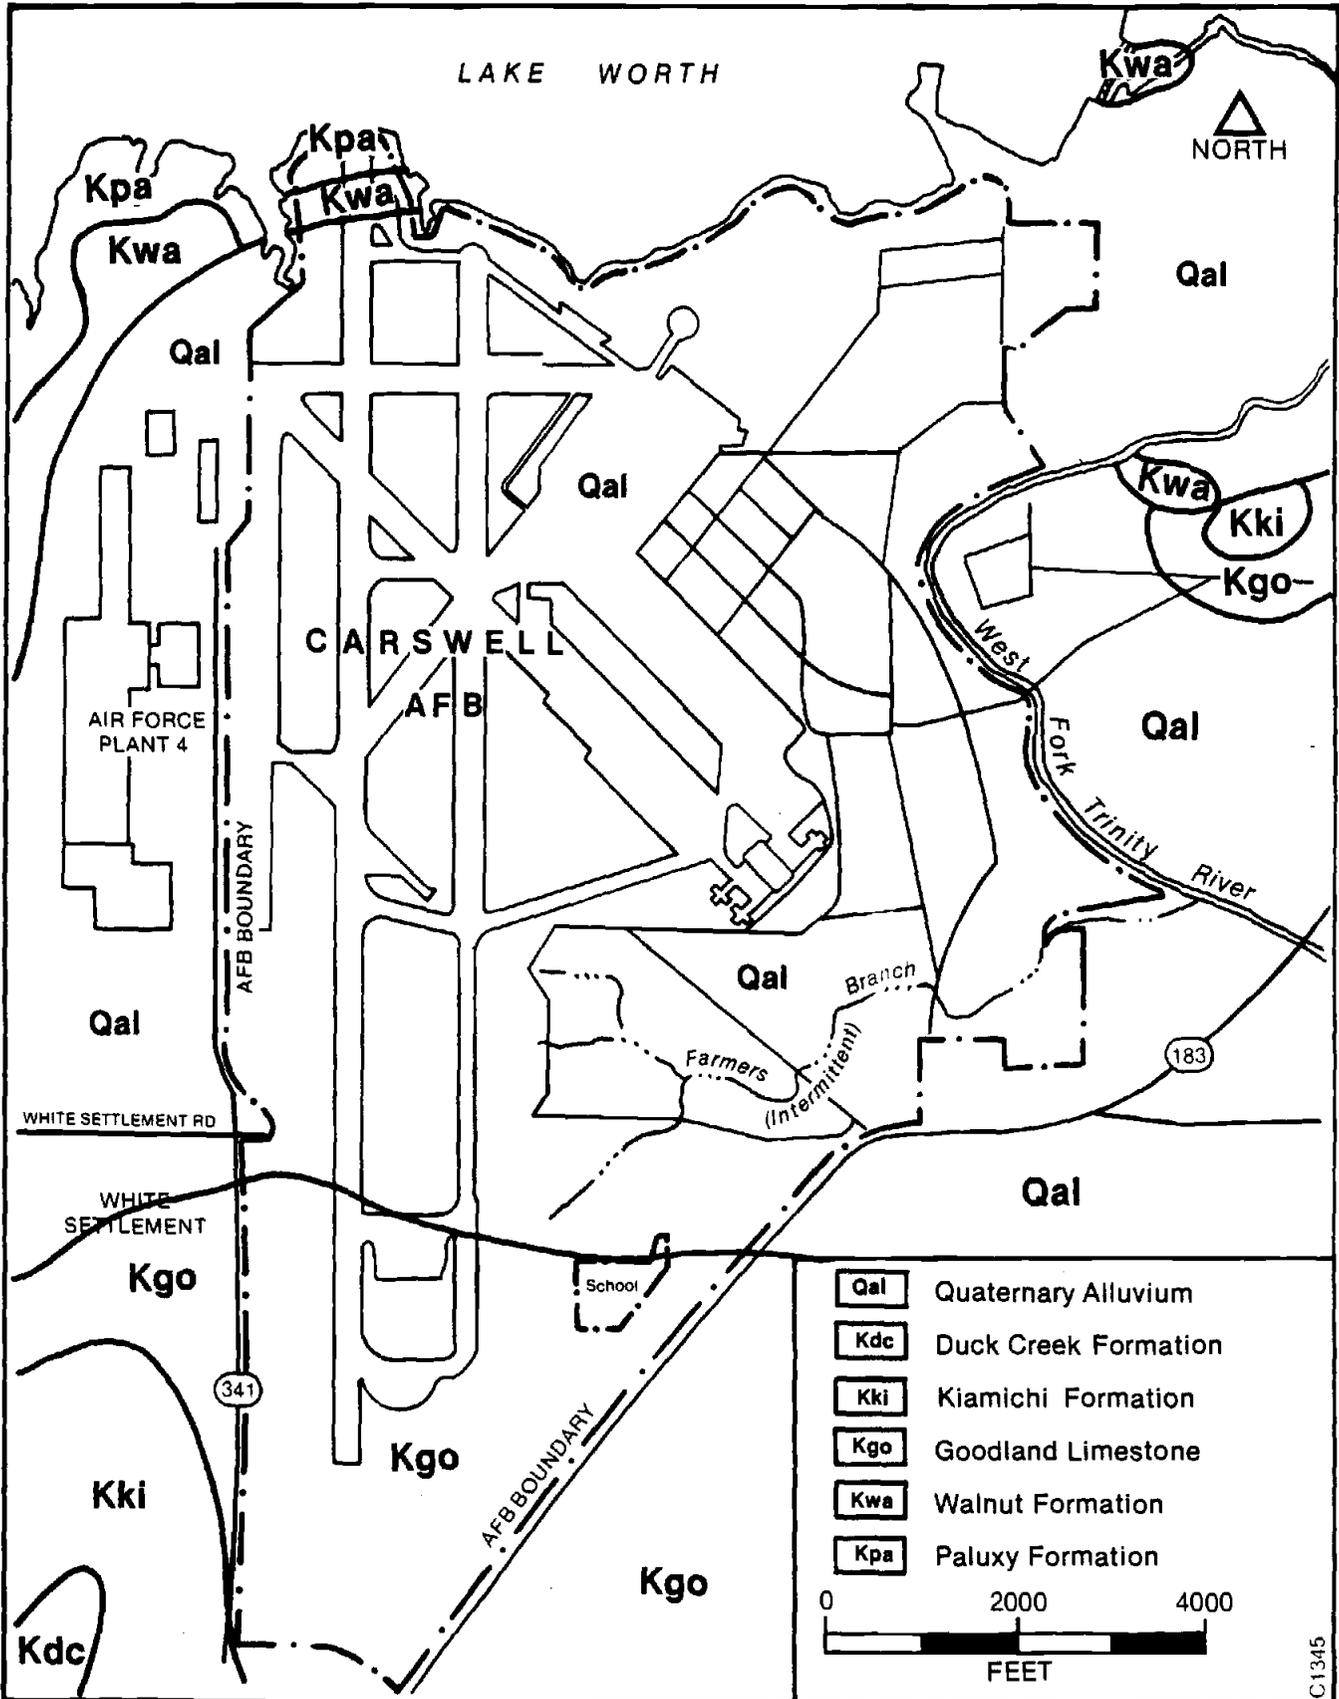
Figure 2-4. Geologic Map of Carswell AFB, Texas.

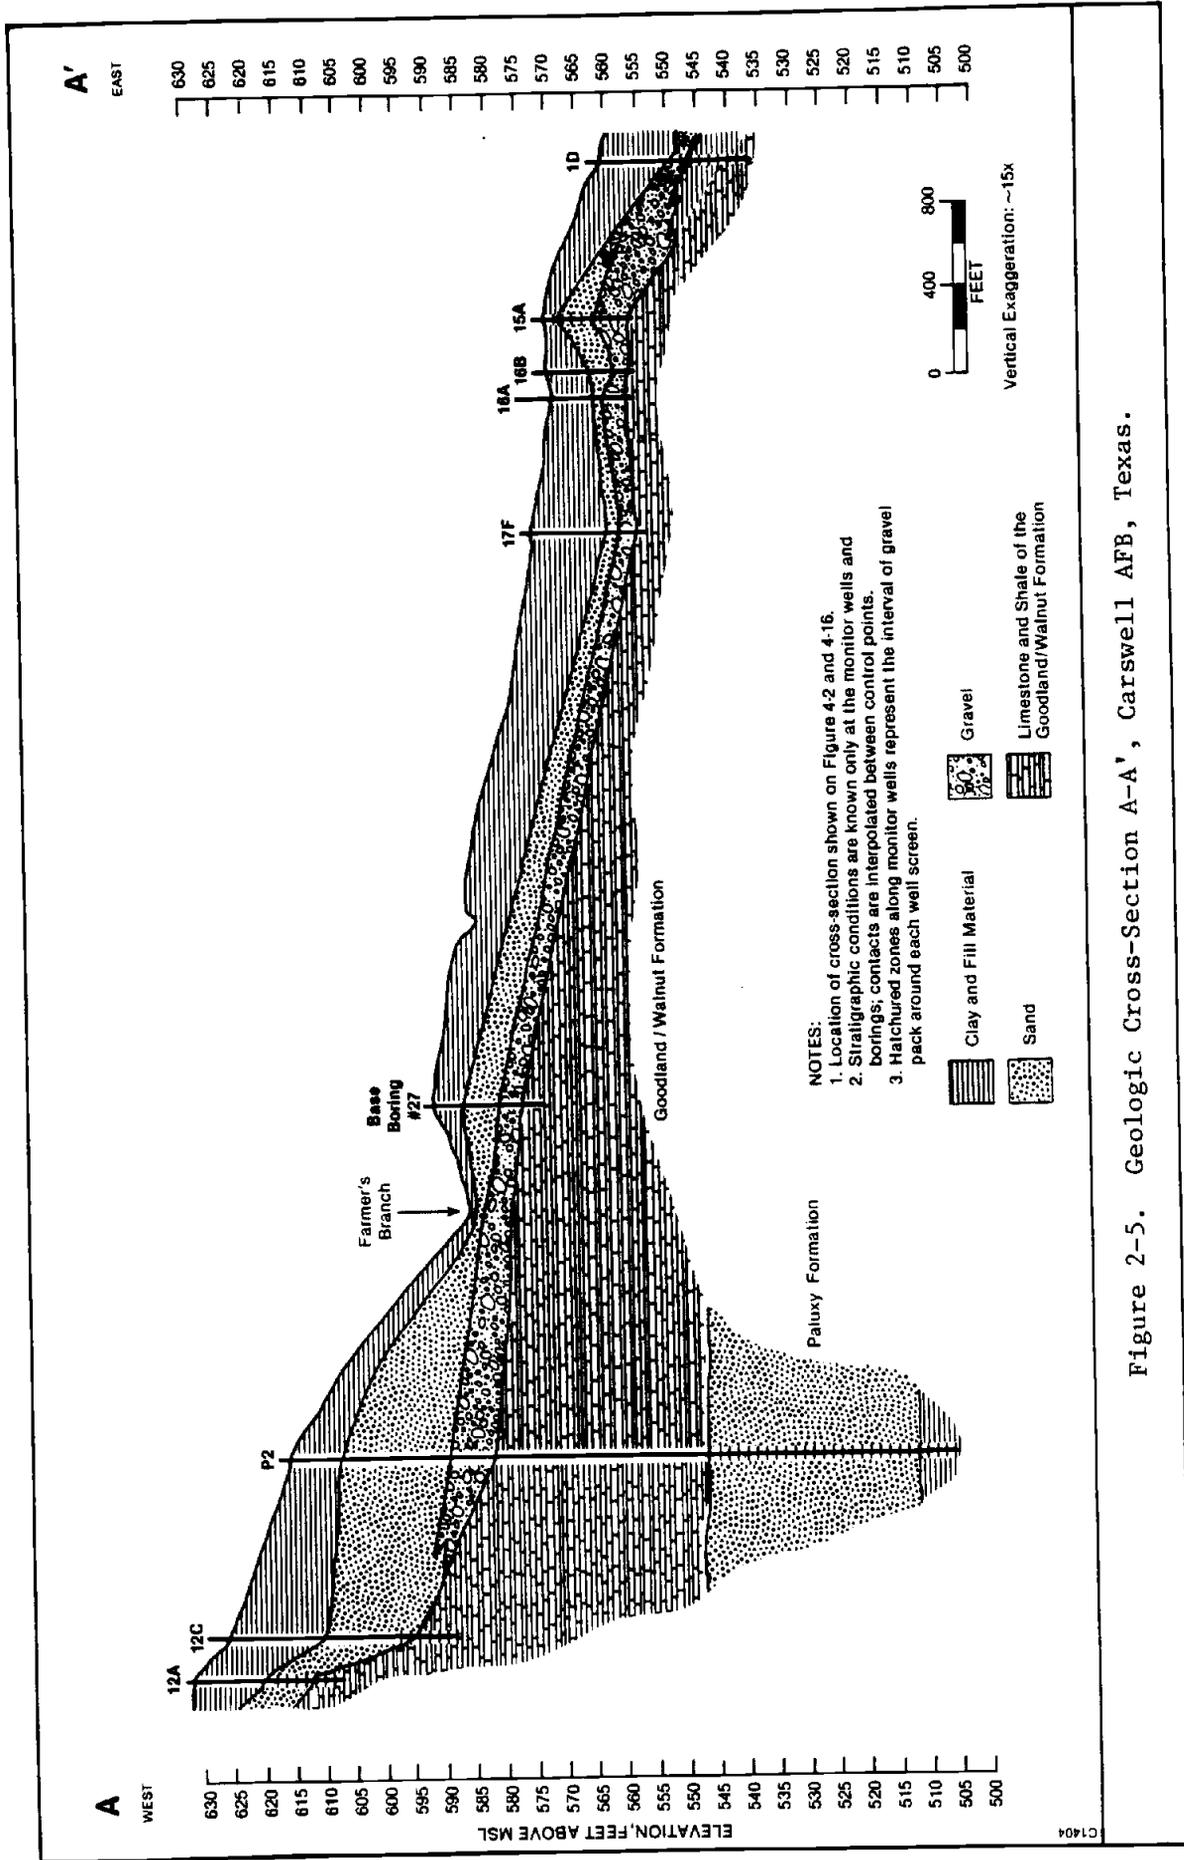
Figure 2-5. Geologic Cross-Section A-A', Carswell AFB, Texas.

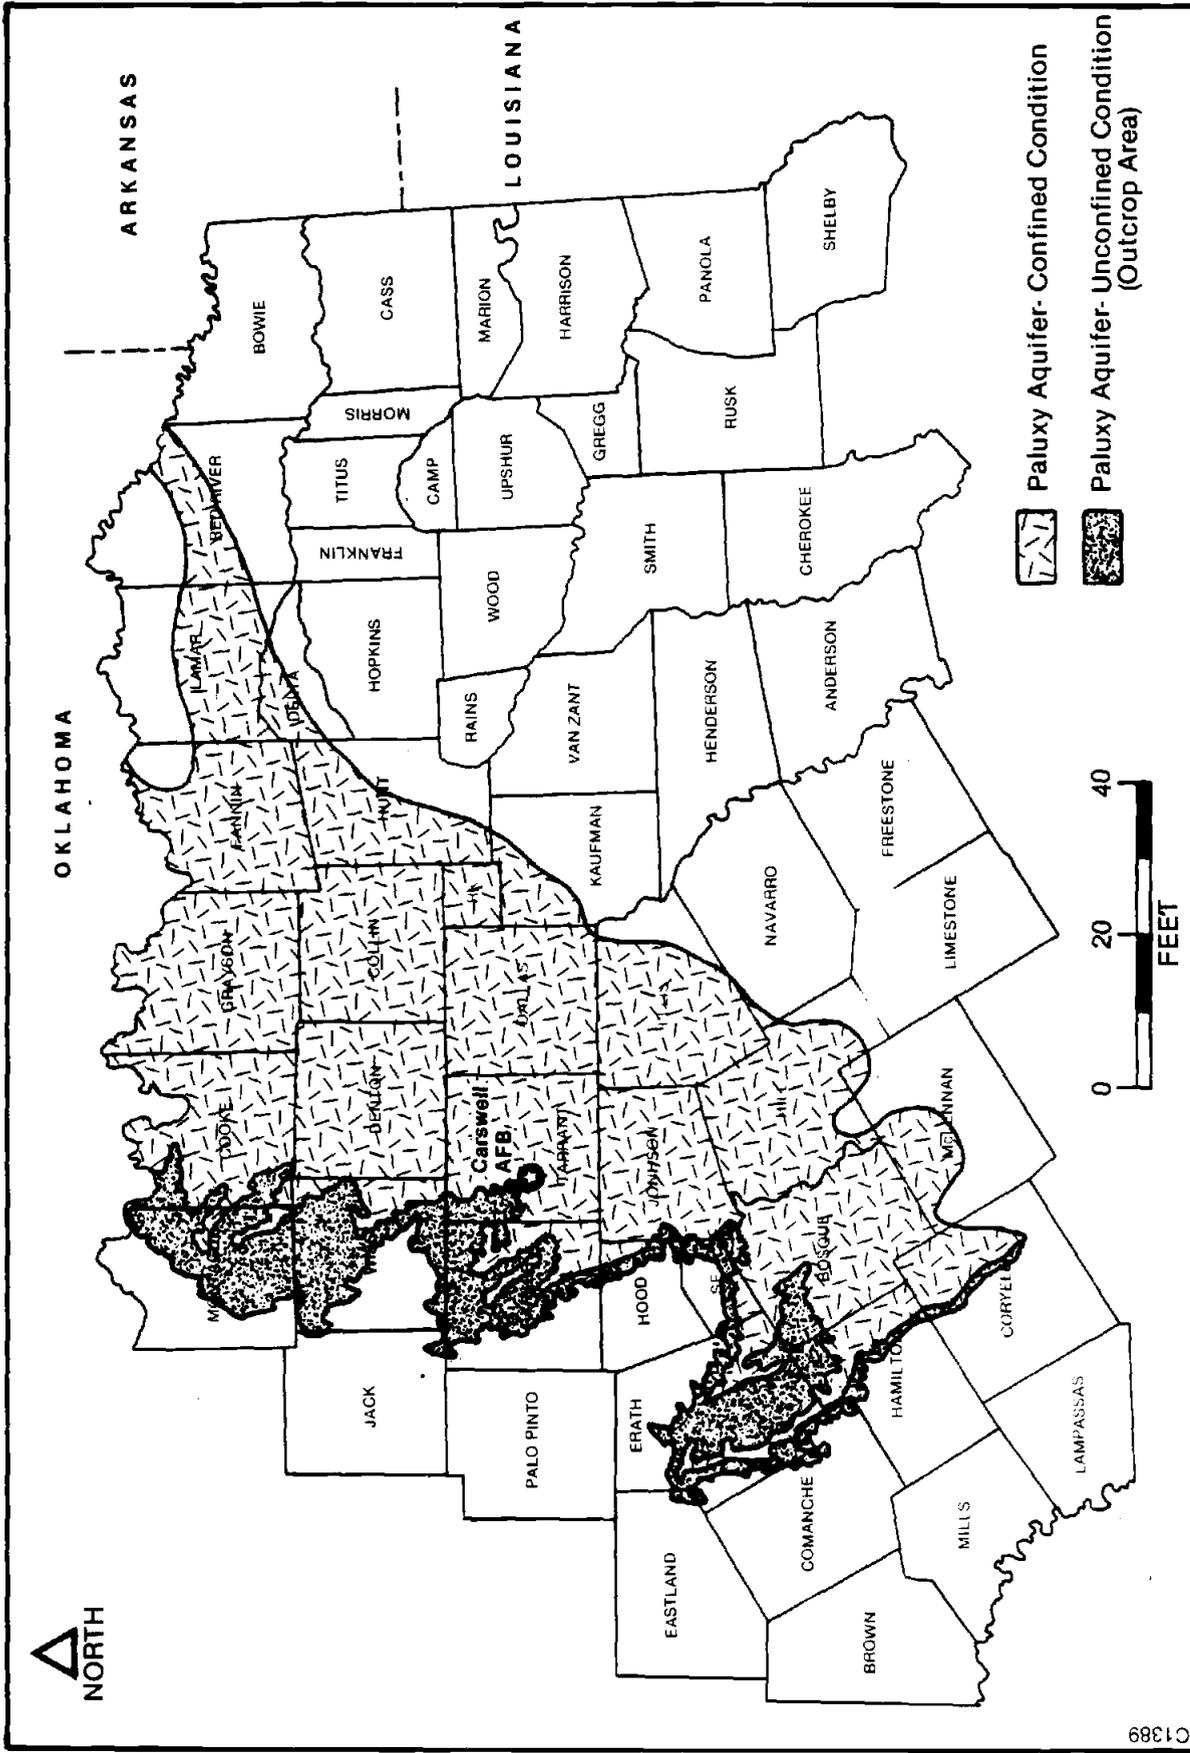
Figure 2-6. Areal Extent of the Paluxy Aquifer, North Texas.

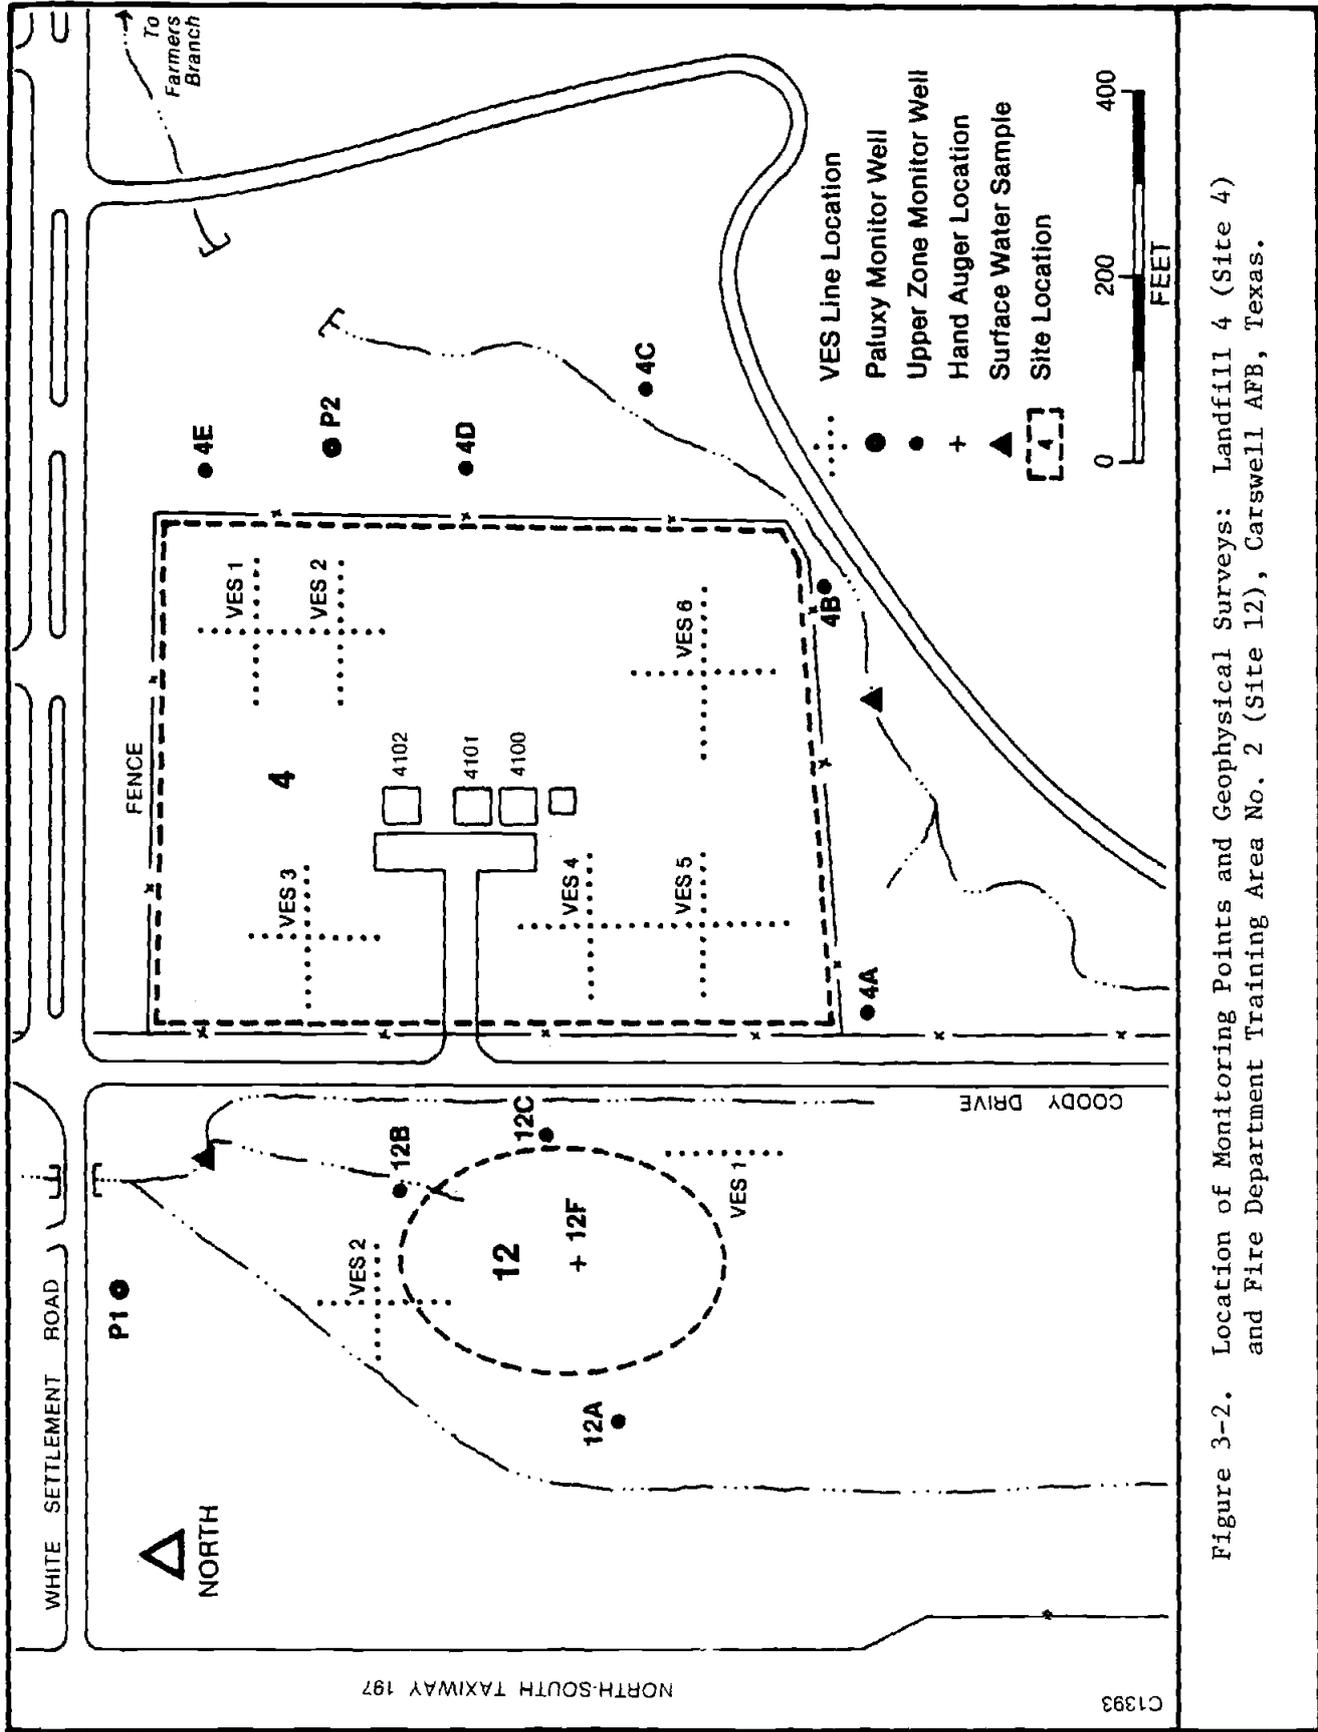
Figure 3-2. Location of Monitoring Points and Geophysical Surveys: Landfill 4 (Site 4) and Fire Department Training Area No. 2 (Site 12), Carswell AFB, Texas.

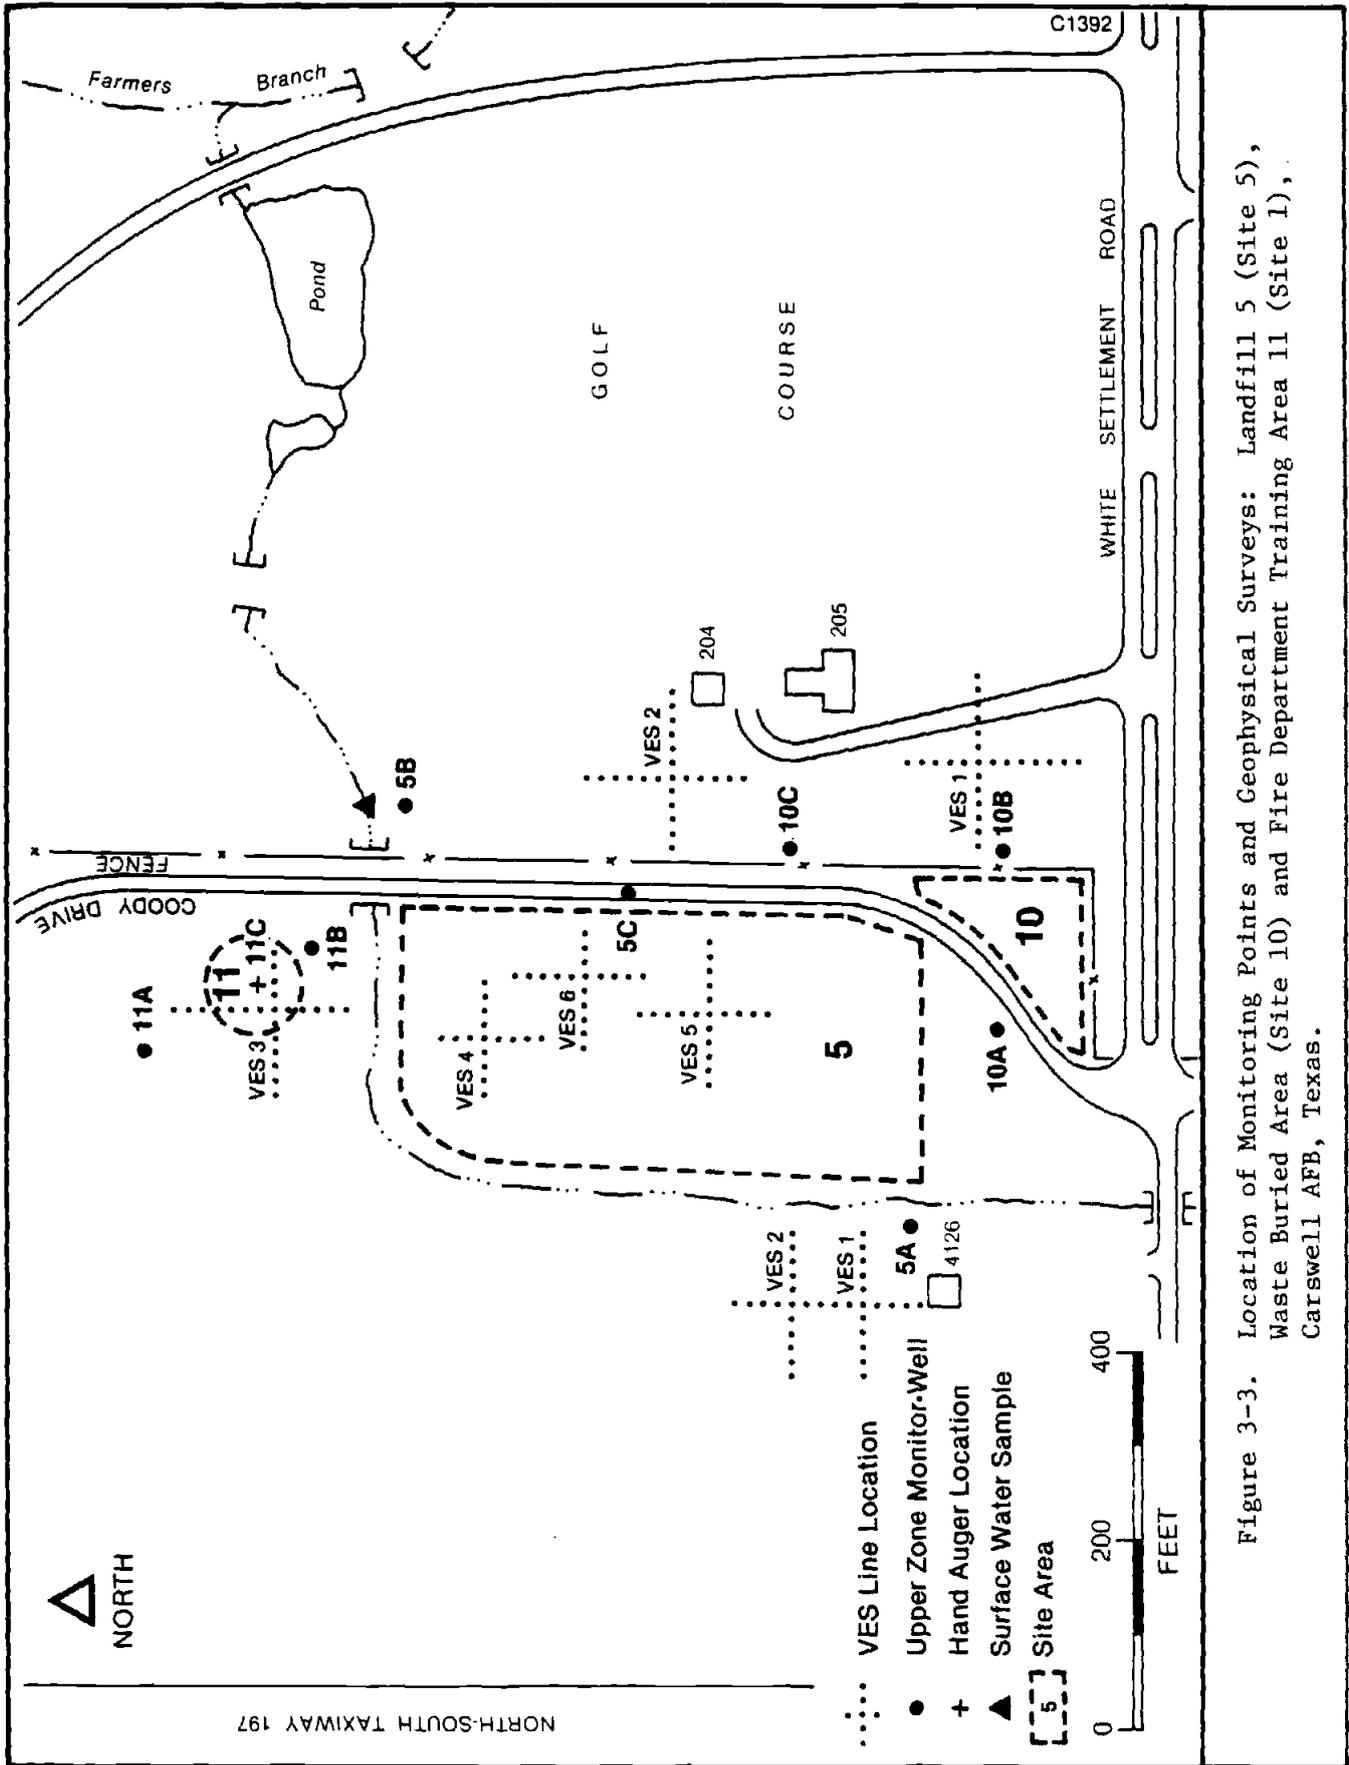
Figure 3-3. Location of Monitoring Points and Geophysical Surveys: Landfill 5 (Site 5), Waste Buried Area (Site 10) and Fire Department Training Area 11 (Site 1), Carswell AFB, Texas.

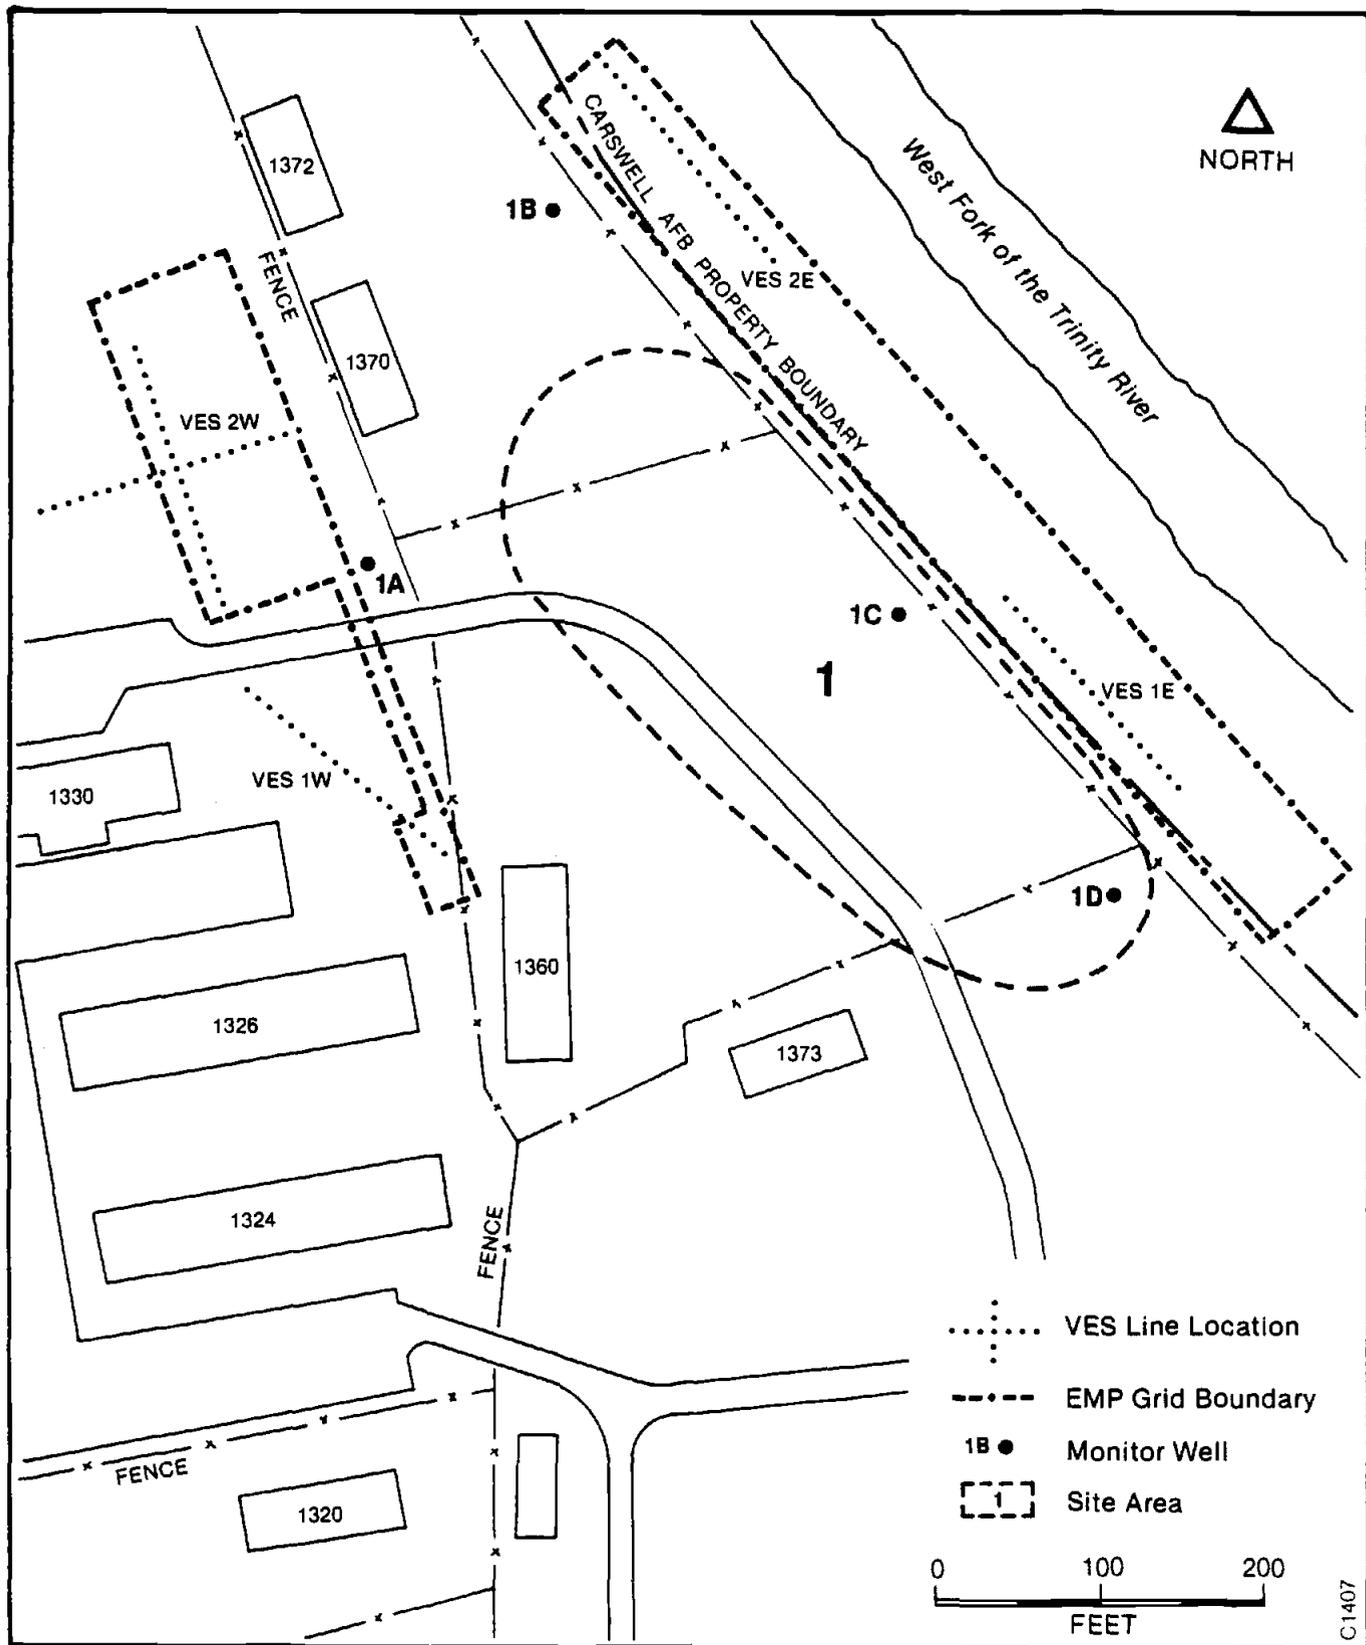
Figure 3-4. Location of Monitor Wells and Geophysical Surveys: Landfill No. 1 (Site 1), Carswell AFB, Texas.

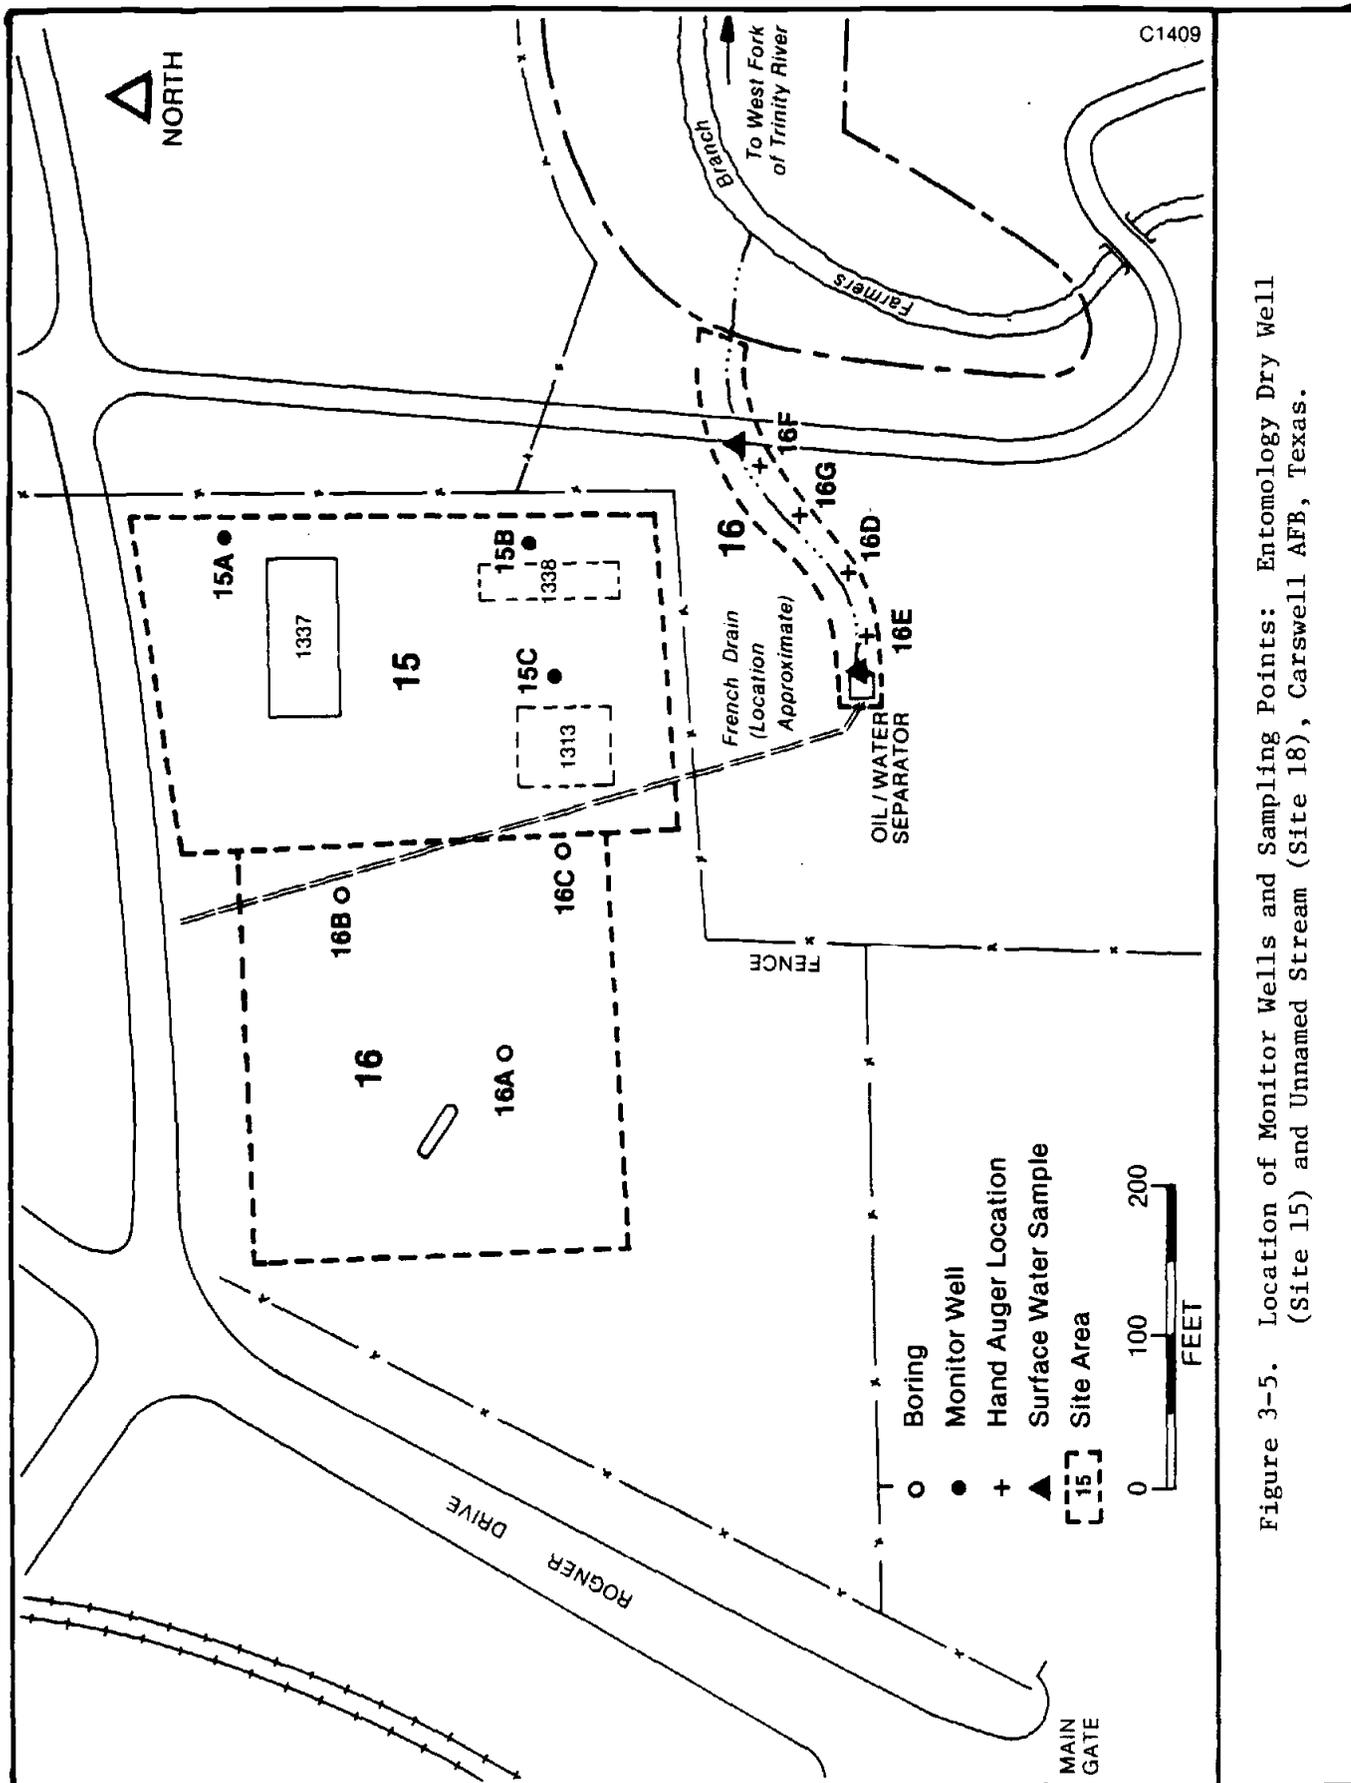
Figure 3-5. Location of Monitor Wells and Sampling Points: Entomology Dry Well (Site 15) and Unnamed Stream (Site 18), Carswell AFB, Texas.

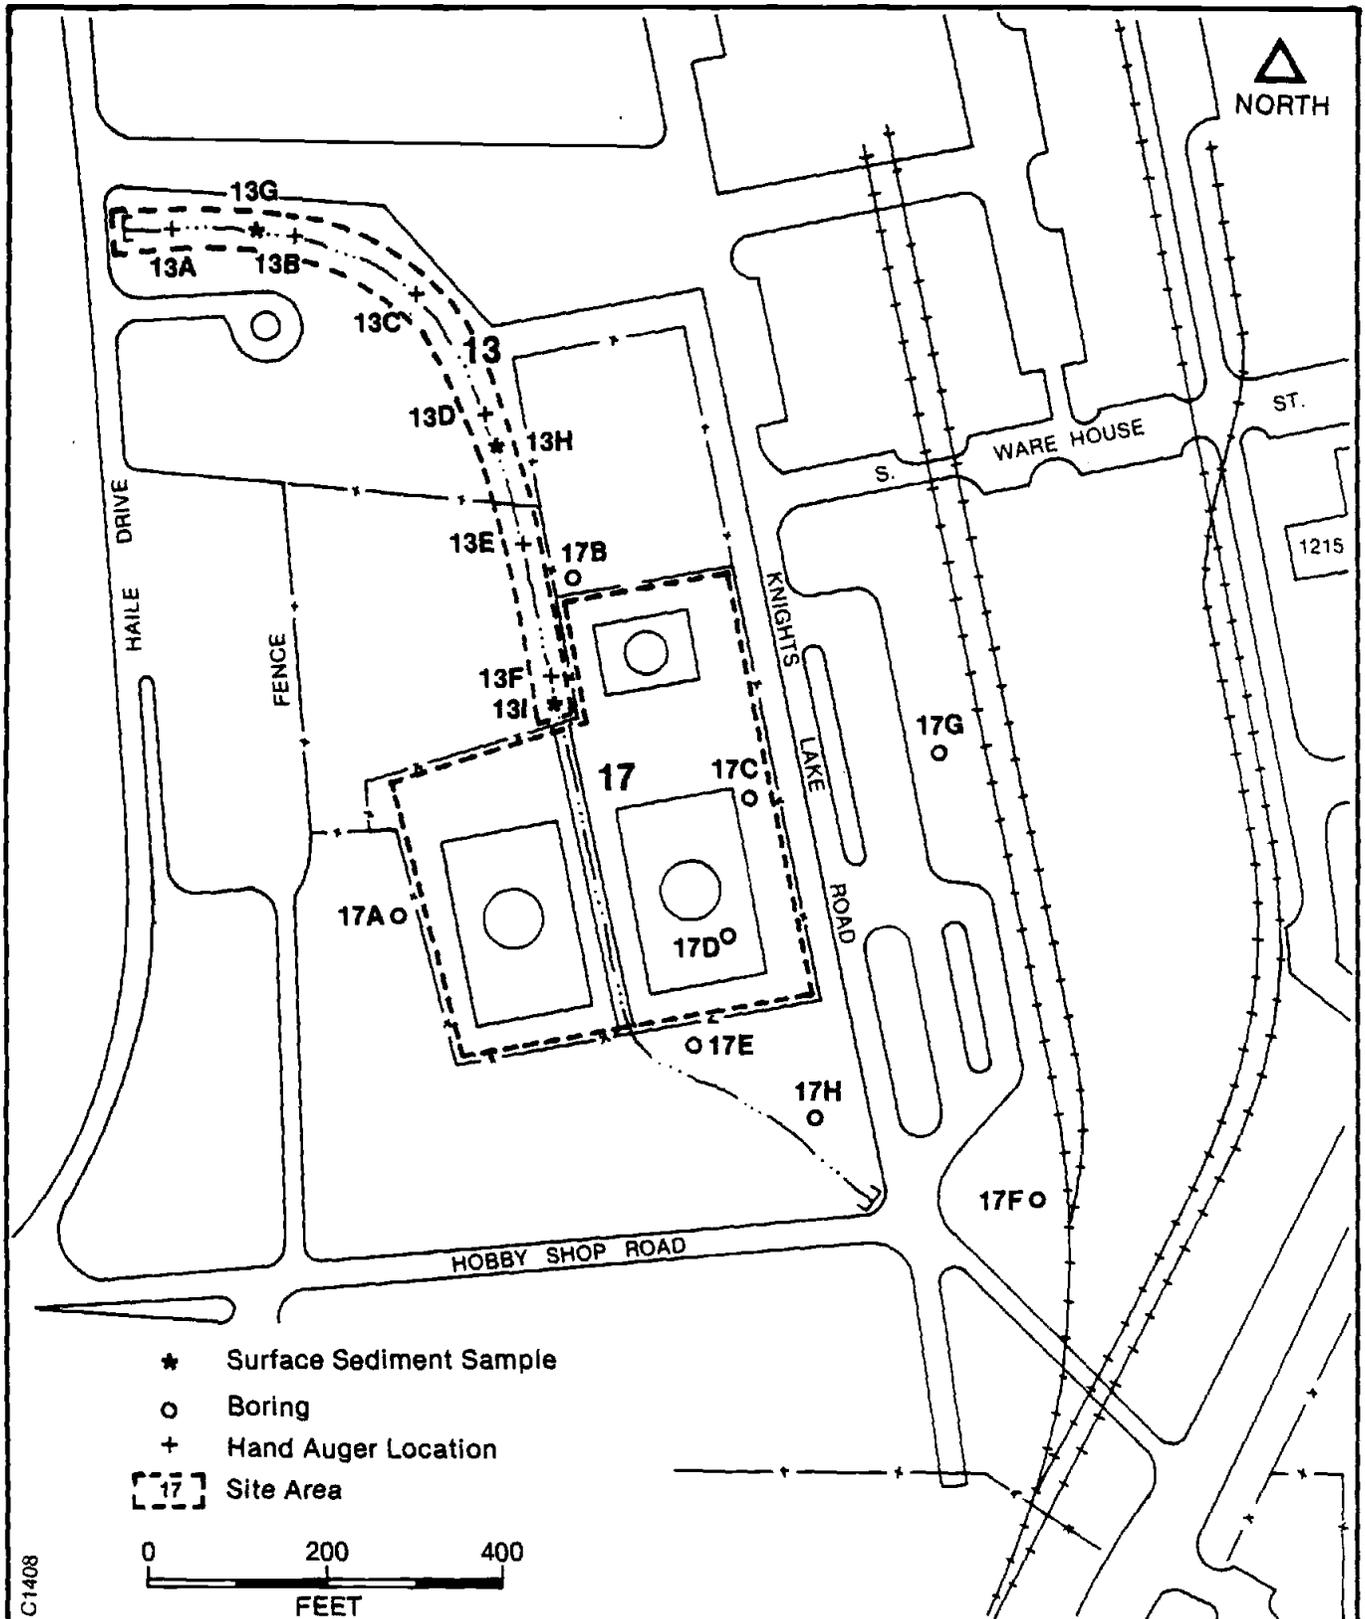
Figure 3-6. Location of Boreholes and Sampling Points: Flightline Drainage Ditch (Site 13) and POL Tank Farm (Site 17), Carswell AFB, Texas.
