FINAL INSTALLATION RESTORATION PHASE 2 CONFIRMATION QUANTIFICATION STAGE  
1 VOLUME 1 NAS FORT WORTH TX  
10/1/1986  
RADIAN CORPORATION

**INSTALLATION RESTORATION PROGRAM  
PHASE II - CONFIRMATION/QUANTIFICATION  
STAGE 1  
VOLUME 1 - FINAL REPORT**

**CARSWELL AFB, TEXAS**

**OCTOBER 1986**

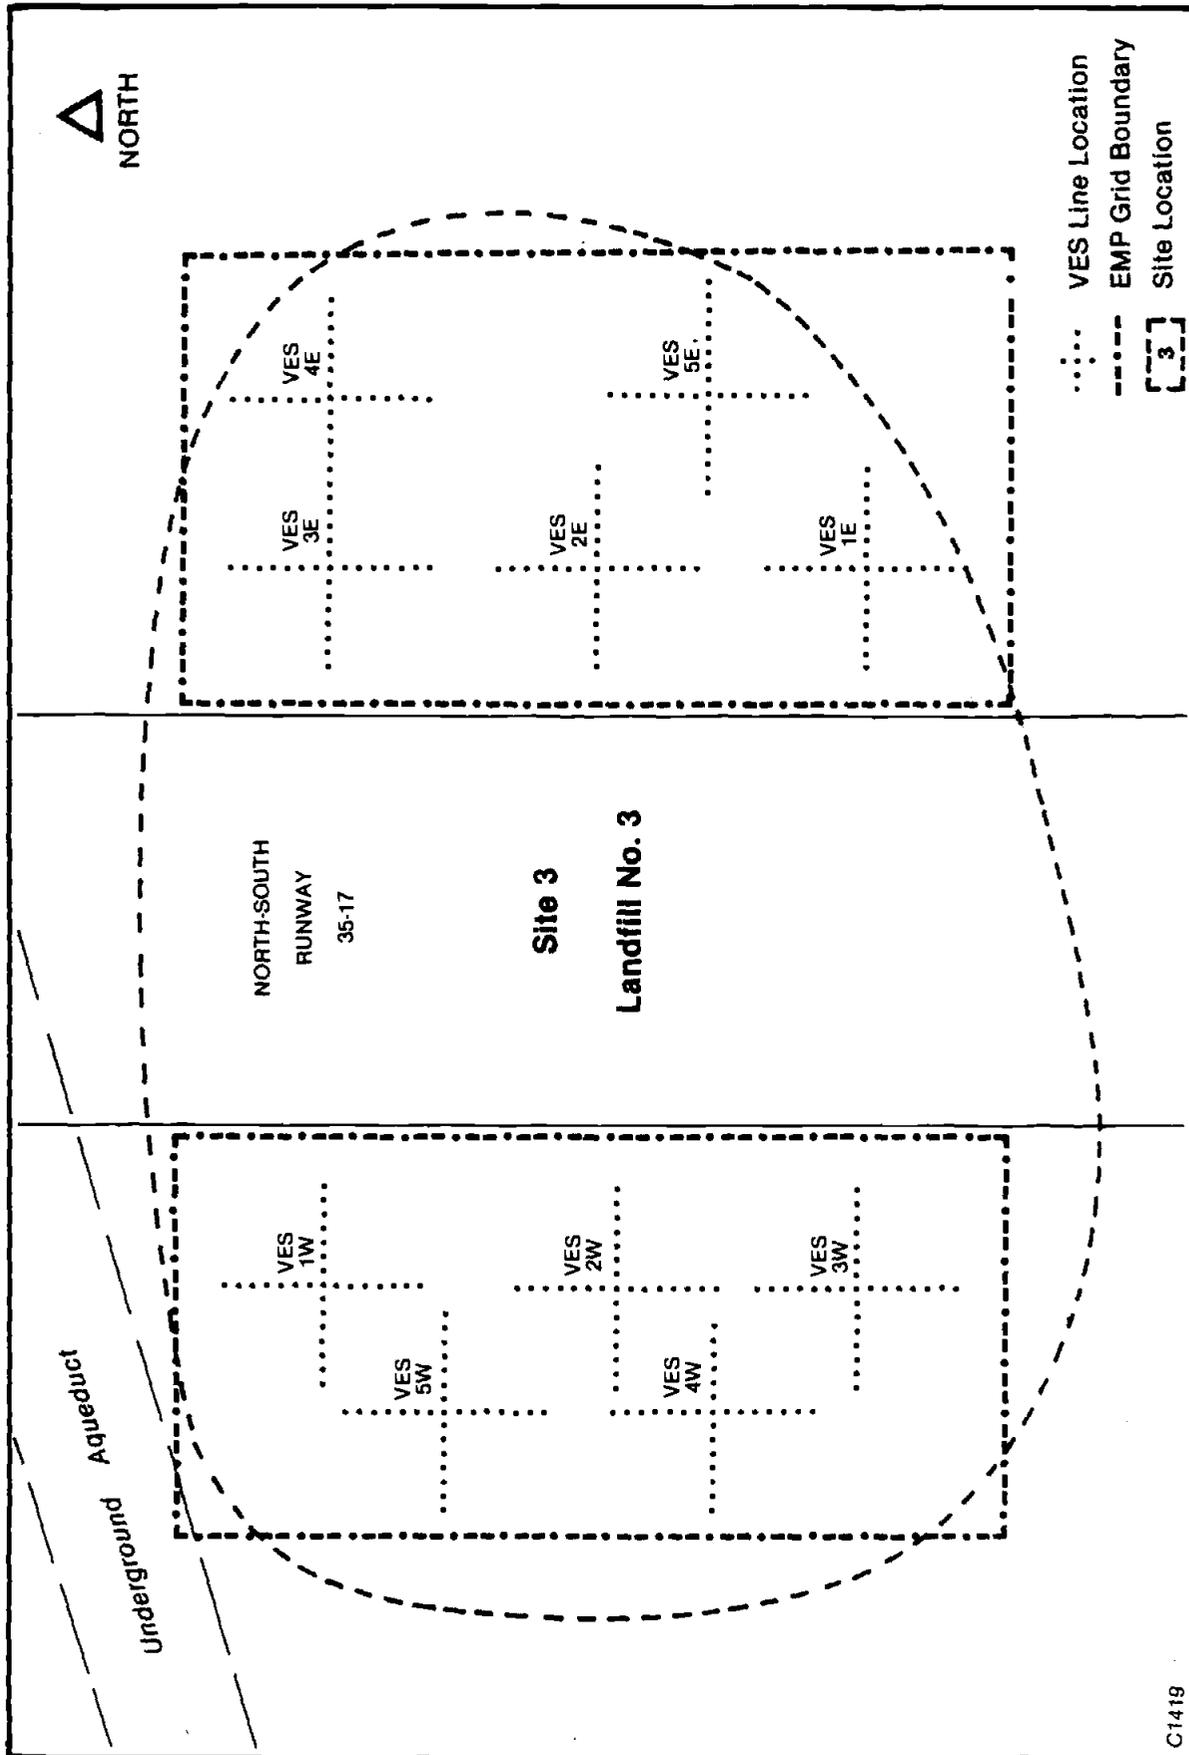
Figure 3-7. Location of Geophysical Surveys, Landfill No. 3 (Site 3).

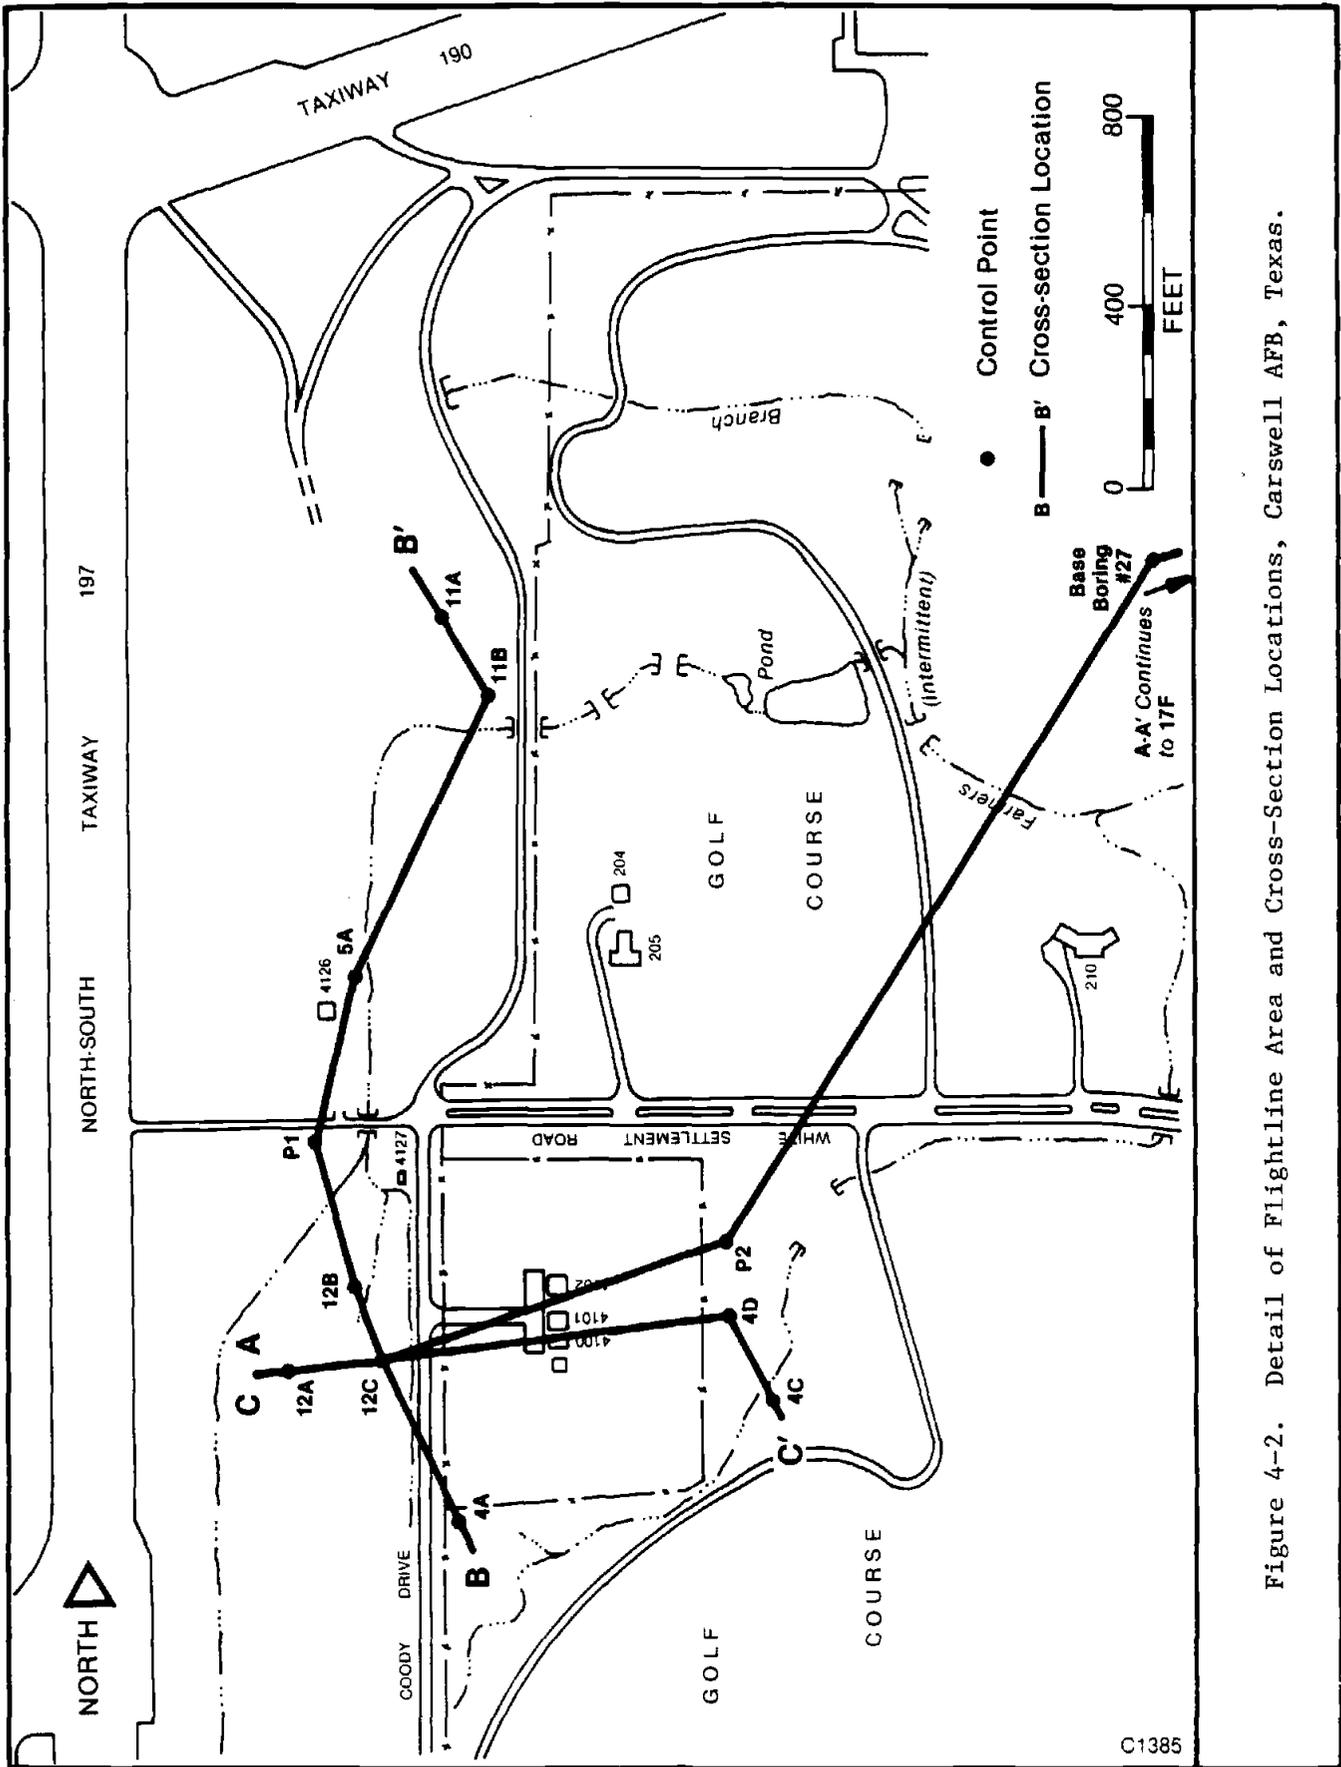
Figure 4-2. Detail of Flightline Area and Cross-Section Locations, Carswell AFB, Texas.

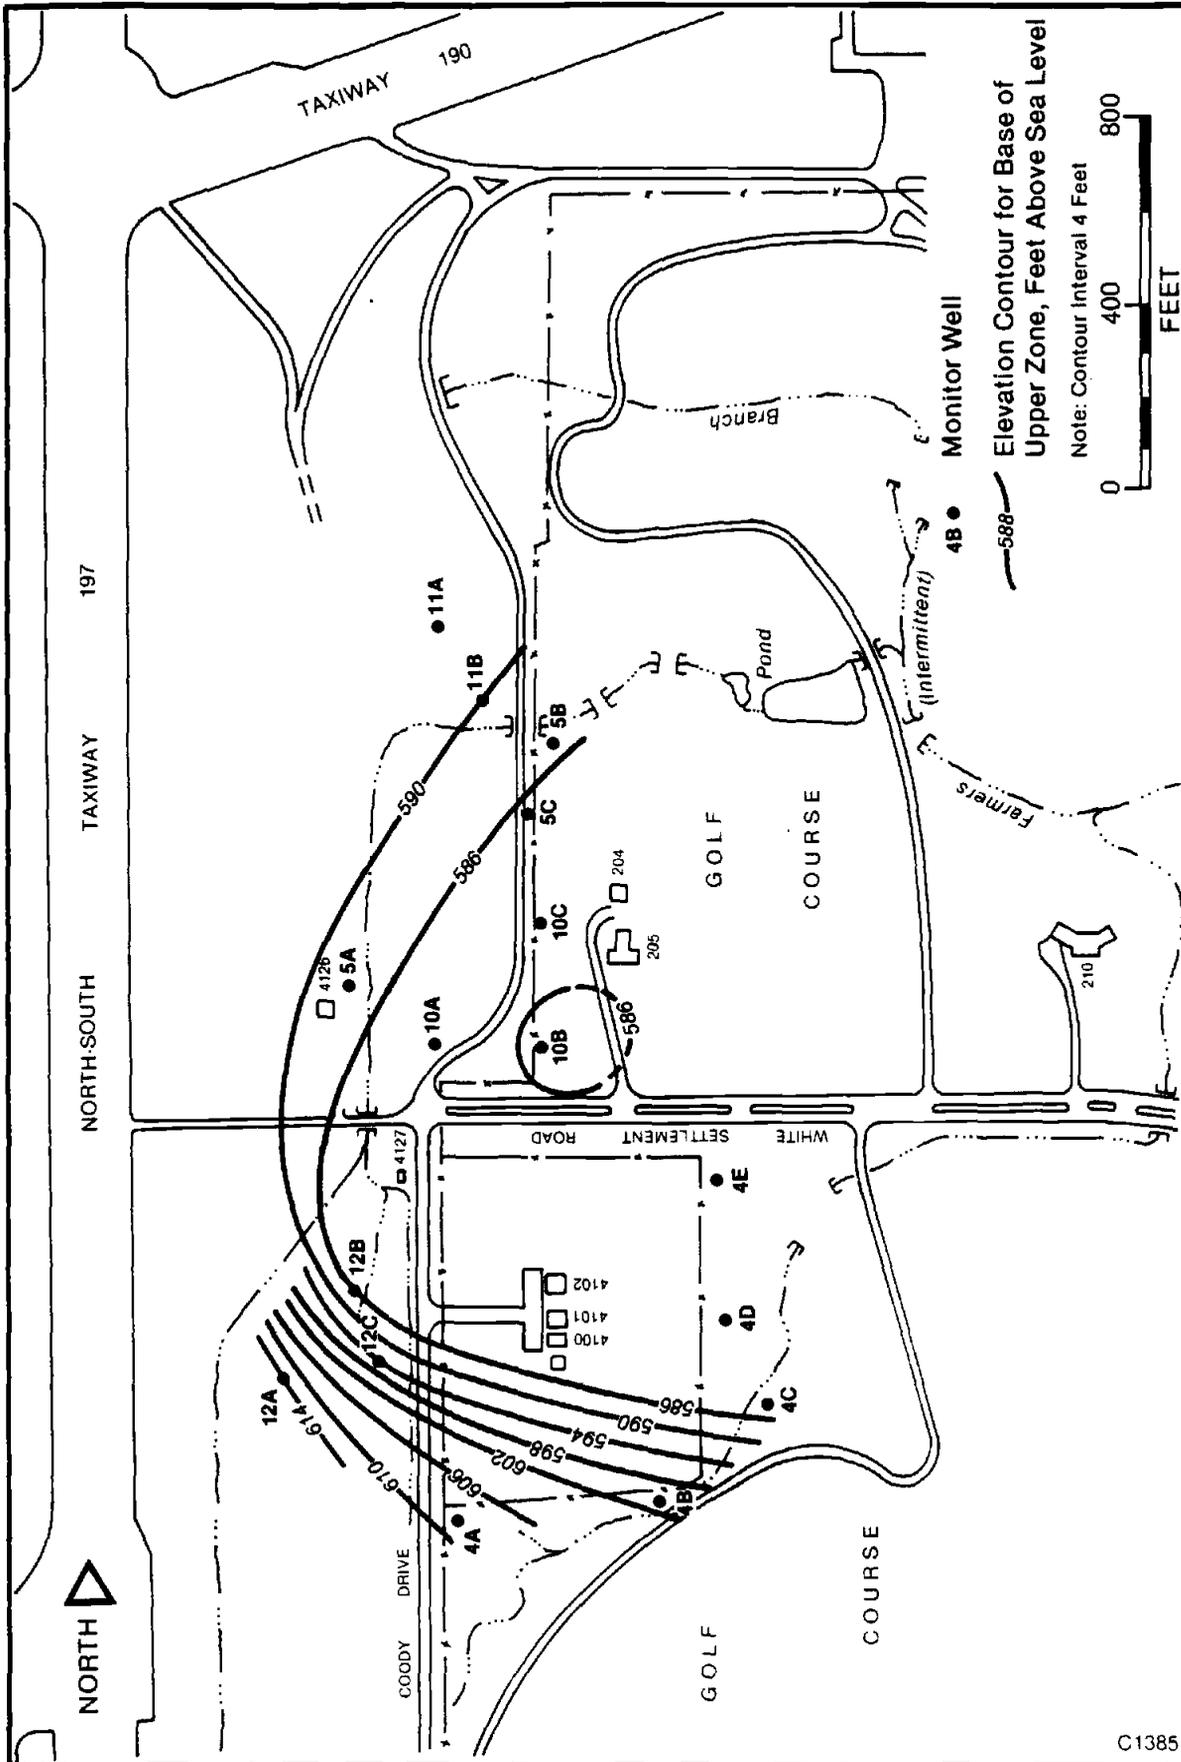
Figure 4-3. Contour Map of the Base of the Upper Zone, Carswell AFB, Texas.

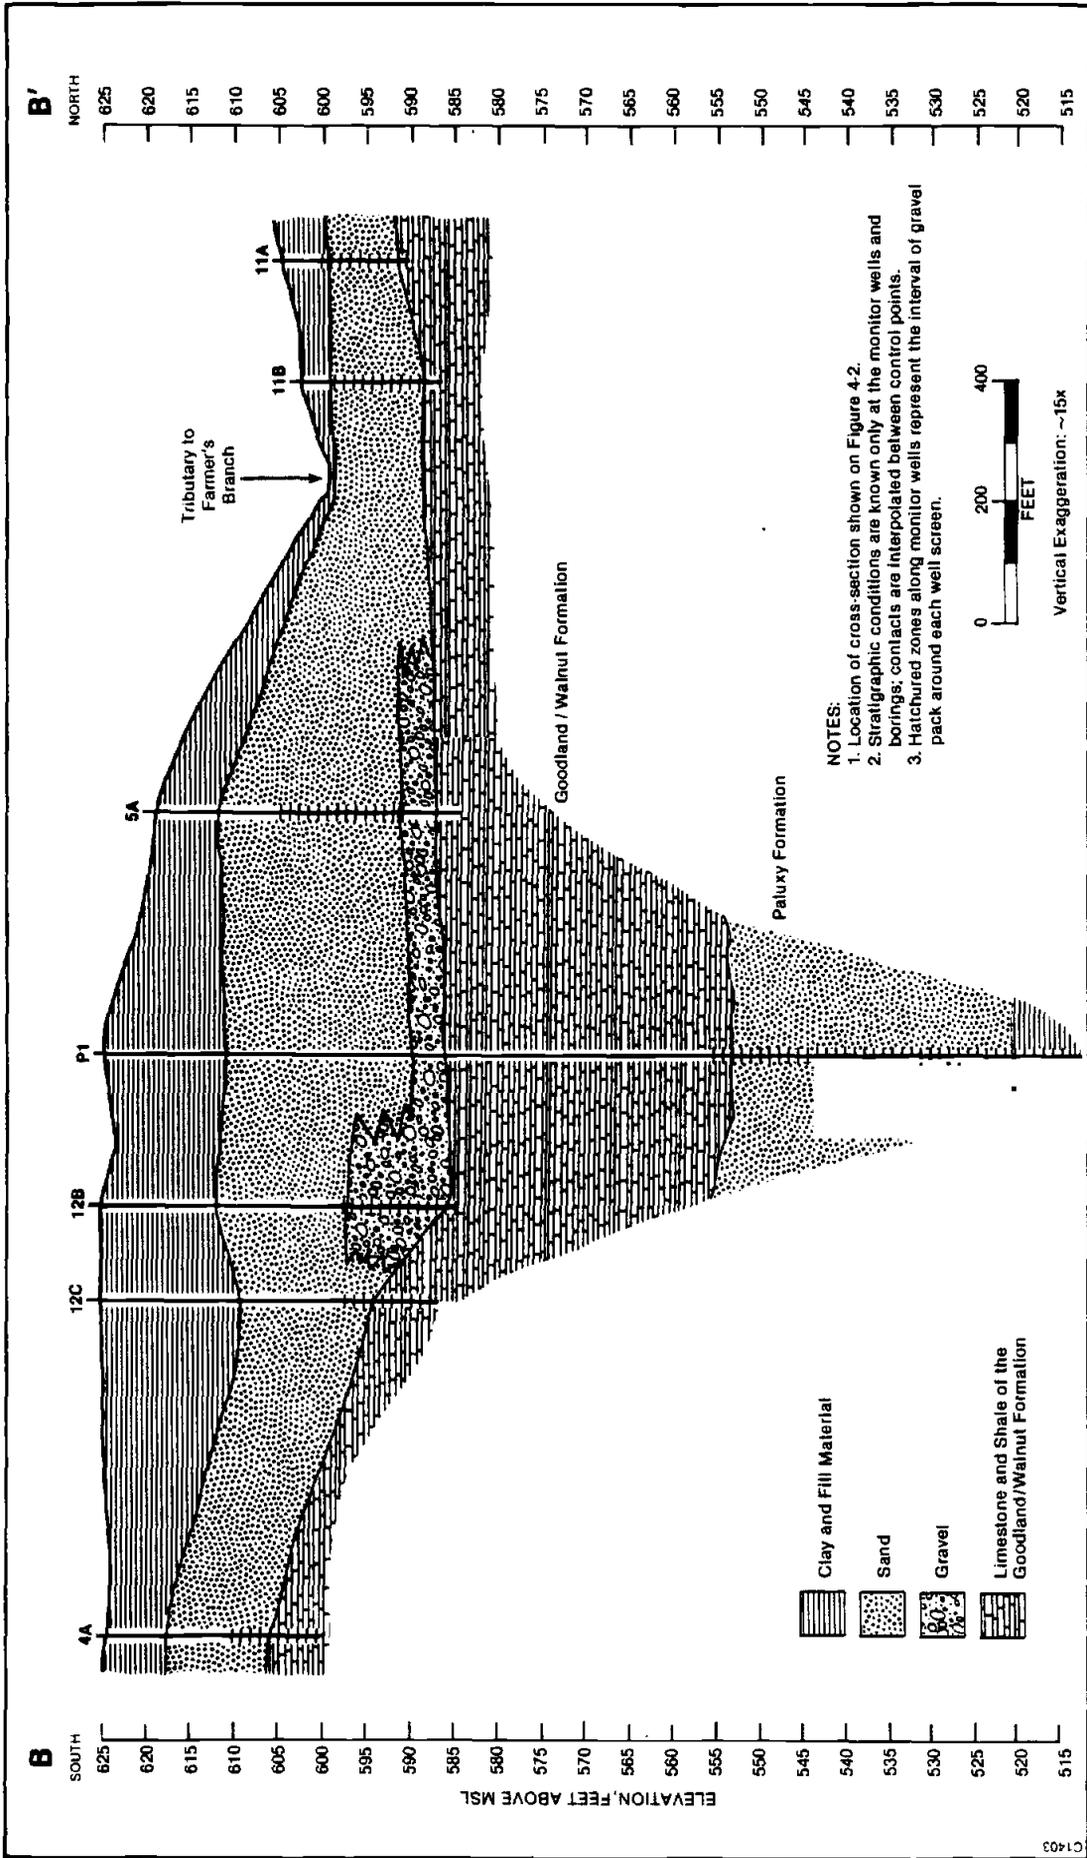
Figure 4-4. Geologic Cross-Section B-B', Carswell AFB, Texas.

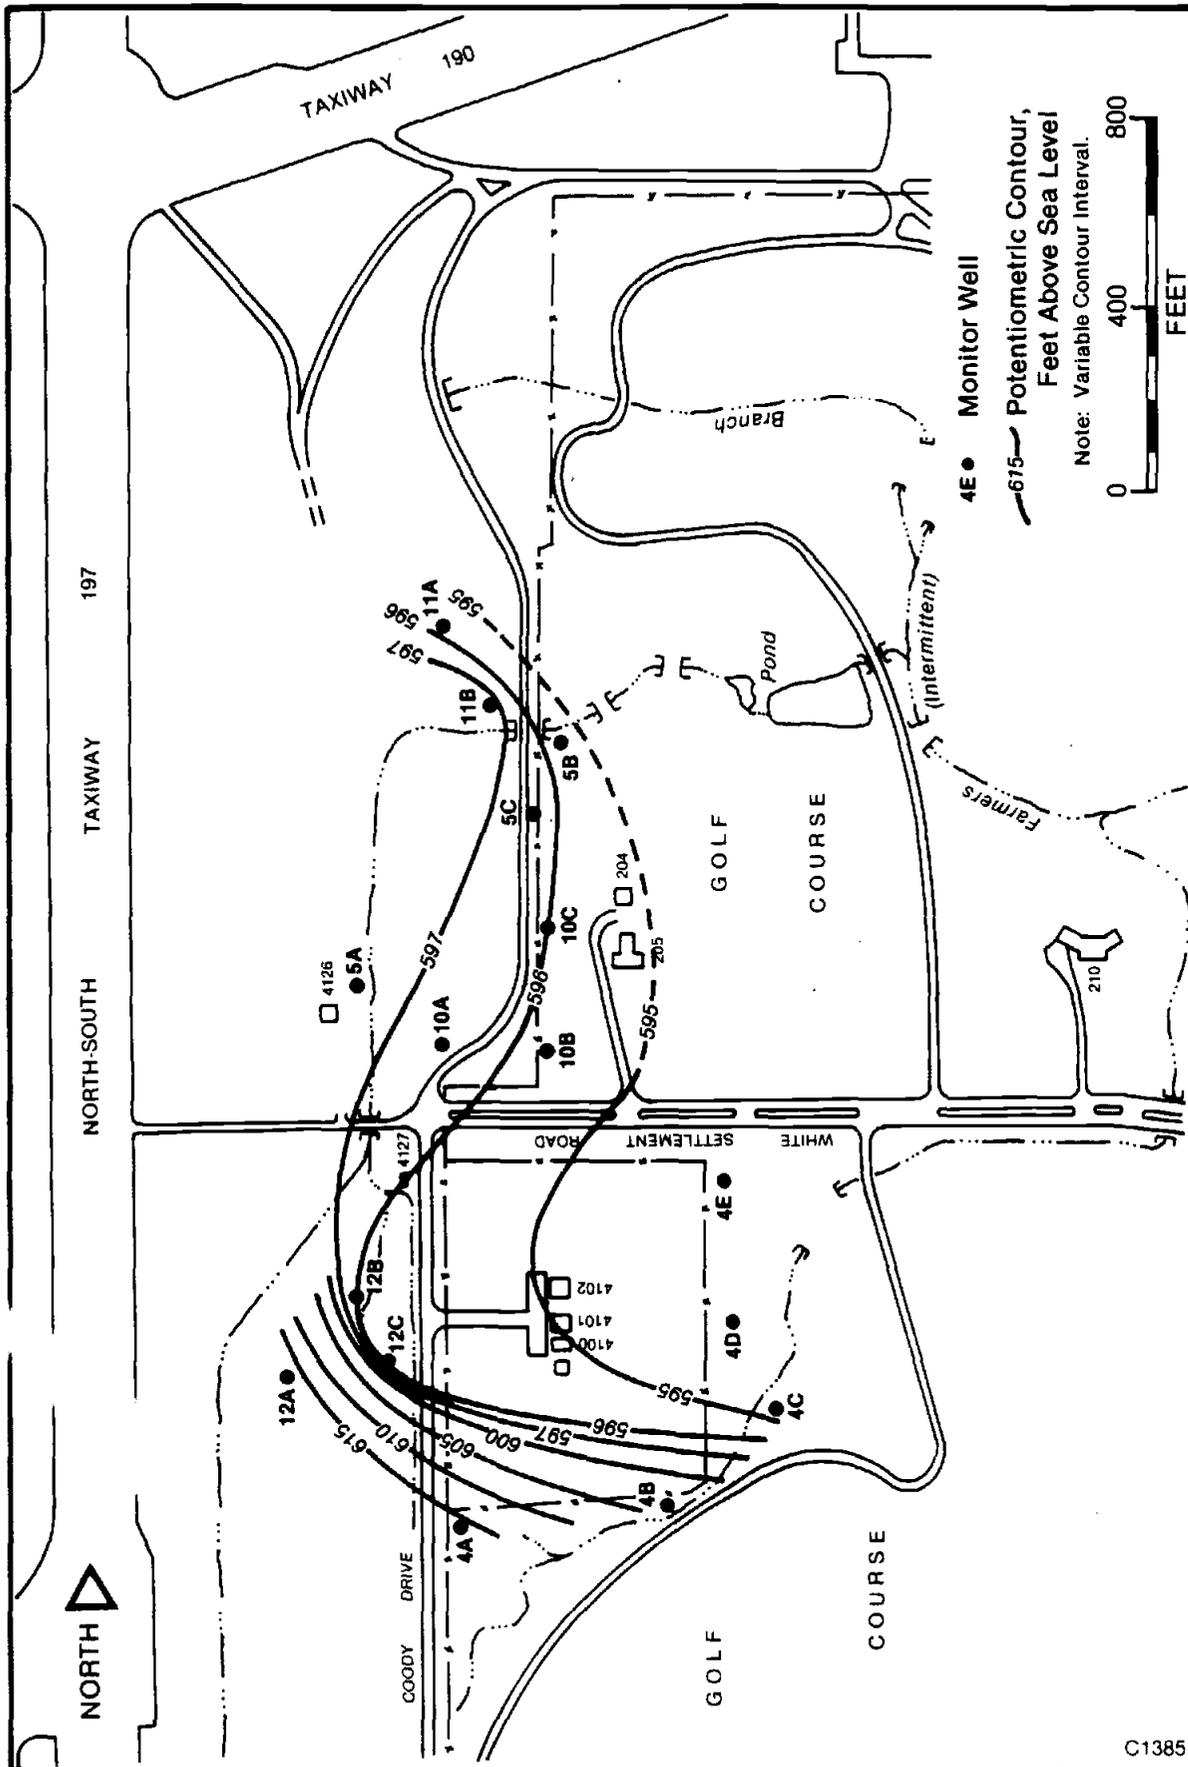
Figure 4-5. Potentiometric Surface Map of the Upper Zone, Flightline Area, Carswell AFB, Texas.

Ground water occurs in the upper zone and Paluxy aquifer underlying the flightline area. Table 4-4 provides the results of water level measurements made at monitor wells in the Flightline area. A potentiometric surface map (Figure 4-5) of the flightline area reveals that the elevation of the ground water table in the upper zone generally reflects the shape of the contact between the bedrock and the upper zone. This is particularly evident in the area of Fire Training Area 2, where both the contact and the water table have steep gradients. The position of the water table also reflects to a lesser degree the overlying topography; downgradient is generally to the east, as is the slope of the land surface. A steep hydraulic gradient occurs only in the extreme southwest part of the area; most of the flightline area has a very low hydraulic gradient as seen by the widely-spaced contours at Sites 5

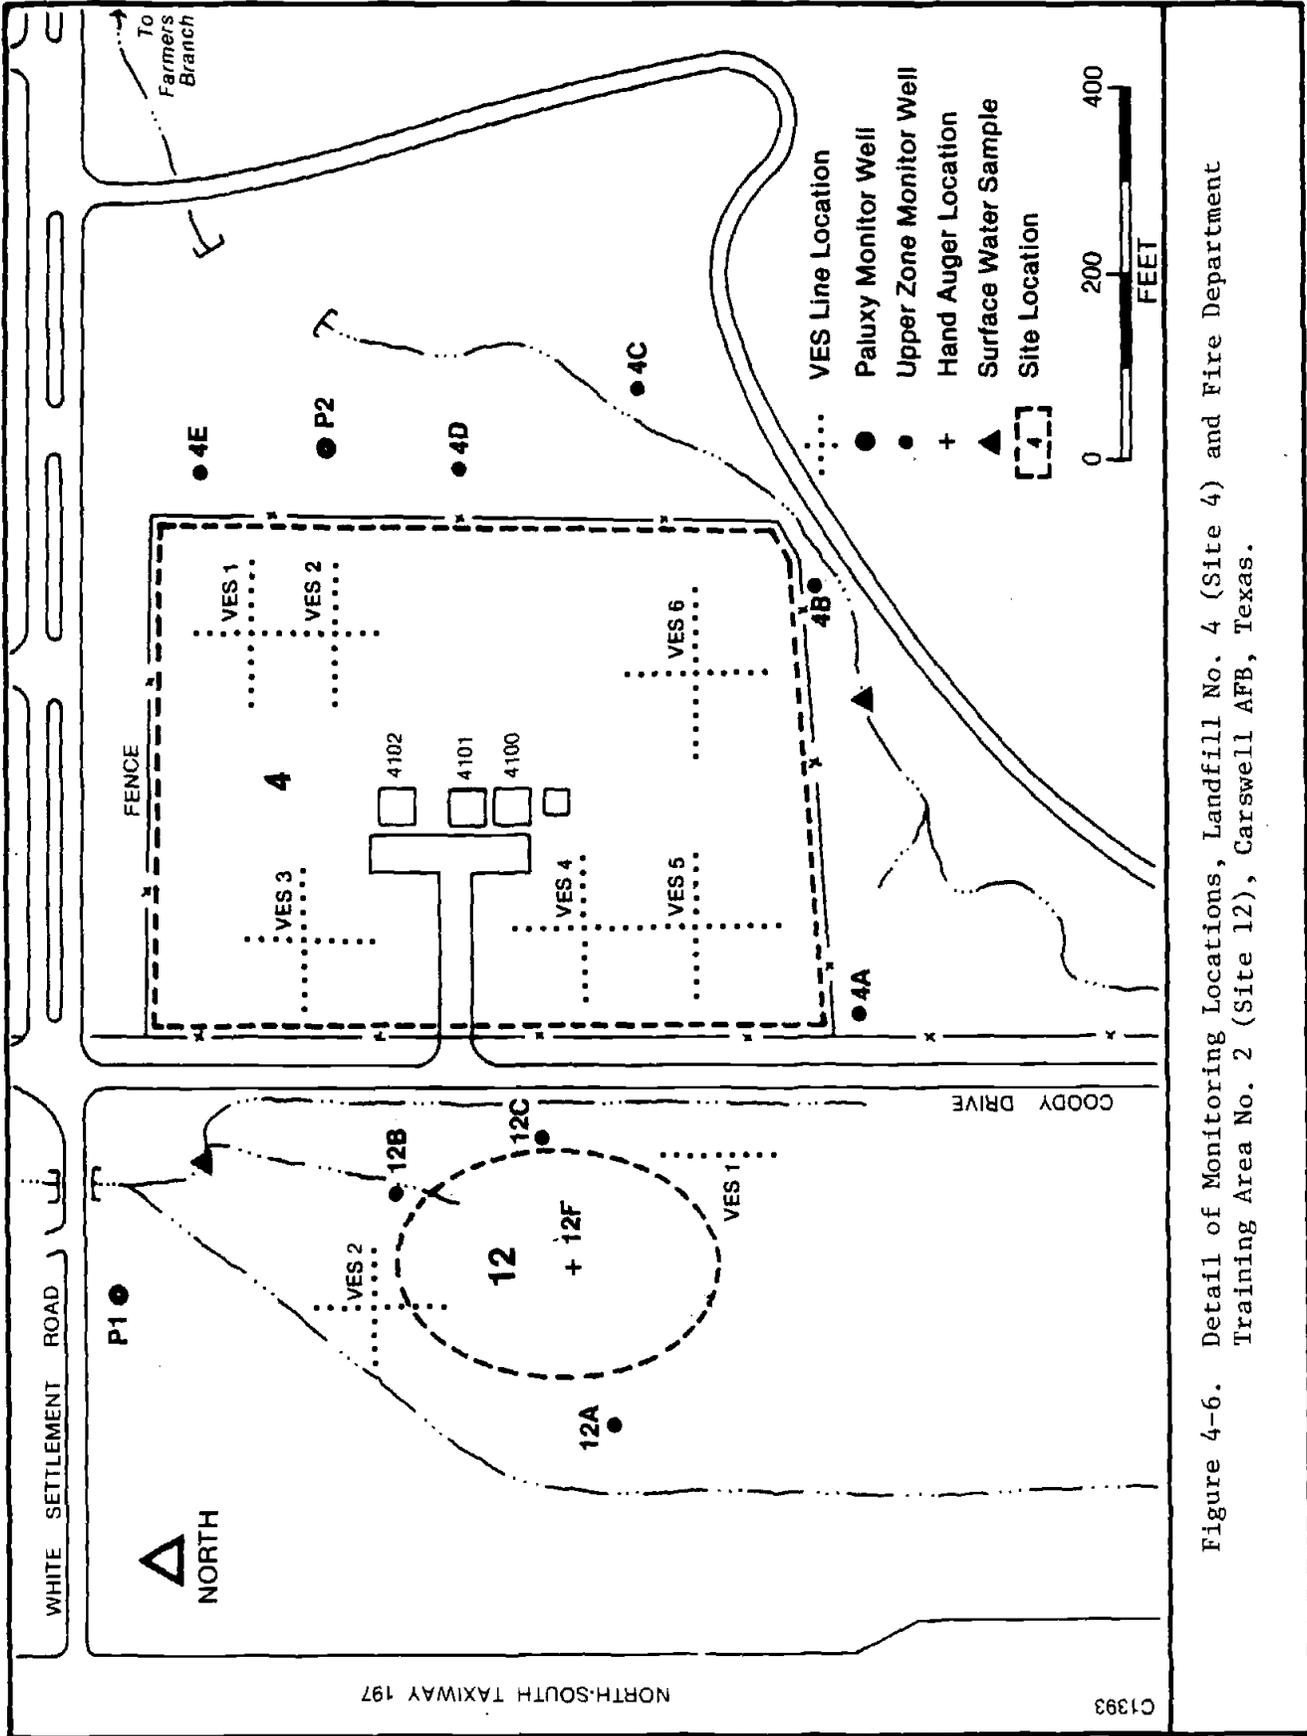
Figure 4-6. Detail of Monitoring Locations, Landfill No. 4 (Site 4) and Fire Department Training Area No. 2 (Site 12), Carswell AFB, Texas.

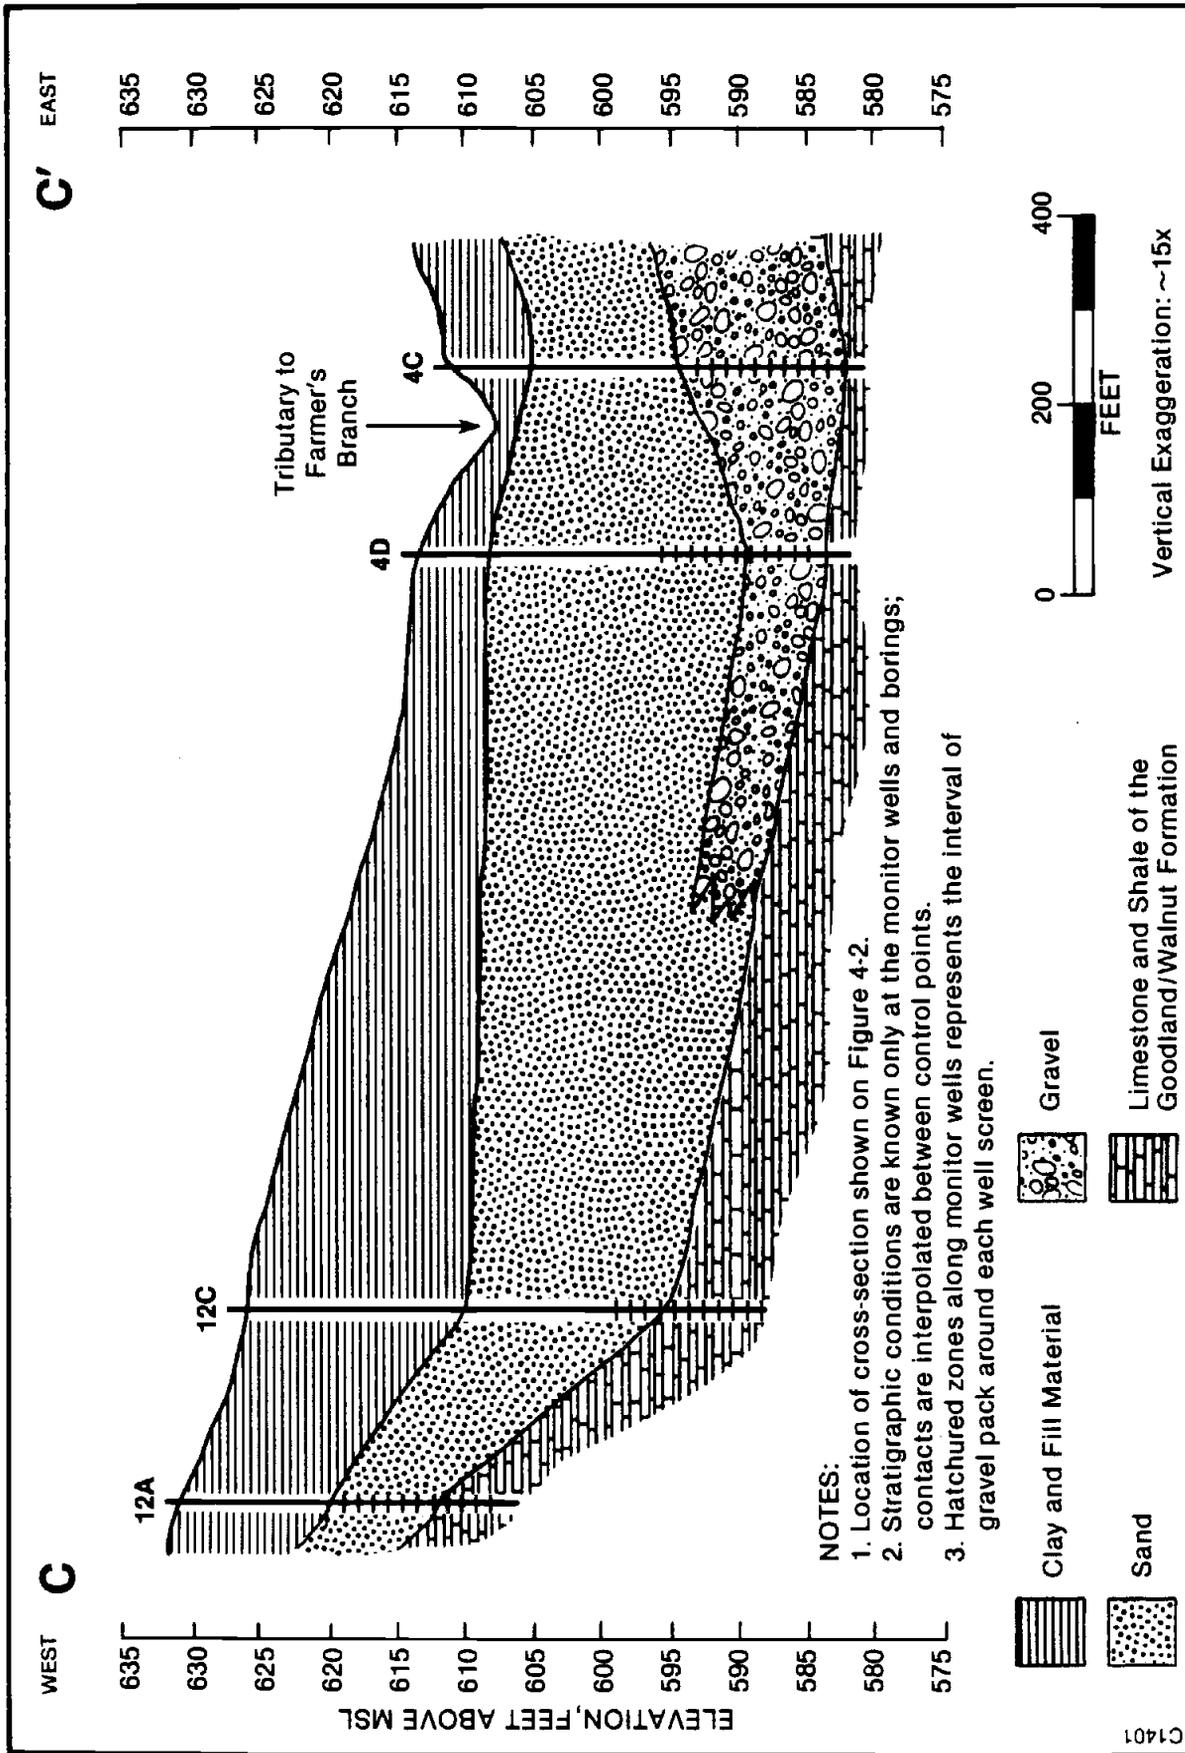
Figure 4-7. Geologic Cross-Section C-C', Carswell AFB, Texas.

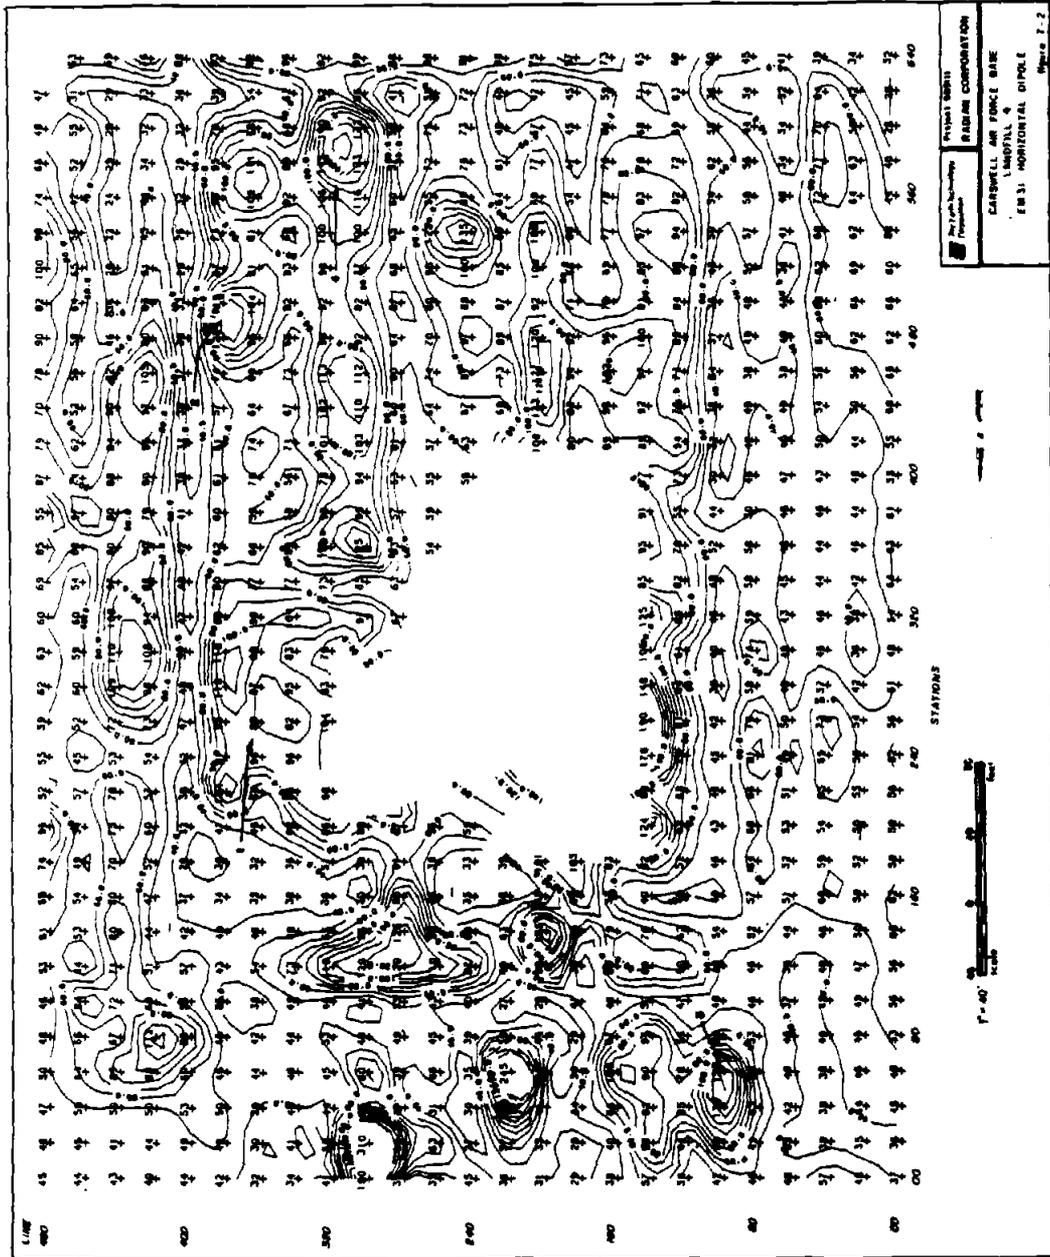
Figure 4-8. Electromagnetic Profile Data (EM31), Landfill 4, Carswell AFB, Texas.

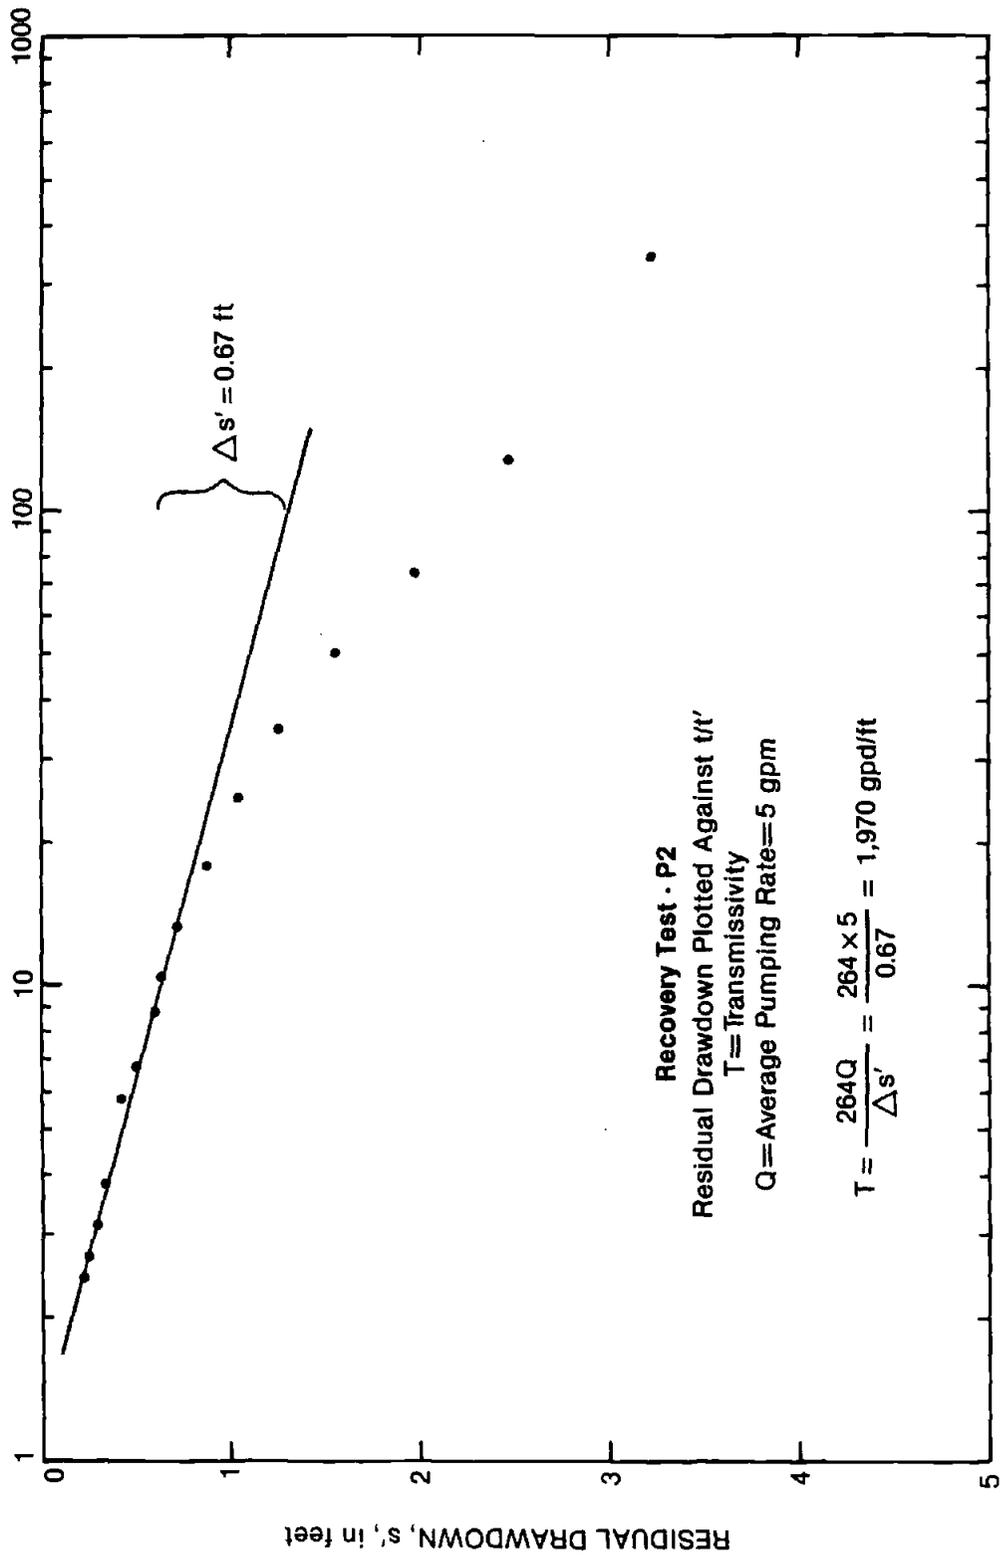
Figure 4-9. Plot of Recovery Test Data, Well P2, Carswell AFB, Texas.

Recovery test data were analyzed for aquifer transmissivity by plotting the residual drawdown versus the ratio  $t/t'$  ( $t$ =time after pumping started,  $t'$ =time after pumping stopped). Figure 4-9 presents the recovery data and the graphical analysis which indicate that the transmissivity of the upper Paluxy is 1,970 gallons per day per foot. This value is consistent with

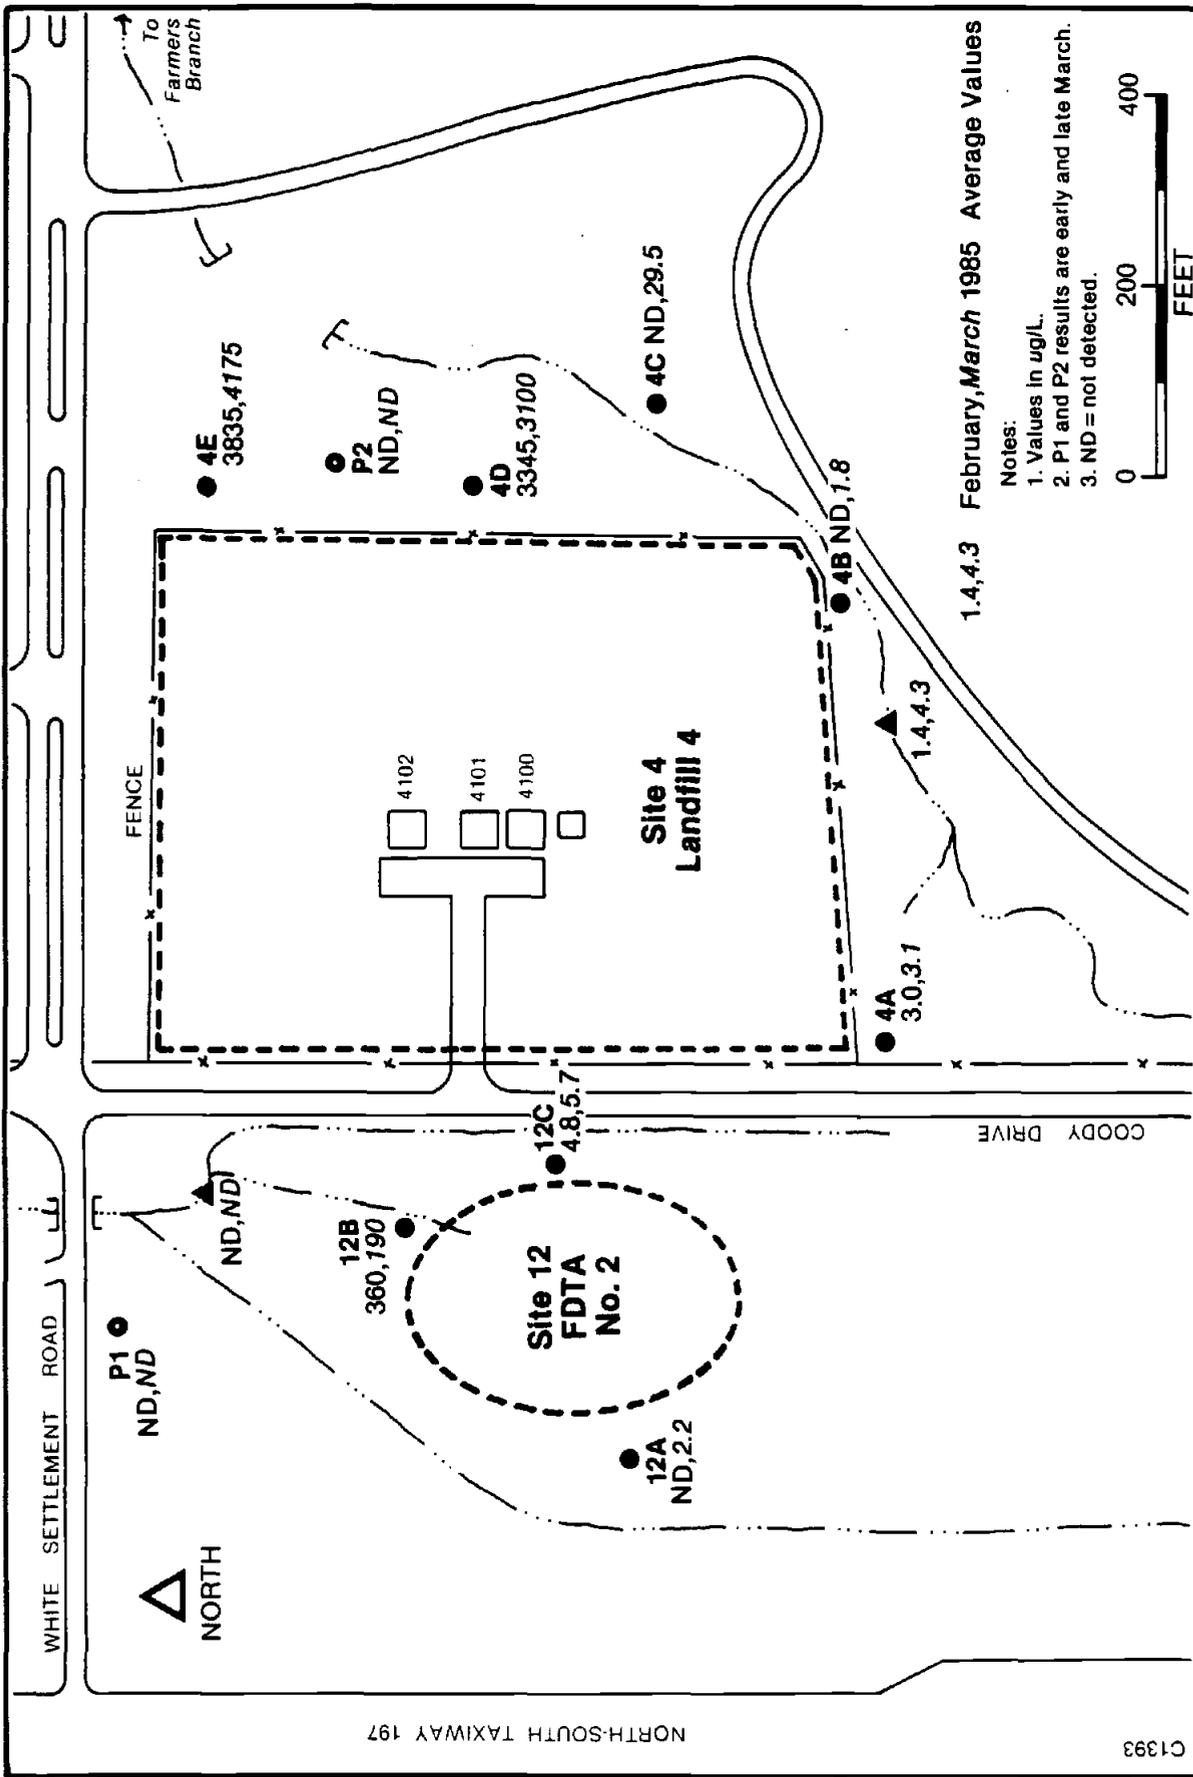
Figure 4-10. Areal Distribution of TCE in Water, Landfill No. 4 (Site 4) and Fire Department Training Area No. 2 (Site 12), Carswell AFB, Texas.

Results of analyses of ground water at the five upper zone monitor wells indicates that the upper zone water has levels of volatile organic compounds (principally TCE) that exceed EPA drinking water guidelines downgradient (east) of the landfill. Figure 4-10 illustrates the areal distribution of

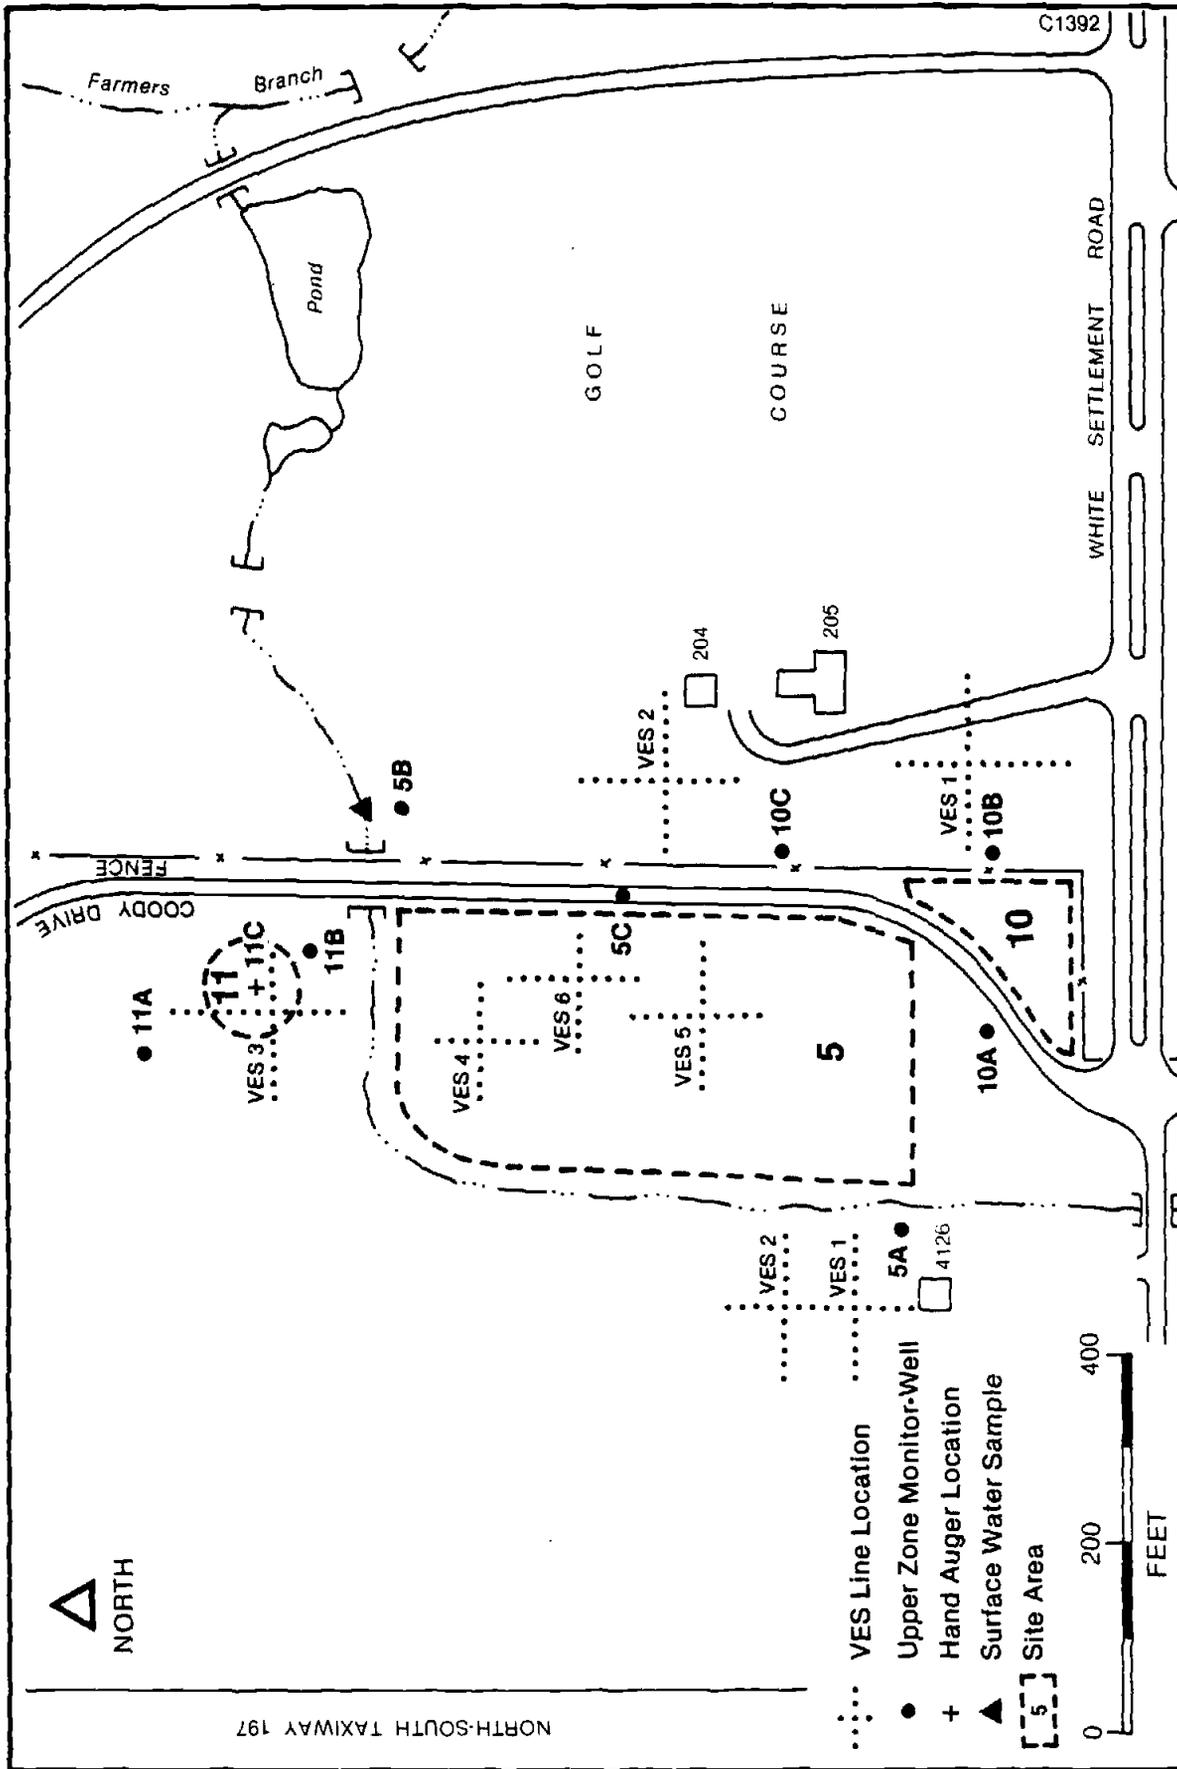
Figure 4-11. Detail of Monitoring Locations, Landfill No. 5 (Site 5), Waste Burial Area (Site 10) and Fire Department Training Area No. 1 (Site 11), Carswell AFB, Texas.
