FINAL INSTALLATION RESTORATION PHASE 2 CONFIRMATION QUANTIFICATION STAGE  
1 VOLUME 1 NAS FORT WORTH TX  
10/1/1986  
RADIAN CORPORATION

**INSTALLATION RESTORATION PROGRAM  
PHASE II - CONFIRMATION/QUANTIFICATION  
STAGE 1  
VOLUME 1 - FINAL REPORT**

**CARSWELL AFB, TEXAS**

**OCTOBER 1986**

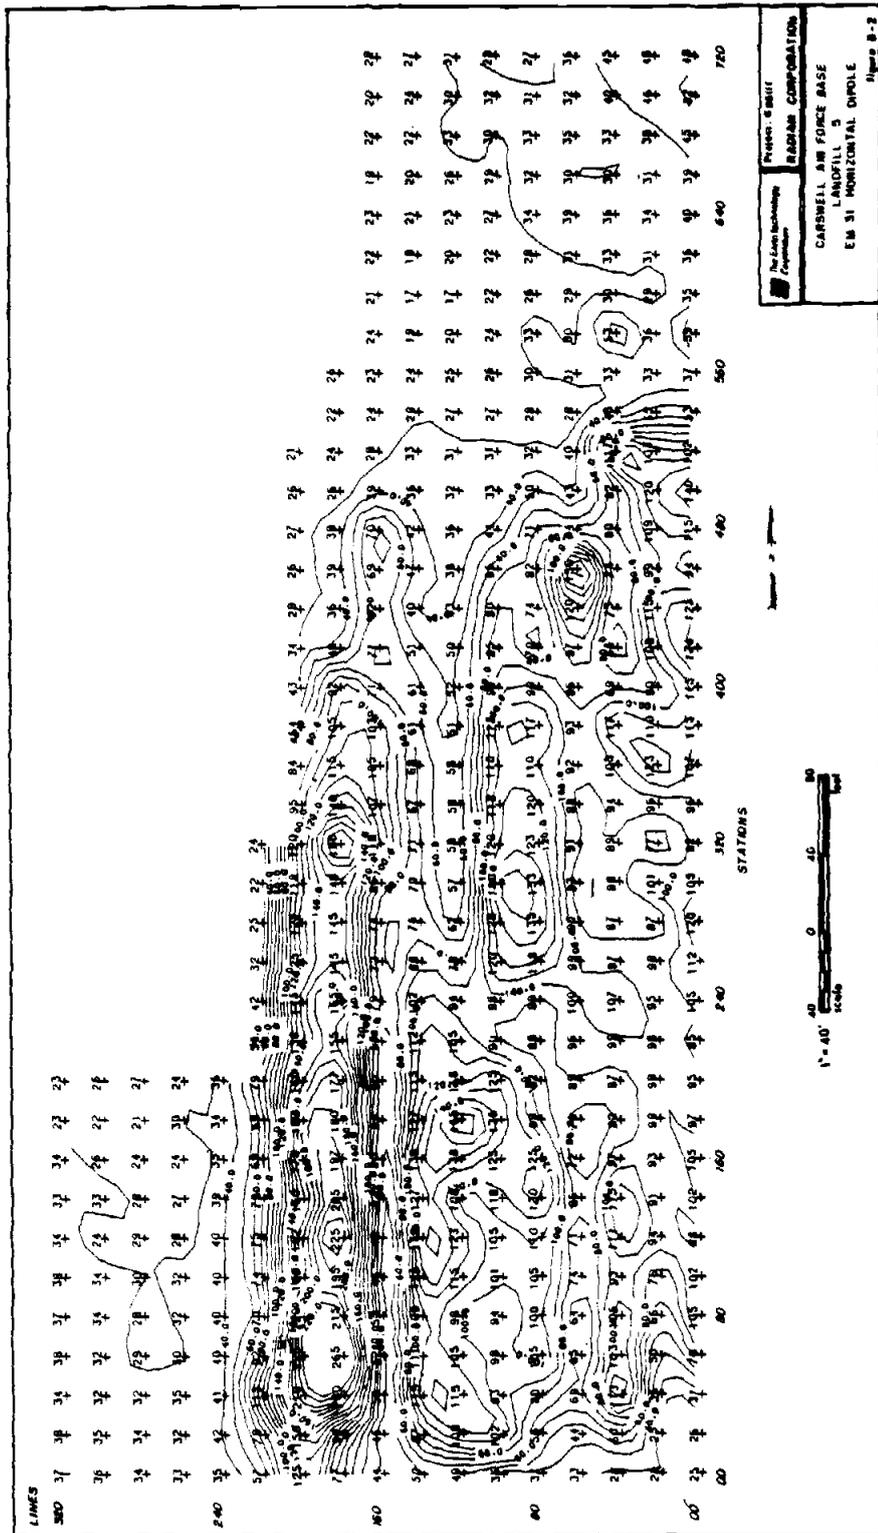
Figure 4-12. Electromagnetic Profile Data (EM31), Landfill No. 5 (Site 5) and Fire Department Training Area No. 1 (Site 11), Carswell AFB, Texas.

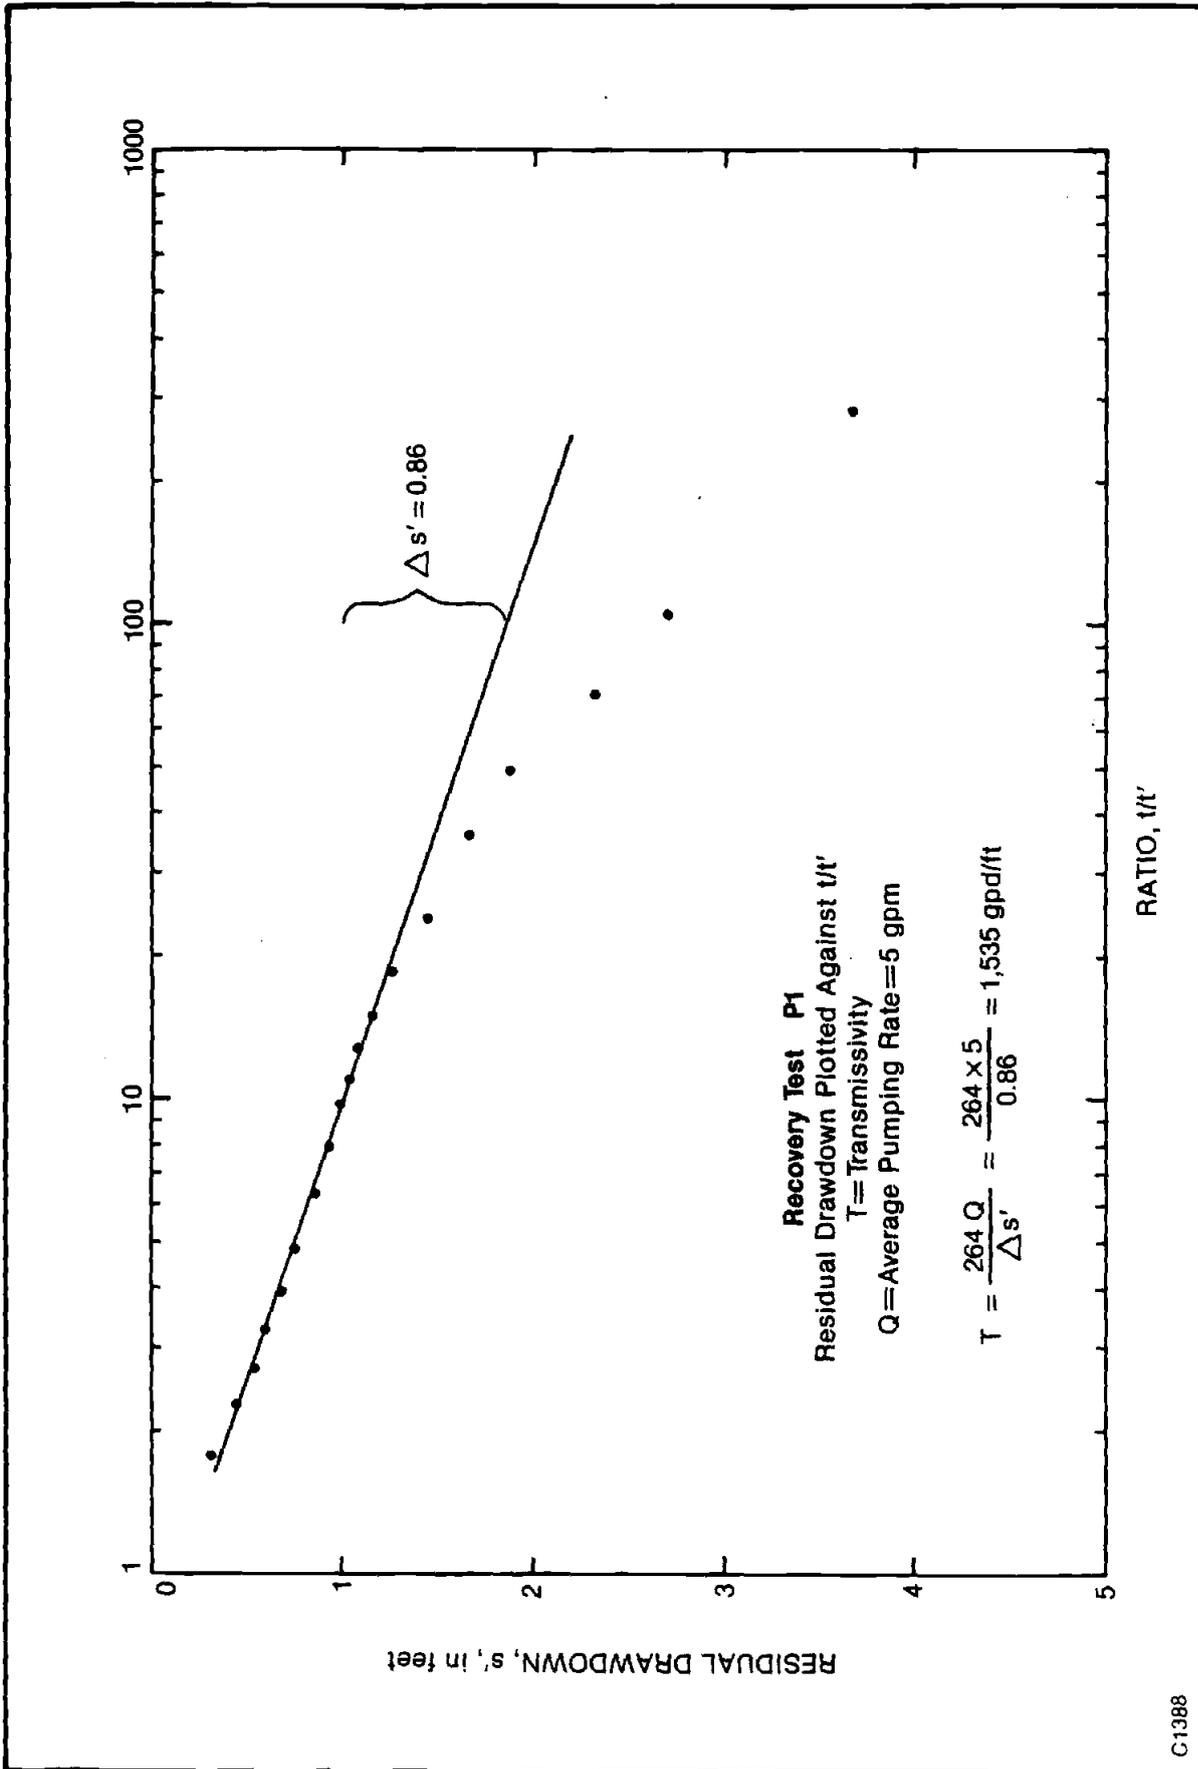
Figure 4-13. Plot of Recovery Test Data, Well P1, Carswell AFB, Texas.

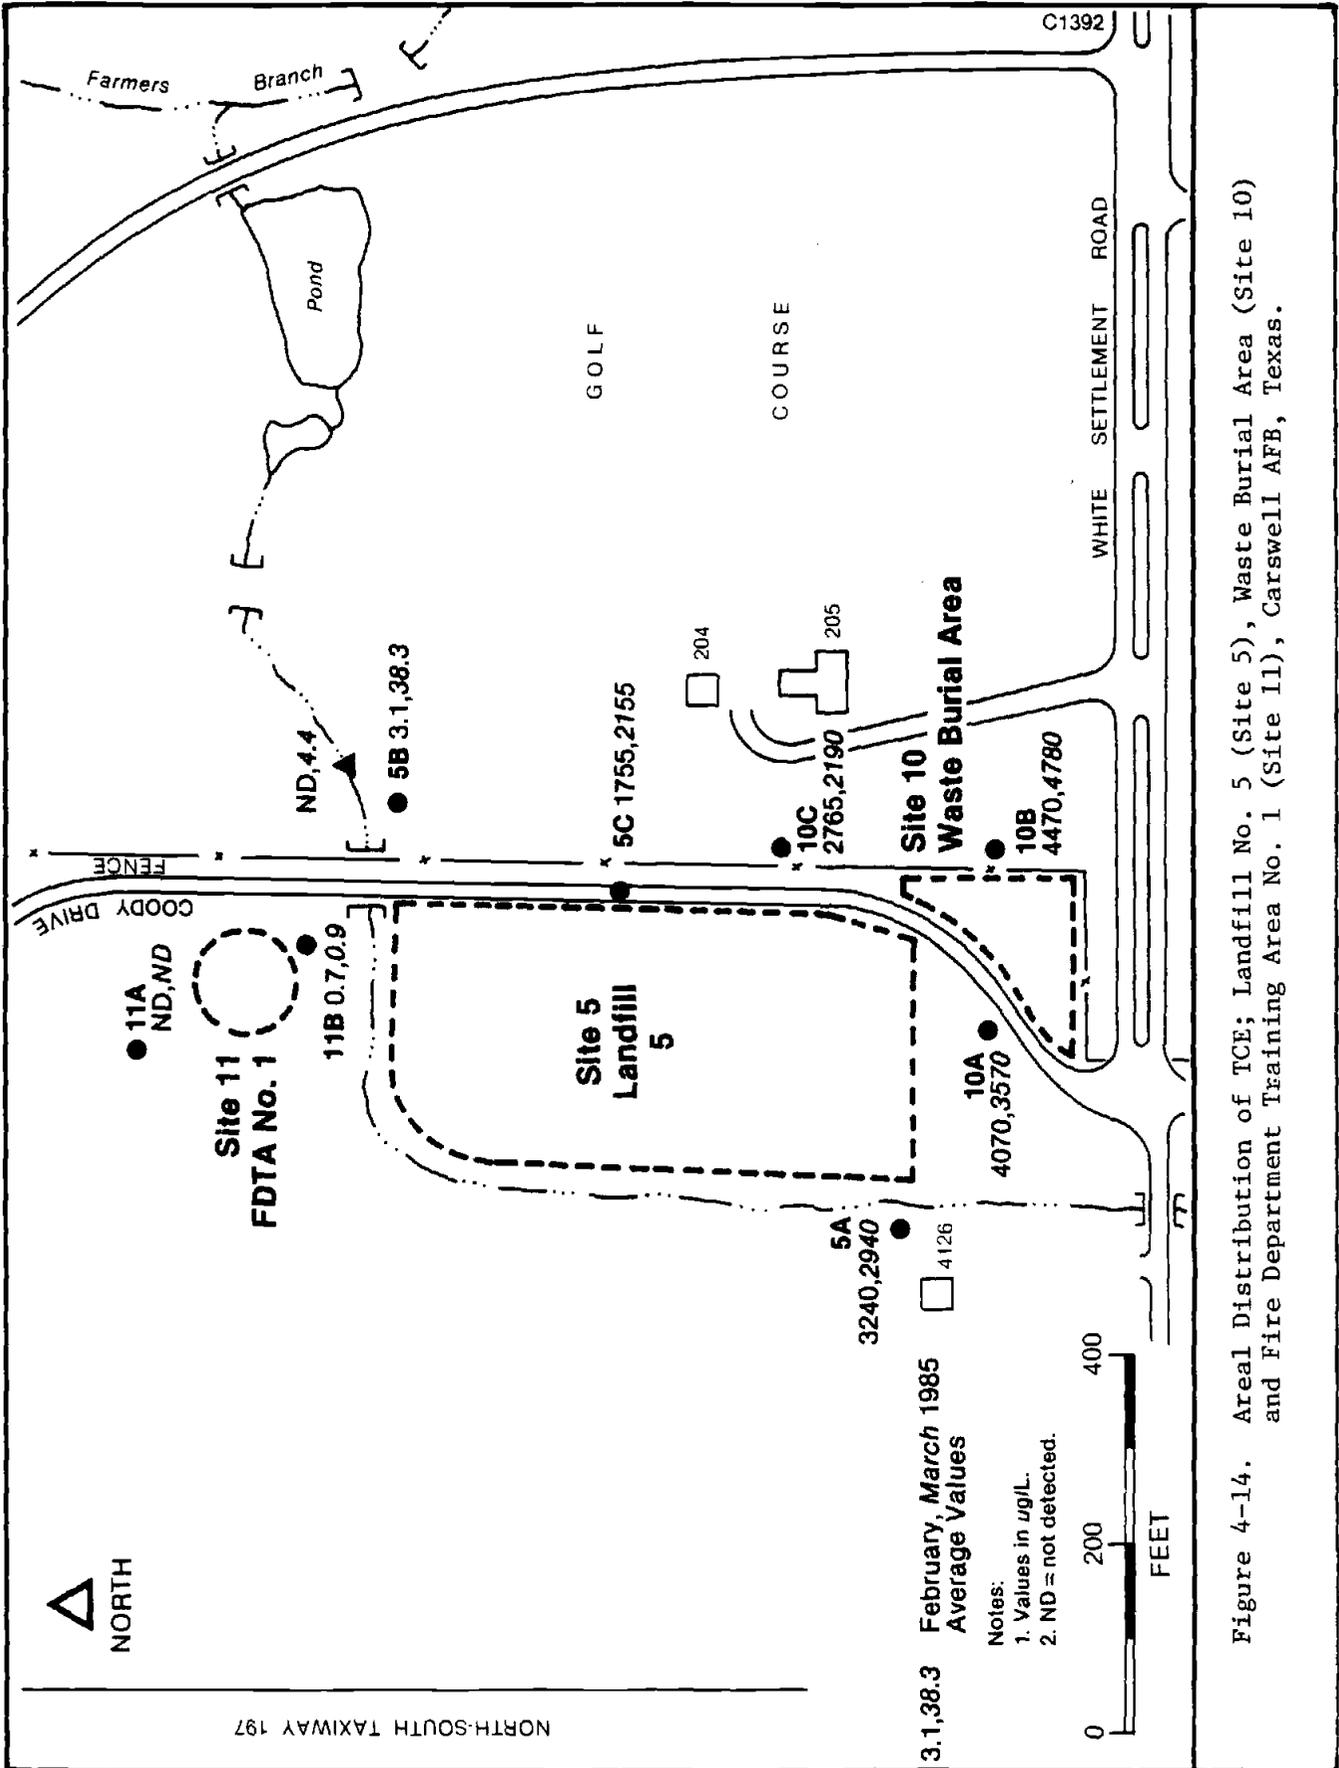
Figure 4-14. Areal Distribution of TCE; Landfill No. 5 (Site 5), Waste Burial Area (Site 10) and Fire Department Training Area No. 1 (Site 11), Carswell AFB, Texas.

Results of soil and ground water sampling conducted at Landfill 5 indicate that the upper zone contains elevated levels of halogenated organic compounds. Figure 4-14 illustrates the areal distribution of TCE, the principal contaminant observed in the upper zone at Landfill 5 and the Waste Burial Area. Several soil samples corresponding to the occurrence of ground water during drilling contained volatile organic compounds. Soil in the saturated zone at well 5A, hydraulically upgradient of the landfill, contained high levels of trichloroethene. Similarly, samples collected at well 5C, both in the unsaturated and saturated zone, indicate contamination with trans-1,2-dichloroethene and trichloroethene, as well as levels of the aromatic compounds

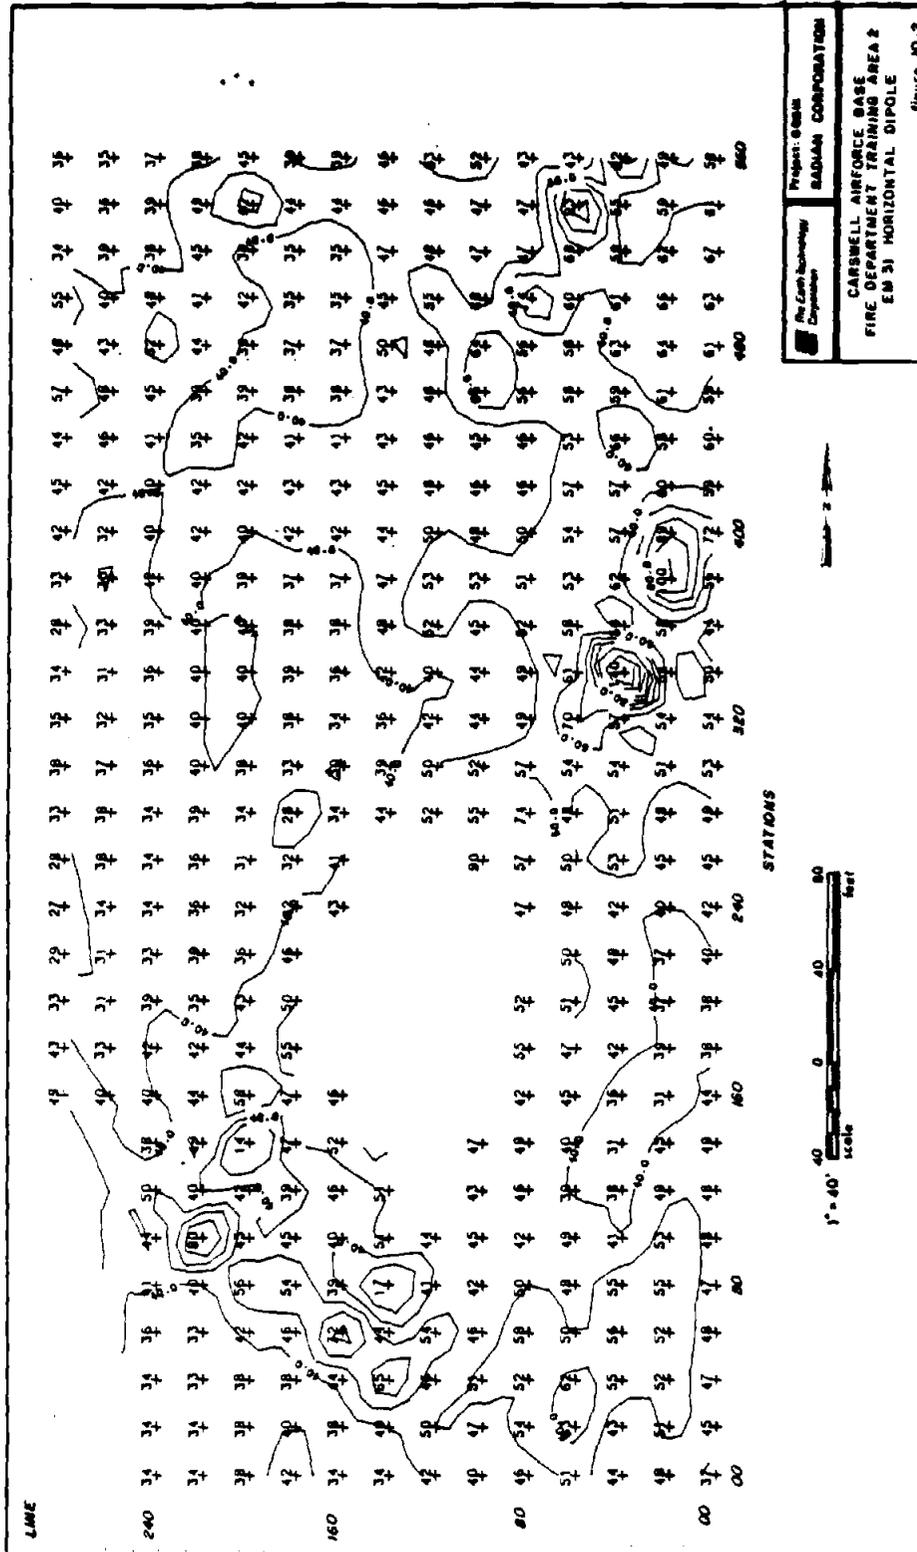
Figure 4-15. Electromagnetic Profile Date (EM31), Fire Department Training Area No. 2 (Site 12), Carswell AFB, Texas.

At this site, the EMP data were distorted by several features. The areas affected are: the northwest corner which contains a buried sewer pipe running approximately NE-SW, the line along station 450 where an underground telephone cable is located, the area between the fuel storage tank and the training pit containing several buried sprinkler pipes, and the line at approximately station 80 where there is a buried pipe or cable. The EM31 (horizontal) data shown in Figure 4-15 reveals an area of anomalously high

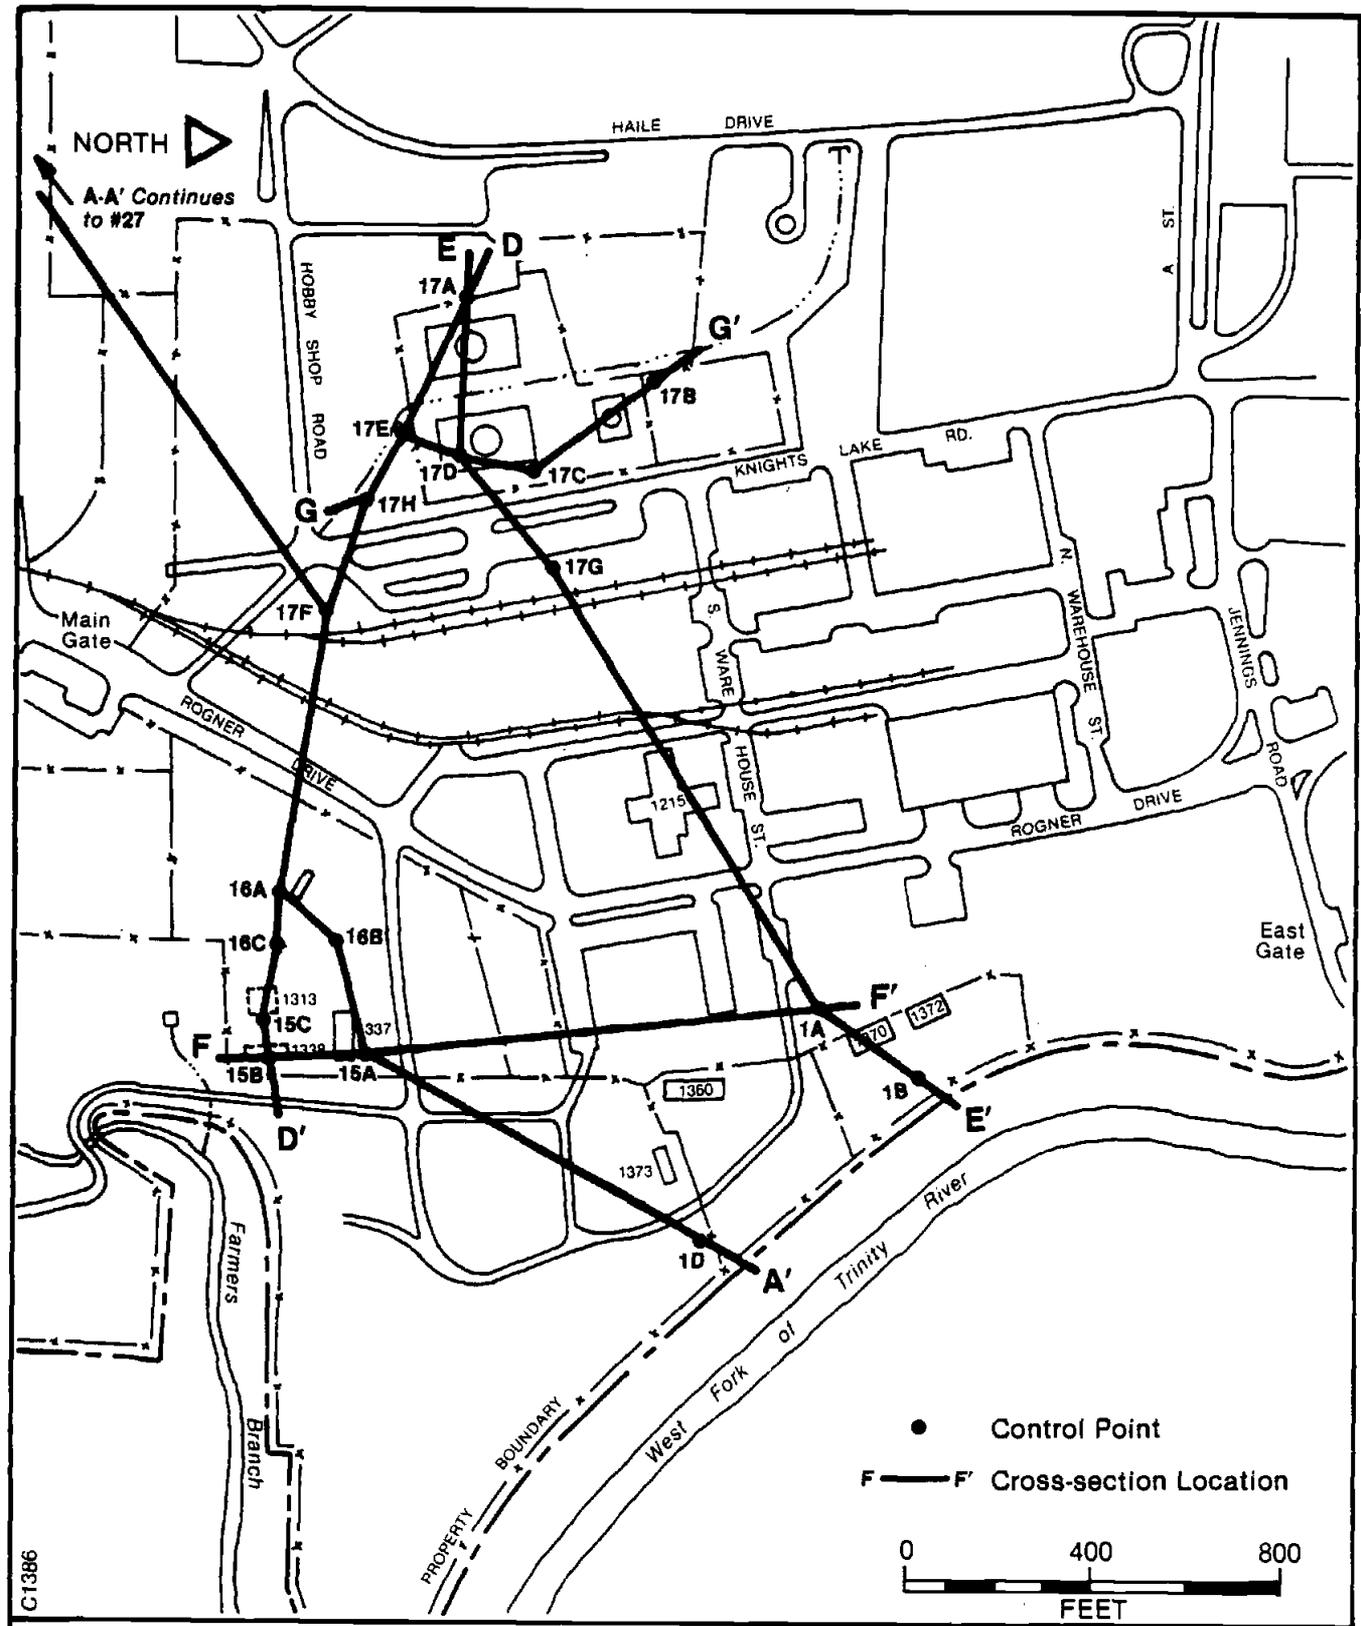
Figure 4-16. Detail of Monitoring Locations, East Area, Carswell AFB, Texas.

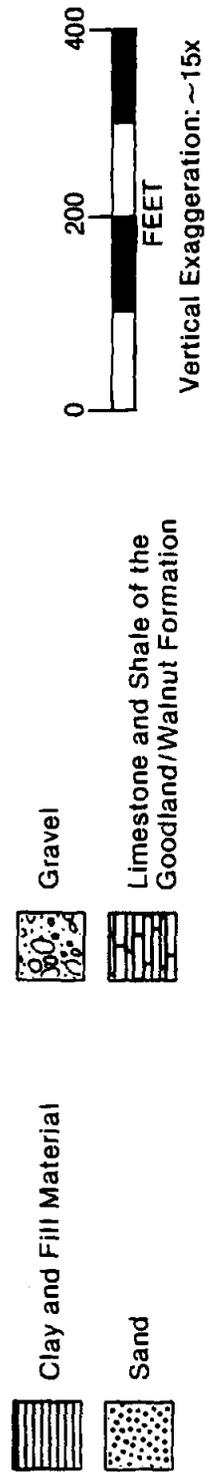
Figure 4-20. Geologic Cross-Section G-G', Carswell AFB, Texas.

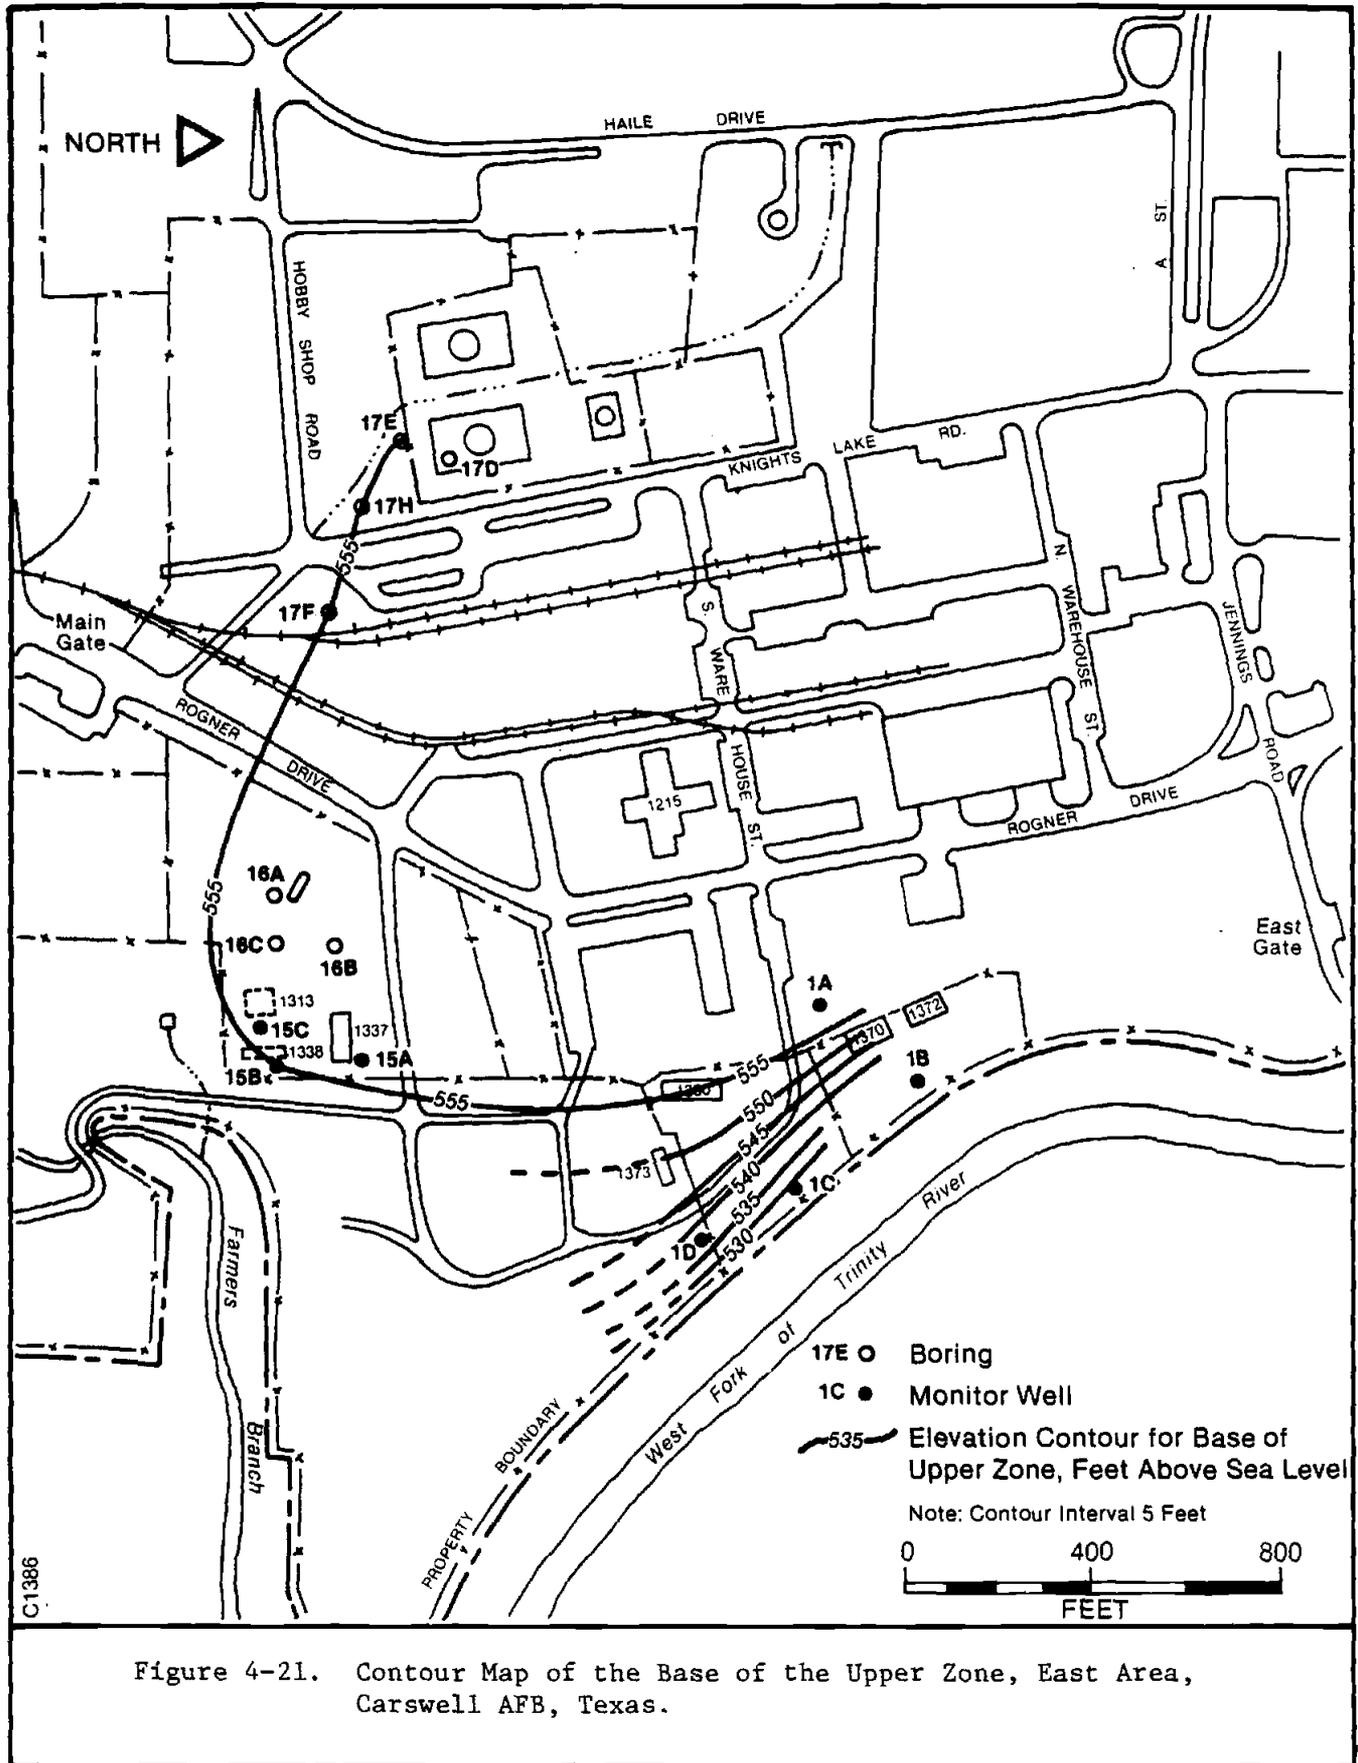
Figure 4-21. Contour Map of the Base of the Upper Zone, East Area, Carswell AFB, Texas.

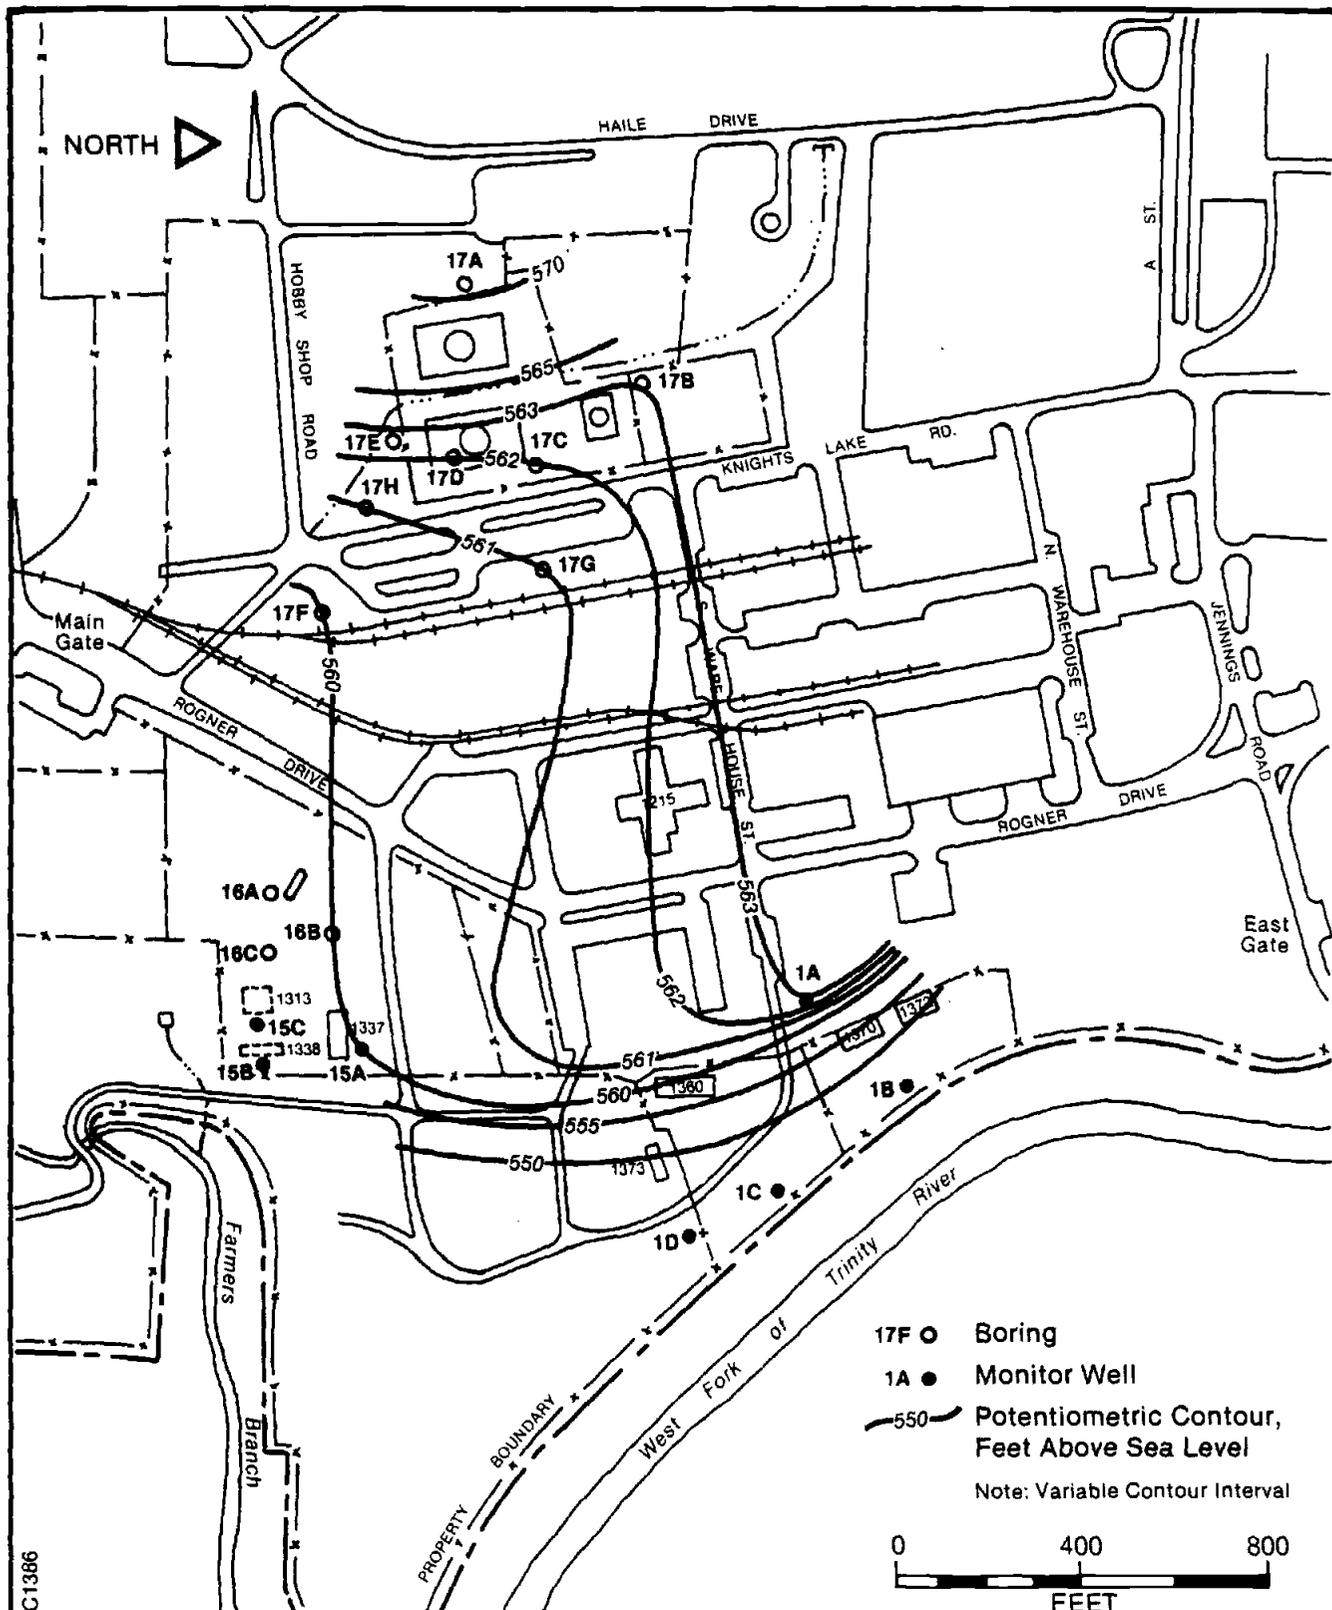
Figure 4-22. Potentiometric Surface Map of the Upper Zone, East Area, Carswell AFB, Texas.

Figure 4-22. The closely spaced contours of the water table in the DPDO area mirrors that of the surface of the Goodland Limestone. This similarity in limestone and water table surfaces is expected because the water in the upper zone is perched on top of the Goodland. Ground-water flow beneath Site 1 is eastward to northeastward, directly to the West Fork of the Trinity River.

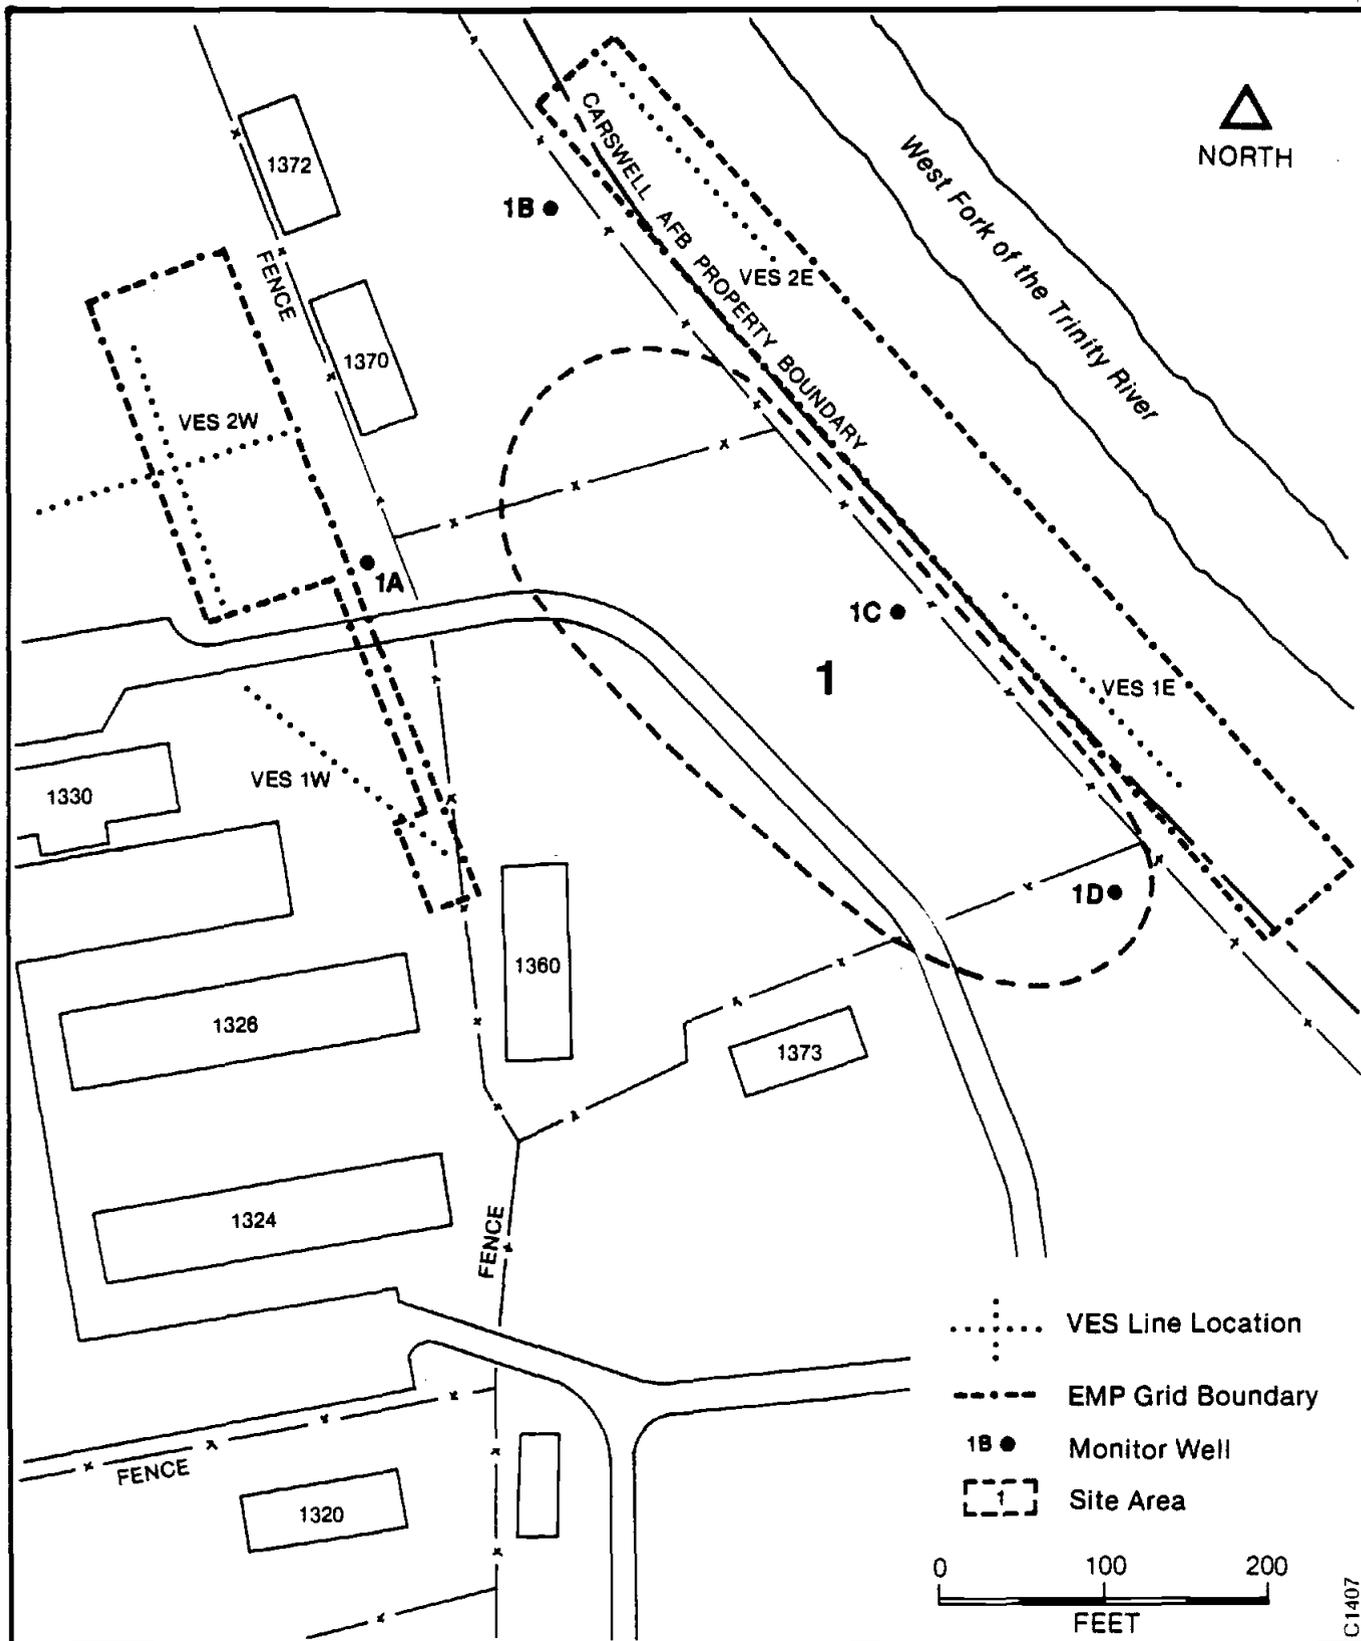
Figure 4-23. Location of Monitor Wells and Geophysical Surveys: Landfill No. 1 (Site 1), Carswell AFB, Texas.

Site 1 is located at the DRMO yard. The locations of the upper zone monitor wells installed at Site 1 are shown on Figure 4-23. The upgradient well, 1A, is located in the southeast corner of the park bordering the DRMO to the west. Well 1A is the most shallow of the Site 1 wells, with the Goodland Limestone only 7 feet below the surface. Wells 1B and 1C are located inside of the DRMO yard. Well 1B, in the north yard, was completed at 20 feet without encountering limestone. Well 1C, located in the south yard, was completed upon reaching a shale member of the Goodland Limestone at a depth of 33 feet. Well 1D, located south of the DRMO compound, encountered the Goodland Limestone at 23 feet. Wells 1B and 1C were completed flush to the ground surface, in meter boxes. Wells 1A and 1D were completed above ground.

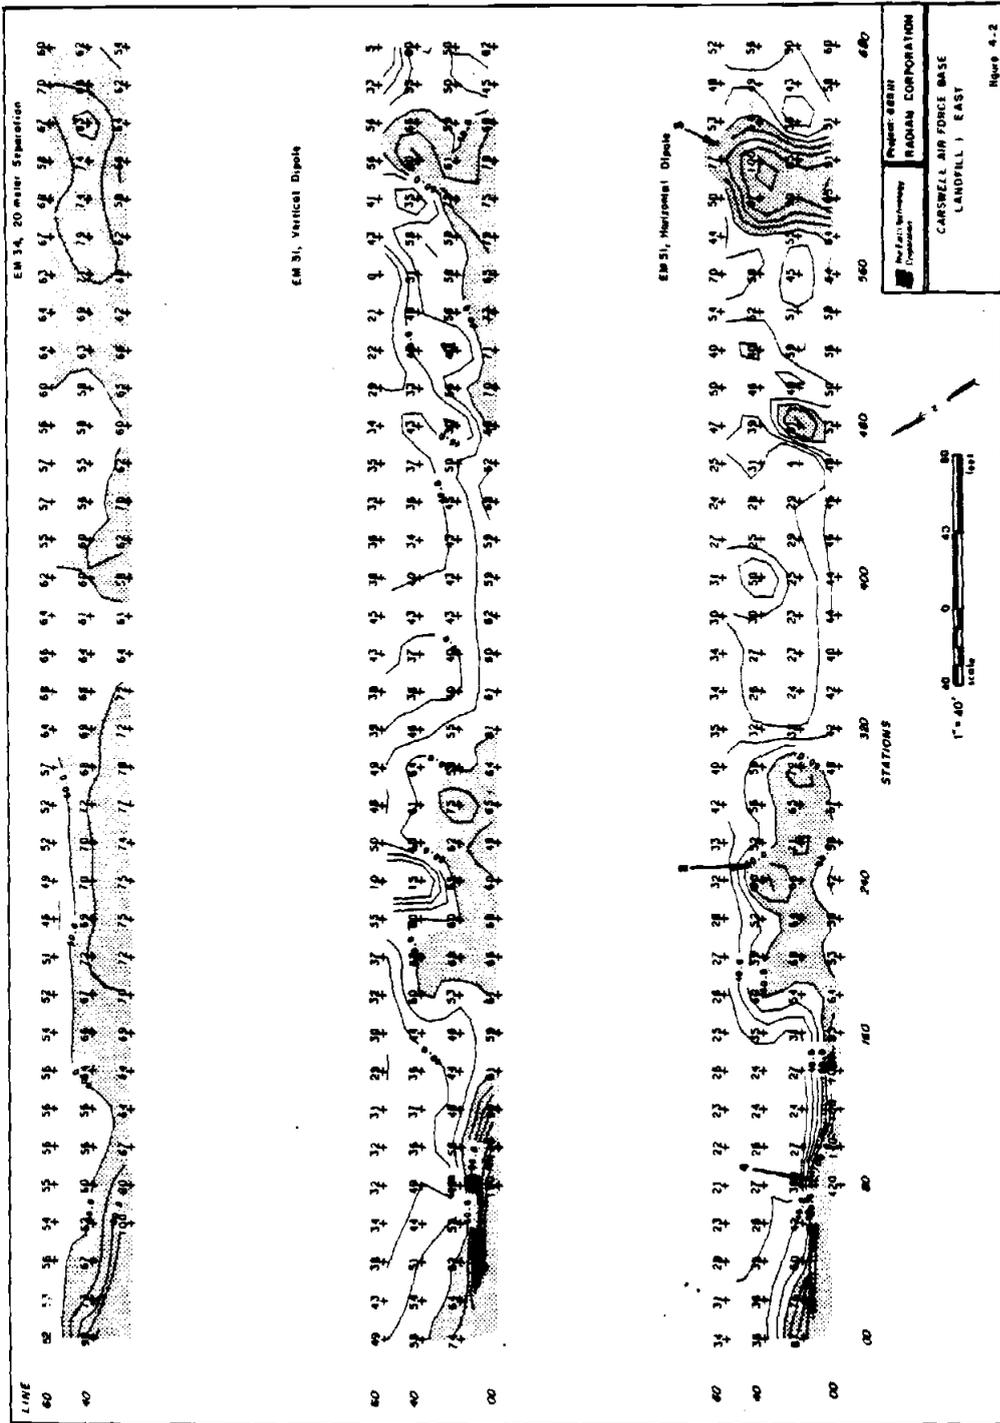
Figure 4-24. Electromagnetic Profile Date (EM31), Landfill No. 1 (Site 1), East, Carswell AFB, Texas.

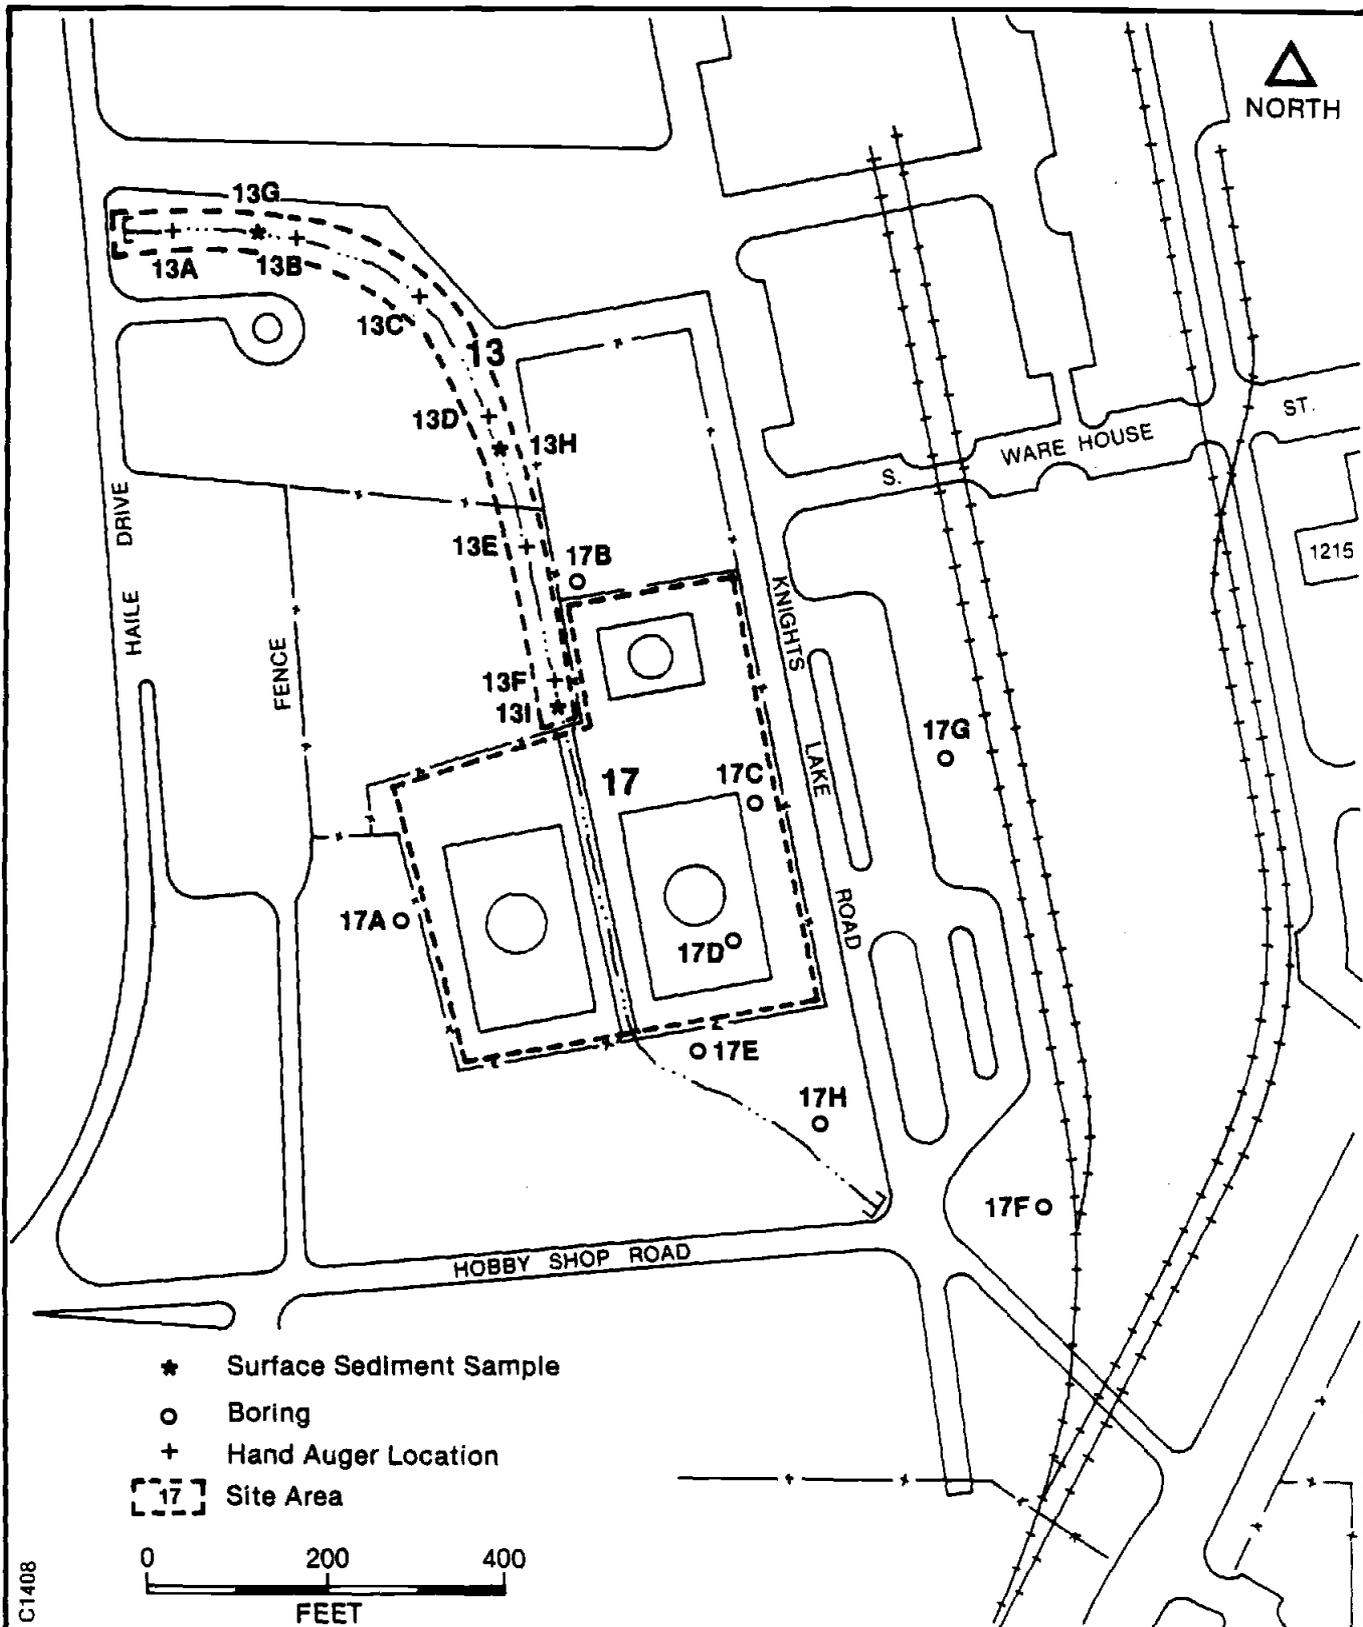
Figure 4-25. Locations of Sampling Points; Flightline Drainage Ditch (Site 13) and POL Tank Farm (Site 17), Carswell AFB, Texas.

The investigation of Site 13 consisted of six hand-augering six borings and collecting of 3 surface sediment samples. Sample locations are shown on Figure 4-25. The borings were spaced evenly along the Flightline Drainage Ditch between where the ditch emerges east of Haile Drive and to where the ditch becomes concrete lined as it enters the POL Tank Farm. The surface sediment samples were evenly spaced across the same area.
