FINAL INSTALLATION RESTORATION PHASE 2 CONFIRMATION QUANTIFICATION STAGE  
1 VOLUME 1 NAS FORT WORTH TX  
10/1/1986  
RADIAN CORPORATION

**INSTALLATION RESTORATION PROGRAM  
PHASE II - CONFIRMATION/QUANTIFICATION  
STAGE 1  
VOLUME 1 - FINAL REPORT**

**CARSWELL AFB, TEXAS**

**OCTOBER 1986**

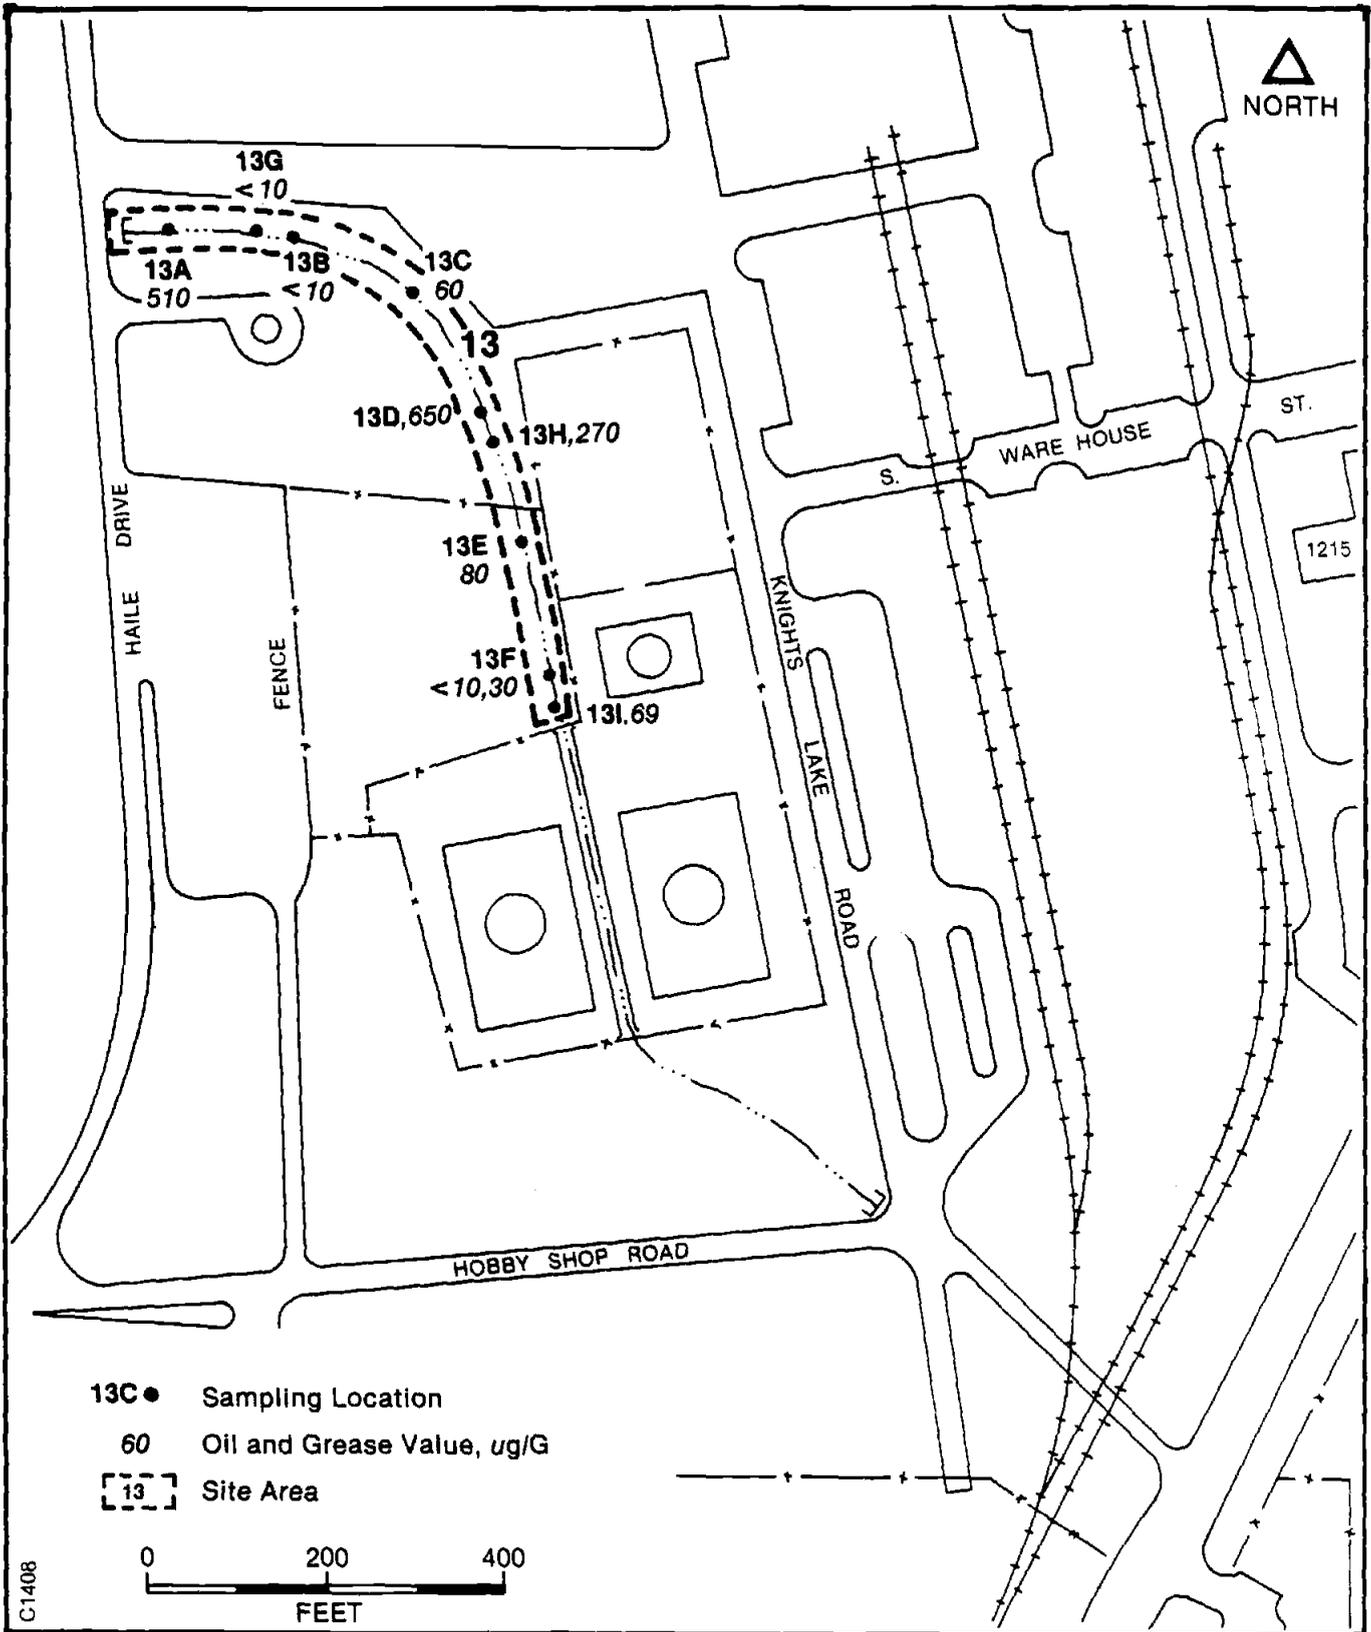
Figure 4-26. Oil and Grease of Surface Soils, Flightline Drainage Ditch (Site 13), Carswell AFB, Texas.

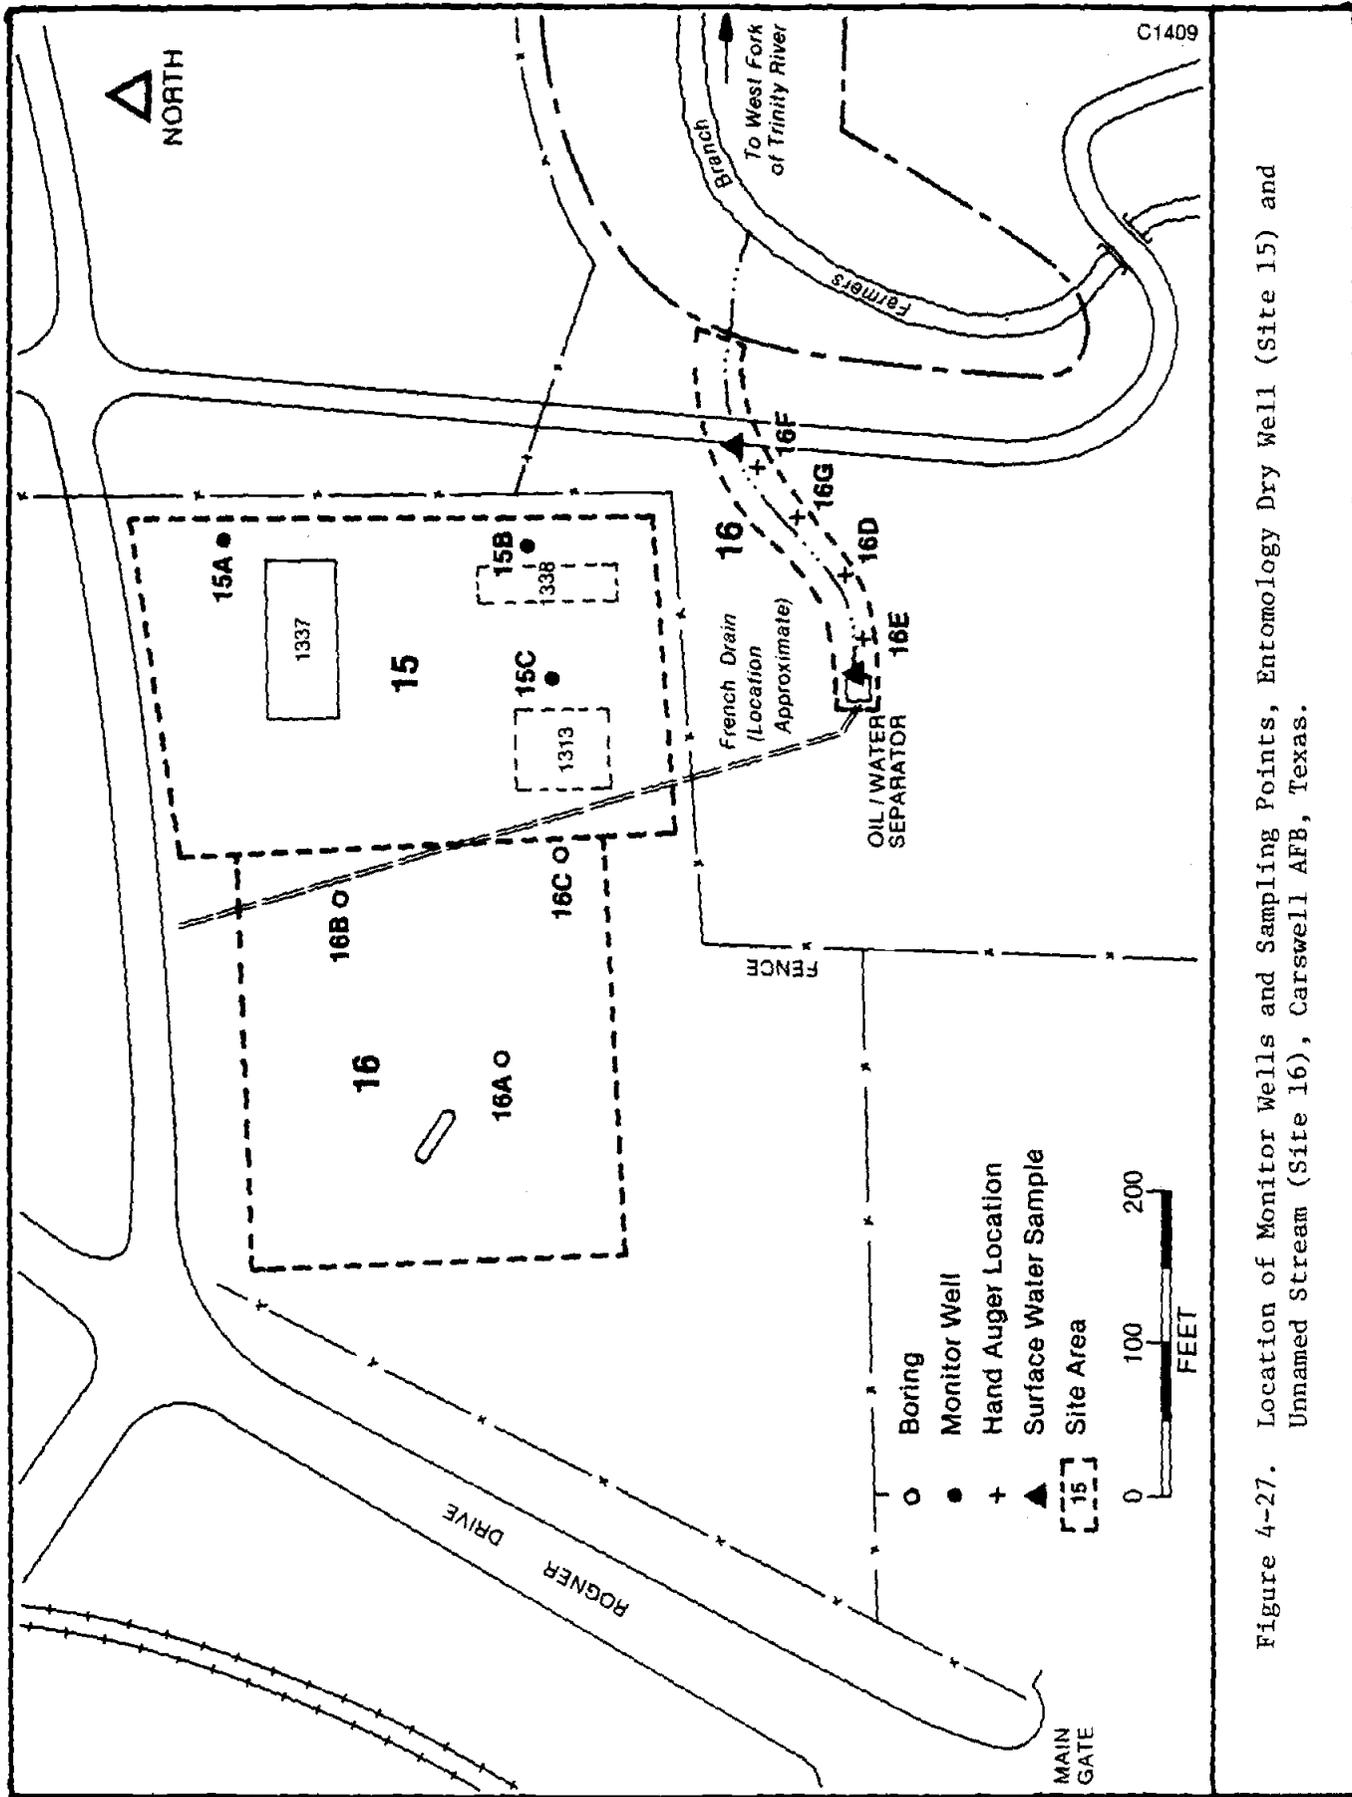
Figure 4-27. Location of Monitor Wells and Sampling Points, Entomology Dry Well (Site 15) and Unnamed Stream (Site 16), Carswell AFB, Texas.

Site 15 is located in the area of Building 1337, east of Rogner Drive near the Main Gate (Figure 4-27). The upgradient well, 15A, is located north of Building 1337. This well was completed flush to the ground surface in a meter box. Well 15B is located south of Building 1337, next to the fence along the eastern boundary of the site. Well 15C is West of 15B; both were completed above ground. Both of these wells are near the former location of Buildings 1313 and 1338. Well 15A encountered a shale of the Goodland Limestone at 14 feet below ground surface and the well was completed at that depth. Wells 15B and 15C both penetrated the Goodland at approximately 9 feet below land surface and were completed at a depth of 10 feet.

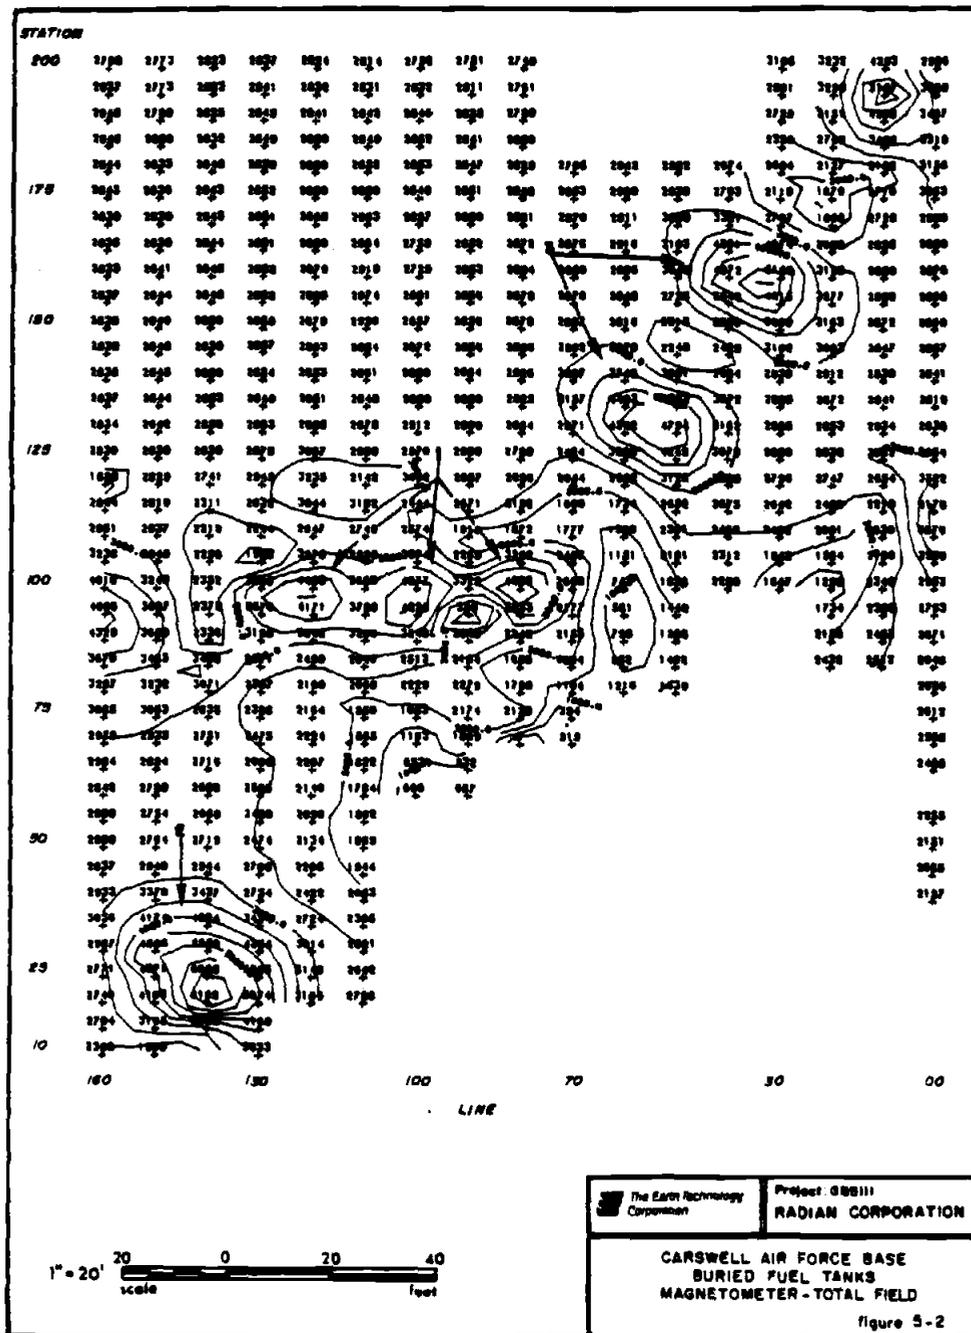
Figure 4-28. Results of Magnetometer Survey, Unnamed Stream (Site 16), Carswell AFB, Texas.
