COMPREHENSIVE ENVIRONMENTAL SURVEY BUILDING 27 NS GREAT LAKES IL
12/16/2004
RAYMOND PROFESSIONAL GROUP, INC.

**COMPREHENSIVE ENVIRONMENTAL SURVEY
NAVAL STATION GREAT LAKES, ILLINOIS
BUILDING 27**

Raymond Project No. 876885

December 16, 2004

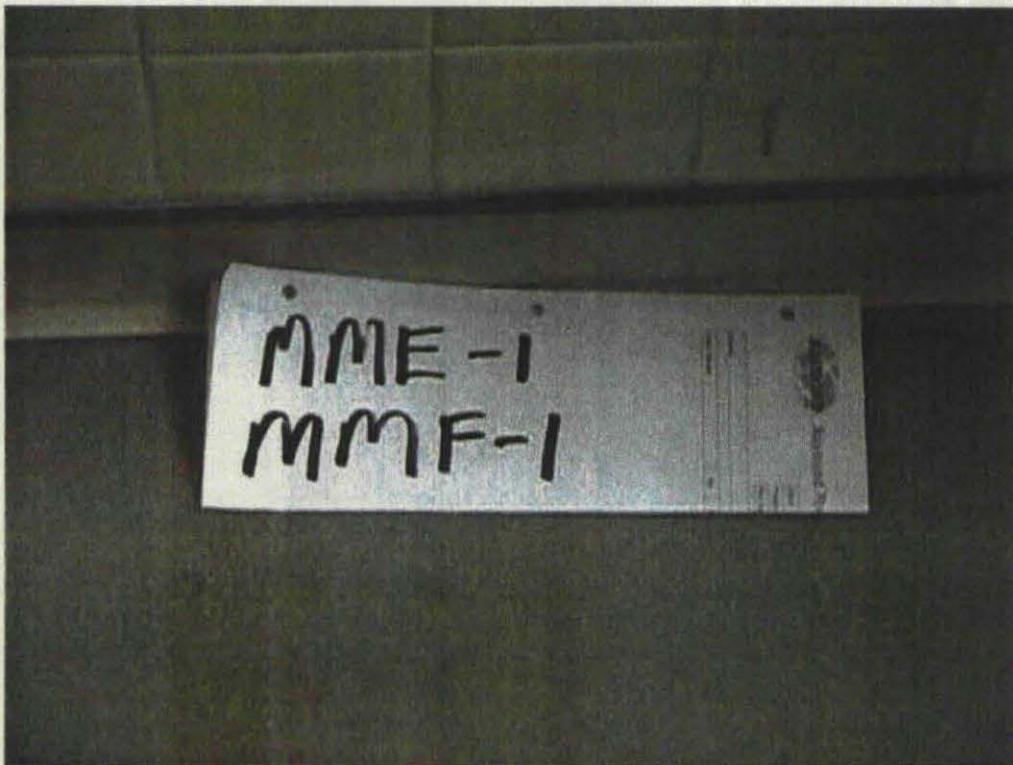
Samples MME-1 – Cream Baseboard, and MMF-1 – Mastic under MME

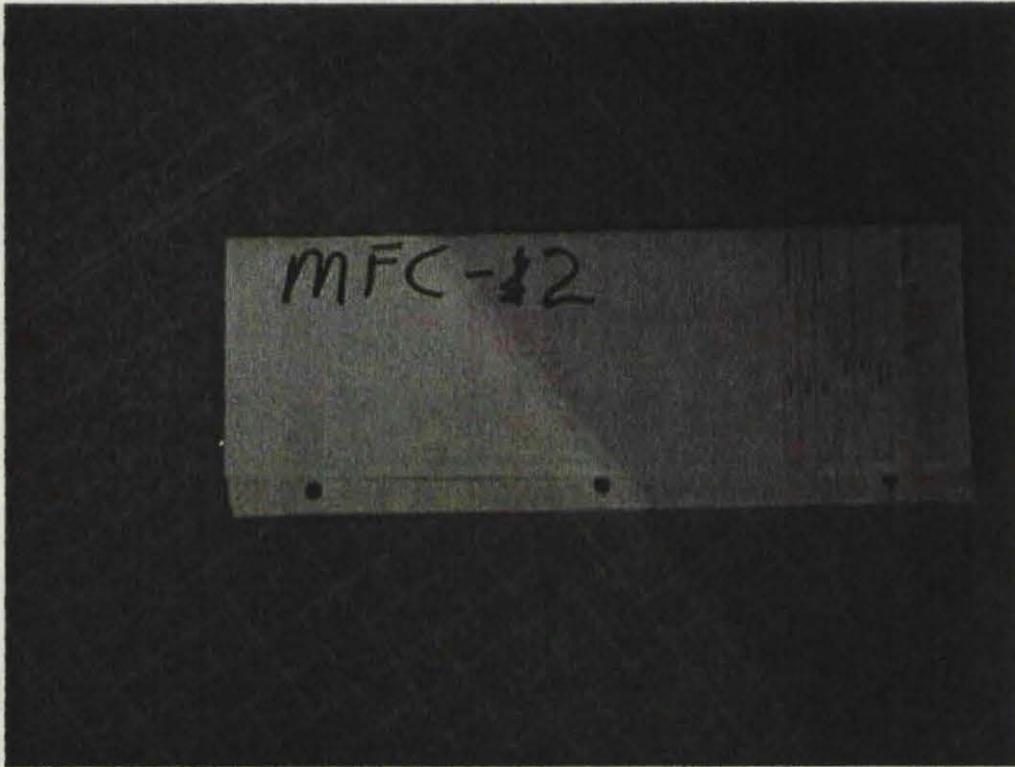
Sample MFC-1 – 12" x 12" Floor Tile – square pattern

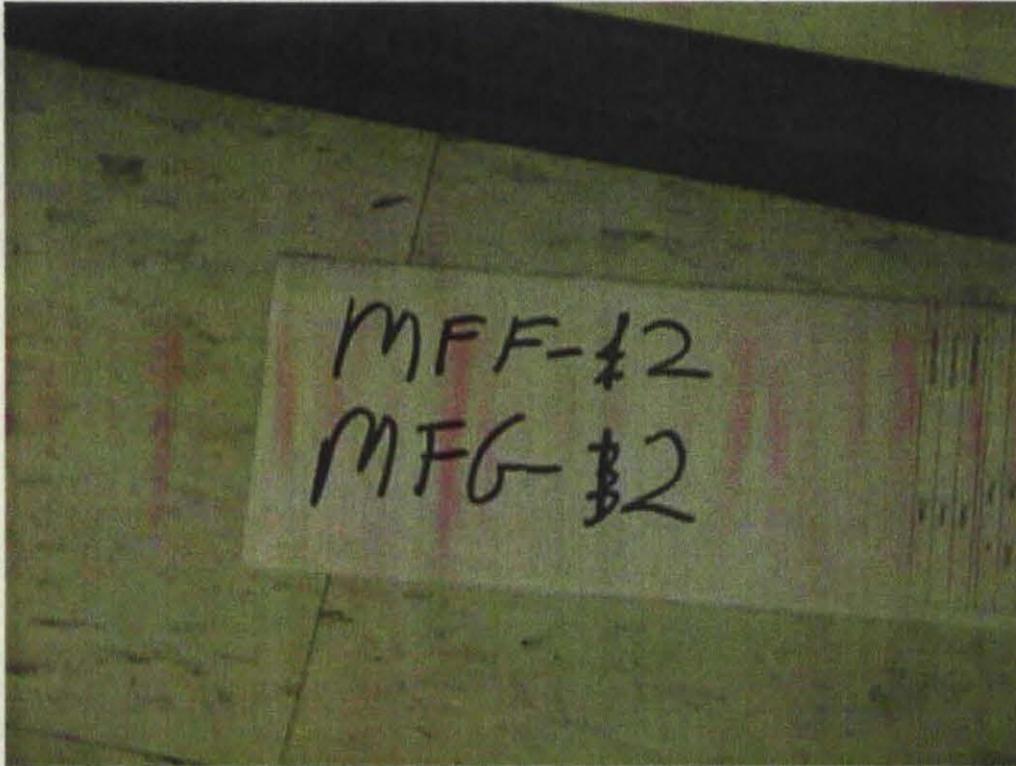
Samples MFF-1 – 12" x 12" Floor Tile, and MFG-1 – Mastic under MFF

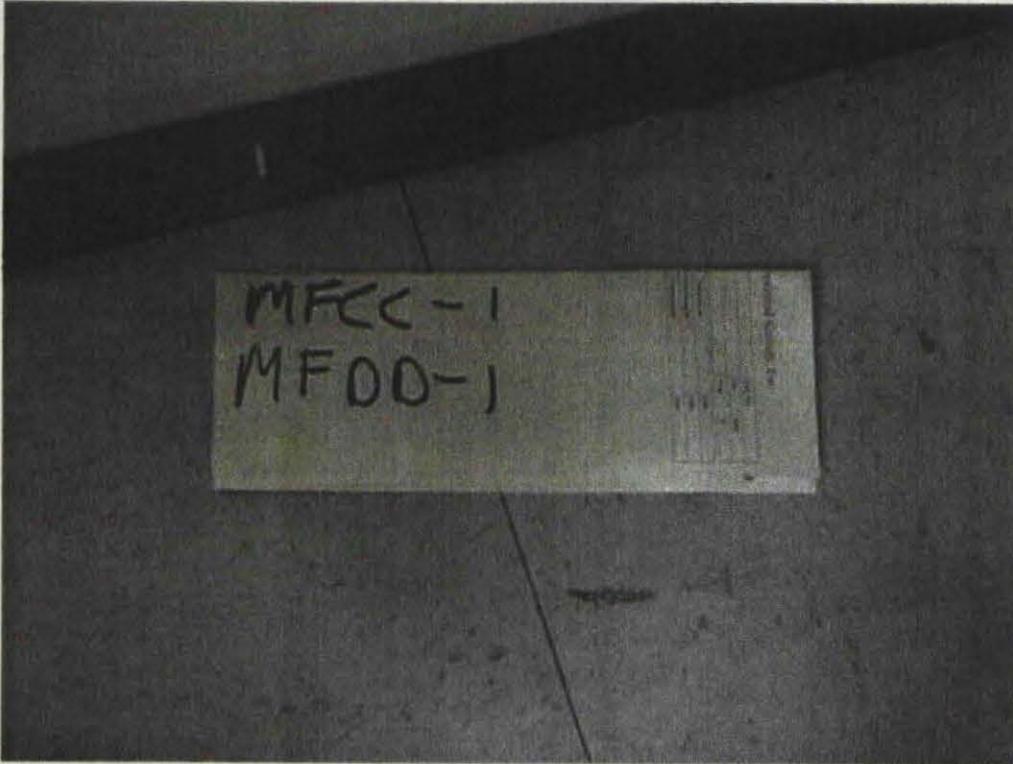
Samples MFAA-3 – 9" x 9" Brown-Red Floor Tile, and MFBB-3 – Mastic under MFAA

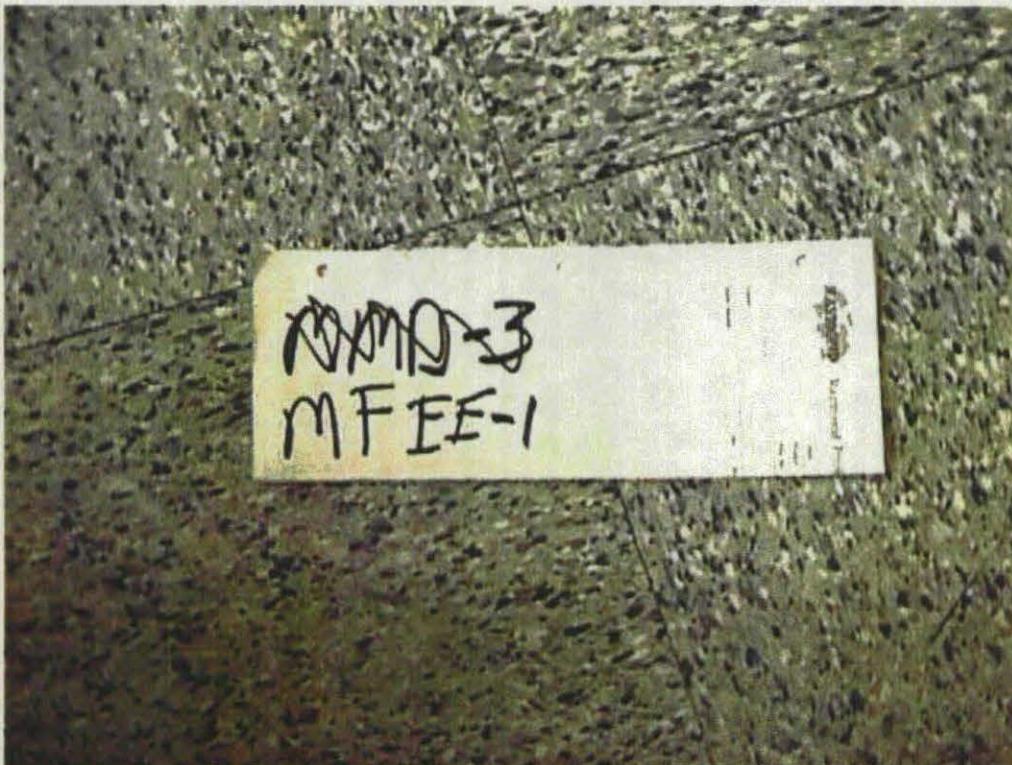
Samples MFCC-3 – 12" x 12" Light Blue Floor Tile, and MFDD-3 – Mastic under MFCC

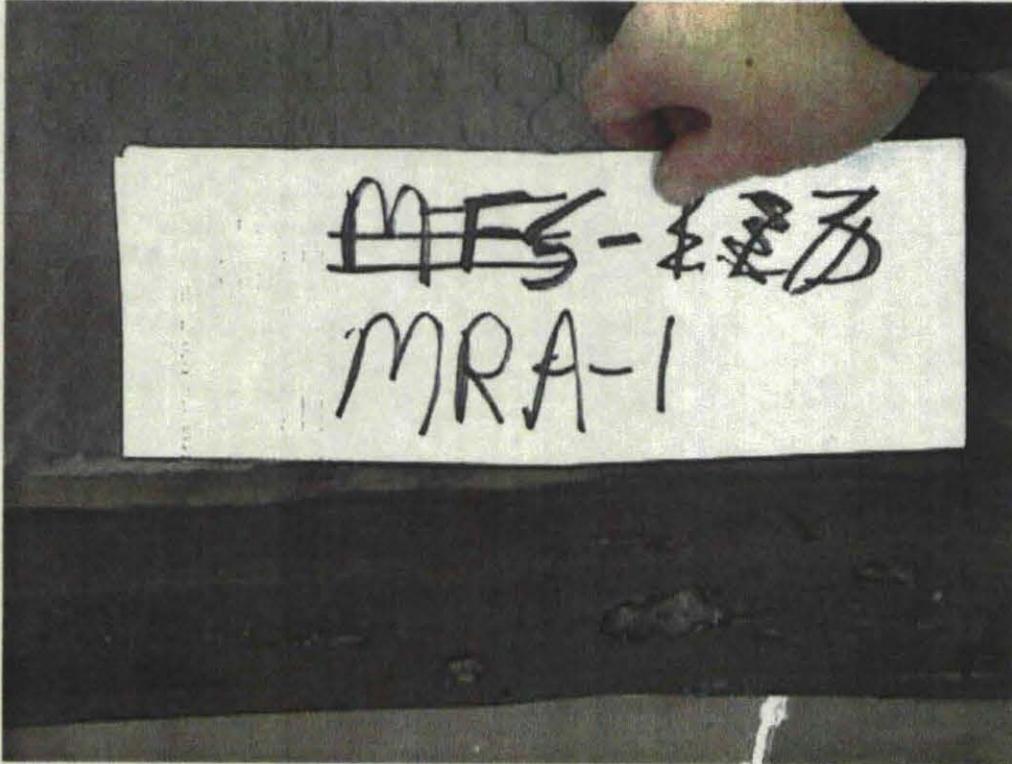
Sample MFEE-3 12" x 12" Black/White Specks Floor Tile

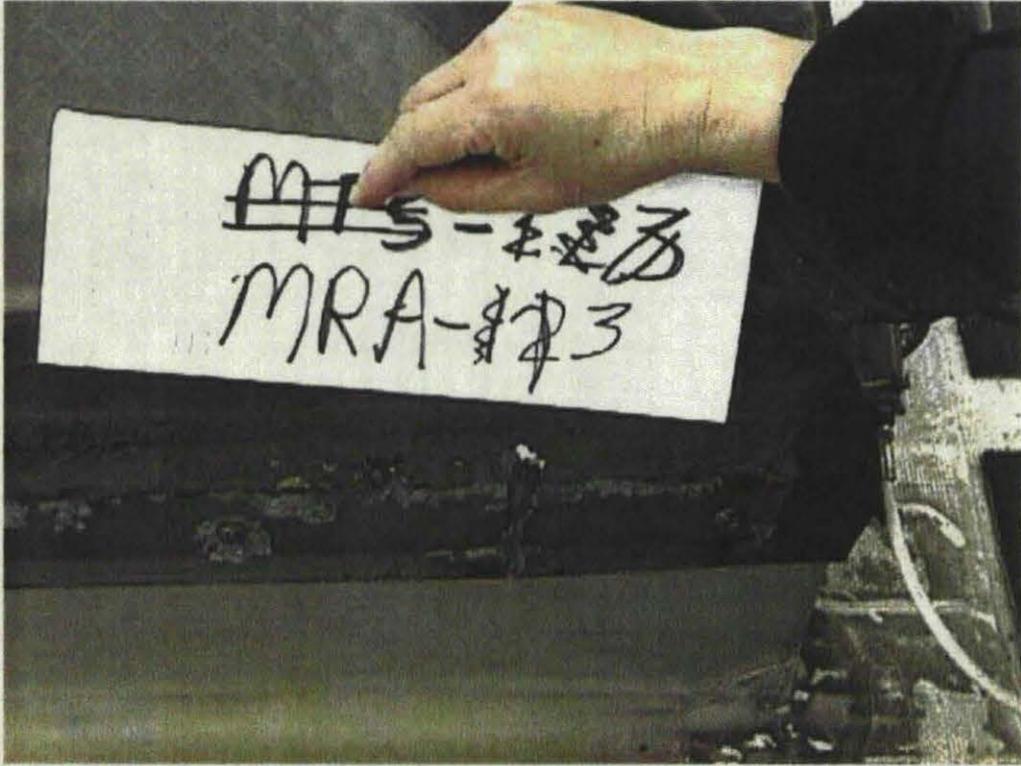
Sample MRA-2 – Roof Flashing

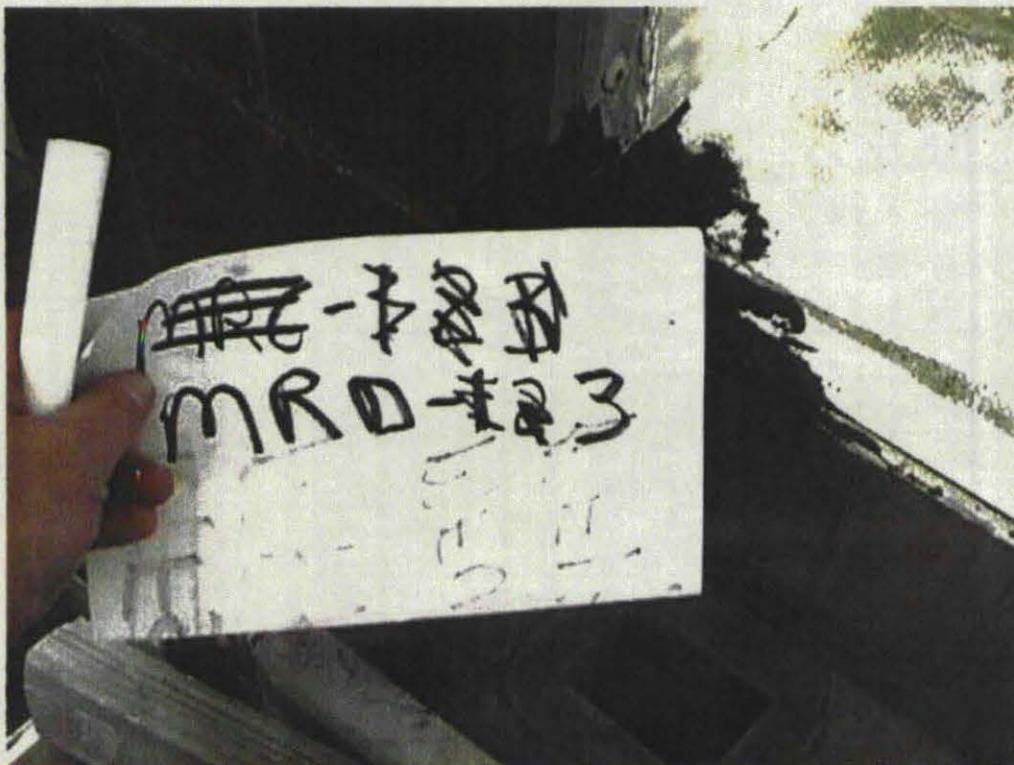
MRD-2 – Roof Flashing (soft)

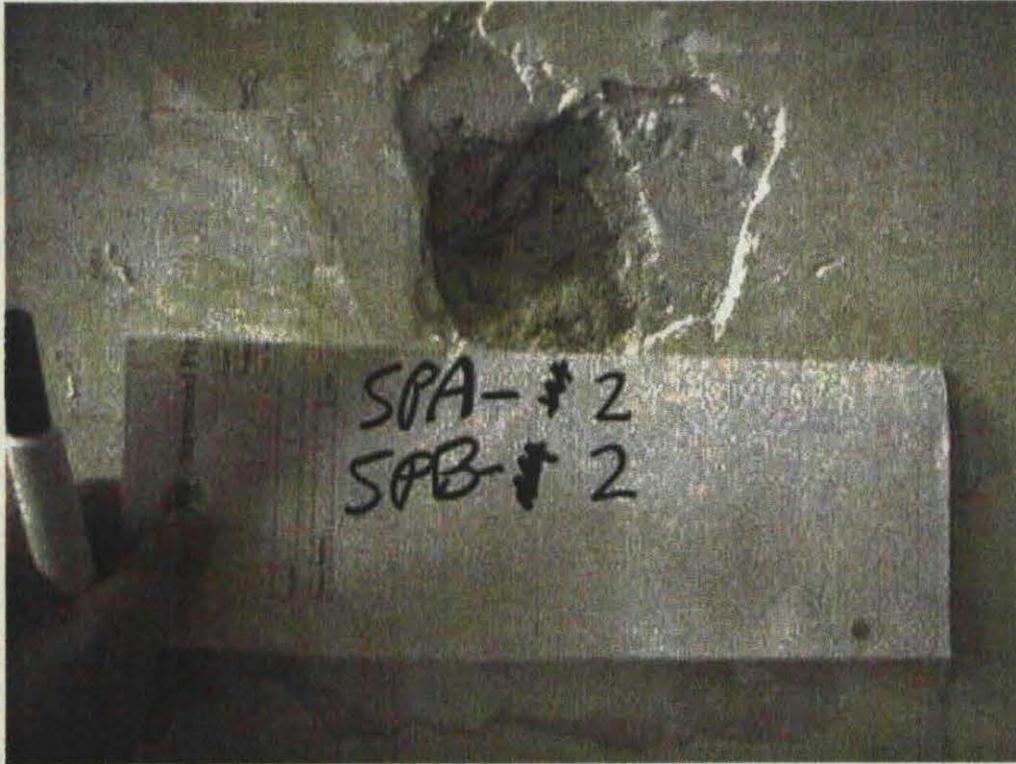
Samples SPA-1 – Wall Plaster – skim coat, and SPB-1 – base coat
