Final
Asbestos Inspection Report
for

Naval Activity Puerto Rico
Ceiba, Puerto Rico

Volume 3 of 7

Buildings 646 through 1698

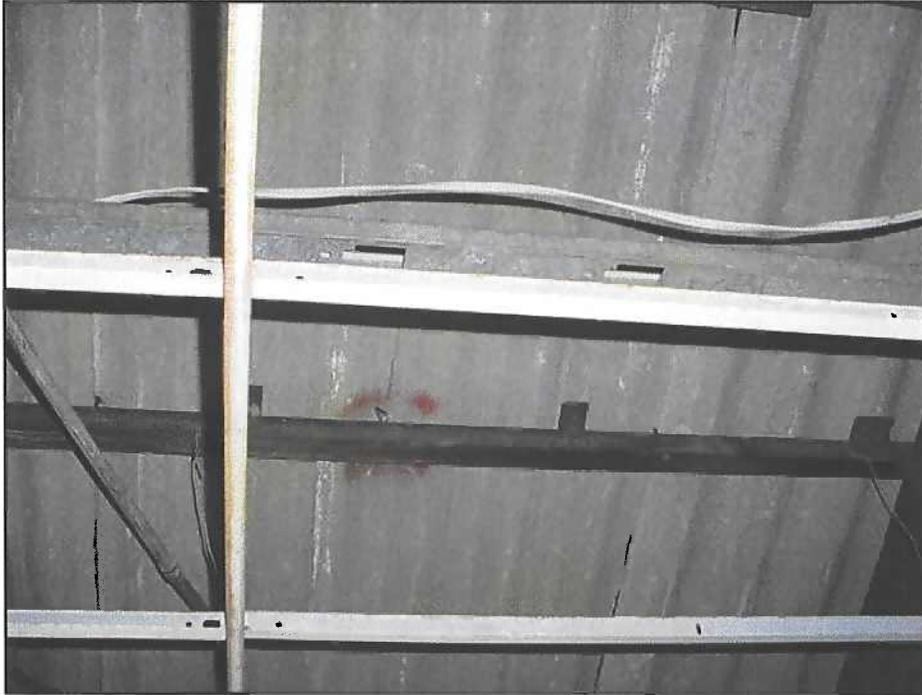
NOTE: ROOFING MATERIAL IS AN ACM.

Corrugated cement roof panels (Material #005) seen from below

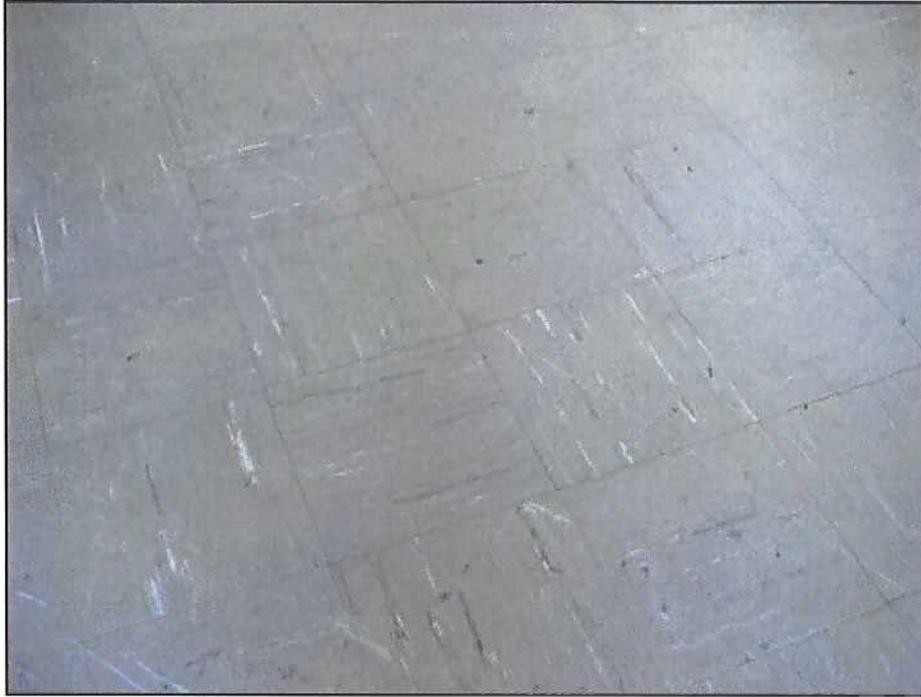
1'x1' tan with brown and white streaks vinyl floor tile (Material #001) over ACM floor adhesive (Material #002)

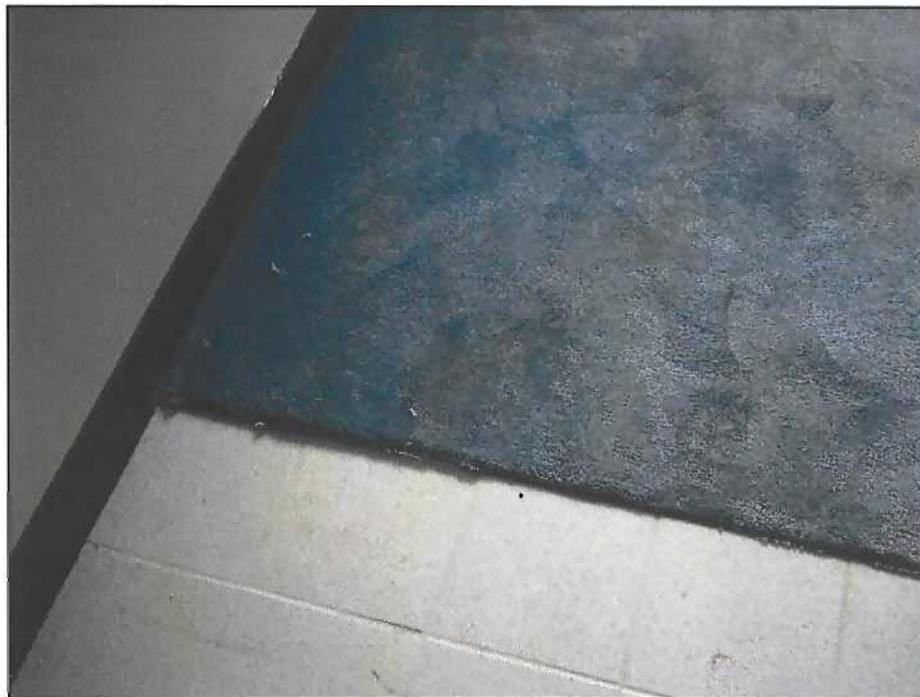
Carpet concealing residual black flooring adhesive (Material #001)

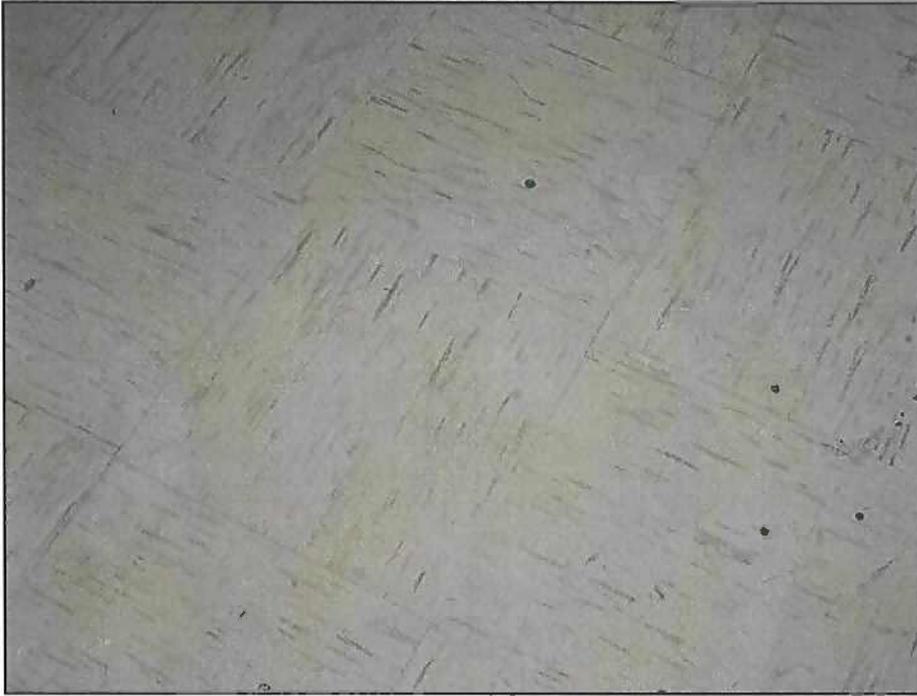
1'x1' tan with gray streaks floor tile (Material #005)

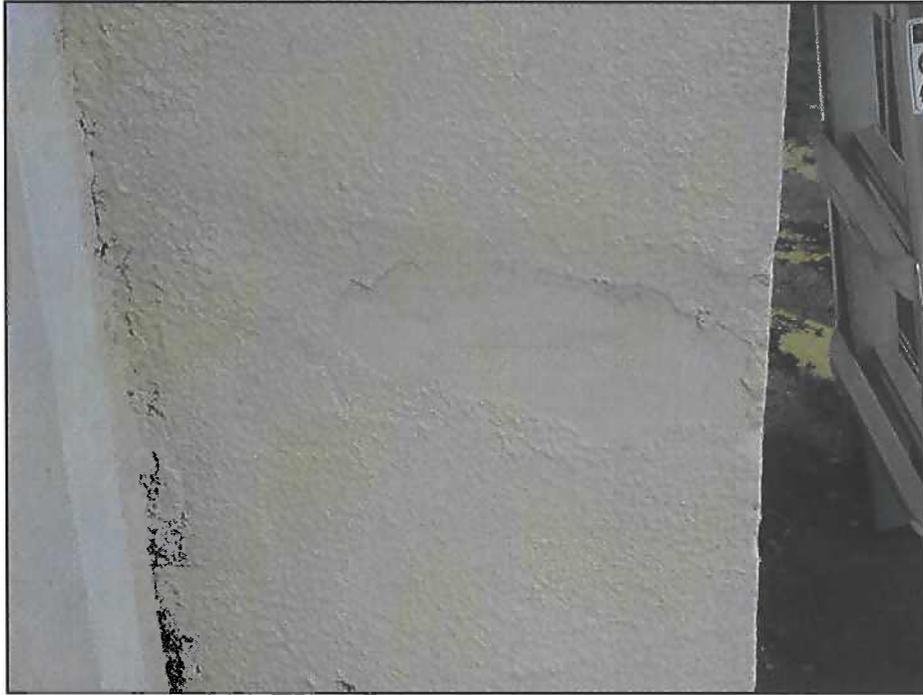
Exterior stucco (Material #016)

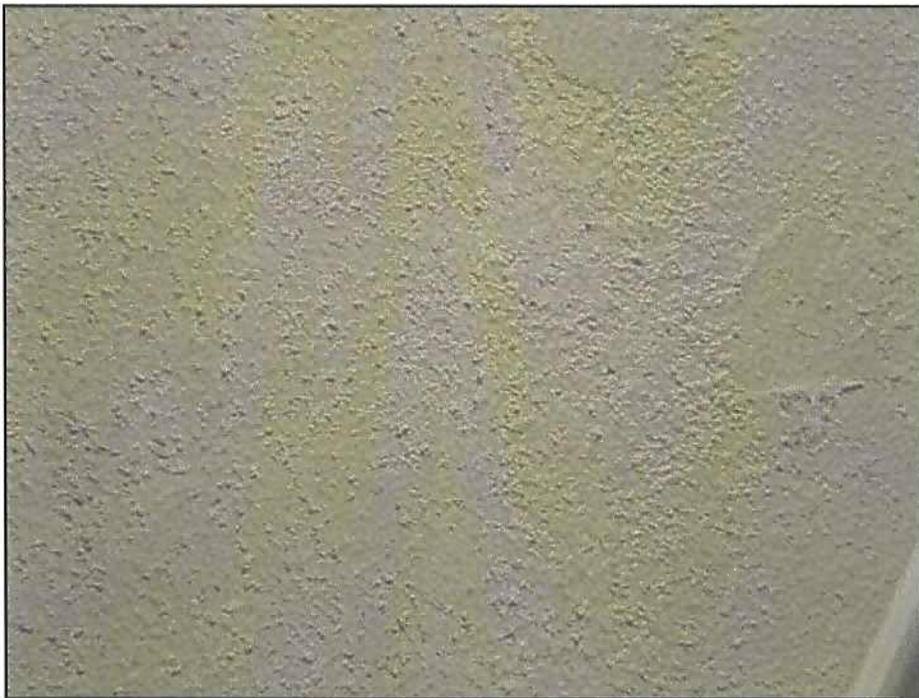
Interior stucco (Material #022)

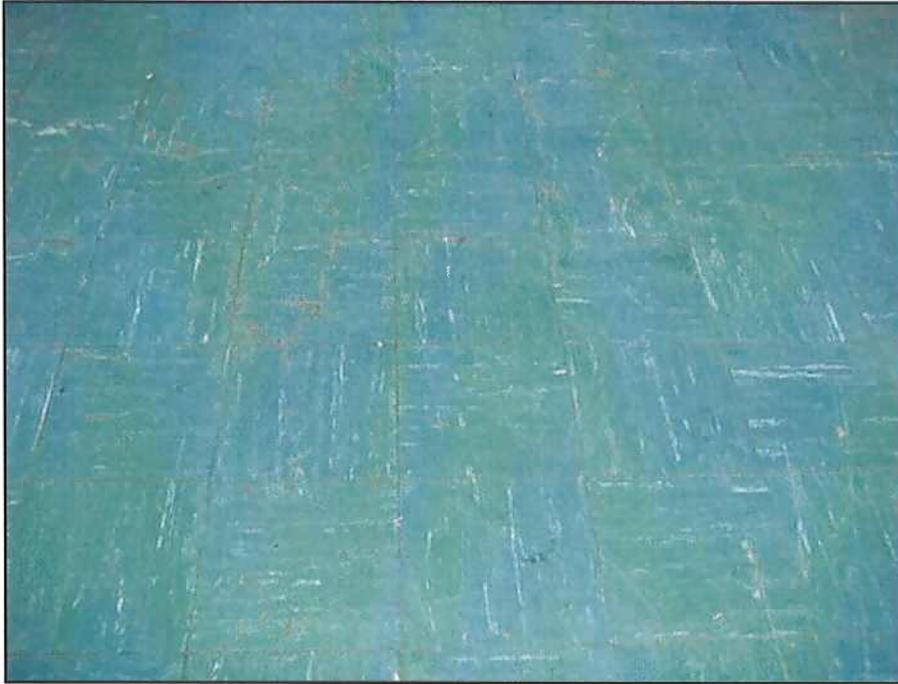
1' x1' green with white streaks vinyl floor tile (Material #003) over ACM adhesive (Material #004)

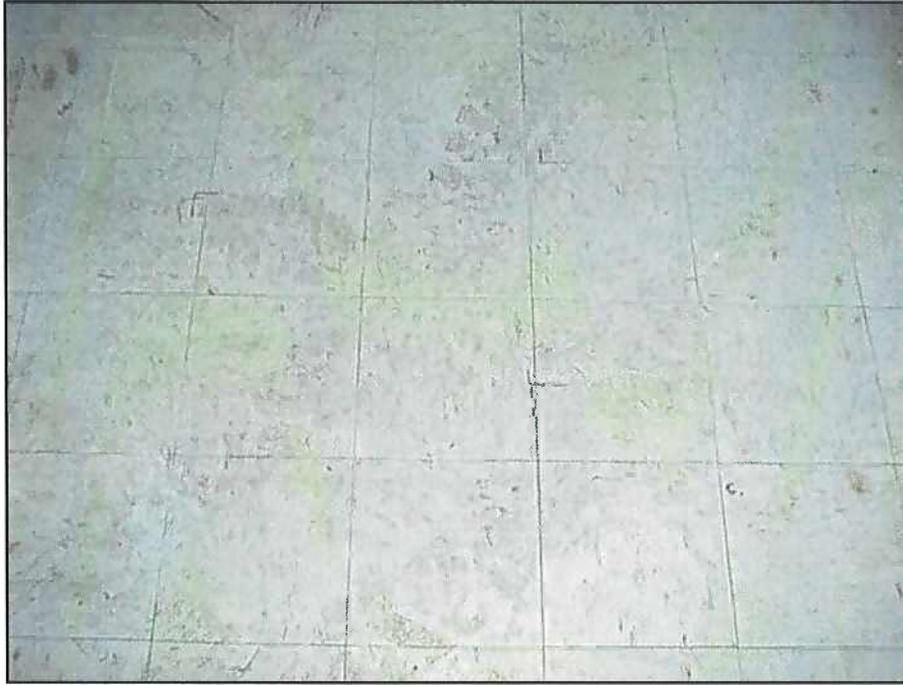
9"x 9" white with green spots vinyl floor tile (Material #005) over ACM adhesive (Material #006)

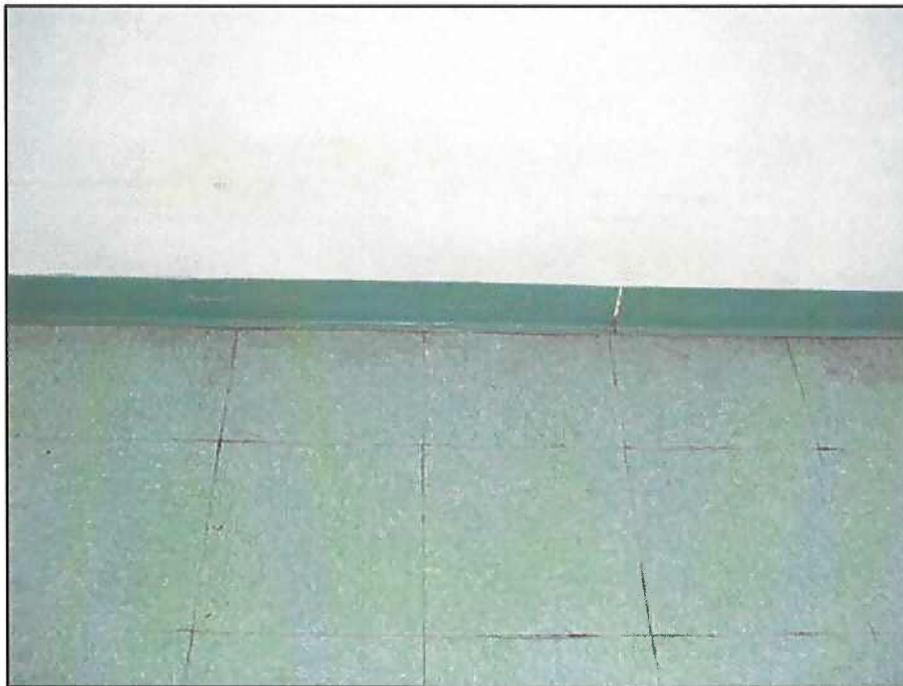
Green rubber cove base over brown cove base adhesive (Material #007)

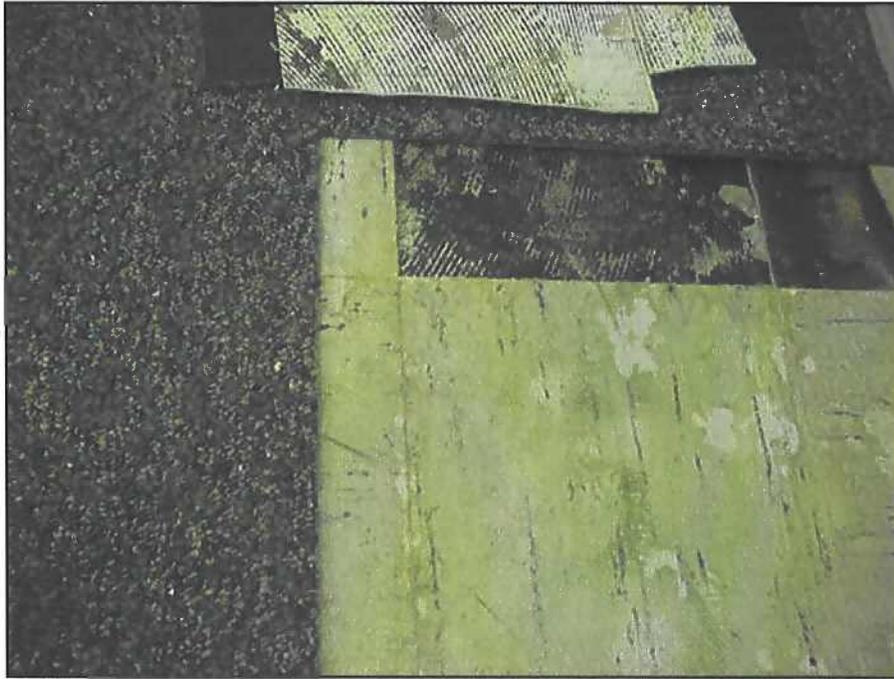
MATERIAL NUMBER	MATERIAL TYPE (MATERIAL DESCRIPTION)	ASBESTOS CONTENT	MATERIAL LOCATION(S)	FRIABLE	CONDITION	QUANTITY	COMMENTS
001	VINYL FLOOR TILE (9" X 9" WHITE WITH BLACK STREAKS)	6% CH	102 126	No	UNDAMAGED	792 SF	
002	FLOOR ADHESIVE (BLACK, UNDER 9" X 9" WHITE WITH BLACK STREAKS VINYL FLOOR TILE)	2% CH	102 126	No	UNDAMAGED	792 SF	
004	VINYL FLOOR TILE (9" X 9" BROWN WITH RED AND WHITE STREAKS)	2% CH	103 113	No	UNDAMAGED	594 SF	
009	FLOOR ADHESIVE (BLACK, UNDER 9" X 9" BROWN WITH RED AND WHITE STREAKS VINYL FLOOR TILE)	10% CH	103	No	UNDAMAGED	270 SF	
011	FLOOR ADHESIVE (BLACK, UNDER 1'X 1' GREEN WITH WHITE STREAKS VINYL FLOOR TILE)	8% CH	103	No	UNDAMAGED	270 SF

9"x 9" white with black streaks vinyl floor tile (Material # 001) and associated black mastic (Material # 002)

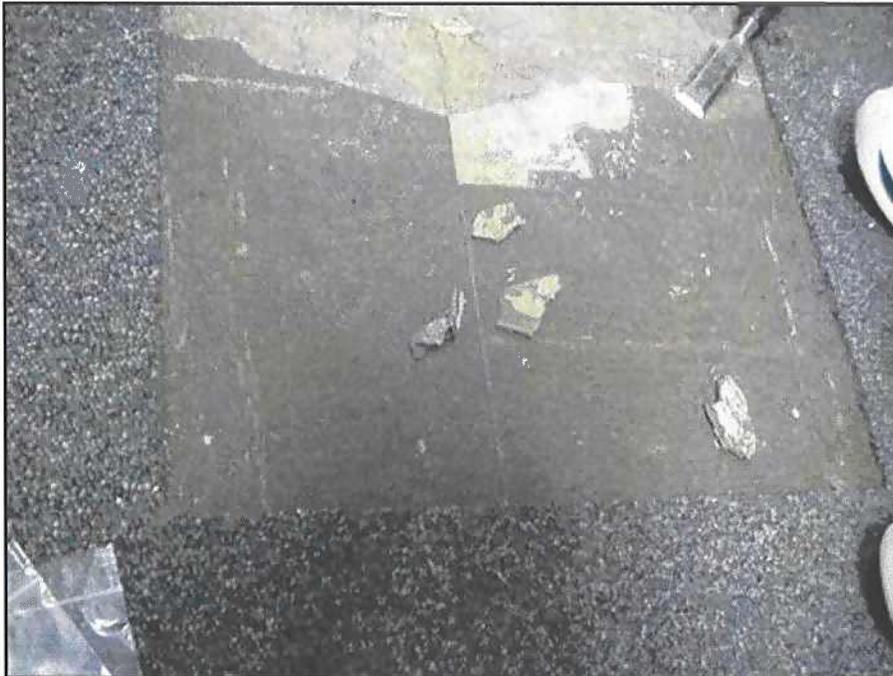
9"x 9" brown with red and white streaks vinyl floor tile (Material #004)

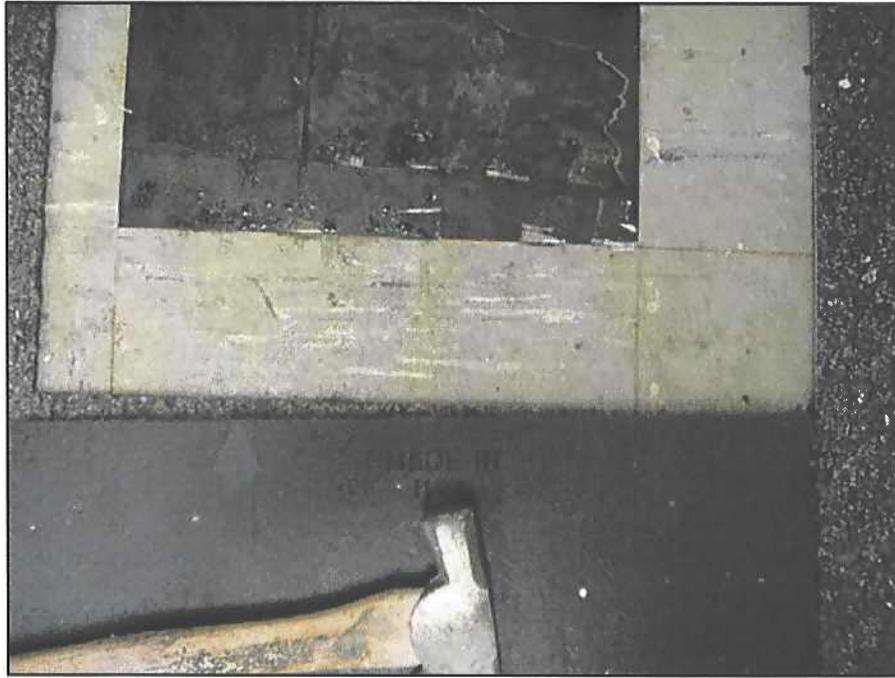
Black floor adhesive under Material #004 (Material #009), and black floor adhesive under Material #010 (Material #011)

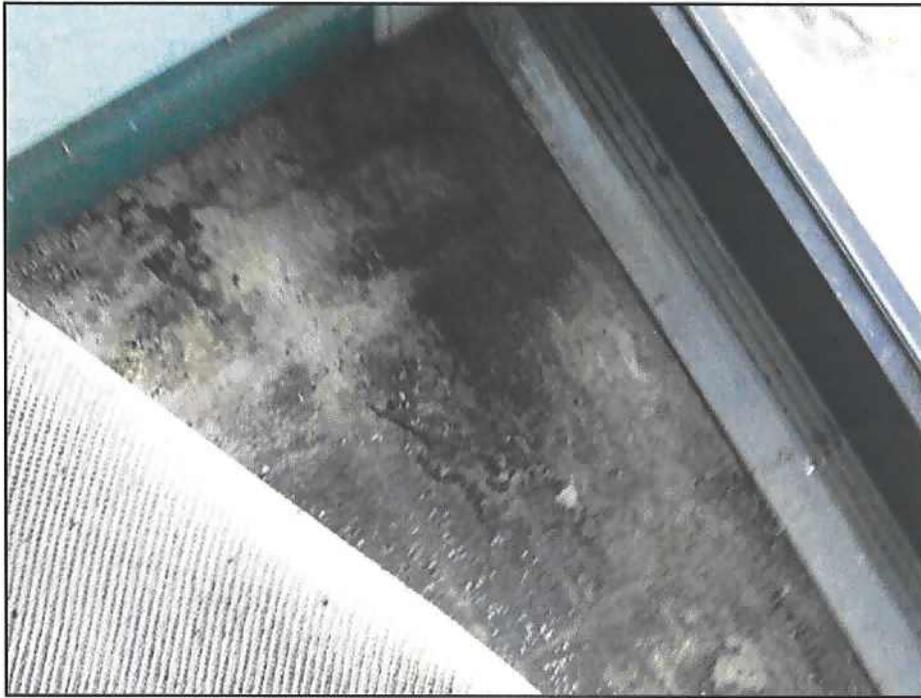
MATERIAL NUMBER	MATERIAL TYPE (MATERIAL DESCRIPTION)	ASBESTOS CONTENT	MATERIAL LOCATION(S)	FRIABLE	CONDITION	QUANTITY	COMMENTS
005	FLOOR ADHESIVE (YELLOW/BLACK, UNDER CARPET)	4% CH	1 4 5 6	No	UNDAMAGED	2,017 SF

Carpet adhesive (Material #005)

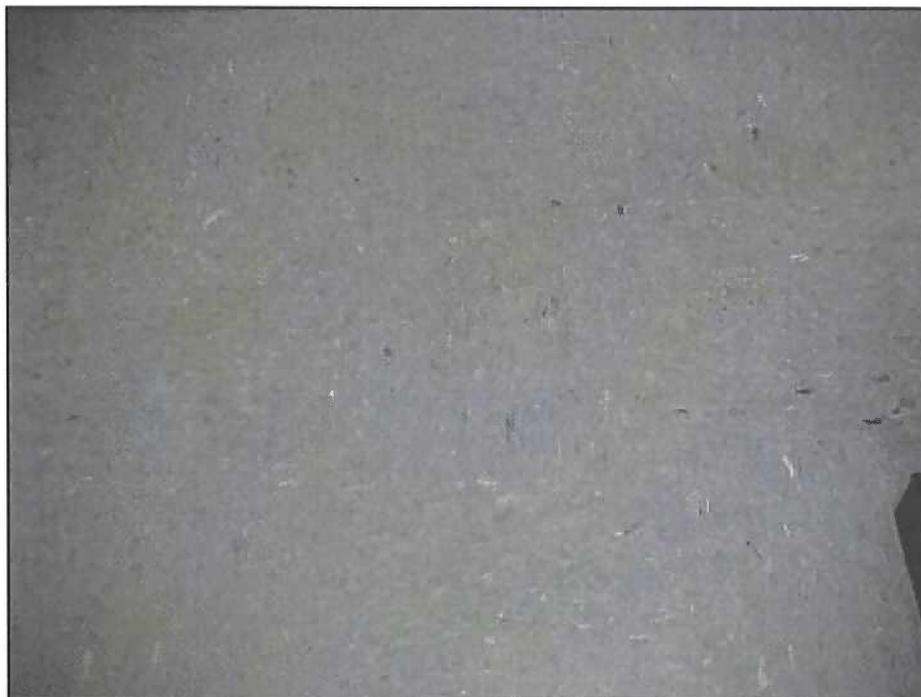
MATERIAL NUMBER	MATERIAL TYPE (MATERIAL DESCRIPTION)	ASBESTOS CONTENT	MATERIAL LOCATION(S)	FRIABLE	CONDITION	QUANTITY	COMMENTS
002	FLOOR ADHESIVE (BLACK, UNDER 1' X 1' GRAY VINYL FLOOR TILE)	Layer 1 ND Layer 2 4% CH	1 2	No	UNDAMAGED	374 SF	
009	VINYL FLOOR TILE (9" X 9" GREEN)	7% CH	4 6	No	UNDAMAGED	472 SF	
010	FLOOR ADHESIVE (BLACK, UNDER 9" X 9" GREEN VINYL FLOOR TILE)	4% CH	4 6	No	UNDAMAGED	472 SF	
011	ASPHALTIC ROOFING MATERIALS (BLACK)	4% CH	ROOF	No	UNDAMAGED	3,842 SF

Vinyl floor tile (Material #001) over ACM floor adhesive (Material #002)

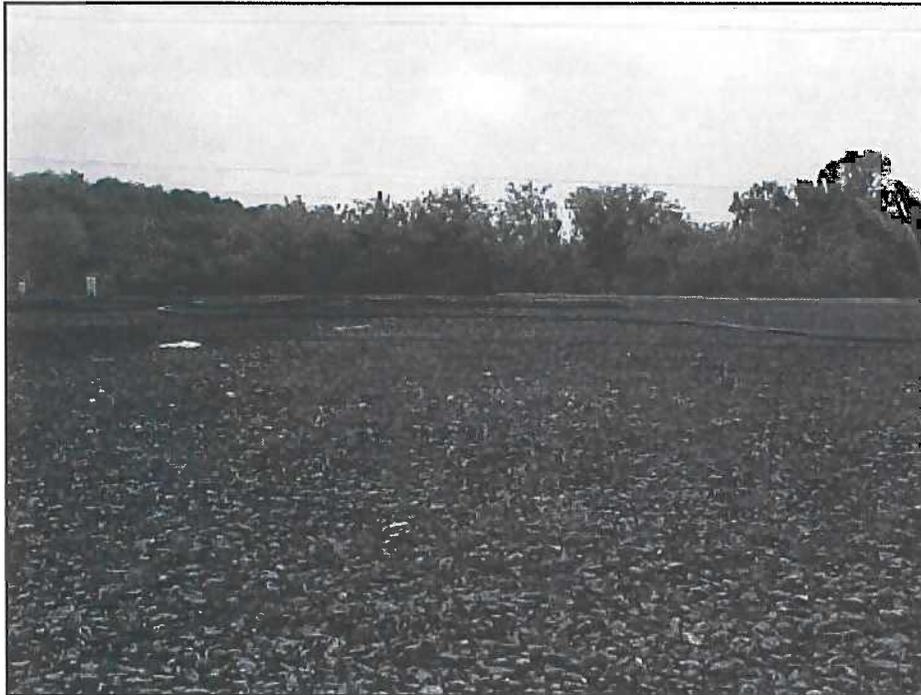
Asphaltic roofing material (Material #011)

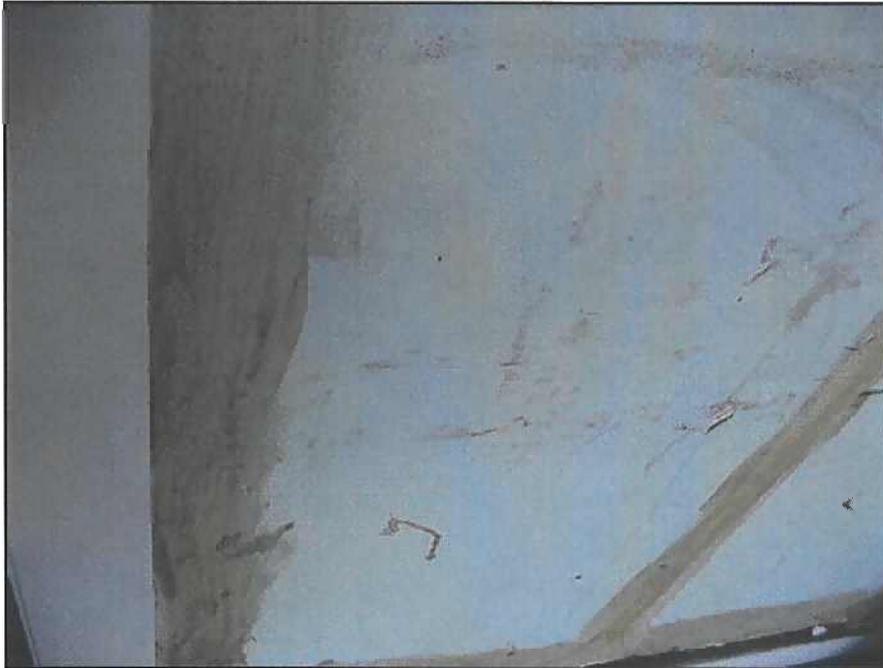
Half-inch thick wallboard with tan paper, white core, and joint compound (Material #001)

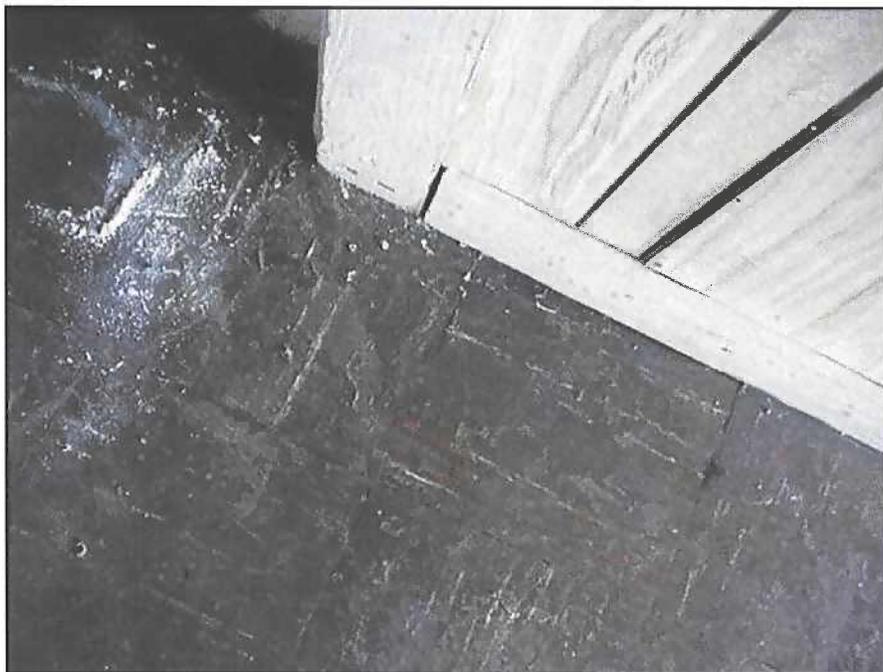
9"x 9" brown with red and white streaks vinyl floor tile (Material # 002) and associated floor adhesive (Material #003)

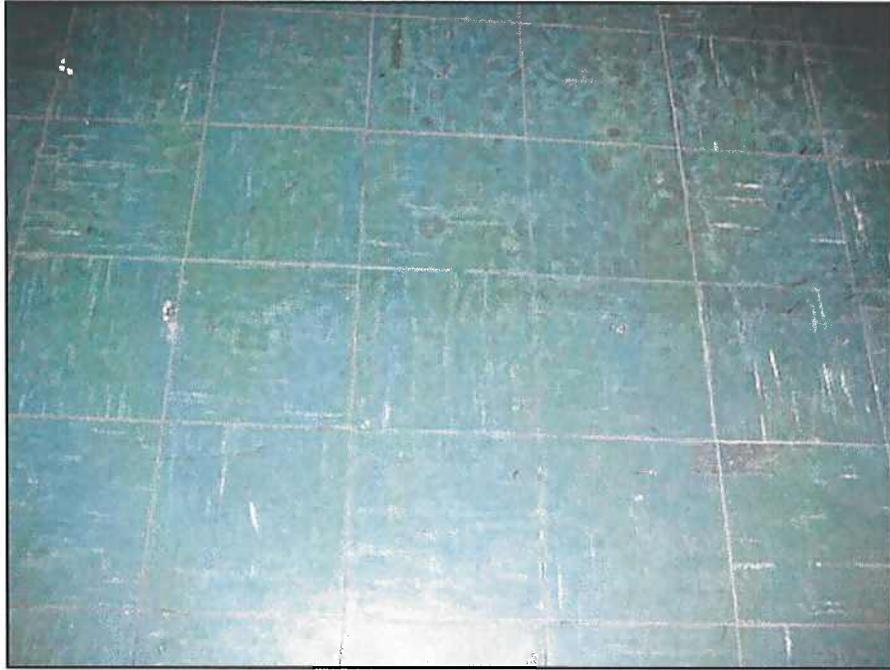
9"x 9" green with white streaks vinyl floor tile (Material # 004)

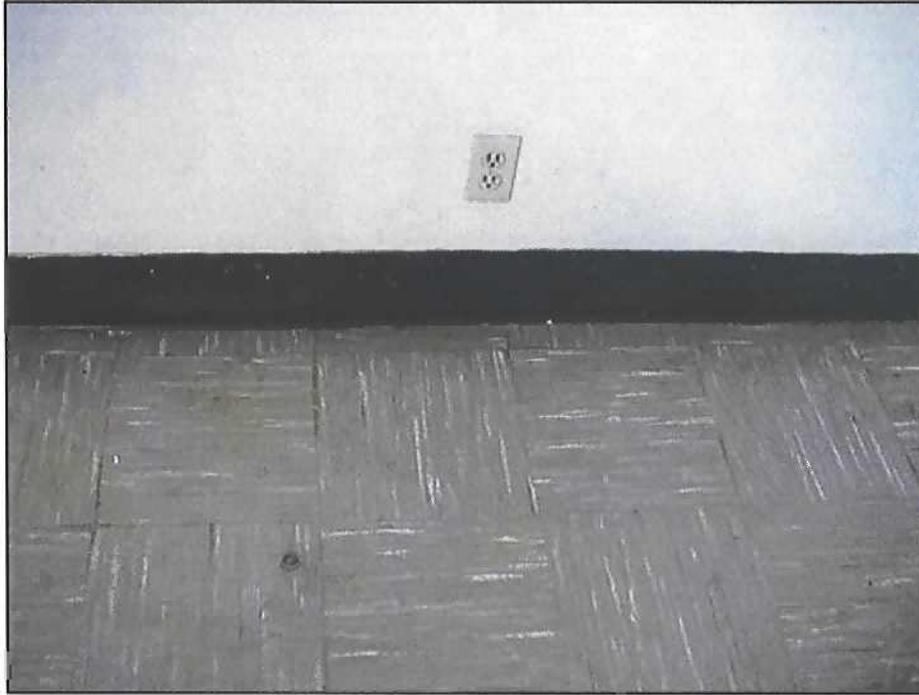
MATERIAL NUMBER	MATERIAL TYPE (MATERIAL DESCRIPTION)	ASBESTOS CONTENT	MATERIAL LOCATION(S)	FRIABLE	CONDITION	QUANTITY	COMMENTS
003	FLOOR ADHESIVE (WHITE, UNDER 002)	2% CH	003 004 005 006 008 009	No	UNDAMAGED	1,313 SF	
007	FLOOR ADHESIVE (RED, UNDER 006)	7% CH	003 004 005 006 008 009	No	UNDAMAGED	1,313 SF

1'x1' brown with white and orange streaks vinyl floor tile over ACM floor adhesives (Materials #003 and #007)

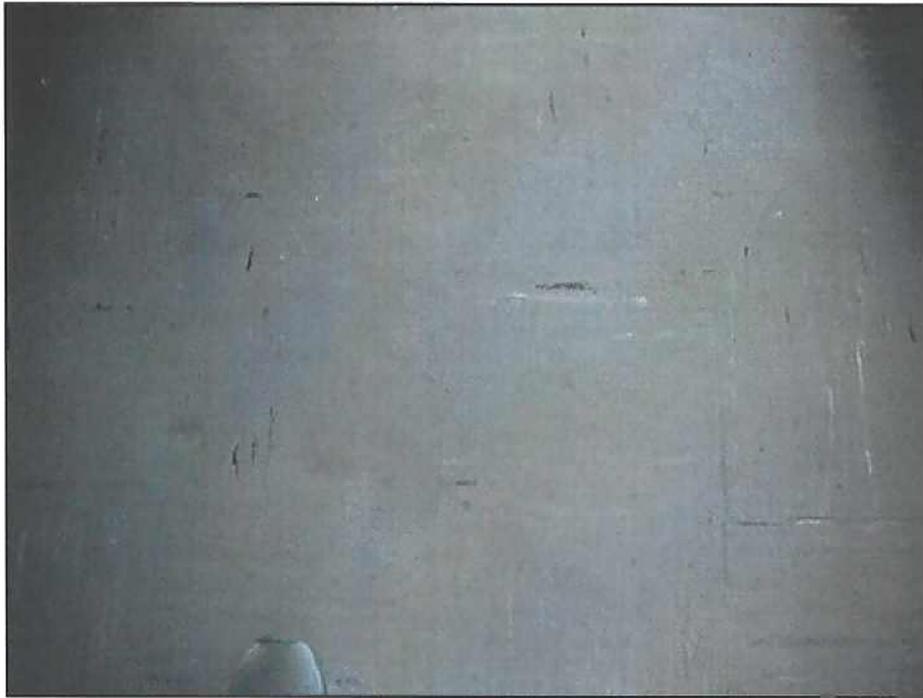
Non-ACM 1' x 1' gray with black and white streaks vinyl floor tile (Material #001) over black floor adhesive (Material #002)

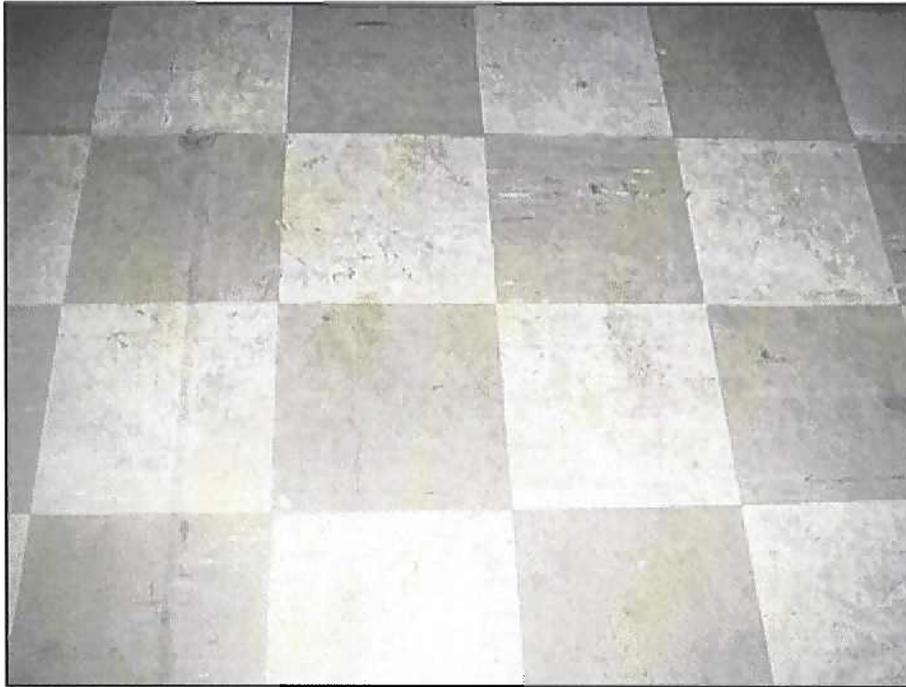
Vinyl floor tile (Material #001 and #002) over ACM adhesive (Material #003)

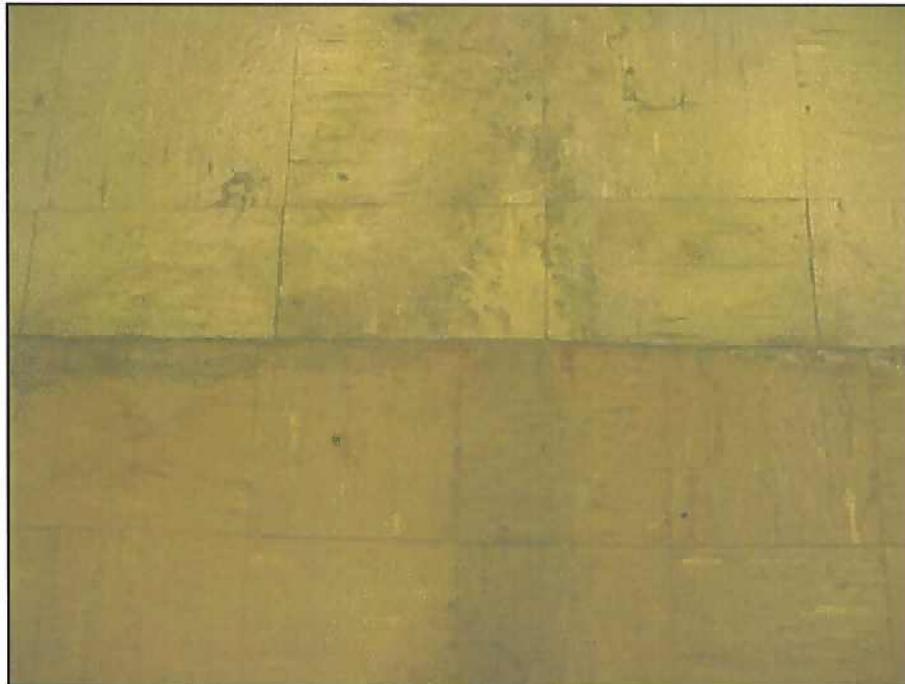
9"x 9" Brown vinyl floor tile (Material #011)

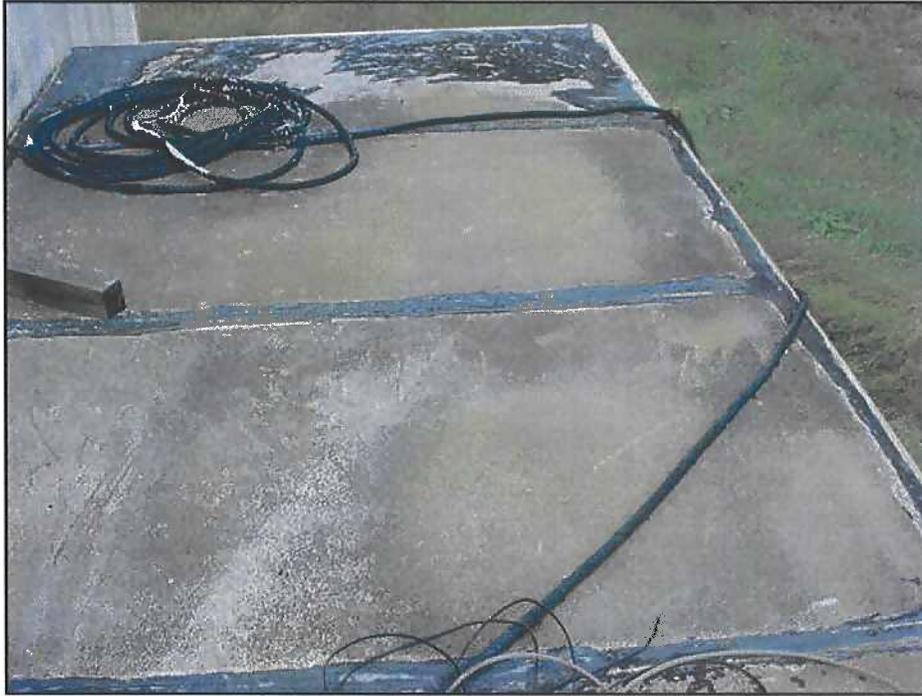
MATERIAL NUMBER	MATERIAL TYPE (MATERIAL DESCRIPTION)	ASBESTOS CONTENT	MATERIAL LOCATION(S)	FRIABLE	CONDITION	QUANTITY	COMMENTS
001	ASPHALTIC ROOFING MATERIALS (GRAY, ROOF FLASHING)	10% CH	EXTERIOR	No	UNDAMAGED	50 SF	THIS MATERIAL IS LOCATED ABOVE ROOM 2.
002	ASPHALTIC ROOFING MATERIALS (BLACK, ROOF FLASHING)	12% CH	EXTERIOR	No	UNDAMAGED	500 SF

Asphaltic roofing materials (Material # 001)

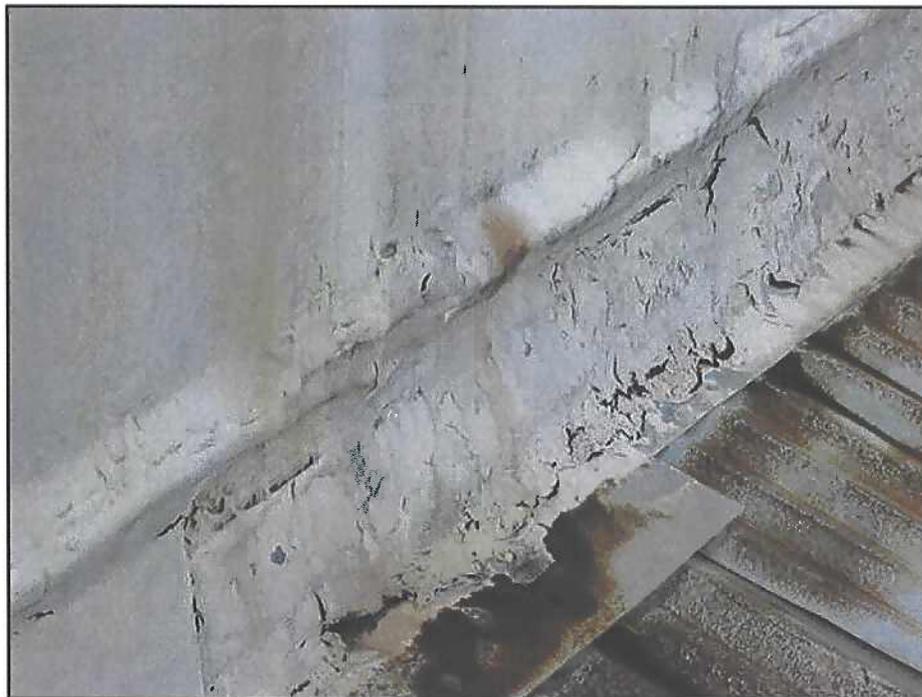
Asphaltic roofing materials (Material # 002)

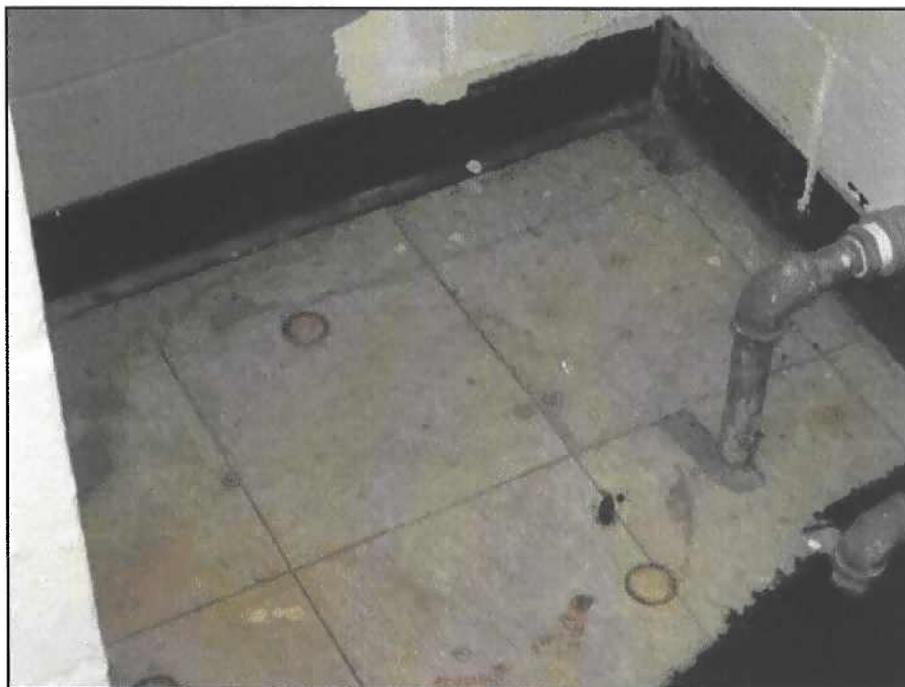
9"x9" tan with gray mottle vinyl floor tile (Material #002) over floor adhesive (Material #003)

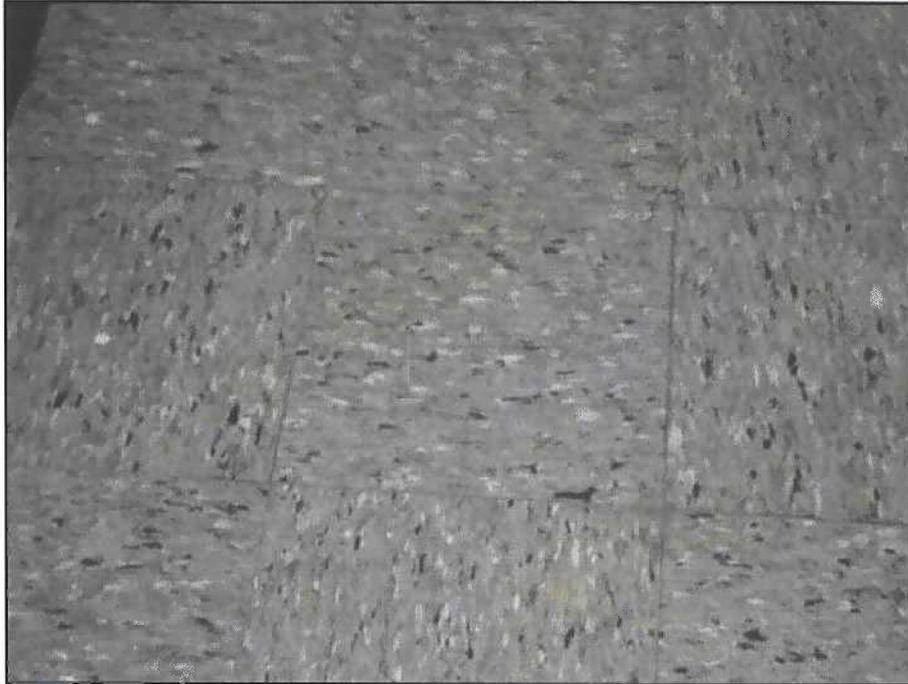
1'x1' brown, white and tan mottled vinyl floor tile (Material #006) over floor adhesive (Material #007)

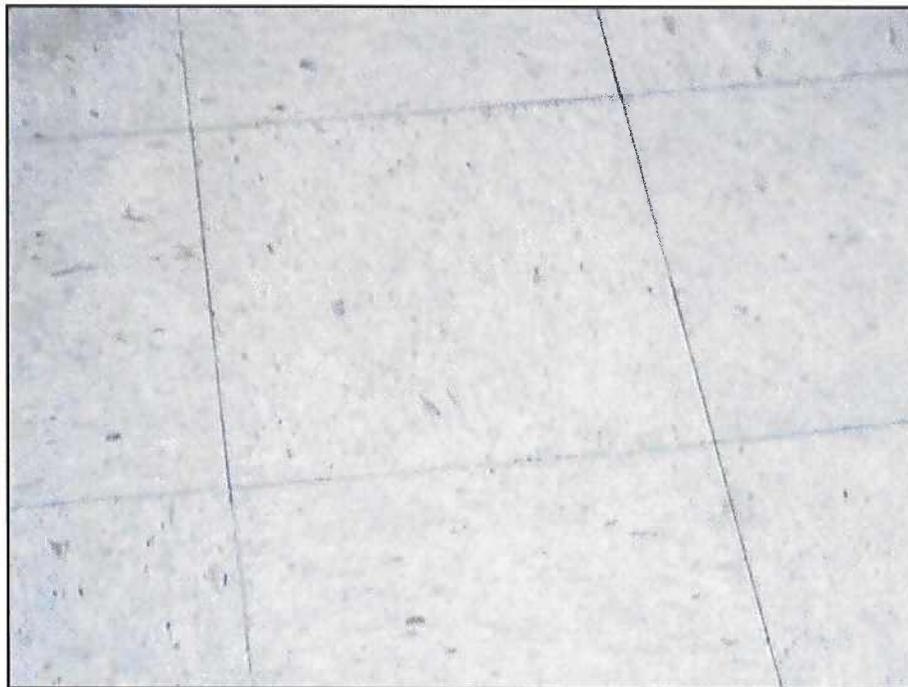
1'x1' tan with brown mottle vinyl floor tile (Material #008) over floor adhesive (Material #009)

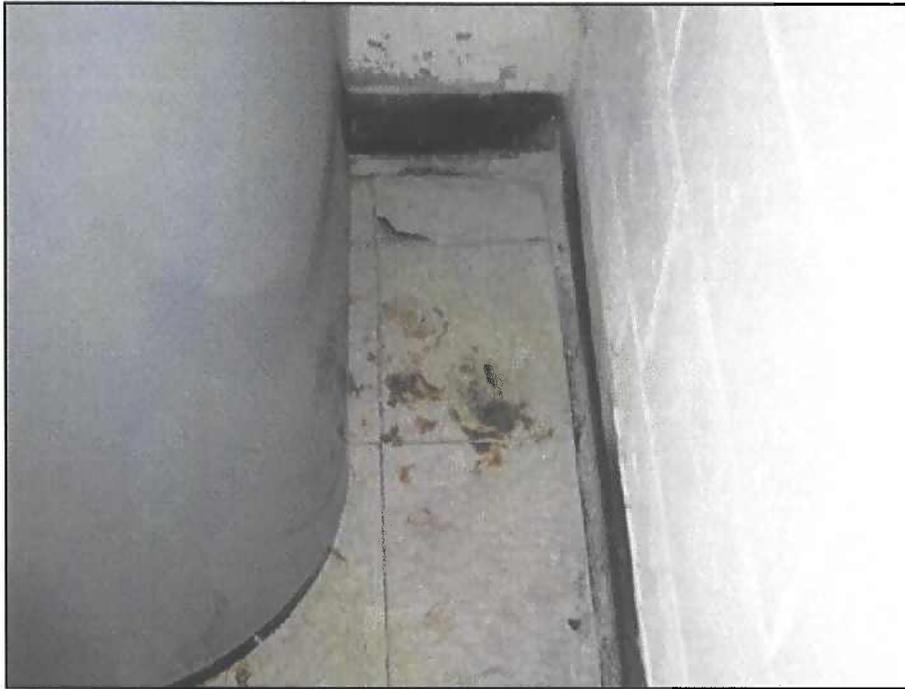
9"x9" tan with brown mottle vinyl floor tile (Material #006) over floor adhesive (Material #007)

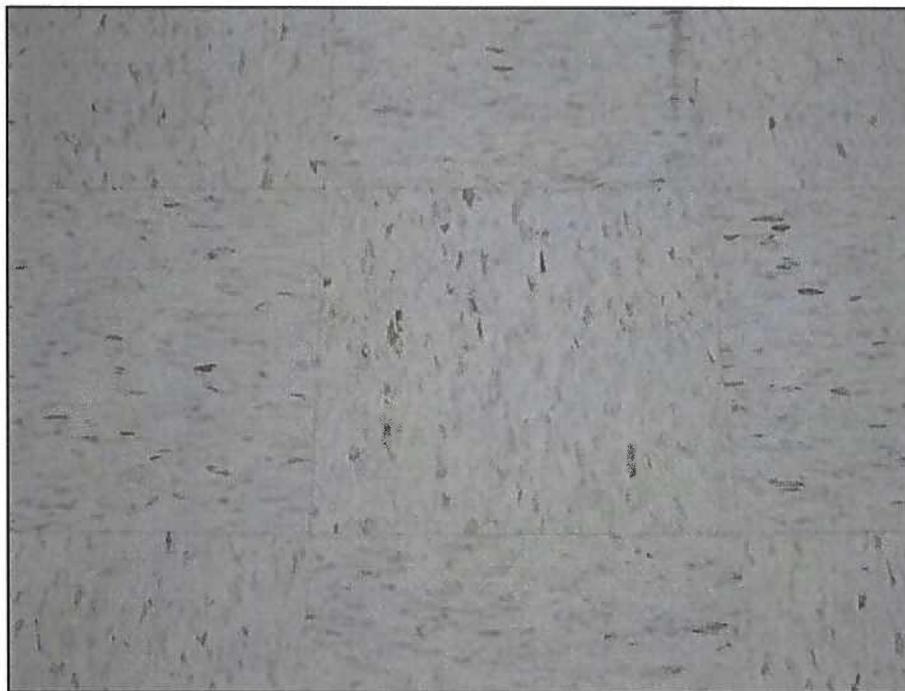
1'x1' white with brown spots vinyl floor tile (Material #010) over ACM floor adhesive (Material #011)

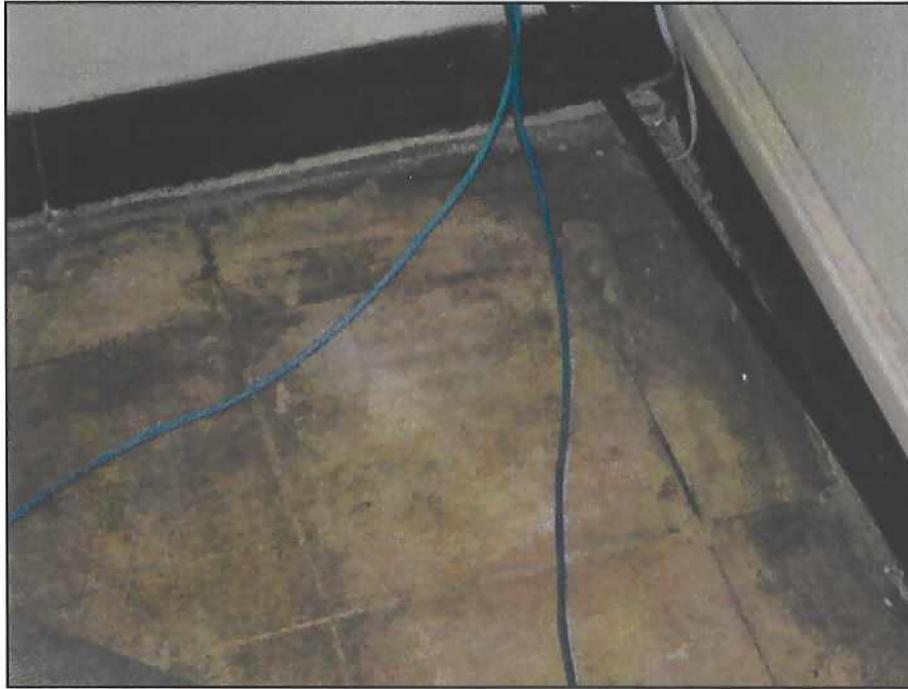
9"x9" white vinyl floor tile (Material #010) over ACM floor adhesive (Material #011)

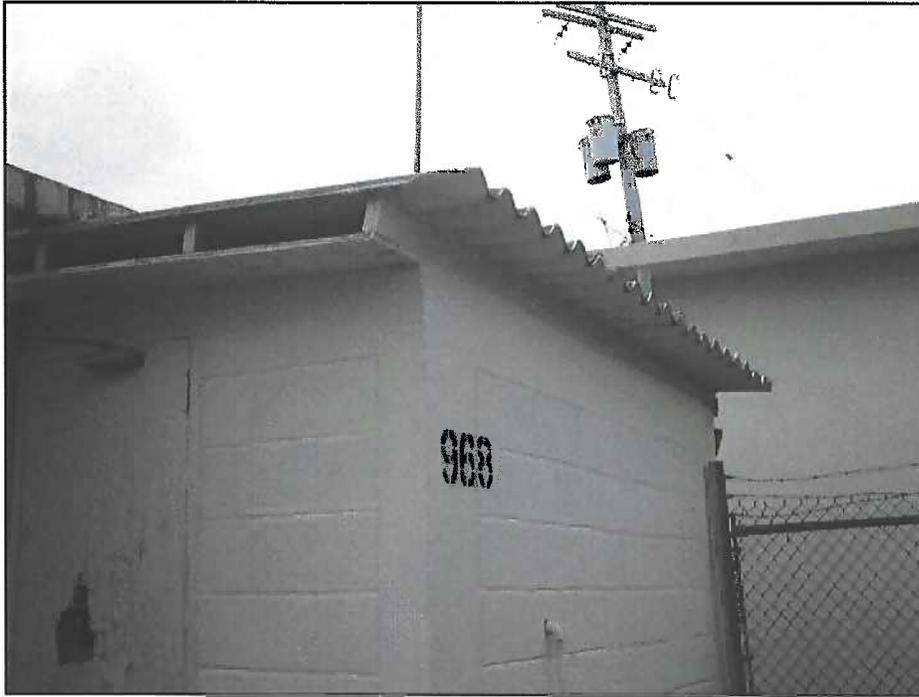
Building 968 is identified as “Sewage Pumping Sta (Capehart)” and is approximately 280 square feet in size. One suspect homogeneous material was identified and sampled. This material, corrugated cement roof panels (Material #001), was found to be ACM. No friable, damaged, and accessible ACM was identified.

Corrugated cement roof panels (Material #001)

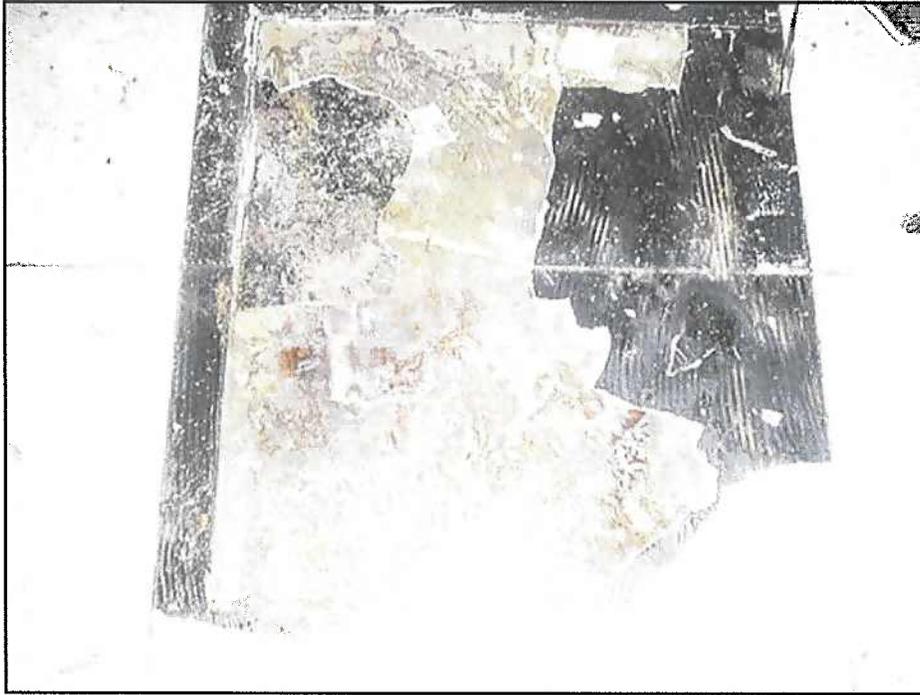
Building 982 is identified as “Battery Shop” and is approximately 2,460 square feet in size. Nine suspect homogeneous materials were identified and sampled. One material, floor adhesive (Material #003), was found to be ACM. No friable, damaged, and accessible ACM was identified.

Black floor adhesive (Material #003) under 1' x1' gray mottled vinyl floor tile (Material #002)

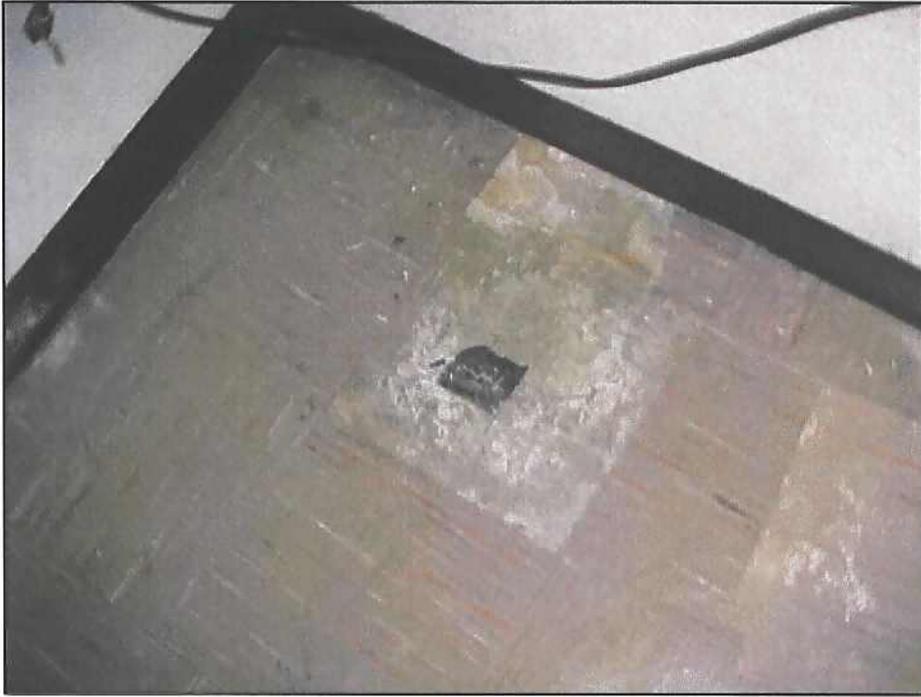
Vinyl floor tile (Material #008)

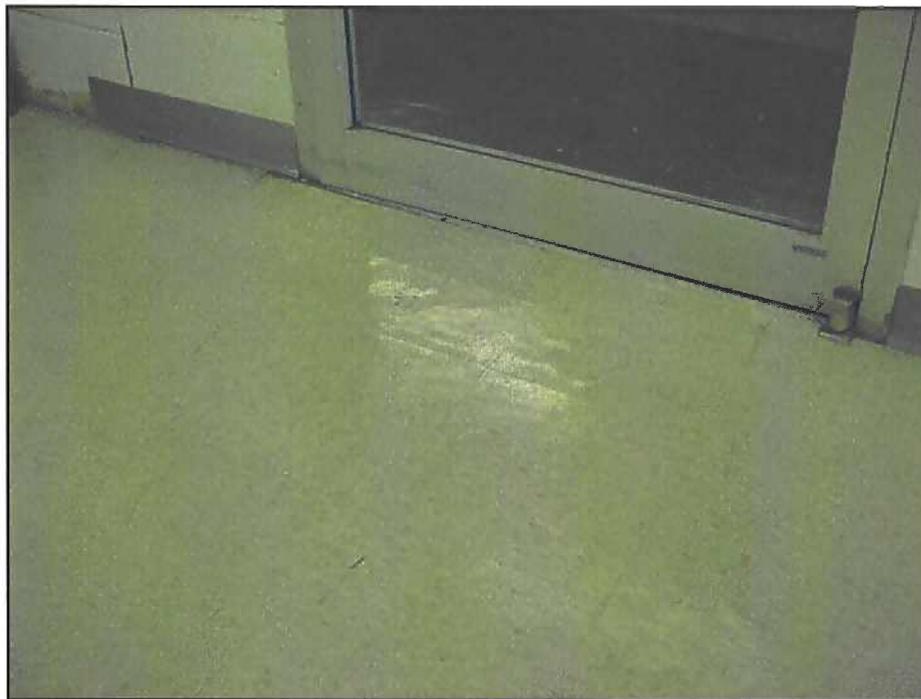
Vinyl floor tile (Material #006) over ACM floor adhesive (Material #007)
