Final
Asbestos Inspection Report
for

Naval Activity Puerto Rico
Ceiba, Puerto Rico

Volume 3 of 7

Buildings 646 through 1698

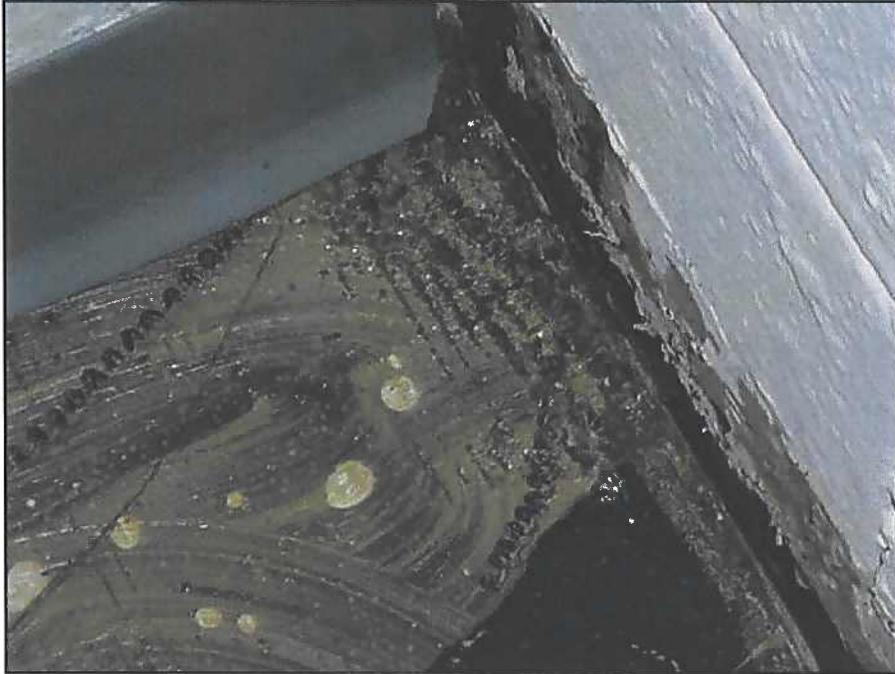
Floor adhesive (Material #015)

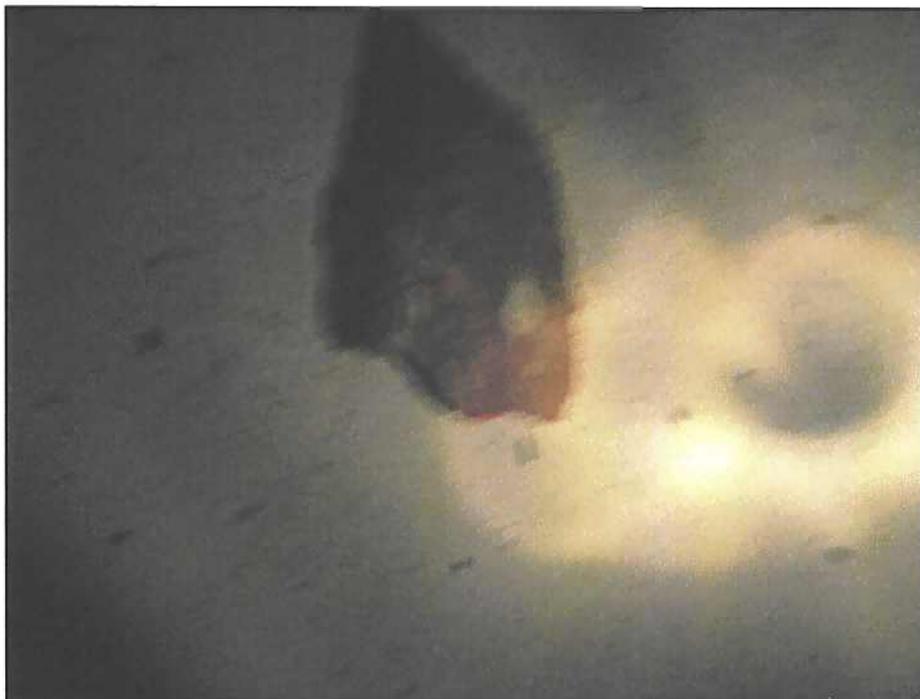
9"x 9" Pink vinyl floor tile (Material #011) over ACM floor adhesive (Material #012)

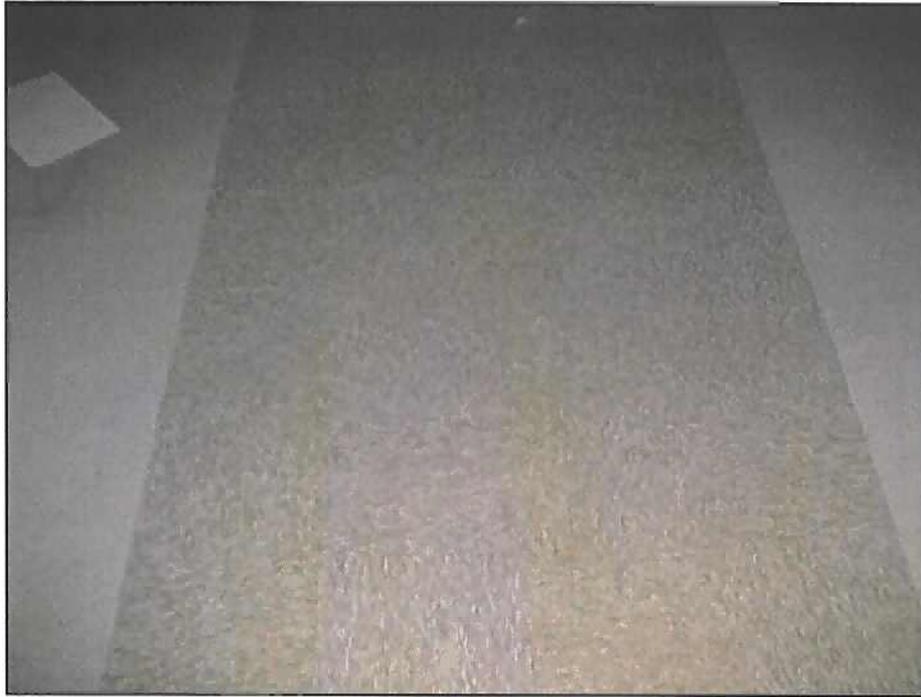
MATERIAL NUMBER	MATERIAL TYPE (MATERIAL DESCRIPTION)	ASBESTOS CONTENT	MATERIAL LOCATION(S)	FRIABLE	CONDITION	QUANTITY	COMMENTS
007	FLOOR ADHESIVE (BLACK, UNDER 1' X 1' BEIGE VINYL FLOOR TILE)	6% CH	6	No	UNDAMAGED	576 SF

Vinyl floor tile (Material #006) over ACM adhesive (Material #007)

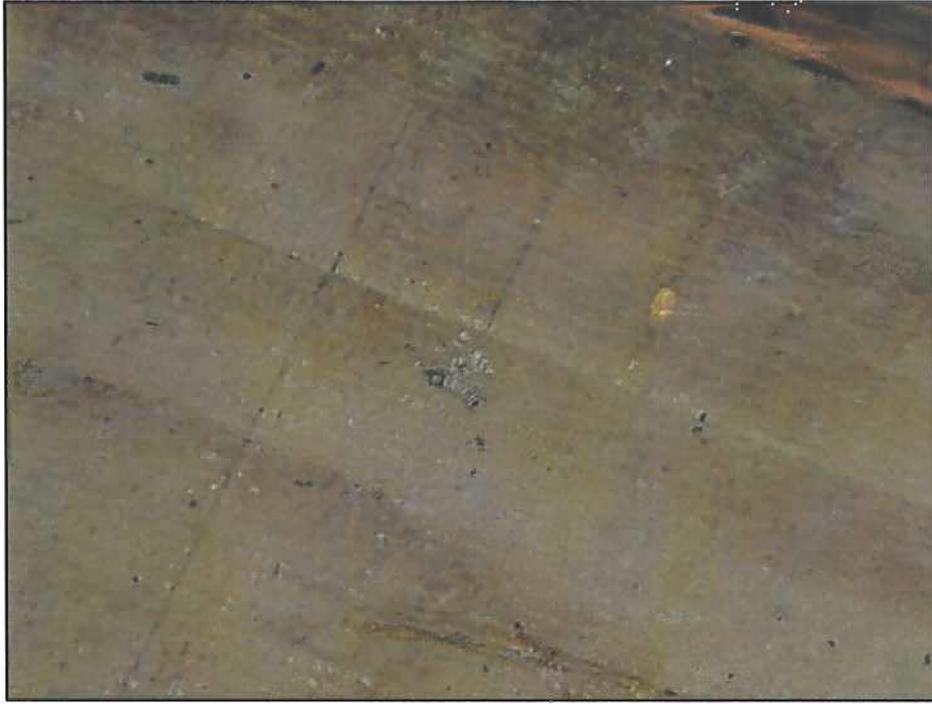
Vinyl floor tile (Material #003)

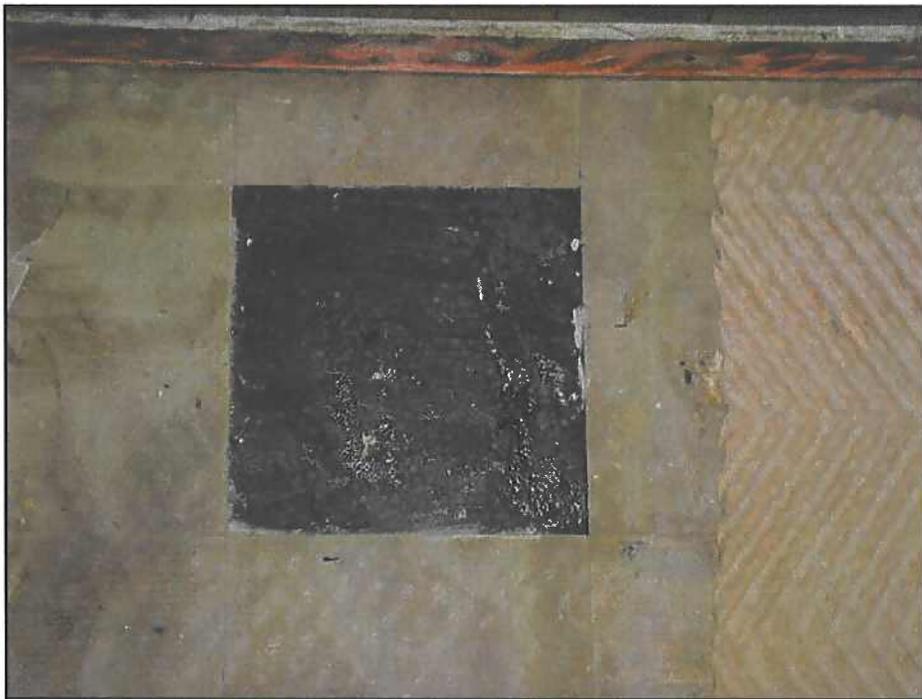
Floor adhesive (Material #004)

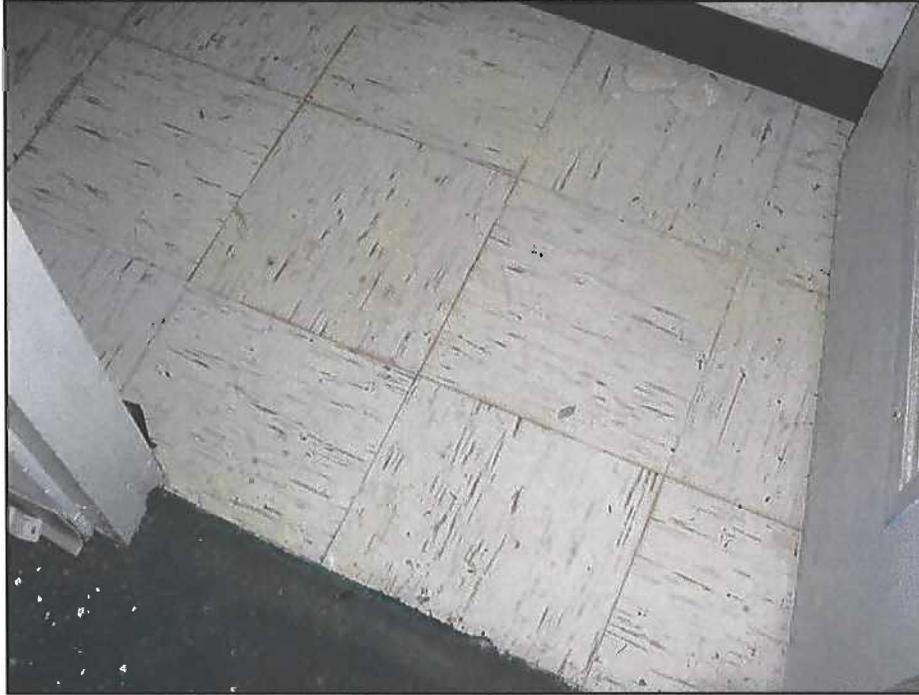
Vinyl floor tile (Material #009) shown above, and associated floor adhesive (Material #010), not shown

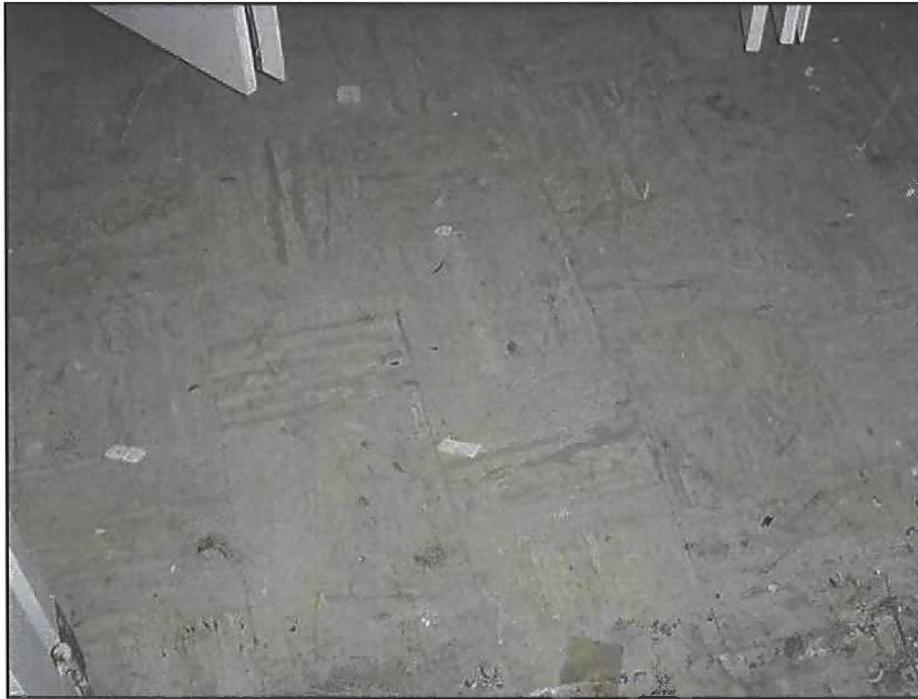
Vinyl floor tile (Material #012) shown above, and associated floor adhesive (Material #013), not shown

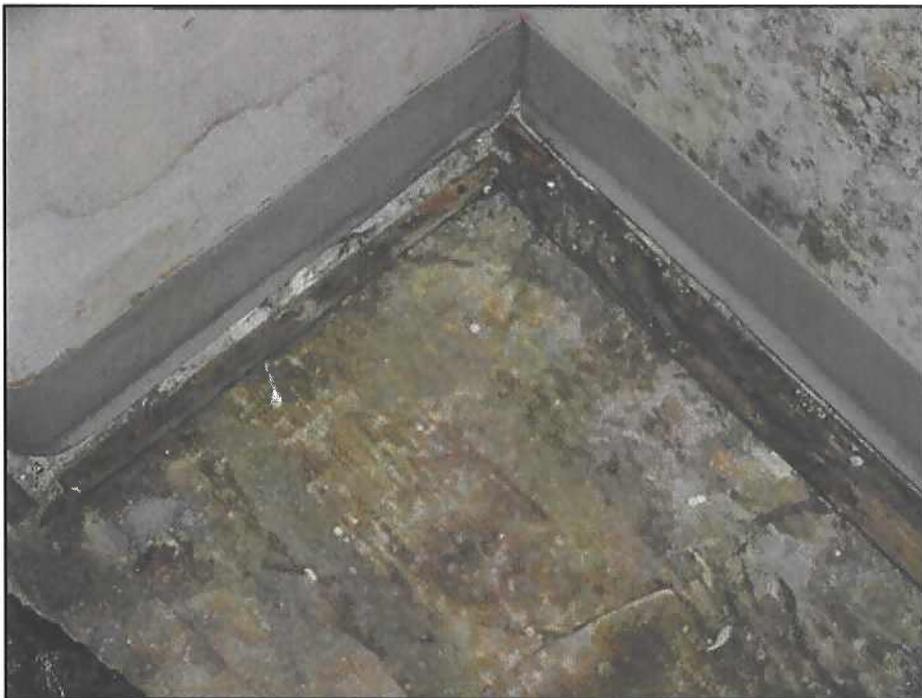
Vinyl floor tile (Material #017) and associated floor adhesive (Material #018)

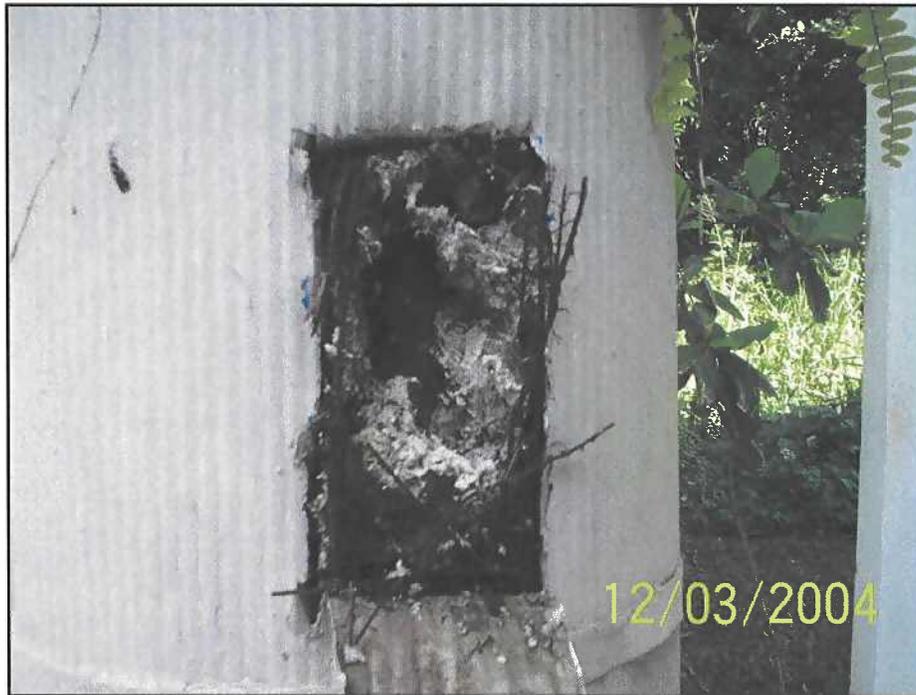
HOMOGENEOUS MATERIAL	BUILDING NUMBER	QUANTITY
THERMAL PIPE & FITTING INSULATION (Material Number 008)	1686	1 LF

Gray, fibrous pipe and fitting insulation (Material #008)

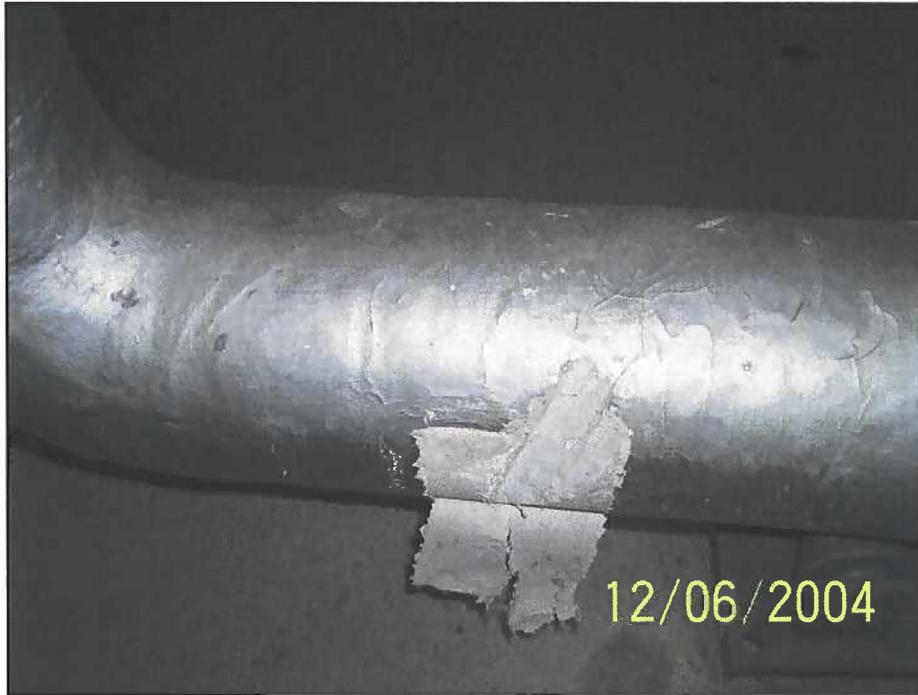
White, cementitious pipe insulation (Material #014)

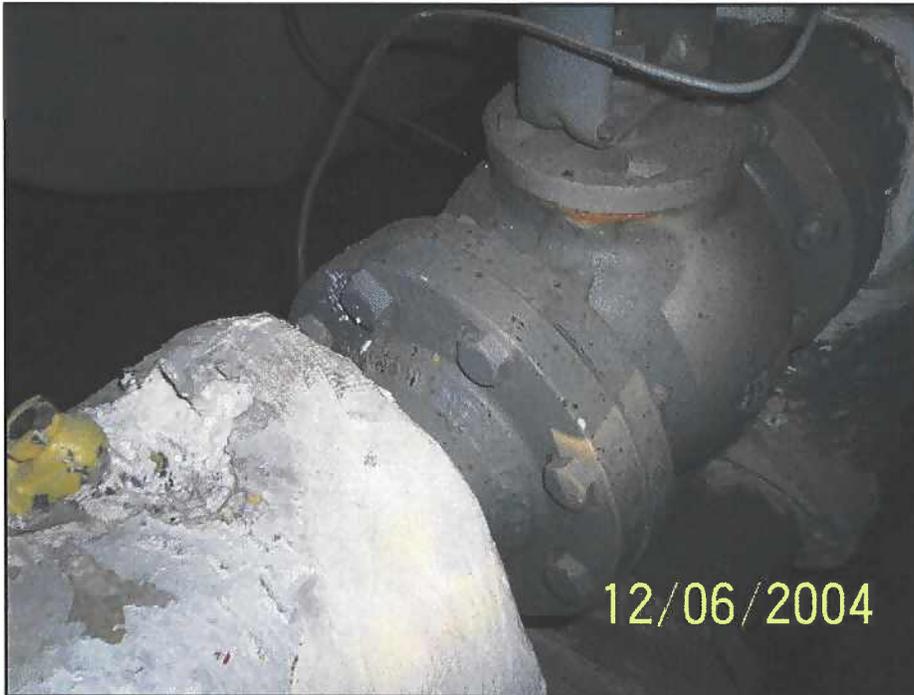
Black and tan sheet gasket (Material #015)

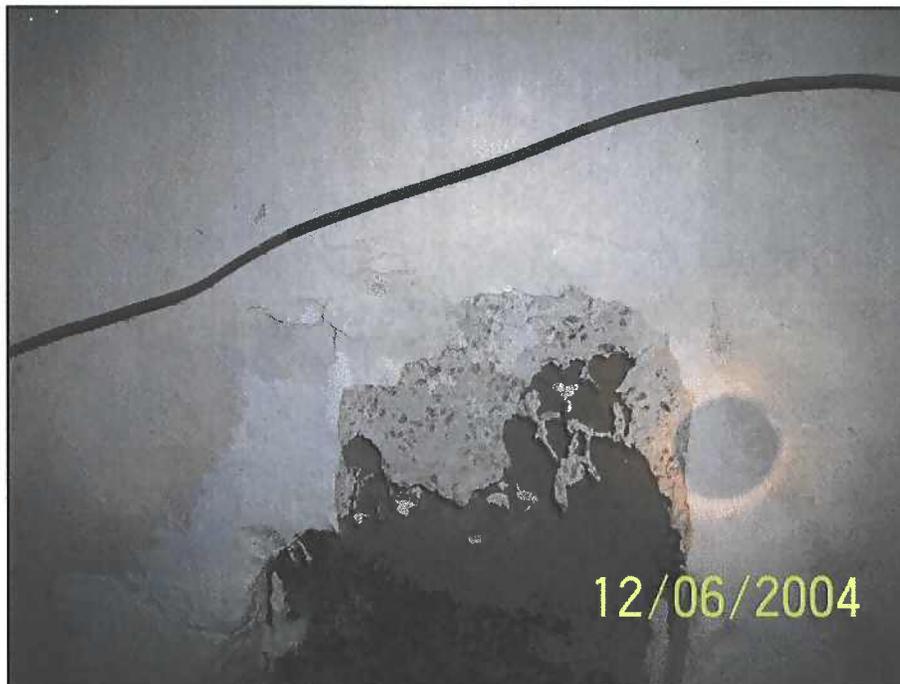
White cloth-like tank insulation (Material #017)

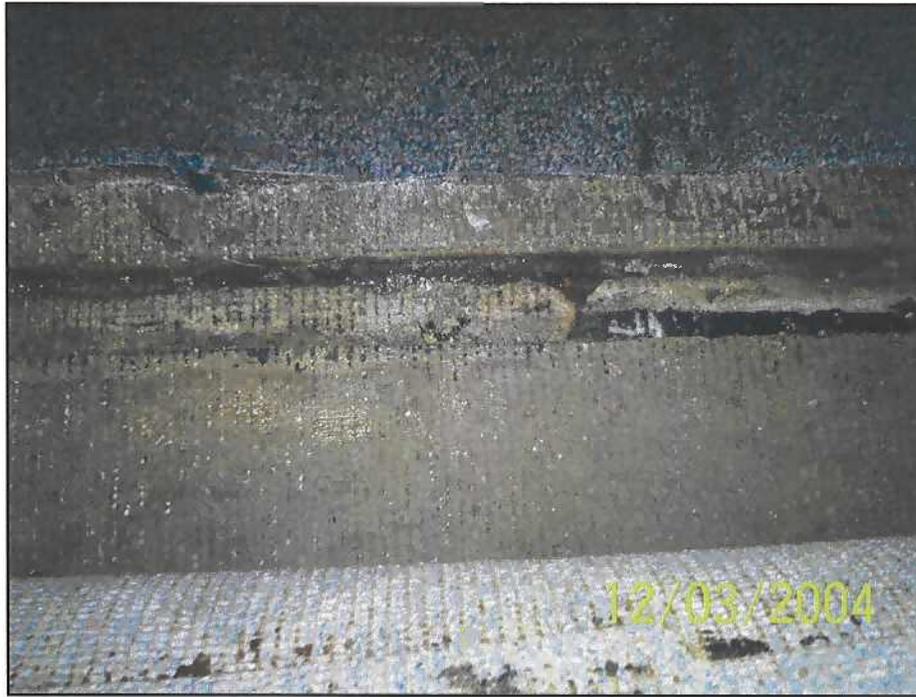
Flooring layers: carpet adhesive, black vinyl floor tile, and black mastic (Material #001)

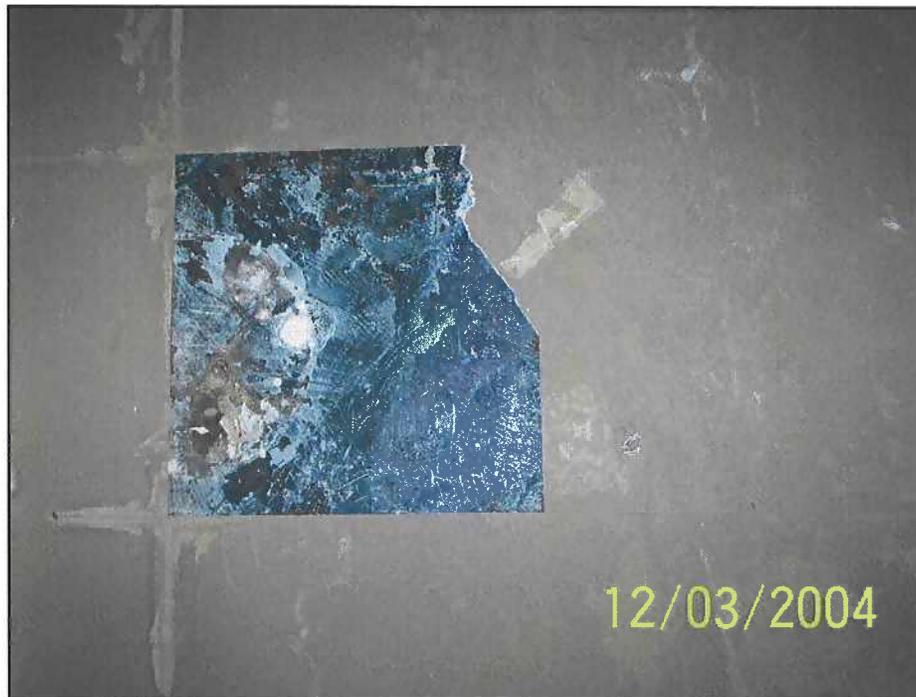
1' x 1' white vinyl floor tile with black mastic (Material #005)

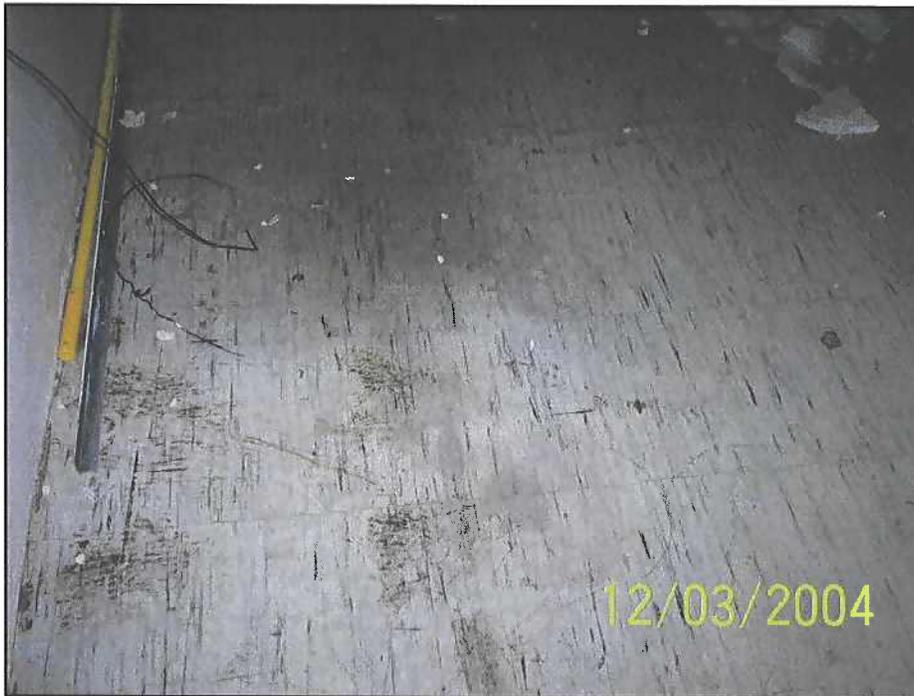
1' x 1' white with streaks vinyl floor tile with tan mastic (Material #006)

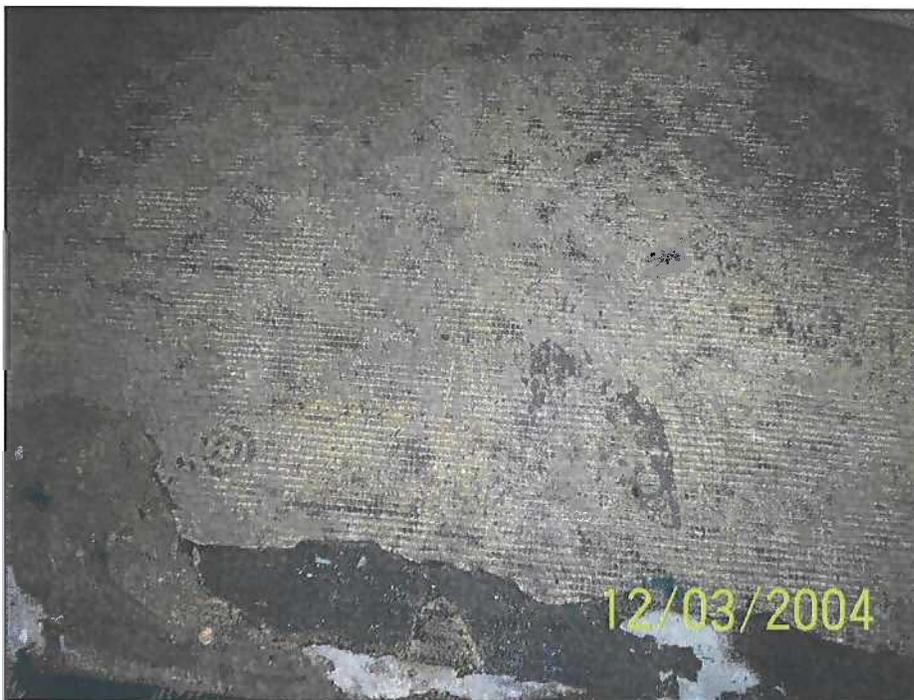
1' x 1' green vinyl floor tile with black mastic (Material #010)

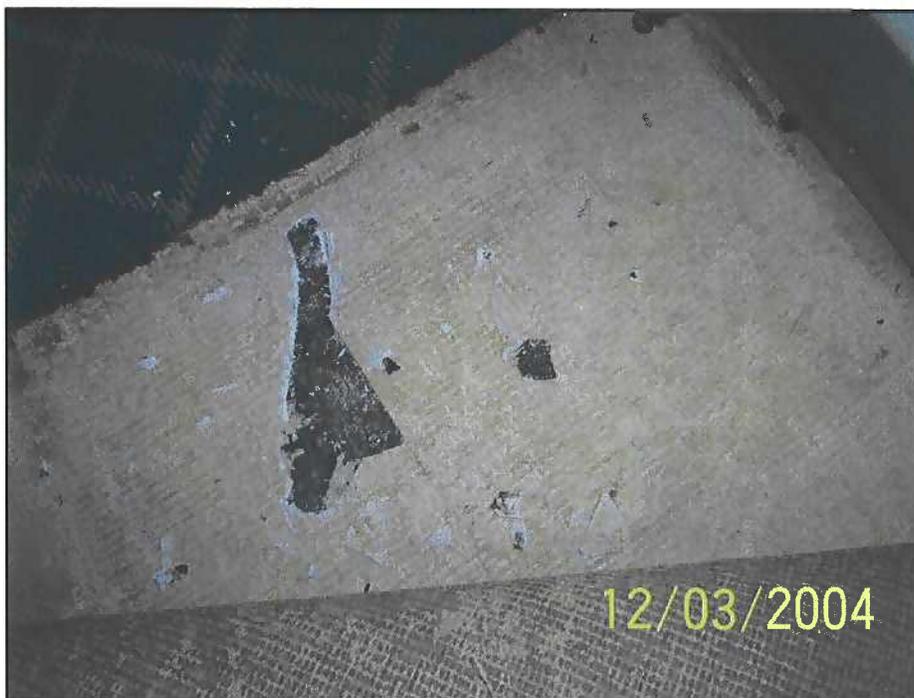
1' x 1' light gray vinyl floor tile with various adhesives (Material #011)

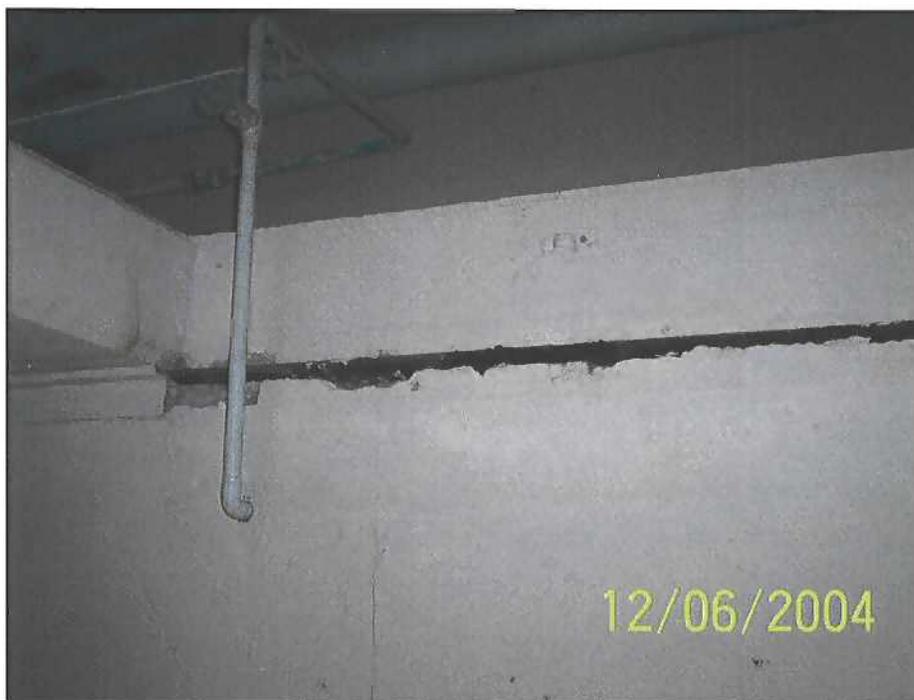
MATERIAL NUMBER	MATERIAL TYPE (MATERIAL DESCRIPTION)	ASBESTOS CONTENT	MATERIAL LOCATION(S)	FRIABLE	CONDITION	QUANTITY	COMMENTS
001	VINYL FLOOR TILE (LAYERS: CARPET ADHESIVE, BLACK VFT, BLACK MASTIC)	Layer 1 ND Layer 2 5% CH	3 4 LOBBY-HALL1	No	UNDAMAGED	1,240 SF	
005	VINYL FLOOR TILE (1'X1' WHITE (RUST COVERED) WITH BLACK MASTIC)	Layer 1 ND Layer 2 6% CH	HALL2	No	SIGNIFICANT D	1,000 SF	
006	VINYL FLOOR TILE (1'X1' WHITE WITH STREAKS, WITH TAN MASTIC)	Layer 1 4% CH Layer 2 ND	4	No	DAMAGED	200 SF	
010	VINYL FLOOR TILE (1'X1' GREEN, UNDER CARPET, WITH BLACK MASTIC)	Layer 1 ND Layer 2 3% CH Layer 3 5% CH	1 2 7	No	UNDAMAGED	570 SF	
011	VINYL FLOOR TILE (1'X1' LT GREY, VARIOUS ADHESIVES)	Layer 1 ND Layer 2 ND Layer 3 4% CH	5 6	No	UNDAMAGED	450 SF	
016	CAULK (CREAM, CEMENTITIOUS, ON EXPANSION JOINT)	5% CH	MECH ROOM FOR POOL	No	DAMAGED	30 LF

Caulk: cream, cementitious, on expansion joint (Material #016)
